# NBS MONOGRAPH 158

## Corrosion and Protection of Steel Piles in a Natural Seawater Environment

This report describes the first eight years of a long term program in which twenty-three coating systems and five cathodic protection systems are evaluated on their ability to protect steel piles in offshore conditions. These systems are made up of nonmetallic coatings, metallic pigmented coatings, nonmetallic coatings on metal filled coatings, nonmetallic coatings on metallic coatings, metallic coatings, and cathodic protection on bare and coated piles.

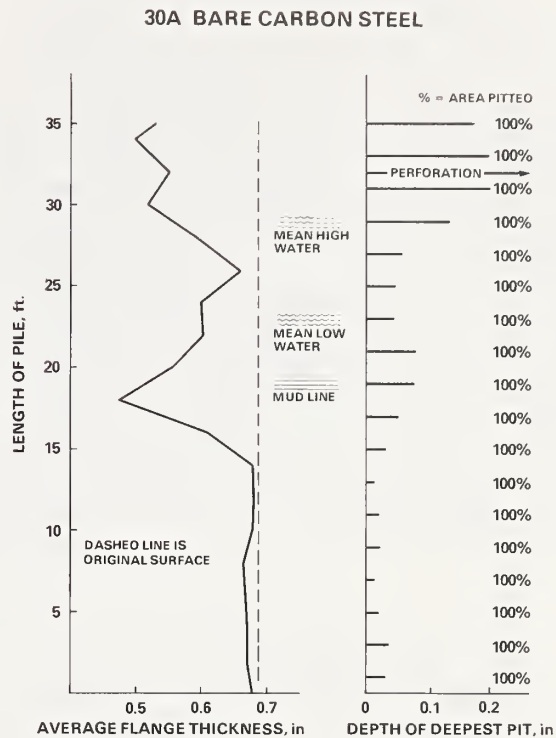
FIGURE 7

Specimen 30A is practically identical in behavior to 1A as illustrated in figure 7. This figure also displays data on the deepest pits found along the length of the pile. This data indicates that a perforation of the pile developed at about the thirty-two foot level within the six years of exposure. This perforation occurred in the web which is the portion of the pile between the two outer flanges. Pitting

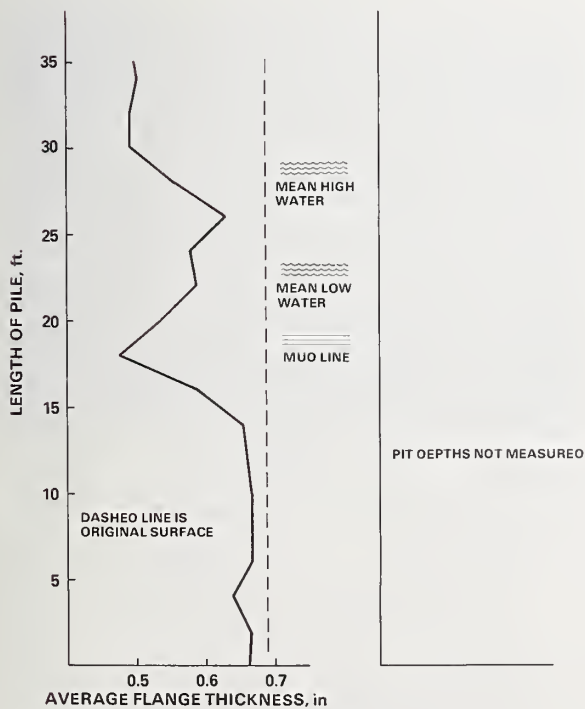
FIGURE 6

The actual observed corrosion as determined from the flange thickness measurements made after cleaning for pile 1A is illustrated in figure 6. The average flange thickness of the pile is plotted for the entire length of the pile. The dashed line indicates the location of the original surface. This thickness measurement reflects the corrosion on *both surfaces* of the flange. One can see from the diagram that a large part of the corrosion occurs above the high water line. The average corrosion rate in this region is on the order of 8 to 12 mils per year (45 to 65 mdd). The region below the high water mark has a relatively low corrosion rate. However, the corrosion damage increases as the erosion zone is approached. The corrosion rate between the high water mark and the mud line ranges from 4 to 8 mils per year (20 to 45 mdd) on the average. Within the erosion zone the observed corrosion is also high. Note that the changing mud line has caused deterioration between 14 and 21 ft (4.3 to 6.4 m) from the bottom of the pile. This effect will be seen on all piles. In this narrow band the average corrosion rate for pile 1A is approximately 9 mils per year (50 mdd).

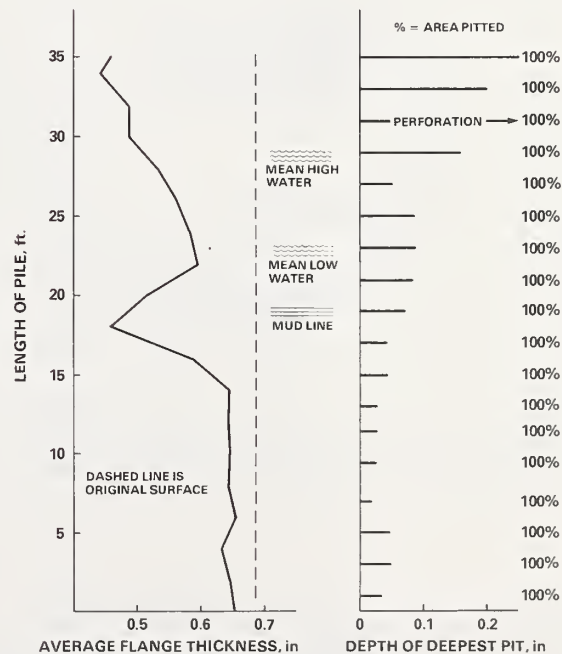
FIGURE 8

Figure 8 illustrates the corrosion deterioration observed on Specimen 31A. The bare carbon steel H-pile has developed more metal loss below the mud line than either 1A or 30A, and is of the order of 2 to 3 mils per year (10 to 15 mdd). Its pitting characteristics are very similar to those of 30A even to the perforation.

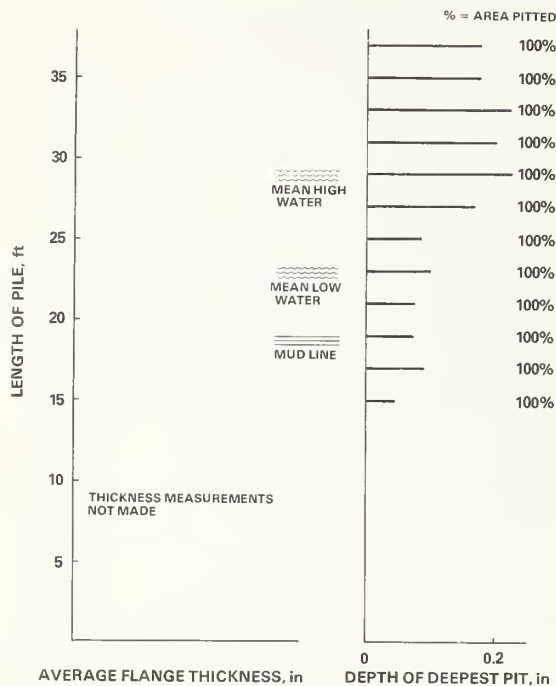
FIGURE 9

The bare pipe pile, 26A, developed pitting very similar to that found in the bare H-piles with the exception that pitting did not develop below the mud line (fig. 9). Electrochemical measurements were not made on this pile. However, measurements made on 26B indicate that the corrosion rate on the bare pipe piles is slightly higher (25%) than that of the H-piles. Because of the geometry of the pipe pile, thickness measurements could not be made.

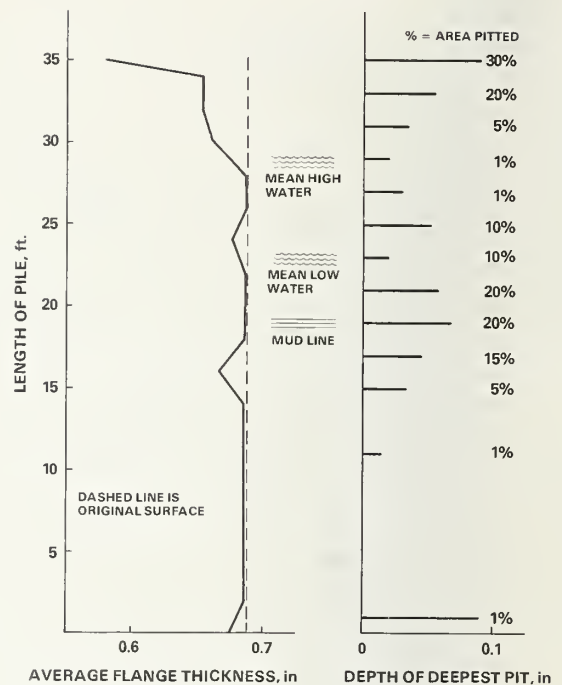
FIGURE 11

still has a coating effectiveness of 60 after five years of exposure. Figure 11 displays the average flange thickness of pile 6A with accompanying pitting. Specimen 6A is typical of the coal tar epoxies in that the greatest attack occurred above the high water line. The deepest pit in this region was less than 0.1 in (0.2 cm). Below the waterline, sand impingement in the erosion zone caused severe damage to the coating. In the atmospheric zone, undercutting of the windows in the coating system is difficult to appraise on this pile because of the extensive general failure of the coating as shown in figure 12. In the tidal zone, undercutting resistance is much improved, but general attack is still apparent (fig. 13). Below the mud line undercutting of the coating is minor. Mechanical damage to the coating during installation of the pile has caused most of the damage seen in figure 14.

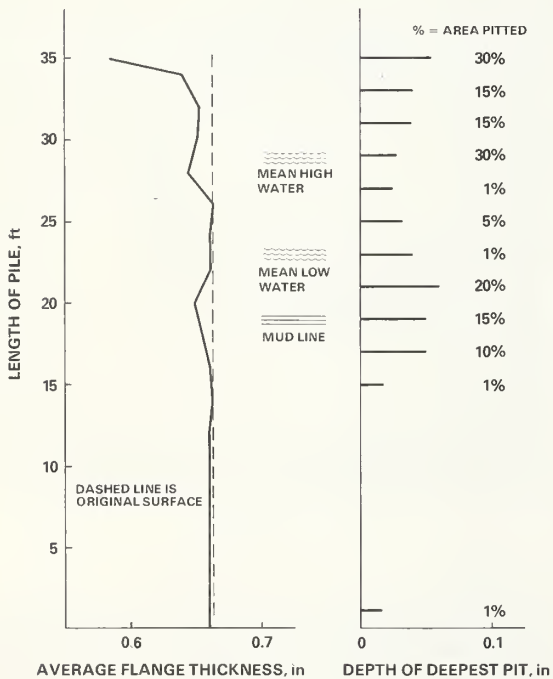
FIGURE 17

In the erosion zone, the coal tar epoxy on mariner steel, System 25, has not fared as well as the same coating on carbon steel (System 4A). Figure 17 indicates loss of metal at the flange in this area. Its pitting resistance below the mud line, however, is far better than any of the other similarly coated piles. Undercutting of the coating in the atmospheric zone is severe as illustrated in figure 24. Coating damage in the tidal zone is also very extensive (fig. 25). Below the mud line, however, figure 26 illustrates that the coal tar epoxy on mariner steel has not been undercut.

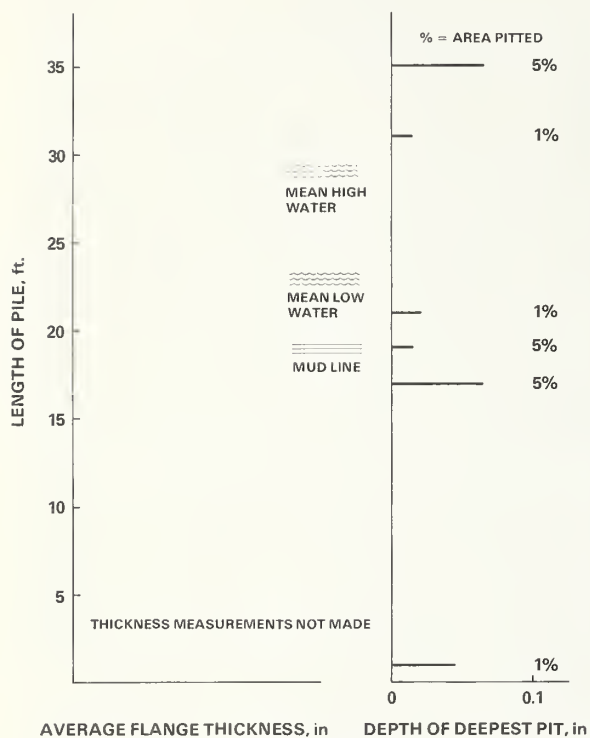
FIGURE 40

The polyester glass flake, System 29, has an average coating thickness of 32 mils (0.8 mm). This system has displayed very good resistance to deterioration. Figure 40 is a plot of the physical measurements made on this coating. It is apparent from this data that the degree of pitting is minor. Flange thickness measurements were not made for two reasons. First, coating breakdown was so minimal that little

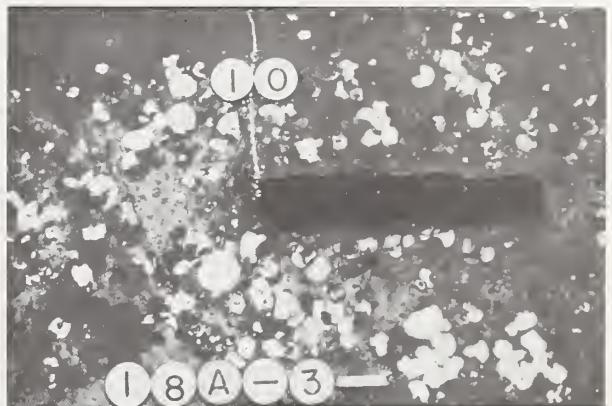
FIGURE 60

minor as shown in figure 60. Below the mud line the effect is negligible as seen in figure 61. Some of the coating damage visible in this photograph is mechanical abrasion due to removal and shipping.

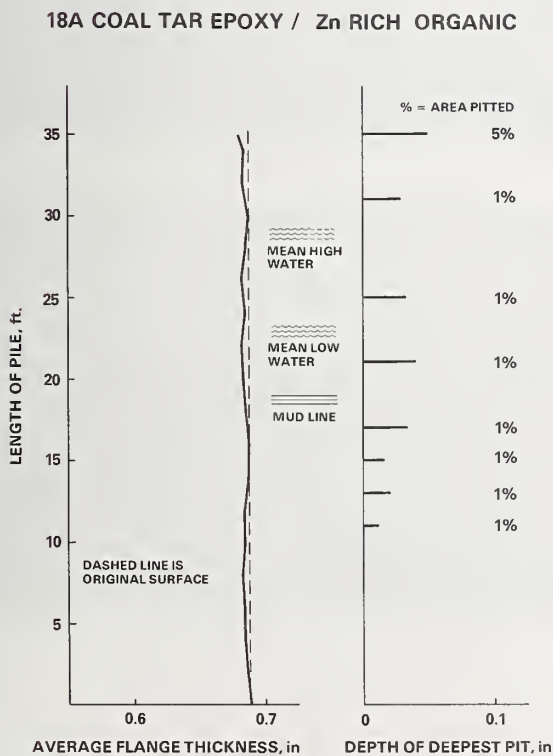
FIGURE 58

The physical measurements on System 18A are illustrated in figure 58. The deterioration of the steel pile has been slight. The coating system has performed well in all of the zones of exposure. Average corrosion rate for the pile has been less than 0.2 mils per year (1 mdd). In the atmospheric zone, damage of the coating at the window has been severe as shown in figure 59. Undercutting of the coating extends almost 2 in (5 cm) beyond the window. Undercutting of the coating in the tidal zone has been

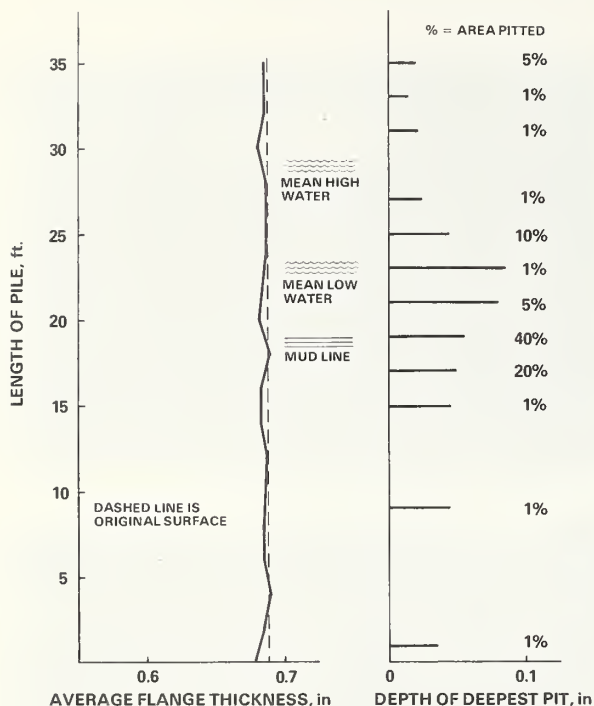
FIGURE 70

of both is slightly over 60. The physical measurement data for pile 19A is plotted in figure 70. Attack of the pile has been general over its length. However, there was more attack in the erosion zone than this data, taken 1 in (2.5 cm) from the edge, indicates. The corrosion extended from the 15-ft mark to the 20-ft mark on the inner surface of the flanges and 2 to 3 in from the edge. This attack is indicated by the pit depth measurements of figure 70. Its average corrosion rate is about 0.2 mils per year (1 mdd). Undercutting in the atmospheric zone shown in figure 71 extends less than 0.5 in (1.2 cm) beyond the window with some edge deterioration evident. General deterioration has been extensive in the tidal zone. Figure 72 is a photograph of the window in this region that reveals less than 0.1 in (0.2 cm) undercutting. Below the mud line undercutting was also less than 0.1 inches (0.2 cm) as shown in figure 73. The coating was damaged mechanically, but no undercutting was found under the surrounding encrustation.

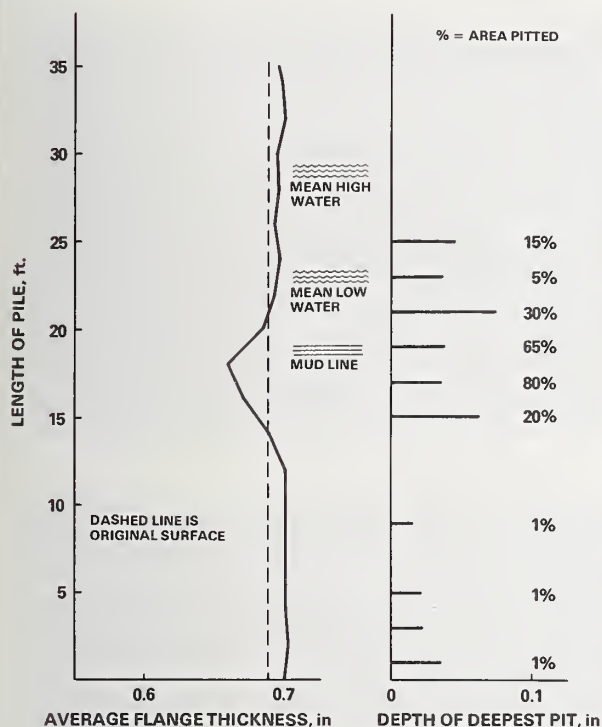
FIGURE 74

Pile 22A, vinyl mastic over inorganic zinc rich, has a relative coating effectiveness slightly above 60 after six years. The flange thickness measurements are illustrated in figure 74.

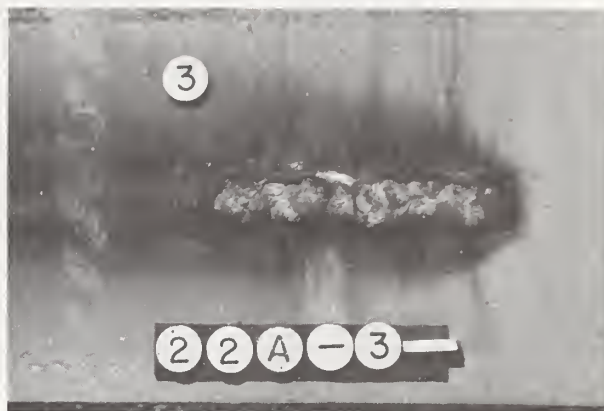
FIGURE 75

There is very little attack in the atmospheric zone. Undercutting in this area is less than 0.1 in (0.2 cm) as shown in figure 75. In the tidal zone general deterioration of the coating has taken place, but with very little actual metal loss. This is illustrated in figure 76. Undercutting here is also less than 0.1 in (0.2 cm). Below the mud line undercutting extends about 0.2 in (0.5 cm) beyond the window as figure 77 shows. Notice the blistering of the coating in the surrounding area. The overall average corrosion rate for pile 22A is less than 0.25 mils per year (1.4 mdd).

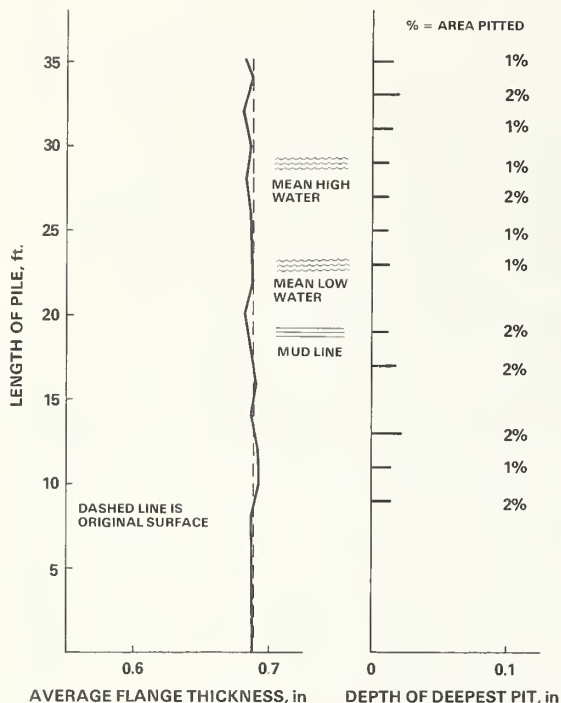
FIGURE 83

Pile 15A, polyvinylidene chloride over zinc flame spray, is unusual in that the electrochemical readings indicate that initially its coating effectiveness decreased as the non-metallic coating failed, but then the metallic zinc coating proceeded to provide protection. Consequently, the coating effectiveness of the system improved as illustrated in figure 78. Total coating effectiveness below the water line is well above 85. In general, the zinc seems to have developed some nonconducting film, probably an oxide, that has brought this improvement about. The average flange thickness measurements are plotted in figure 83. Total metal
