**NBS MONOGRAPH 58**

# **Corrosion of Steel Pilings in Soils**

Melvin Romanoff

Reprinted from the Journal of Research of the National  
Bureau of Standards—C. Engineering and Instrumentation  
Vol. 66C, No. 3, July–September 1962

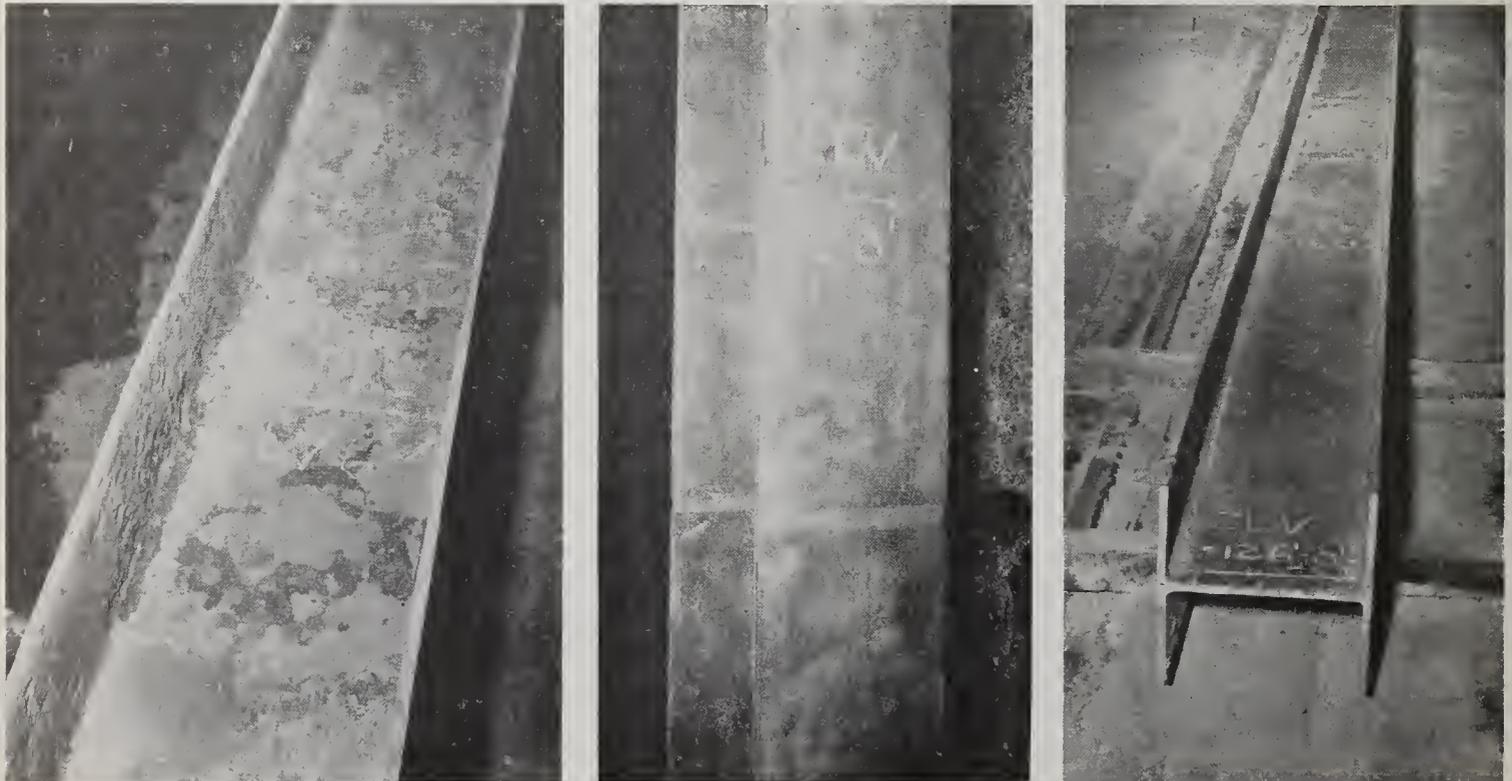
FIGURE 1. Sections of the 139-ft H-piles pulled from Sparrows Point, Maryland, after exposure for 18 years.

The pattern and amount of corrosion on the two piles were about the same. Corrosion was confined to two areas. One area extended from the top of the piles, which was above ground level, and extended through the zone exposed to the cinder and slag fill in the water table zone. The other corroded area occurred between elevations -115 to -118 ft where the piles passed through a sand and gravel bed.

Figure 1 shows the condition of pile II-S at three different levels.

Left, water table zone consisting of fill material; center, clay soil stratum at about elevation -30 ft; and right, coarse sand and gravel stratum underlain by clay between elevations -110 and -126 ft. The pile was cleaned by sandblasting. Note the excellent condition of the butt weld at the splice in the center photograph.

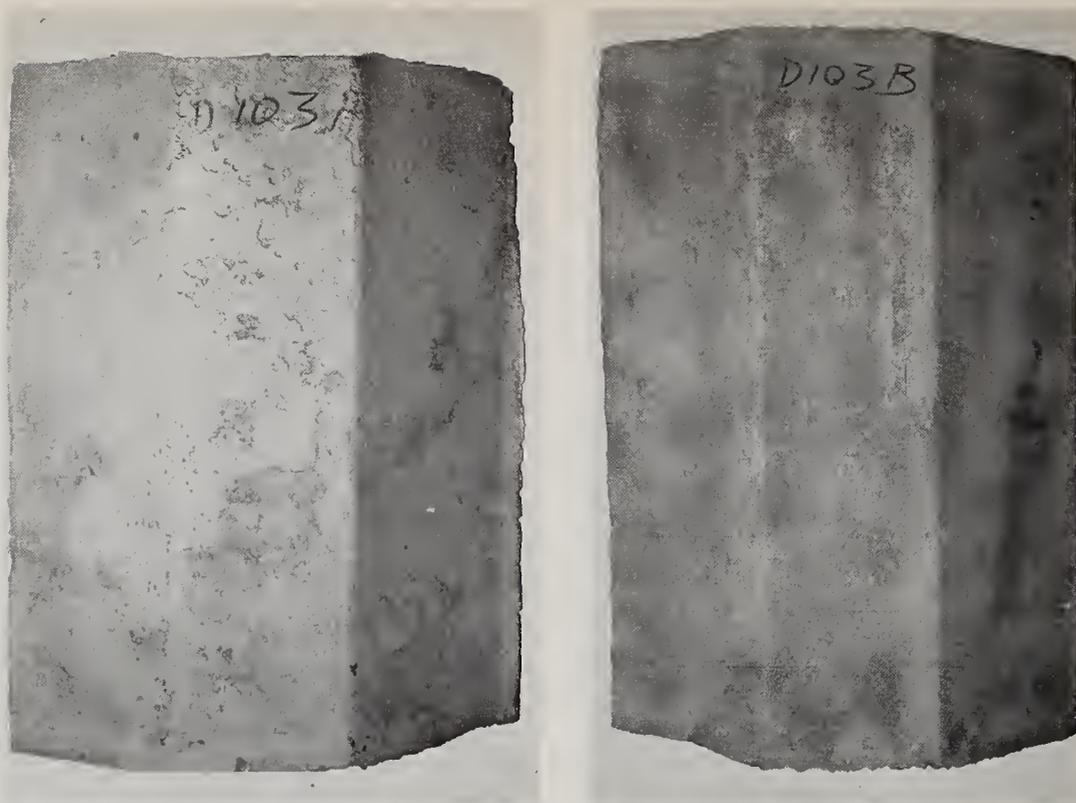
FIGURE 3. Sections (1.5 ft by 1 ft) cut from a piling which was pulled from the north upstream wingwall of the Grenada Dam Spillway at Grenada, Mississippi, after exposure for 12 years.

Sections were cleaned by sandblasting.  
 D103A, section of pile exposed to fill soil.  
 D103B, section of pile exposed to natural soil.

251.5 to 246.0 ft: Many scattered pits up to 50 mils in depth. Seven pits measured between 68 and 80 mils, and two pits 88 and 122 mils in depth. Pits were of similar depth on both sides of the pile, but much less numerous on the side facing the spillway. About 50 percent of the mill scale was intact on the spillway side and 10 percent on the other side. The reduction in cross section of the three most corroded areas measured between 6 to 8 percent of the original wall thickness.

246.0 to 244.0: No measureable pits beyond the thickness of the mill scale (8 mils) were found in this zone. About 50 percent of the mill scale was intact in this area.

244.0 to 237.5: About 75 percent of the mill scale was present over the surfaces in this zone. No measurable pits were found except two at elevation 241.0 ft which were 13 mils in depth. The average wall thickness of a 17 × 22 in. section removed from this zone was 0.37 in. after cleaning by sandblasting.

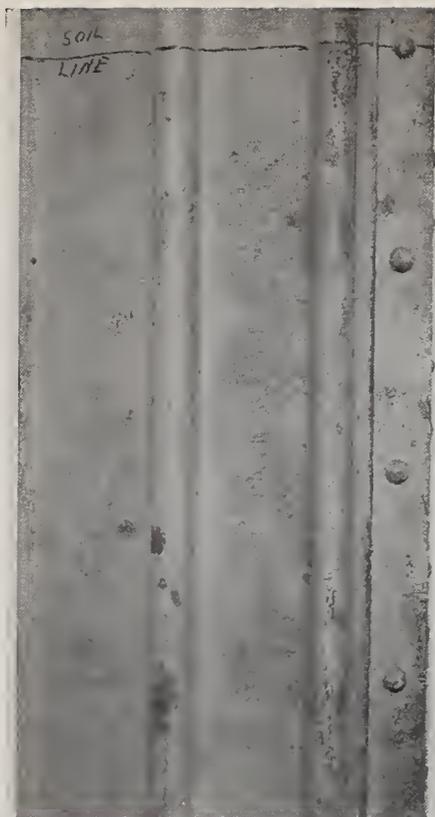
FIGURE 4. A 3-ft section of steel sheet piling exposed below the soil line in a cofferdam structure in the Lumber River near Boardman, North Carolina.

Exposure, 37 years.

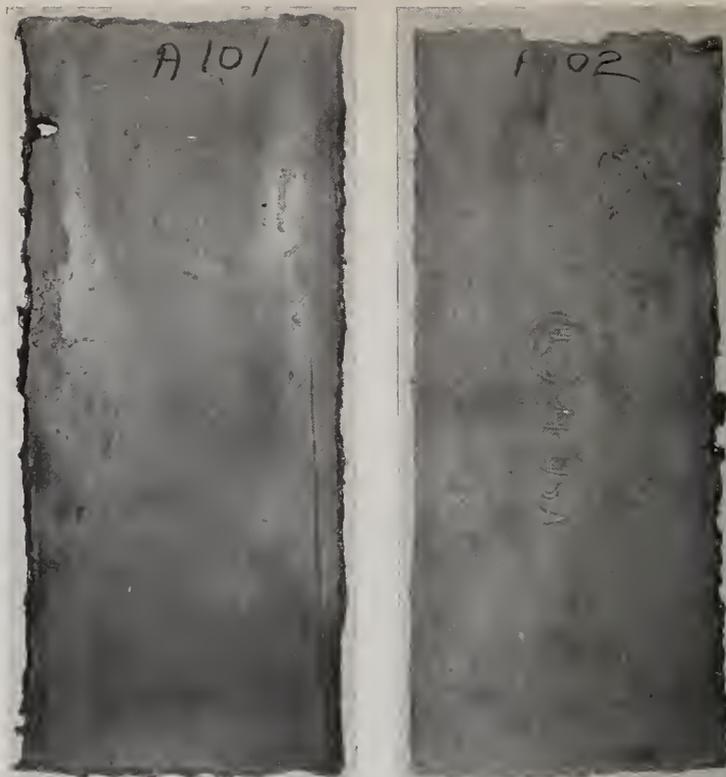
FIGURE 5. Steel sheet piling sections (2 ft by 1 ft) cut from two locations on the Memphis Floodwall after exposure for 6.3 years.

A 2 ft by 1 ft section removed from the pile is shown in figure 5.

The sections were cleaned by sandblasting.

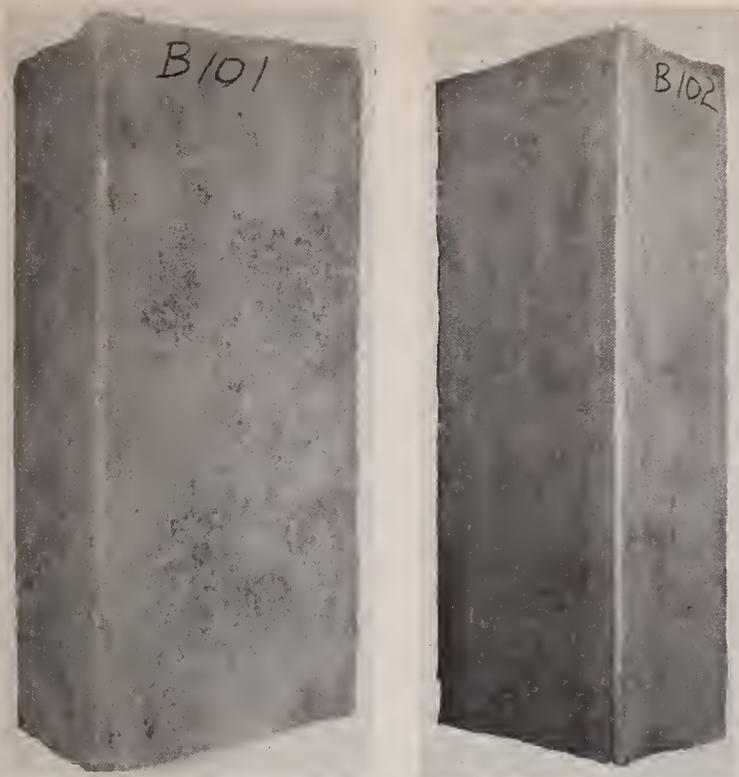
FIGURE 6. Sandblasted sections of Z-type sheet piling cut from two different locations in the Vicksburg Floodwall after exposure for 7 years.

Although cinders were present in the soil at both locations, no significant corrosion occurred.

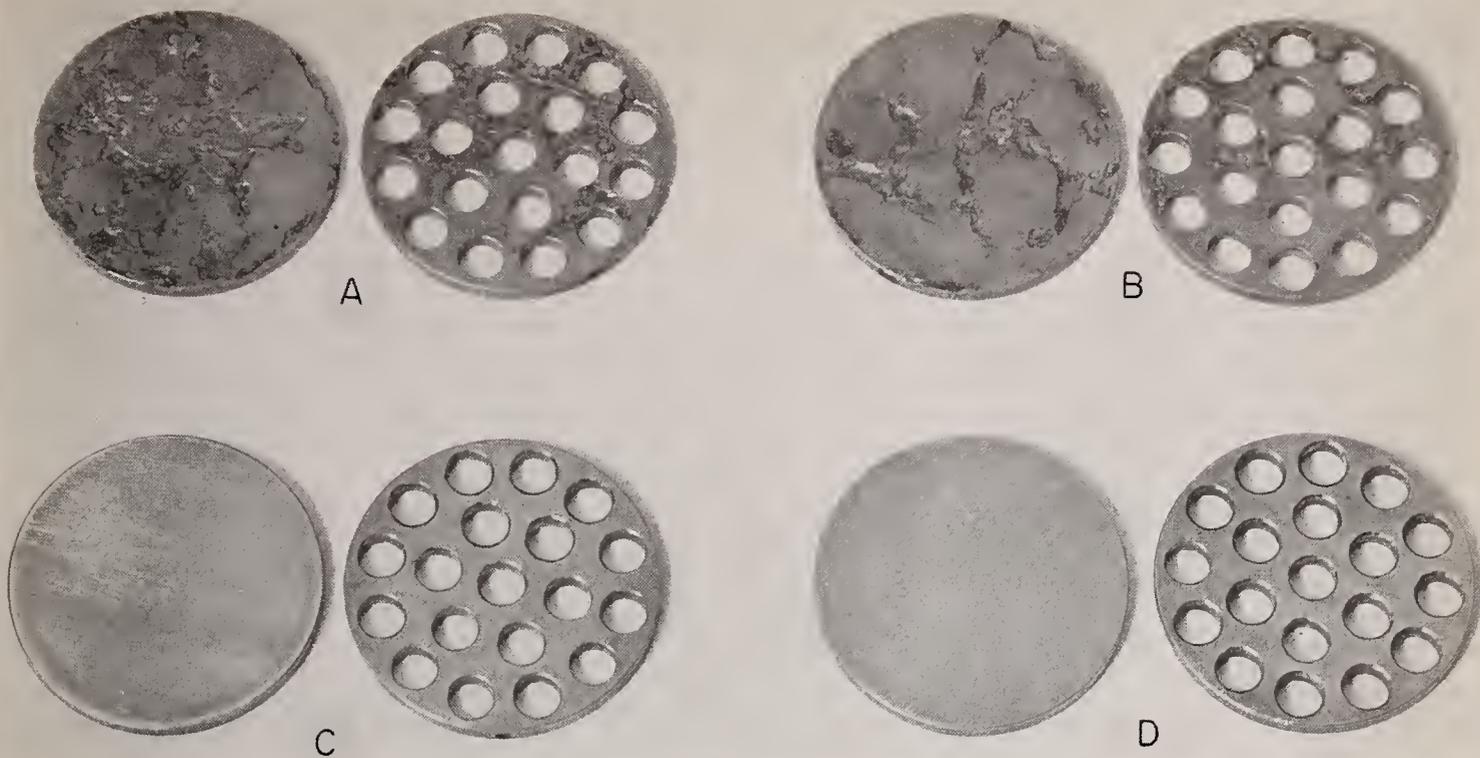
FIGURE 7. Corrosiveness of soil samples from Bonnet Carre Spillway as indicated by electrode weight losses after 6 months in modified Denison corrosion cells.

Electrode sets A and C set up under aerated and unaerated conditions, respectively, with soil samples obtained at 22 ft depth from surface of ground. Electrode sets B and D set up under aerated and unaerated conditions, respectively, with soil samples obtained at 45 ft depth.
