NIST NCSTAR 1-1C

**Federal Building and Fire Safety Investigation of the
World Trade Center Disaster**

**Maintenance and Modifications to
Structural Systems**

September 2005

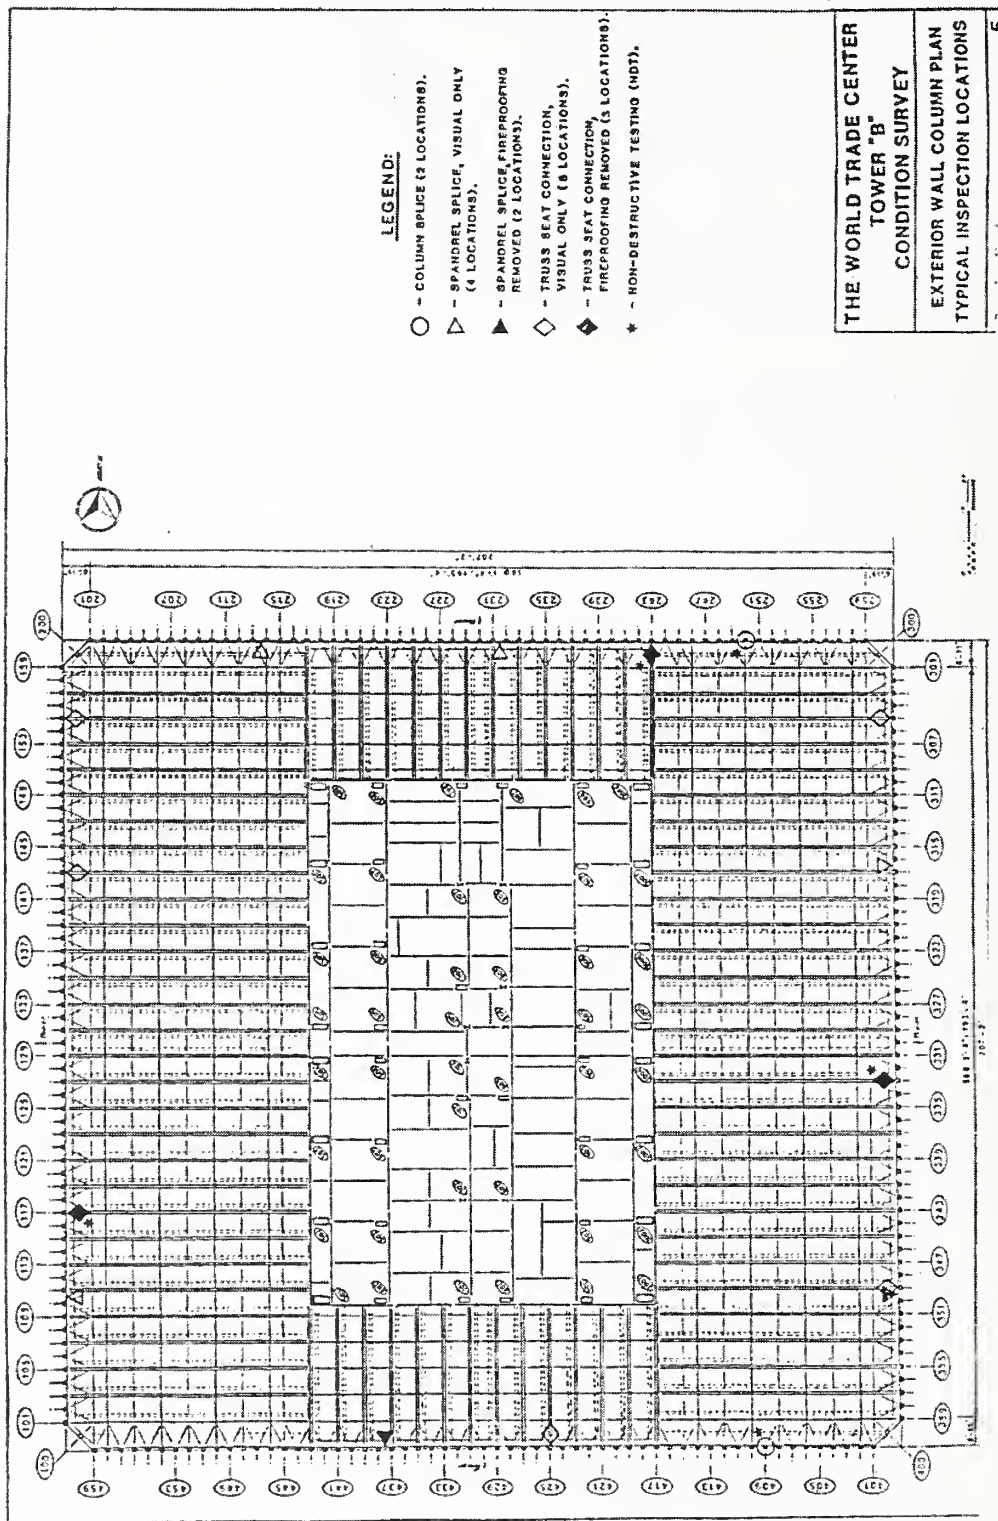
Figure 3-1. Typical inspection locations of exterior wall per 1990 Condition Survey Report of WTC 2.

Inspection of the exterior walls was made from inside the building. Inspection locations are indicated in Fig. 3–1, which is Drawing 5 from the report (PANYNJ 1990).

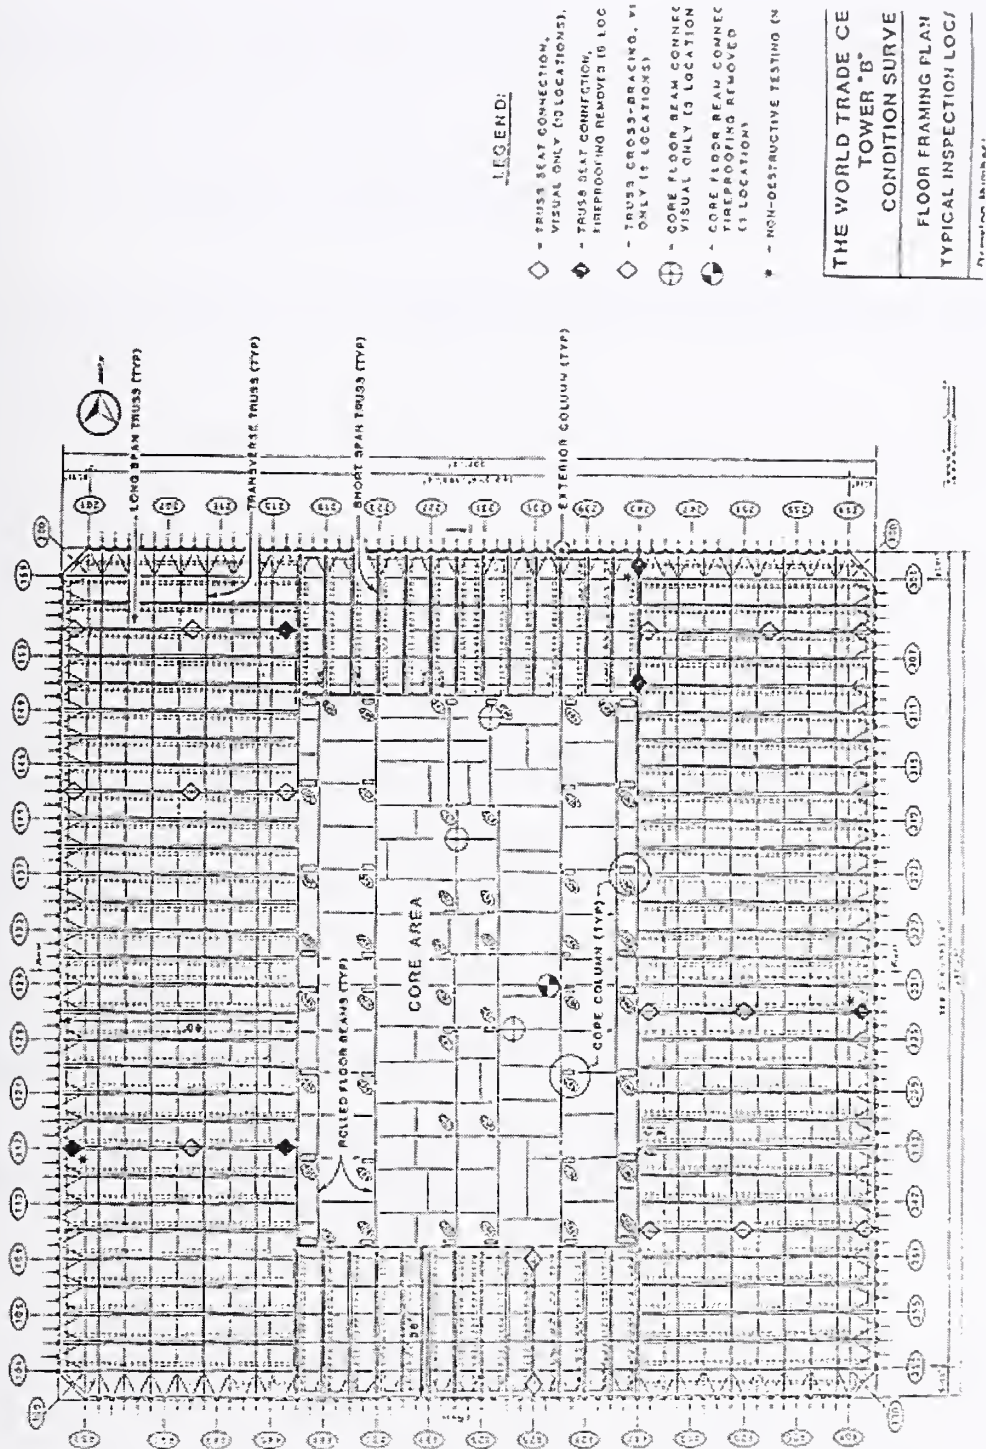
Figure 3-3. Typical inspection locations of floor framing per the 1990 Condition Survey Report of WTC 2.

Floors 9 through 41—Floor framing inspected in this zone was found to be in good condition. Light corrosion was observed on all core beams and beam connections, and on main truss connections on floors 28 and 37.

According to the report, the most significant deficiencies in this zone were found at the damping units (see Table C-1 in the survey report). Damping units on floors 18 and 37 were observed to be missing one fastener at each unit. Two fasteners were found to be missing in one damping unit on floor 29, as well as on floor 38. Also, at floor 38, a damping unit was observed to be missing four fasteners. According to the structural drawings (WSHJ 1967a), four fasteners were required to connect the damping unit to the member attached to the bottom chord of the floor truss, and two fasteners were required to connect the damping unit to the exterior column.
