**NIST NCSTAR 1-3**

**Federal Building and Fire Safety Investigation of the  
World Trade Center Disaster**

**Mechanical and Metallurgical  
Analysis of Structural Steel**

September 2005

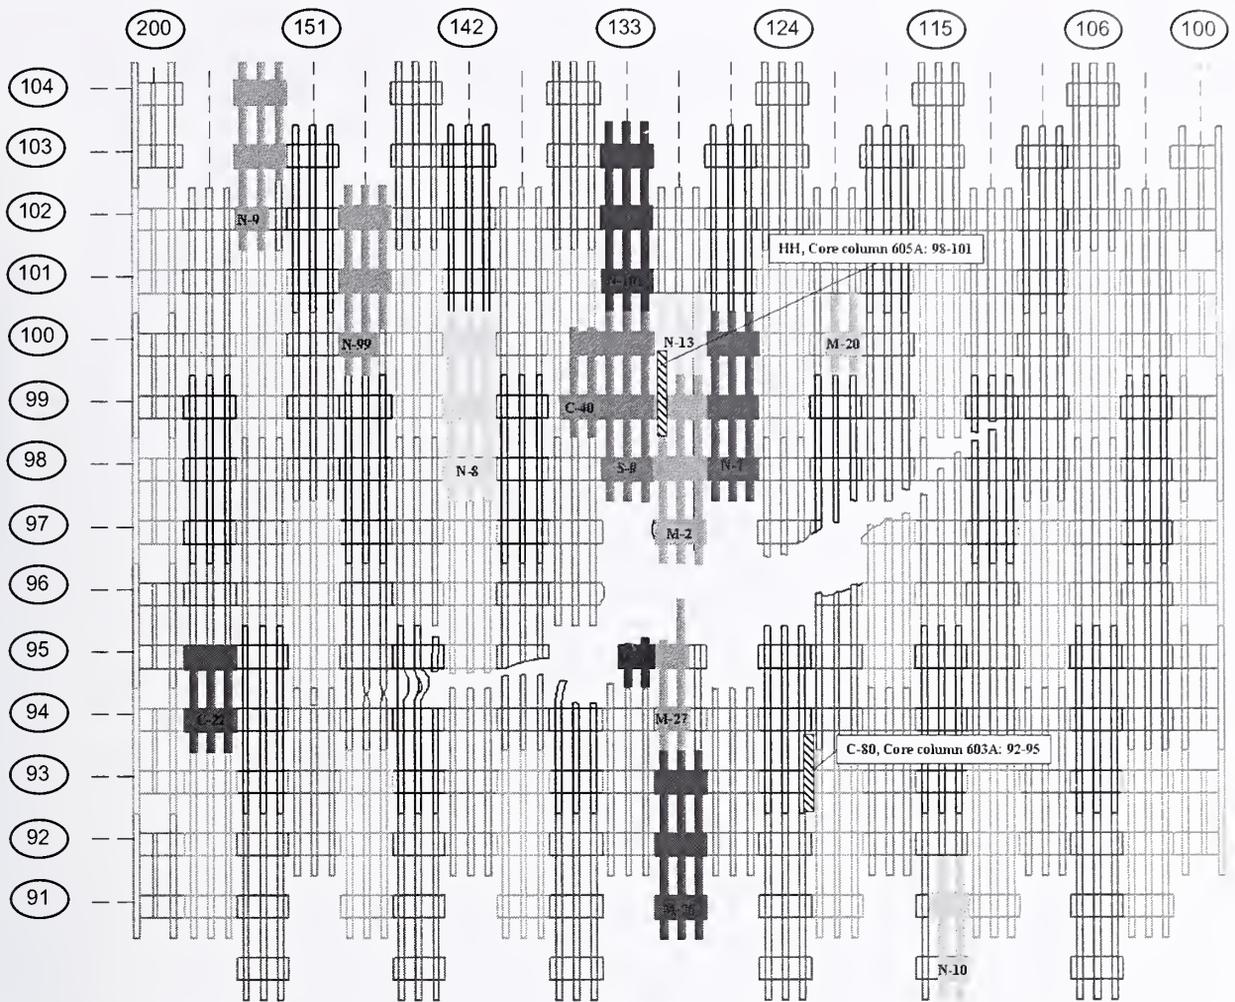
Photographic evidence indicated that damage to WTC 1 due to aircraft impact occurred from the 94th to 99th floors and was bounded by columns 111 through 152. For WTC 2, the impact area was lower, with damage found from the 77th to 85th floors. While the damage appeared to be bounded by column lines 411 and 440, the starboard wing of the aircraft may have struck columns even closer to the southeast corner of the building. This area was persistently obscured by smoke, however, and no clear images were available. From this information, NIST was able to determine which perimeter panels and core columns could be used to comment on damage (physical and fire) and possible failure mechanisms in this area. Fig. 5–5a shows an overlay of the recovered exterior panels in and around the impact zone of WTC 1. Samples C-80 and HH, both core columns, were also identified as residing near the impact zone. The recovered portion of each column is approximately represented in this image. No similar impacted exterior panels were recovered for WTC 2; however, two core columns were recovered, Fig. 5–5b.

**Figure 5–5a. Interpreted column damage, from photographic evidence, to north face of WTC 1, with overlay of recovered steel identified by NIST. Colored regions represent recovered portions. Both core columns (#603 and #605) are in the second row from the north face of WTC 1.**

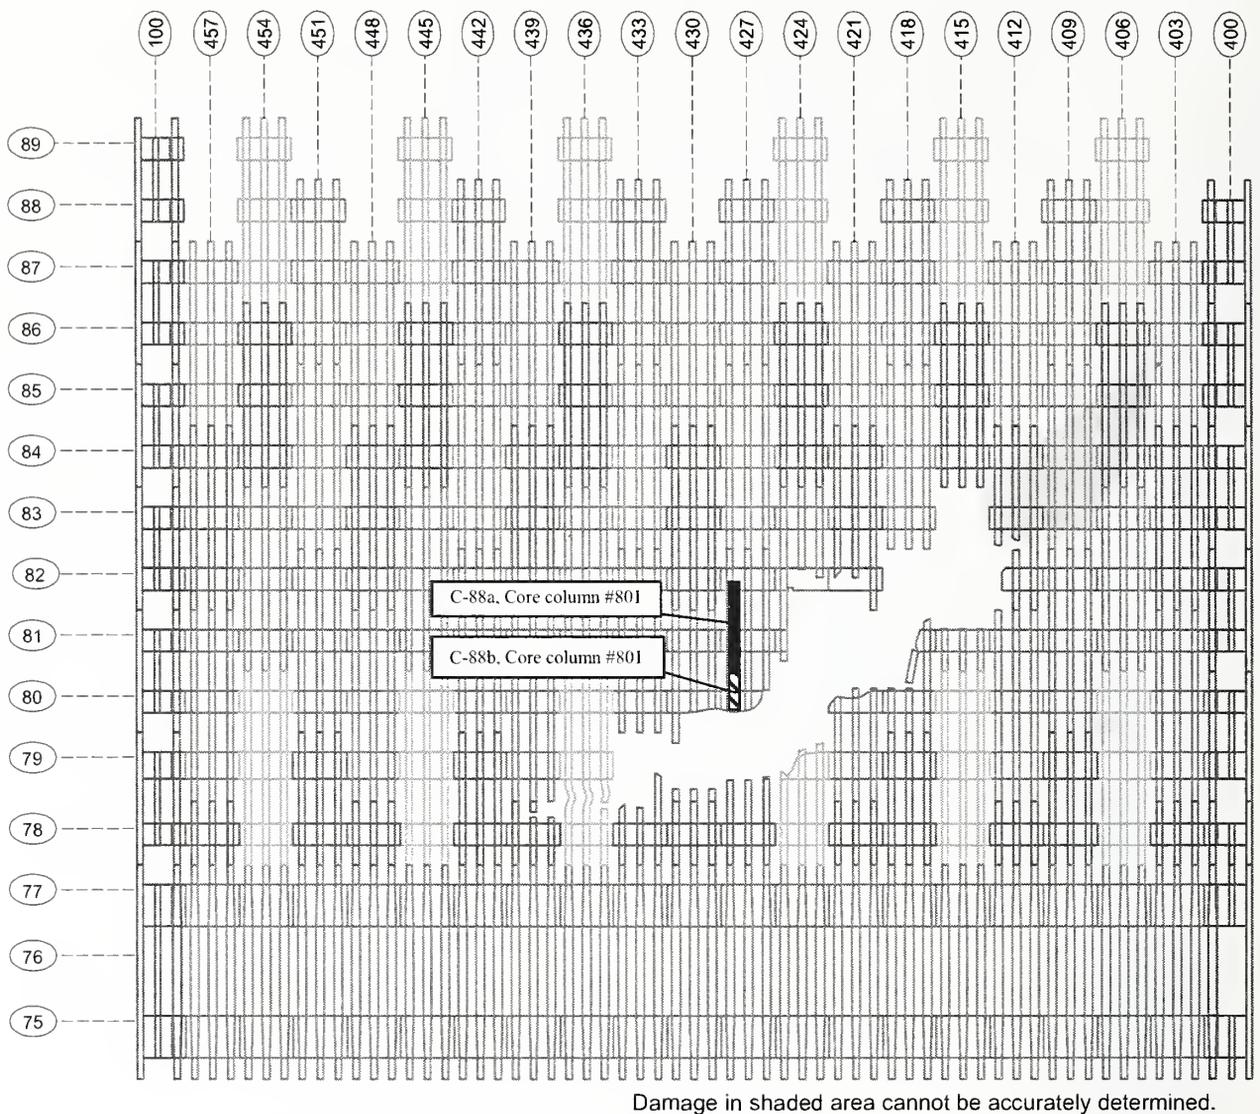
**Figure 5-5b. Interpreted column damage, from photographic evidence, to south face of WTC 2, with overlay of recovered steel identified by NIST. Samples shown represent recovered portions. Core column line 801 is in the row closest to the south face of WTC 2.**

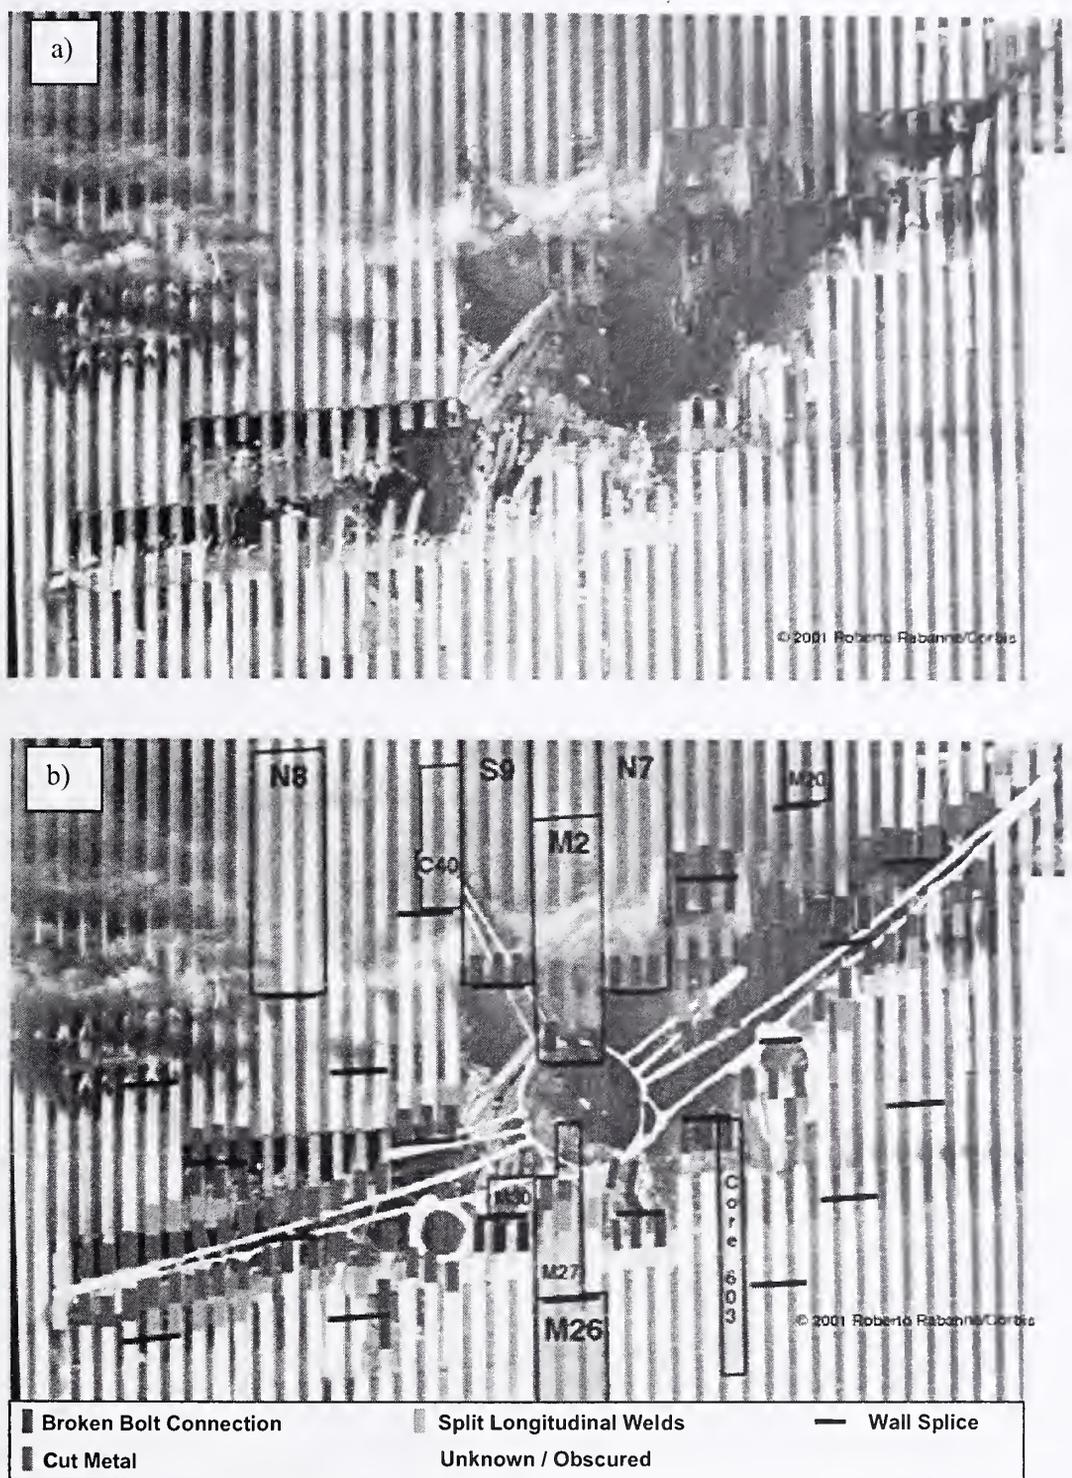
Figure 6-1. (top) Enhanced image showing the impact hole in the north face of WTC 1, and (bottom) overlay of an outline of a Boeing 767 that has been distorted to get a best approximate fit with damage to WTC 1. The location and type of localized damage has been indicated.

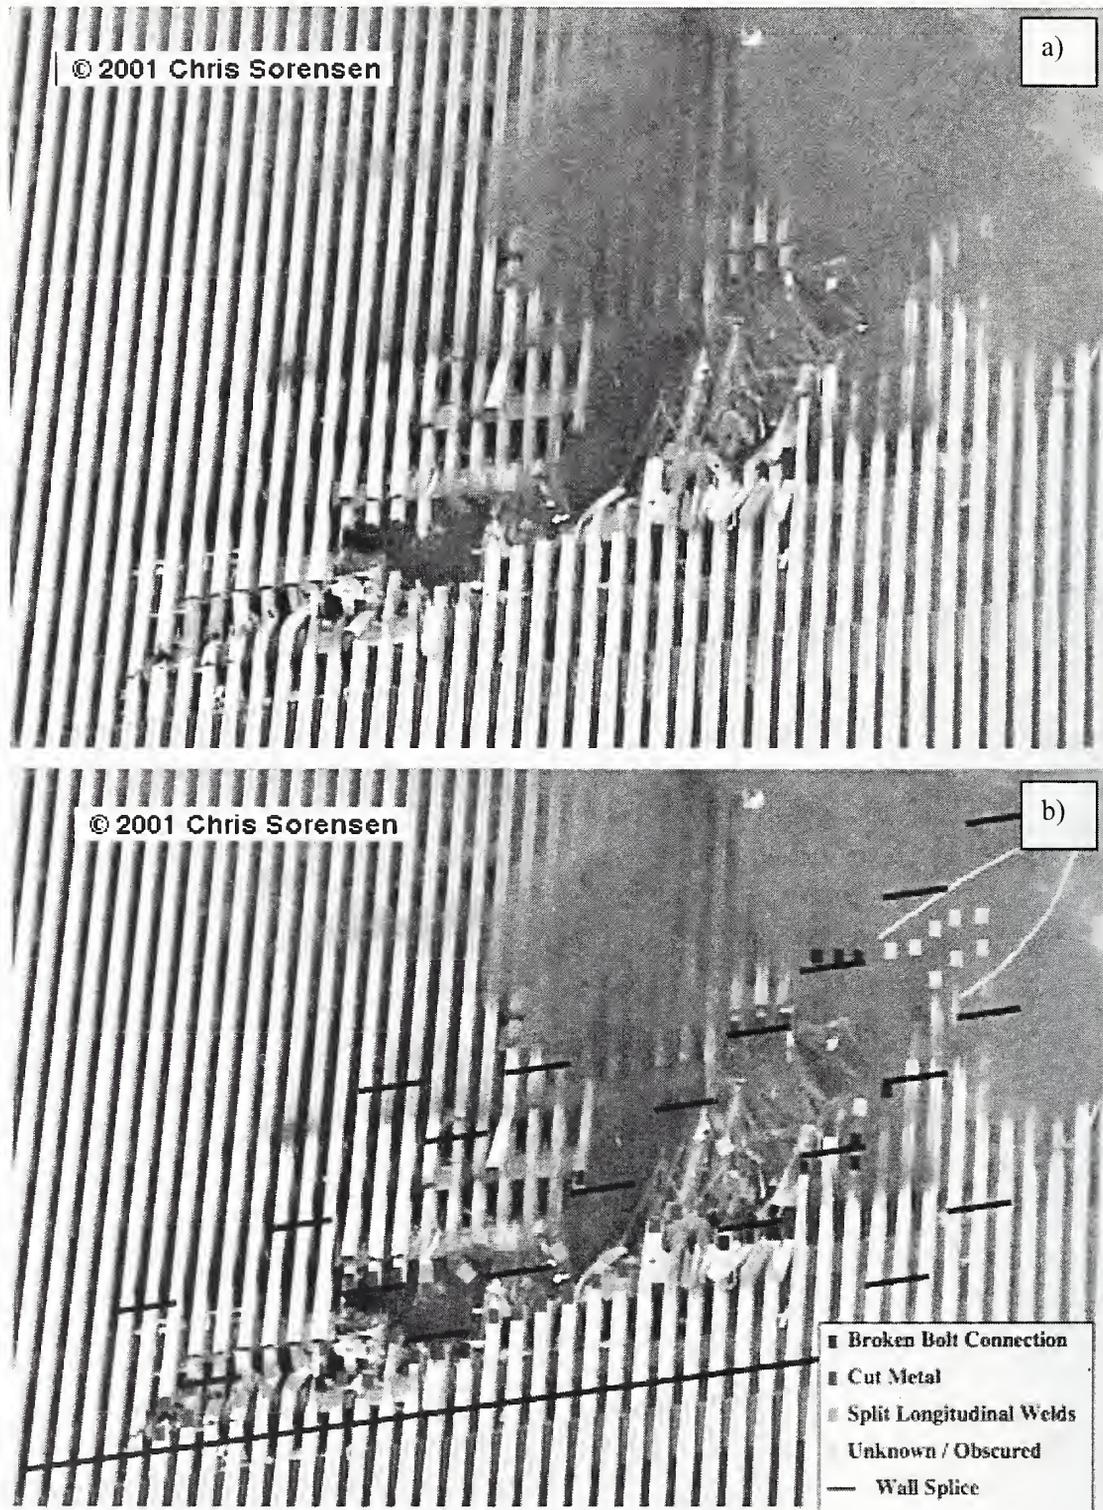
Figure 6-2. (top) Enhanced image showing the impact hole in the south face of WTC 2 and (bottom) overlay of the location and type of localized damage.

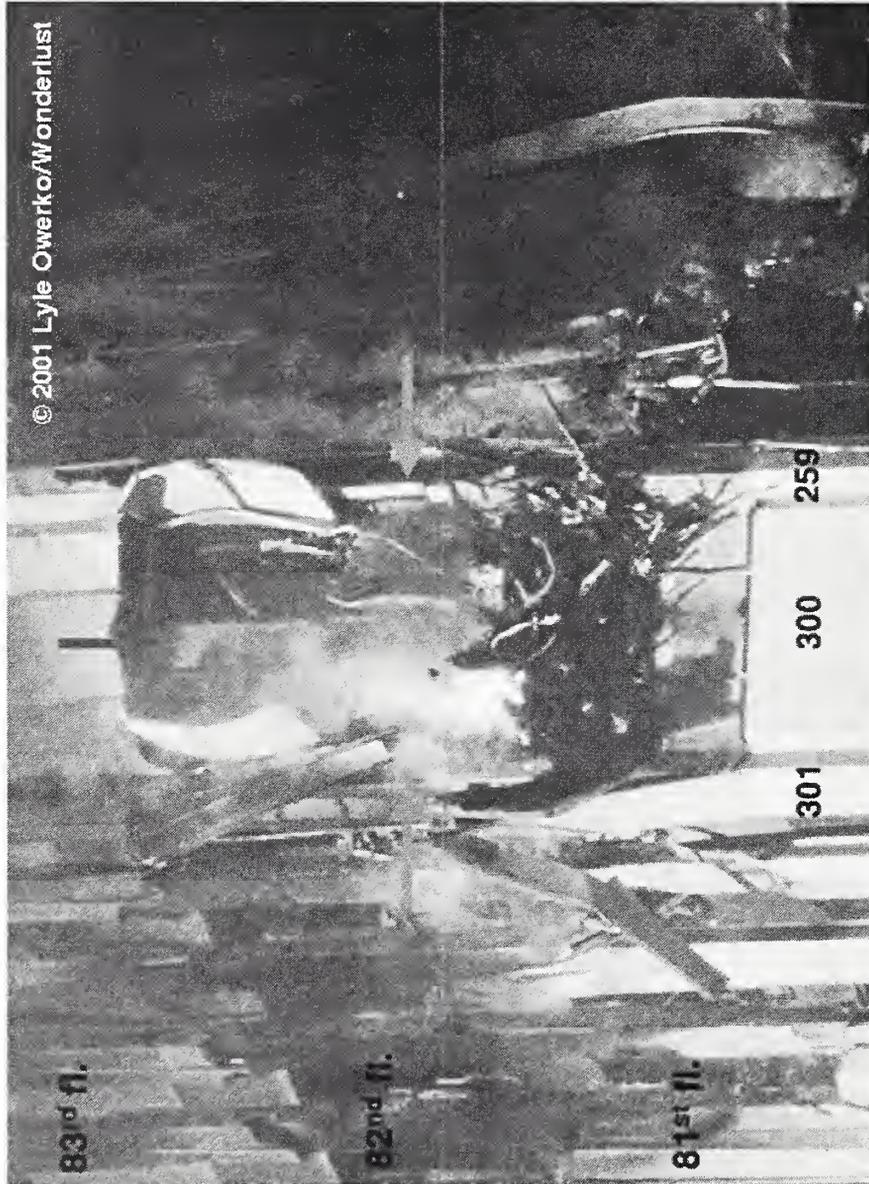
Figure 6-3. Damage to northeast corner of WTC 2 at 81st floor. The red arrow indicates an intact column 300 at the 82nd floor. Other photographs confirm that the spandrel connecting column 300 to columns 259 and 301 is also intact (location indicated by green arrows).

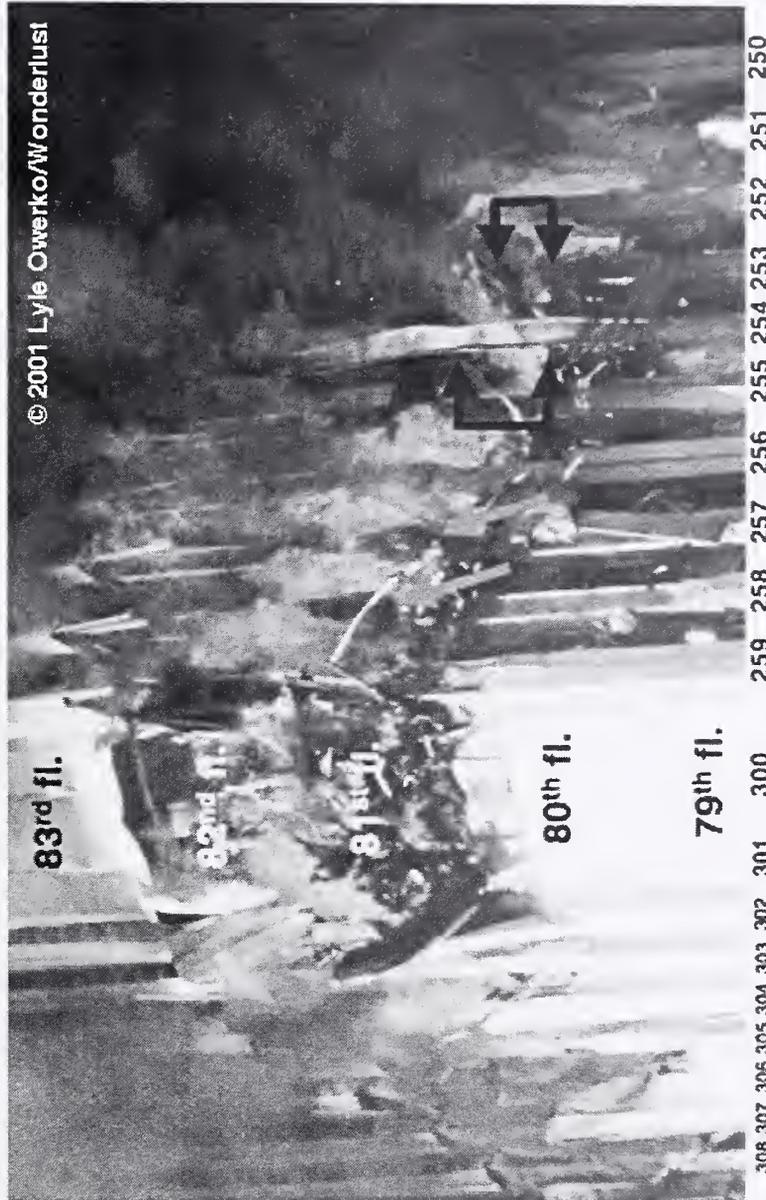
Figure 6-4. Damage to columns on north face of WTC 2 near northeast corner due to internal impact by debris. Broken vertical column bolted connections (green arrows) are visible, along with an intact outer web on column 254 (red arrows) and missing column sections (blue arrows).

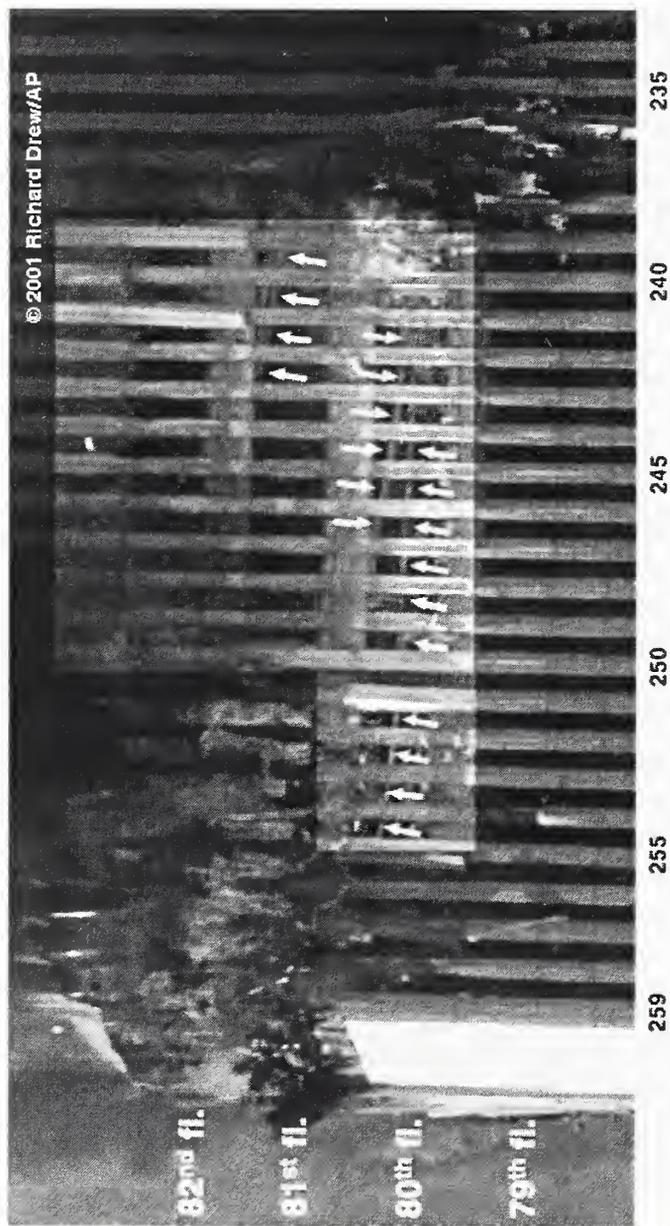
Figure 6-5. Dropped floors on north face of WTC 2.

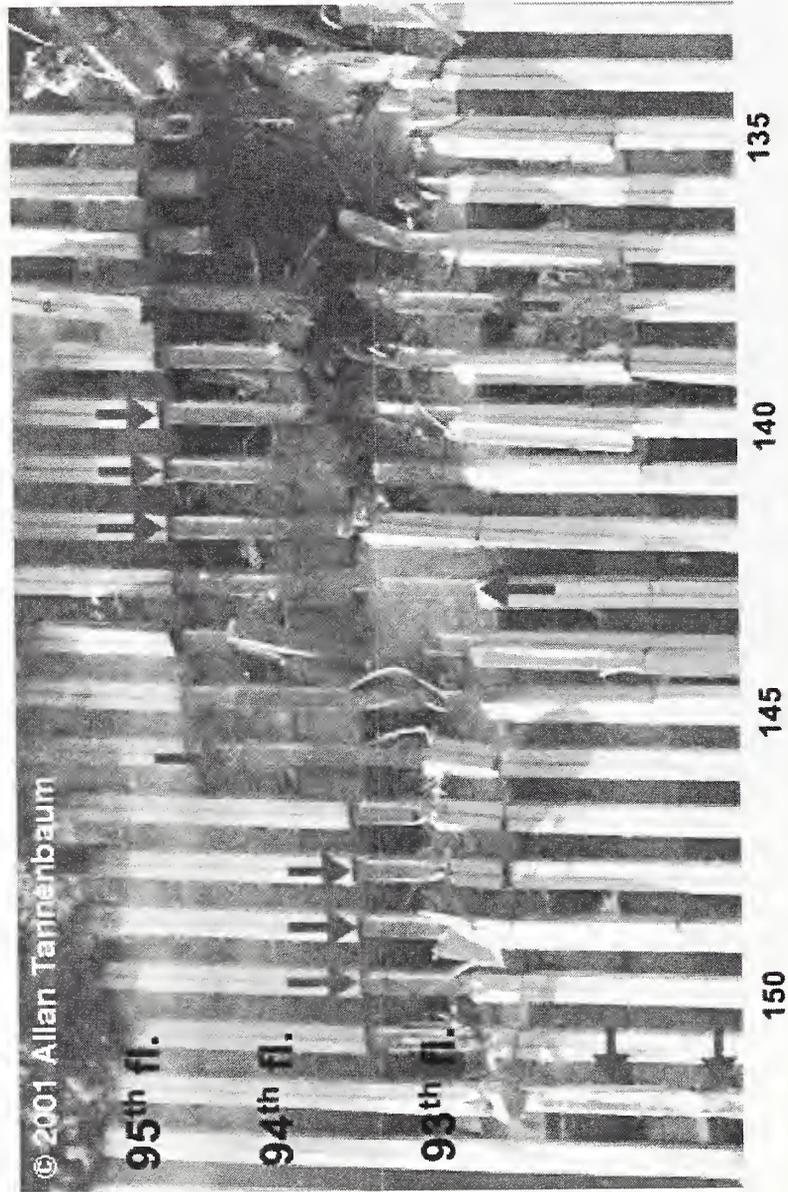
Figure 6-8. Port side of impact hole in north face of WTC 1 showing missing fireproofing. The red arrows indicate a few of the many instances of missing fireproofing around the impact hole. The region roughly approximated as the area where the aluminum panels were dislodge has been digitally enhanced for clarity.

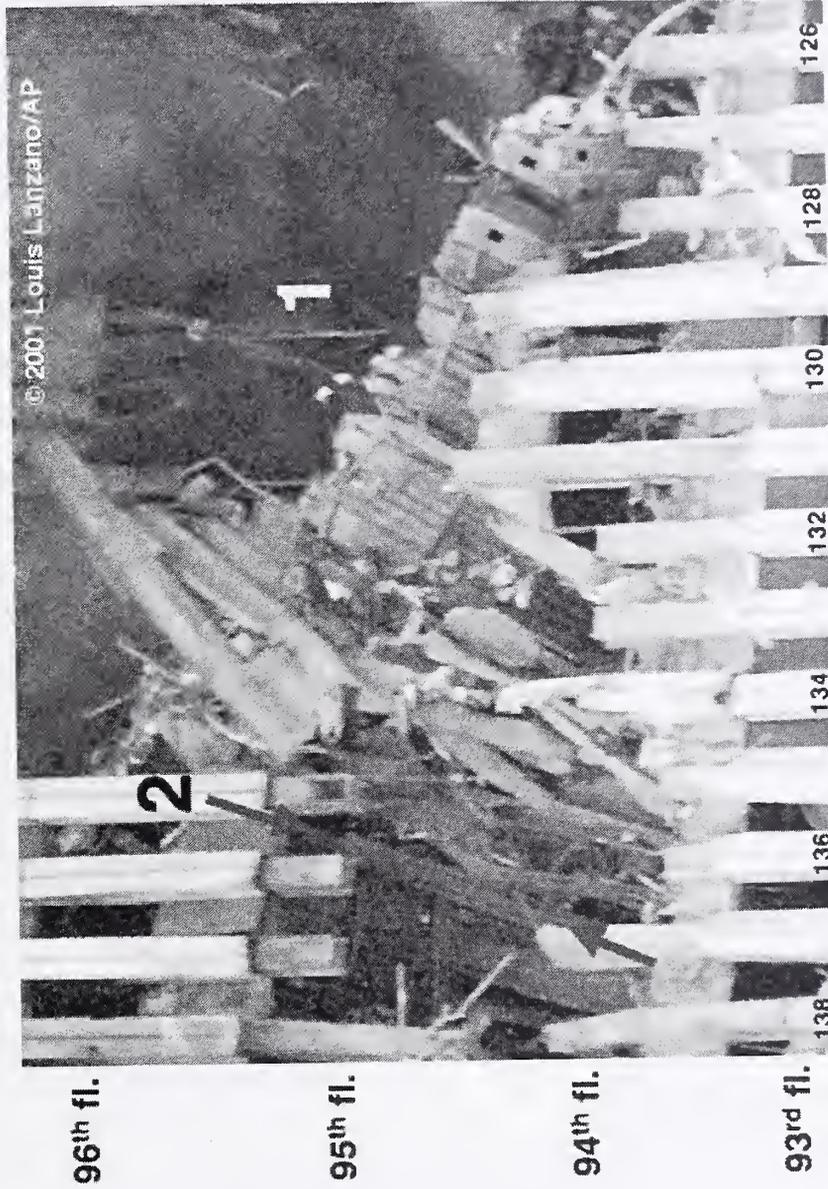
Figure 6-9. Missing fireproofing on floor trusses that fell into impact hole on north face of WTC 1. The arrows labeled "1" are three trusses where the lower or upper chords can be seen, and can distinguish the line that separates the two angle iron components. The arrows labeled "2" lie at either end of a lower chord of a truss that fell farther inside the building, and is made up of four angle irons (a double truss). The red paint color being visible and the fact that the line between the angle iron can be seen indicated that the fireproofing was displaced.

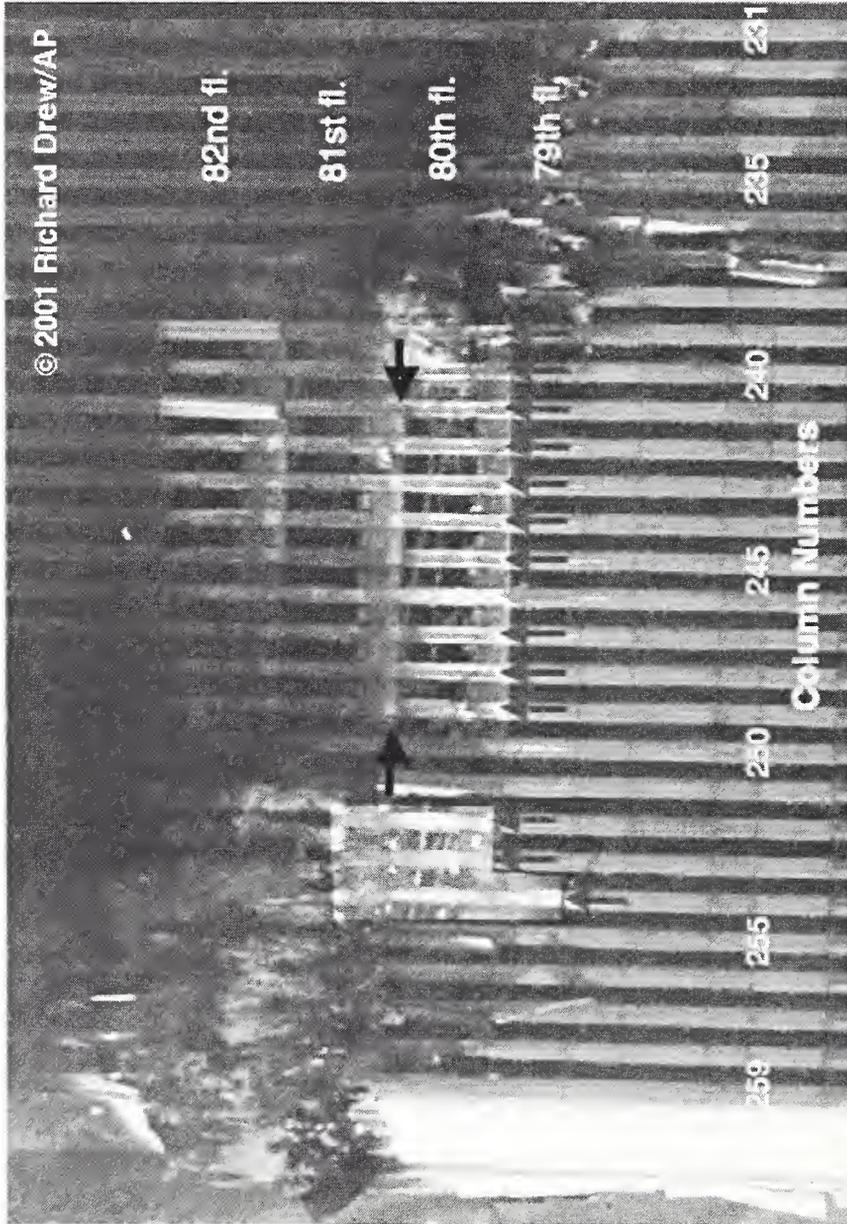
Figure 6-10. Missing façade and fireproofing on north face of WTC 2. Two regions have had contrast and gamma adjusted to enhance visibility of the features. Red arrows indicate columns with missing or damaged fireproofing. Missing or damaged fireproofing determinations were made from this and several other photos taken at different times and angles. Blue arrows indicate white features where some sort of coating has preserved the fireproofing in place.

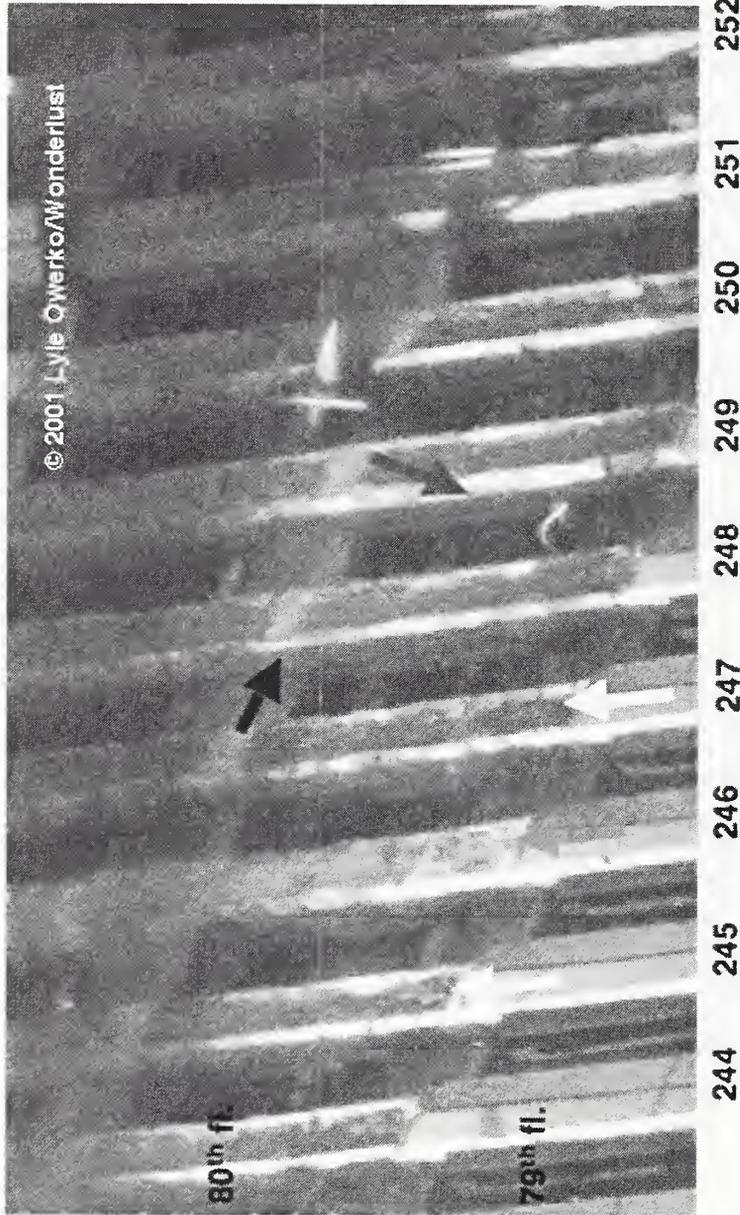
**Figure 6-11. Missing fireproofing on flanges of exterior columns of north face of WTC 2. Fireproofing has come off, revealing red Tnemec paint of the column (red arrows). This image also shows how the outer web regions have been partially or completely denuded of fireproofing. Damage is evidenced by shading by sunlight - compare green (undamaged fireproofing) and white (damaged fireproofing) arrows. Blue arrow indicates same type of white coated area of fireproofing as previous figure that adhered when material above and below was dislodged.**

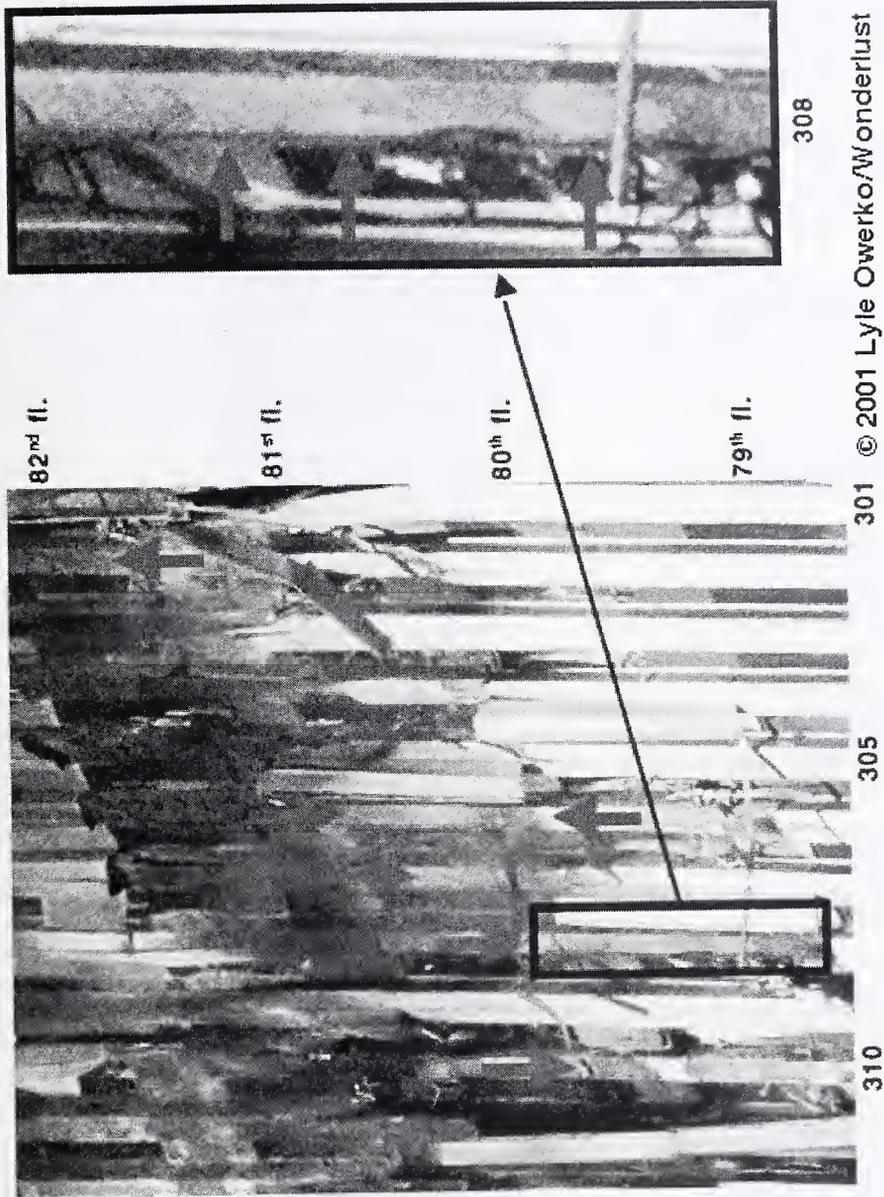
Figure 6-12. Damage to fireproofing on east face of WTC 2 due to internal impact. Red arrows highlight areas where fireproofing has been damaged. The blowup to the right shows a column where the red Tnemec paint of the column is visible.

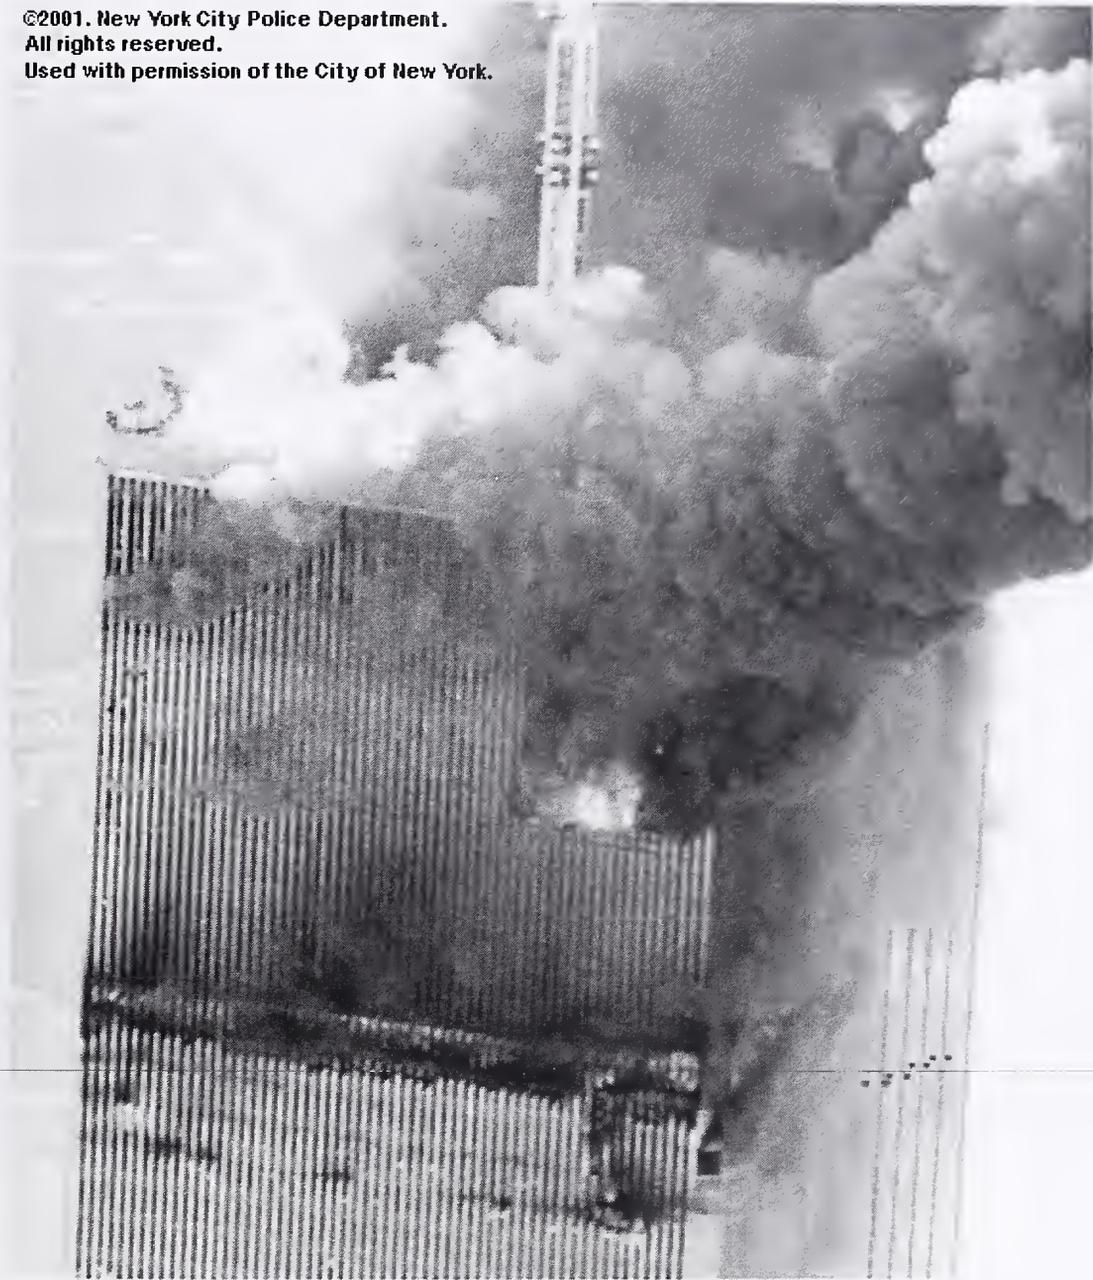
Figure 6–14. Inward bowing of south face (at right, with dark lines overdrawn) of WTC 1.  
Taken at 10:23 a.m. from an NYPD helicopter.

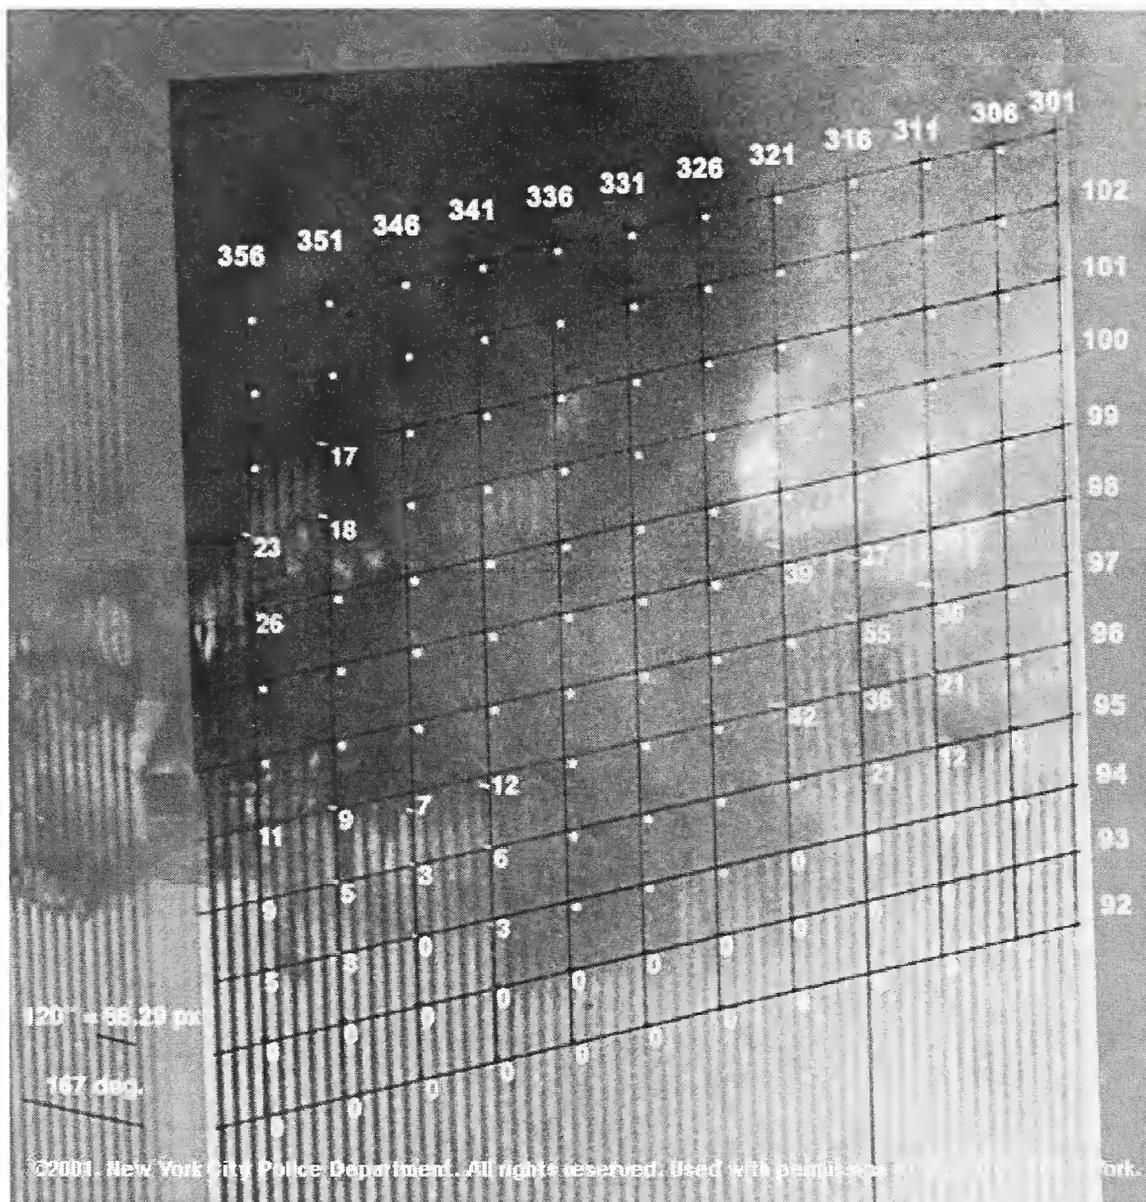
**Figure 6–15. Pull in of south face of WTC 1 at 10:23 a.m. showing considerable displacements of outer columns into the building. Faint white vertical features are the aluminum façade of the exterior. Maximum visible inward displacement of the columns is 55 in. +/- 6 in. Poor resolution leads to large uncertainties in measurements; a large fraction of the south face of the building is obscured by smoke.**

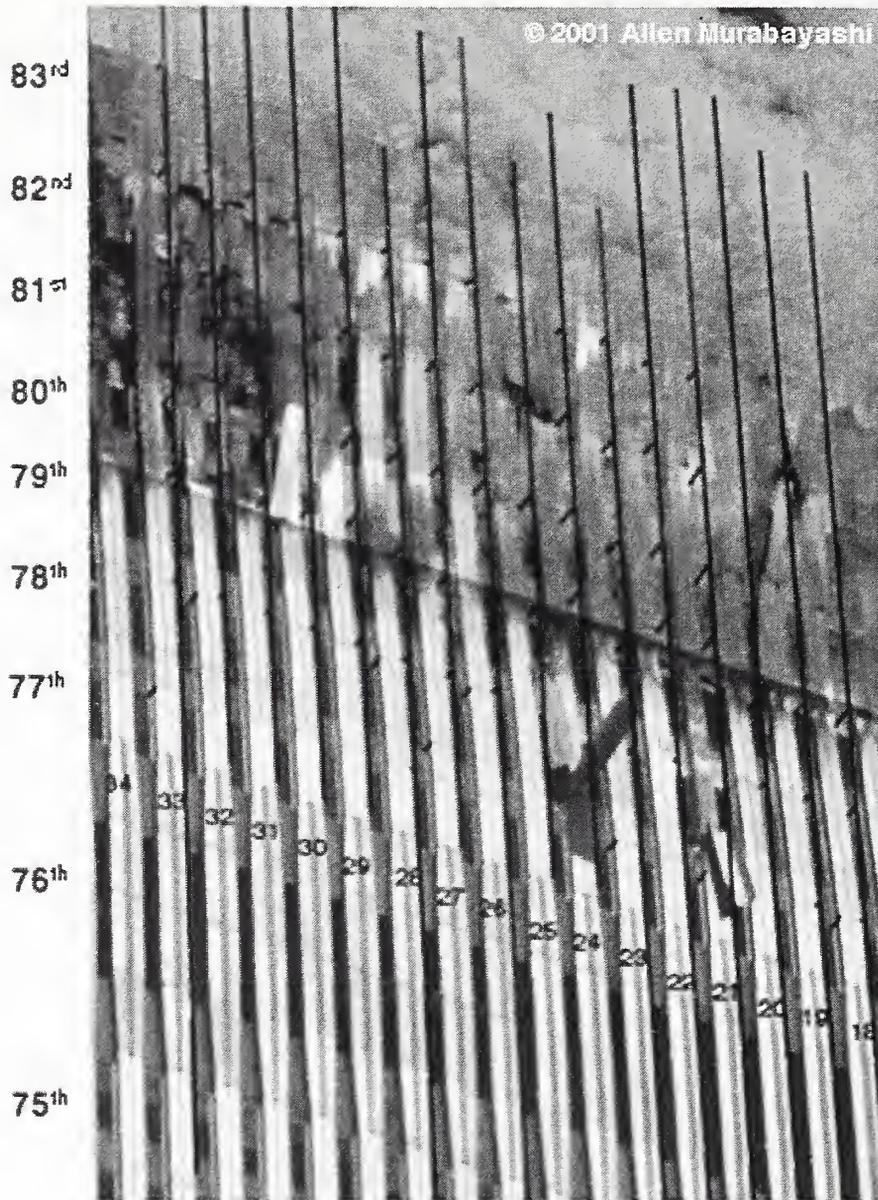
**Figure 6–16.** East face of WTC 2 at 9:53:04 a.m. showing a larger amount of pull in. The vertical black lines were drawn to establish the original line of the exterior wall columns, and the shorter line segments are drawn at the same angle as the nearest observable joint in the exterior aluminum panels to establish the inward bowing distance. For actual column numbers, add a “3” to the front of the two-digit designations in the image.

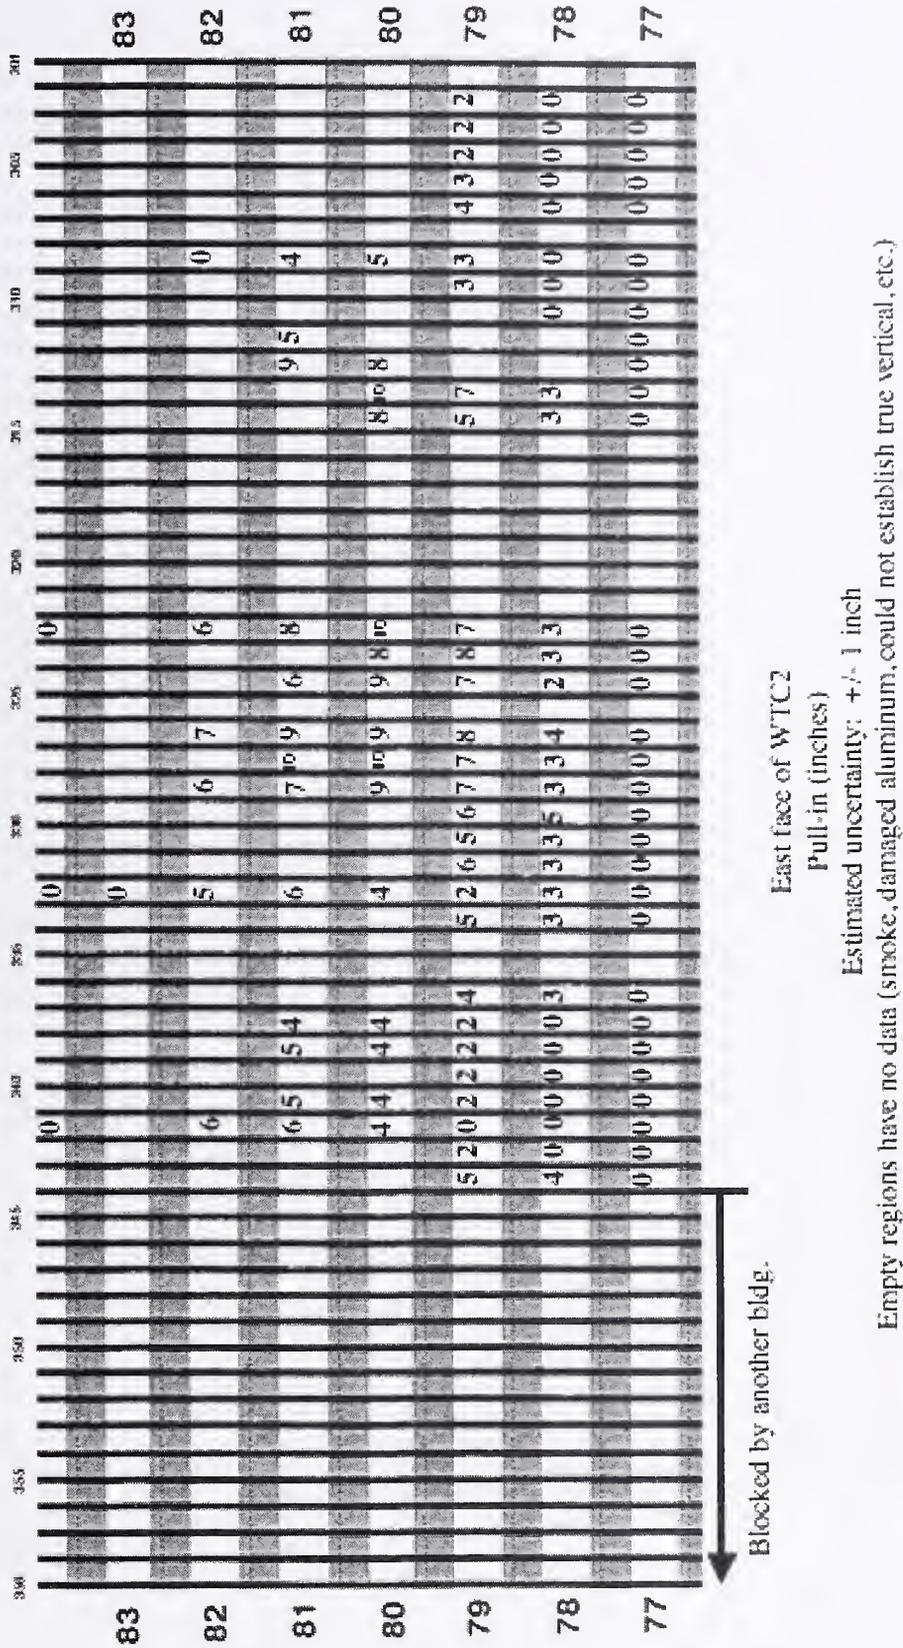
Figure 6-17. Map of inward displacements of the east outer face of WTC 2 inward at 9:21:29 a.m. Each measurement refers to the upper left corner of the window within which the number resides. Measurements were in inches. The colors refer to groups of 5 in. displacements (0-5: black, 6-10: blue) for easier visualization.

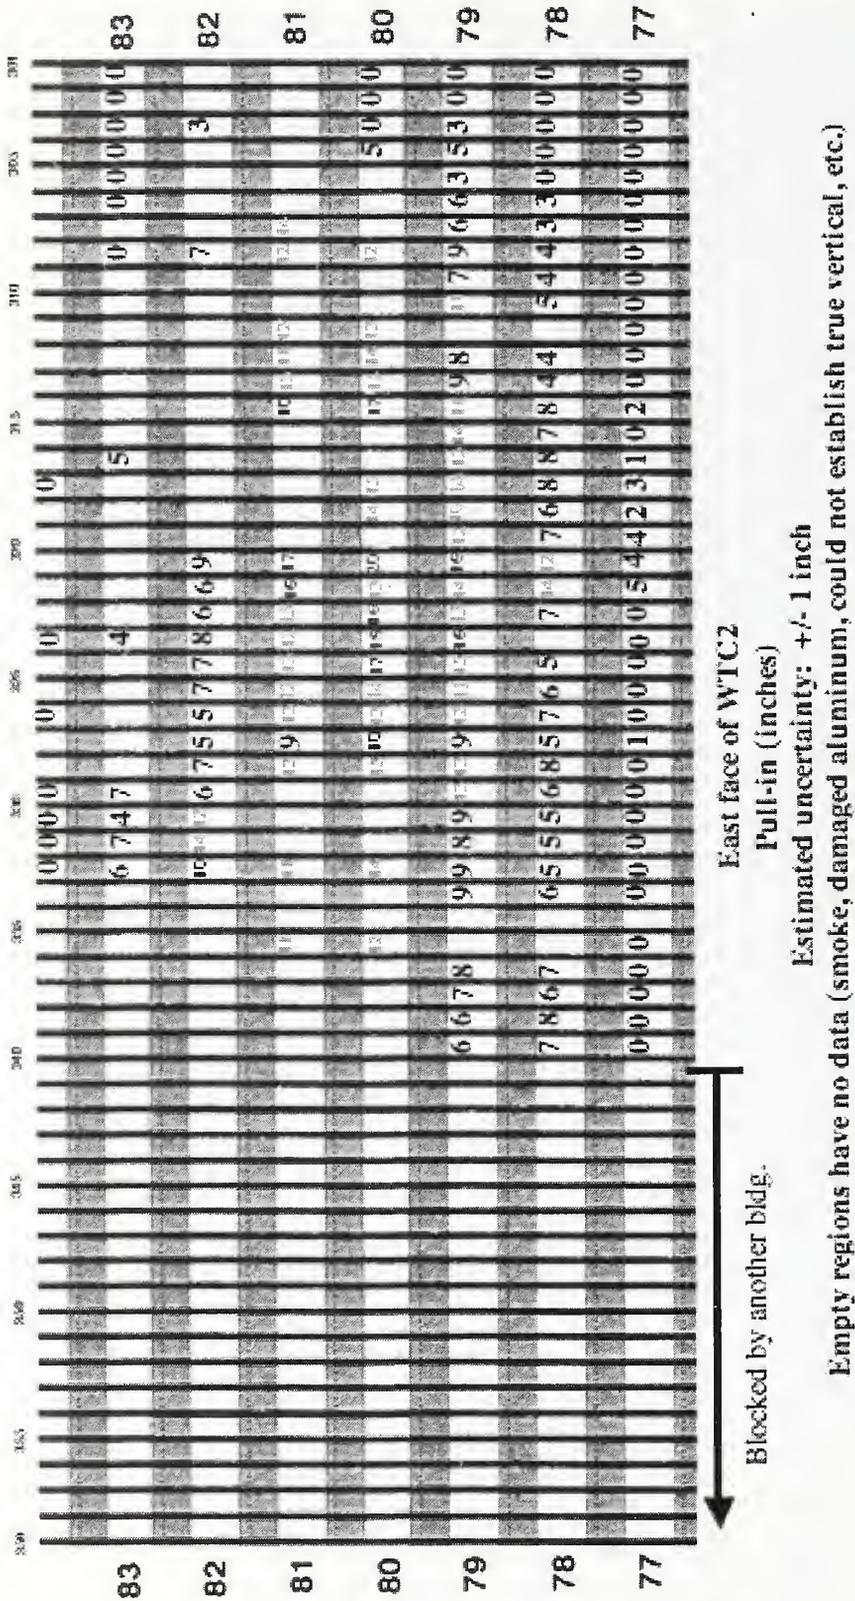
Figure 6-18. Map of pull in displacements of the east outer face of WTC 2 inward shortly before collapse. Each measurement refers to the upper left corner of the window within which the number resides. Measurements were in inches. The colors refer to groups of 5 in. displacements (0-5: black, 6-10: blue, 11-15: orange, 16-20: red) for easier visualization. This data was combined from two images taken by the same photographer at nearly the same location 10 s apart, and it is assumed that the inward deflection did not change appreciably during this time.
