**NIST NCSTAR 1-3**

**Federal Building and Fire Safety Investigation of the  
World Trade Center Disaster**

**Mechanical and Metallurgical  
Analysis of Structural Steel**

September 2005

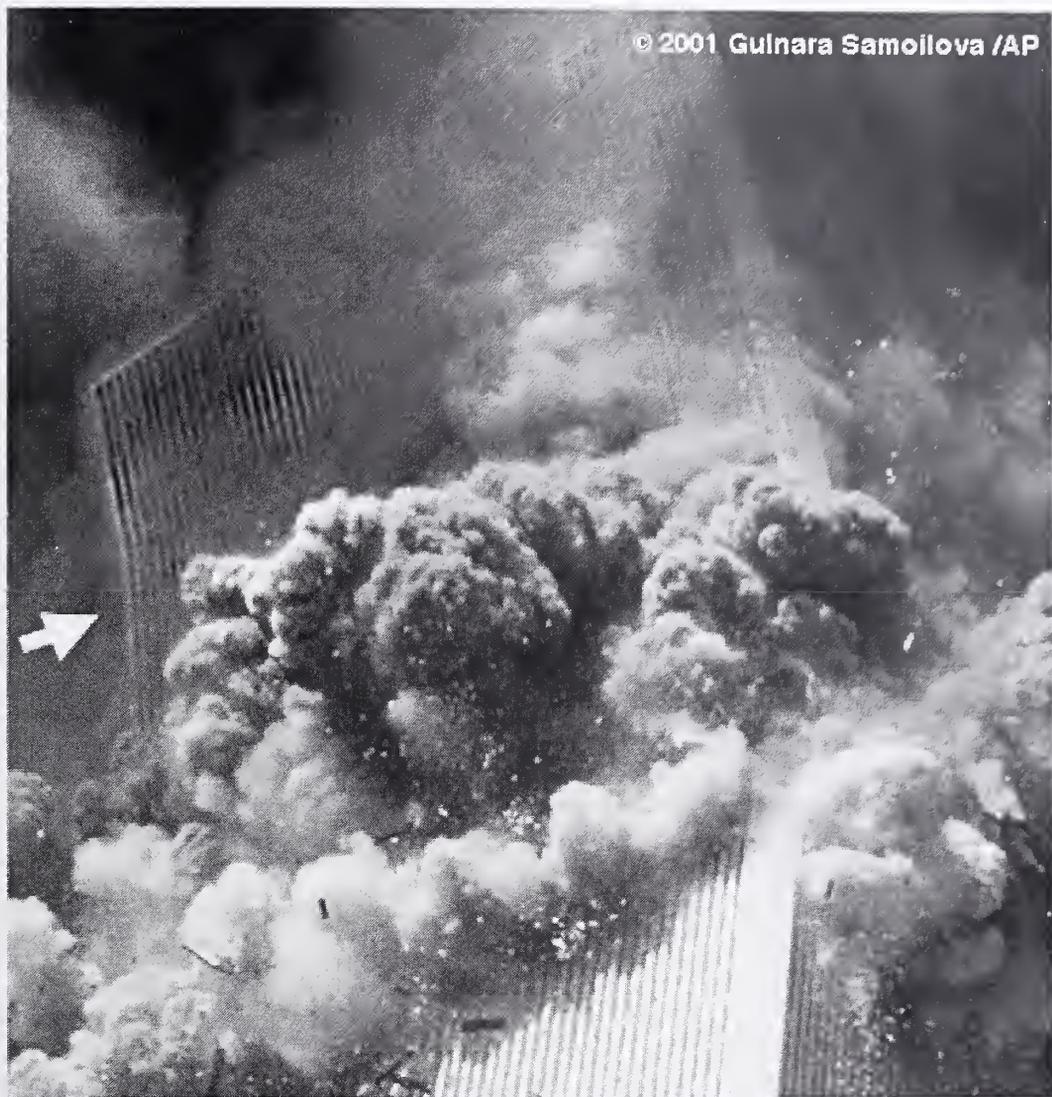
**Figure 6–19. Initial seconds of collapse of WTC 2 viewed from the east-northeast, and kink in the southeast edge of the building near the 106th floor (arrow).**

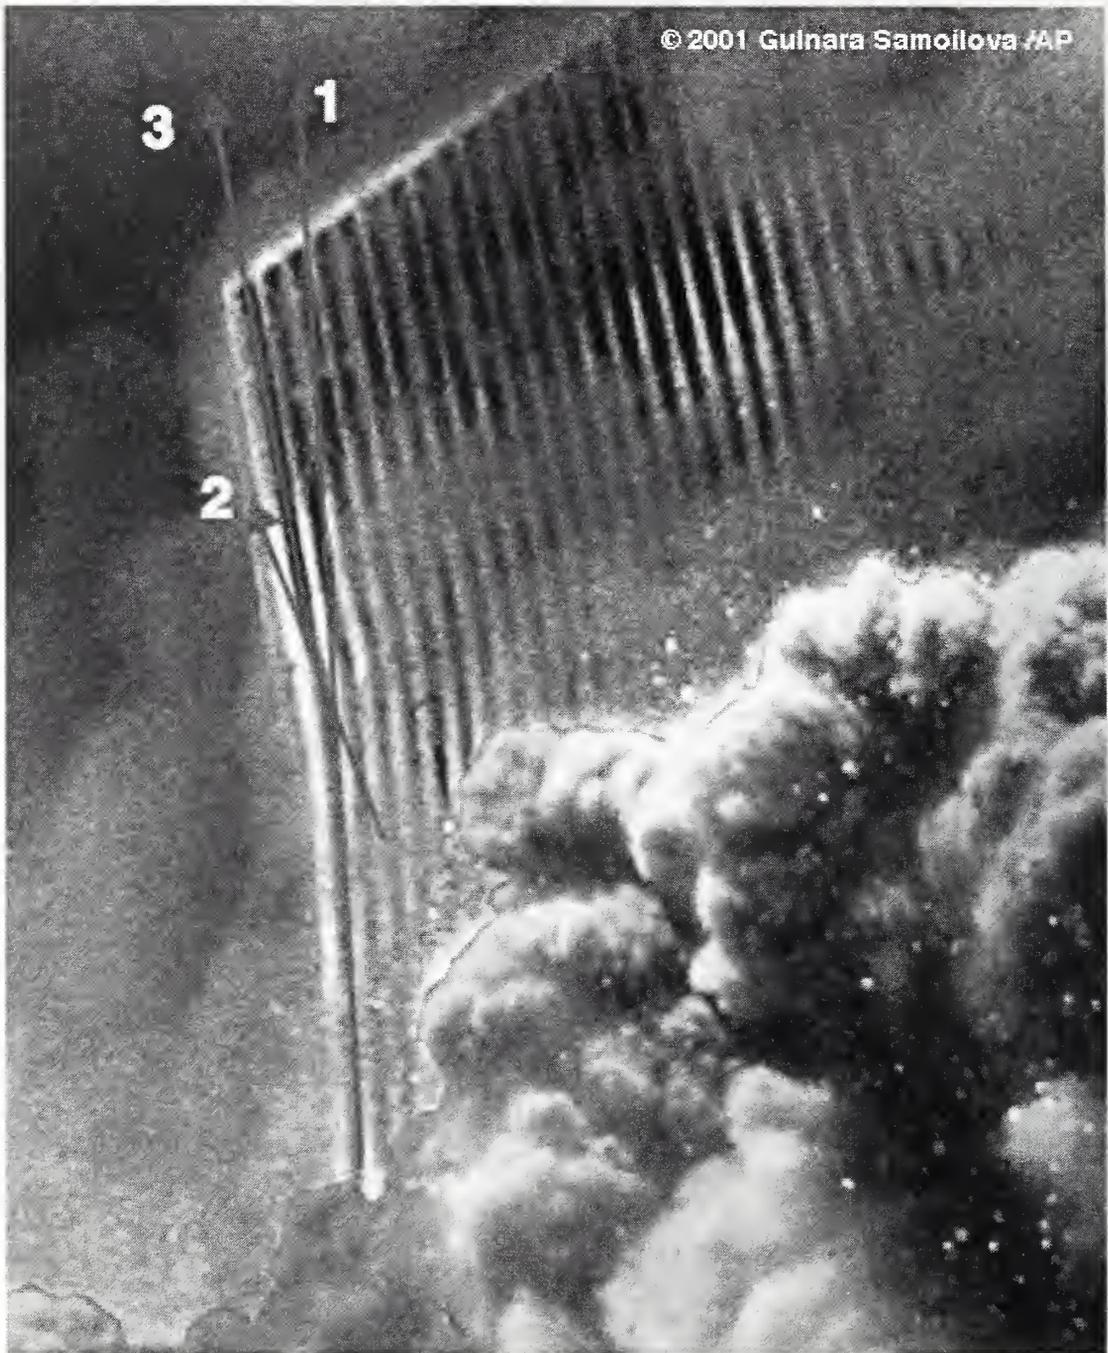
A more detailed analysis of the geometry has been made of this distortion, shown in Fig. 6–20. The kink was in fact a double-kink, and the directions of the axes of bending are shown in the figure. It was believed that this distortion was formed by the sideways shift of loads transmitted via the hat truss and rigid, beam-framed floors of floors 107 to 110, and a more detailed structural analysis can be found in NIST NCSTAR 1-6E. Examination of the right side of the image, after considerable image processing, shows that the NE corner of the building bent, but had no sharp discontinuity. Thus, the sharp kink had not propagated across the face of the building. An image taken approximately 2 s before collapse (Fig. 6–21) shows no bending, so it is believed that the kink developed at either the moment of collapse initiation or during the earliest moments of the collapse process.

**Figure 6–20.** A close-up of the kink area in the previous figure (southeast corner, WTC 2), with overlaid lines to highlight the details of the kink geometry. The edge of the building (1) bends an angle to another direction (2), then bends back somewhat toward the original direction (3).

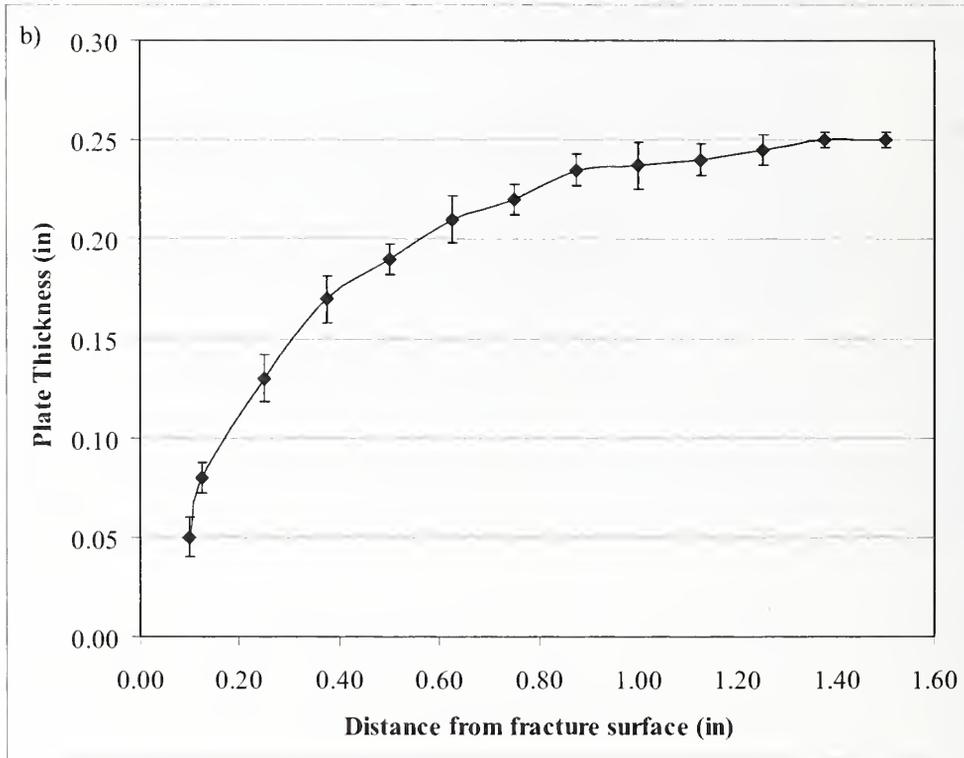
Figure 6-23. Thinning of outer web from column 130 of panel M-2 (A130: 96-99).  
 a) Photograph showing thinning, b) graph indicating plate thinning near fracture surface.

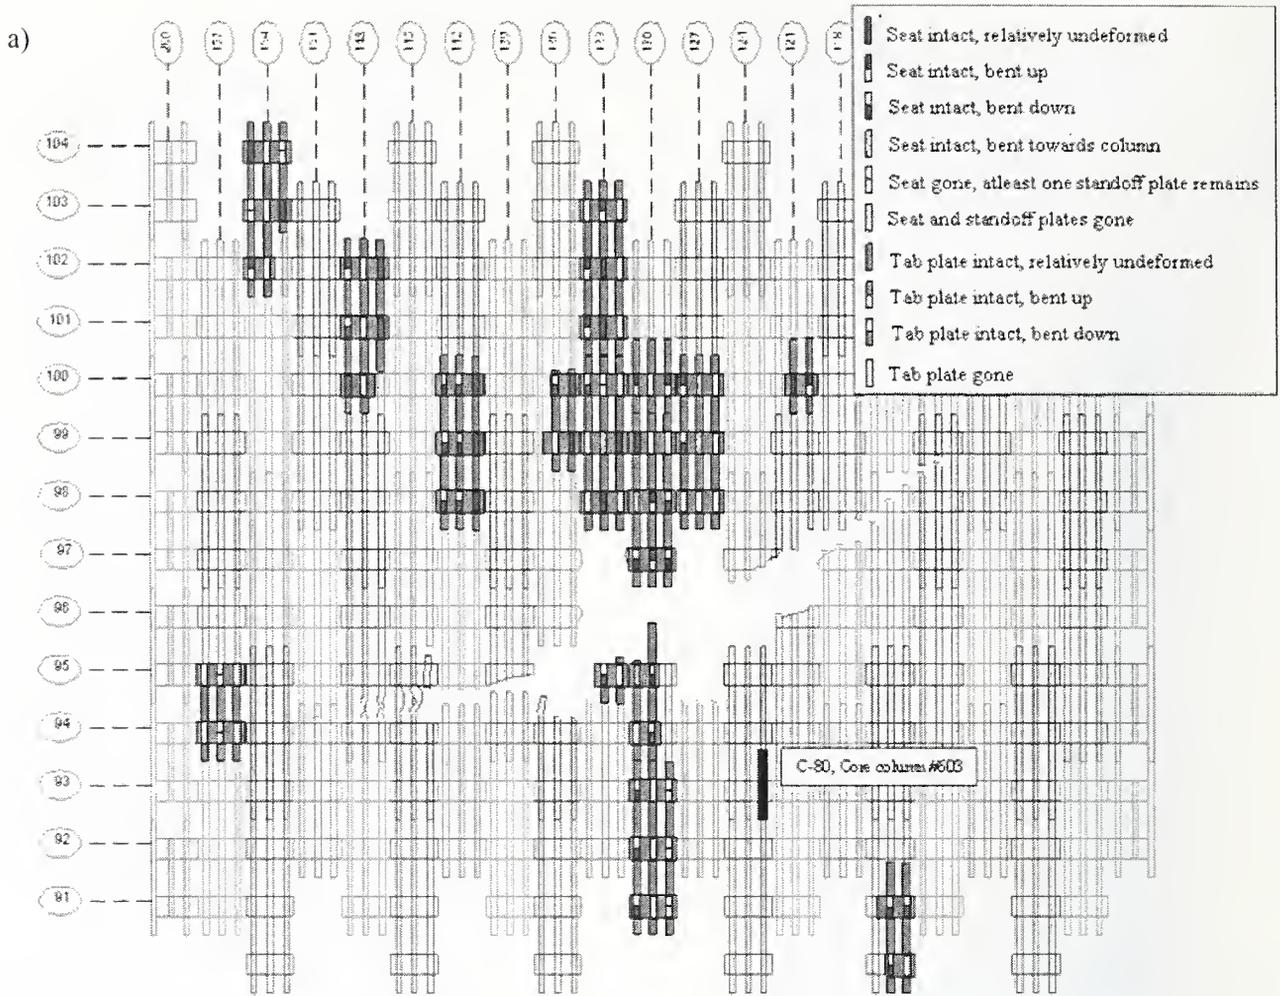
**Figure 6-28a. Damage diagram overlaid with recovered samples and damage of connectors.**

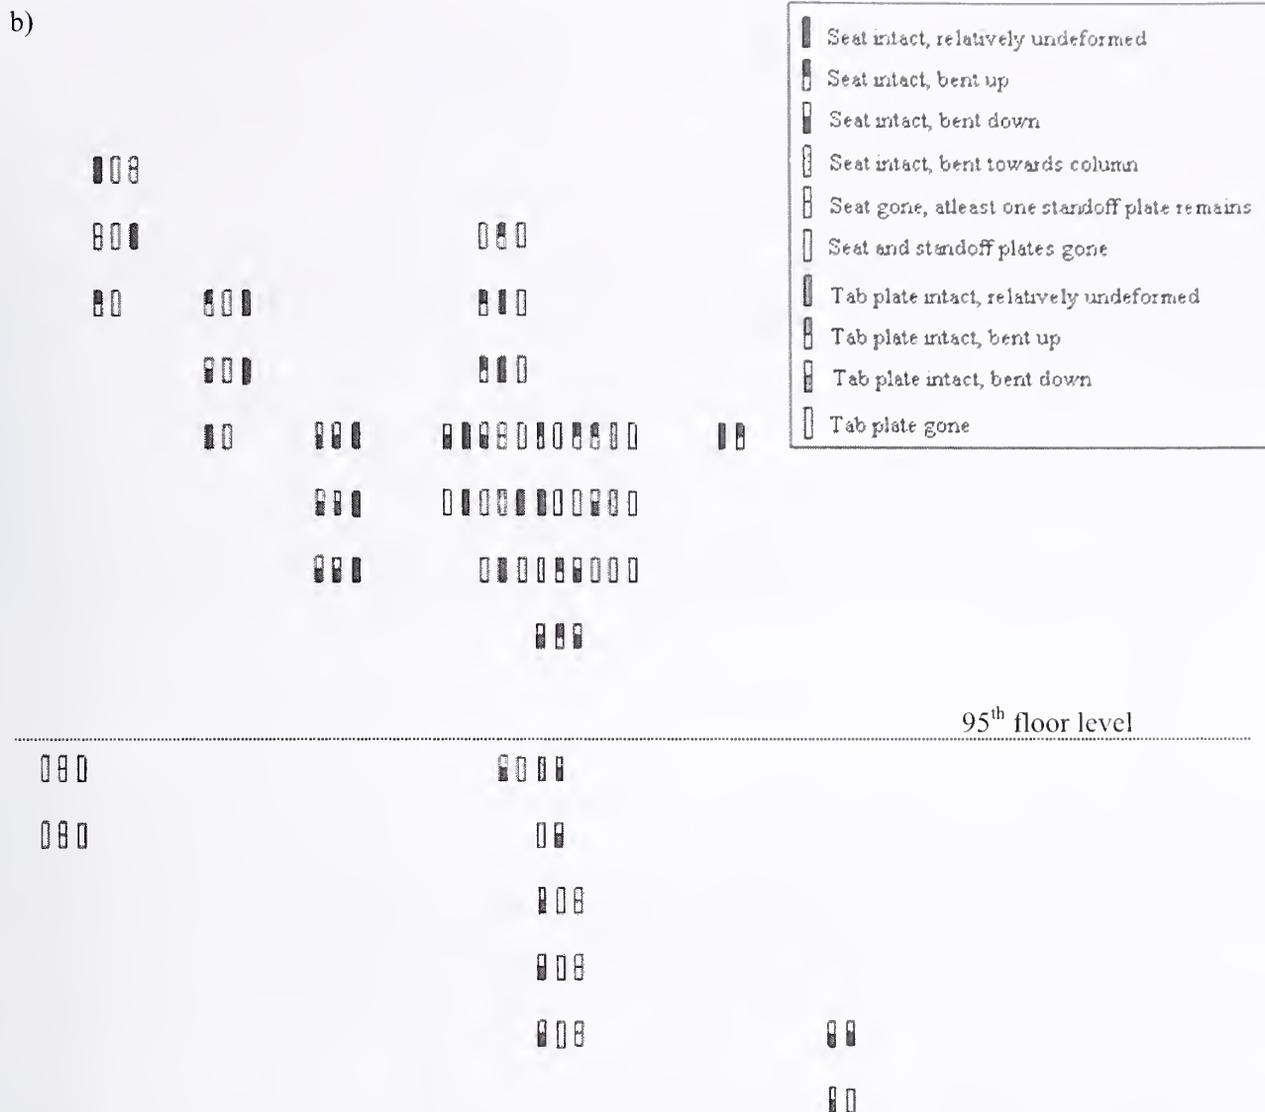
Figure 6–28b. Damage of connectors. At or below the 95th floor, all connectors are either bent down or missing.

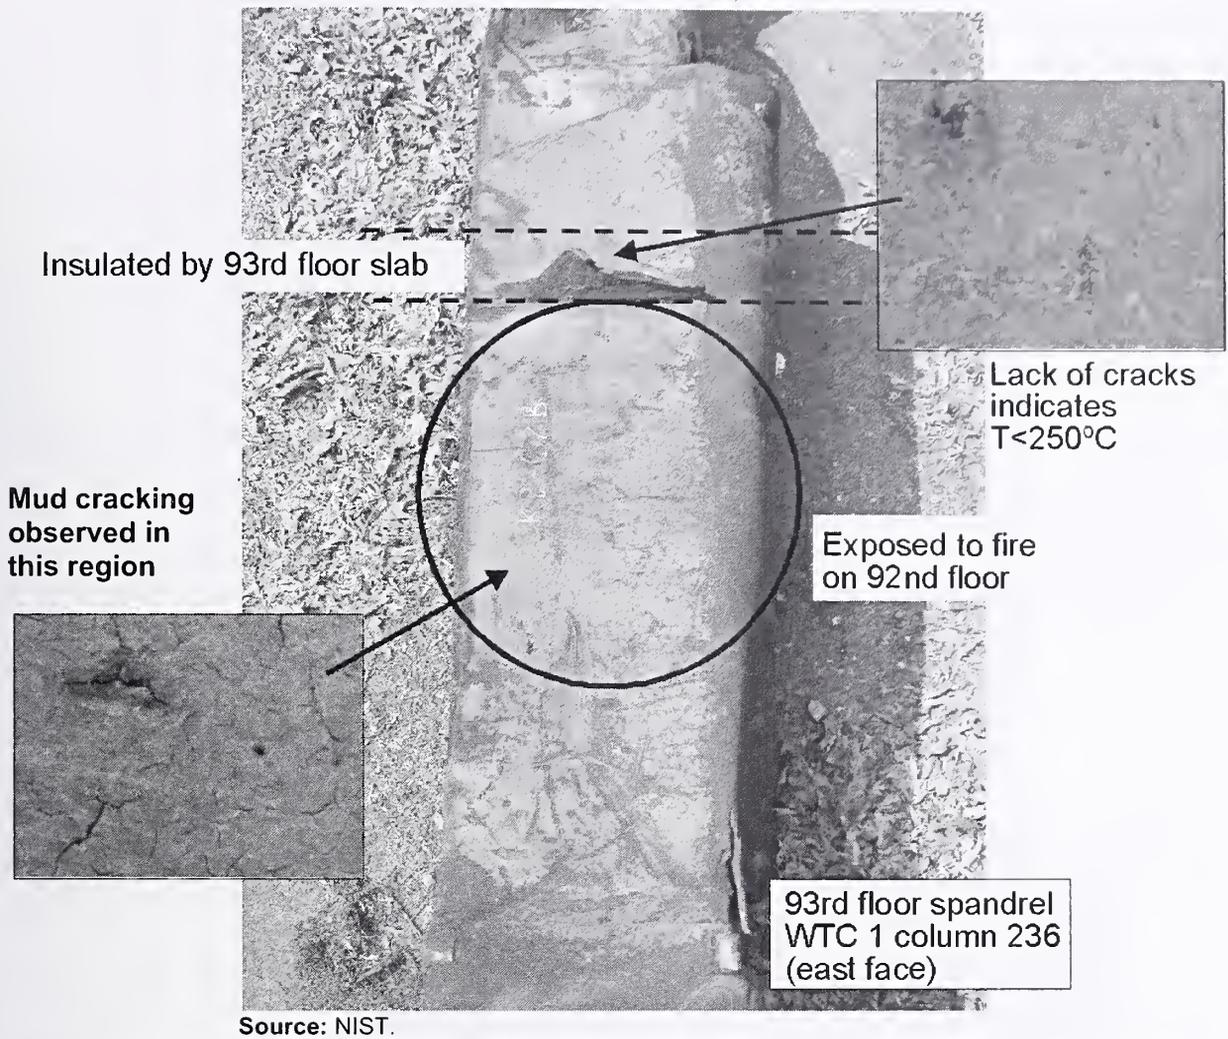
Figure 6–37. Spandrel at the 93rd floor of column 236 from sample K-2 (A236: 92-95). Paint mud cracking was found below the 93rd floor line, no evidence of paint mud cracking was found above floor line.
