NIST NCSTAR 1-3C

Federal Building and Fire Safety Investigation of the
World Trade Center Disaster

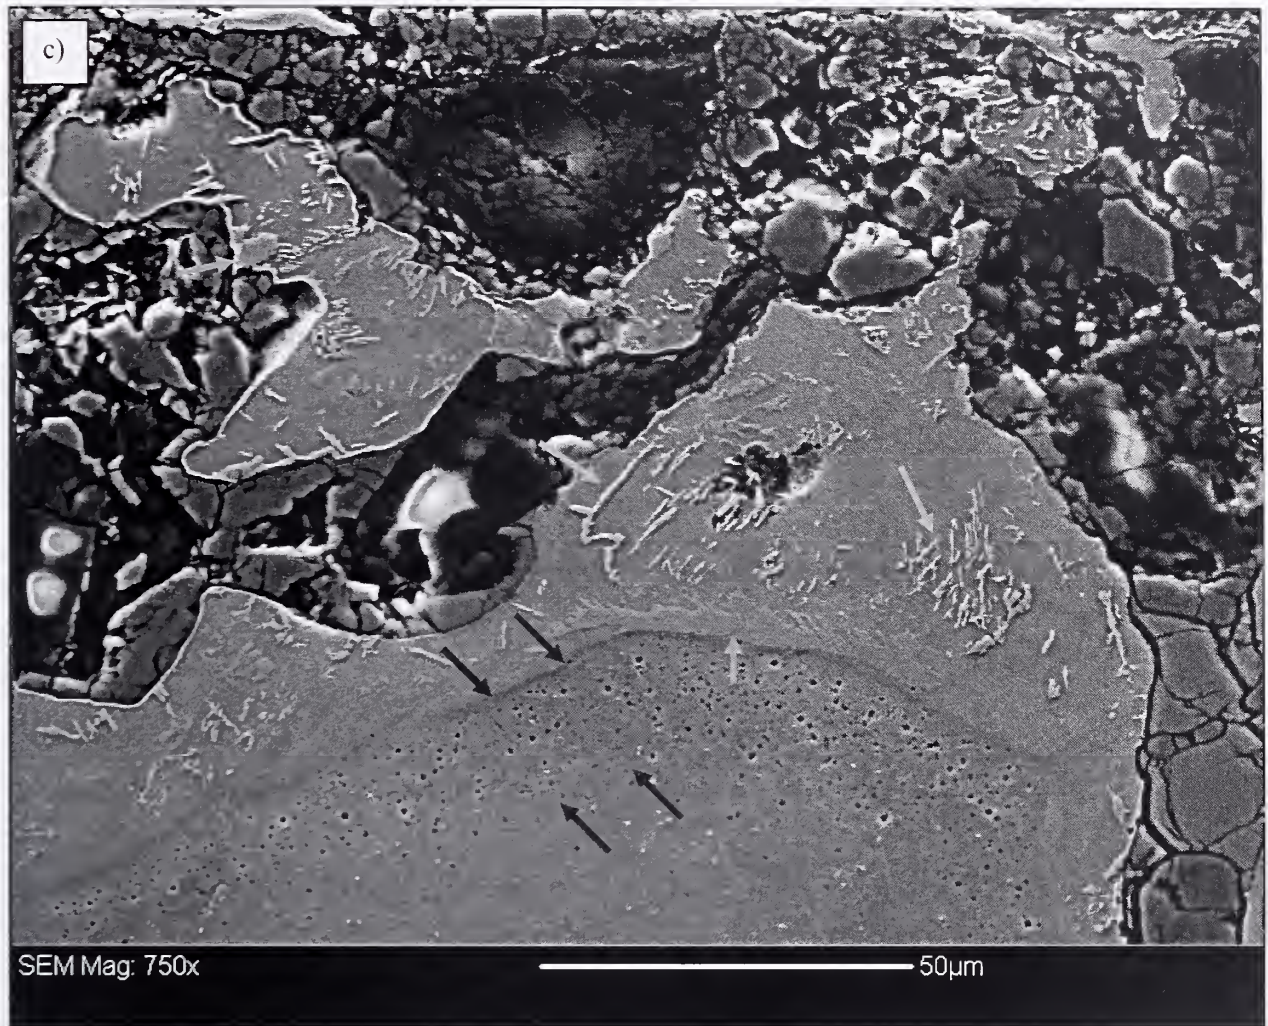
Note: Unless otherwise noted, values are in percentages of observations.

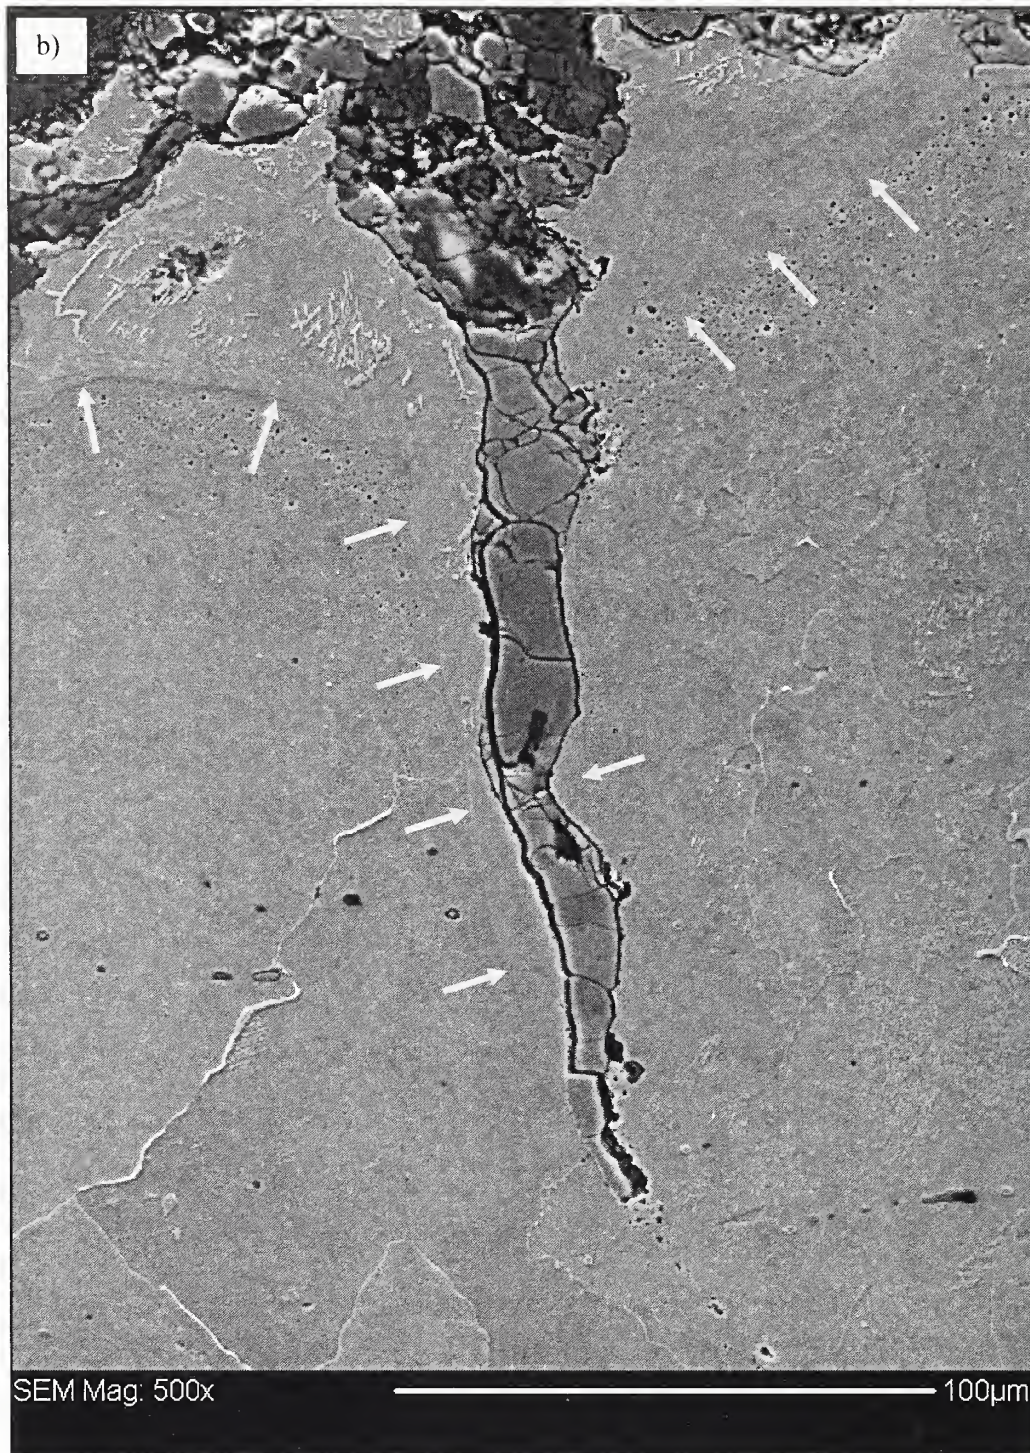
Figure 6–28. Secondary electron image showing the corrosion scale found on sample C-115. c) Blue arrows indicate the internal oxidation zone, green arrows indicate the “feathery” morphology and orange arrows indicated the “needle-like” morphology of corrosion phases observed. Two percent nital and 4 percent picral etch.

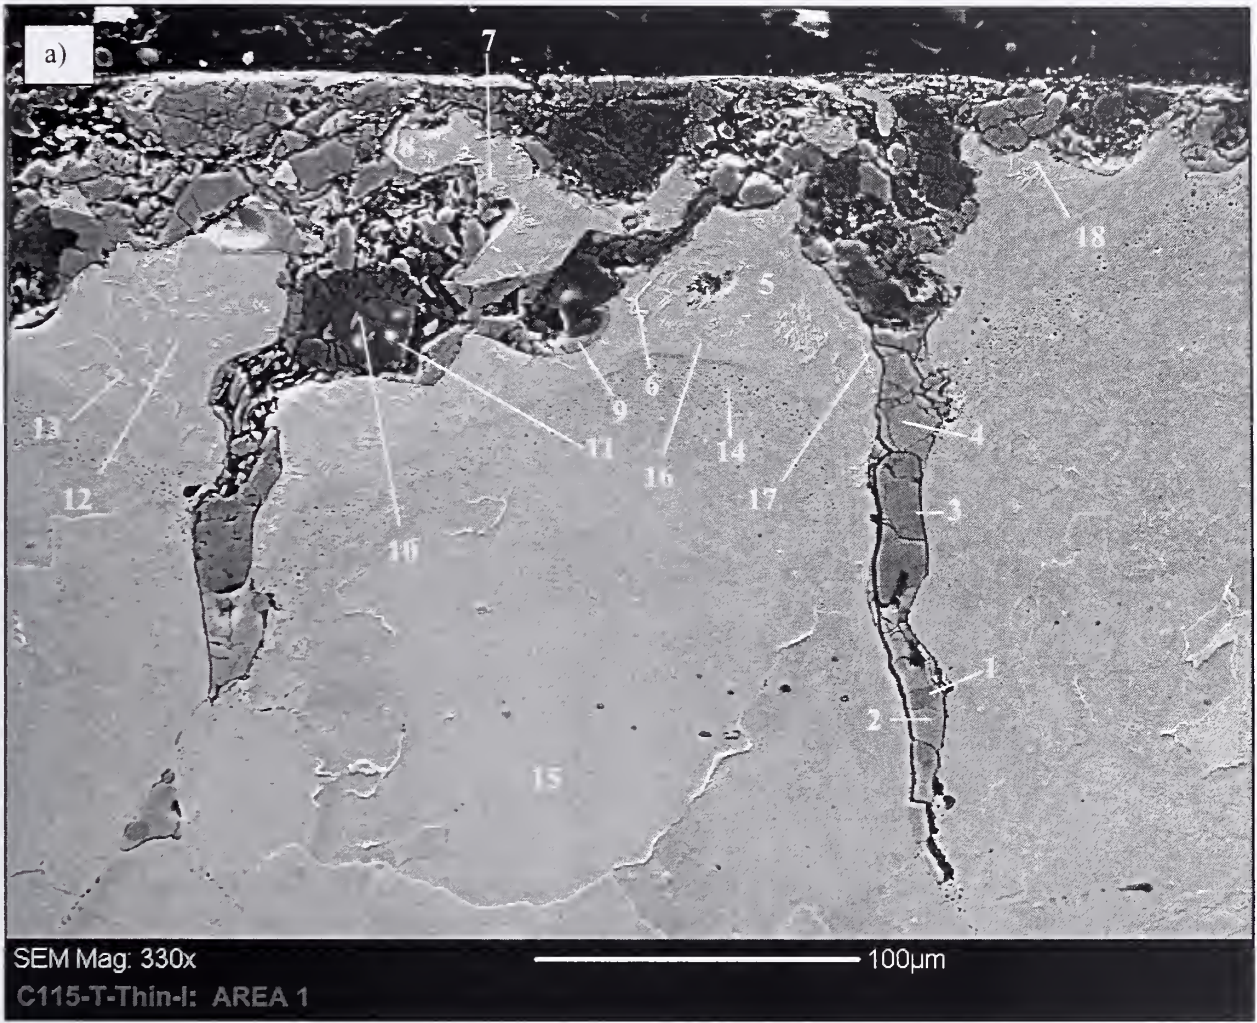
Figure 6-28. Secondary electron image showing the corrosion scale found on sample C-115. b) yellow arrows indicating the Fe-Ni layer between the penetrating corrosion product and internal oxidation zone. Two percent nital and 4 percent picral etch (cont.).

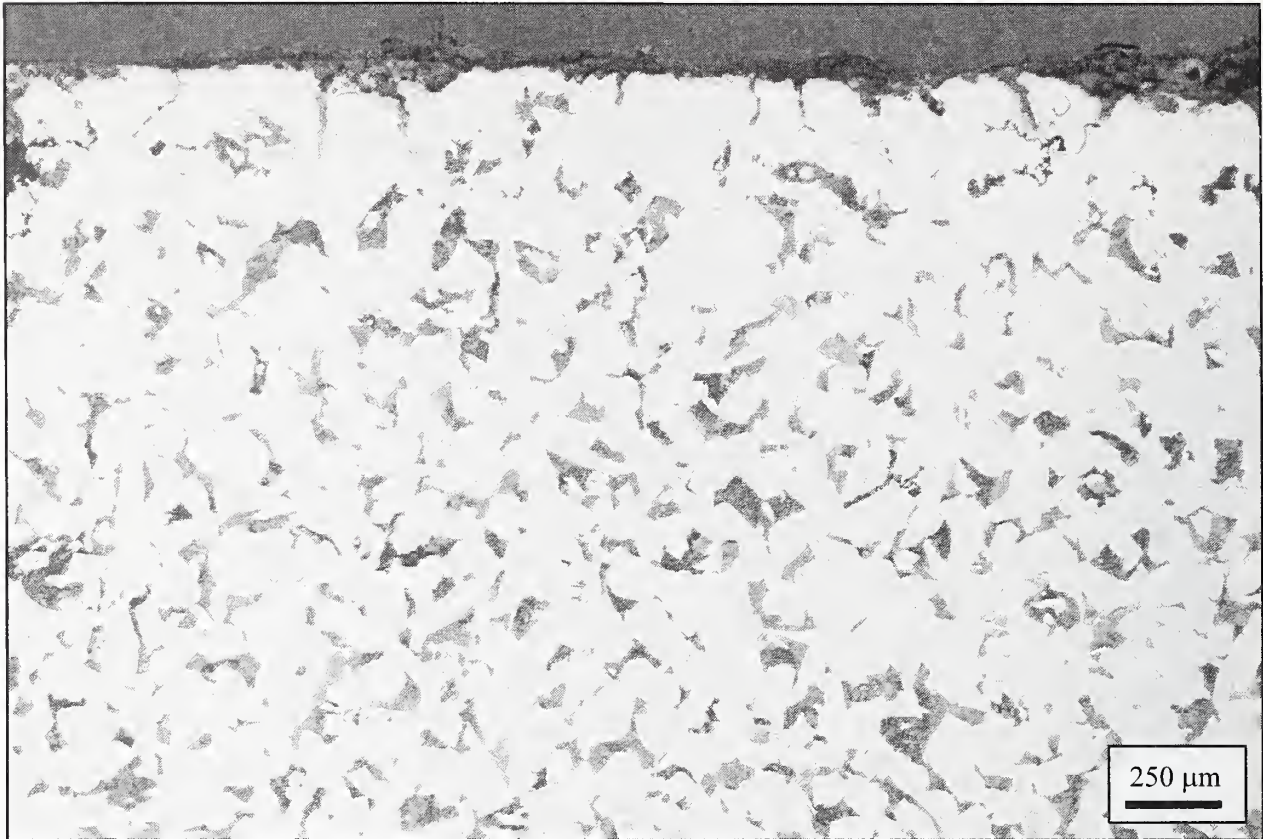
Figure 6–28. Secondary electron image showing the corrosion scale found on sample C-115. a) The location of EDS analysis (results shown in Table 6–3) were indicated. Two percent nital and 4 percent picral etch.

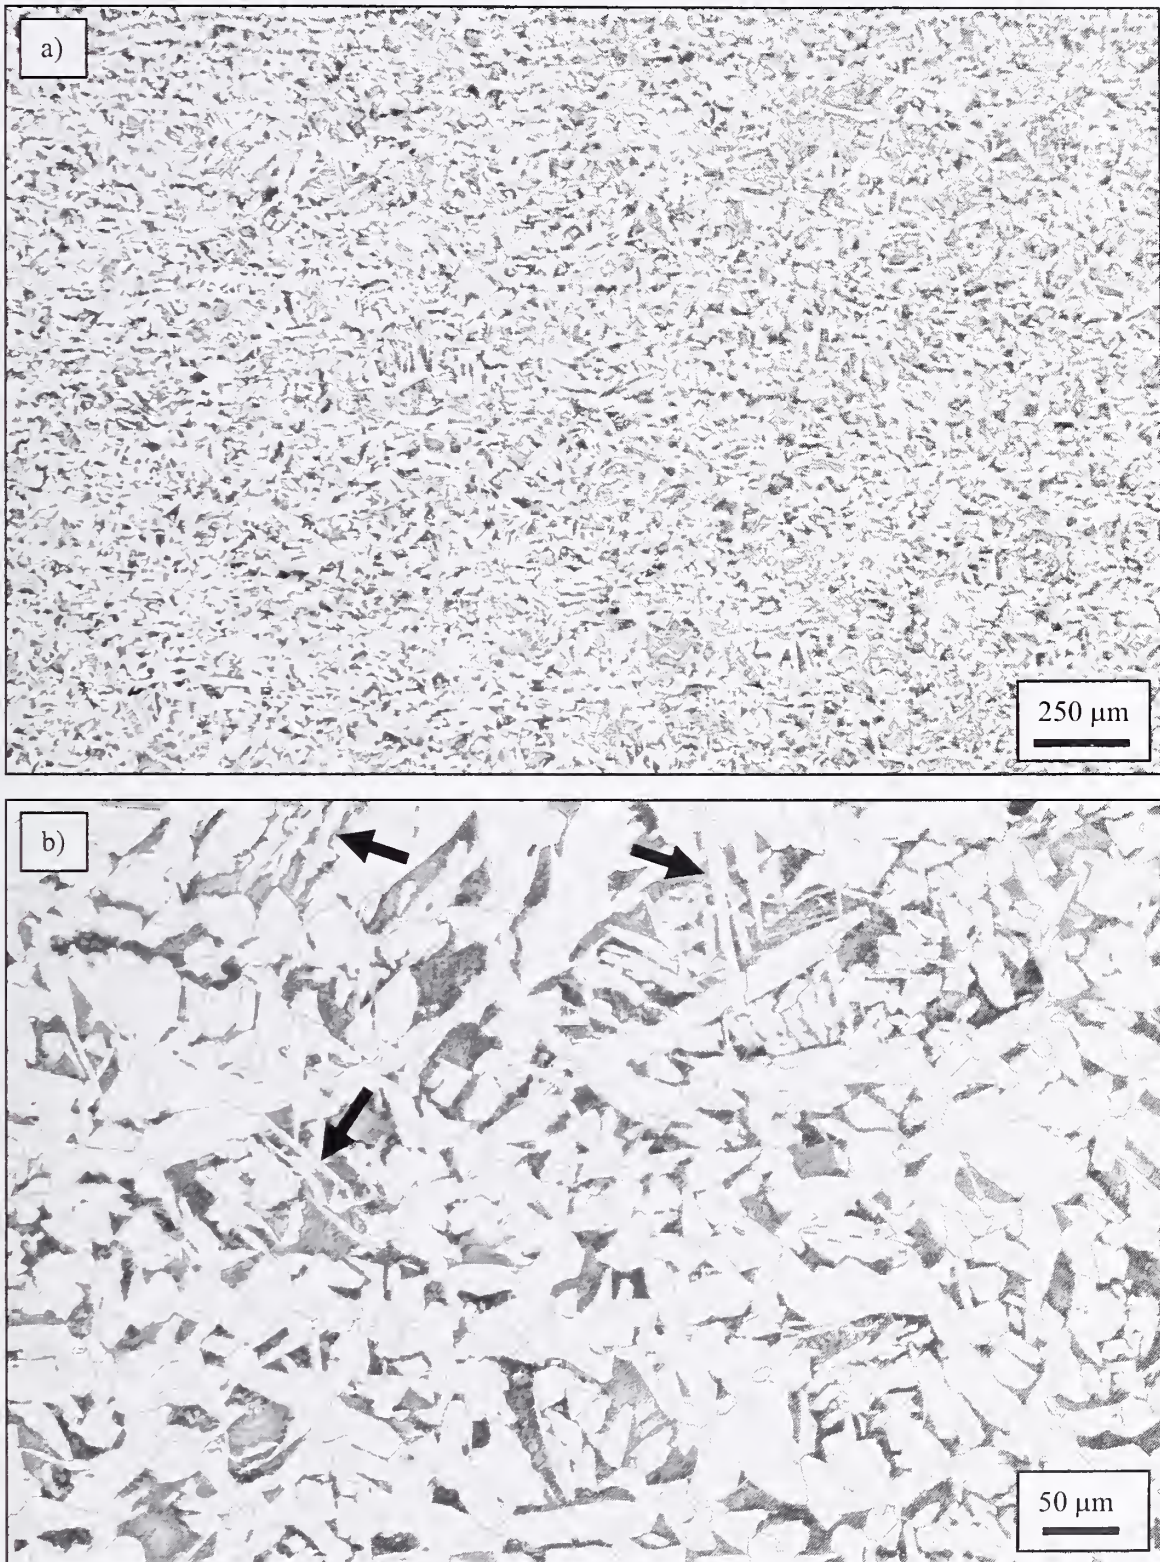
Figure 6-27. Light optical micrograph showing the structure of corrosion scale formed on sample C-115. A decarburization zone was not observed. Two percent nital and 4 percent picral etch.

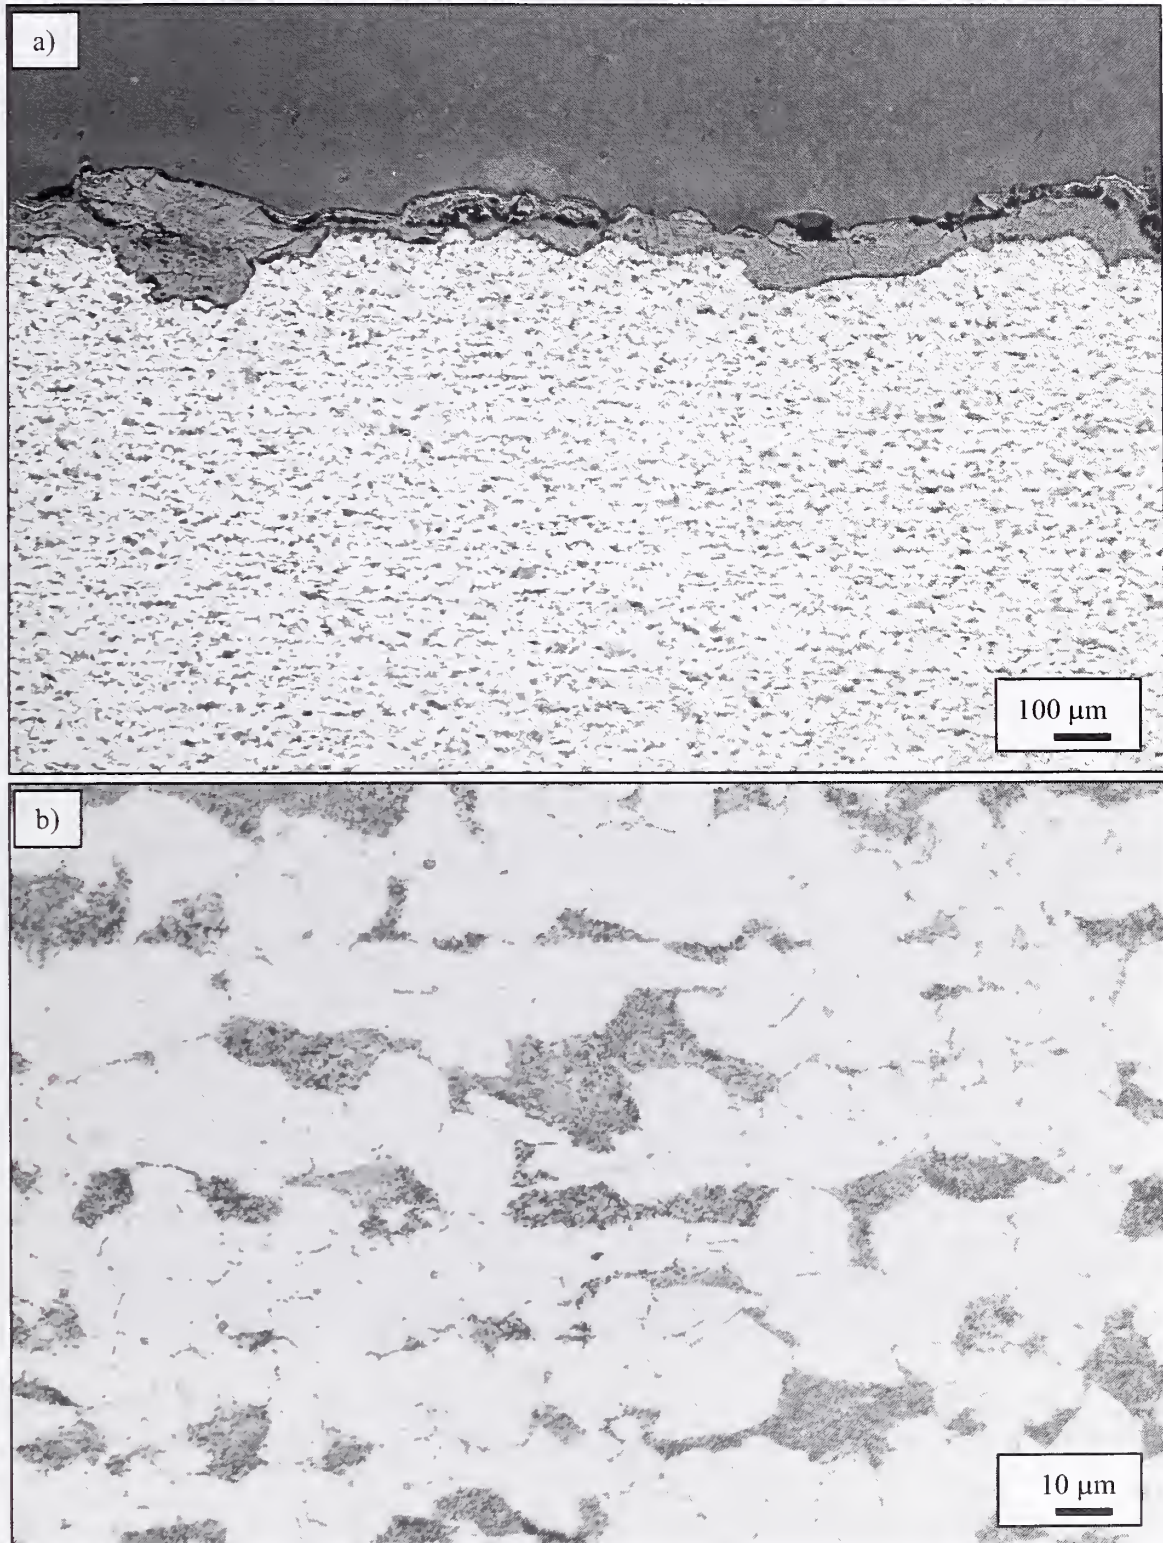
Figure 6–23. Photograph showing the location, size, shape, and orientation of sample removed from panel K-16 prior to its arrival on the NIST campus. Sample was analyzed in FEMA/BPAT study. Yellow areas indicate flame cut edges.

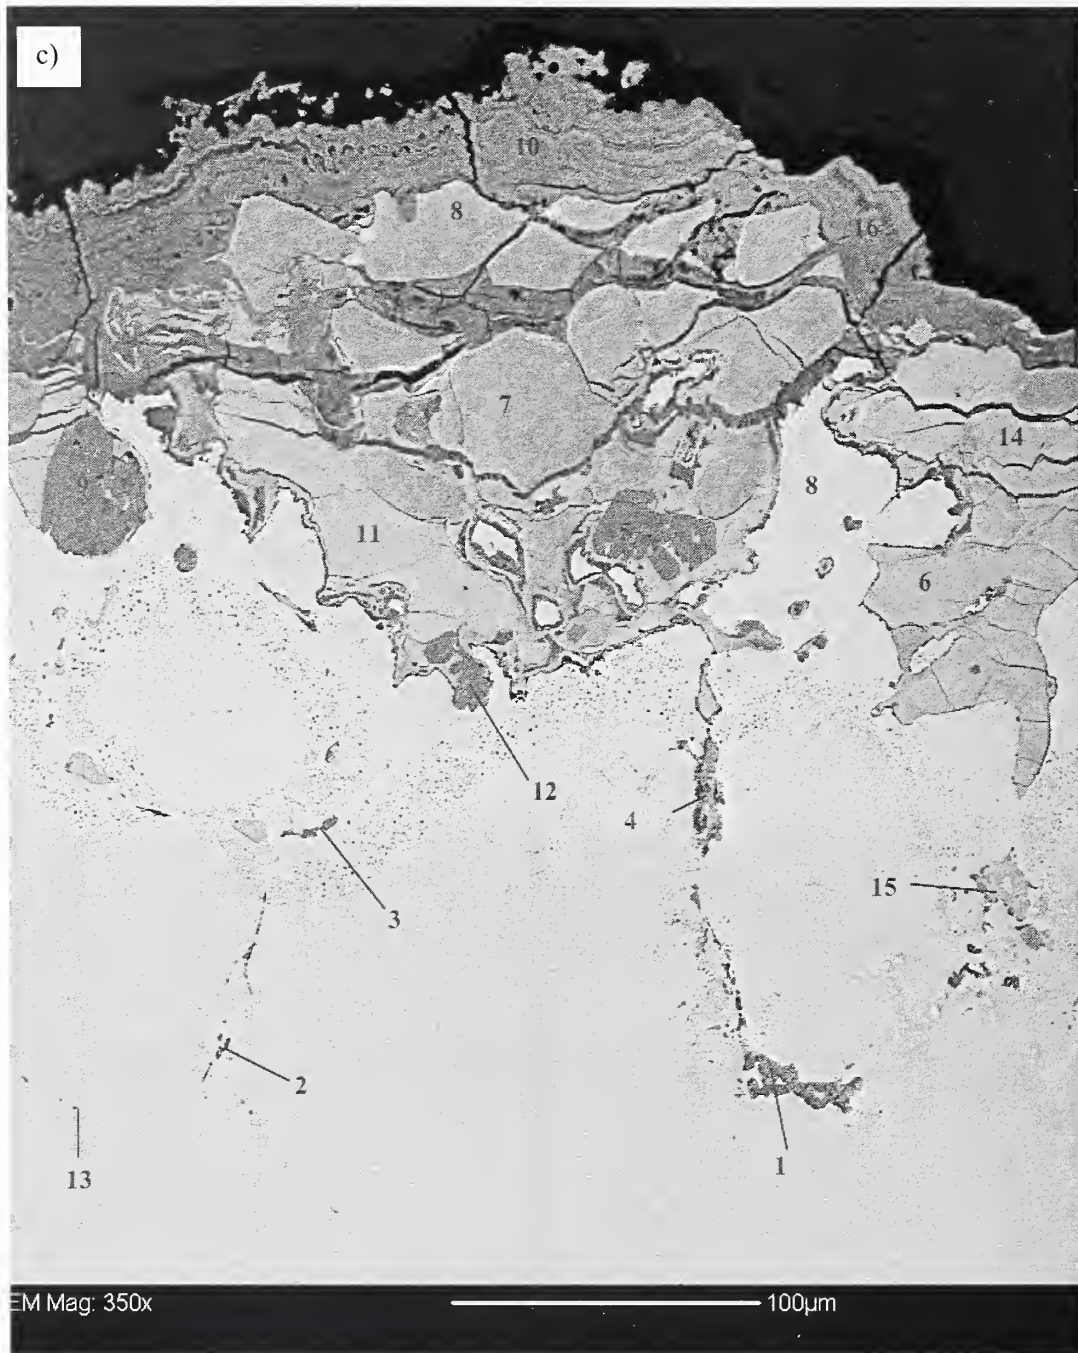
Figure 6–22. Light optical micrographs showing structure of the 50 ksi column labeled K-16 near the base of the column where the corrosion process did not occur. As-built location was not known. a) low magnification and b) pearlite has begun to spheroidize. Two percent nital and 4 percent picral etch.

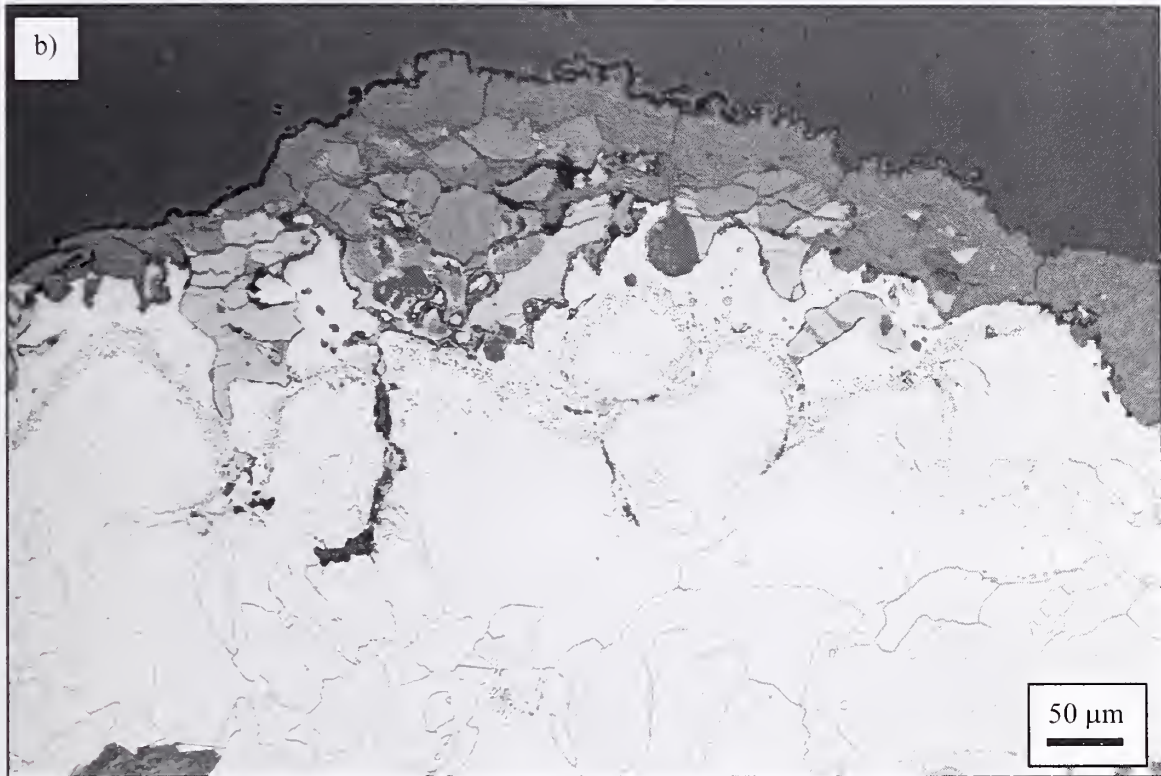
Figure 6-21. c) Secondary electron micrograph showing corrosion scale formation on panel K-16. As-built location was not known. Sample in the as-polished condition (cont.).

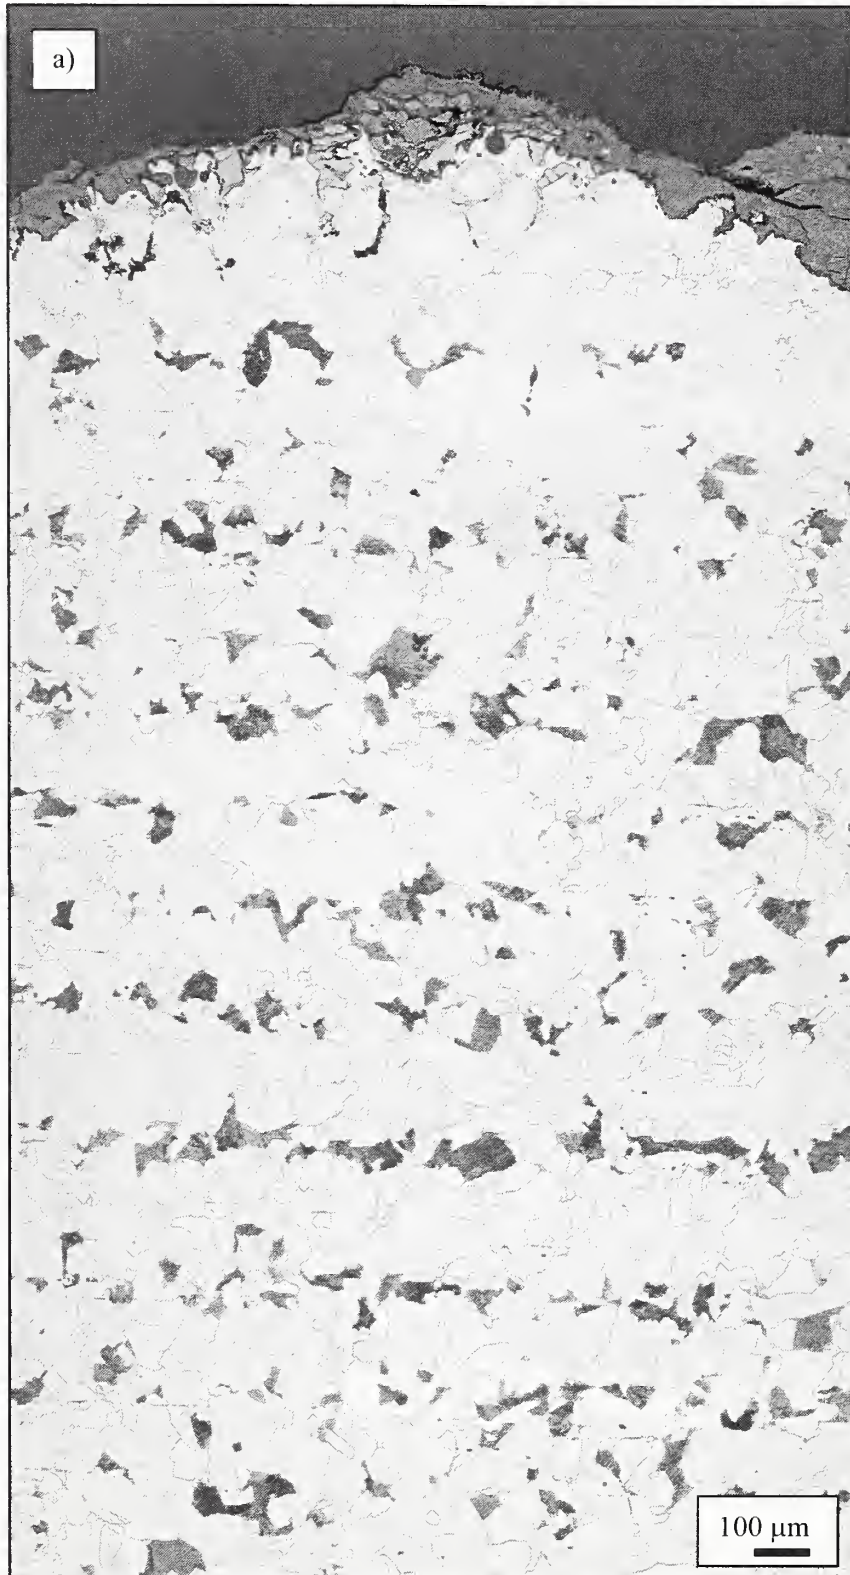
Figure 6–21. b) Light optical micrograph showing the microstructure near the metal-scale interface of the 50 ksi column labeled K-16 near where the corrosion process occurred. As-built location was not known. Two percent nital and 4 percent picral etch (cont.).

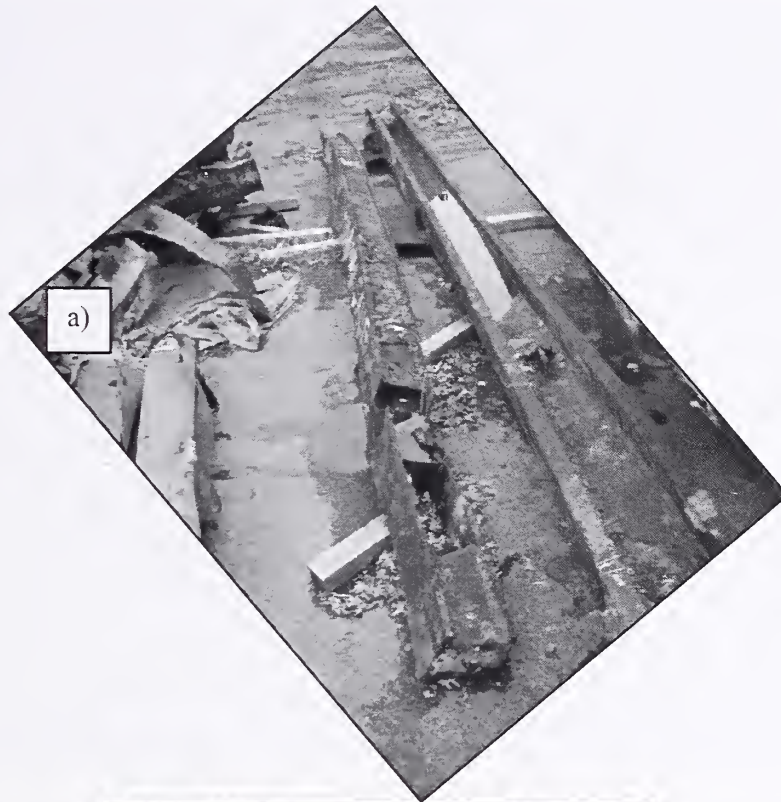
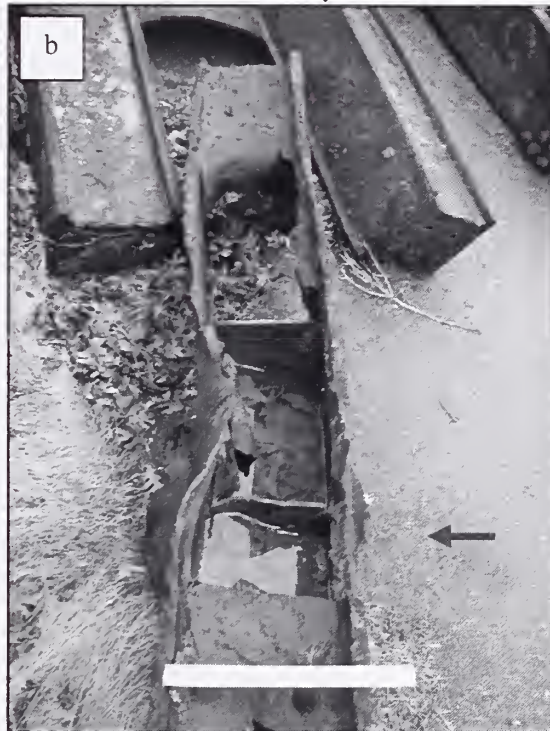
Figure 6–21. a) Light optical micrograph showing banded structure of the 50 ksi column labeled K-16 near where the extreme corrosion process occurred. As-built location was not known. Two percent nital and 4 percent picral etch.

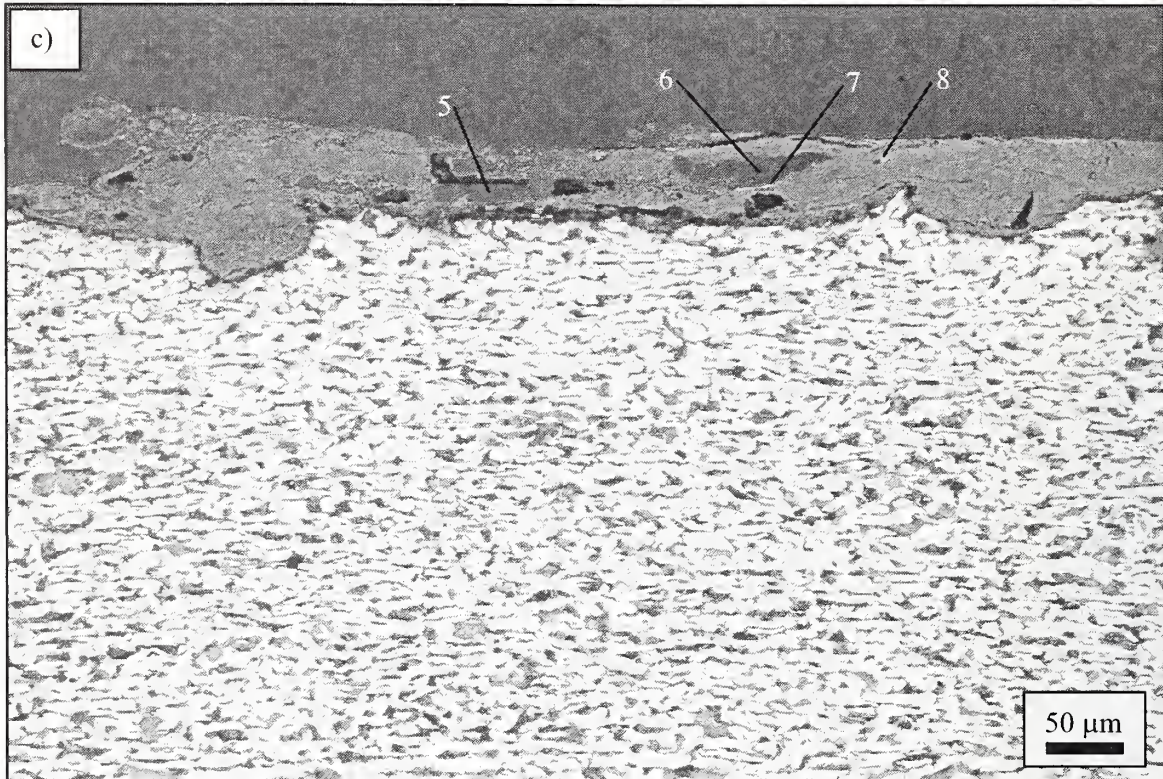
Figure 6-20. a) Overall image of panel K-16 and b) images showing the deterioration of the column due to erosion/corrosion mechanisms. Red arrow indicates direction of photograph seen in Fig. 6-23.

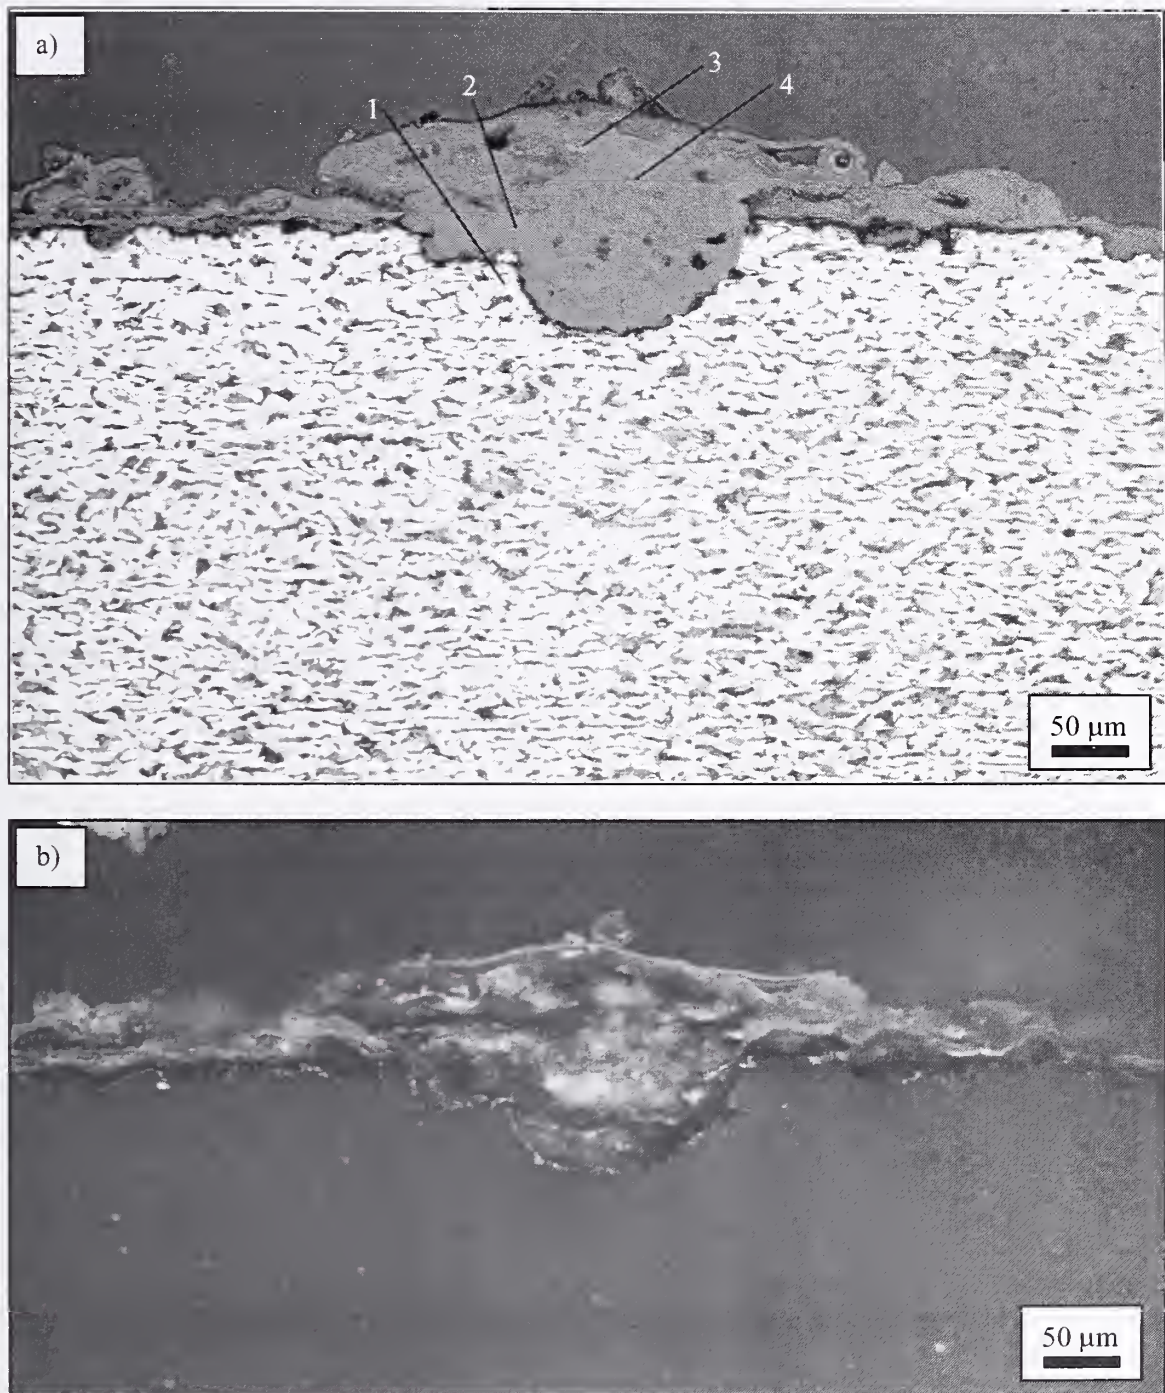
Figure 6–19. Light optical micrographs showing microstructure from flange of column 210 of panel K-1 (A209: 97-100) from the crumpled area above the 98th floor spandrel. c) Characteristic scale formation. Two percent nital and 4 percent picral etch.

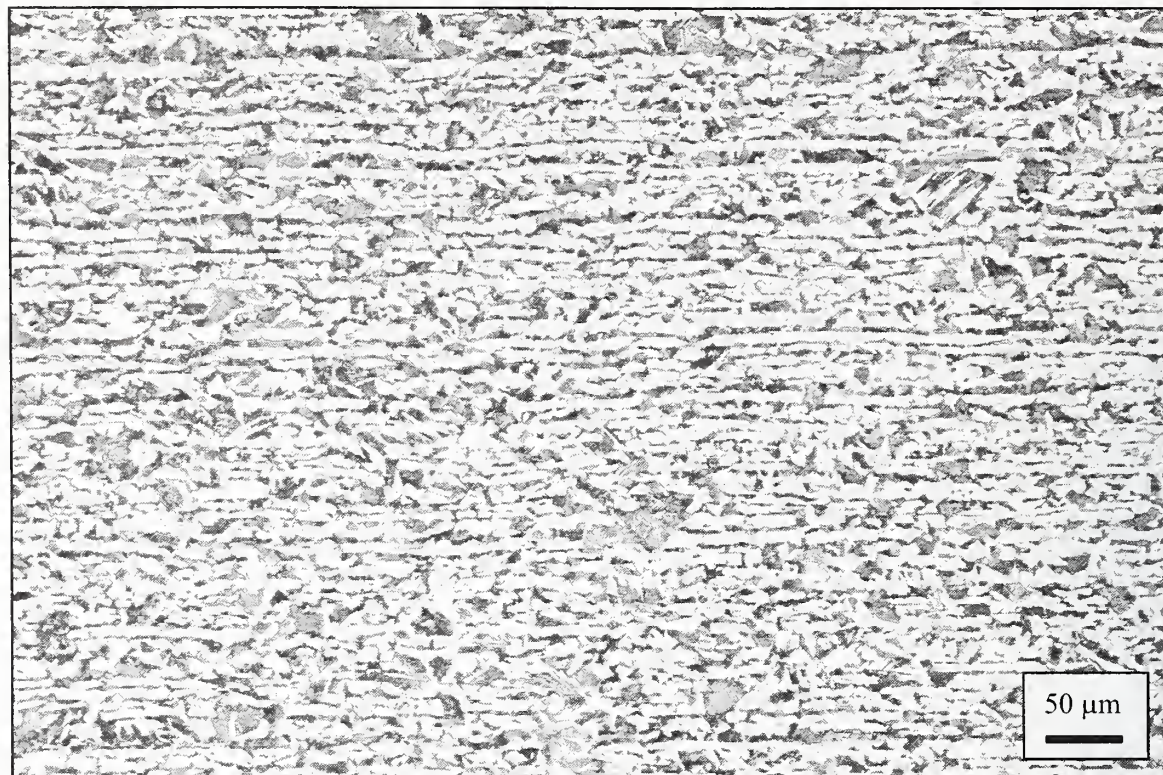
Figure 6–19. Light optical micrographs showing microstructure from flange of column 210 of panel K-1 (A209: 97-100) from the crumpled area above the 98th floor spandrel. a) Characteristic scale formation, 2 percent nital and 4 percent picral etch. b) same area, as polished, using polarized light.

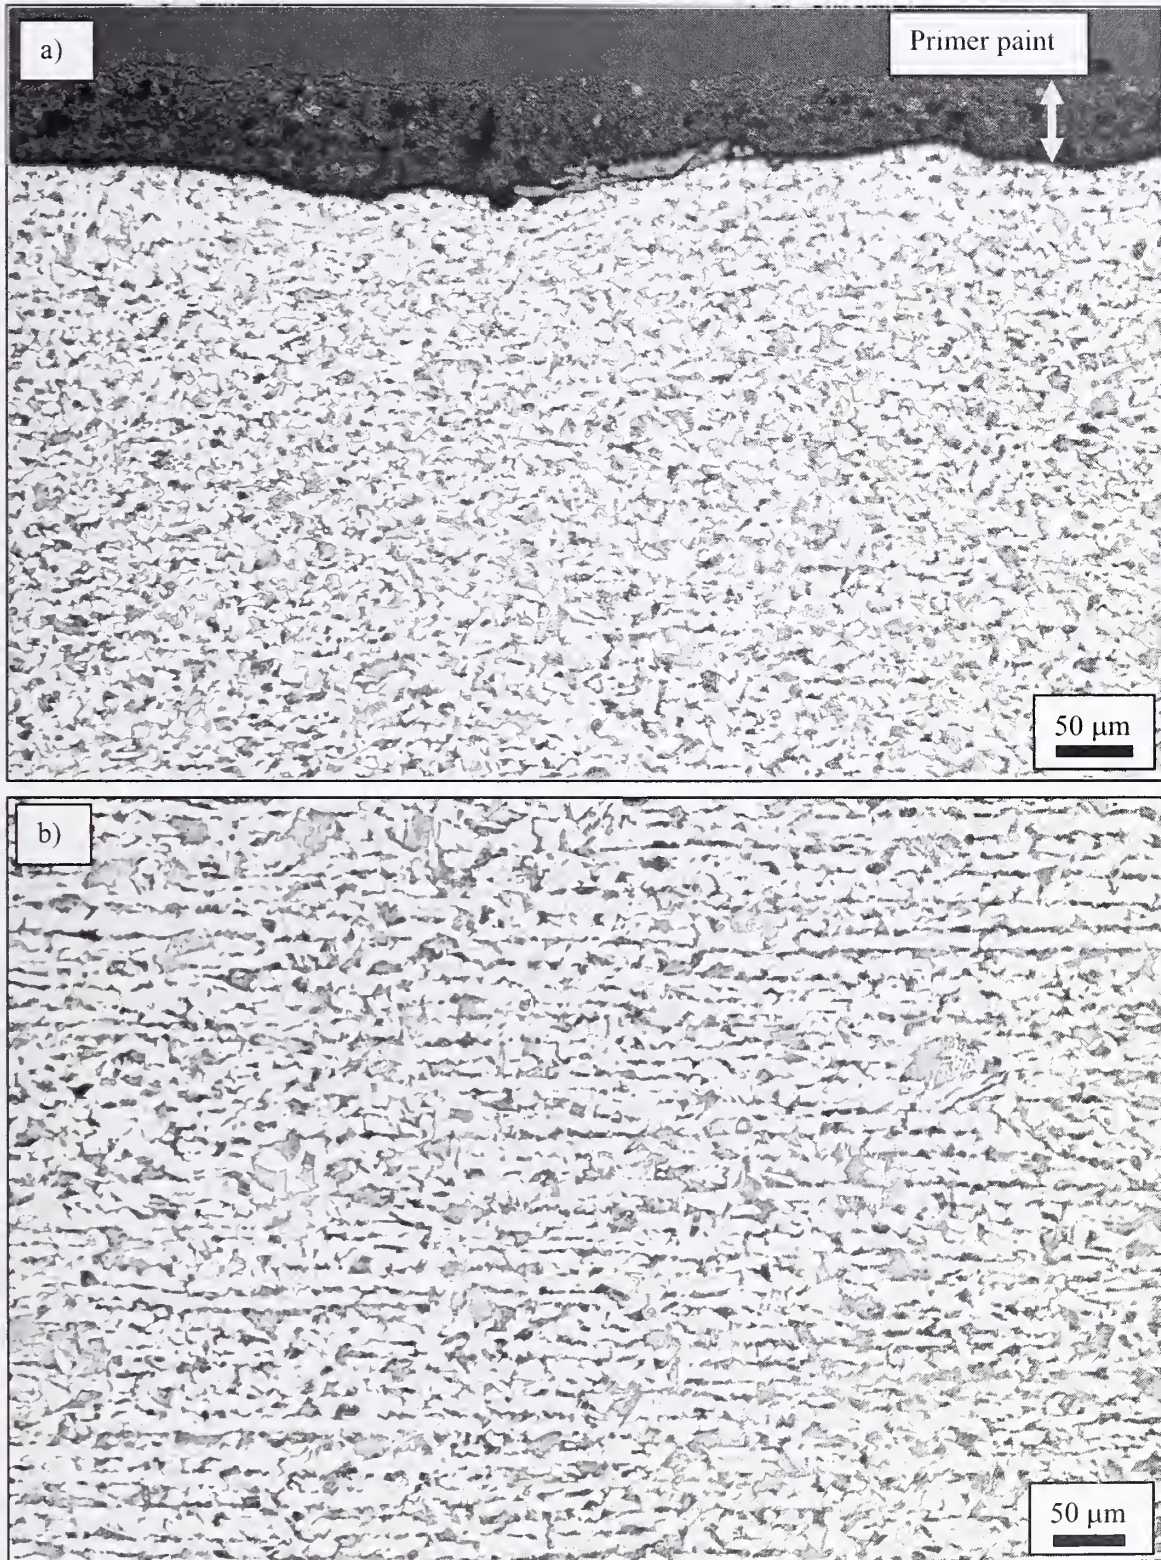
Figure 6–18. Light optical micrograph showing a characteristic microstructure taken at the centerline of a 60 ksi outer web plate. Sample is from panel C-40 (A136: 98-101), column 136 in the 99th floor region of WTC 1. Two percent nital and 4 percent picral etch.

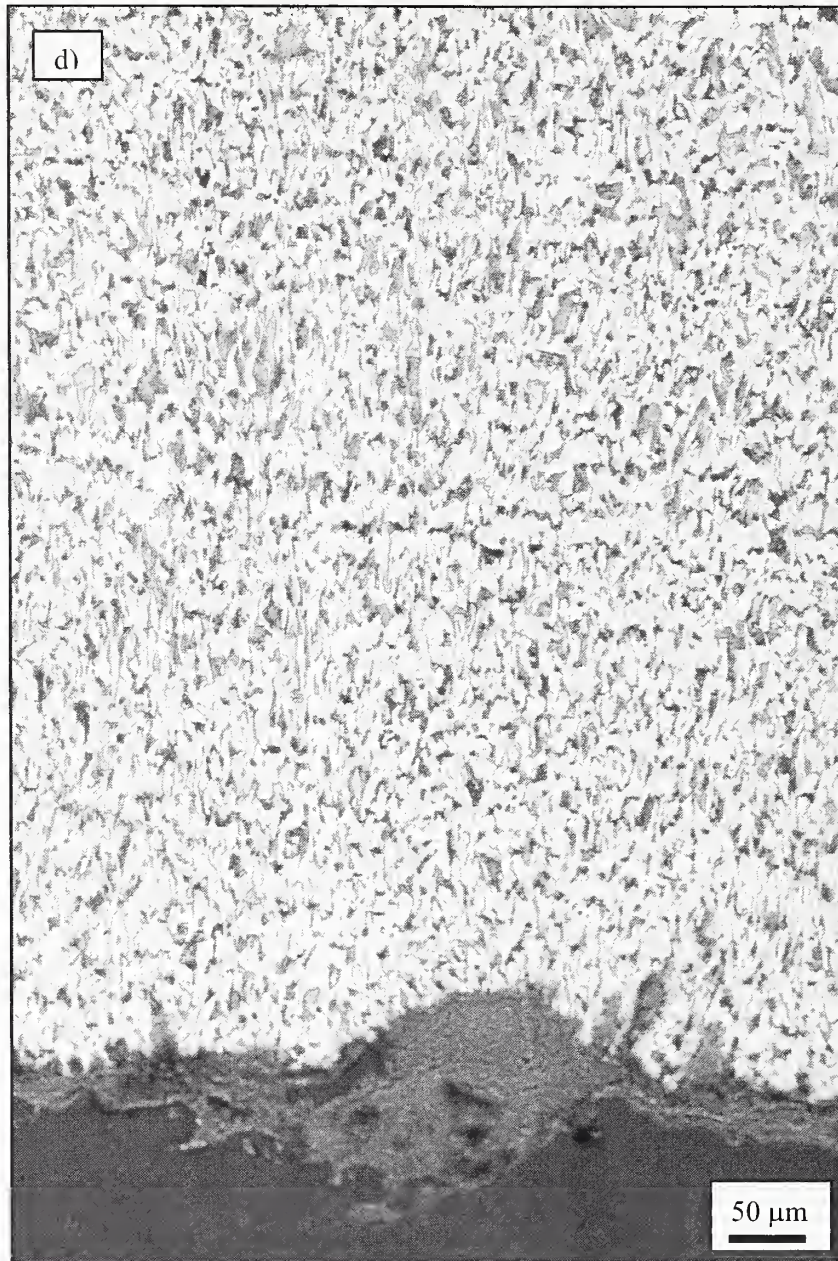
Figure 6–17. Light optical micrographs showing microstructure from flange of column 210 of panel K-1 (A209: 97-100) from the flange below the 98th floor spandrel. a) outer surface of sample and b) center line of plate. Two percent nital and 4 percent picral etch.

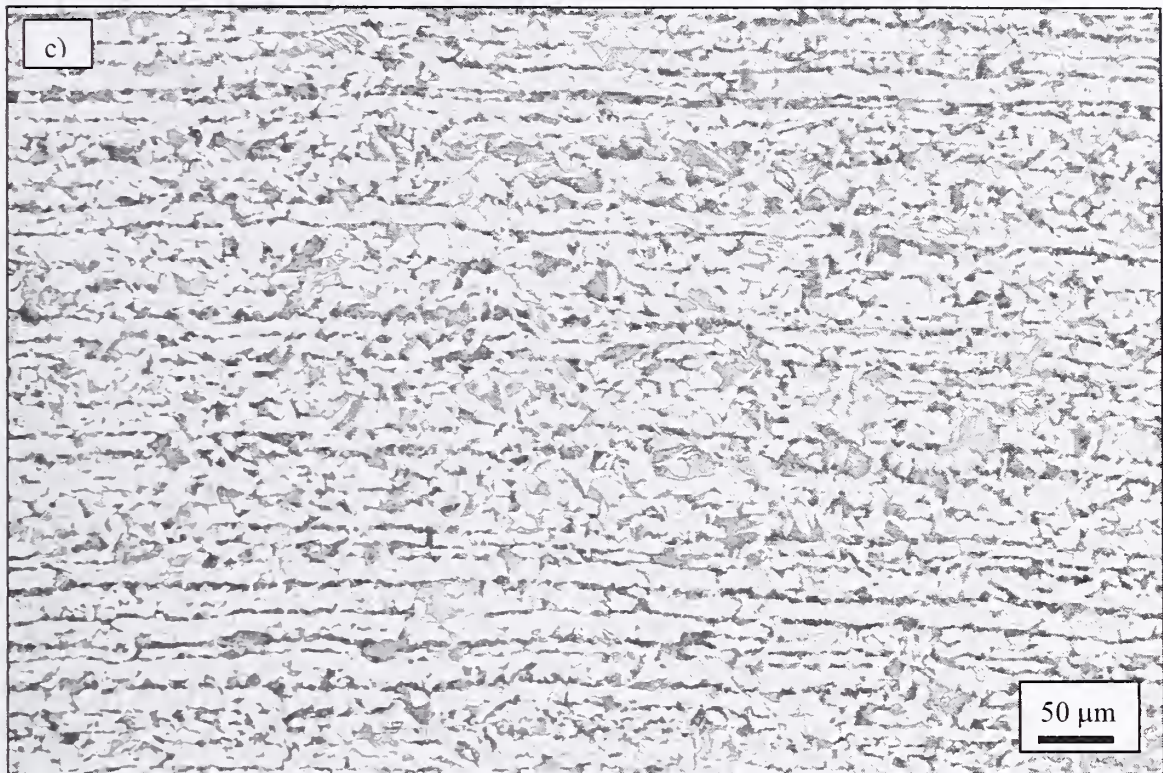
Figure 6–16. Light optical micrographs showing the microstructure from flange of column 210 of panel K-1 (A209: 97-100) from the crumpled area above the 98th floor spandrel. d) inner surface of plate showing compressed constituents of ferrite and pearlite. Two percent nital and 4 percent picral etch.
