NIST NCSTAR 1-3C

Federal Building and Fire Safety Investigation of the
World Trade Center Disaster

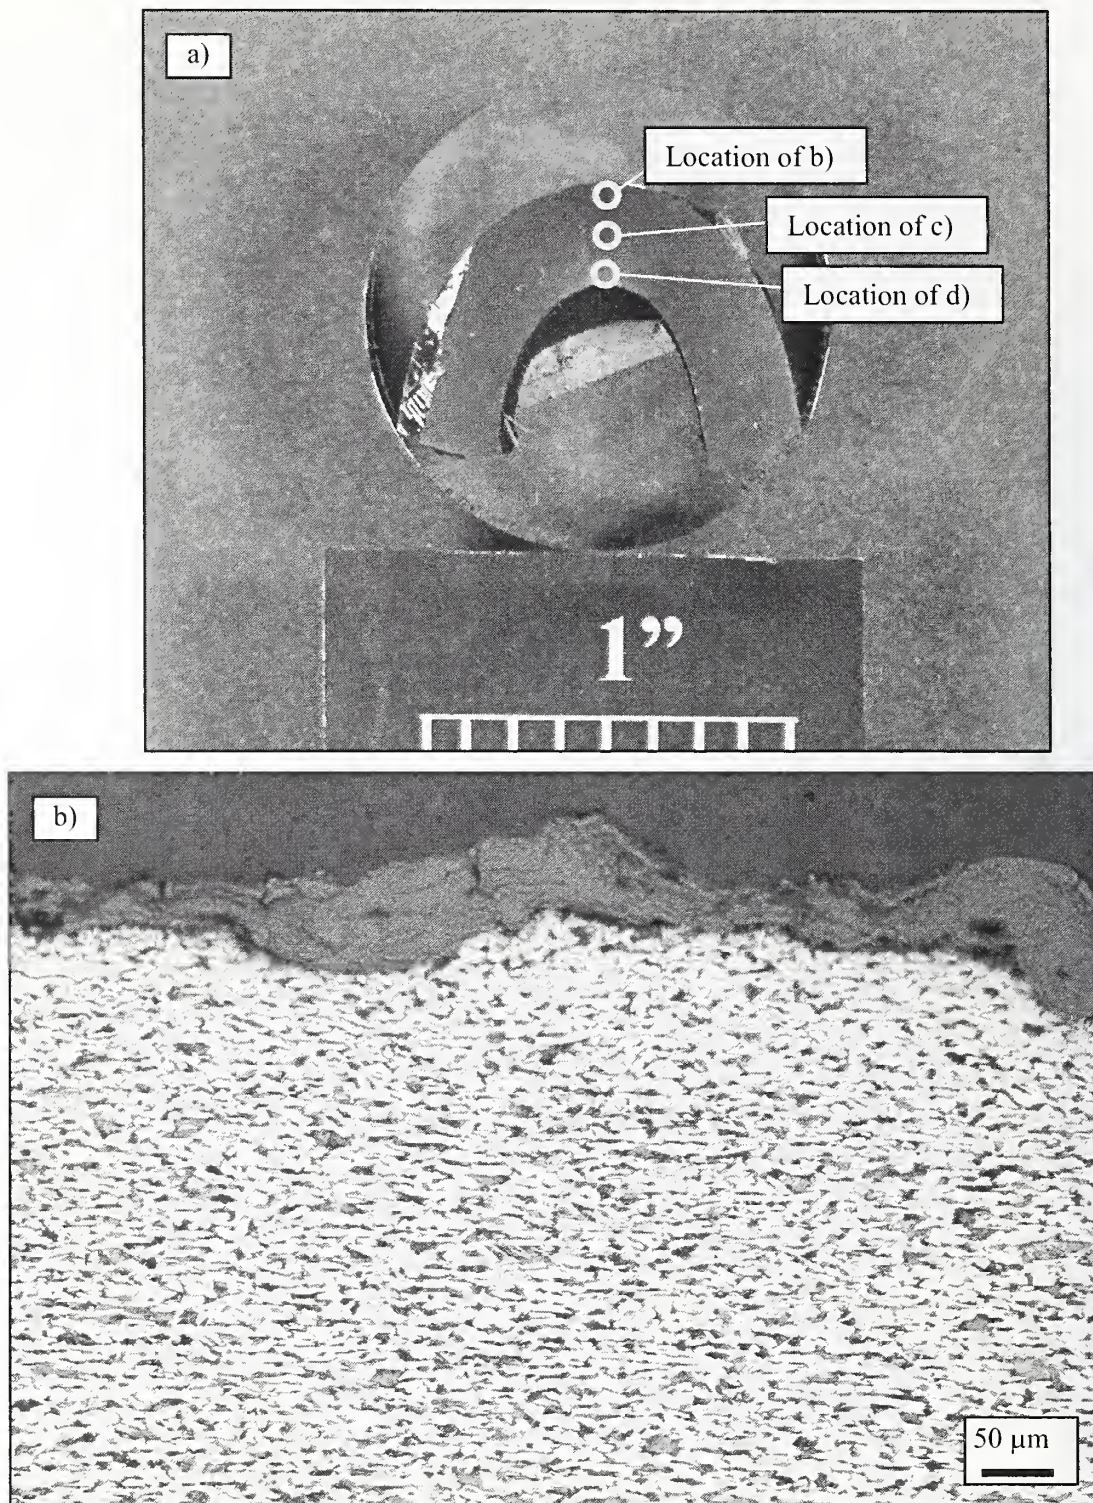
Figure 6–16. Light optical micrographs showing the microstructure from flange of column 210 of panel K-1 (A209: 97-100) from the crumpled area above the 98th floor spandrel. c) centerline of plate showing relatively undeformed grains of blocky ferrite and pearlite colonies. Two percent nital and 4 percent picral etch.

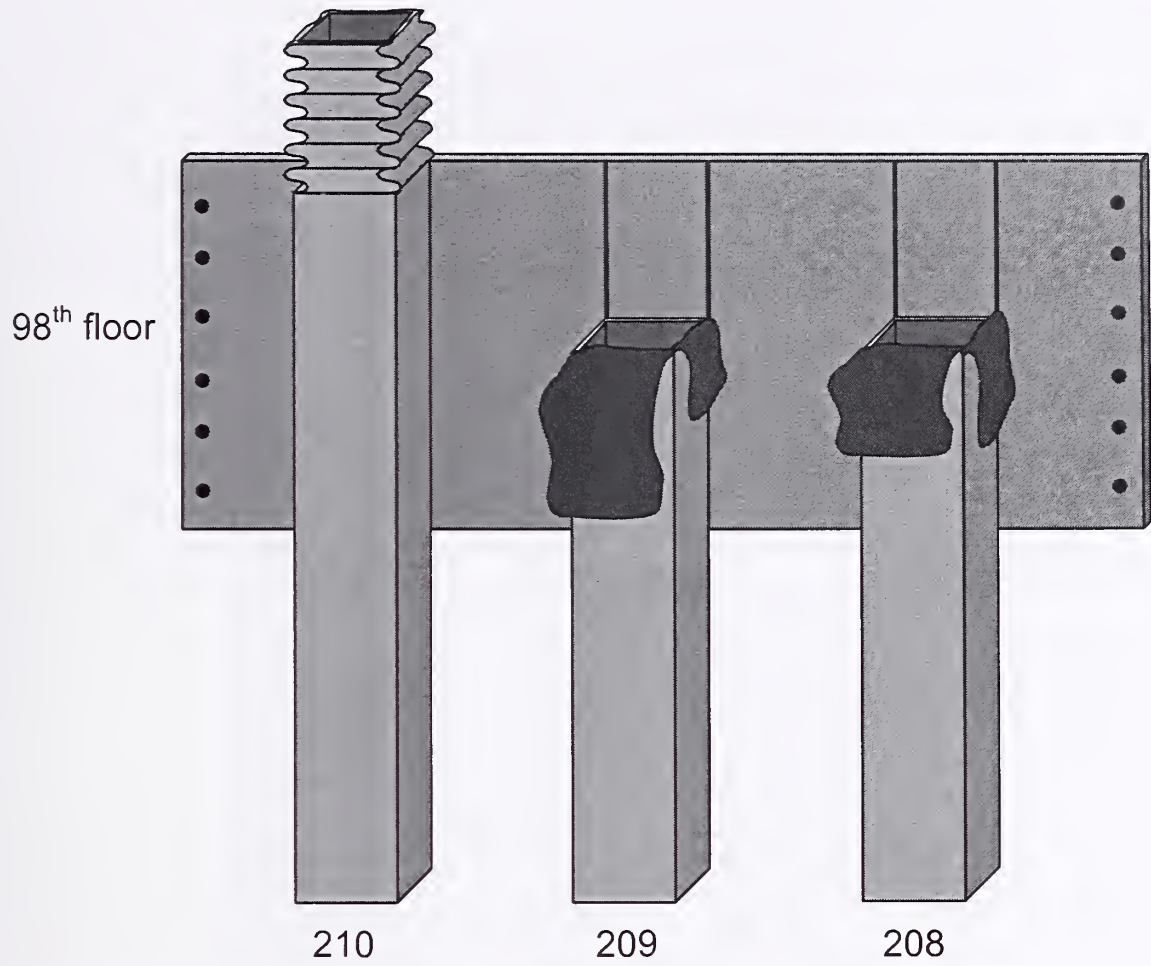
Figure 6–14. Panel K-1 from the east face of WTC 1 (A209: 97-100). a) Schematic showing the damage to the panel when viewed from outside the building looking inward.

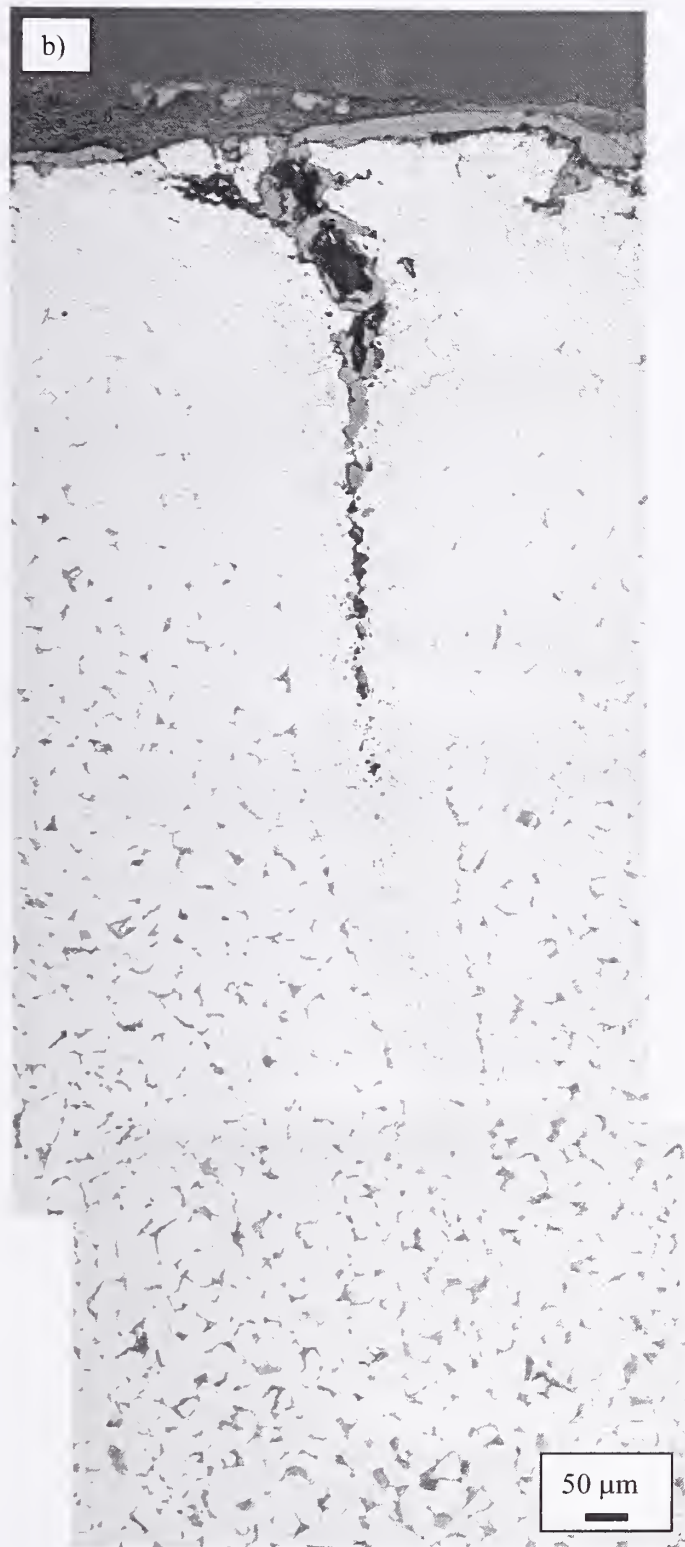
Figure 6-13. Change in microstructure of a truss seat that was heat treated in a laboratory furnace at 625 °C for various times. Pearlite was observed to spheroidize. Sample shown was from panel C-18 (WTC 2, column 231, 95th floor). Two percent nital and 4 percent picral etch.

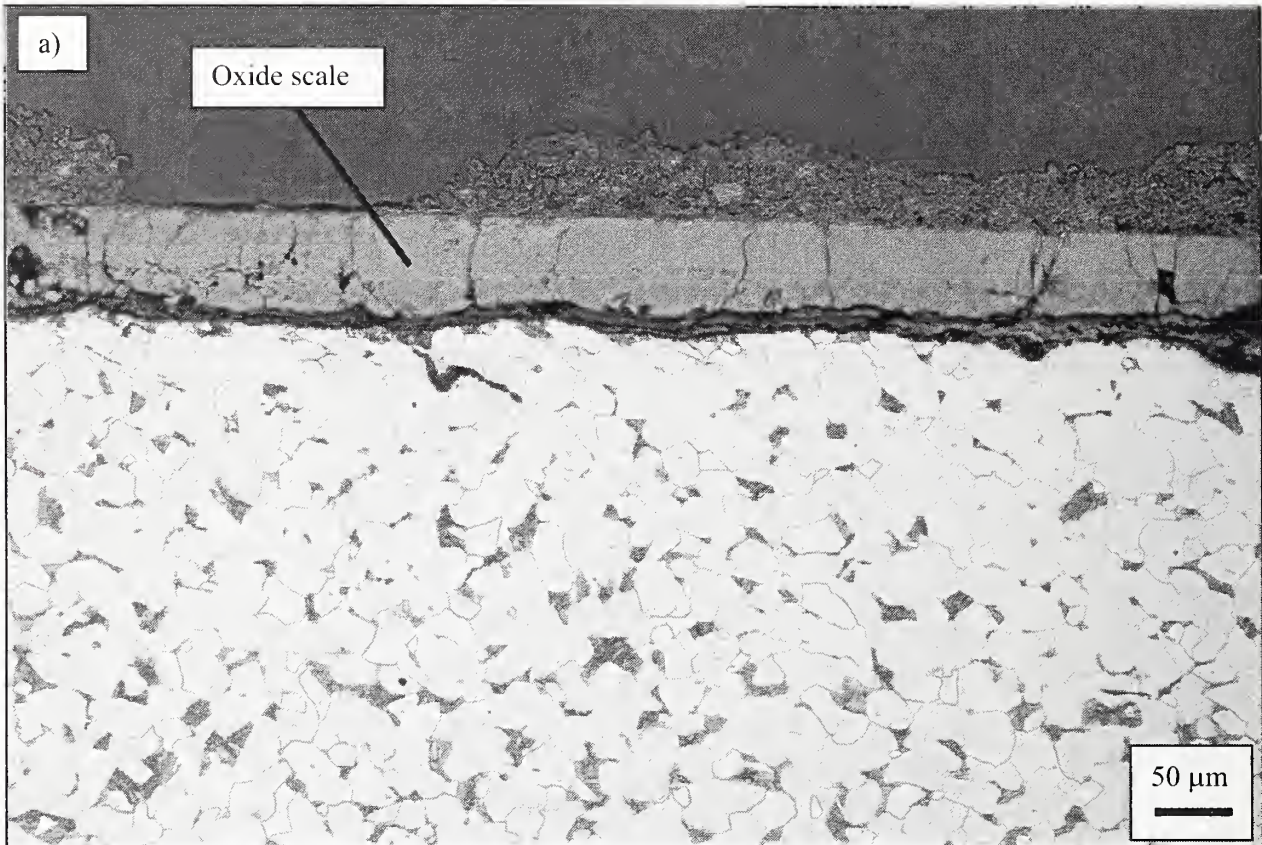
Figure 6–12. Light optical micrographs of the microstructure of a perimeter floor truss seat from the 99th floor of WTC 1, panel N-8 (A142: 97-100). b) penetration of the iron oxide phase with internal oxidation and decarburization fronts possibly due to elevated temperature exposure. Two percent nital and 4 percent picral etch (cont.).

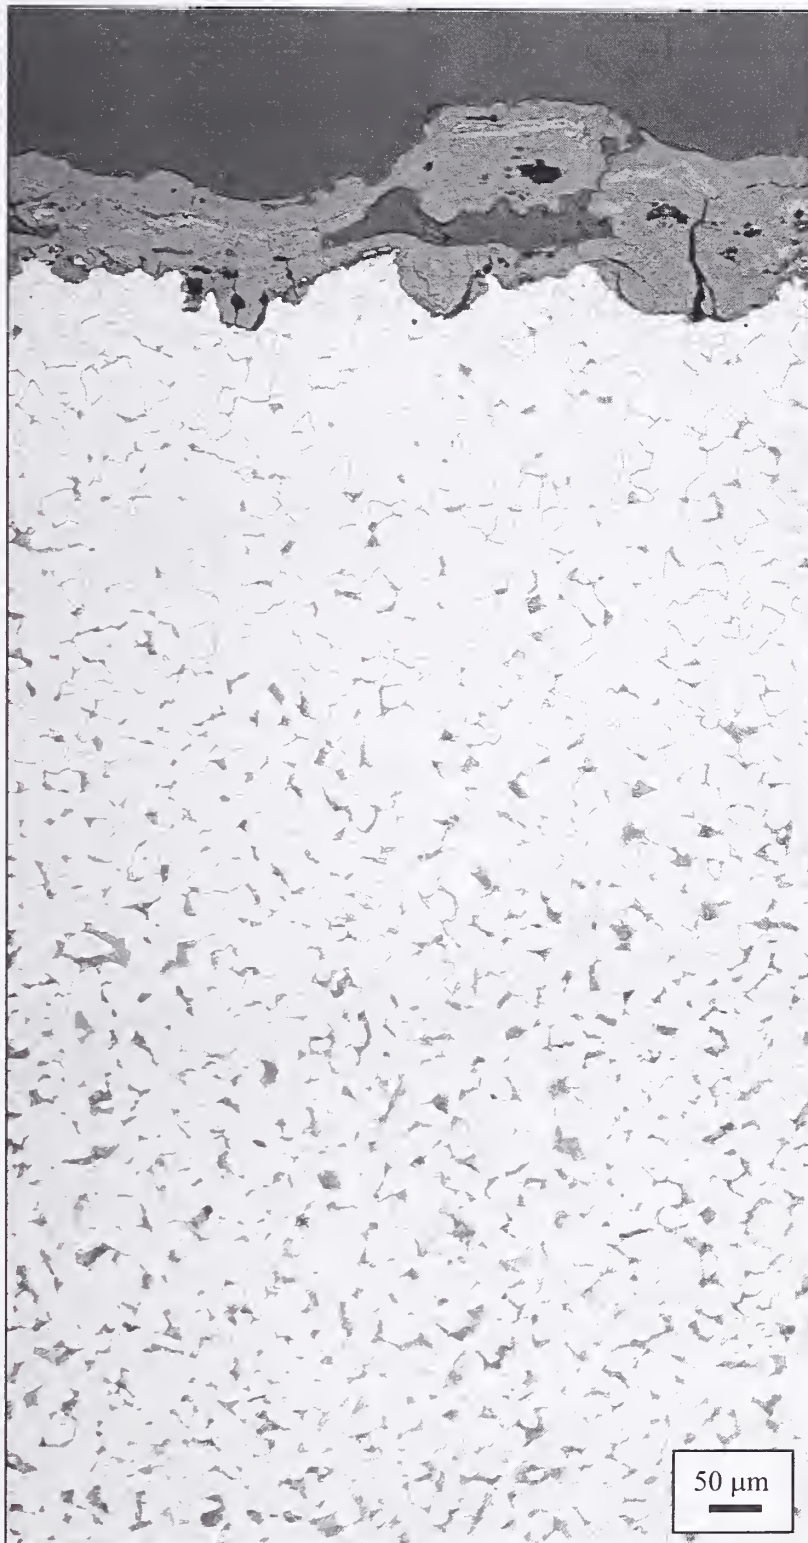
Figure 6–12. Light optical micrographs of the microstructure of a perimeter floor truss seat from the 99th floor of WTC 1, panel N-8 (A142: 97-100). a) Ferrite-pearlite microstructure and developed oxide scale. Two percent nital and 4 percent picral etch.

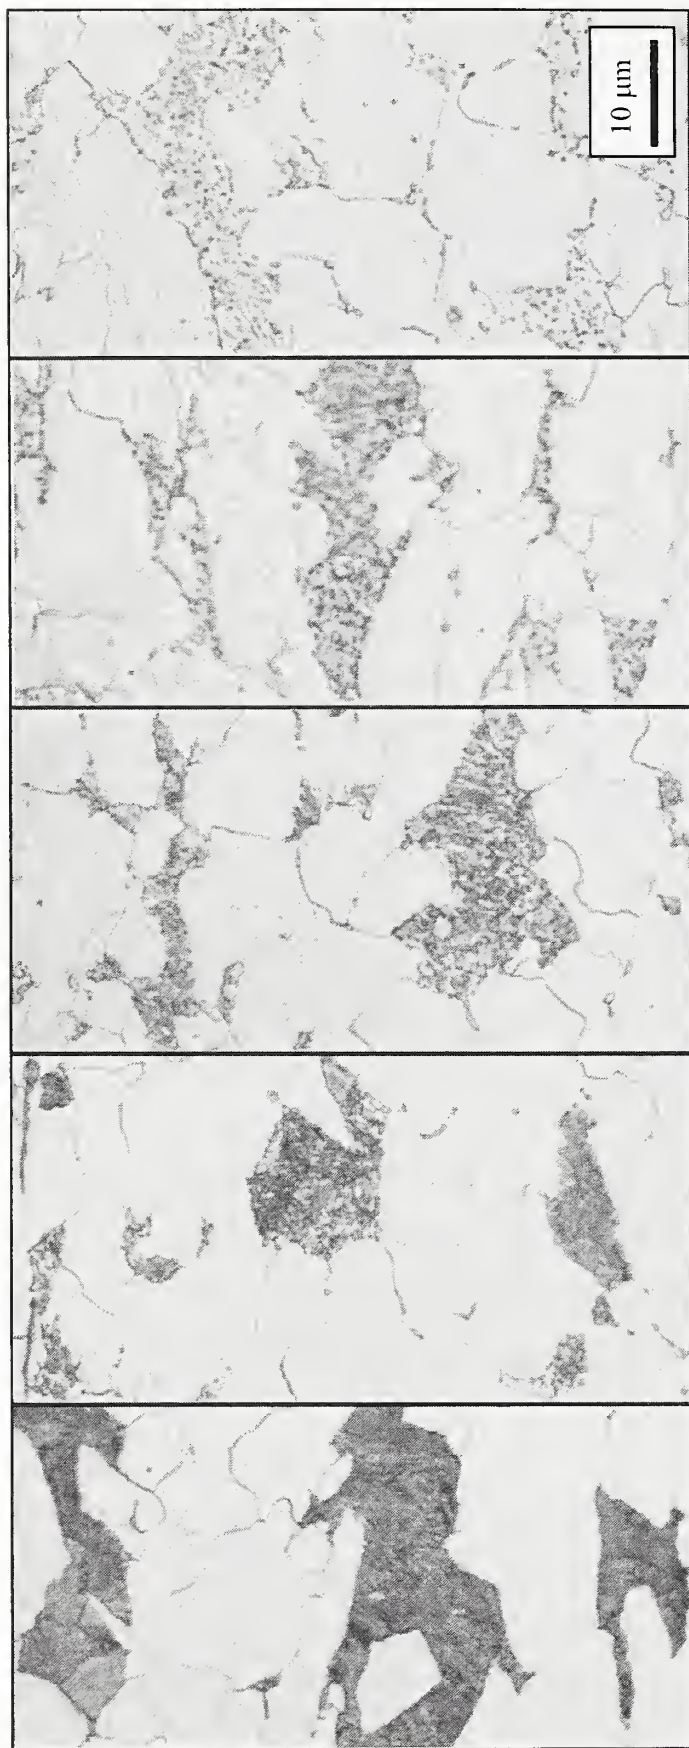
Figure 6–11. Light optical micrograph showing the partially decarburized zone found near the surface of a perimeter floor truss seat from directly above the airplane impact on the 99th floor of WTC 1, panel M-2 (A130: 96-99). Two percent nital and 4 percent picral etch.

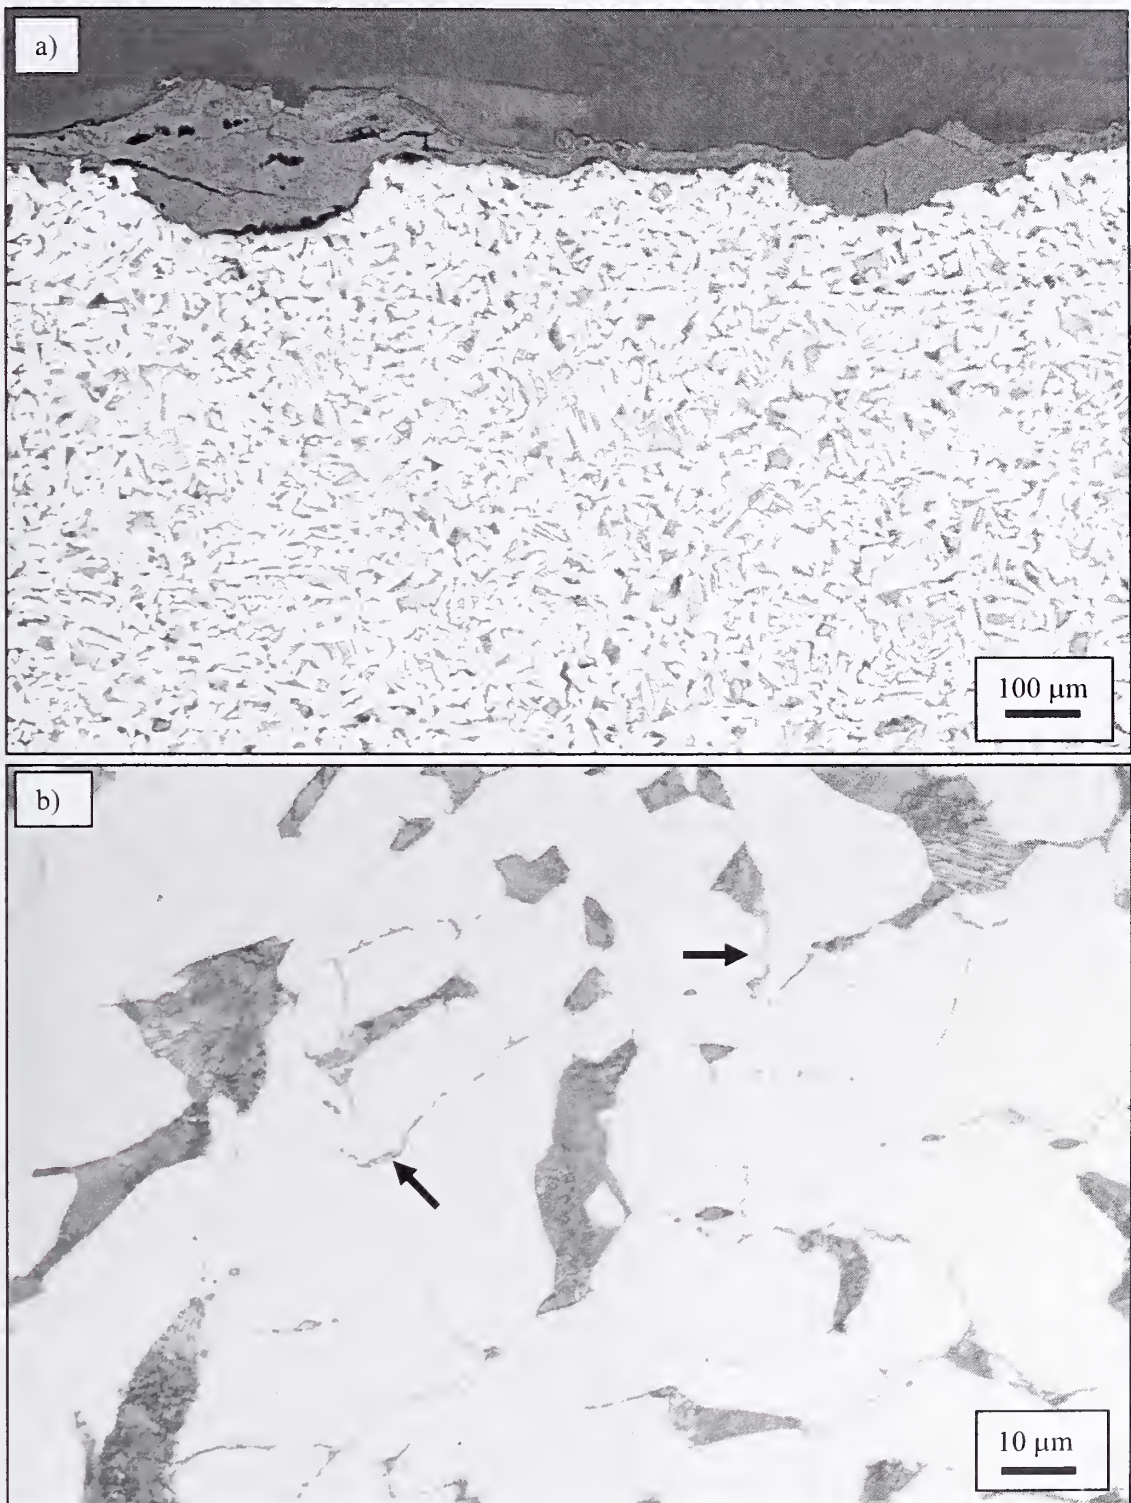
Figure 6–10. Change in microstructure of a 42 ksi spandrel plate that was heat treated in a laboratory furnace at 625 °C for various times. Pearlite was observed to spheroidize. Sample shown was from panel N-9 (WTC 1, 102nd floor spandrel, near column 154). Two percent nital and 4 percent picral etch.

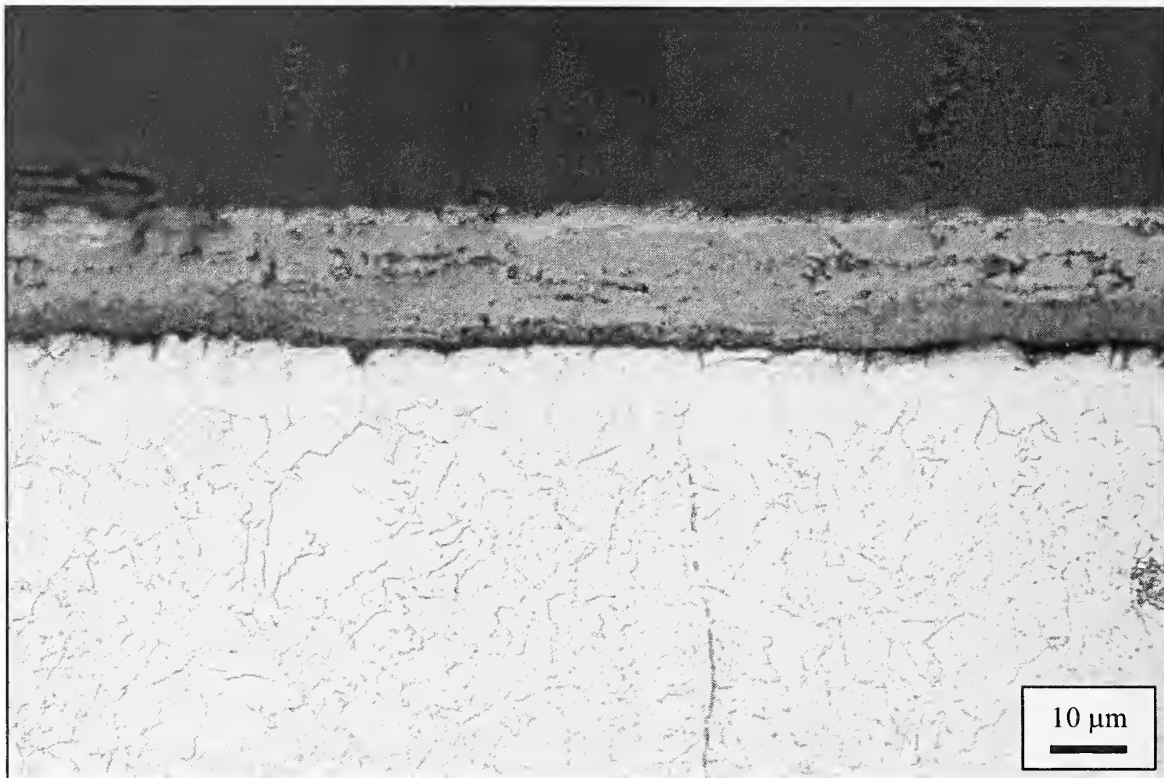
Figure 6–9. Light optical micrographs showing the microstructures from “fire exposed” spandrels. a) Ferrite-pearlite structure and developed oxide scale, b) lamellae were observable in pearlite, carbides (indicated by arrows) decorating ferrite grain boundaries. Both images taken from the 99th floor spandrel of WTC 1, panel M-2 (A130: 96-99). Two percent nital and 4 percent picral etch.

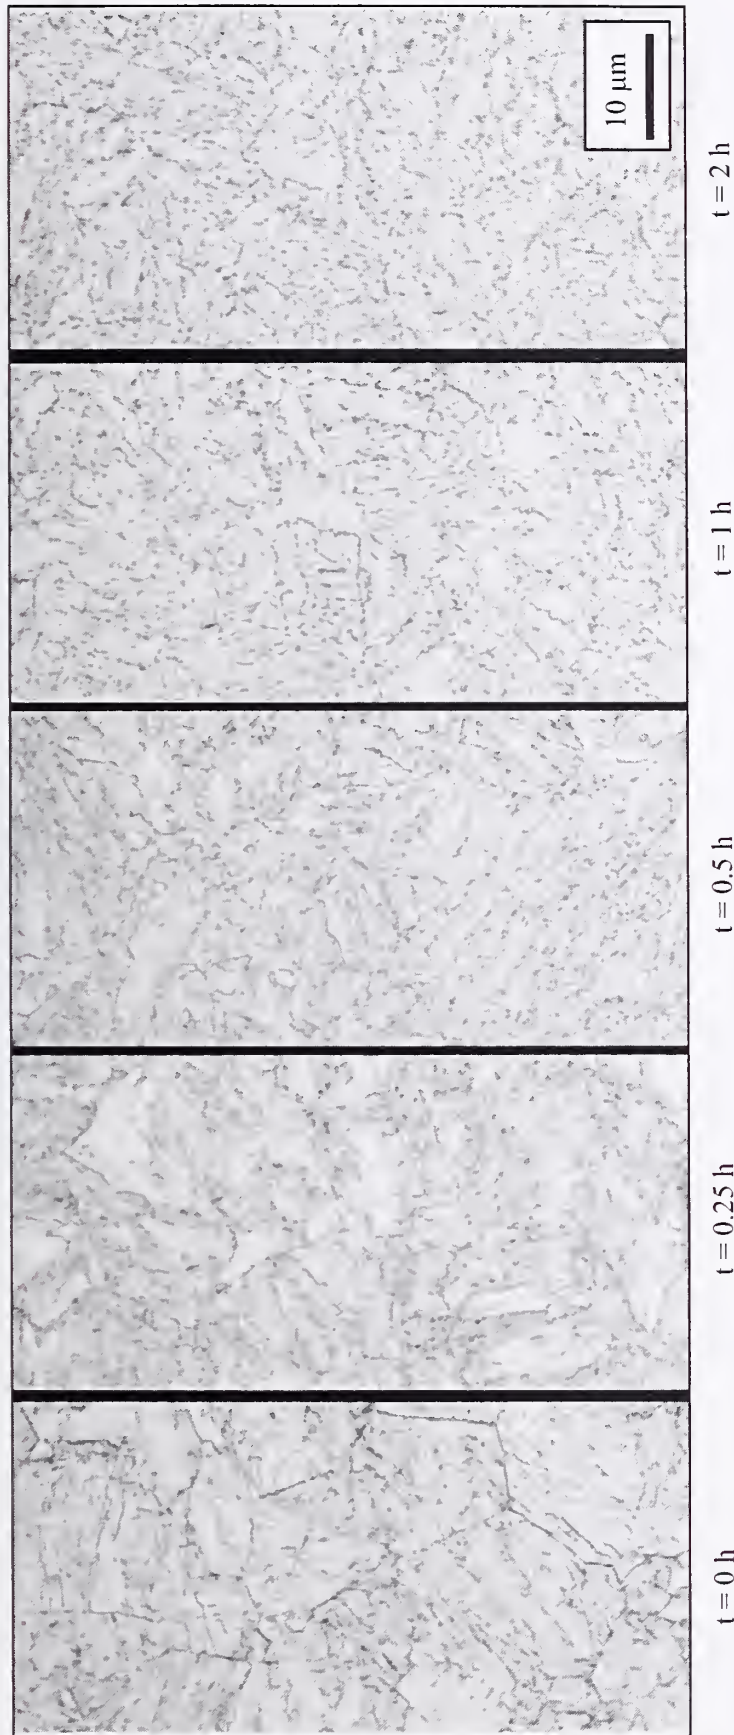
Figure 6–8. Iron oxide scale that developed on a 100 ksi quenched-and-tempered flange plate after isothermal exposure at 625 °C for 2 h. Sample was from panel C-10 (WTC 1, column 451, 88th floor). Two percent nital and 4 percent picral etch.

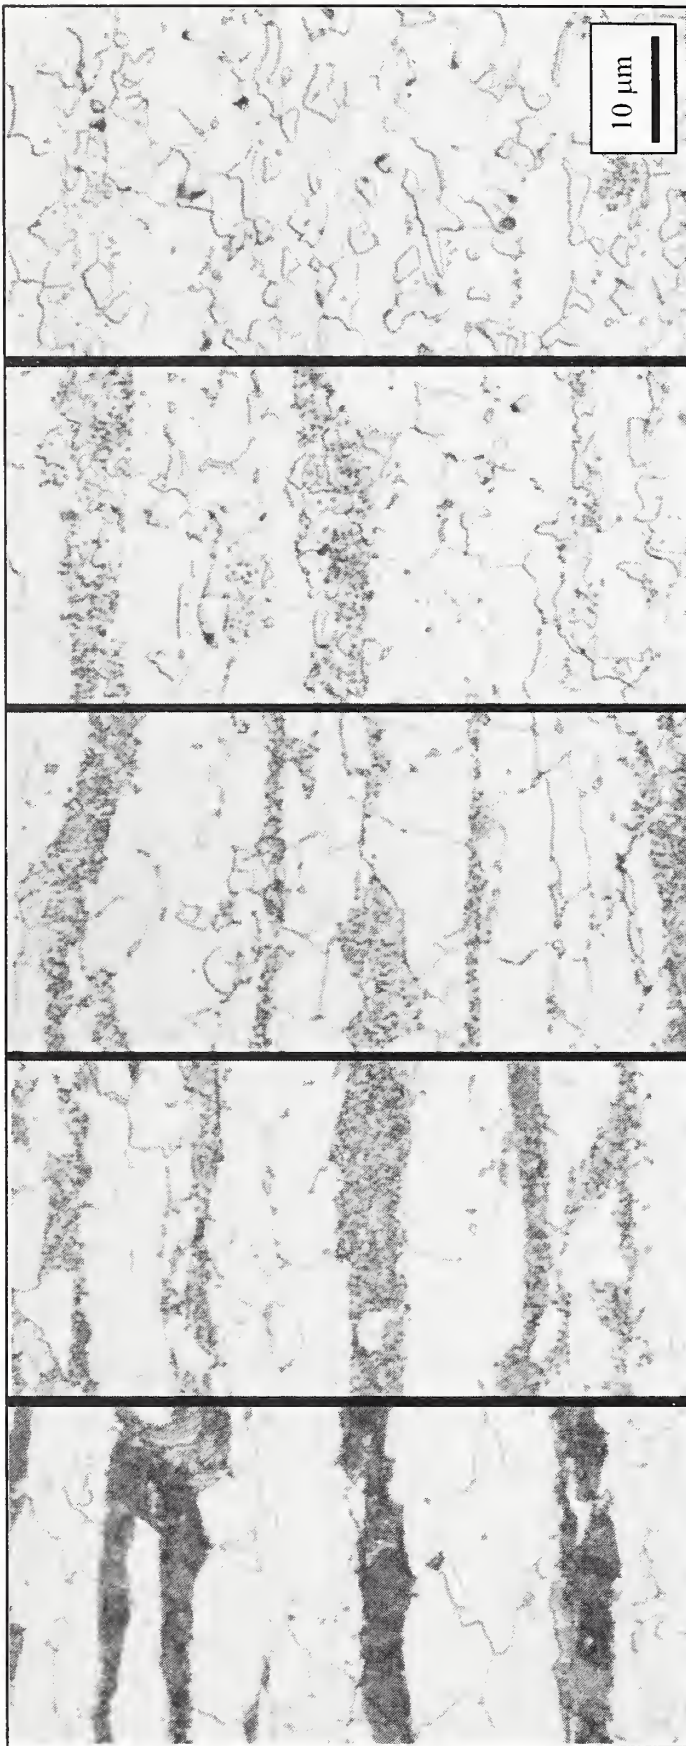
Figure 6-7. Change in microstructure of a 100 ksi flange plate that was heat treated in a laboratory furnace at 625 °C for various times (t). Sharpness of lath boundaries was observed to decrease while the carbide precipitates became more discernible. Sample was from panel C-10 (WTC 1, column 451, 88th floor). Two percent nital and 4 percent picral etch.

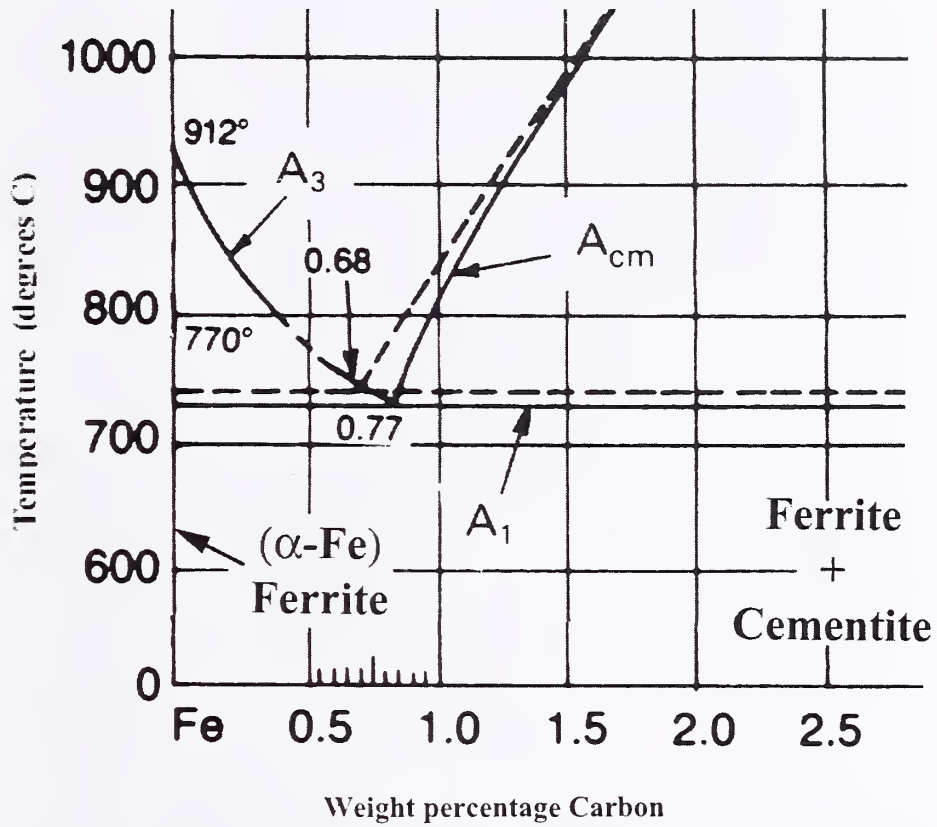
Figure 6-5. Portion of the iron-carbon (Fe-C) phase diagram.

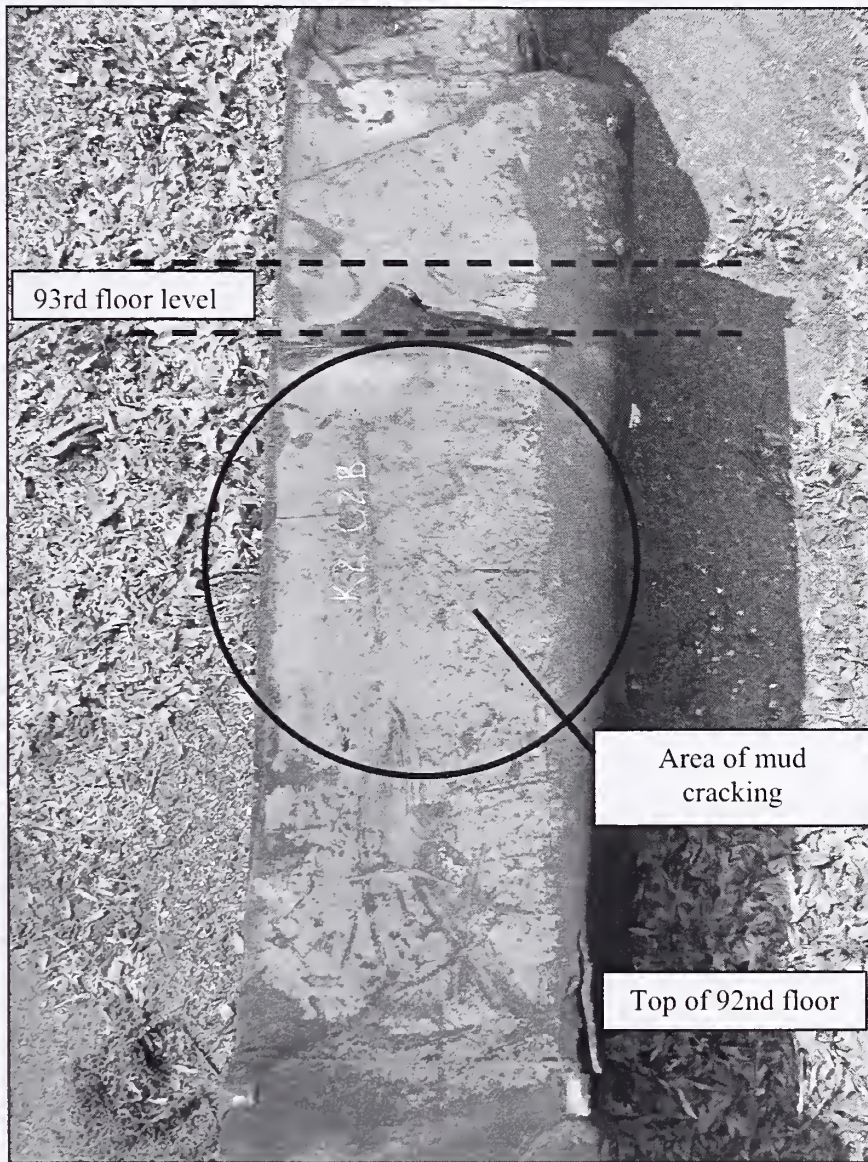
Figure 6–4. Truss seat of the 99th floor on column 143 of WTC 1 from panel N-8 (A142: 97-100). Mud cracking was observed only on the truss seat and standoff plates.
a) Top view showing the re-solidified black plastic with imbedded papers, most likely a binder of some type and b) bottom view showing the drip pattern.

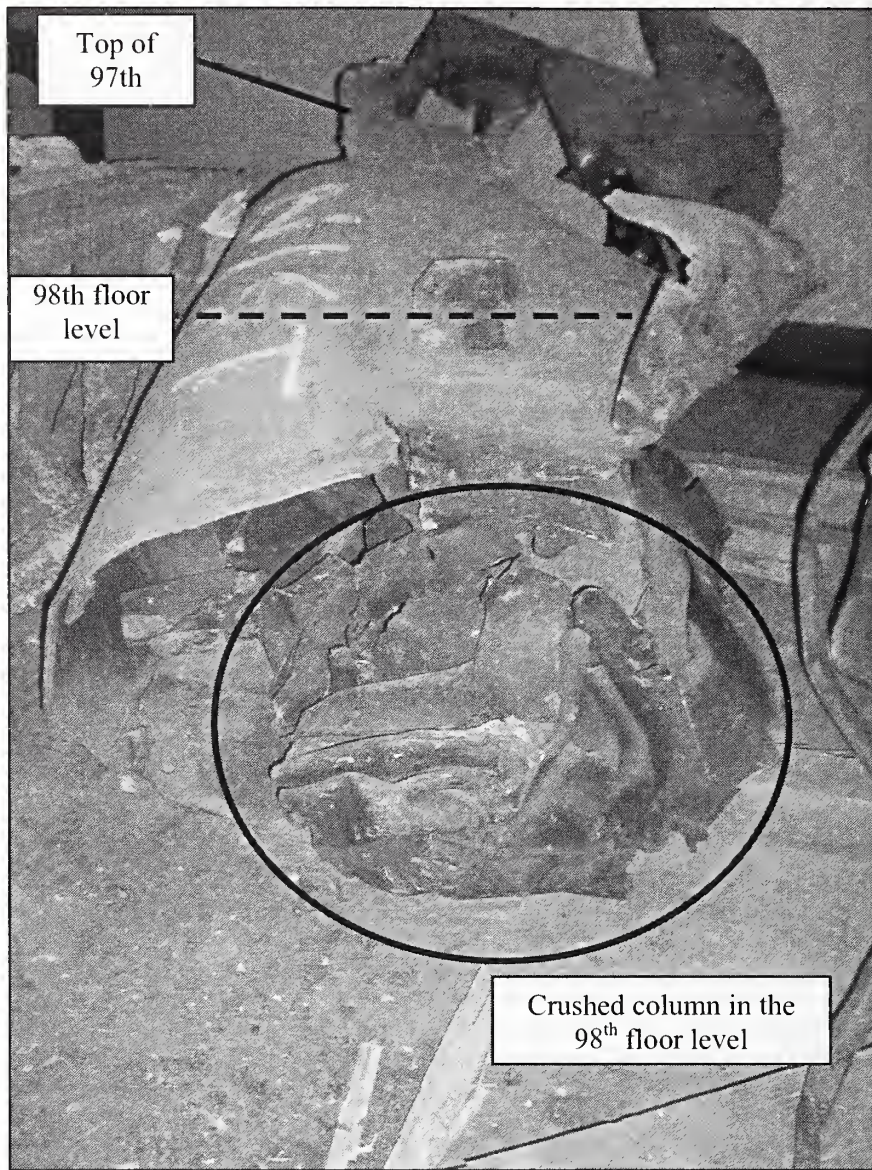
Figure 6–3. Spandrel at the 93rd floor of column 236 of WTC 1 from panel K-2 (A236: 92-95). Mud cracking of the paint occurred below the 93rd floor line. No evidence of mud cracking was observed above the floor line.

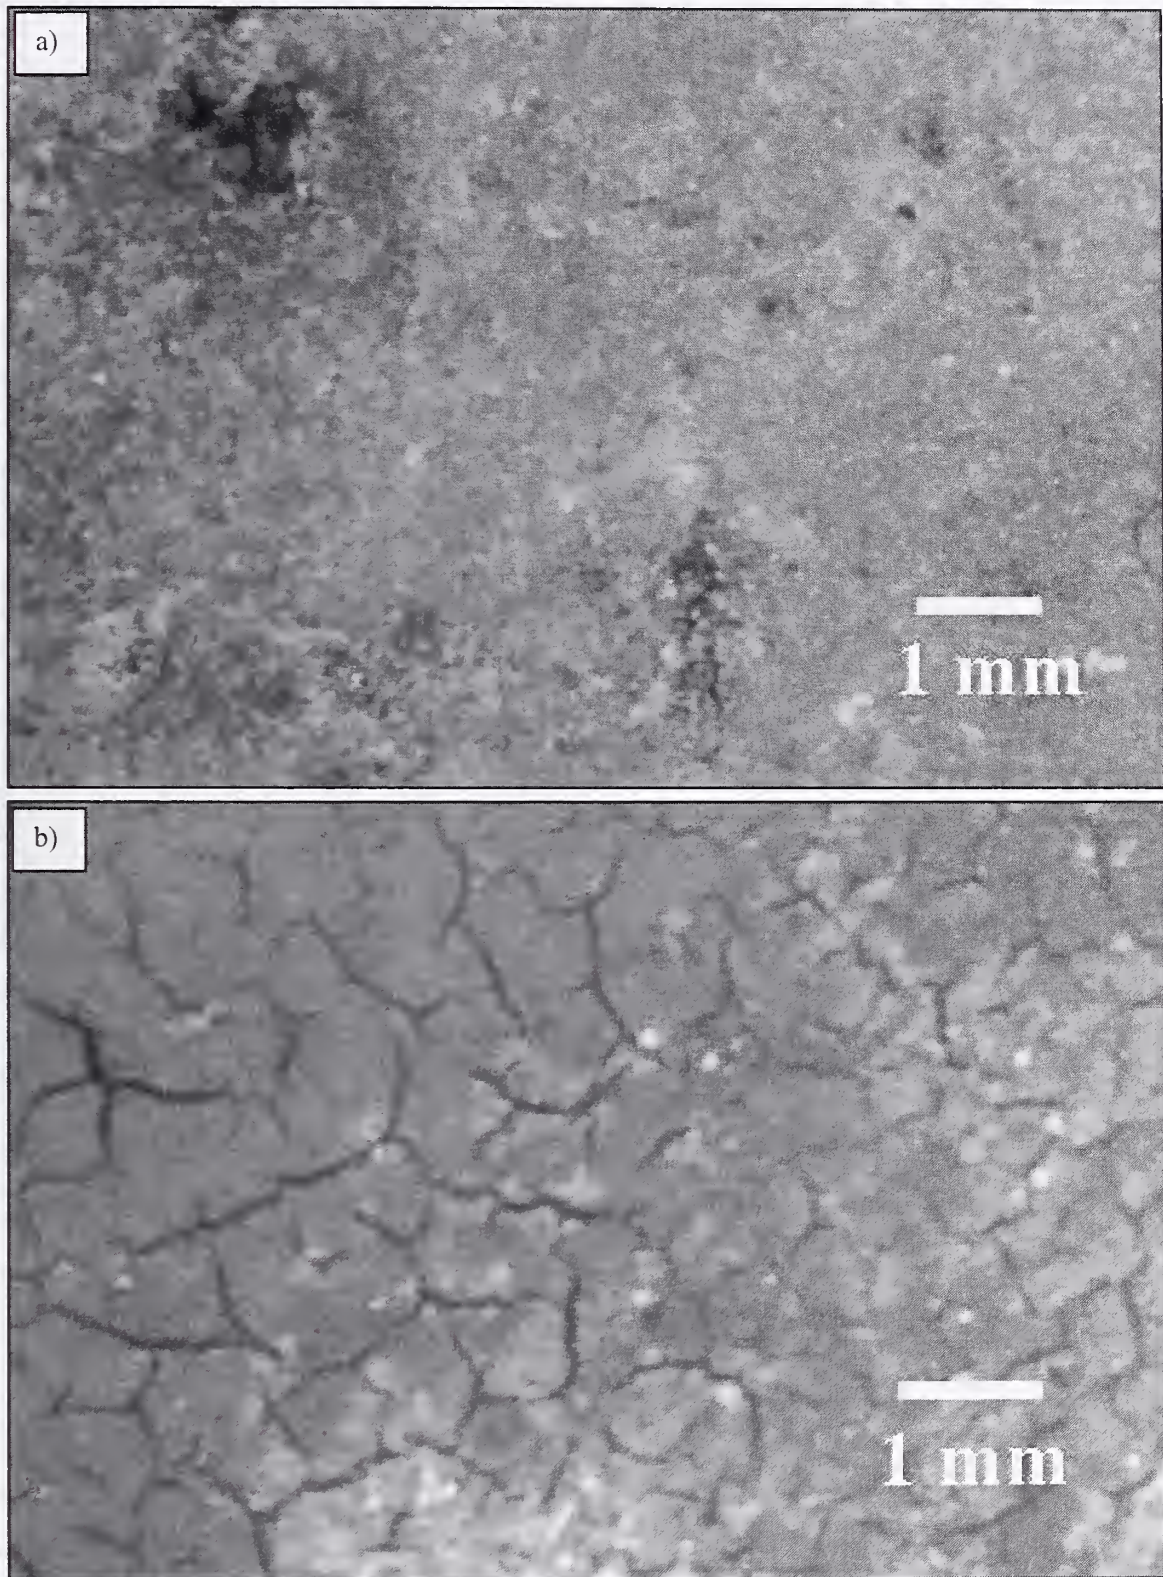
Figure 6–2. Crushed portion of column 210 in the area of the 98th floor of WTC 1 (panel K-1, A209: 97-100). Mud cracking of the paint was observed in crushed portion of this column. The cracking of the paint was a result of either temperature exposure over 250 °C, mechanical deformation, or environmental degradation.

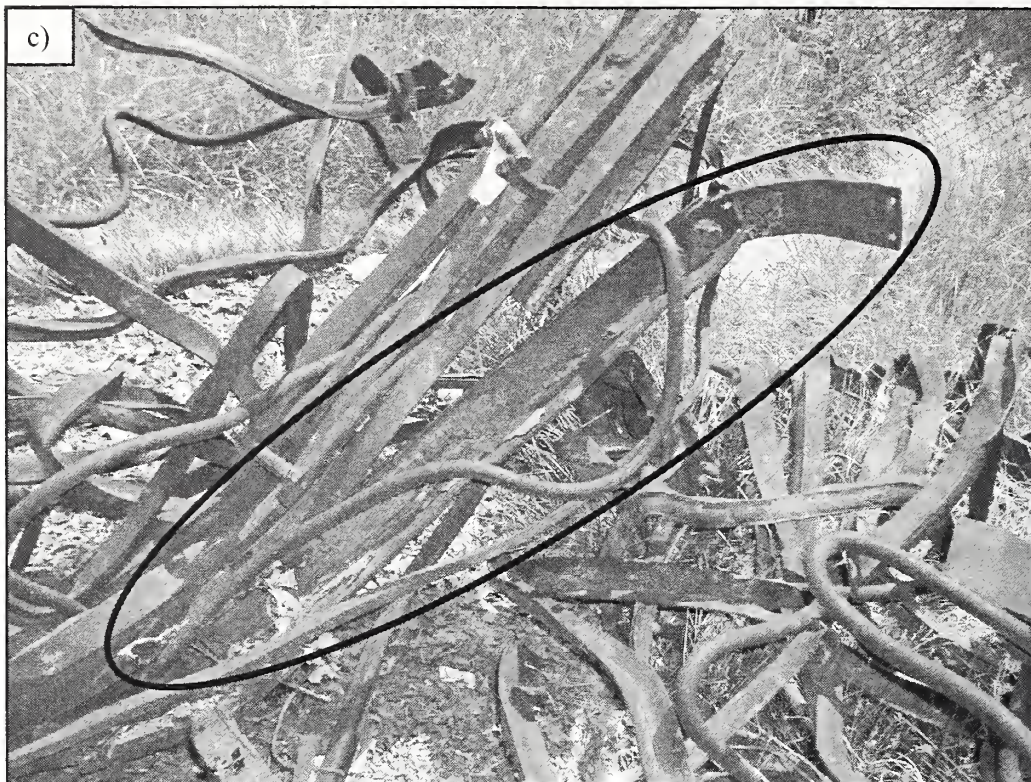
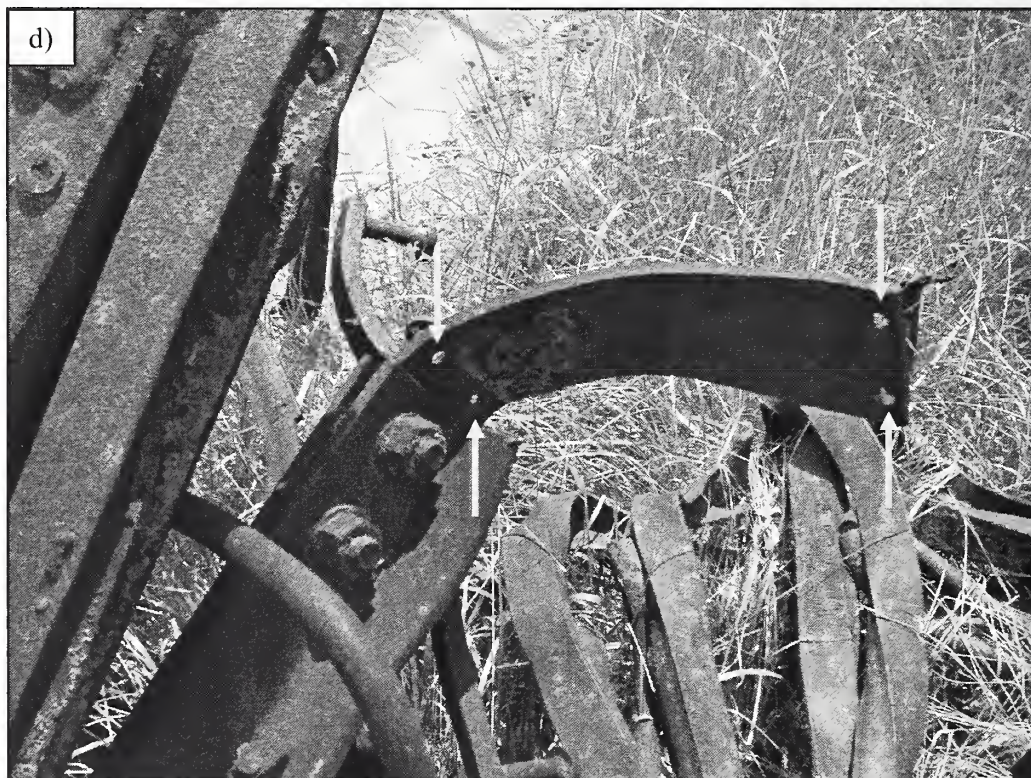
This page intentionally left blank.

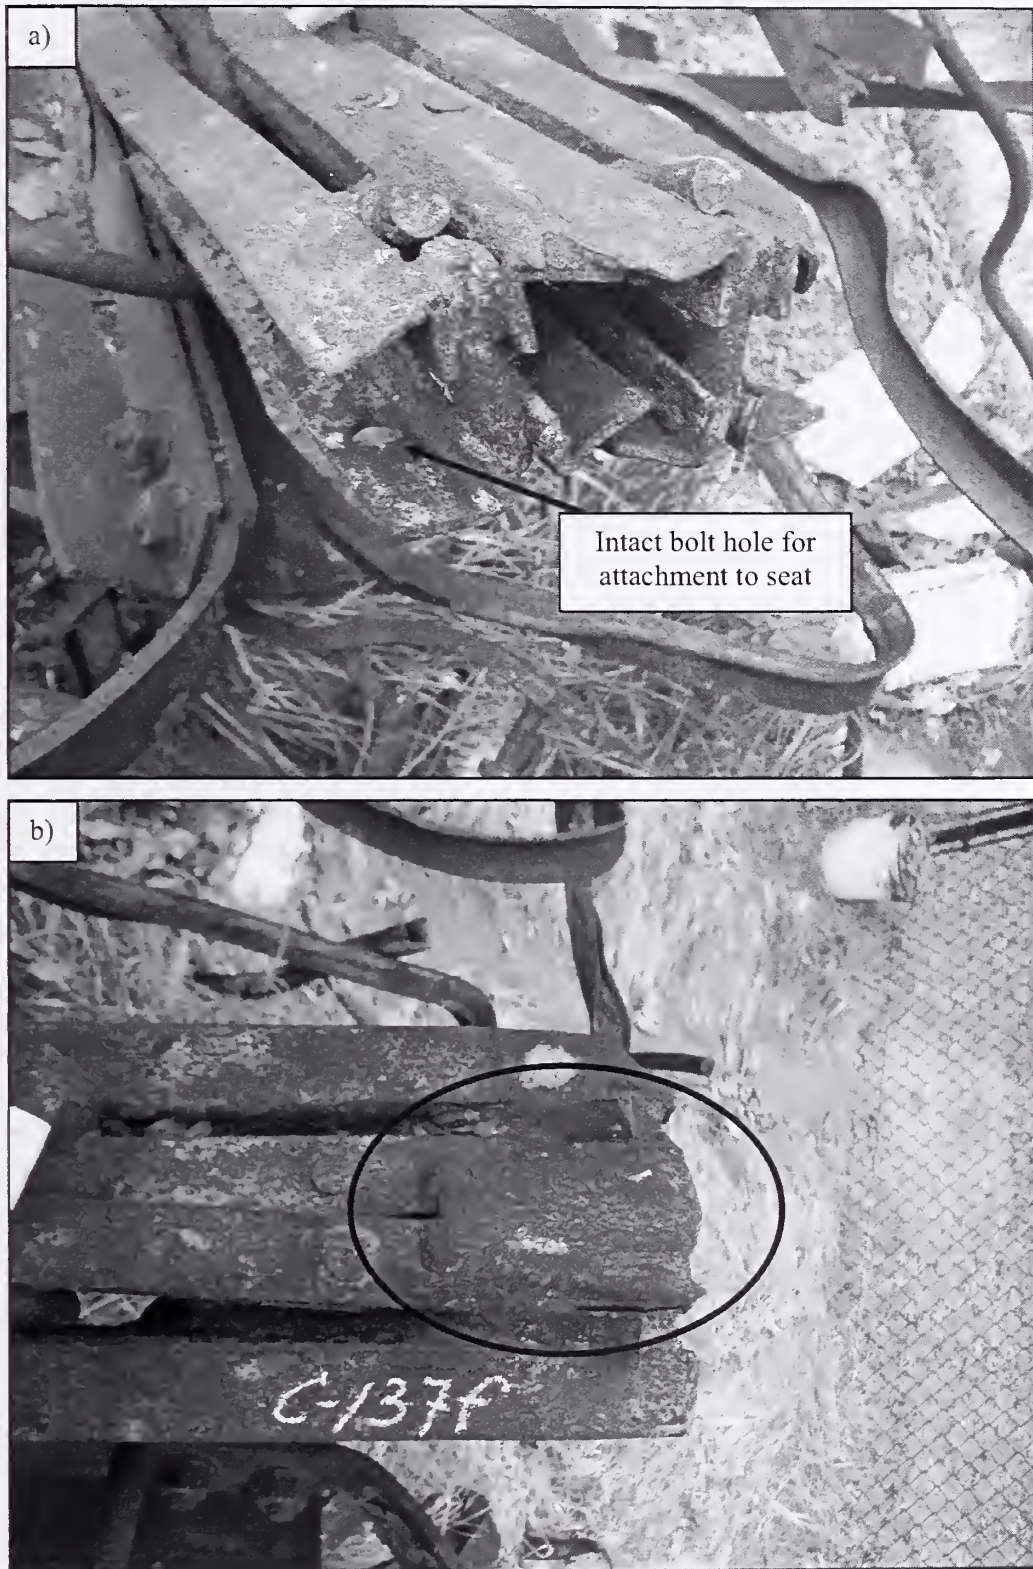
Figure 5-2. Recovered floor truss connectors. c) lower support with attached remnant of viscoelastic damper (as indicated) and d) close-up of remnants of viscoelastic damper showing intact bolt holes (indicating bolt failure) (cont.).

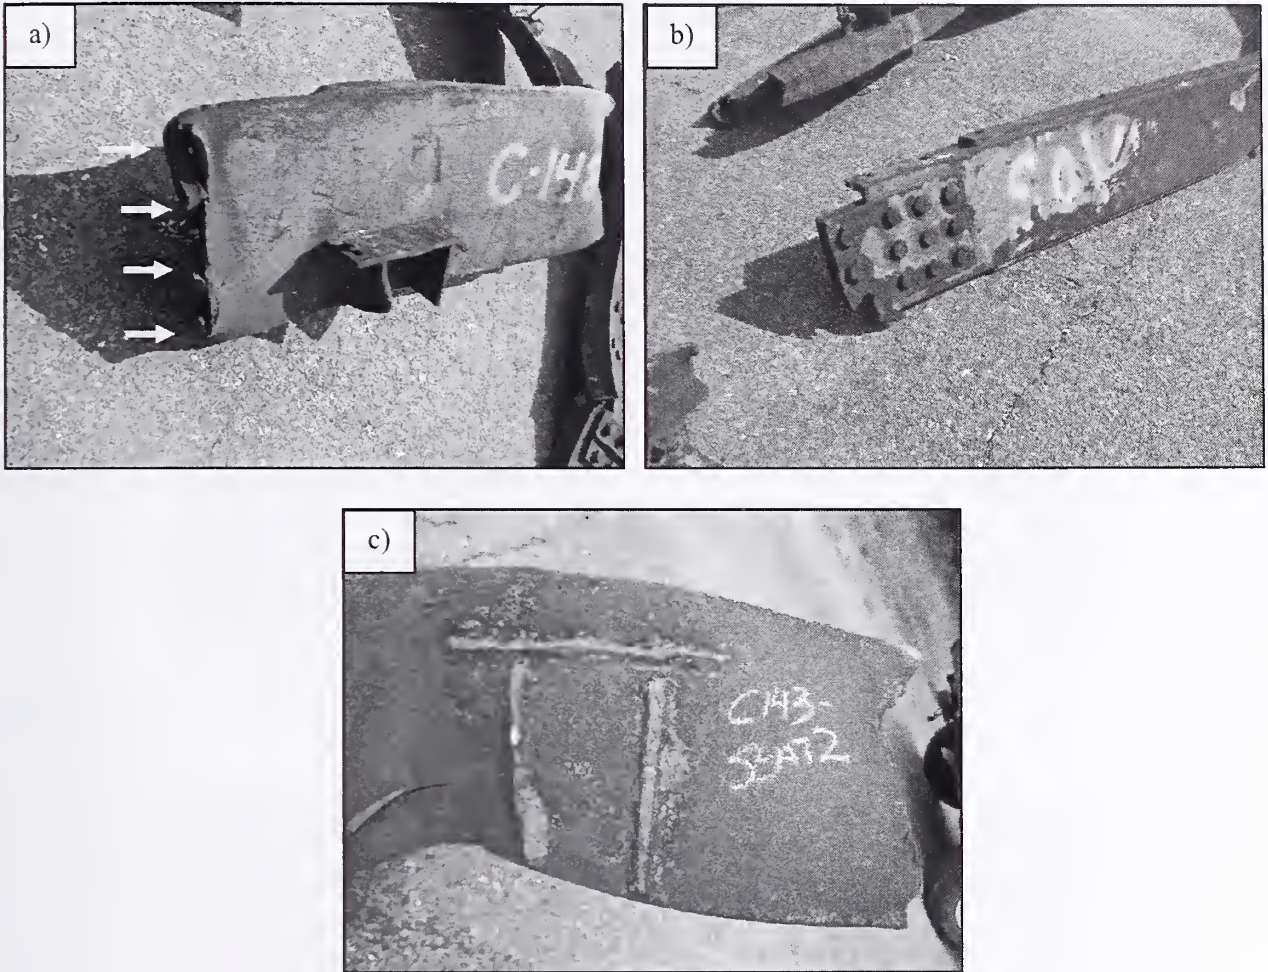
Note: Unless otherwise noted, values are in percentages of observations.
