NIST NCSTAR 1-3C

Federal Building and Fire Safety Investigation of the
World Trade Center Disaster

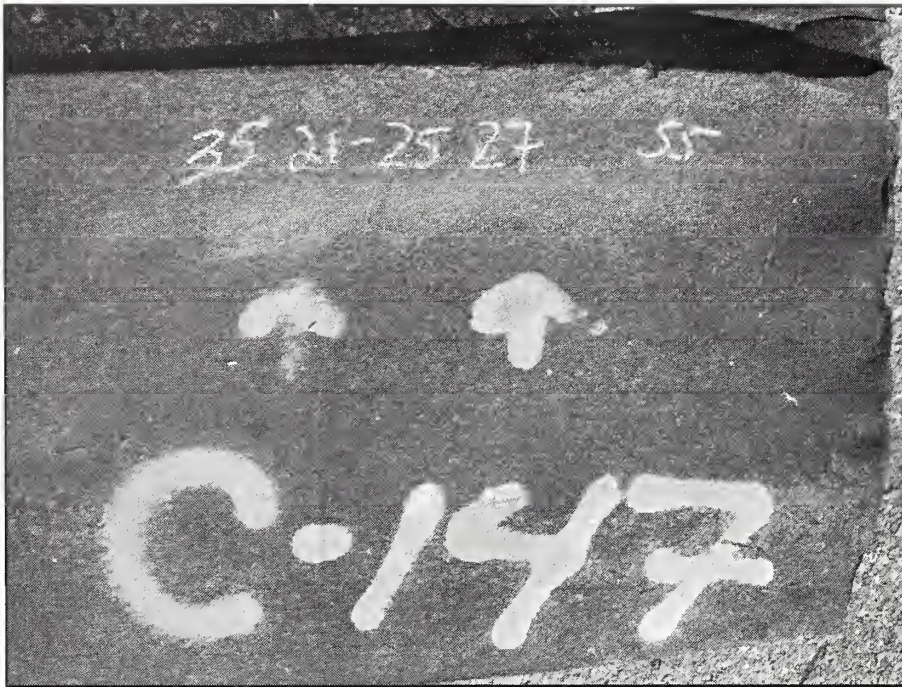
Figure 4–9. Failure modes of core channels. a) Fracture through channel as indicated by arrows, b) failure associated with end connector, and c) seat ripped off at welded connection to channel.

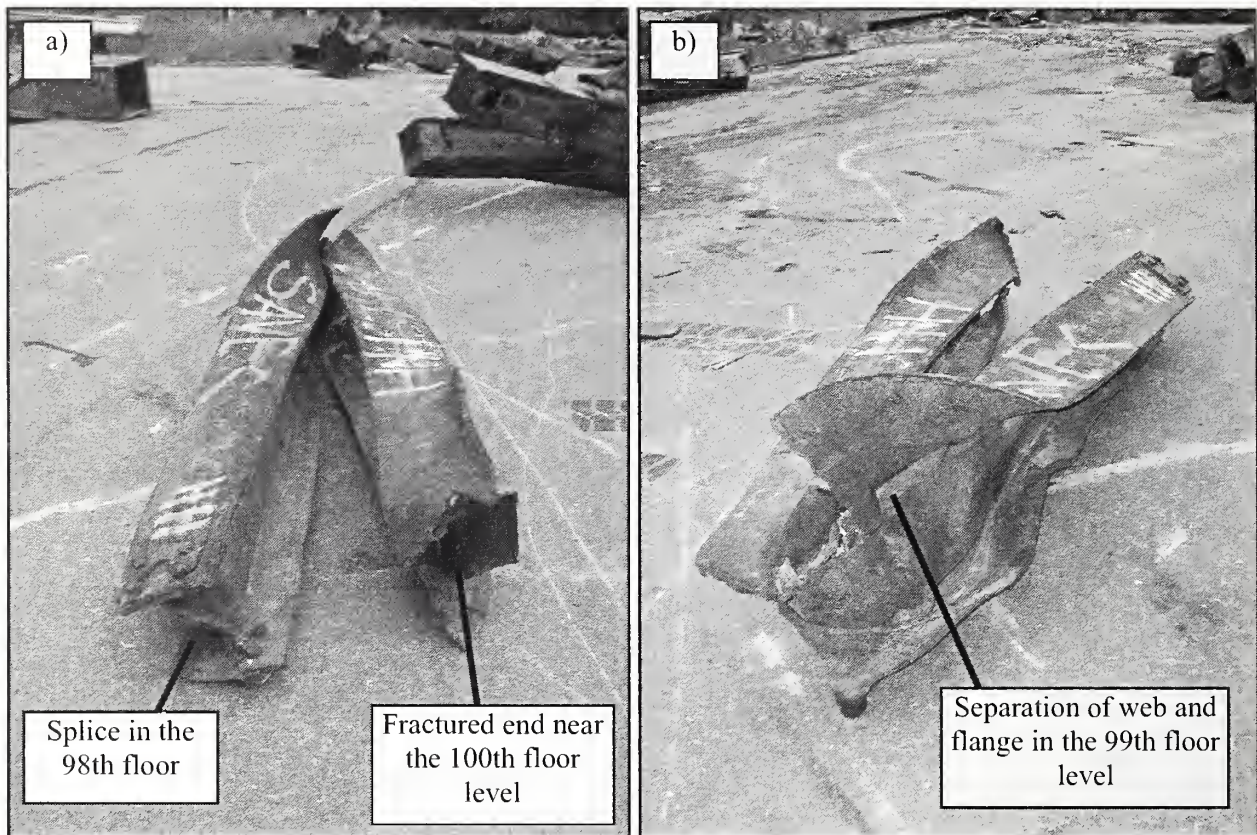
Figure 4–7. Sample C-124 from the core area, apparently used to support stairs as brackets for runs and riser were observable.

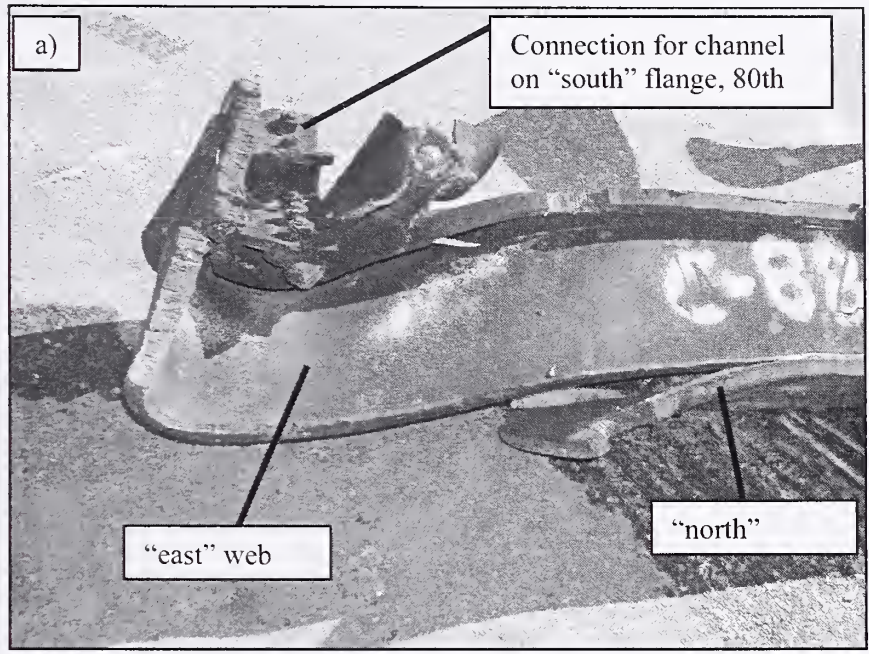
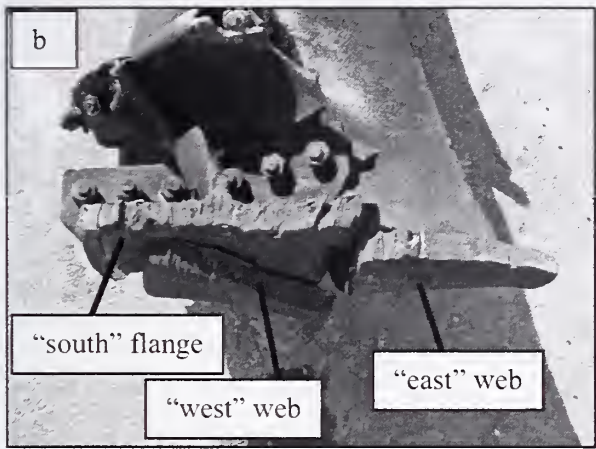
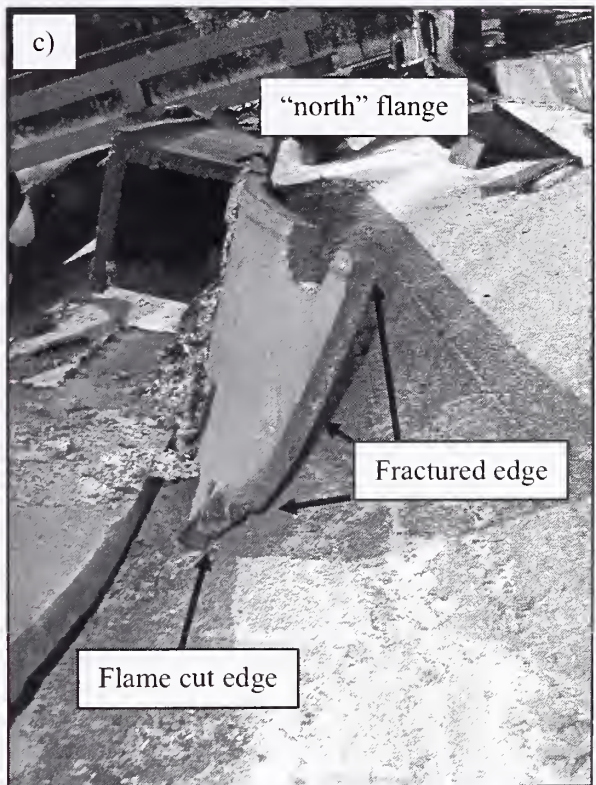
Figure 4–5. Core column HH (605A: 98-101) from the fire floors of WTC 1. a) Failure at both ends and b) separation between flange and web in the 99th floor region.

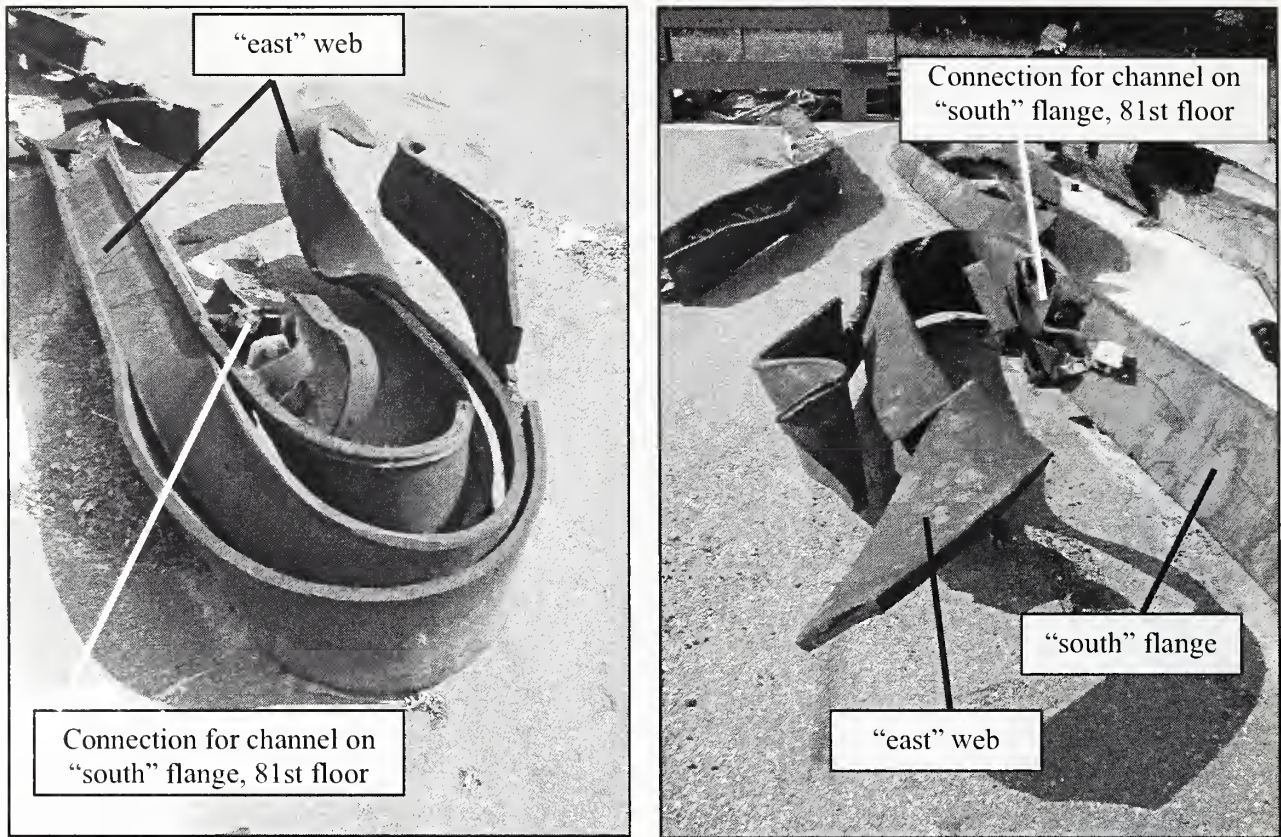
Figure 4–4. Damage associated with core column C-88b (801B: 77-80) from the impact zone of WTC 2. a) Overall view of fractured end, b) bottoms of “south” flange and both webs bent toward the east just below the 80th floor level, ends were flame cut prior to arrival at NIST, and c) “north” flange bent toward the north, majority of plate was fractured with some flame cutting (prior to arrival at NIST).

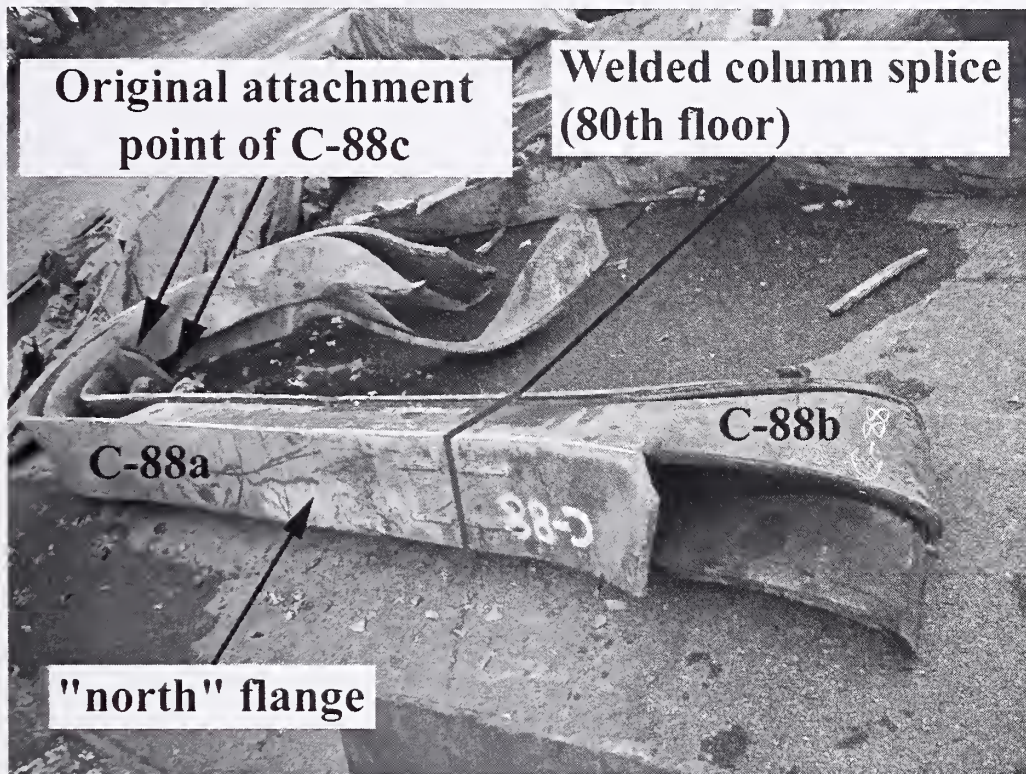
Figure 4-3. Damage associated with core column C-88a (801B: 80-83) from the impact zone of WTC 2.

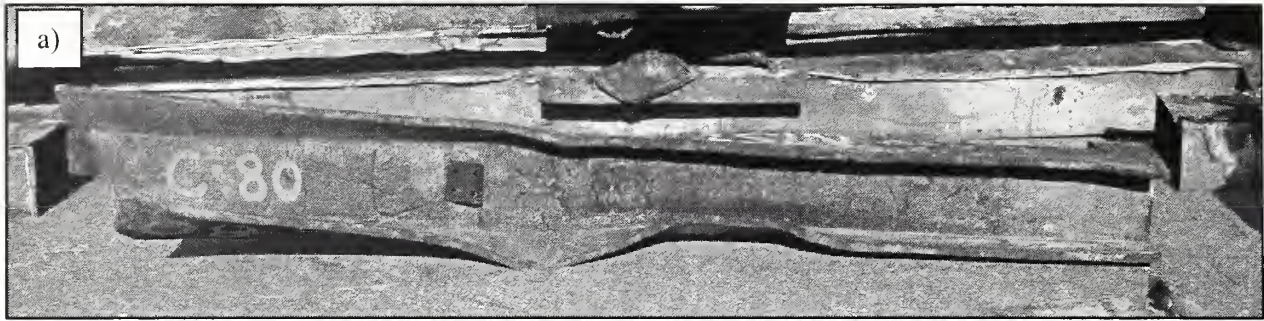
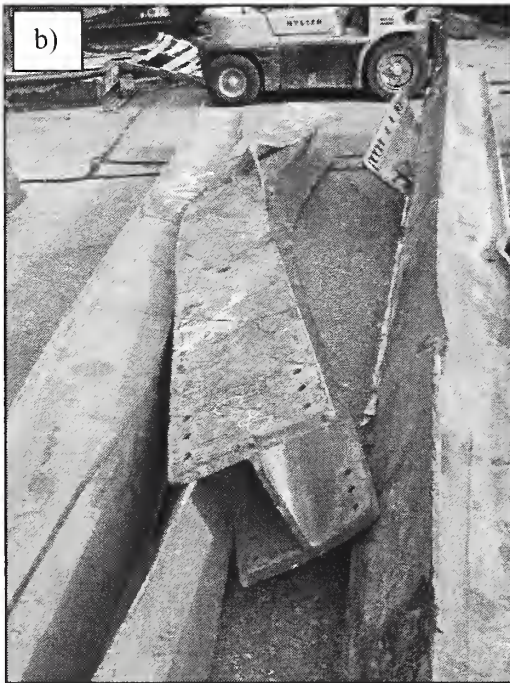
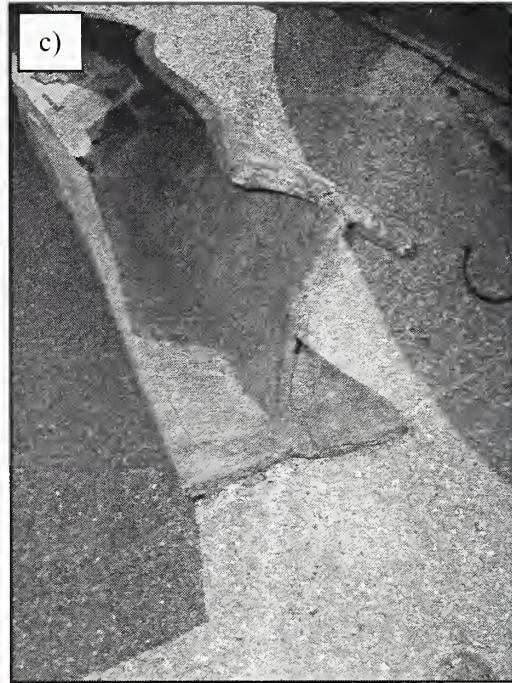
Figure 4–2. Overall view of recovered core columns C-88a (801B: 80-83) and C-88b (801B: 77-80) that were located in the impact zone of WTC 2. The north flange of C-88b may have sustained impact damage. Note that the welded column splice was still intact though the airplane may have struck a portion of this column.

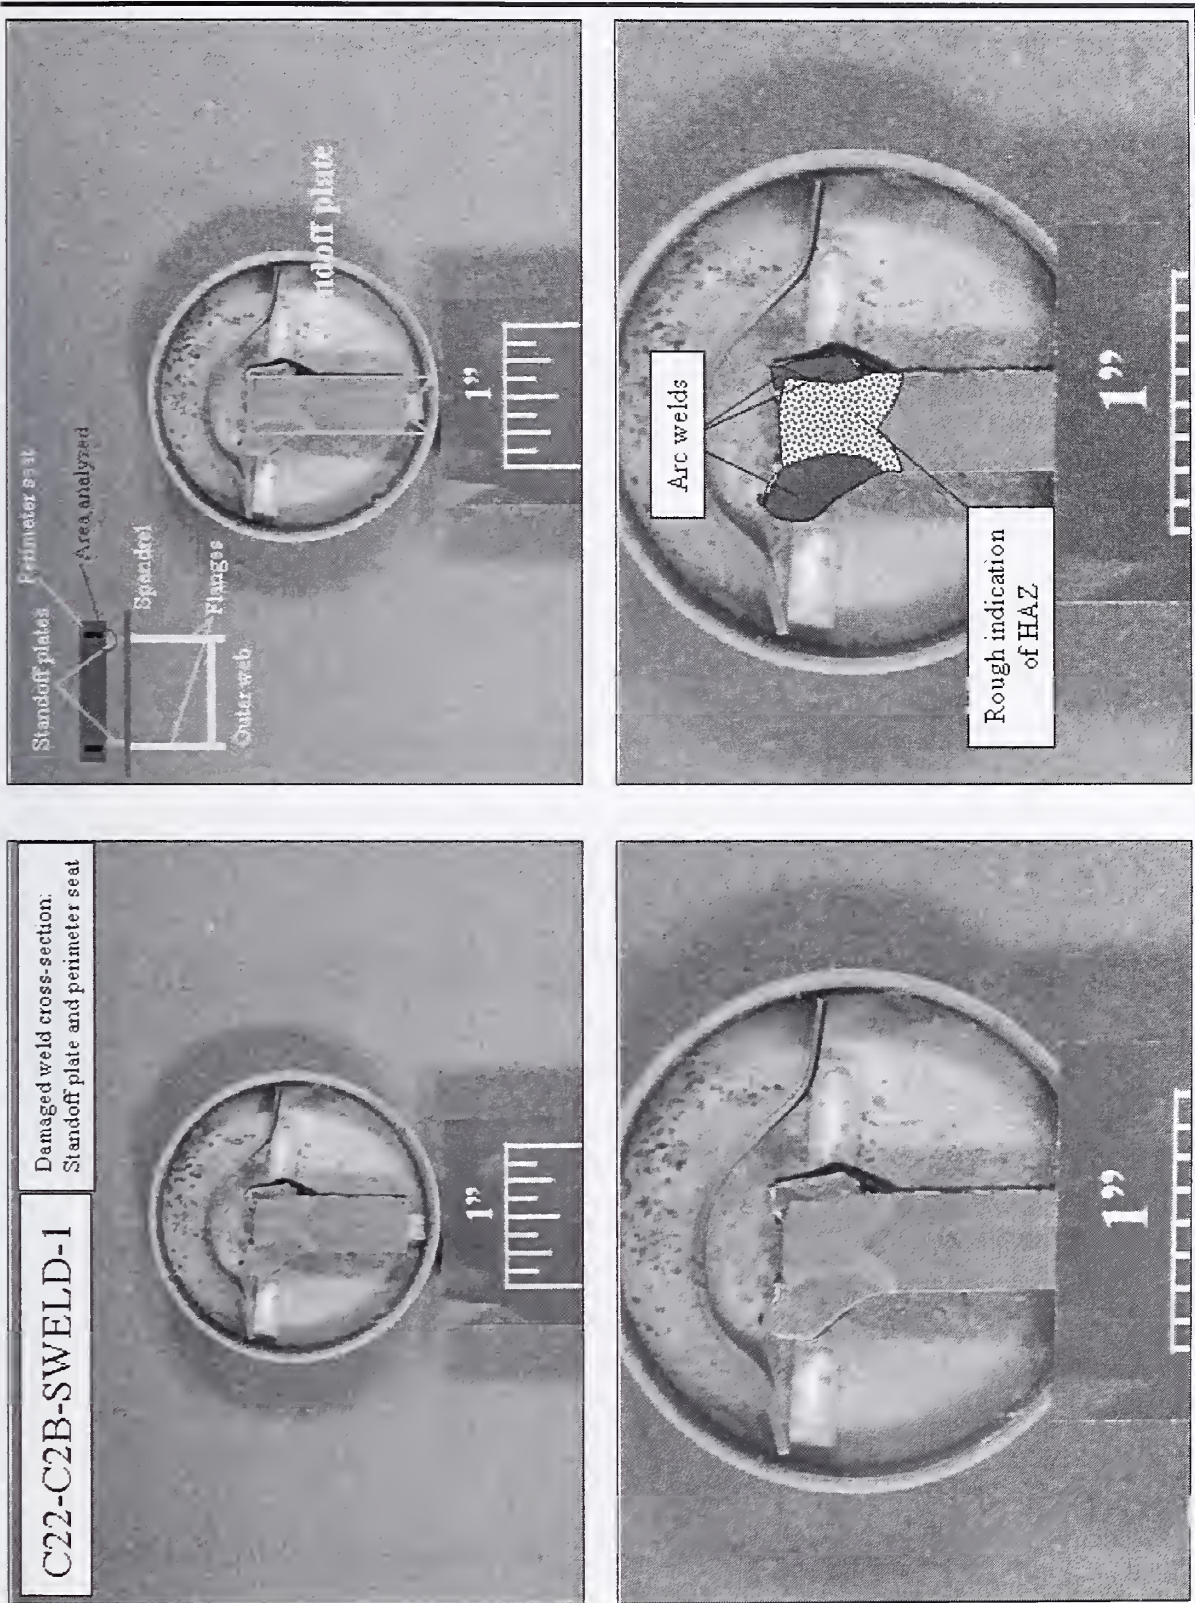
Source: NIST.
 Figure 3-54b. Etched cross-section of fracture near weld between standoff plate and truss seat. Sample was from panel C-22 (A157: 93-96, column 156, 94th floor). Two percent nital and 4 percent picral etch.

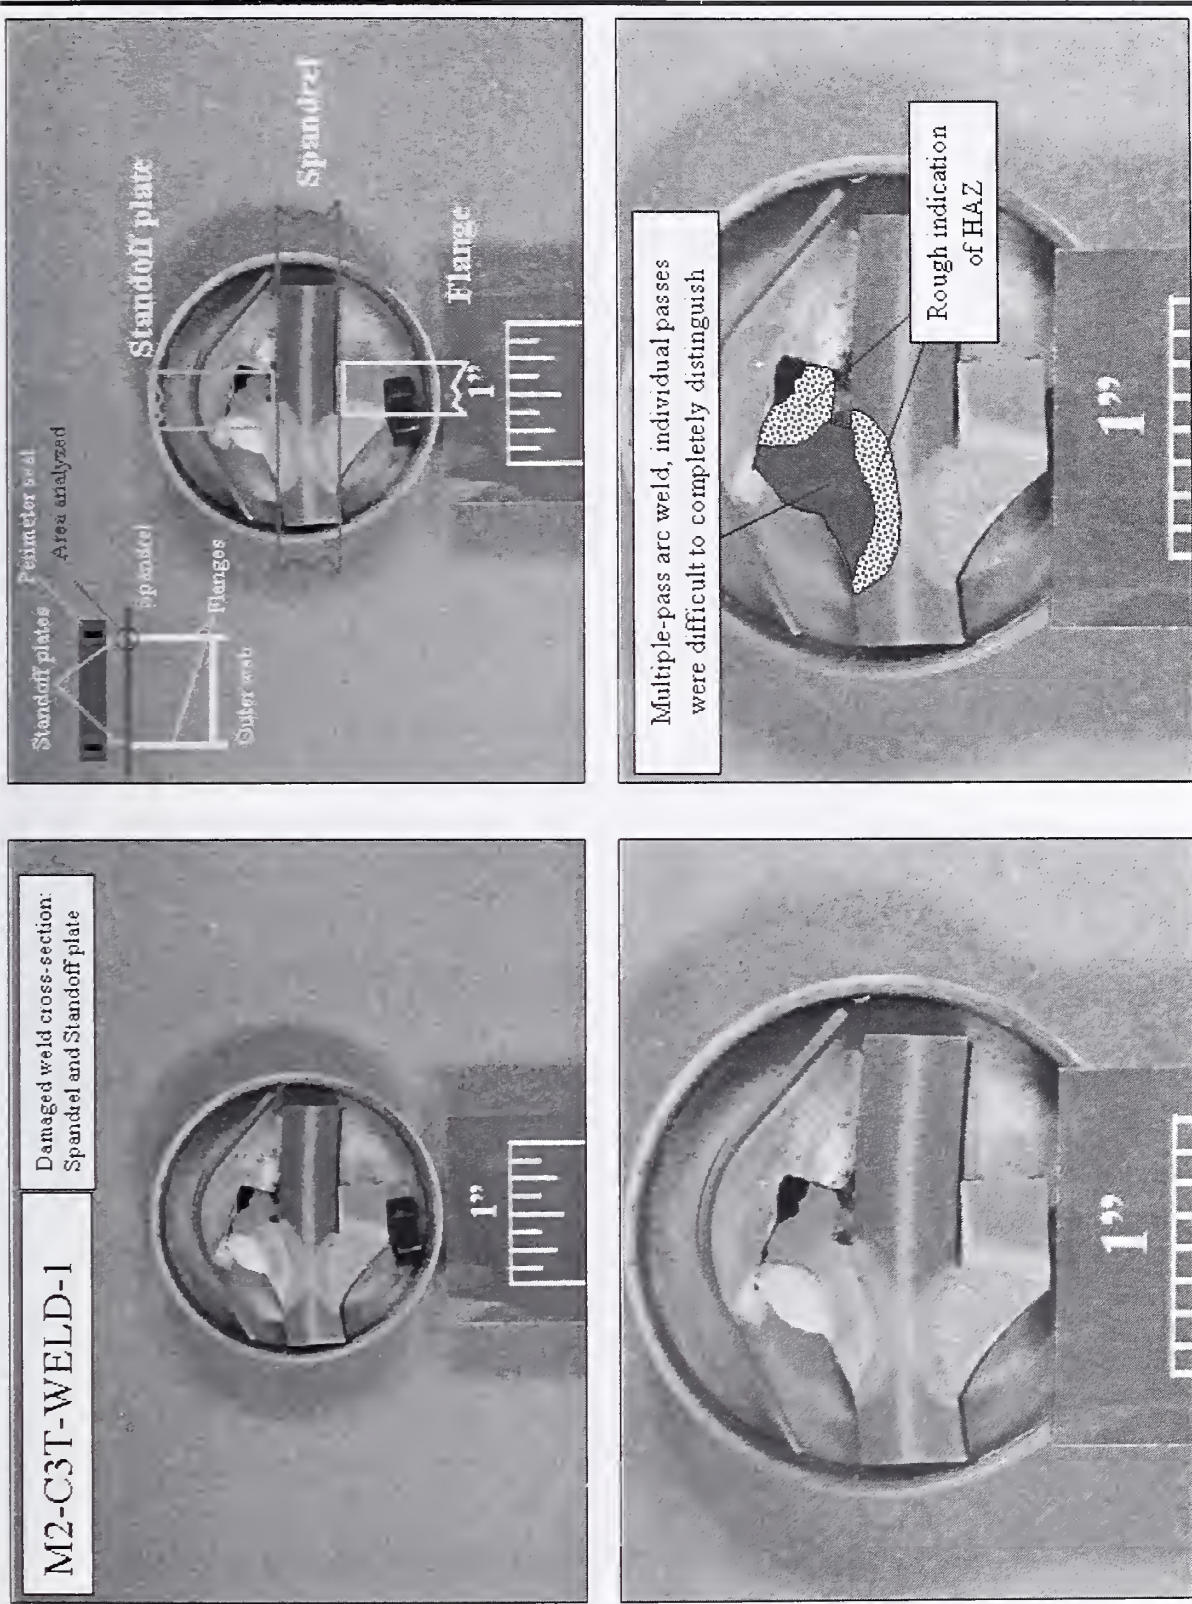
Figure 3-54a. Etched cross-section of intact weld between a standoff plate and truss seat. Sample was from panel N-9 (A154: 101-104, column 153, 103rd floor). Two percent nital and 4 percent picral etch.

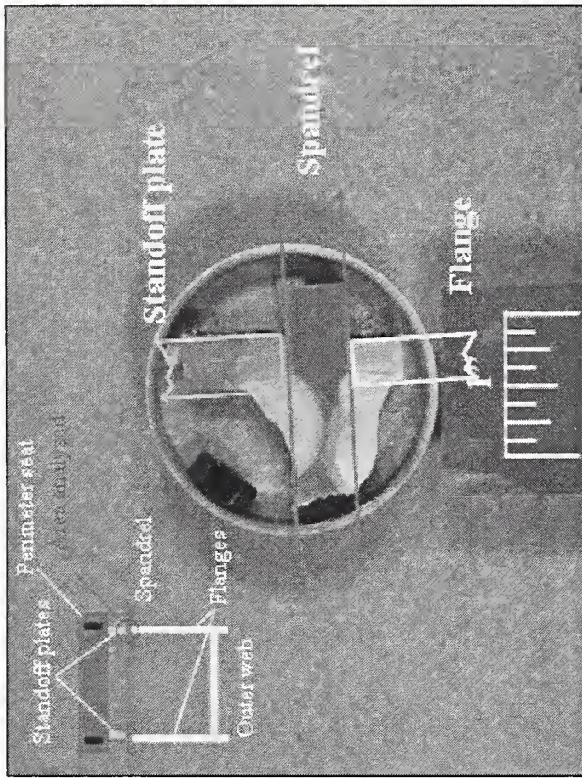
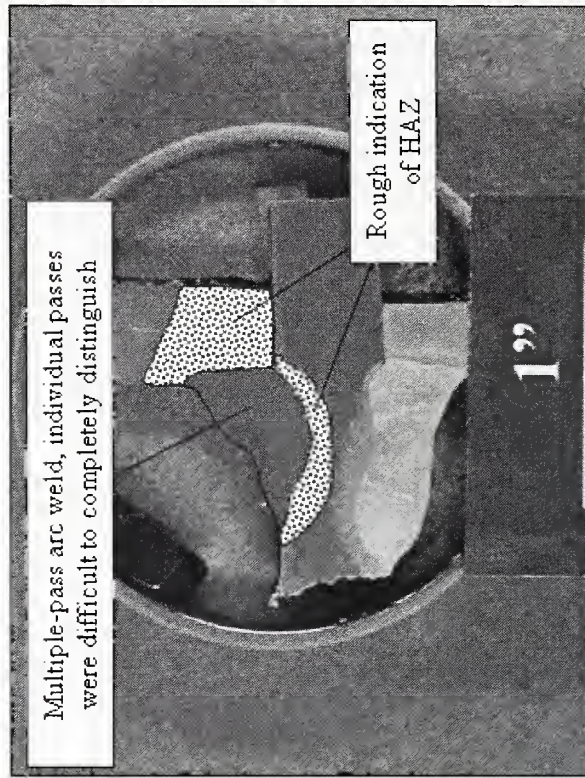
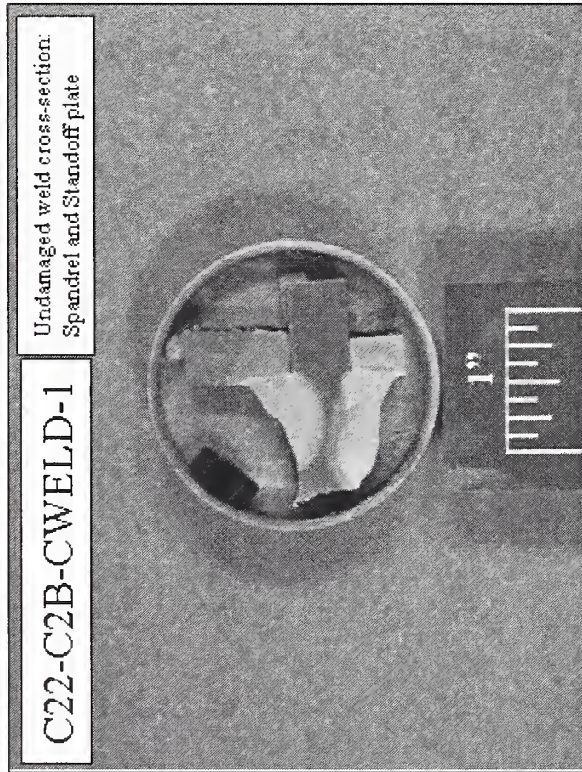
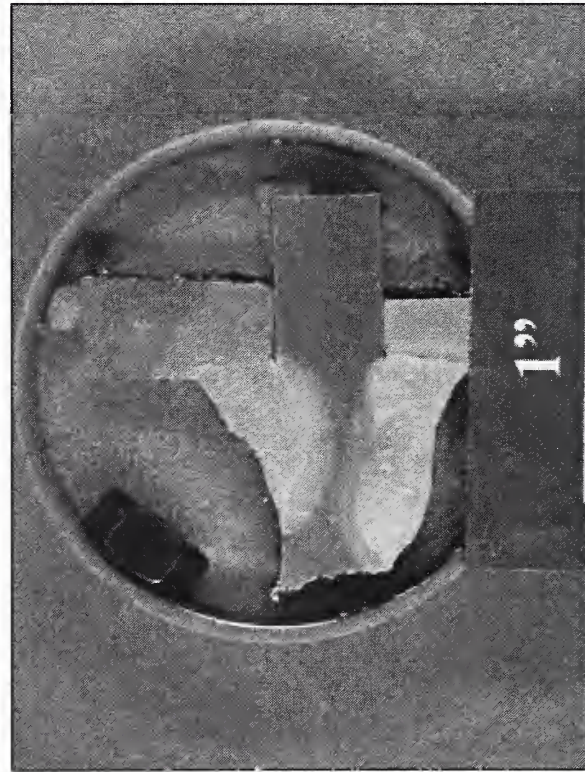
Figure 3-53b. Etched cross-section of fracture near weld between spandrel plate (36 ksi) and standoff plate (42 ksi). Sample was from panel M-2 (A130: 96-99, column 129, 99th floor). Two percent nital and 4 percent picral etch (cont.).

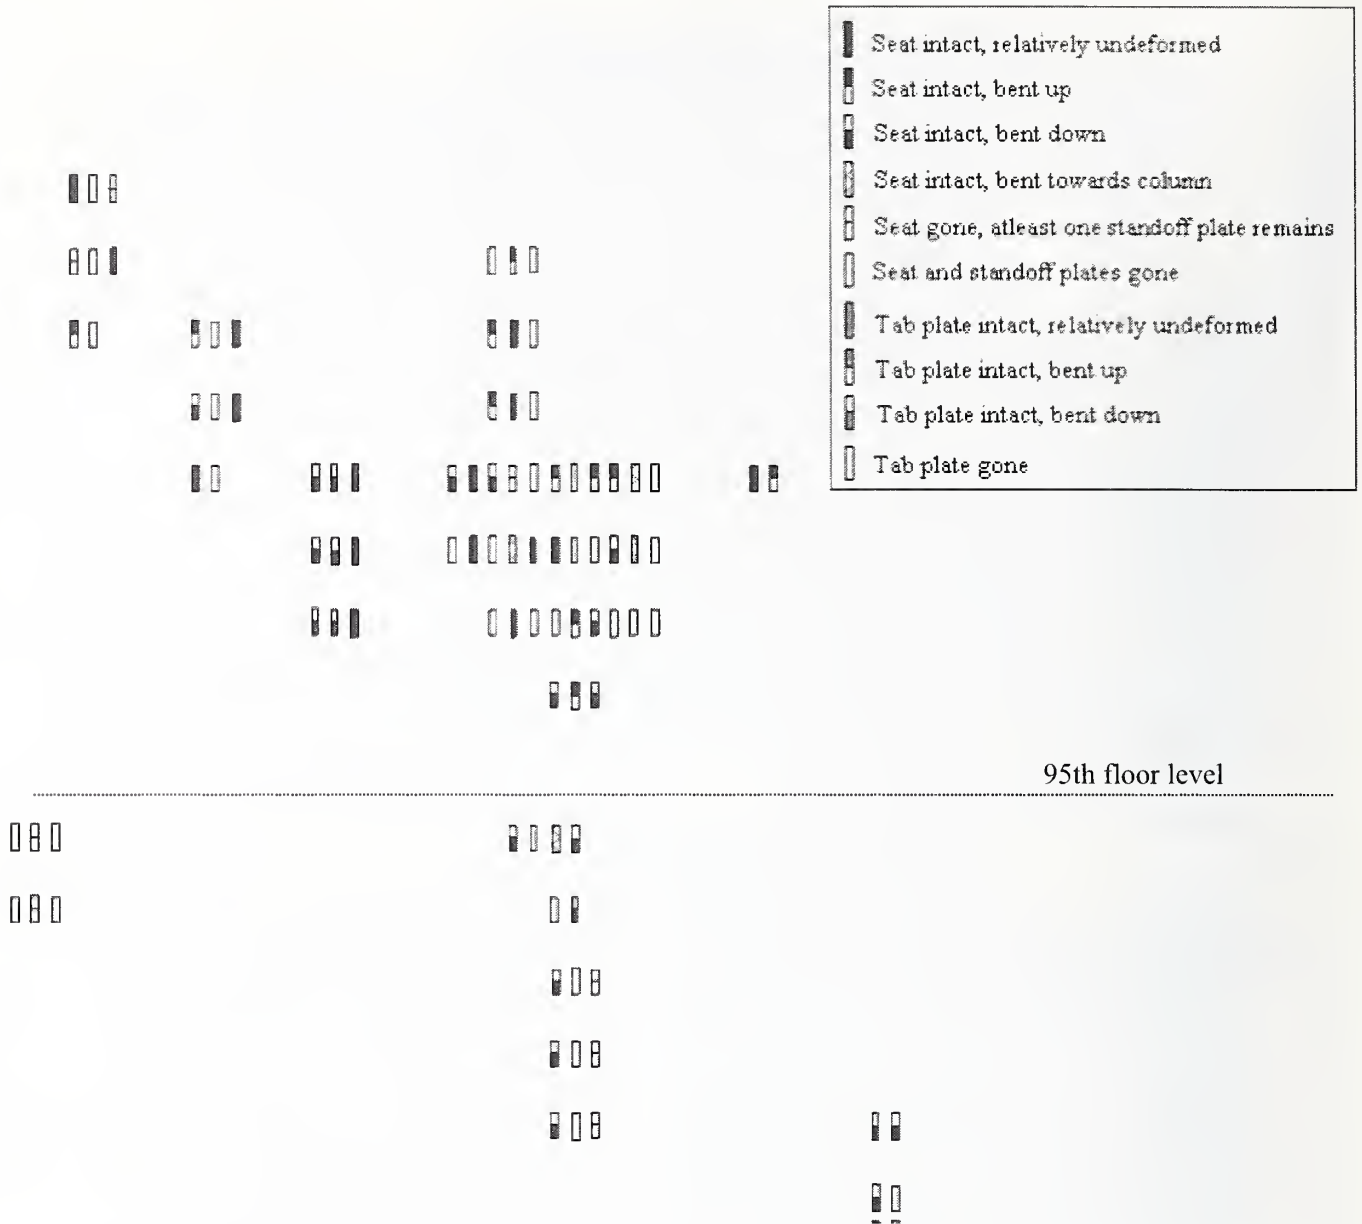
Figure 3-51b. WTC 1, damage of connectors. At or below the 95th floor, all connectors are either bent down or missing.

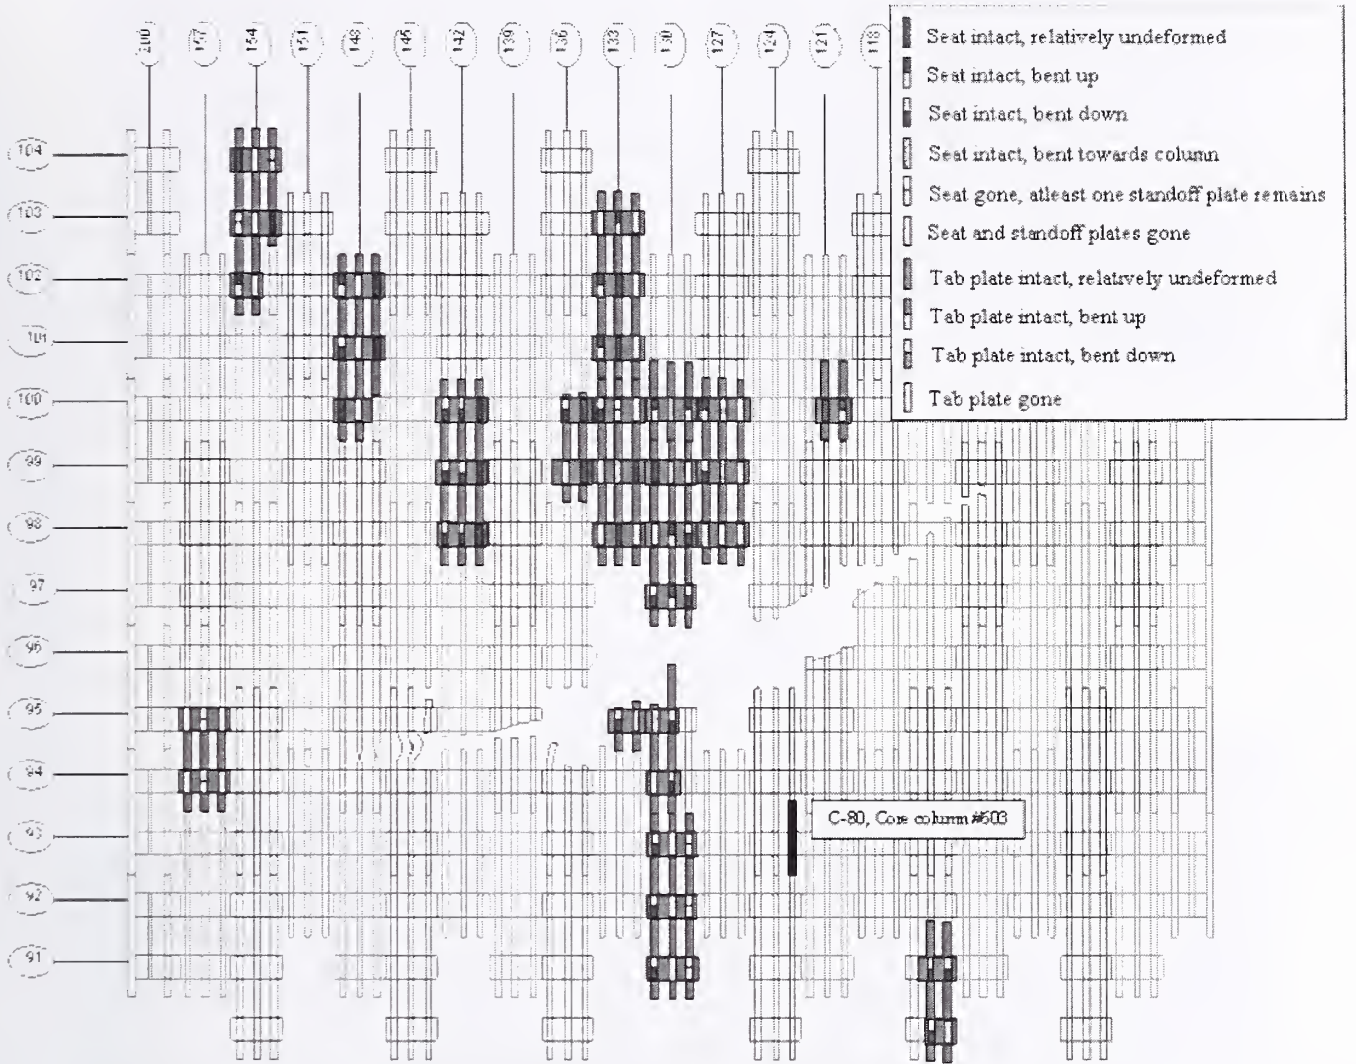
Figure 3-51a. WTC 1, damage diagram overlaid with recovered samples and damage of connectors.

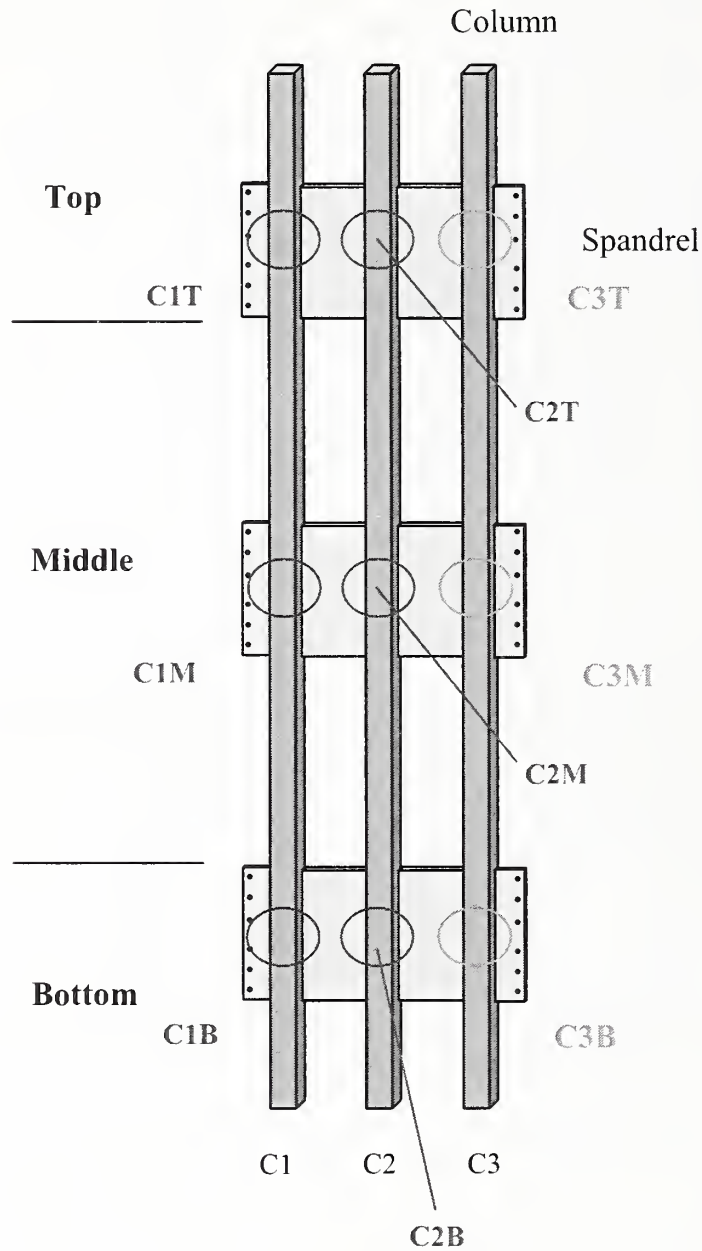
Figure 3-50. Labeling system used by NIST to identify the specific intersections of columns and spandrels of the exterior wall panels.

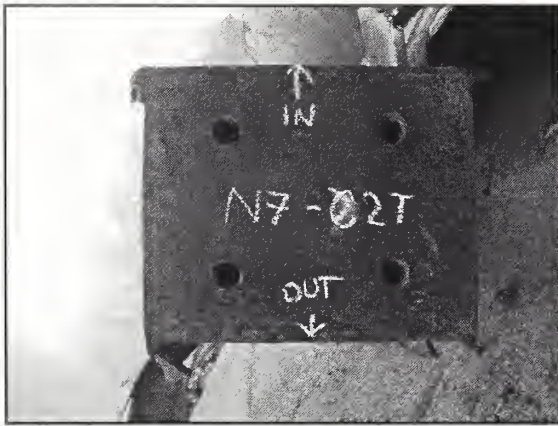
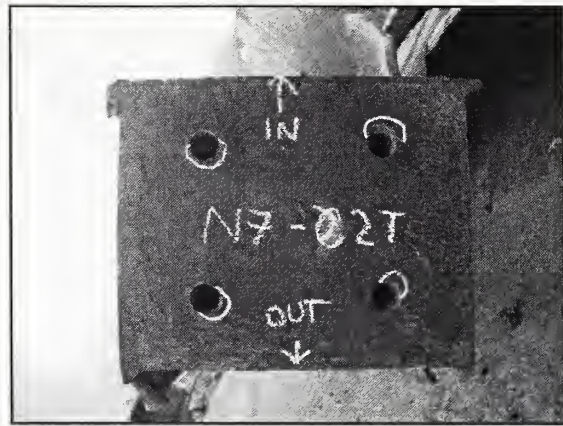
N7-C2T
WTC1
Col 127
F1 100

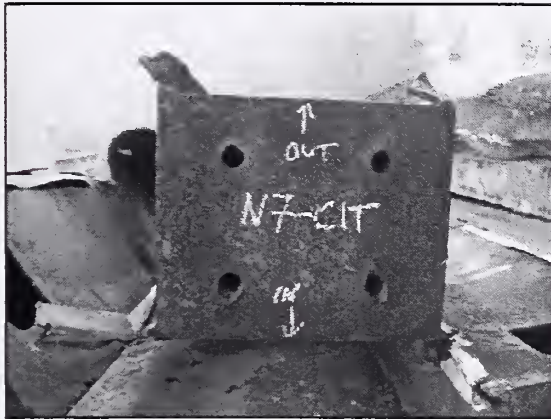
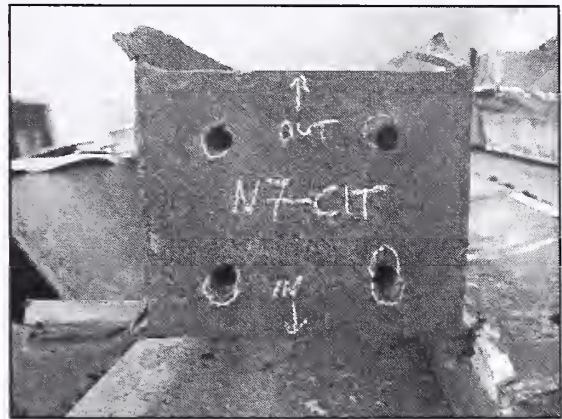
N7-C1T
WTC1
Col 128
F1 100

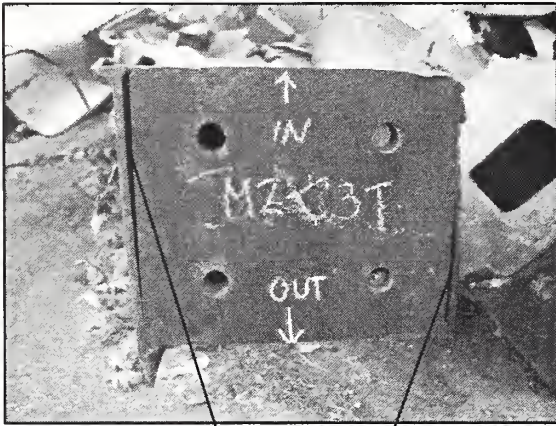
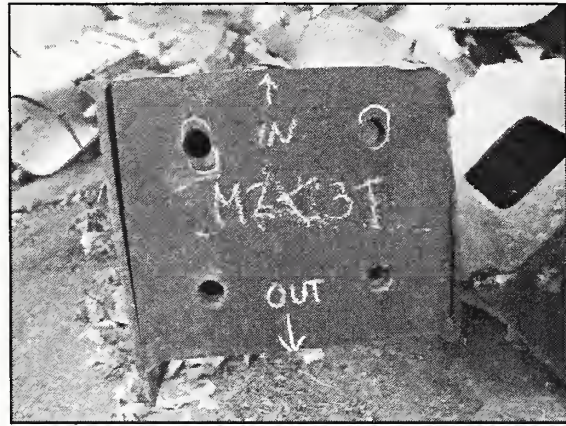
Separation between flange plates and butt plate

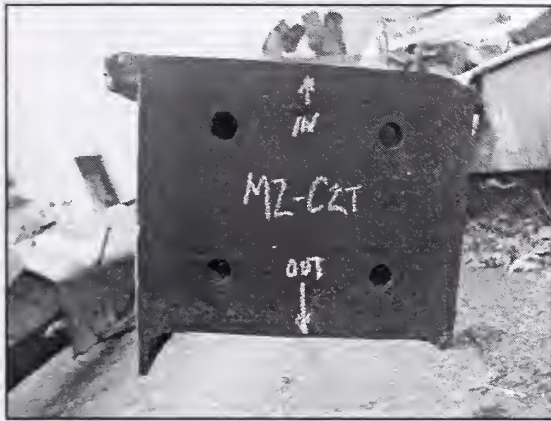
No change in bolt hole shape

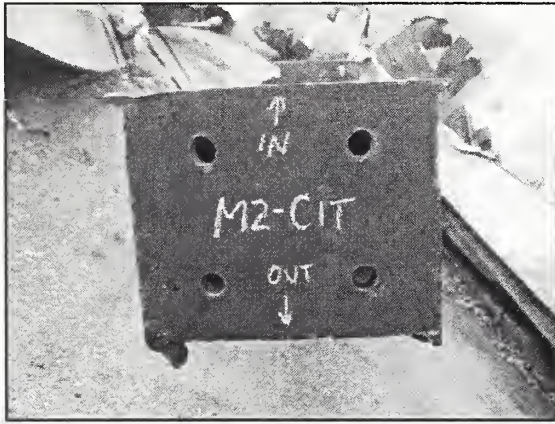
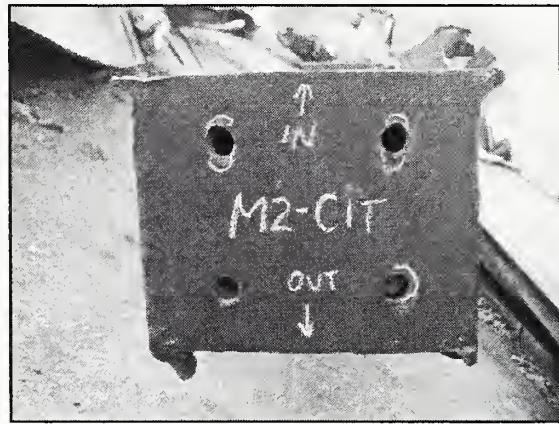
M2-C1T
WTC1
Col 131
F1 99

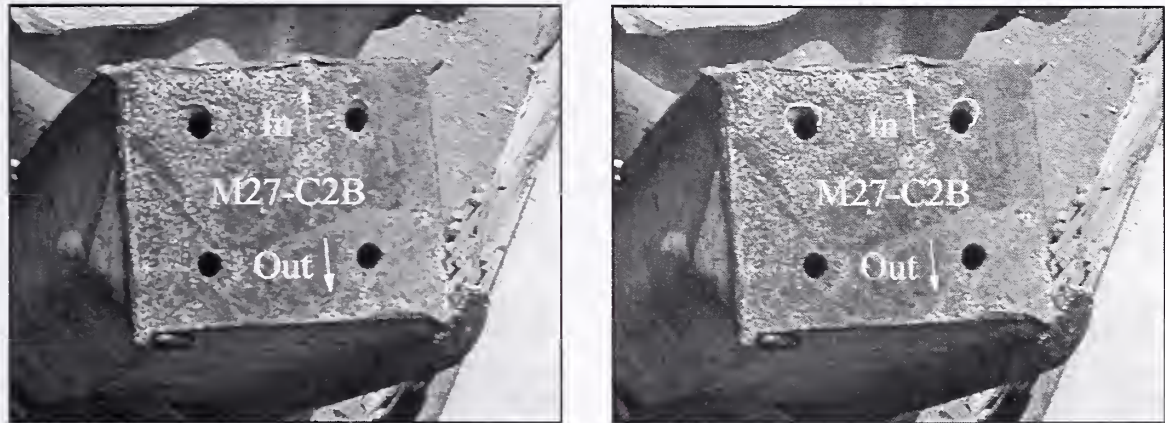
M27-C2B
WTC1
Col 130
F1 93

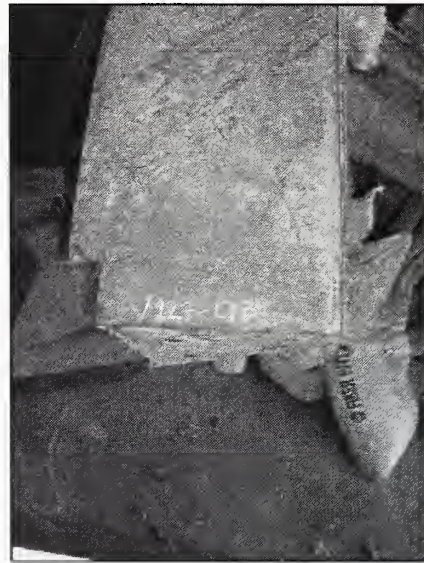
Endplate is bent, no weld failures observed

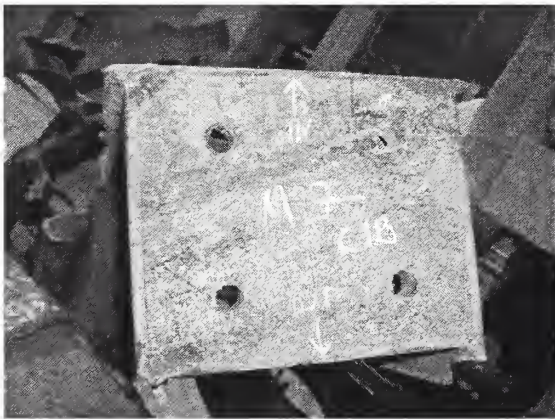
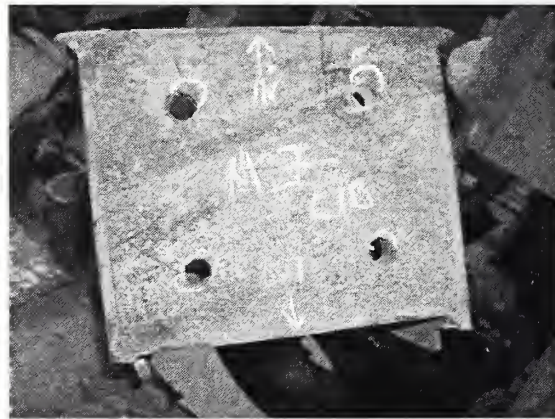
**M27-C1B
WTC1
Col 131
Fl 93**

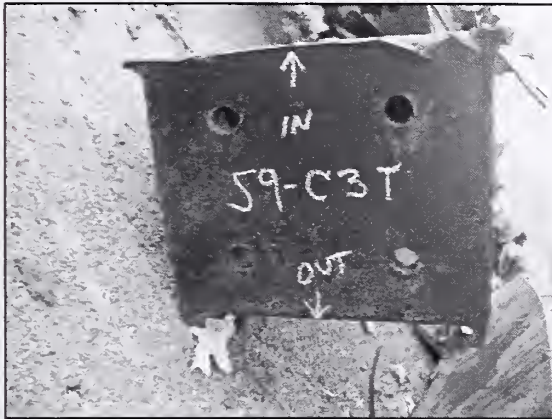
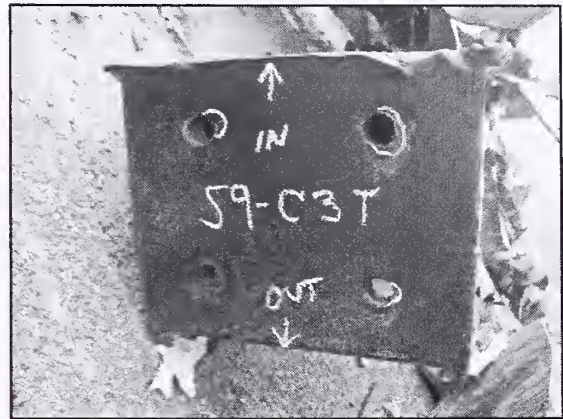
S9-C3T
WTC1
Col 132
F1 100

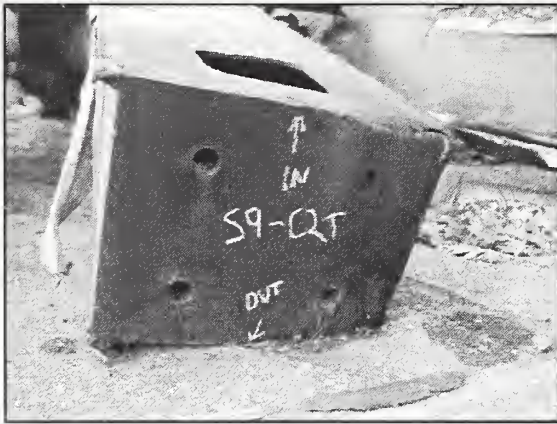
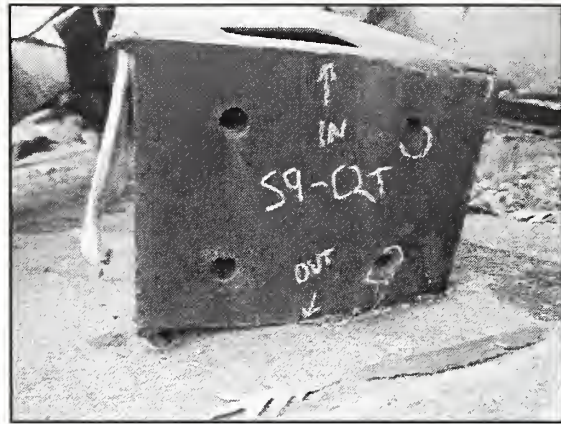
S9-C2T
WTC1
Col 133
F1 100

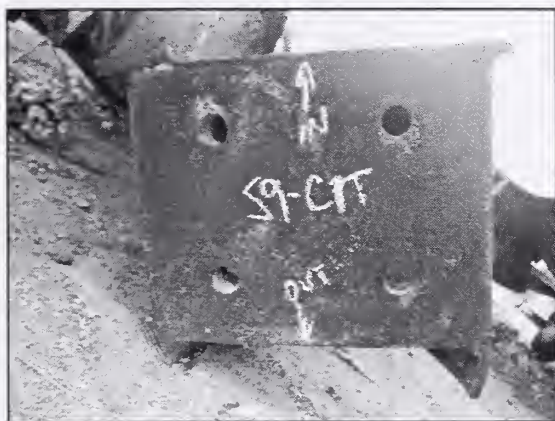
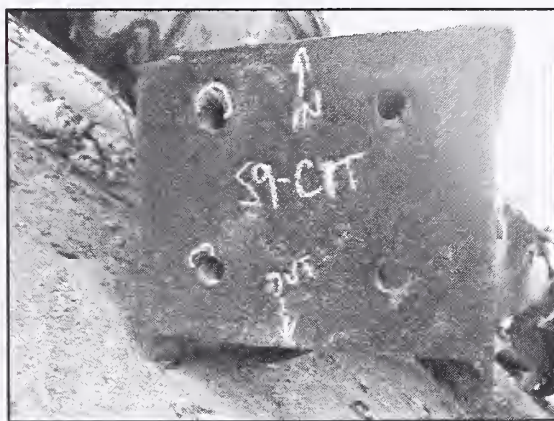
S9-C1T
WTC1
Col 134
F1 100

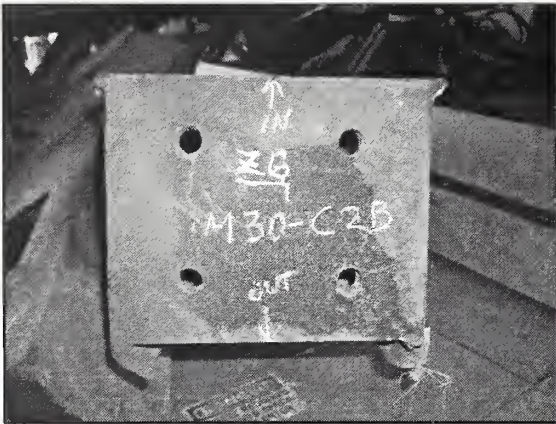
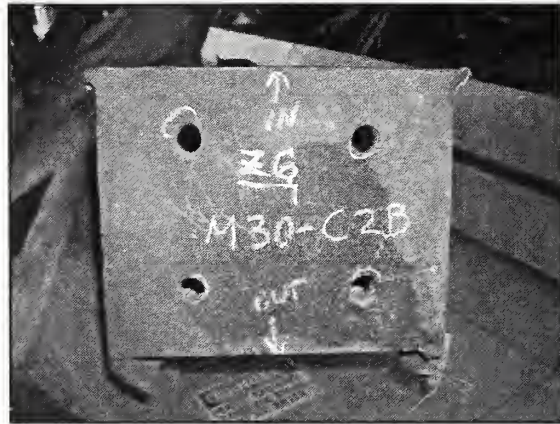
M30-C2B
WTC1
Col 133
Fl 94

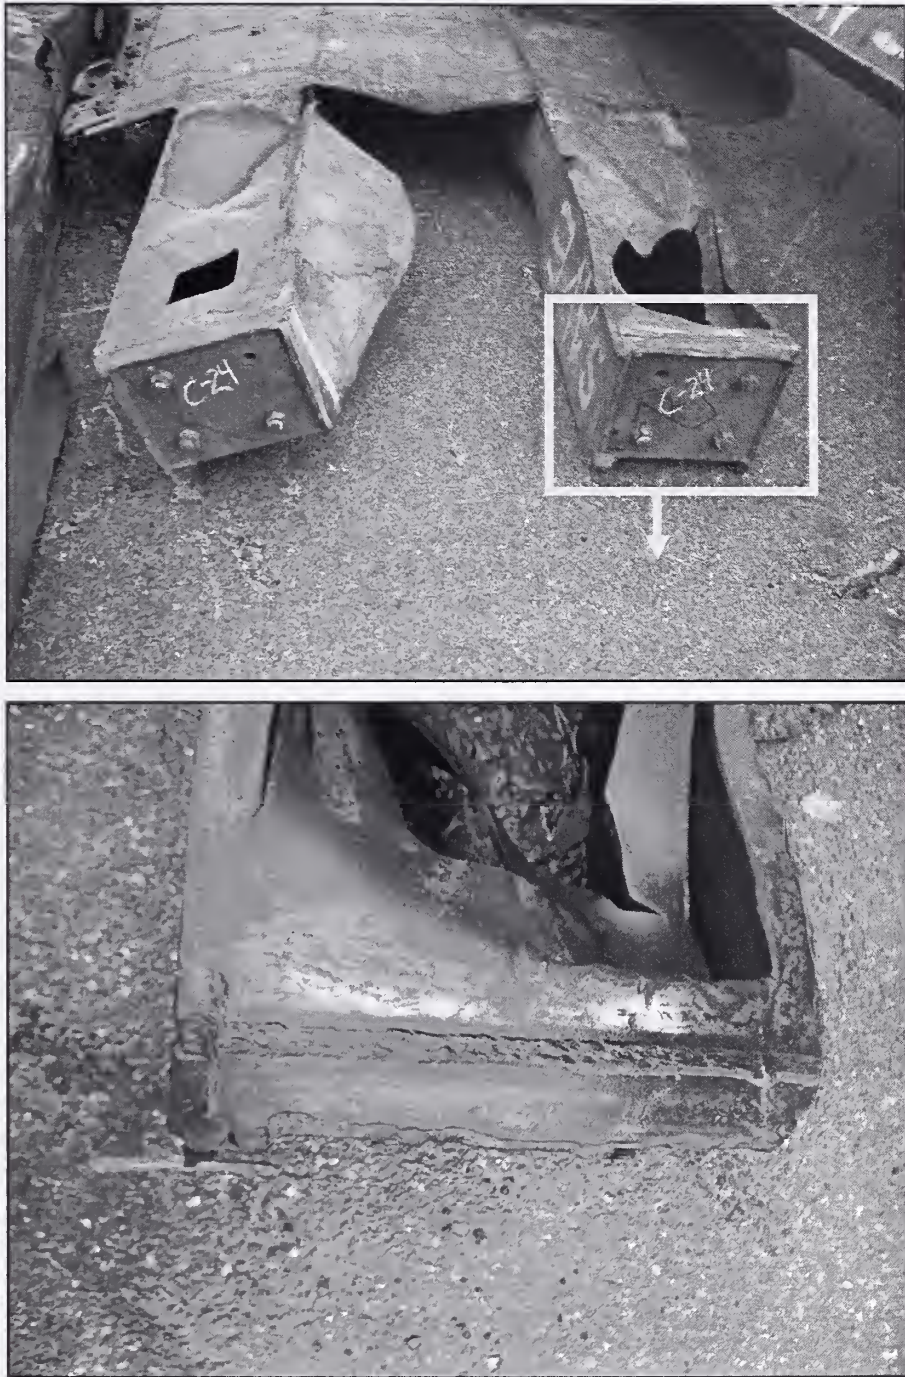
Figure 3-45. Photographs of recovered end plate connections from sample M-30 (A133: 94-97). Both connection failures were due to airplane impact.
