NIST NCSTAR 1-3C

Federal Building and Fire Safety Investigation of the
World Trade Center Disaster

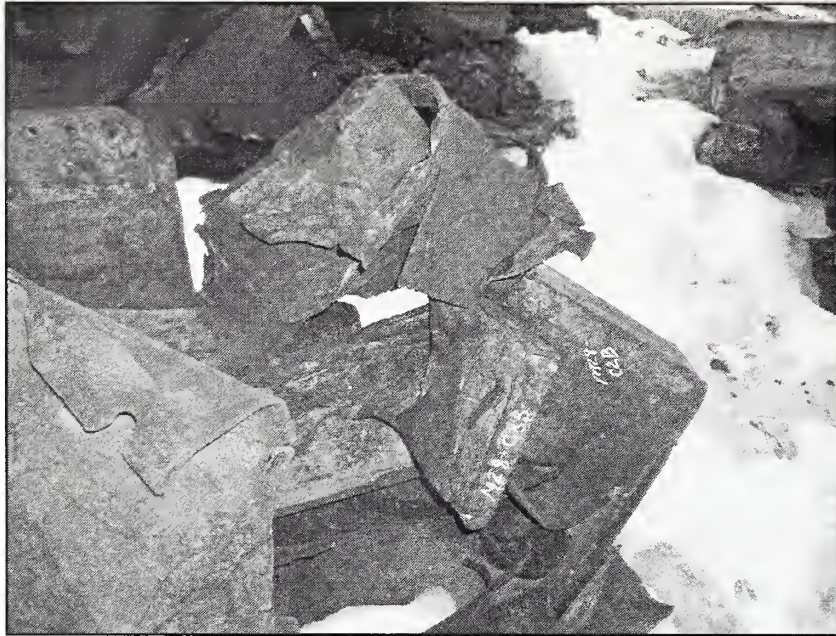
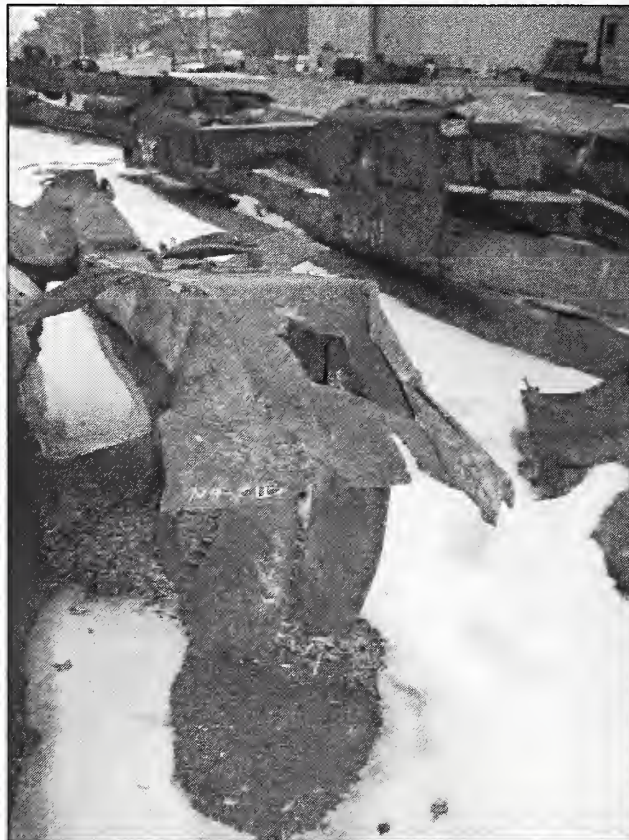
Figure 3–44. Photographic example of Type 3 failure mode for end plate connections, a welded connection with bolts intact, end plate of above or below adjoining column still attached. Sample shown is C-24 (B203: 74-77). Damage of this type may be due to any one of the extreme loading events.

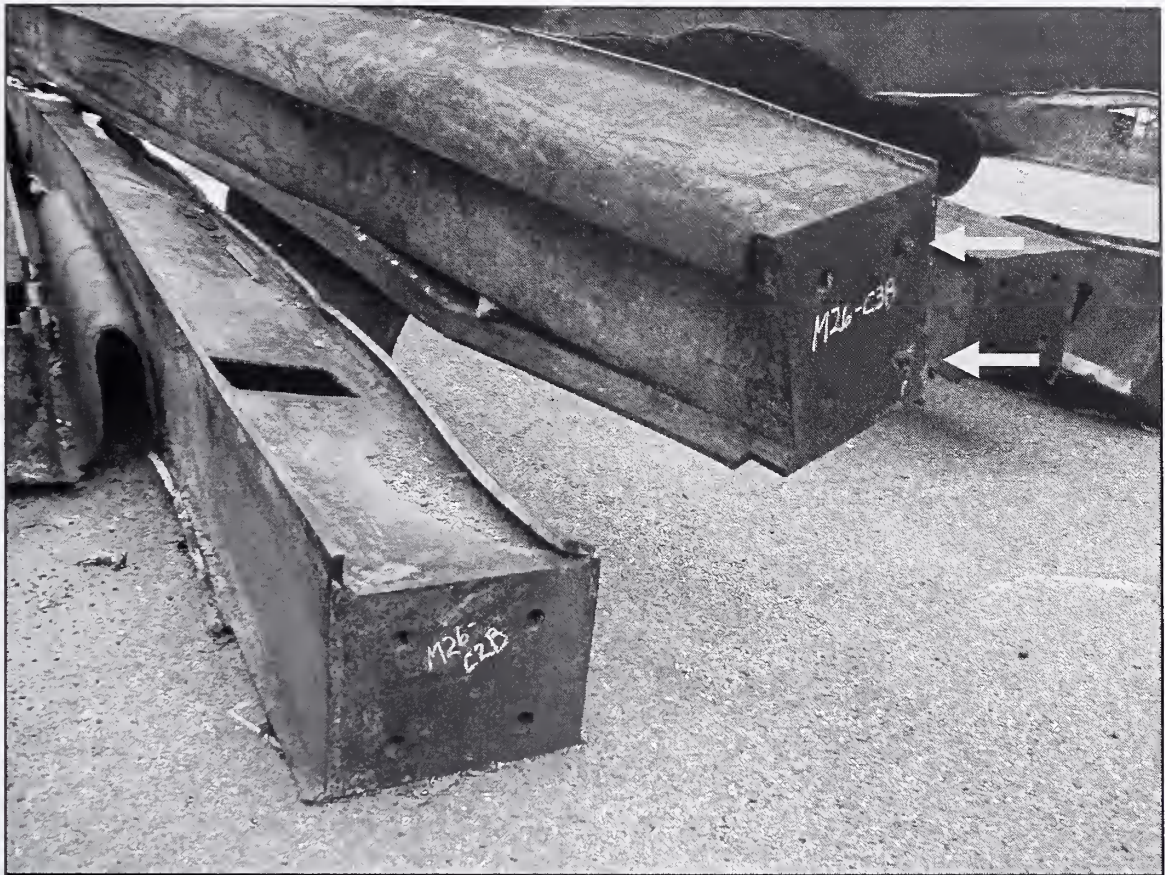
Figure 3–43. Photographic example of Type 2 failure mode for end plate connections. a) Type 2a, partial failure with end plate still remaining (arrows) from M-28 (B345: 98-101) and b) Type 2b, full failure with end plate missing from N-9 (A154: 101-104). Damage of this type may be due to any one of the extreme loading events.

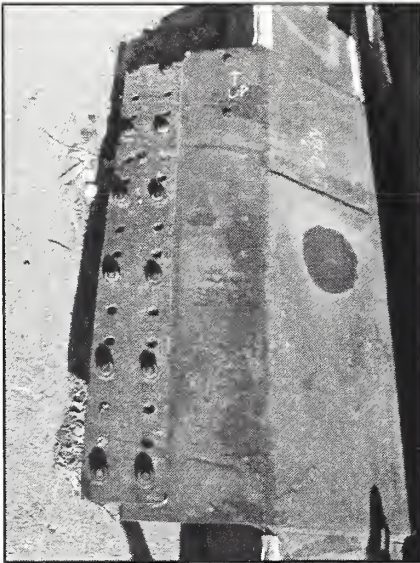
N7-C3T
Column 126, 100th floor

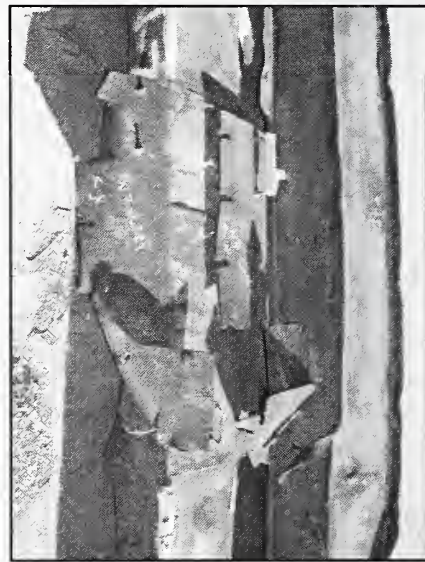
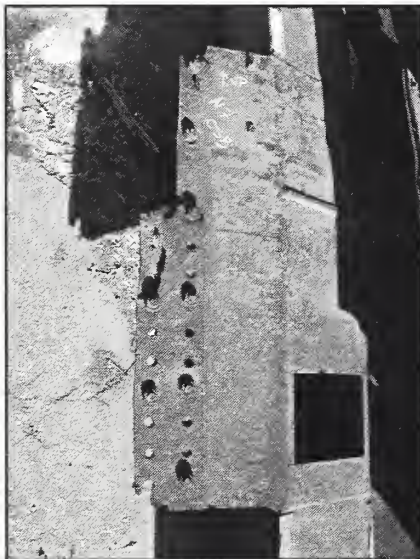
N7-C3B
Column 126, 98th floor

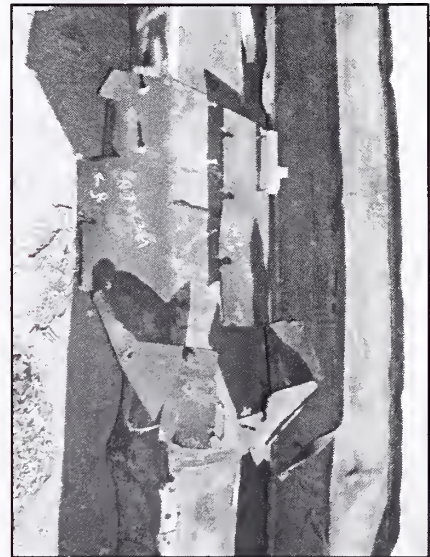
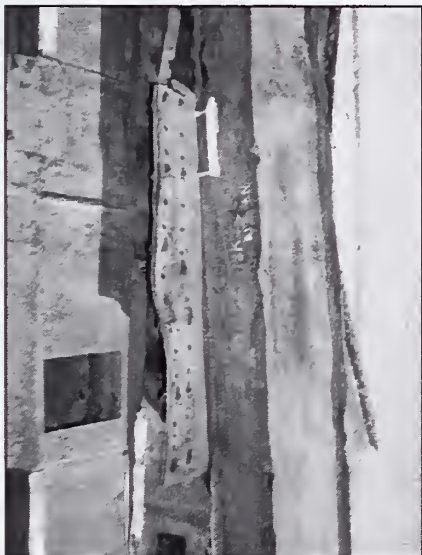
Probable cause of damage: Collapse

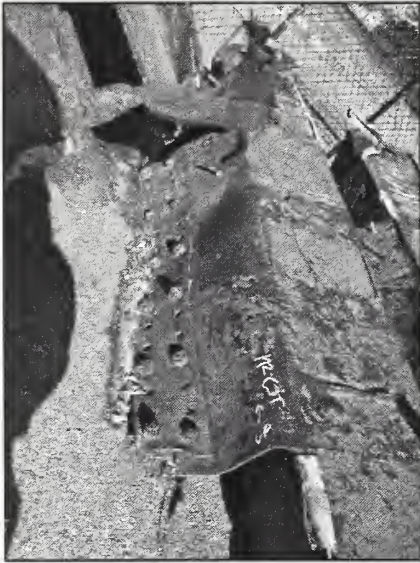
M2-C3T
Column 129, 99th floor

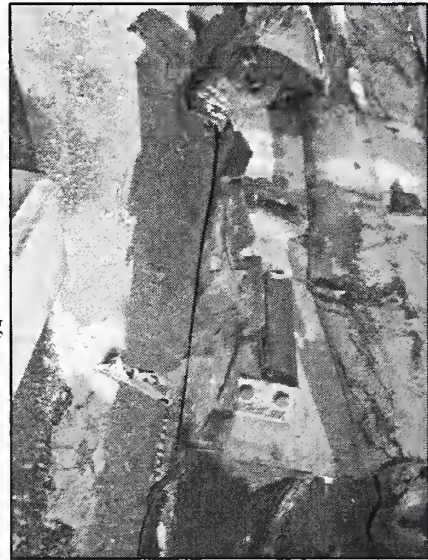
M2-C3B
Column 129, 97th floor

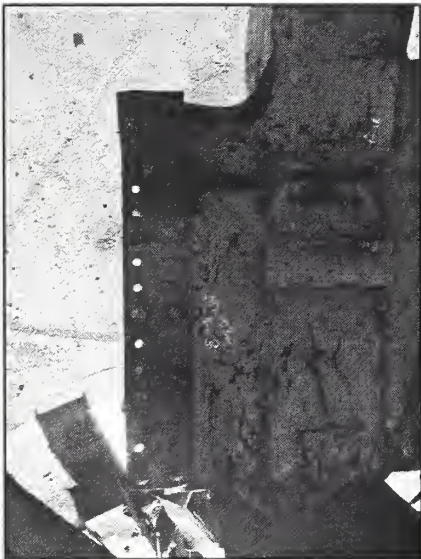
Spandrel Detail: 101
Failure mode: Type 1b
Orientation of image: From inside building looking out.
Probable cause of damage: Impact

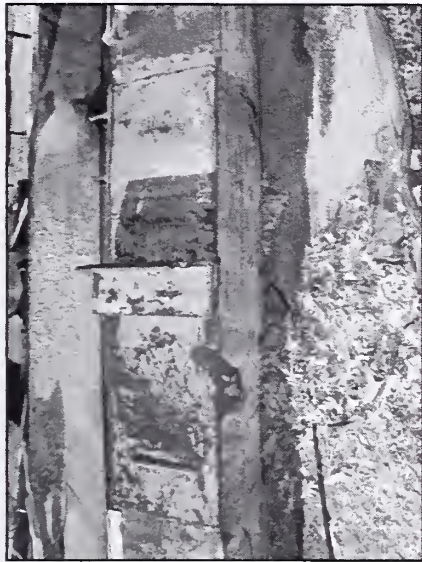
M2-C1T
Column 131, 99th floor

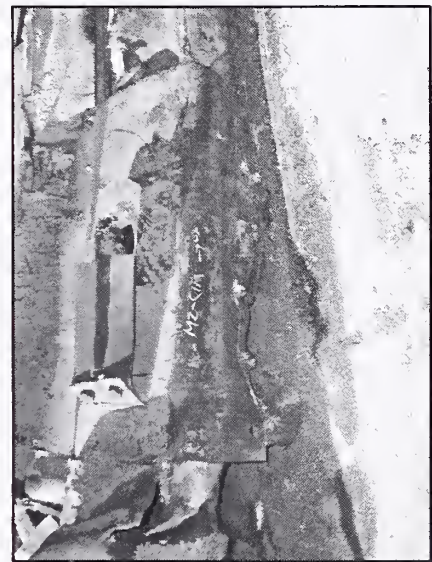
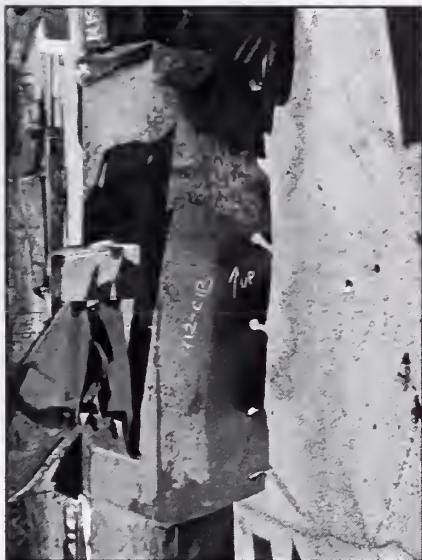
M2-C1B
Column 131, 97th floor

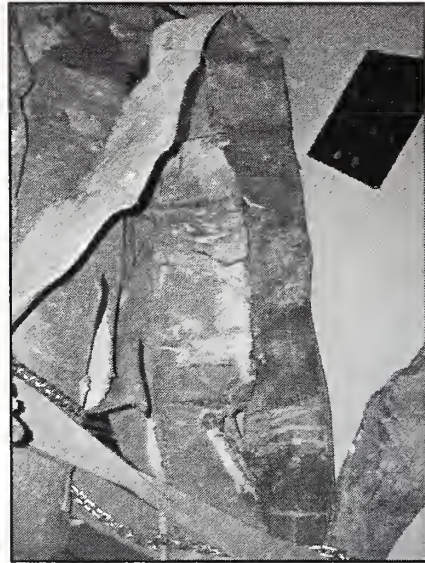
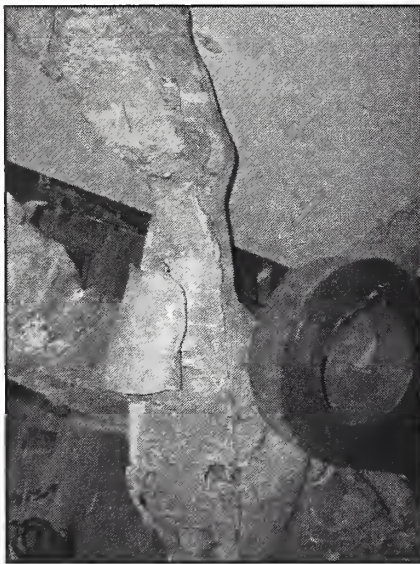
Probable cause of damage: Collapse

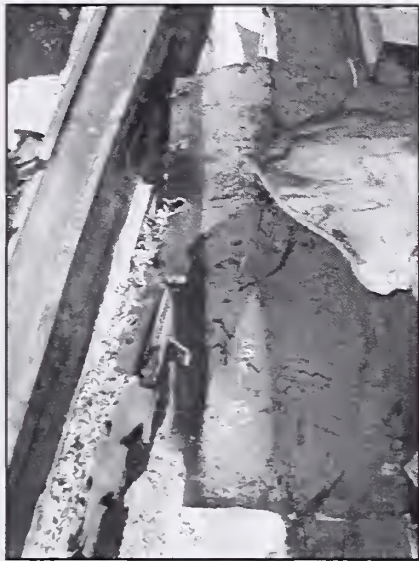
S9-C3T
Column 132, 100th floor

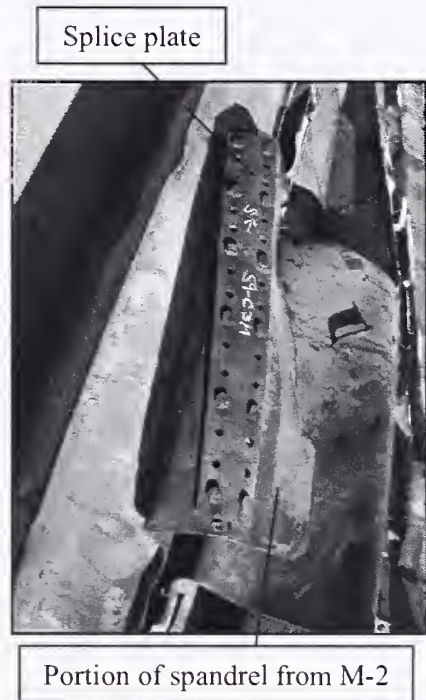
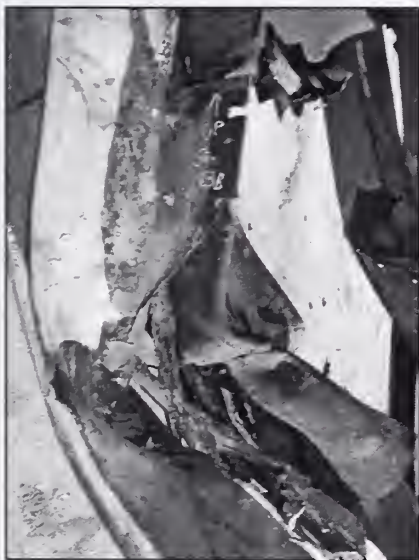
S9-C3B
Column 132, 98th floor

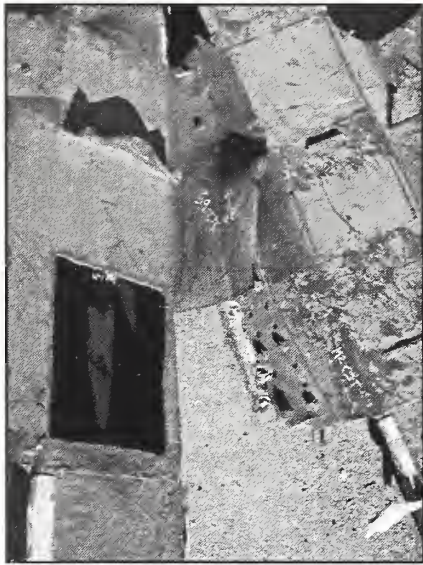
S9-C1T
Column 134, 100th floor

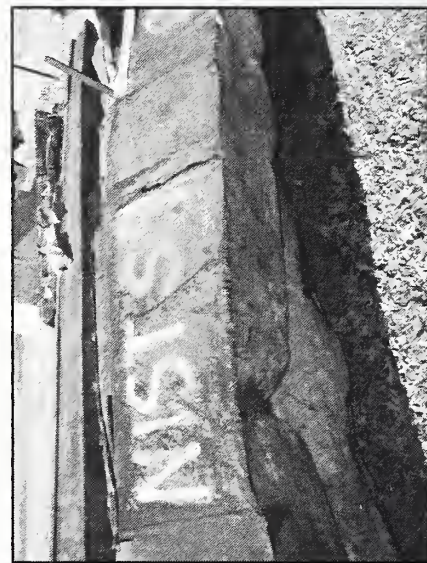
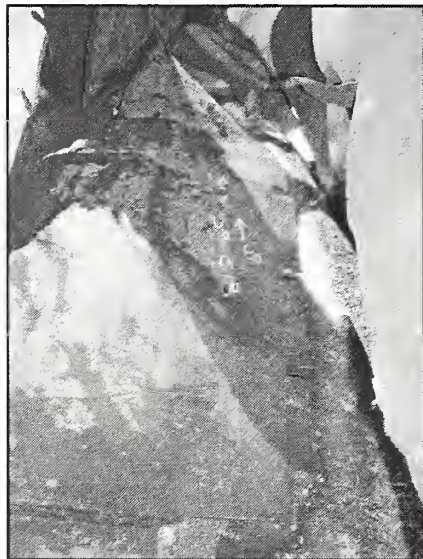
S9-C1B
Column 134, 98th floor

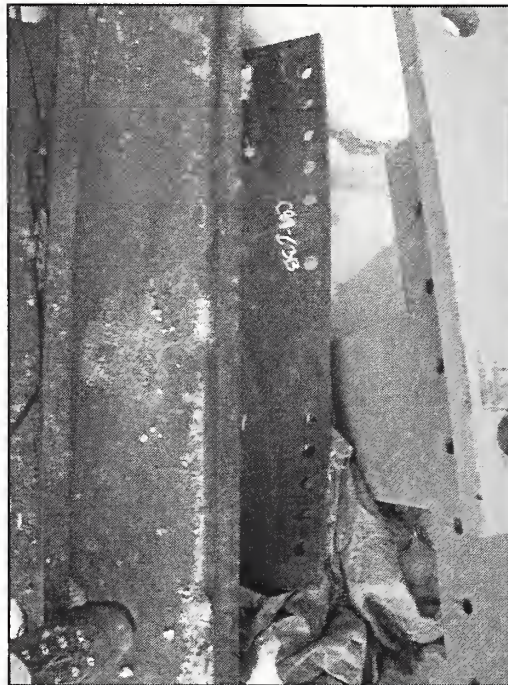
Figure 3–37. Photographs of the recovered spandrel connections from M-30 (A133: 94-97).

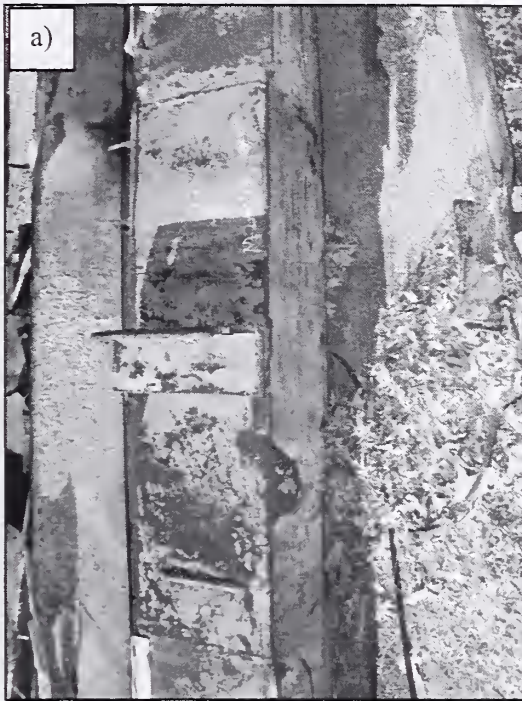
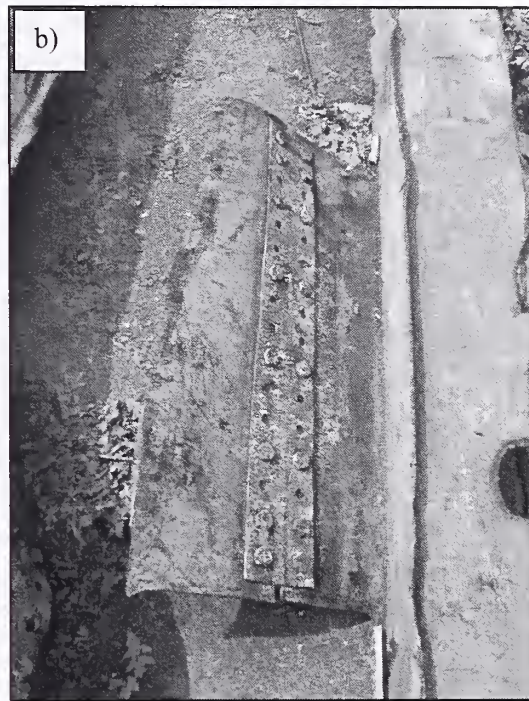
Figure 3–36. Photographic example of Type 5 failure mode for spandrel connections, bolt failure resulting in intact holes in spandrel or splice plate (observed from outside the building looking in) from C-89 (B215: 12-15). Damage of this type may be due to any one of the extreme loading events.

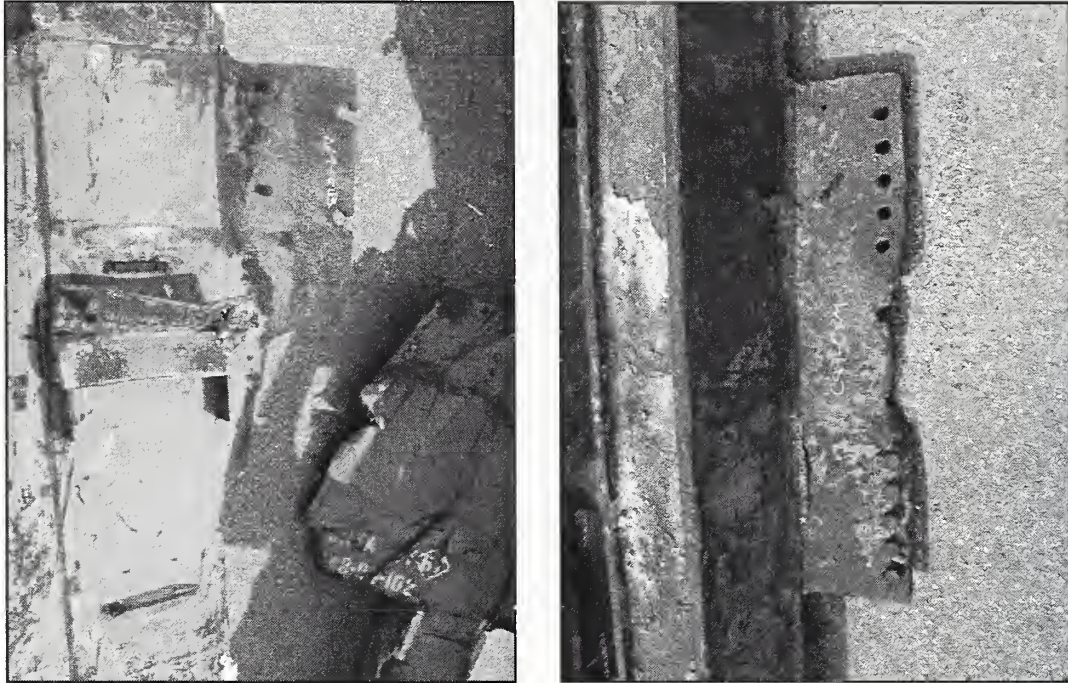
Figure 3–35. Photographic examples of Type 4 failure mode for spandrel connections. a) Type 4a, vertical fracture of observed spandrel plate (observed from inside the building looking out) from M-2 (A130: 96-99) and b) Type 4b, vertical fracture of the neighboring spandrel plate resulting in the observed spandrel connection retaining both the splice plate and portion of spandrel from neighboring panel (observed from outside the building looking in) from C-25 (A206: 89-92). Damage of this type may be due to any one of the extreme loading events.

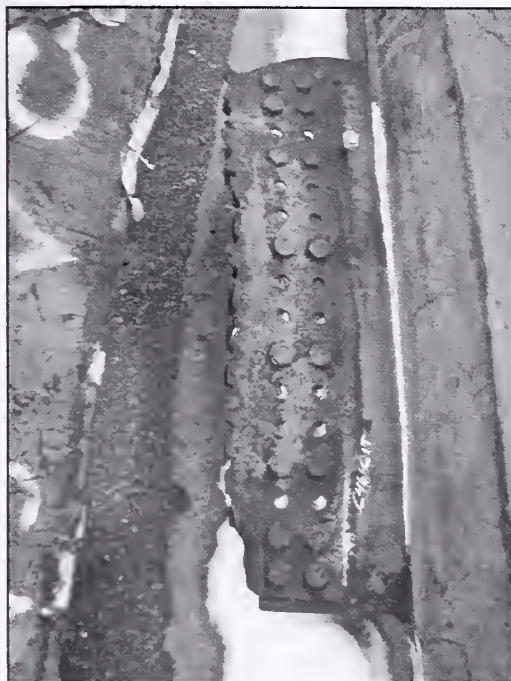
Figure 3–34. Photographic examples of Type 3 failure mode for spandrel connections, mixed mode. Left image orientation was from the inside of the buildings looking out from N-9 (A154: 101-104), right image orientation was from the outside of the building looking in from C-89 (B215: 12-15). Damage of this type may be due to any one of the extreme loading events.

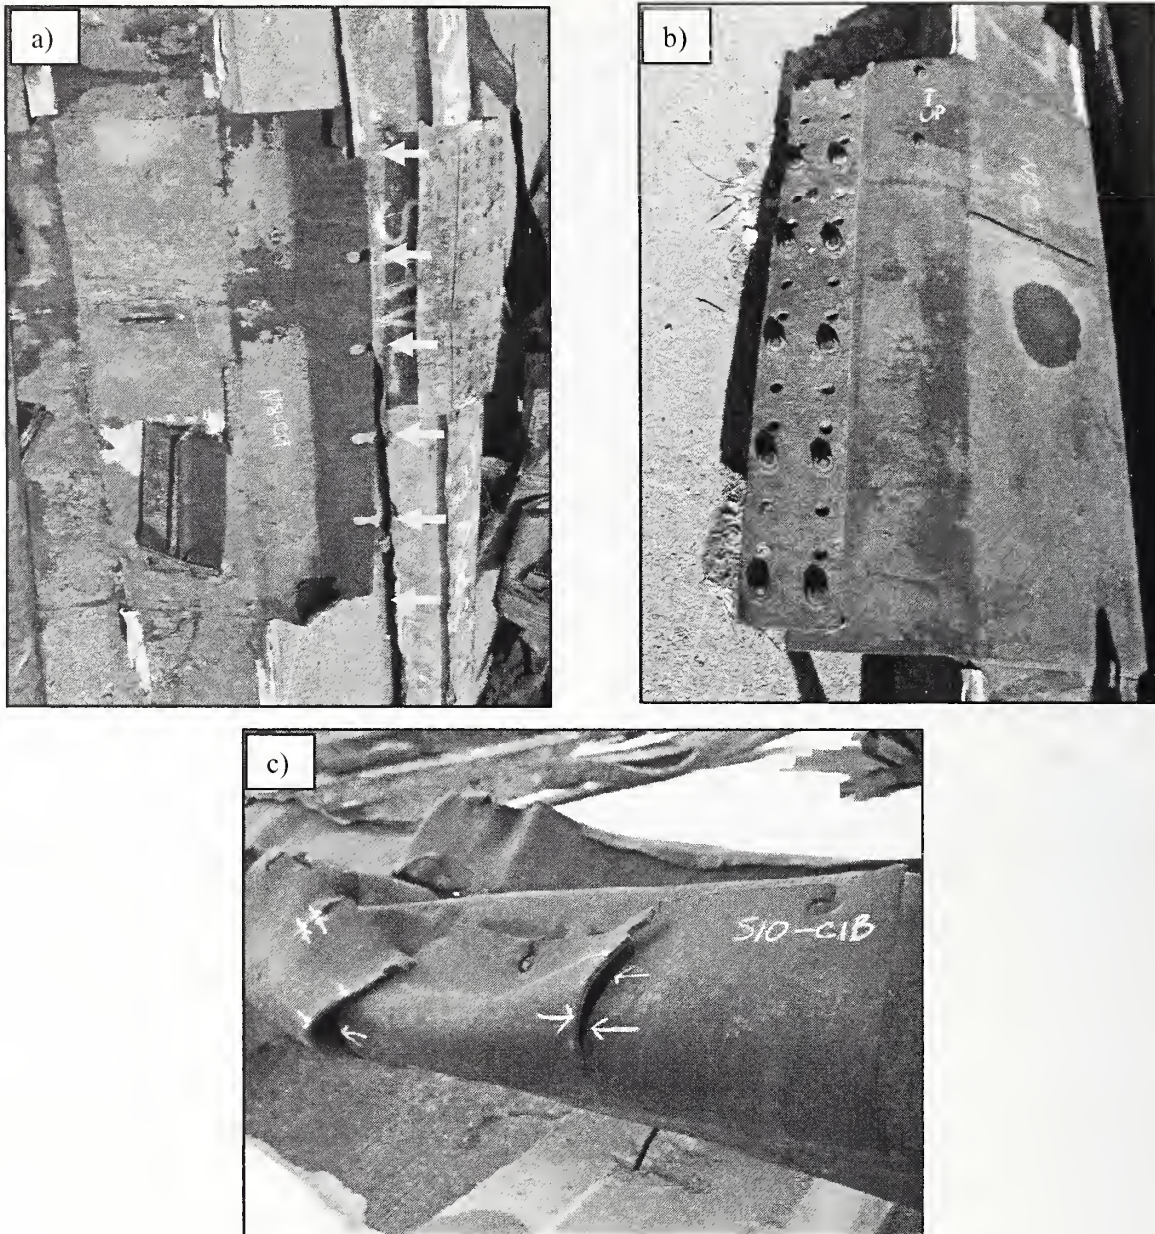
Figure 3–33. Photographic example of Type 2 failure mode for spandrel connections, bolt tear out in splice plate from C-46 (B157: 68-71). Orientation was from the outside of the building looking in. Damage of this type may be due to any one of the extreme loading events.

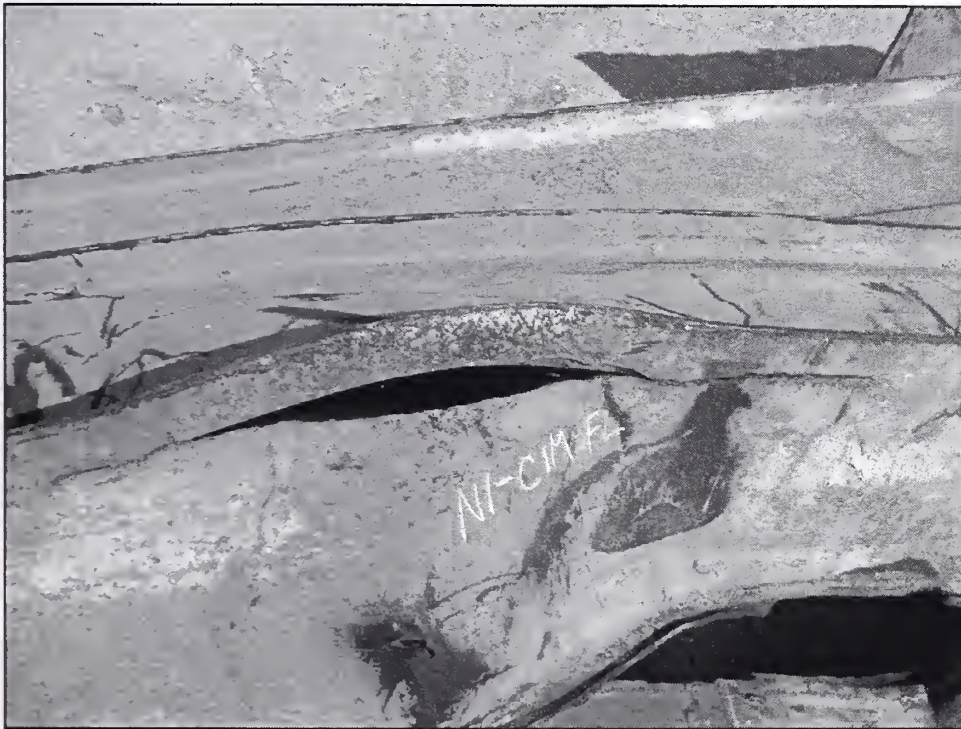
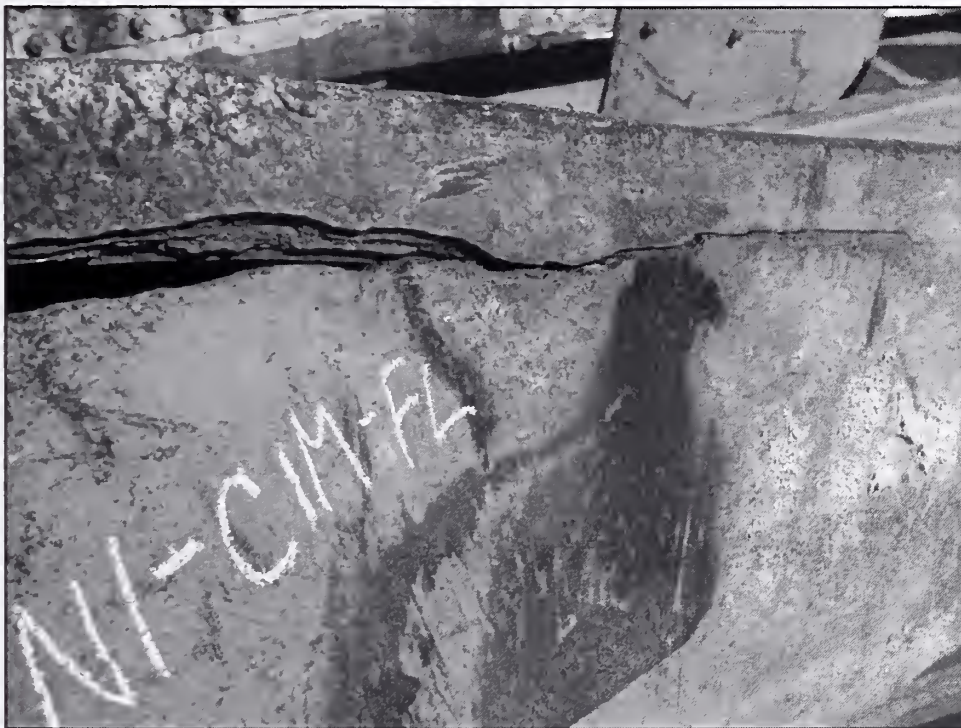
Figure 3–32. Photographic examples of Type 1 failure mode for spandrel connections. a) Type 1a, the observed spandrel connection possessed the tear outs (arrows) from N-8 (A142: 97-100), b) Type 1b, the splice plate and all bolts of the observed spandrel connection remained, thus, tear out occurred in the neighboring spandrel plate to which it was attached from N-7 (A127: 97-100), and c) Type 1c, the observed spandrel connection possessed the tear out, with the additional fracture of the spandrel plate in a horizontal manner from S-10 (A224: 92-95). All orientations are from the inside of the buildings looking out. Damage of this type may be due to any one of the extreme loading events.

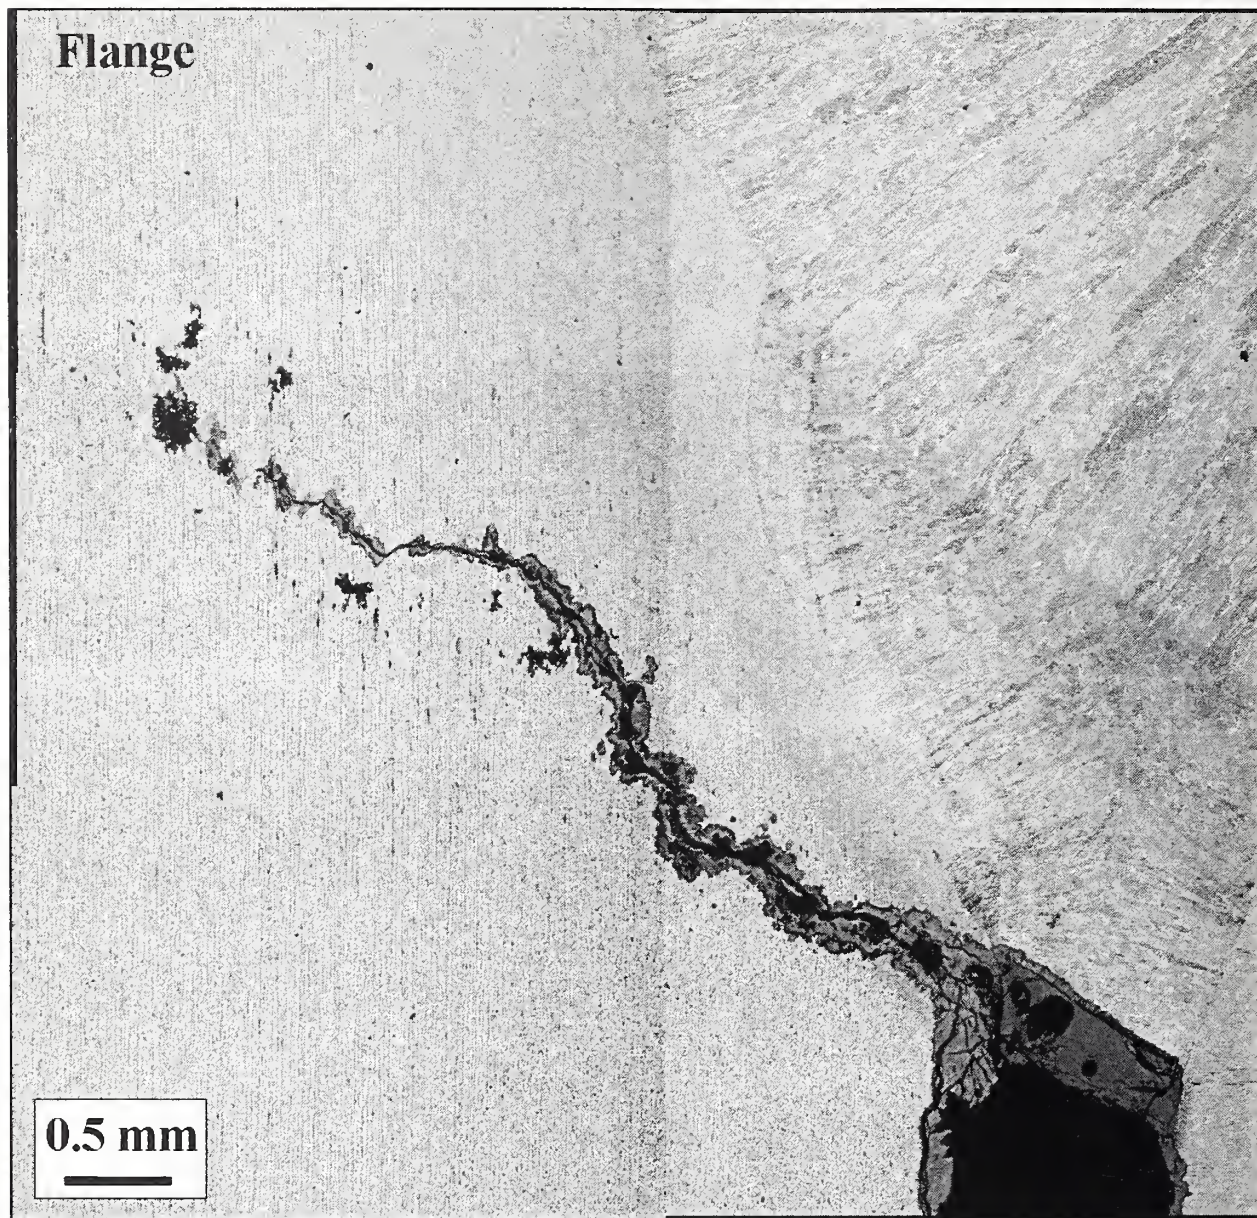
Figure 3-31. Most-likely scenario for fracture associated with weld if second crack of sample S9-C2B-Weld-1 had continued to propagate through the flange plate. Sample shown is from N-1 (A218: 82-85). Damage most likely occurred during the collapse of WTC 1.

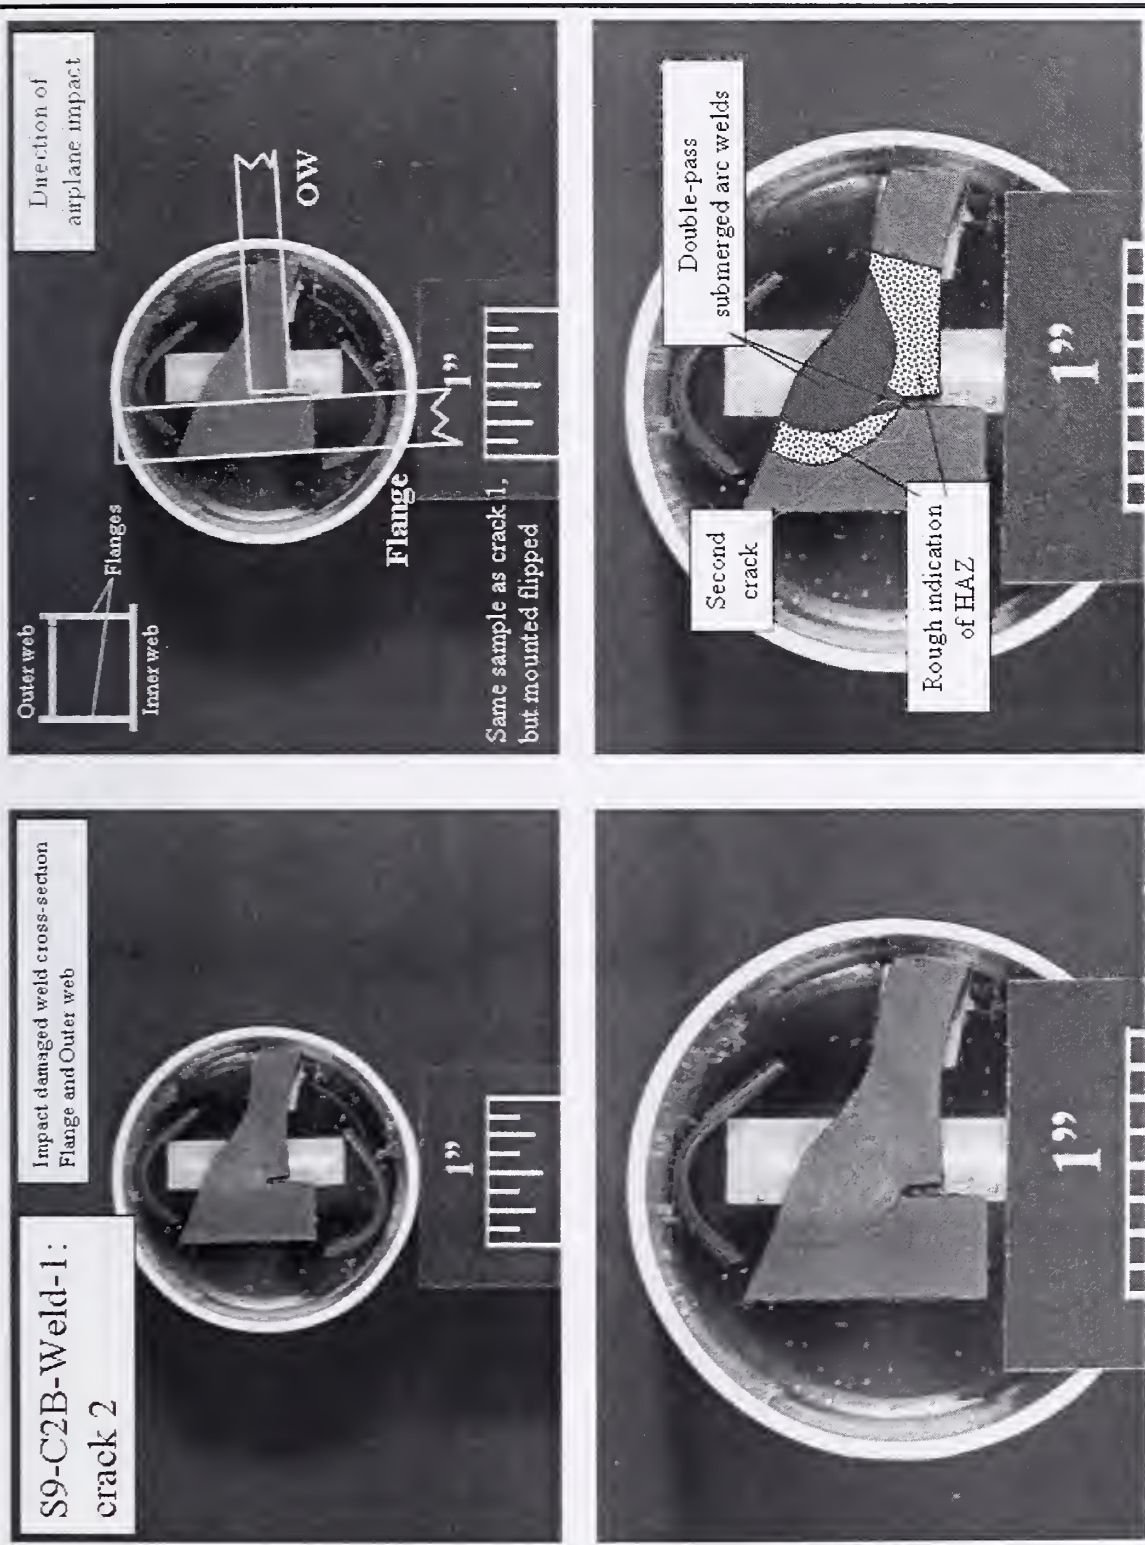
Figure 3–30. Light optical micrograph showing fracture of the flange plate (as seen in Fig. 3–29) initiating in the HAZ of the first submerged arc weld and then propagating into the unaffected base material. Two percent nital and 4 percent picral etch. (A133: 97-100, column 133)

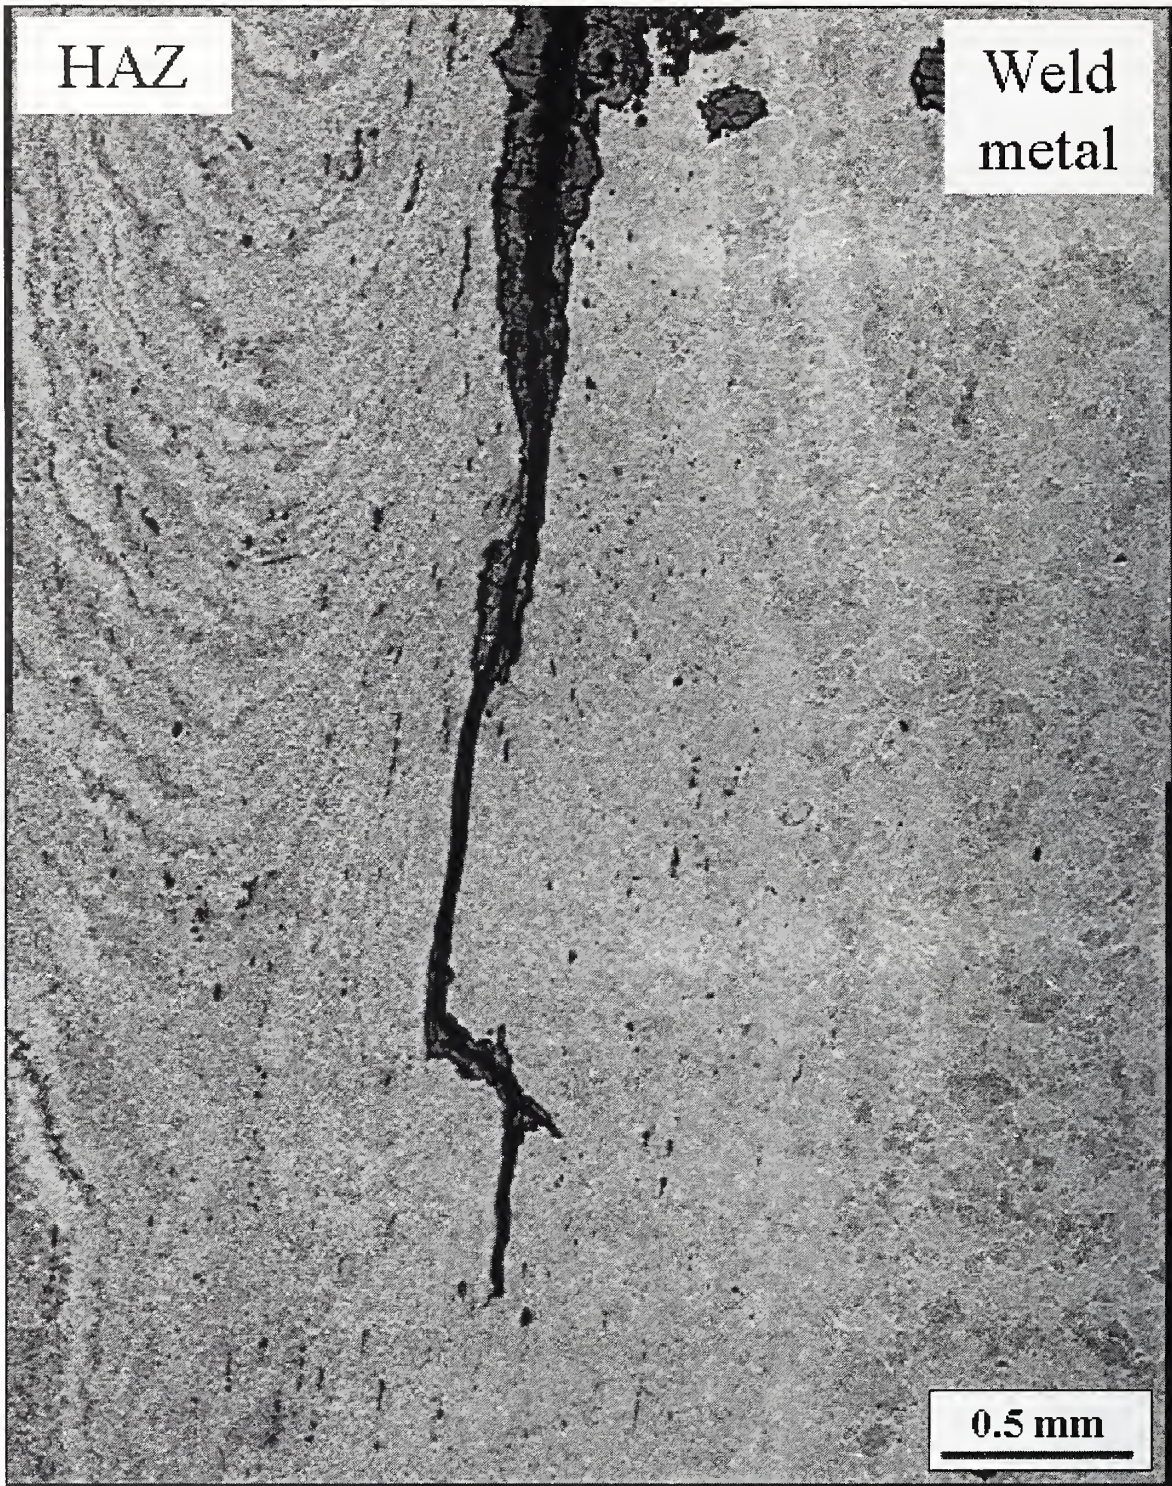
Figure 3-29. Polished and etched cross-section of fracture near weld between outer web and flange. Sample was the same as Fig. 3-25, but from well ahead of the original crack tip and mounted 180 degrees reversed so that viewed from the opposite direction as Fig. 3-26. Note that the crack started in the HAZ of the weld, but traveled into the flange plate. Two percent nital and 4 percent picral etch. (A133: 97-100, column 133)

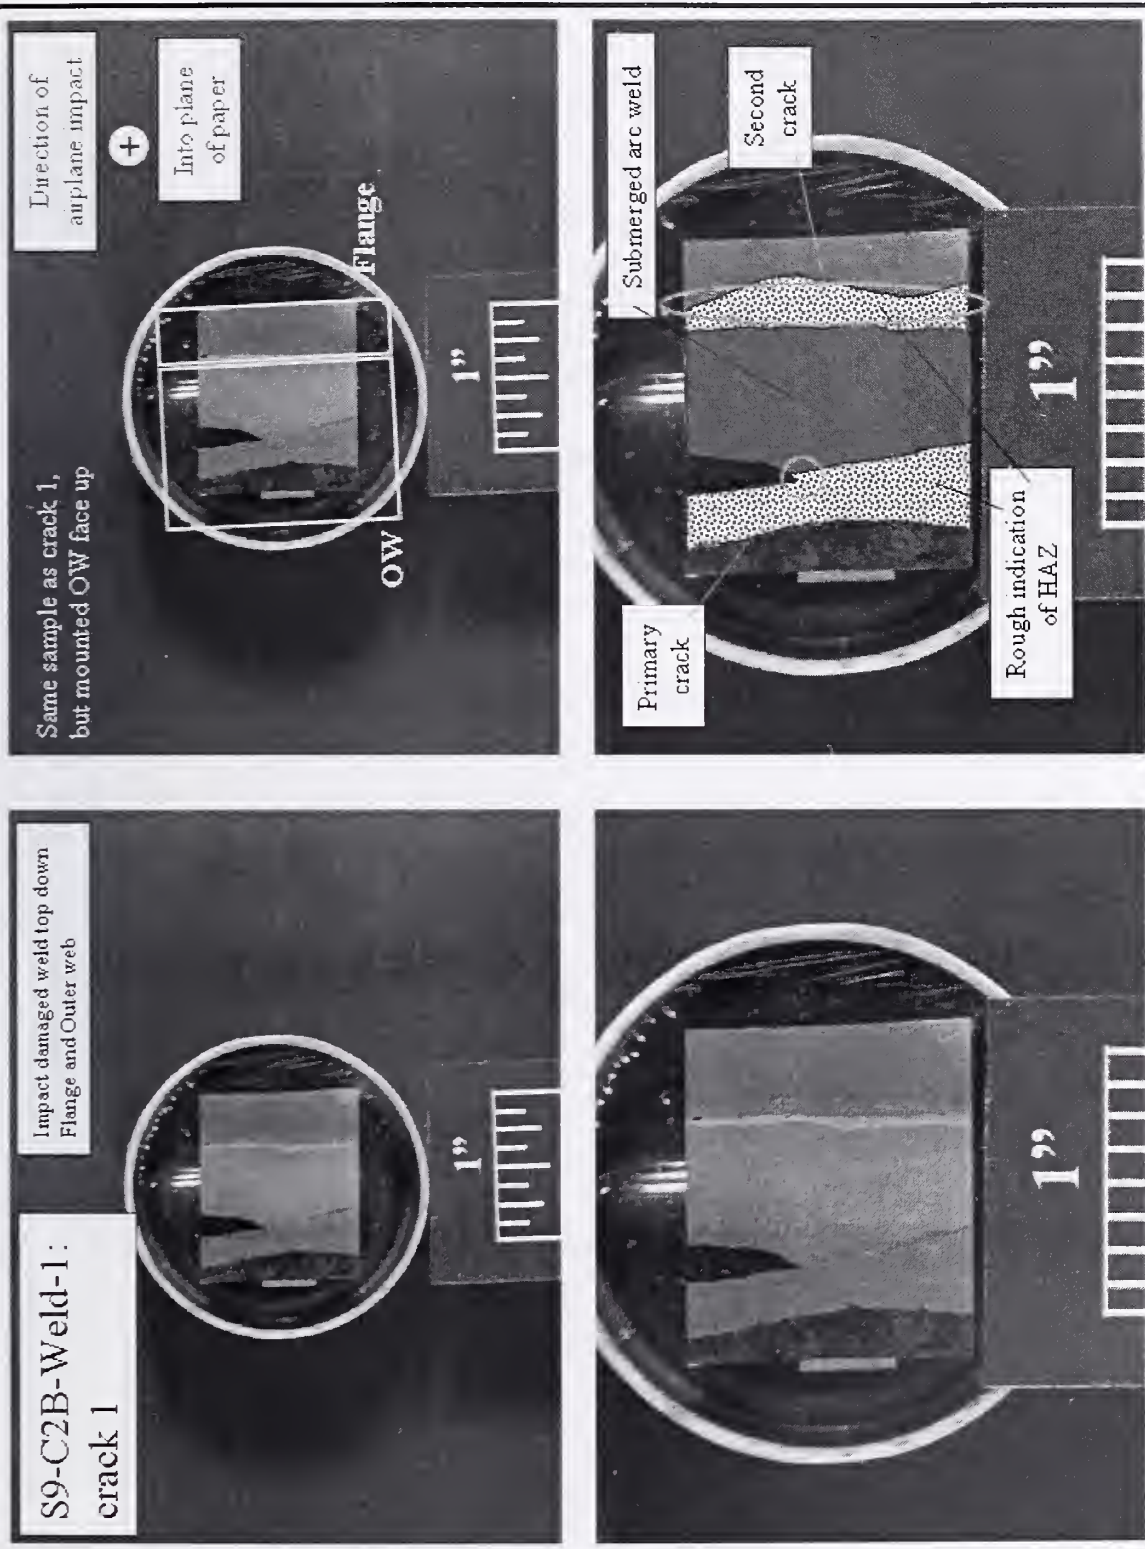
Figure 3–28. Light optical micrograph showing fracture of the outer web (from Fig. 3–27) occurring solely in the HAZ of the plate along the fusion line of the weld. Fracture may have been a result of airplane impact. Two percent nital and 4 percent picral etch. (panel S-9, A133: 97-100, column 133)

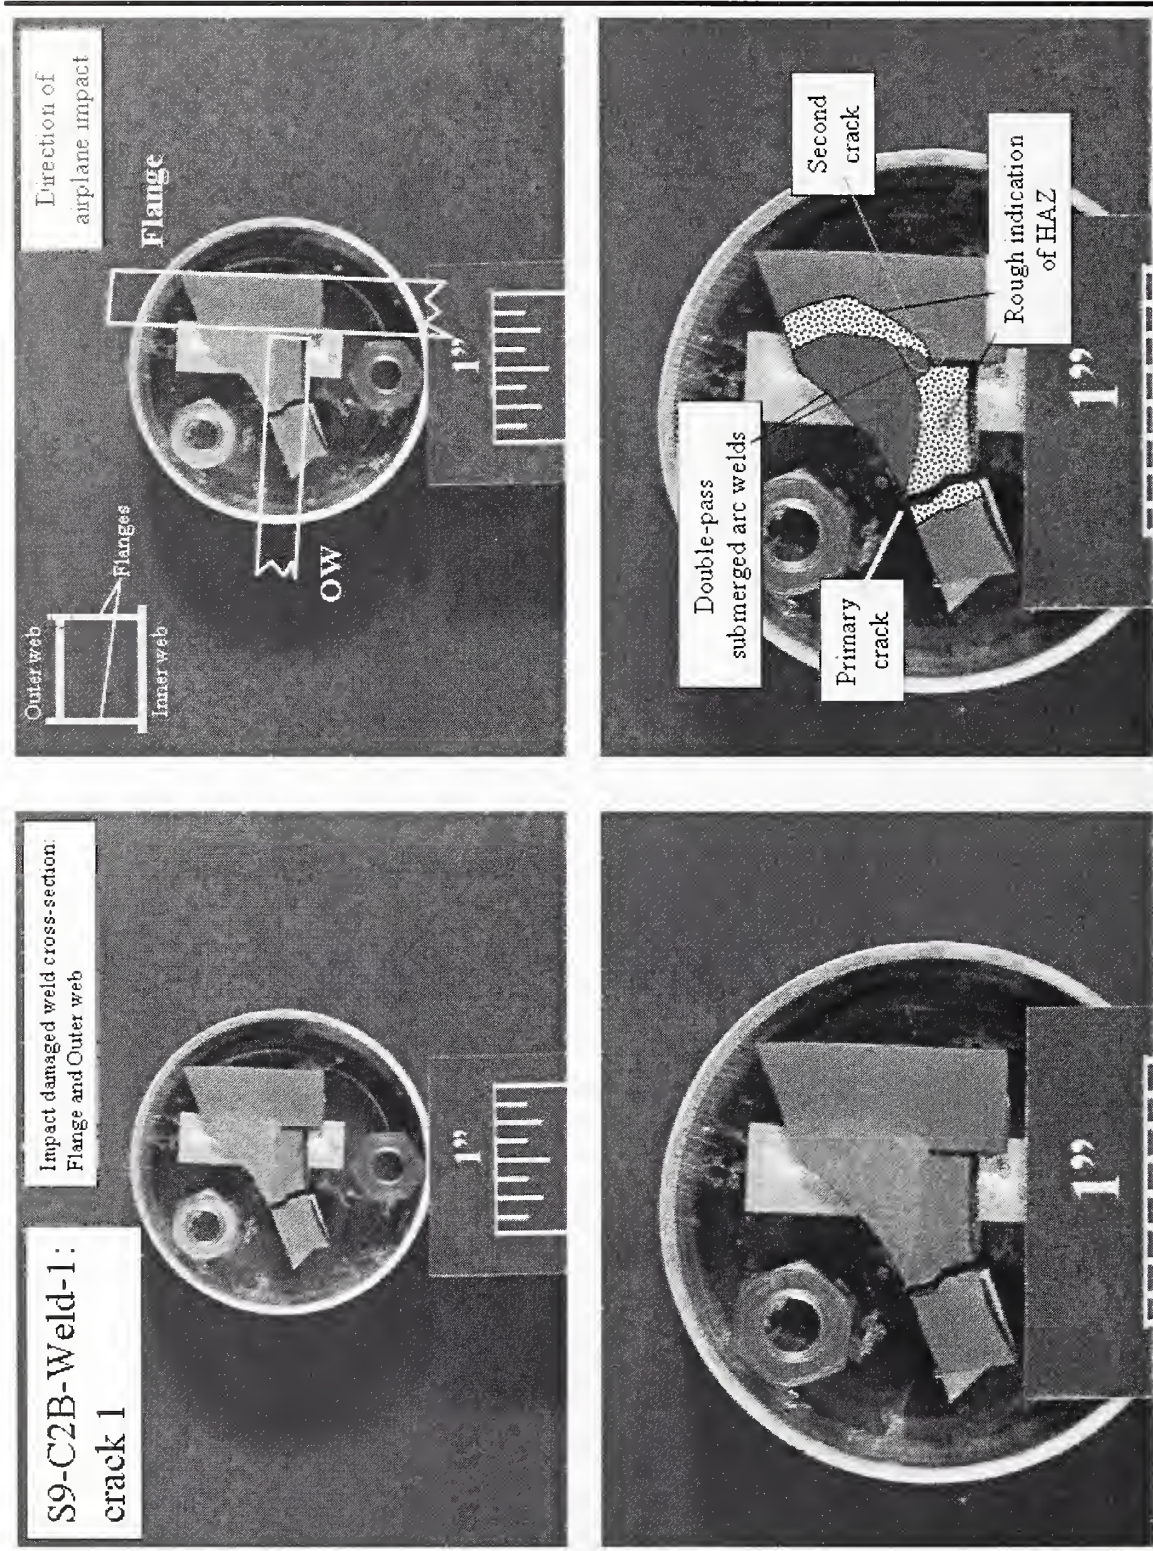
Figure 3-27. Polished and etched "planar" view of fracture near weld between outer web and flange (as seen in Fig. 3-24). The rolling plane of the outer web is parallel to the plane of the paper. Sample was from panel S-9 that was directly hit by the vertical tail assembly of the plane. Two percent nital and 4 percent picral etch. (A133: 97-100, column 133)

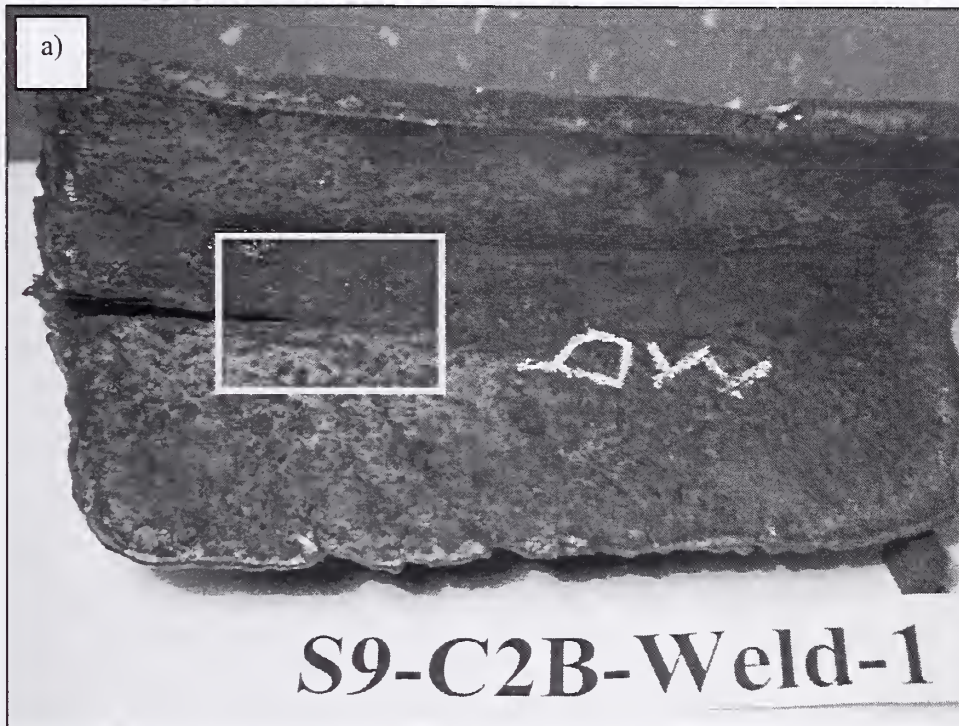
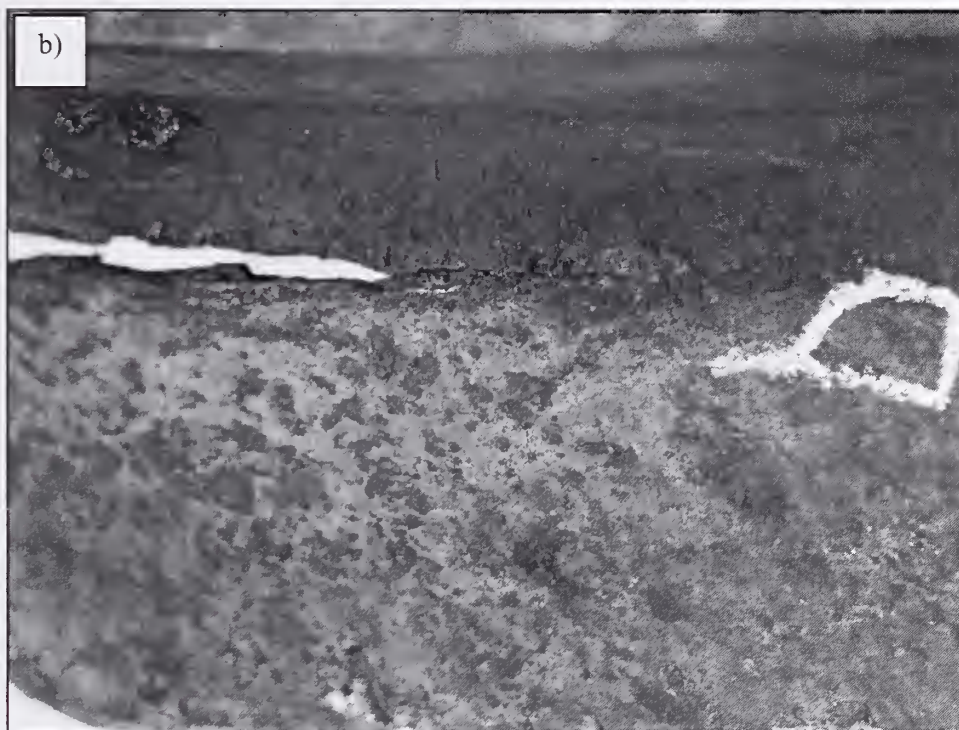
Figure 3-26. Polished and etched cross-section of fracture near weld between outer web and flange (as seen in Fig. 3-24). Sample was from panel S-9 that was directly hit by the vertical tail assembly of the plane. Yellow arrow indicates viewing direction of "planar" sample seen in Fig. 3-27. Two percent nital and 4 percent picral etch. (A133: 97-100, column 133)
