NIST NCSTAR 1-3C

Federal Building and Fire Safety Investigation of the
World Trade Center Disaster

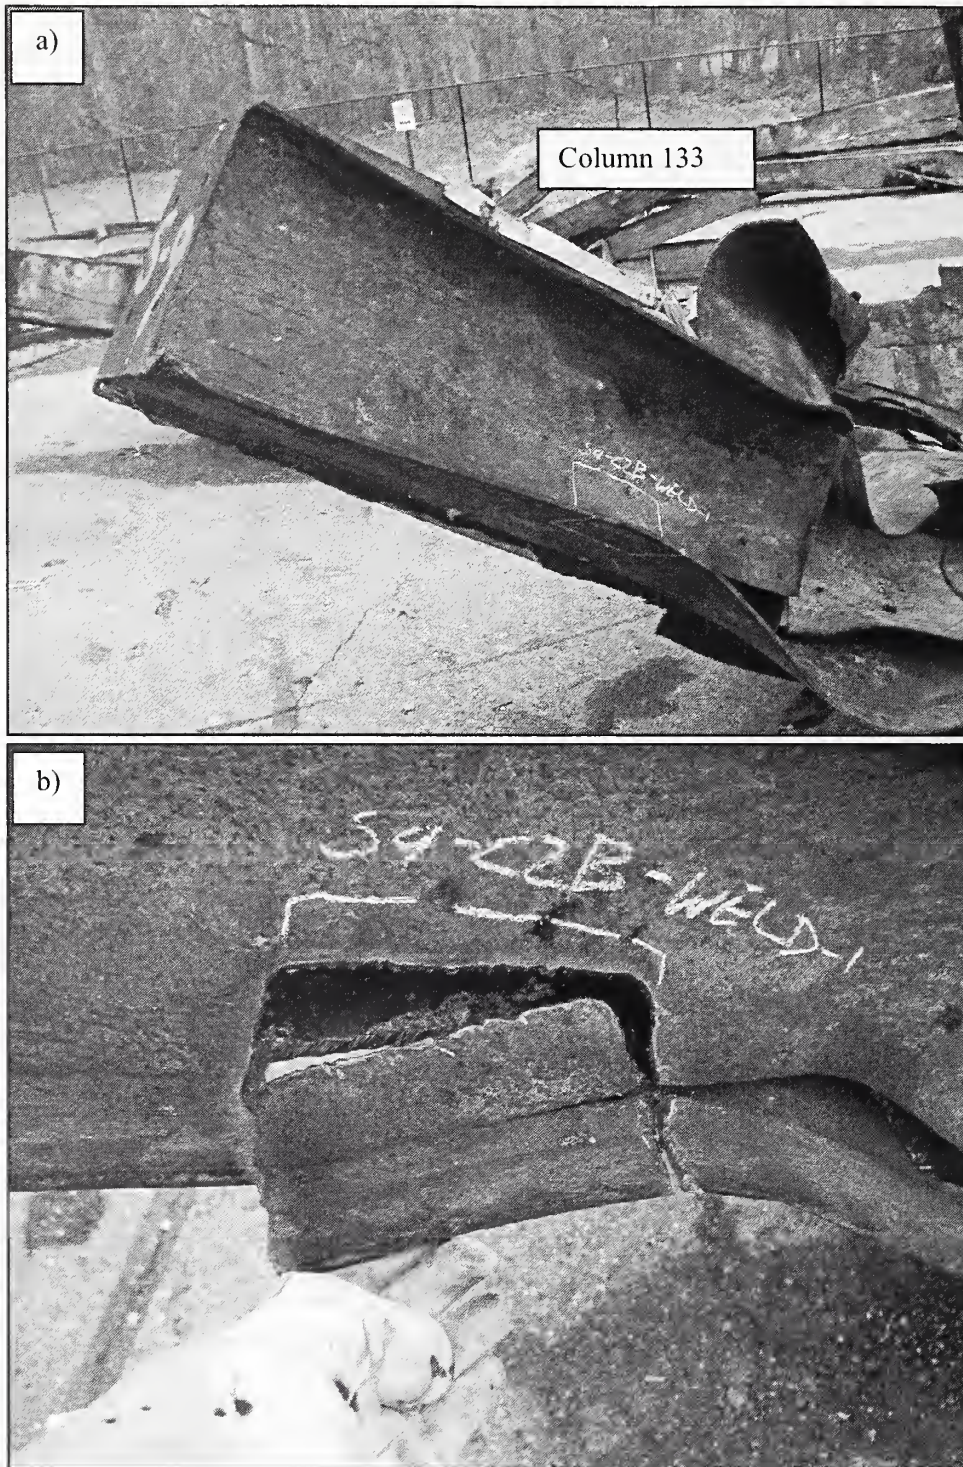
Figure 3–25. Fracture near a weld on a perimeter panel, sample S9-C2B-Weld-1 (A133: 97-100, column 133), laboratory images a) overall and b) close-up of crack and crack front propagating through the outer web. Fracture may be a result of airplane impact (vertical tail assembly) with removal shown in Fig. 3–24.

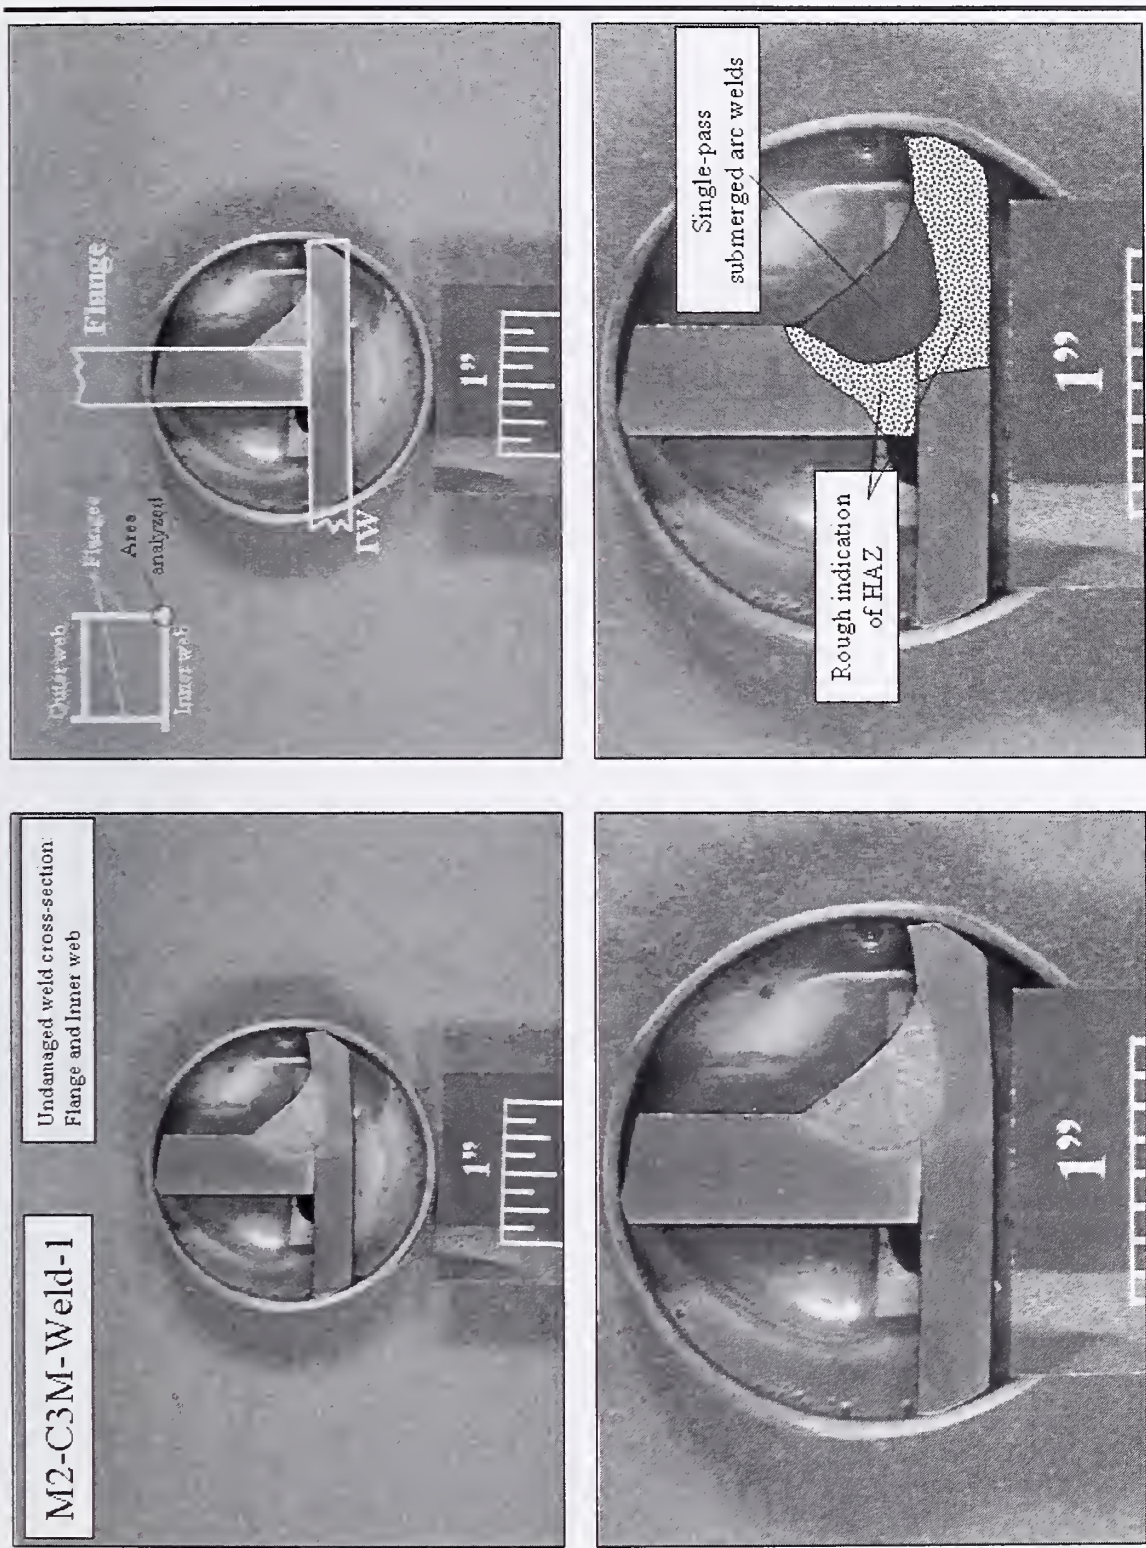
Figure 3–24. Weld fracture sample S9-C2B-Weld-1 (A133: 97-100, column 133), images taken a) prior to sample removal and b) after flame cutting. Panel S-9 was struck by the vertical tail assembly of the airplane.

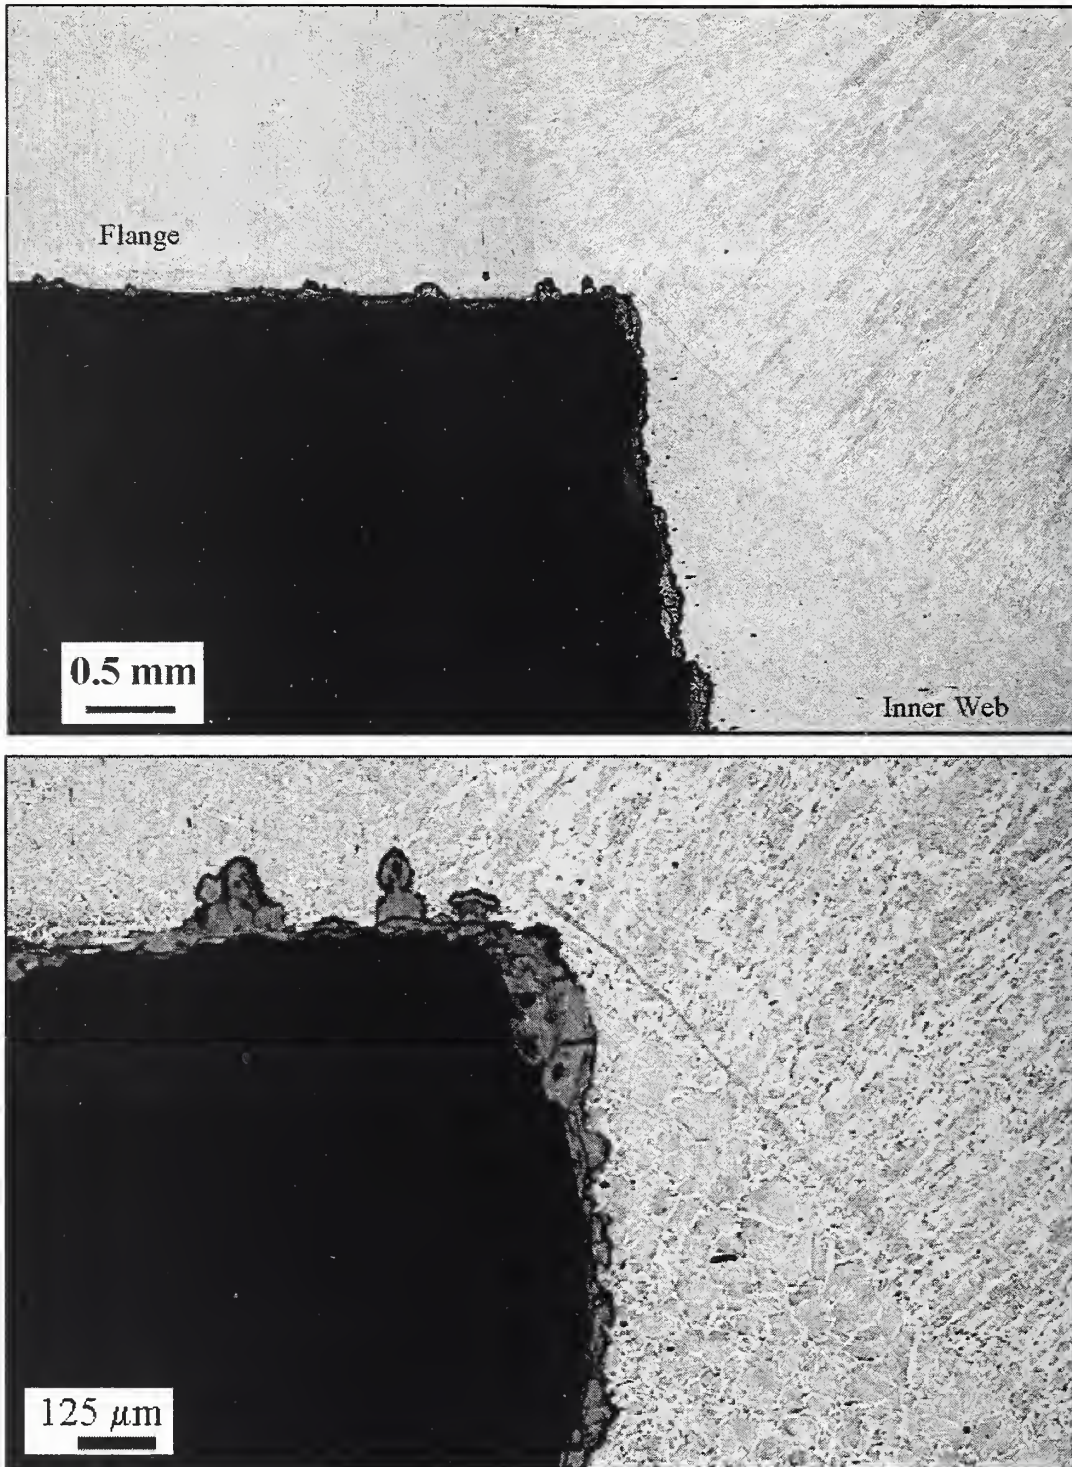
Figure 3–21. Removal of undamaged weld samples. a) Uncut sample labeled S9-C3B-Weld-1 (A133: 97-100, column 132) of a welded joint between a flange and outer web, b) cut sample, c) uncut sample labeled M2-C3M-Weld-1 (A130: 96-99, column 129) of a welded joint between a flange and inner web, and d) cut sample.

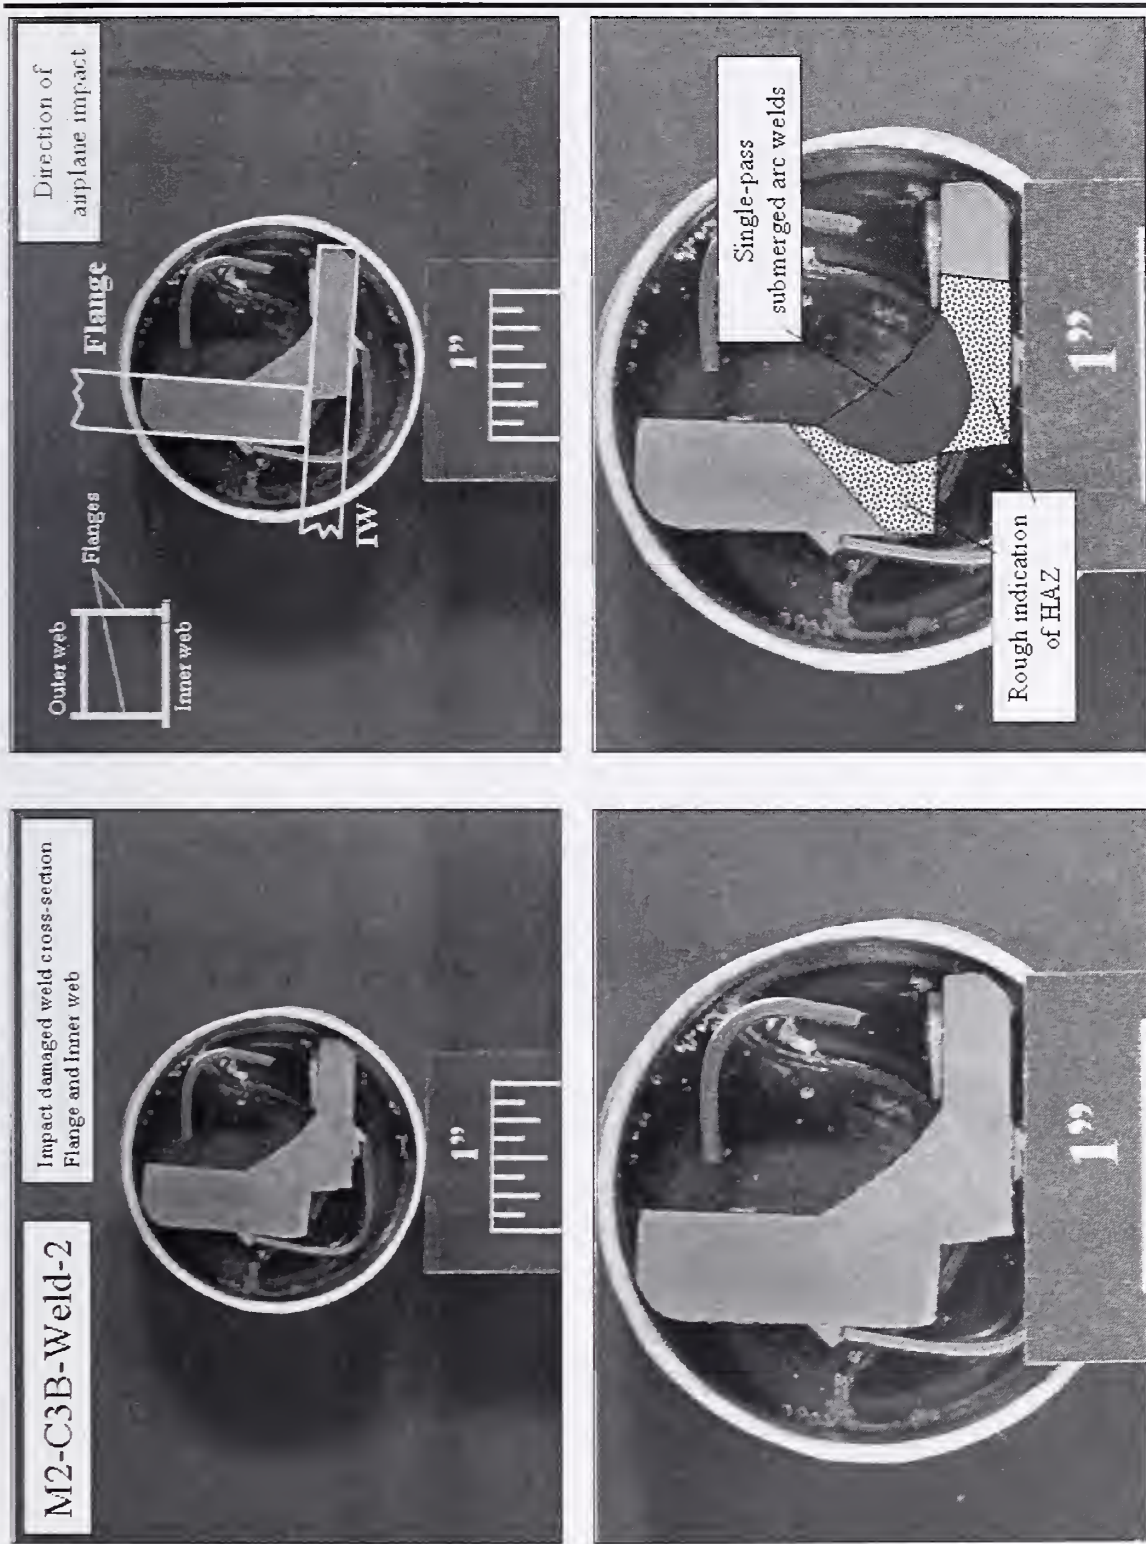
Figure 3-20. Light optical micrograph showing fracture of the inner web (from Fig. 3-18) initiating near the fusion line in the HAZ of the plate. Two percent nital and 4 percent picral etch. (A130: 96-99, column 129).

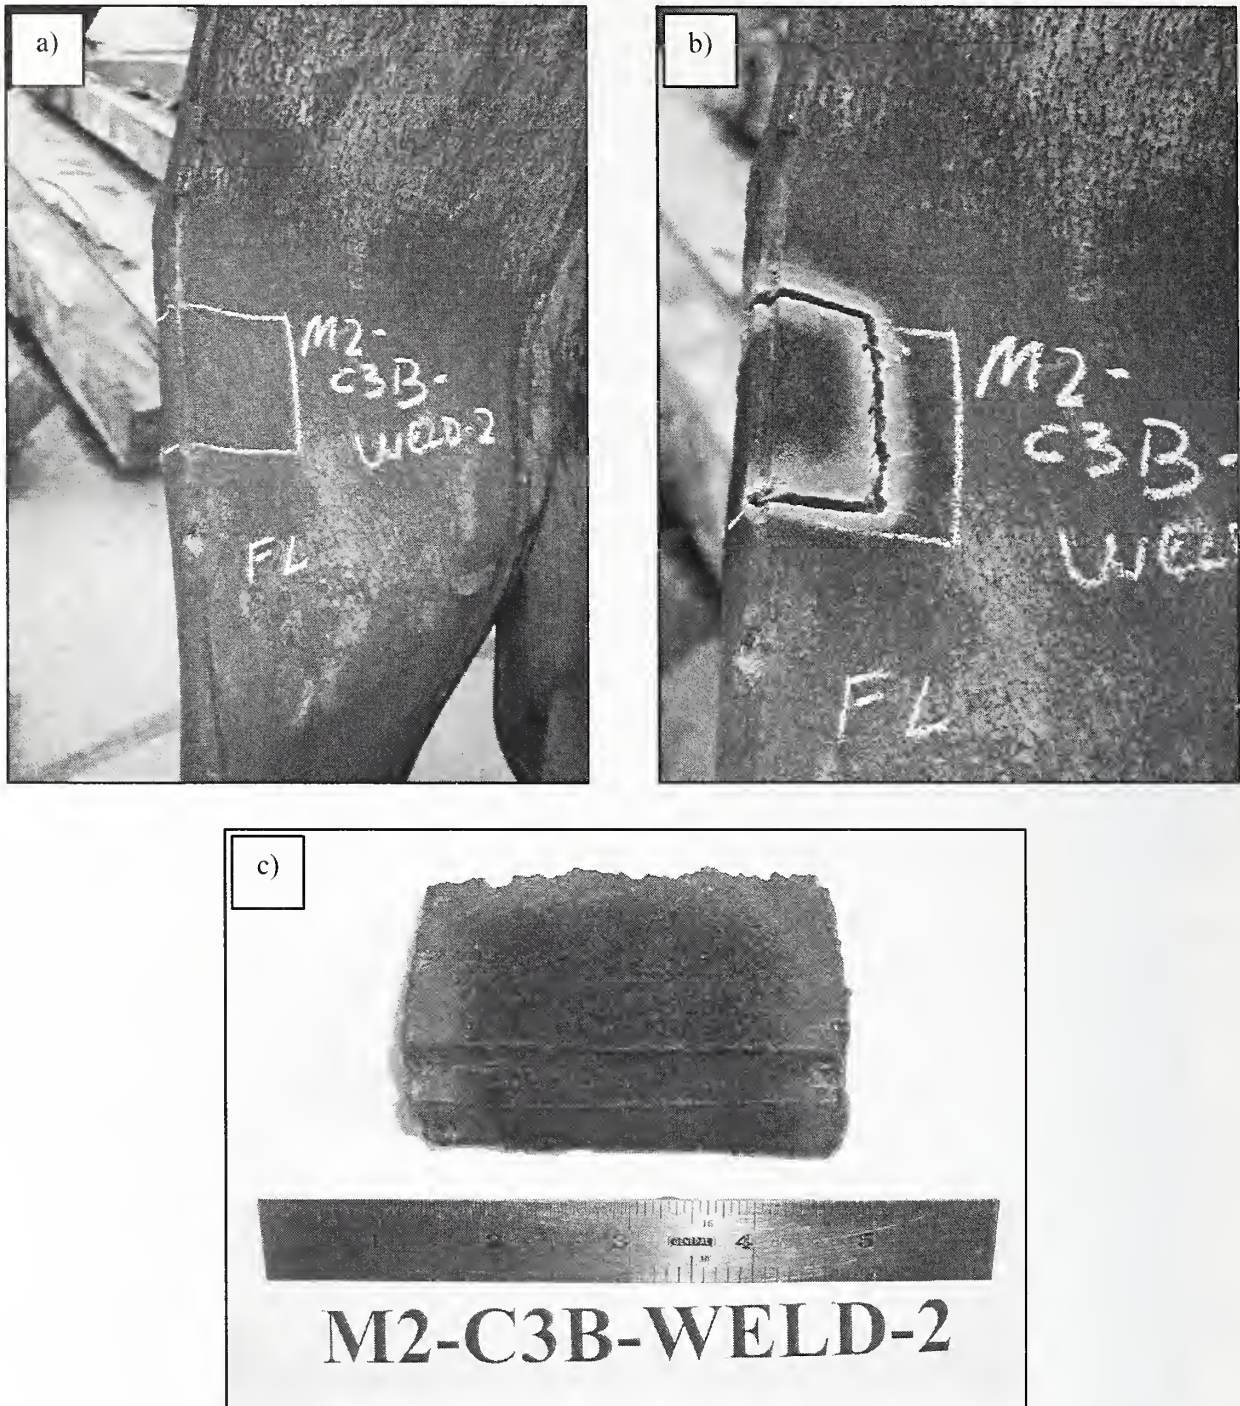
Figure 3-19. Polished and etched cross-section of fracture near weld between inner web and flange as seen in Fig. 3-18. Sample was from panel M-2 (A130: 96-99, column 129) that was directly hit by the plane. Fracture occurred in inner web plate; weld was intact. Two percent nital and 4 percent picral etch.

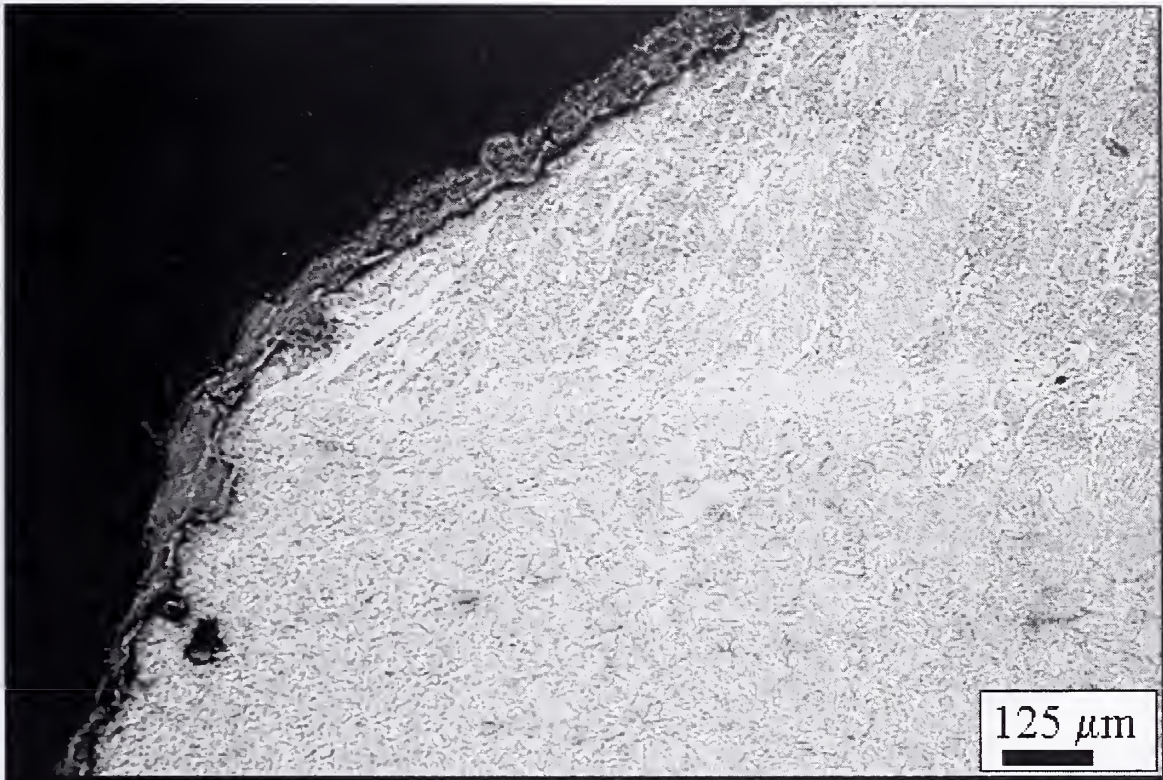
Figure 3-18. Example of fracture near weld of a perimeter column, sample M2-C3B-Weld-2 (A130: 96-99, column 129), images taken a) prior to sample removal, b) after flame cutting, and c) in the laboratory. Fracture was a result of airplane impact.

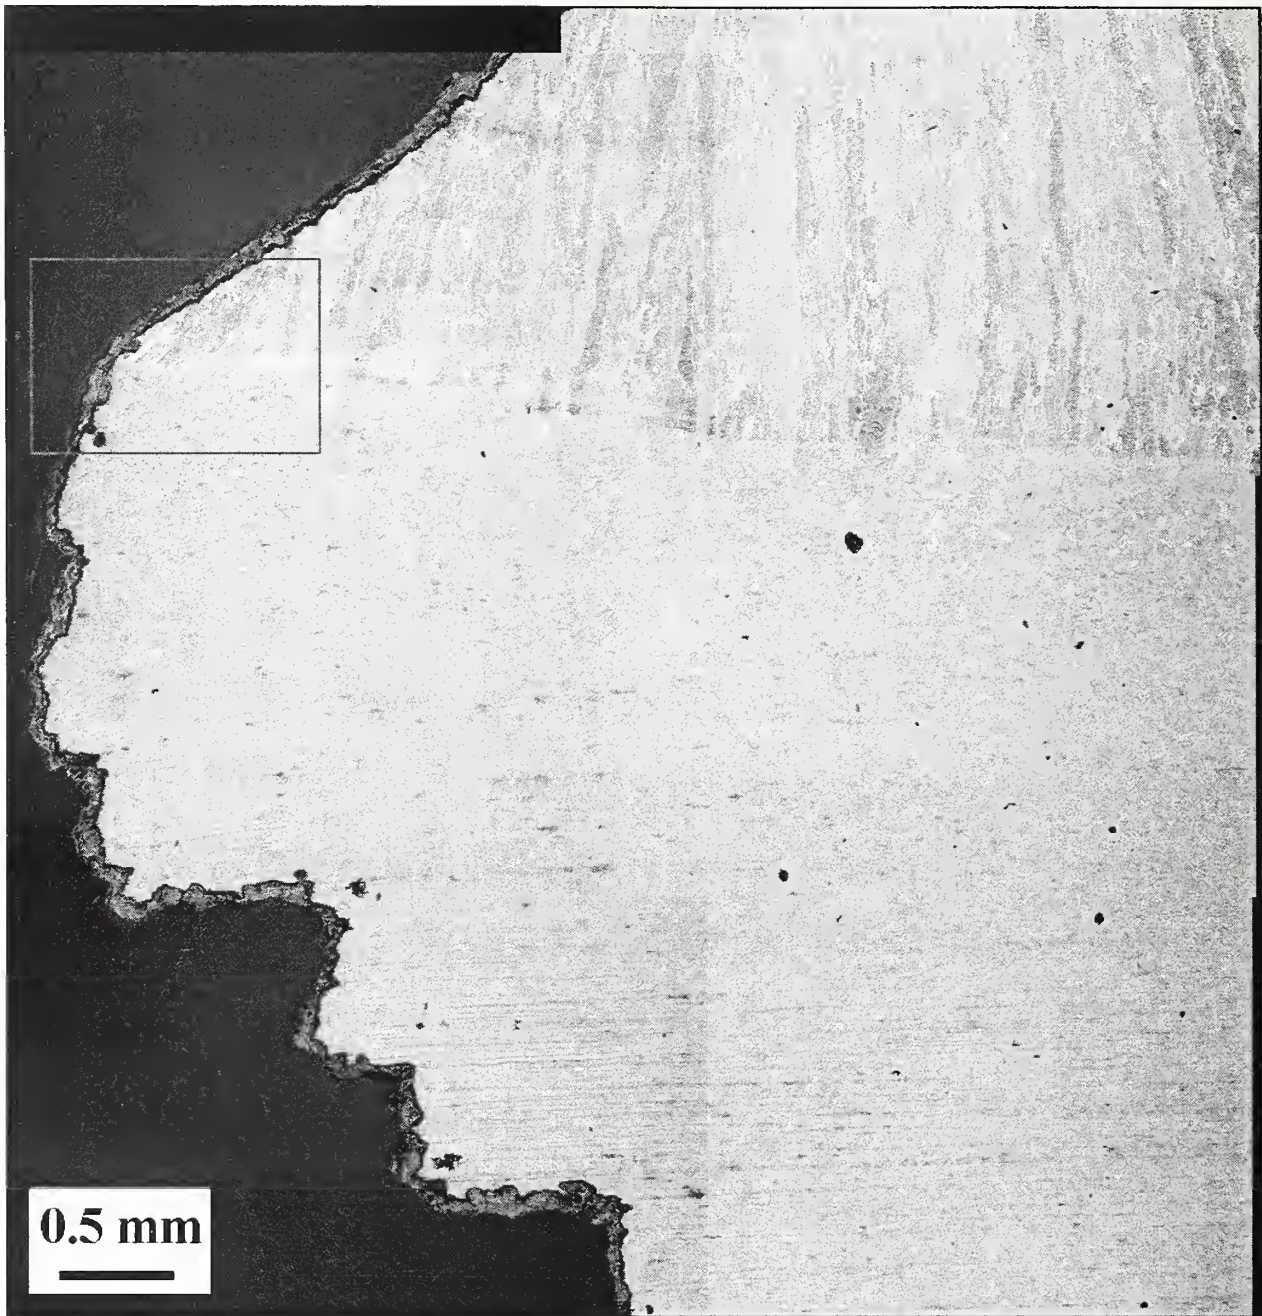
Figure 3–17. Light optical micrograph b) at higher magnification (red box in [a]) showing initiation of fracture at the toe of the weld and traveling through the HAZ of the plate. Two percent nital and 4 percent picral etch. (A130: 96-99, column 129)

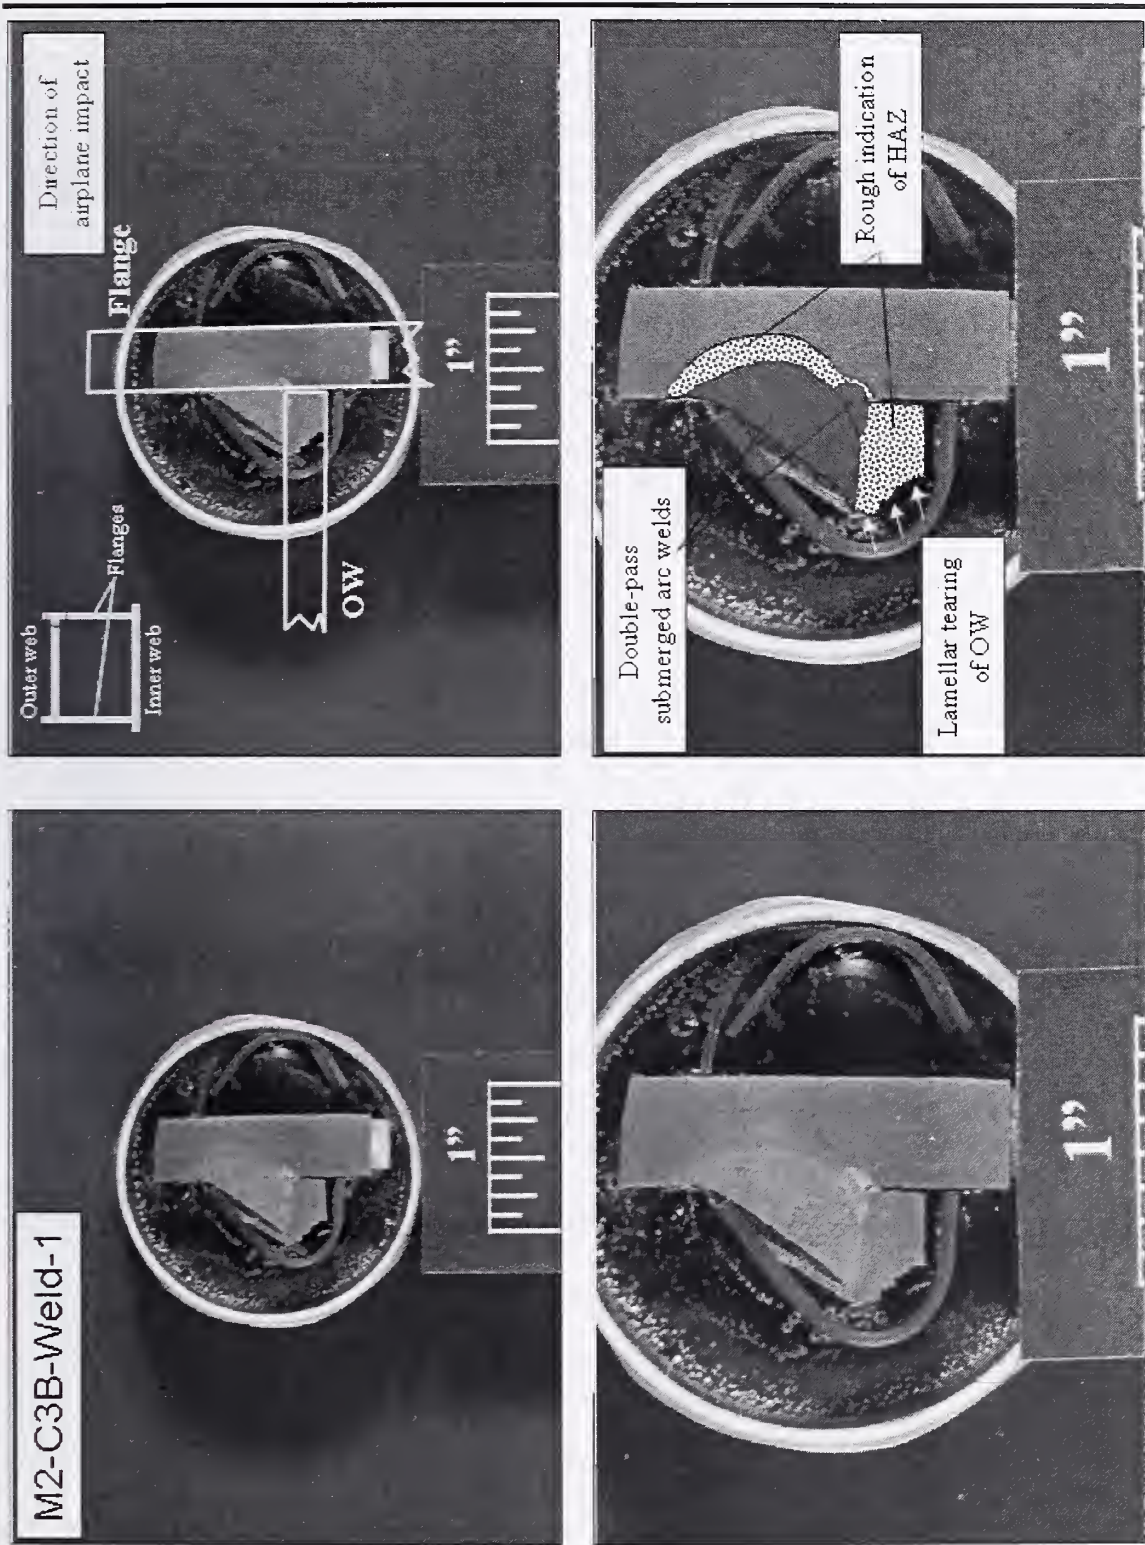
Figure 3-17. Light optical micrograph a) showing fracture of the outer web plate as a result of airplane impact (seen in Fig. 3-14). Fracture initiated at the toe of the weld and traveled through the HAZ of the plate. Two percent nital and 4 percent picral etch. (panel M-2, A130: 96-99, column 129)

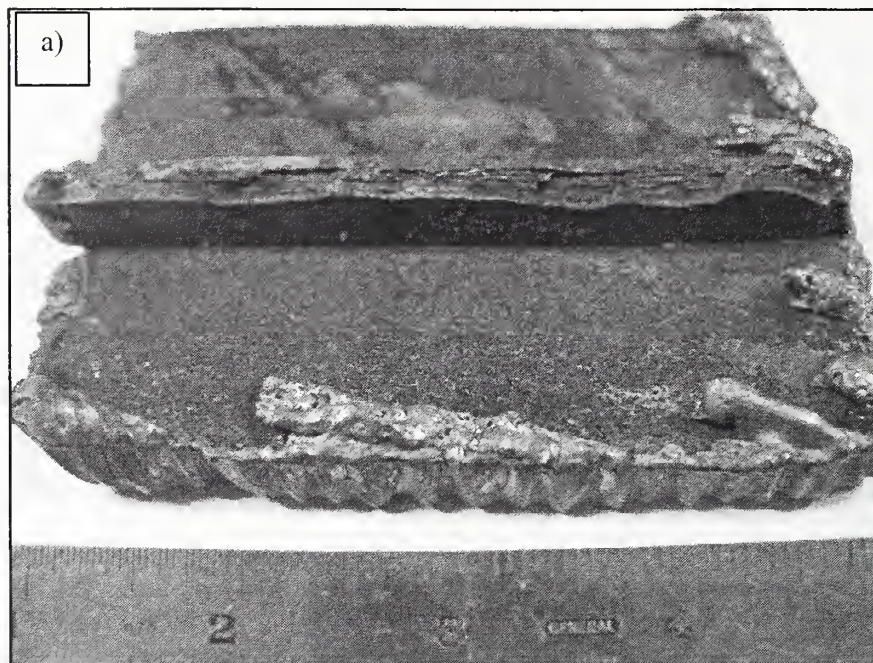
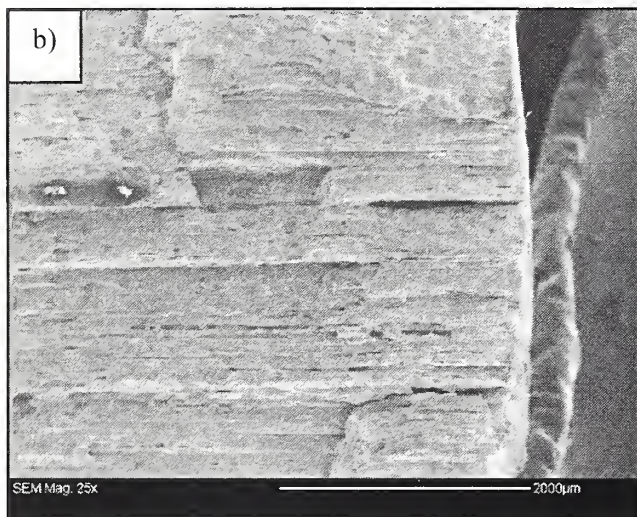
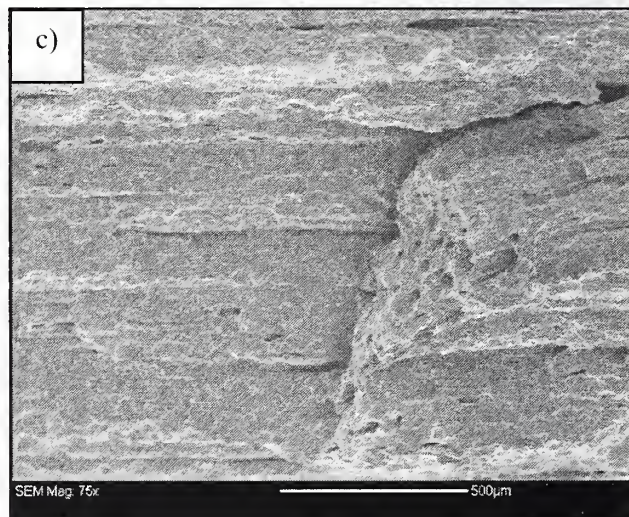
Figure 3-16. Polished and etched cross-section of fracture near weld between outer web and flange as seen in Fig. 3-14. Sample was from panel M-2 (A130: 96-99, column 129) that was directly hit by the plane. Fracture occurred in web plate; weld was intact. Two percent nital and 4 percent picral etch.

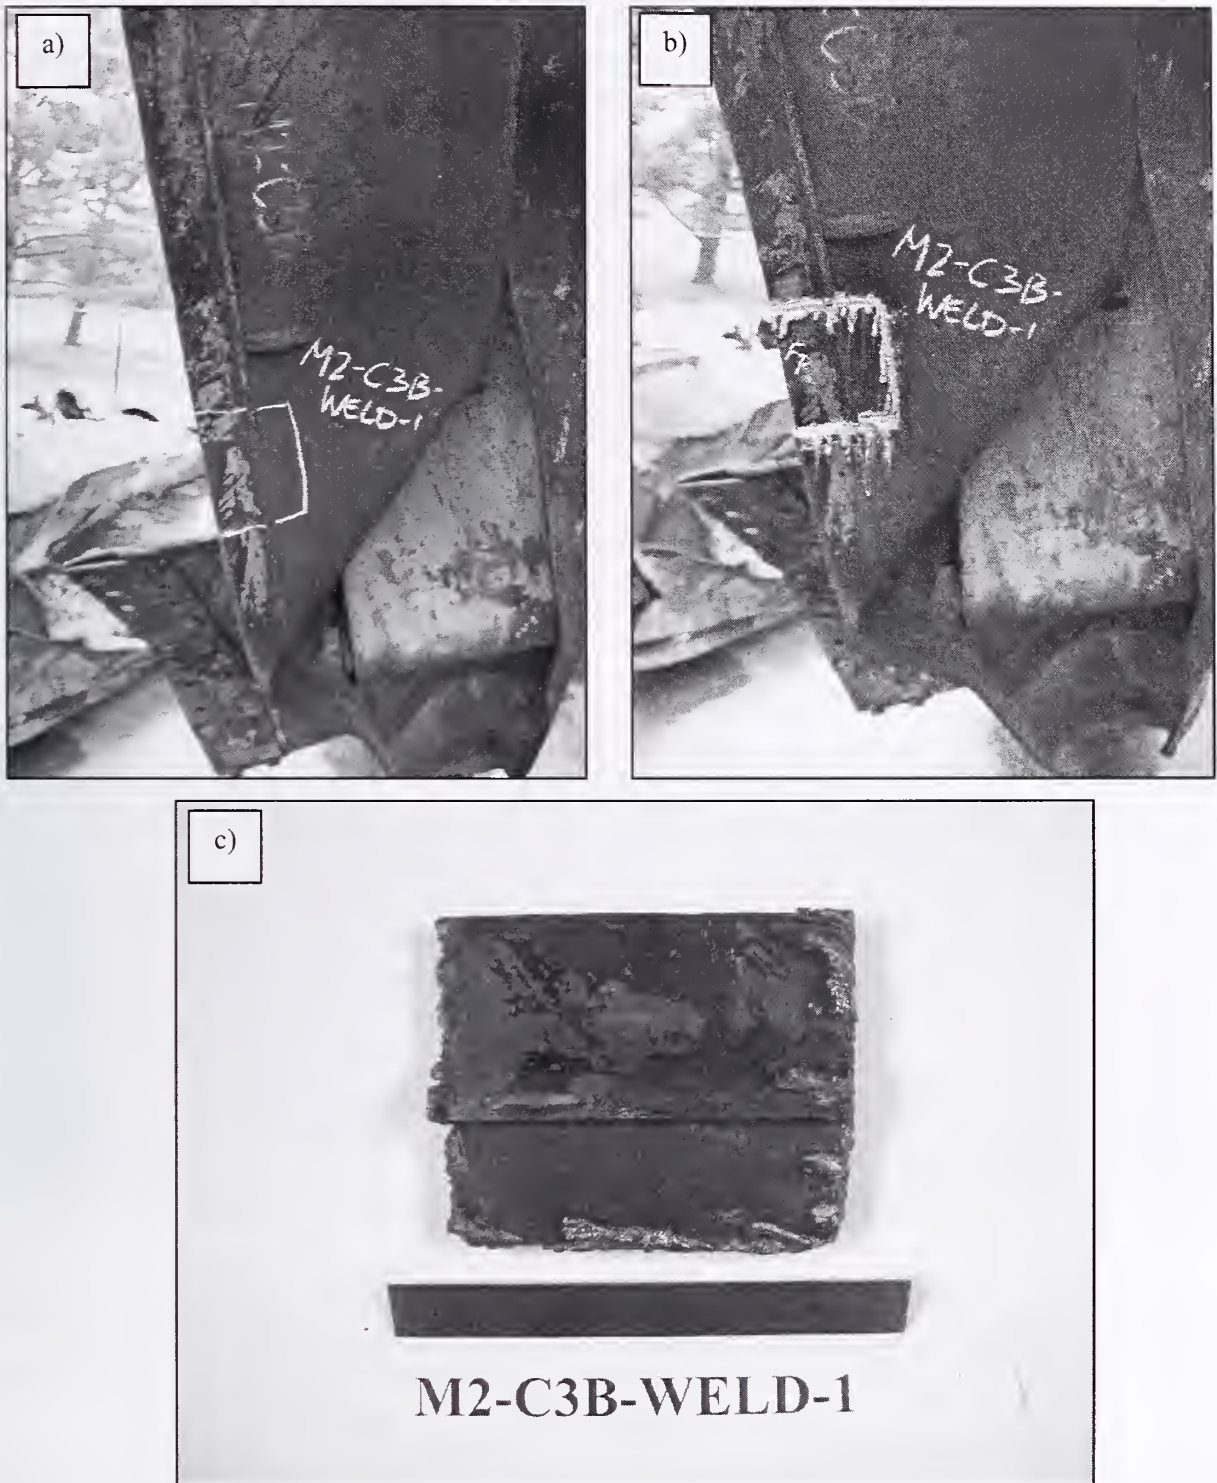
Figure 3–15. Fracture surface for sample M2-C3B-Weld-1 (A130: 96-99, column 129) shown in Fig. 3–14. Fracture features of outer web have “lamellar tearing” type fracture characteristics. a) Light micrograph, b) and c) scanning electron micrographs.

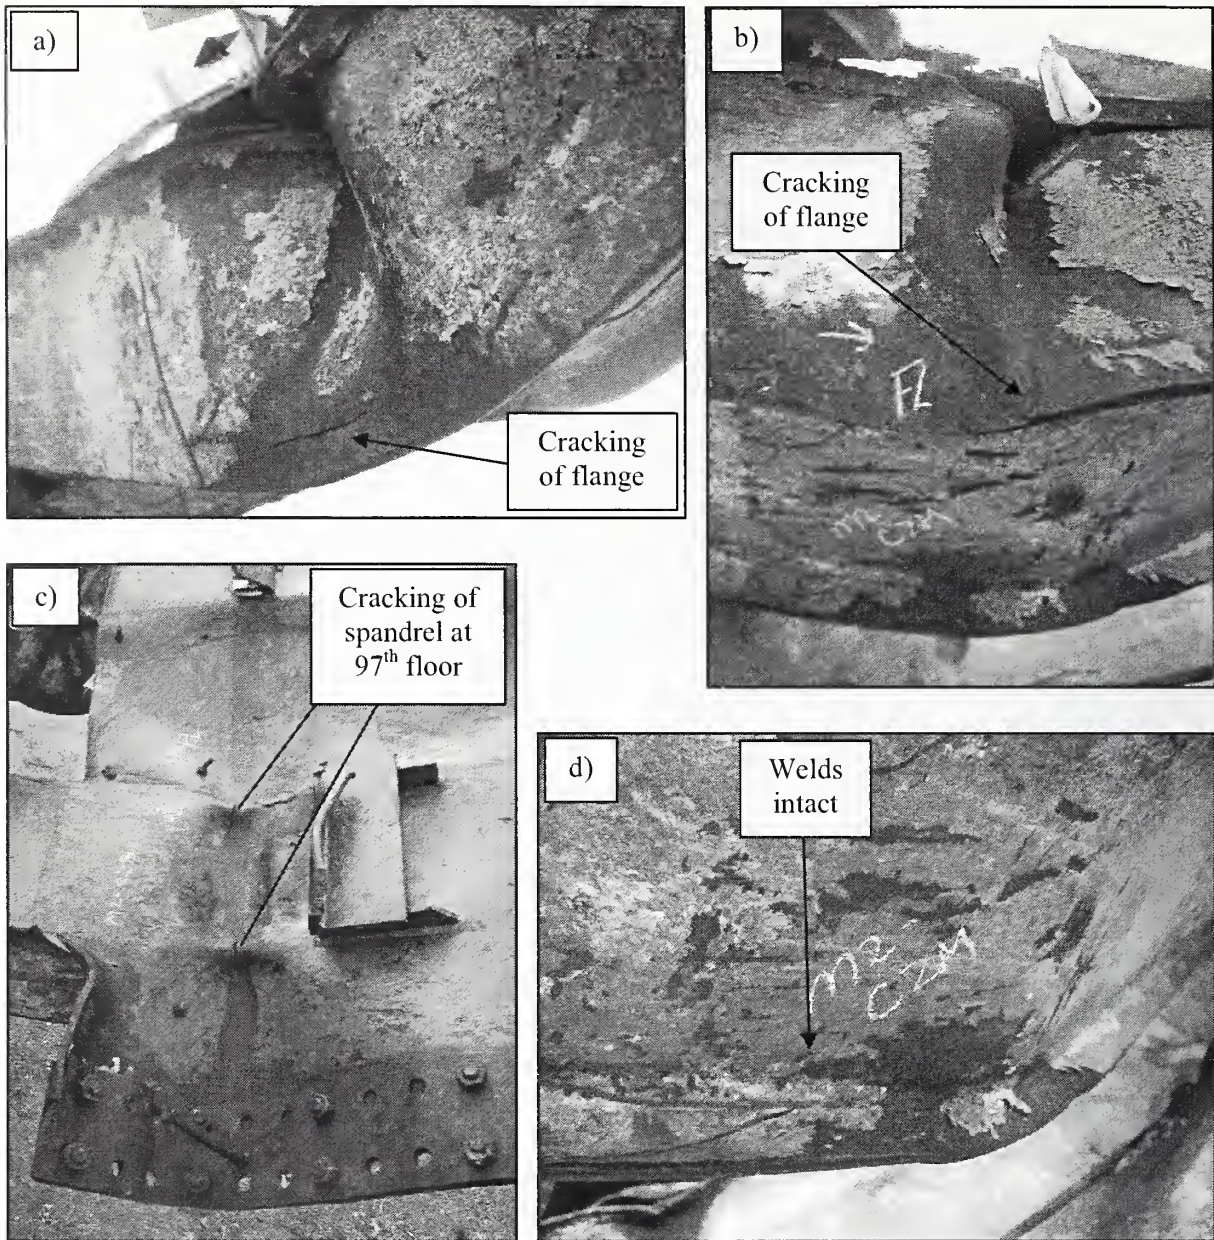
Figure 3–14. Example of fracture near weld of a perimeter column as a result of airplane impact, sample M2-C3B-Weld-1 (A130: 96-99, column 129), images taken a) prior to sample removal, b) after flame cutting, and c) in the laboratory.

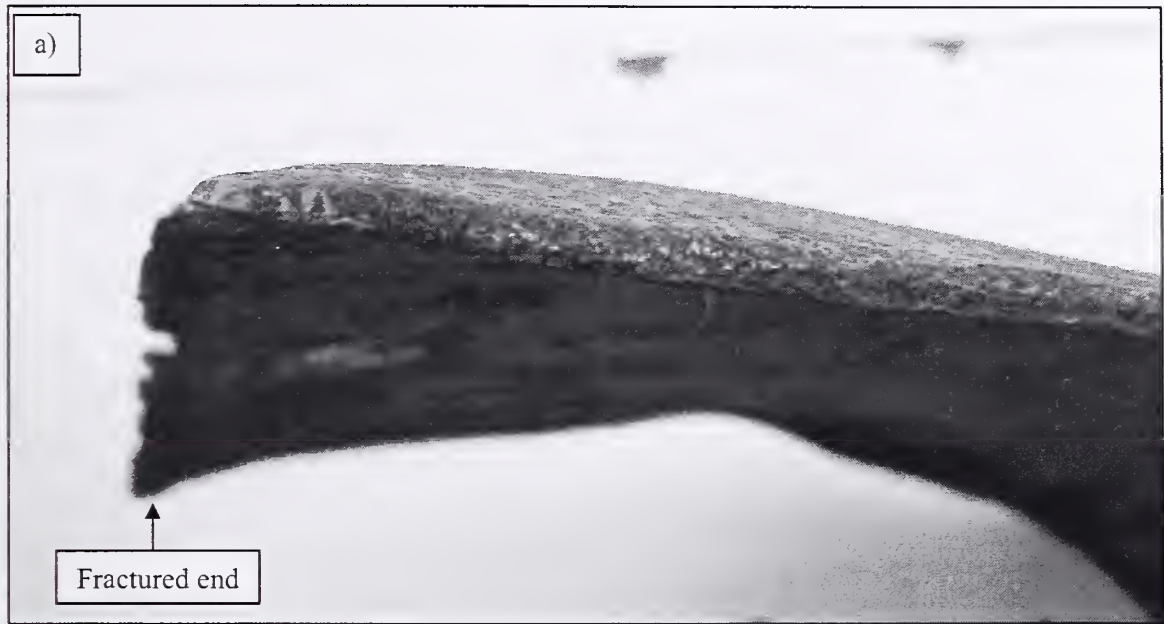
Figure 3-13. Damage images from sample M-2 (A130: 96-99). Panel from WTC 1 was struck by fuselage of airplane and bent about the 97th floor. a) Large buckles observed on the flange plates of column 130, b) cracking of the flange plates on column 130, c) cracking of spandrel at 97th floor level, and d) no cracking near the welds in this area on column 130.

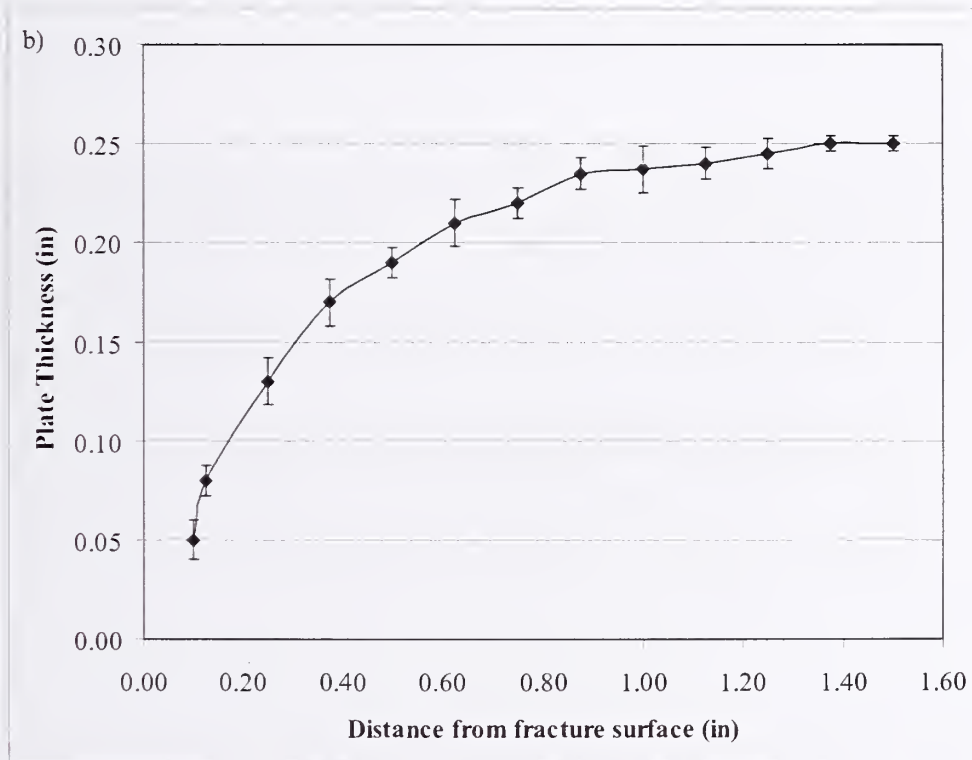
Figure 3-12. Thinning of outer web from column 130 of panel M-2 (A130: 96-99). Tensile failure of the plate was a result of airplane impact into WTC 1. a) photograph showing thinning, b) graph indicating plate thinning near fracture surface.

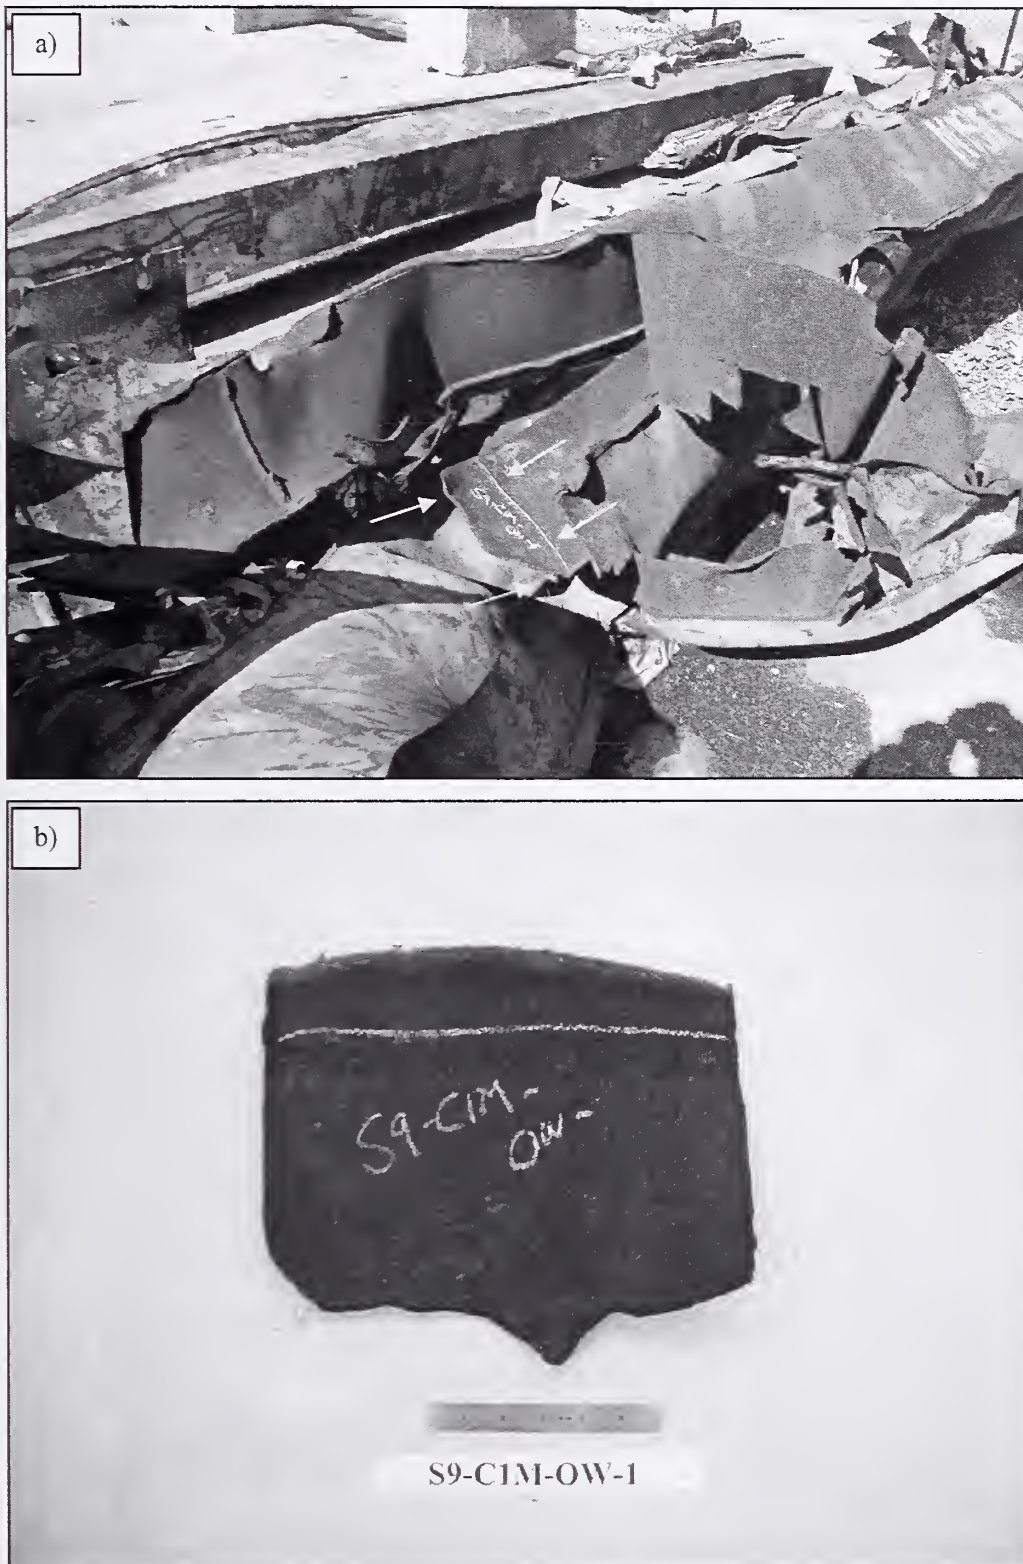
Figure 3-11. Analysis of fractured plate from sample S-9 (A133: 97-100), outer web of column 132. c) graph indicating plate thinning near fracture surface, d) image showing paint cracking as a result of tensile loading of the plate.

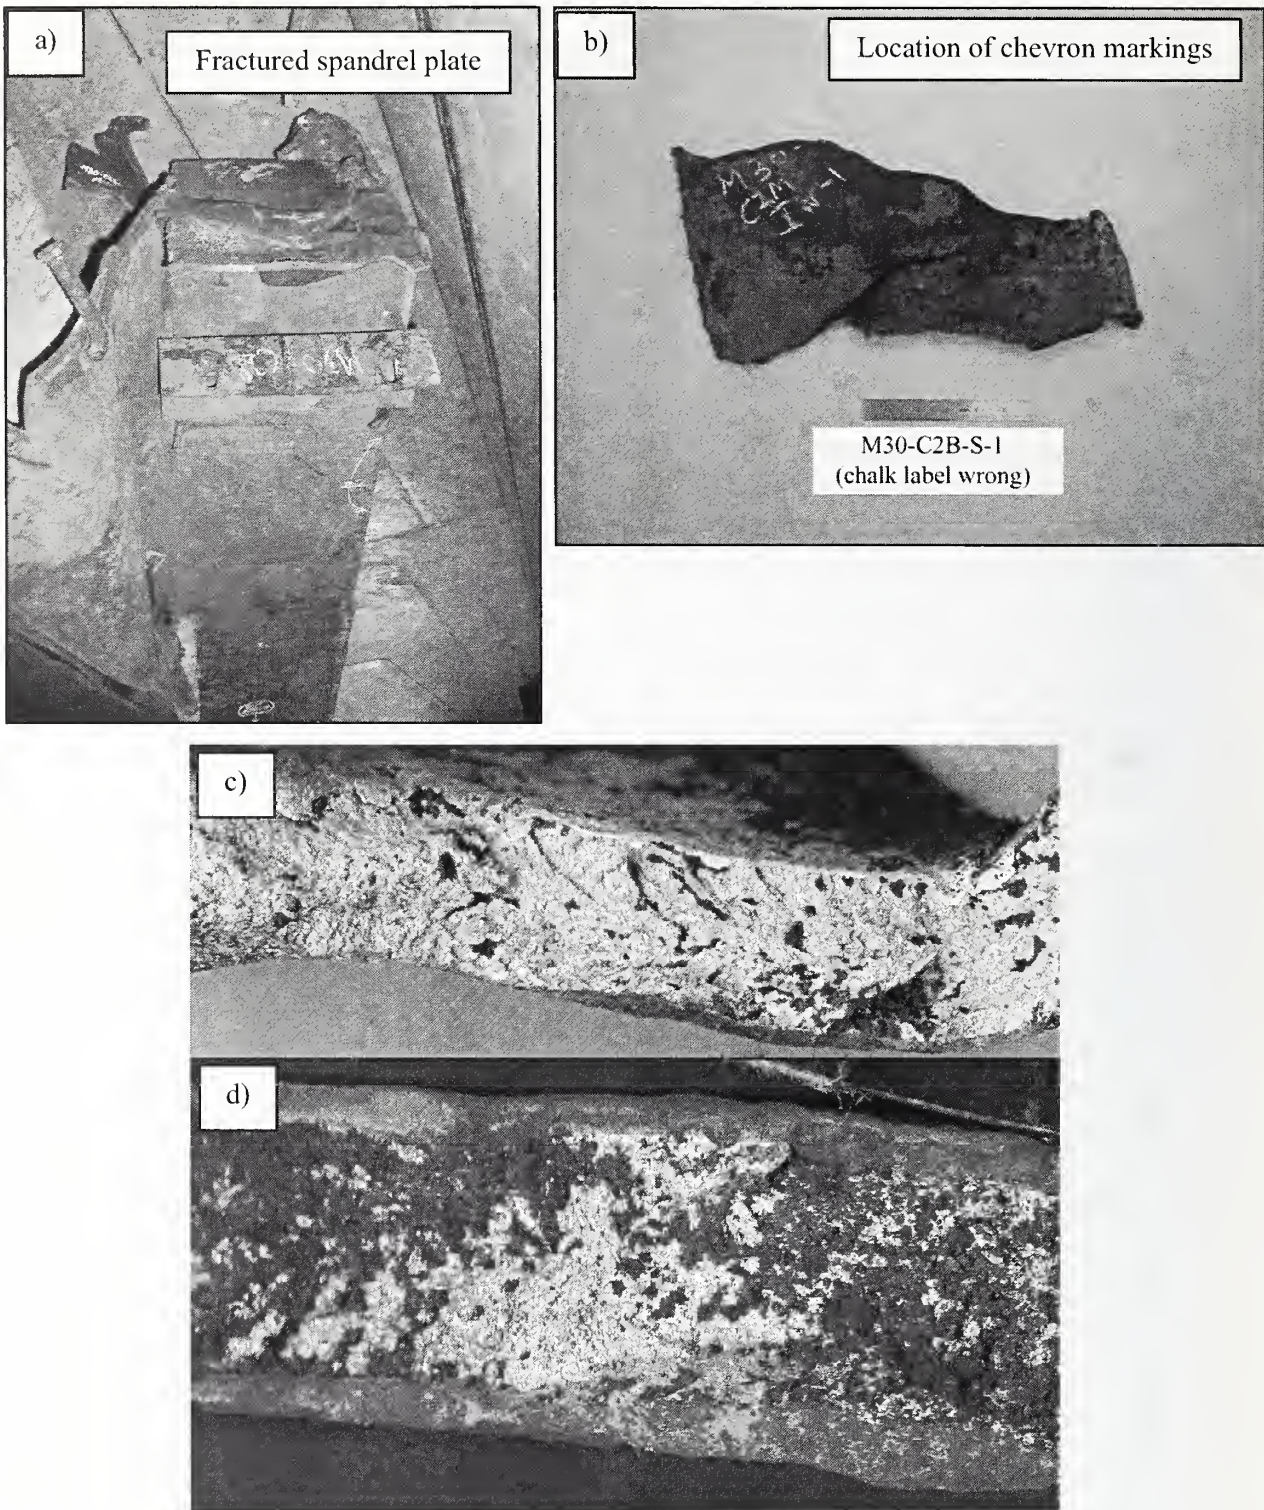
Figure 3-11. Analysis of fractured plate from sample S-9 (A133: 97-100), outer web of column 132. This panel from WTC 1 was struck by the vertical tail assembly. a) Location of sample removed, b) laboratory image showing sample removed.
