NIST NCSTAR 1-3C

Federal Building and Fire Safety Investigation of the
World Trade Center Disaster

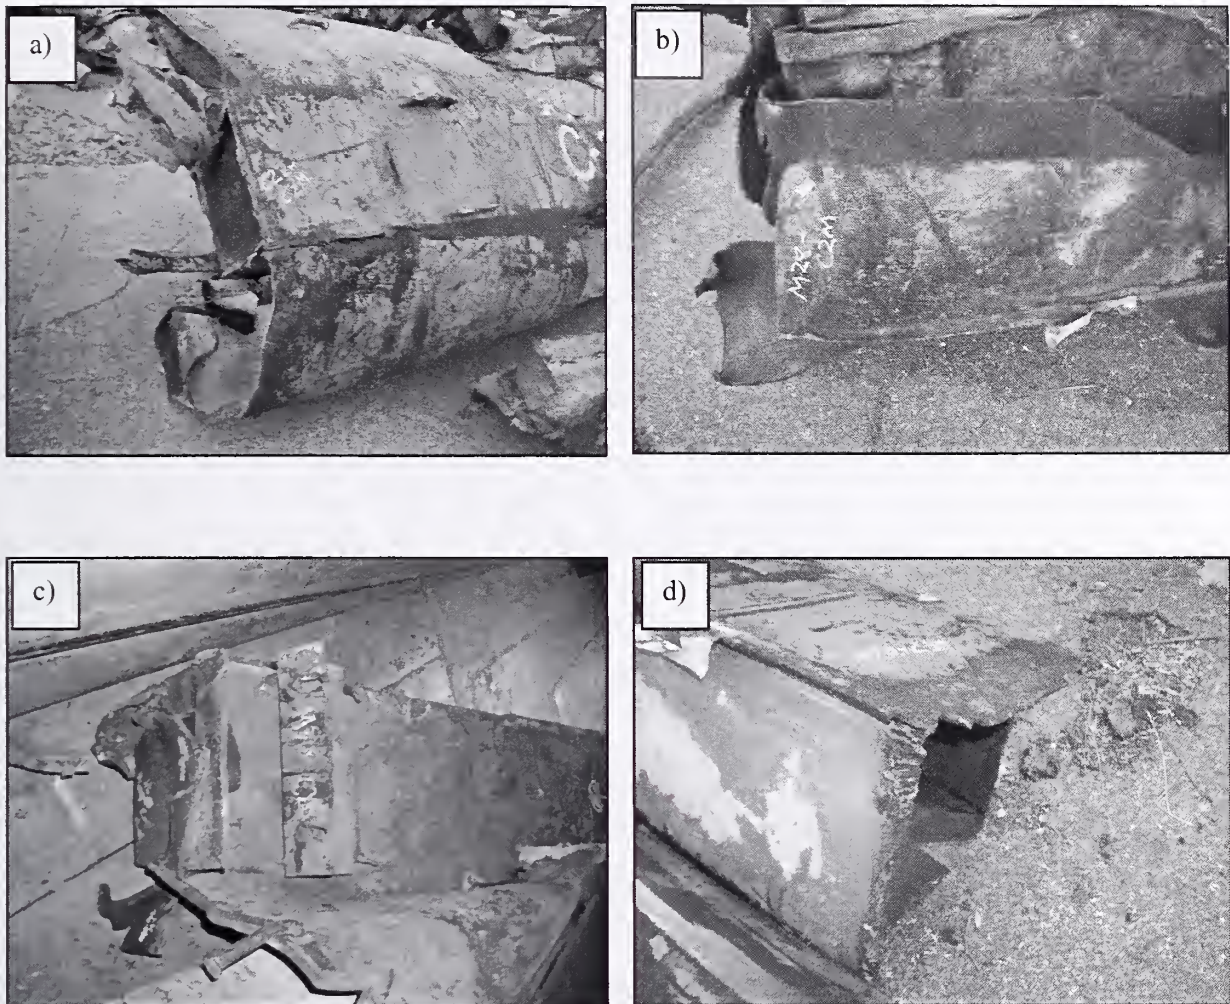
Figure 3-10. Fracture surface of sample M-30 (A133: 94-97), spandrel plate of column 133. Fracture was due to airplane impact of WTC 1. a) Location of sample removed, b) laboratory image showing sample removed, c) fracture shows chevrons running along the length of the crack path, and d) red highlighted area showing the location of small shear lips.

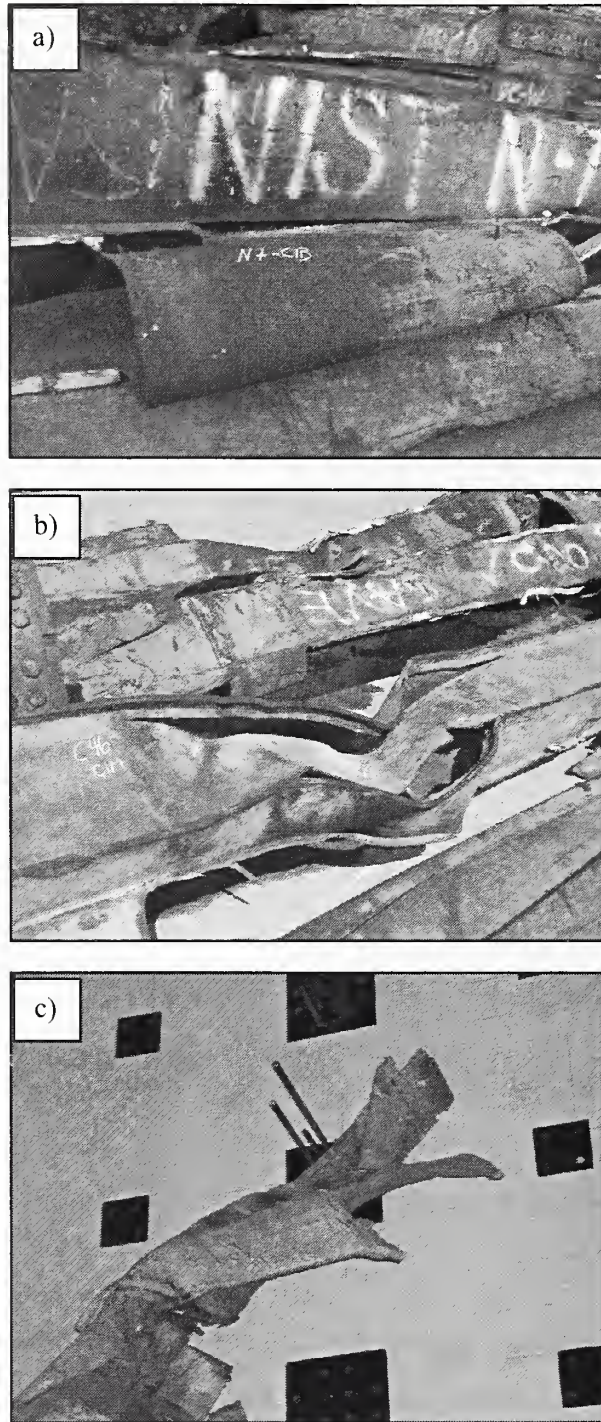
Figure 3–9. Photographic examples of Type 3 damage feature for exterior panel columns, severing of columns. a) Type 3a, sever associated with stiffener or diaphragm plate from C-22 (A157: 93-96), b) Type 3b, sever occurred away from stiffener or diaphragm plate from M-28 (B345: 98-101), c) Type 3c, sever occurred at concrete slab of floor from M-30 (A133: 94-97), and d) end was flame cut during recovery from N-10 (A115: 89-92).

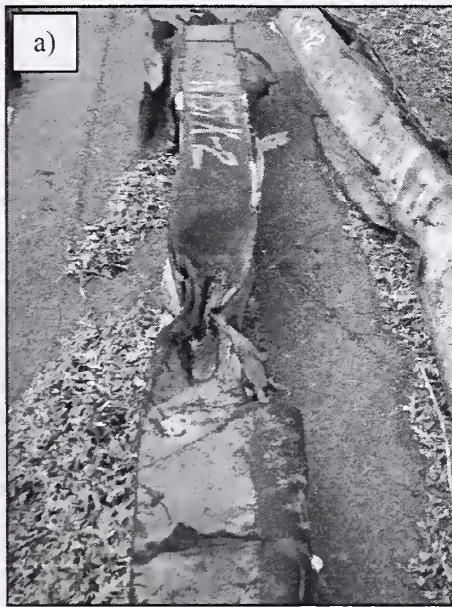
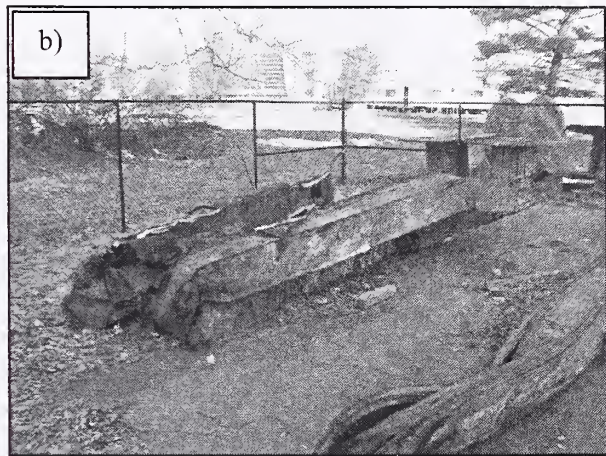
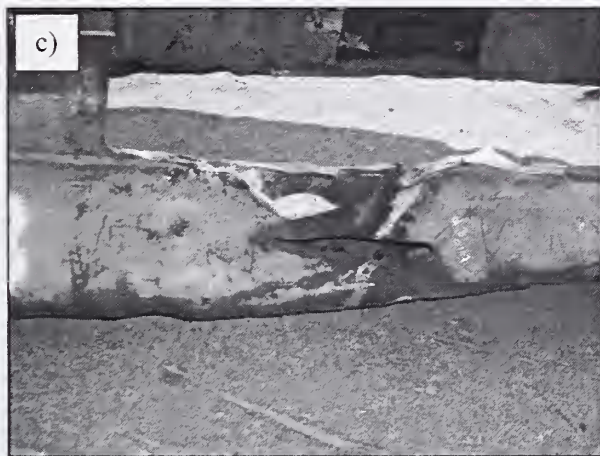
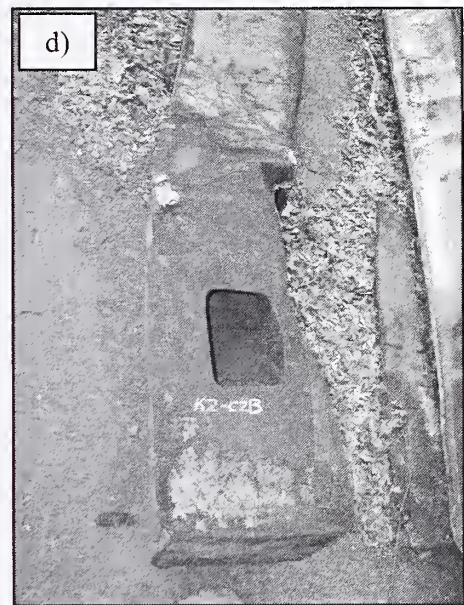
Figure 3–8. Photographic examples of Type 2 damage feature for exterior panel columns, fracture in base plate near fillet welds. a) Type 2a, localized fracture from N-7 (A127: 97-100), b) Type 2b, extensive fracture from C-46 (B157: 68-71), and c) Type 2c, extensive fracture resulting in “splaying” of column from M-27 (A130: 93-96).

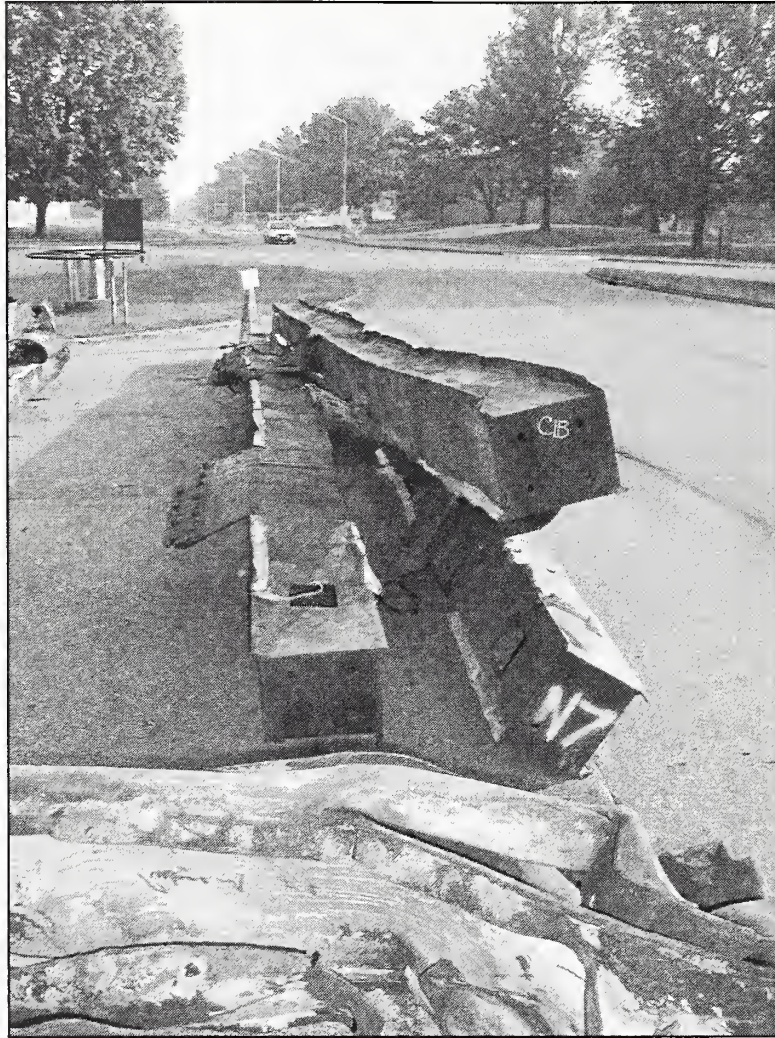
Figure 3–7. Photographic examples of Type 1 damage feature for exterior panel columns, gross physical distortion of flanges and webs. a) Type 1a, crushed columns from K-2 (A236: 92-95), b) Type 1a, crushed column from N-12 (A206: 92-95), c) Type 1b, punctured column from N-8 (A142: 97-100), and d) Type 1c, buckling of column from K-2.

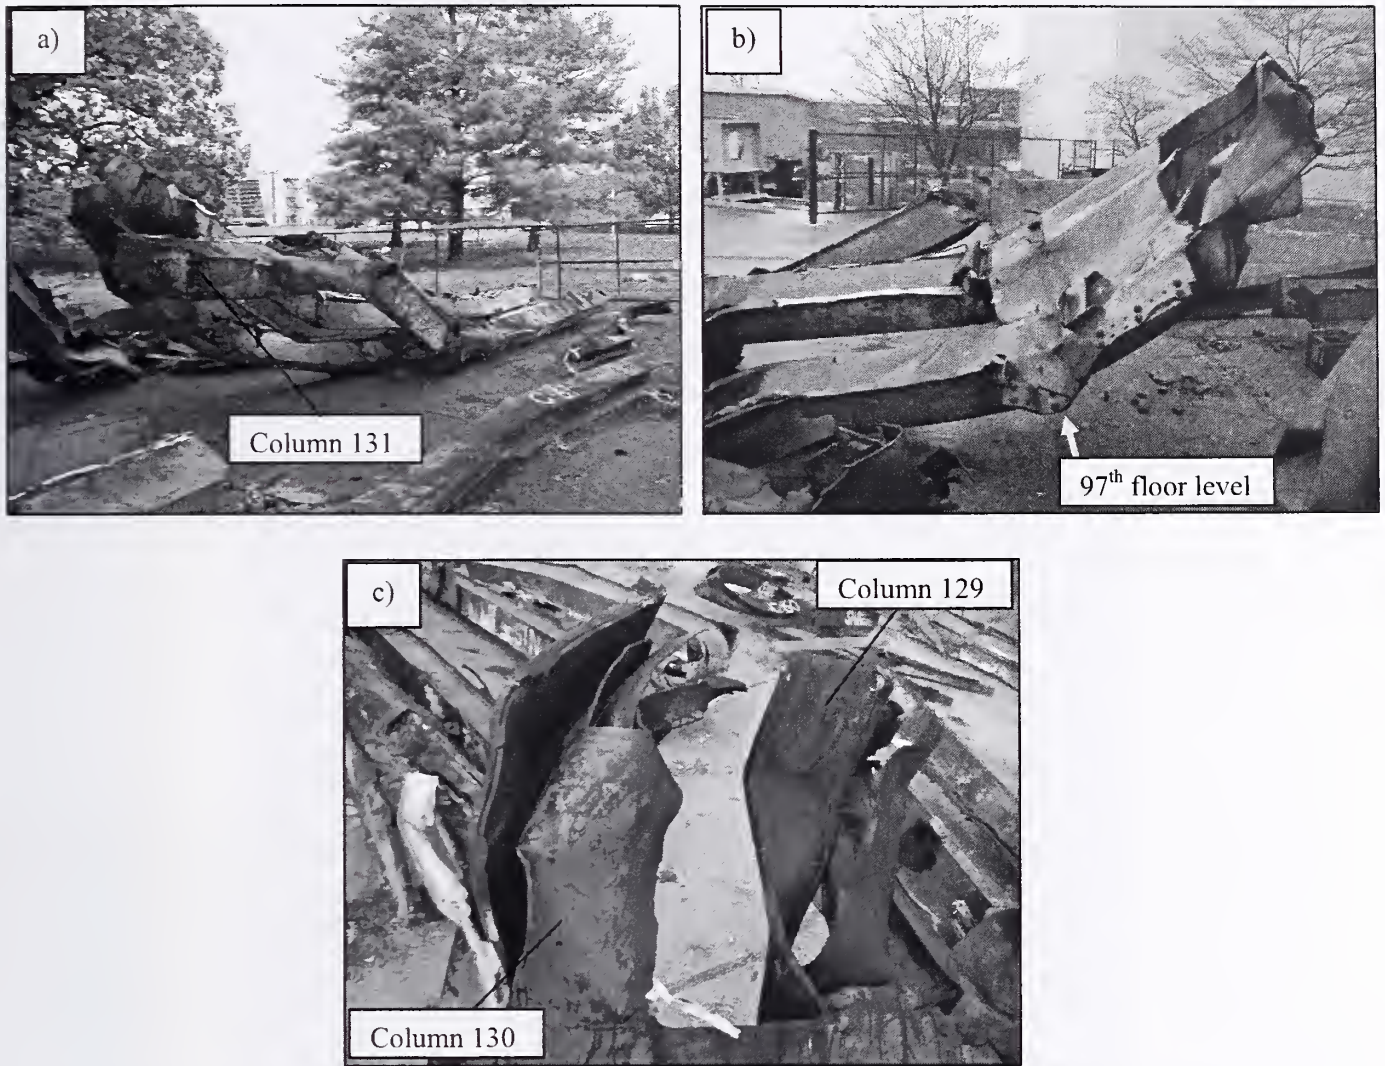
Figure 3–6. Overall image of sample N-7 (A127: 97-100). Panel was in relatively good shape besides being folded inward about an axis parallel to the length of the columns with the outer web of the columns facing outward. This was believed to have happened during the collapse or recovery efforts. The three columns were relatively intact with limited damage.

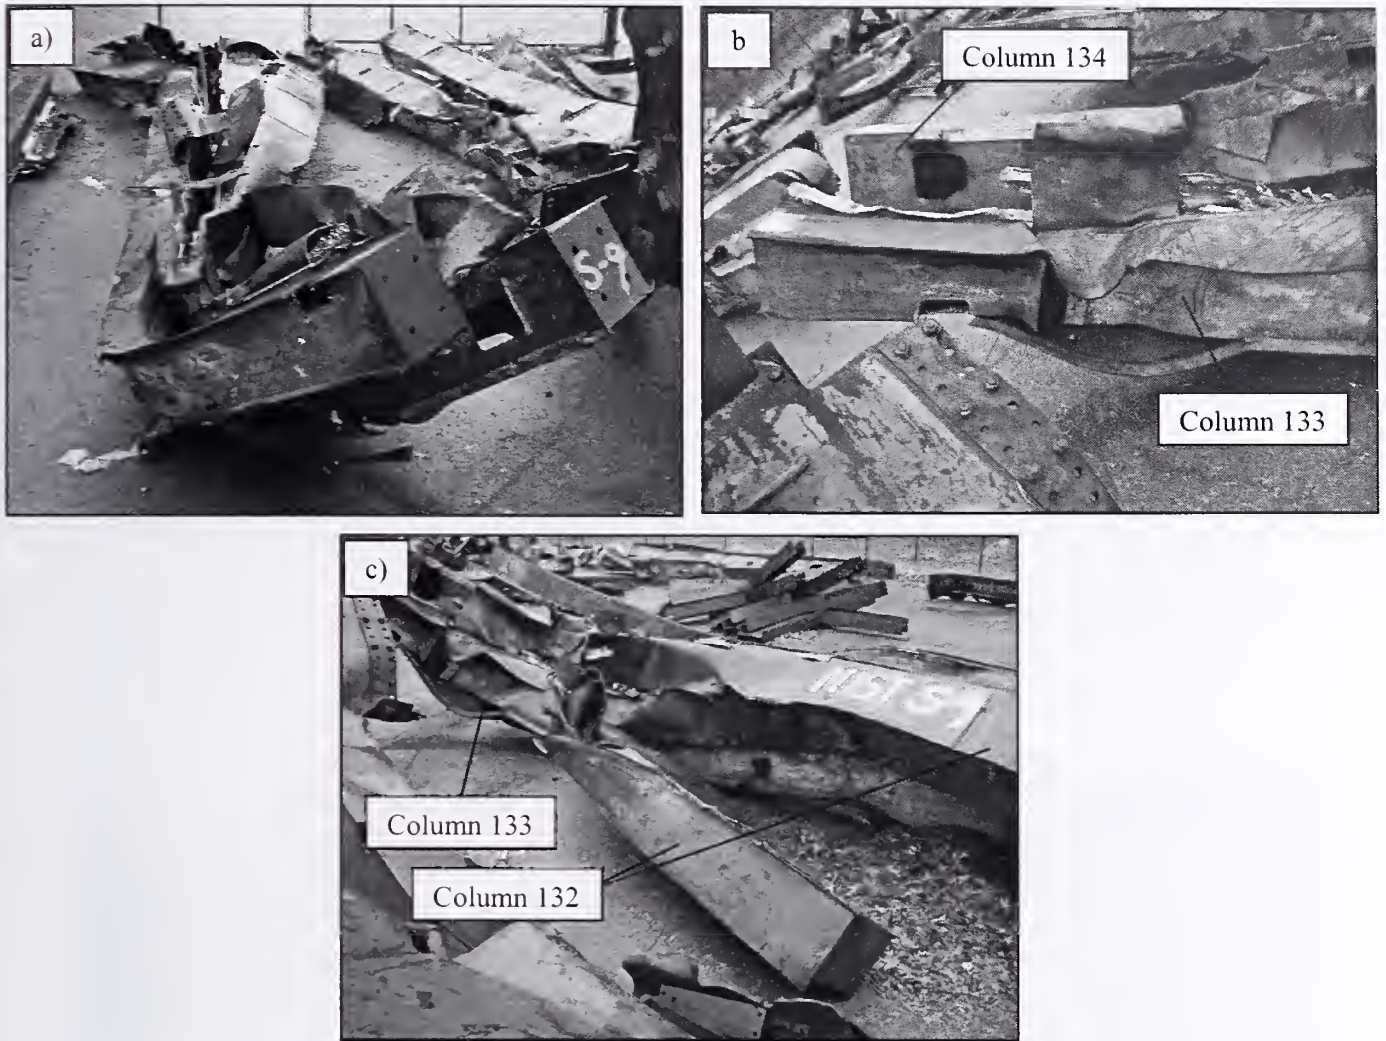
Figure 3–4. Overall view of panel M-27 (A130: 93-96). This panel was from the north face of WTC 1 and struck directly by the nose and fuselage of the plane.

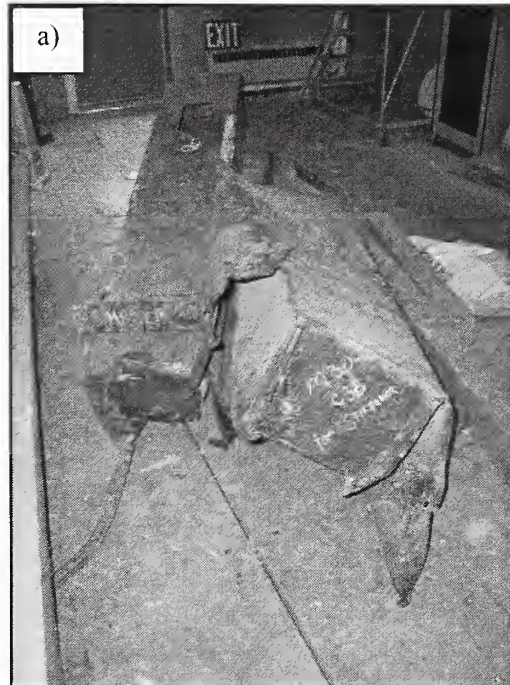
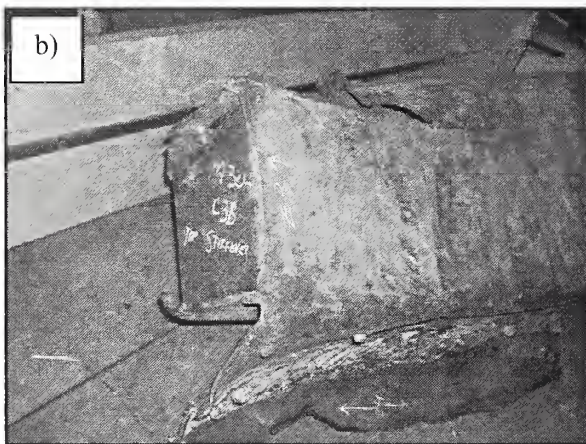
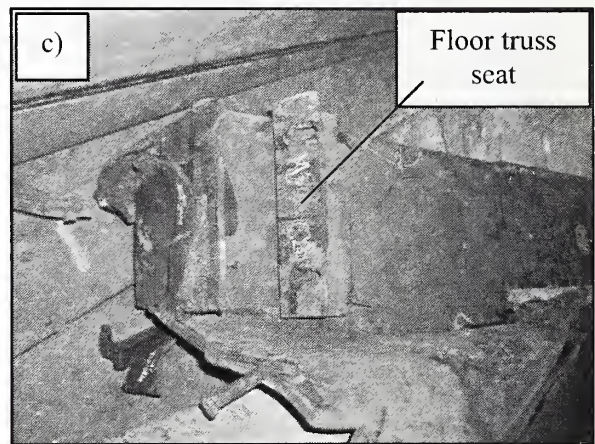
Figure 3–3. a) Overall image of panel S-9 (A133: 97-100) and b) lower portion of panel showing possible damage from airplane impact, bottoms of columns 133 and 134 shown, and c) column 132 that sustained a fair amount of damage.

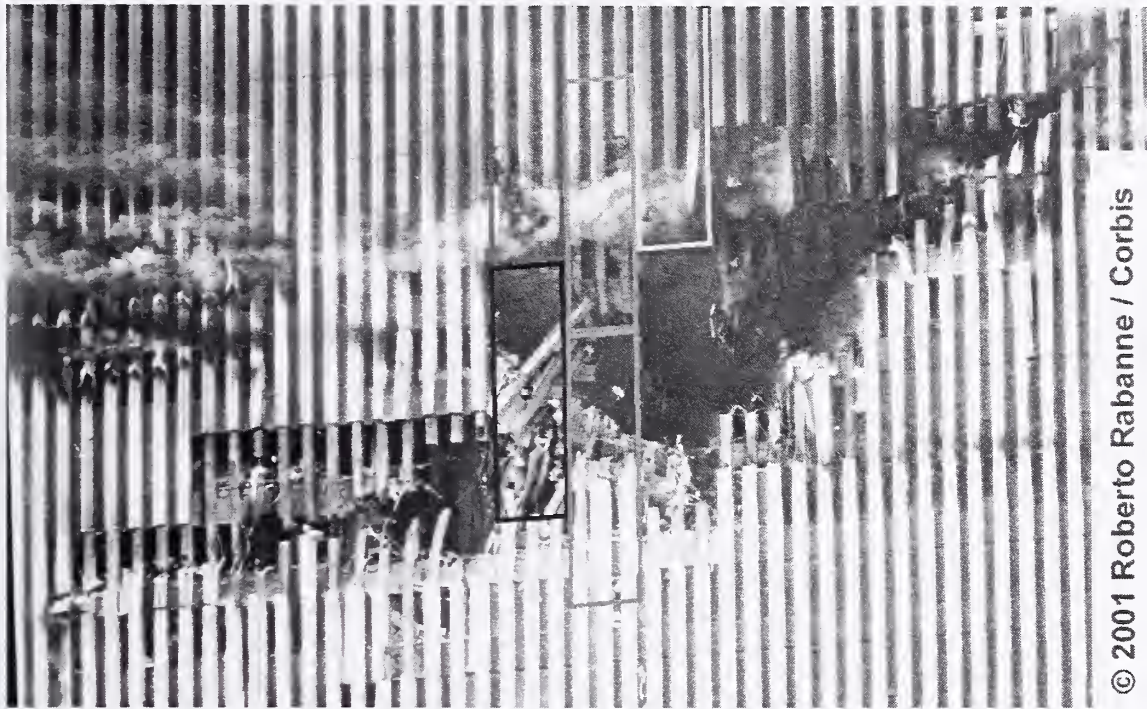
Source: Original photograph copyright Roberto Rabanne 2001.

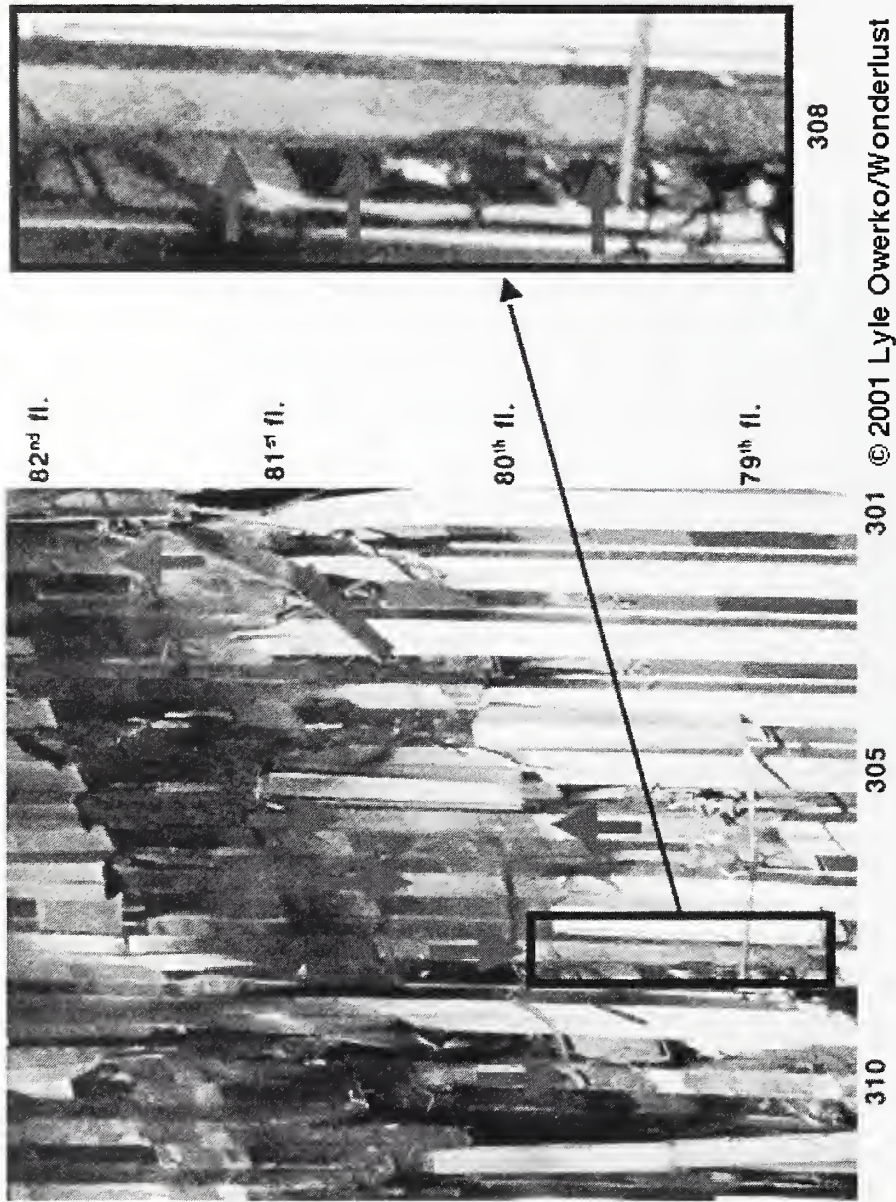
Figure 2-35. Image showing damage to sprayed fire-resistive material on east face of WTC 2 due to internal impact. Red arrows highlight areas where sprayed fire-resistive material has been damaged. The blowup to the right shows a column where the red Tnemec paint of the column is visible.

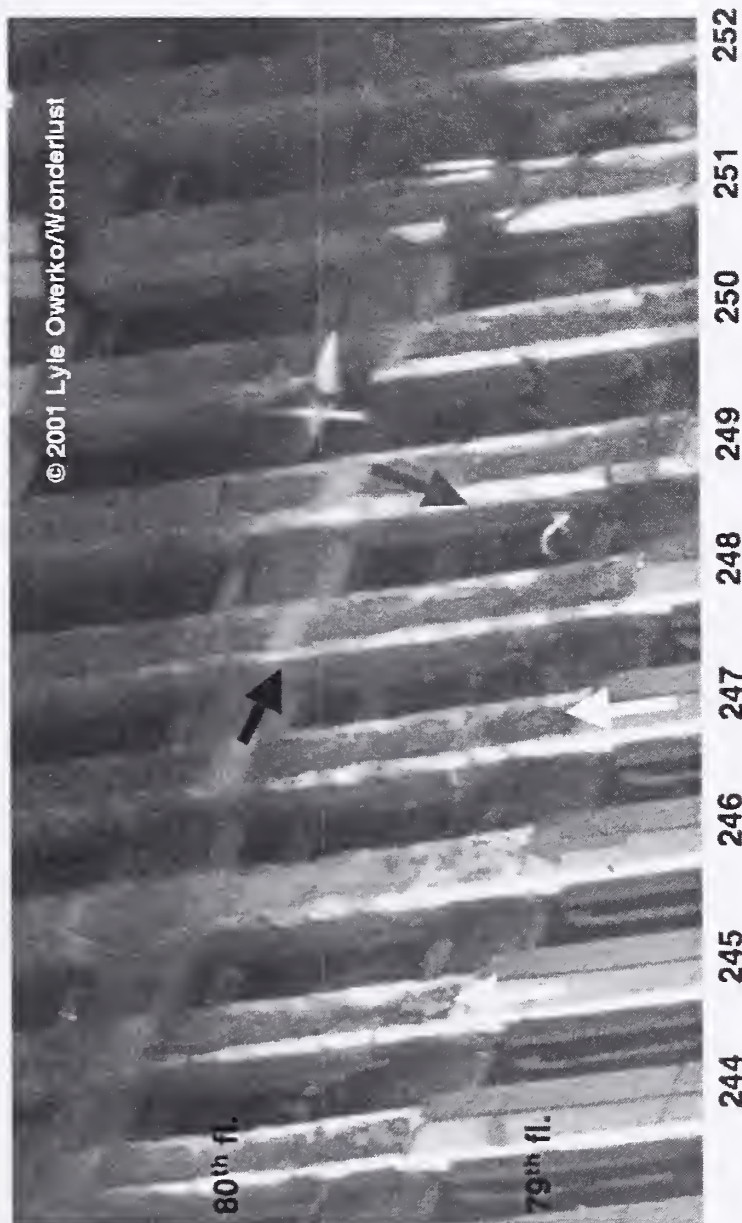
Figure 2-34. Image of missing sprayed fire-resistant material on flanges of exterior columns of N face of WTC 2. Sprayed fire-resistant material has come off, revealing red Tnemec paint of the column (red arrows). This image also shows how the outer web regions have been partially or completely denuded of sprayed fire-resistant material. Damage is evidenced by shading by sunlight - compare green (undamaged sprayed fire-resistant material) and white (damaged sprayed fire-resistant material) arrows. Blue arrow indicates same type of white coated area of sprayed fire-resistant material as previous figure that adhered when material above and below was dislodged.

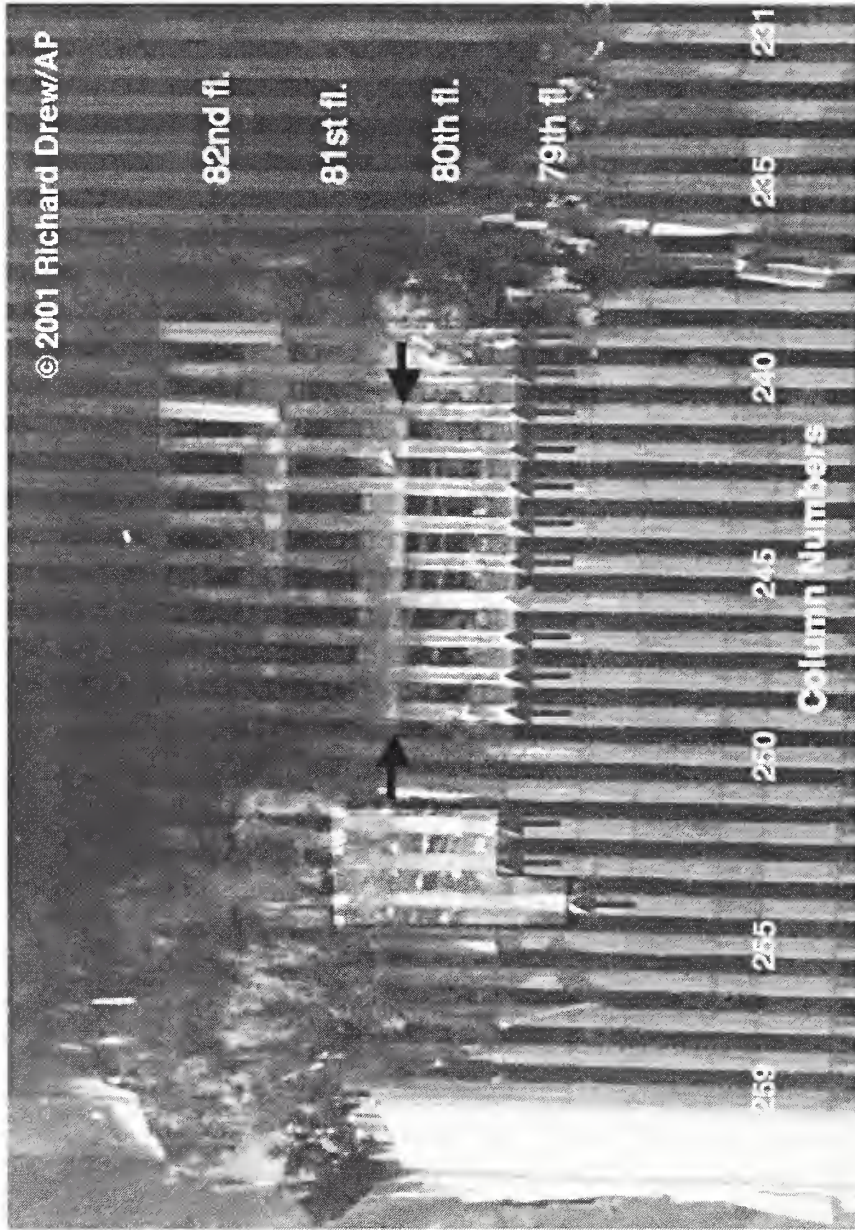
Figure 2-33. Image showing missing facade and sprayed fire-resistive material on N face of WTC 2. Two regions have had contrast and gamma adjusted to enhance visibility of the features. Red arrows indicate columns with missing or damaged sprayed fire-resistive material. Missing or damaged sprayed fire-resistive material determinations were made from this and several other photos taken at different times and angles. Blue arrows indicate white features where some sort of coating has preserved the sprayed fire-resistive material in place.

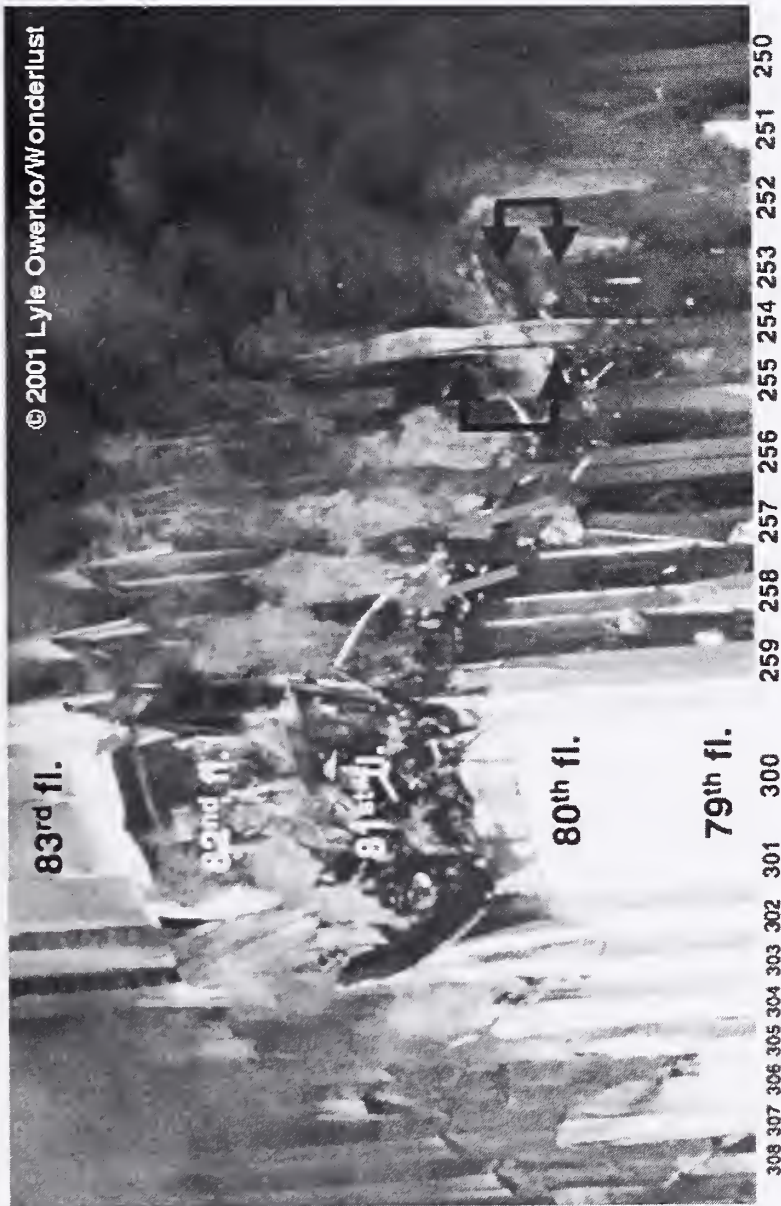
Figure 2-32. Image showing damage to columns on N face of WTC 2 near NE corner due to internal impact by debris. Broken vertical column bolted connections (green arrows) are visible, along with an intact outer web on column 254 (red arrows) and missing column sections (blue arrows).

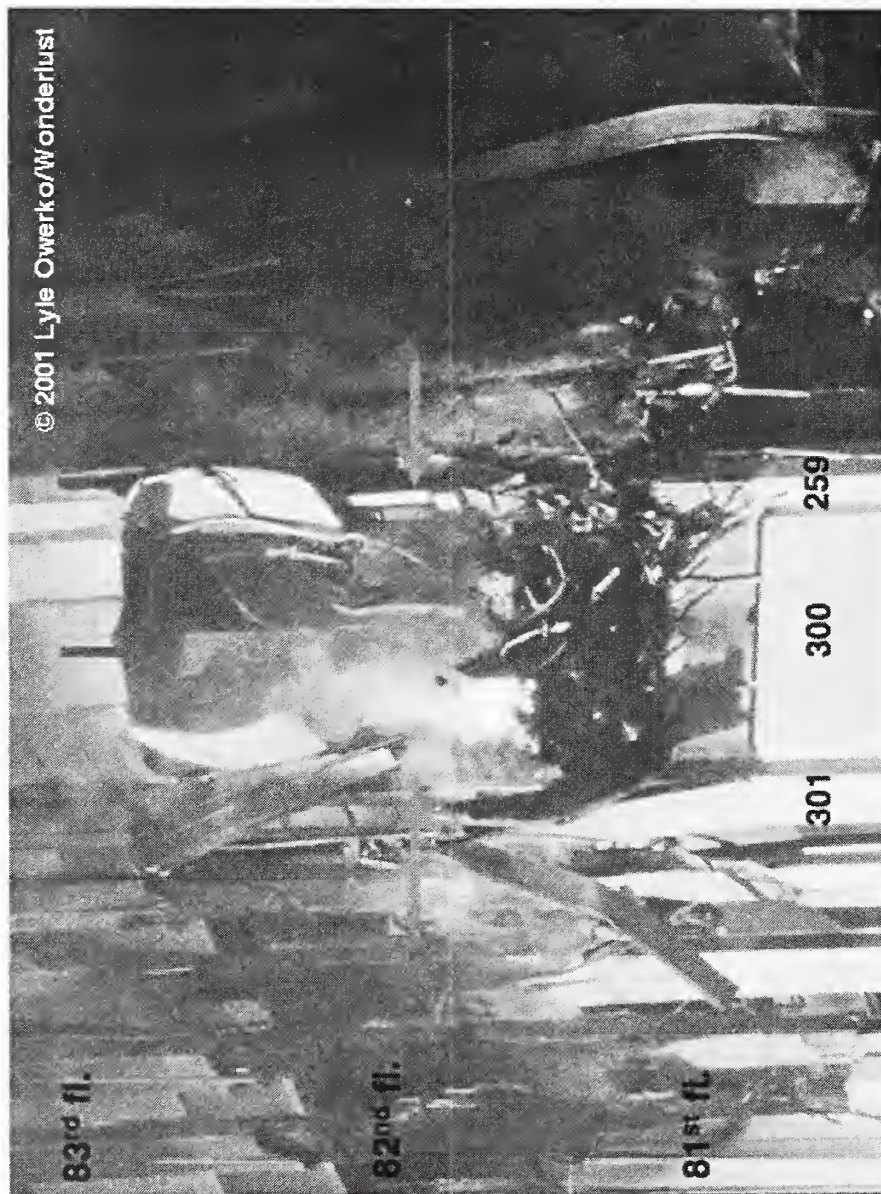
Figure 2-31. Image showing damage to NE corner of WTC 2 at 81st floor. The red arrow indicates an intact column 300 at the 82nd floor. Other photographs confirm that the spandrel connecting column 300 to columns 259 and 301 is also intact (location indicated by green arrows).

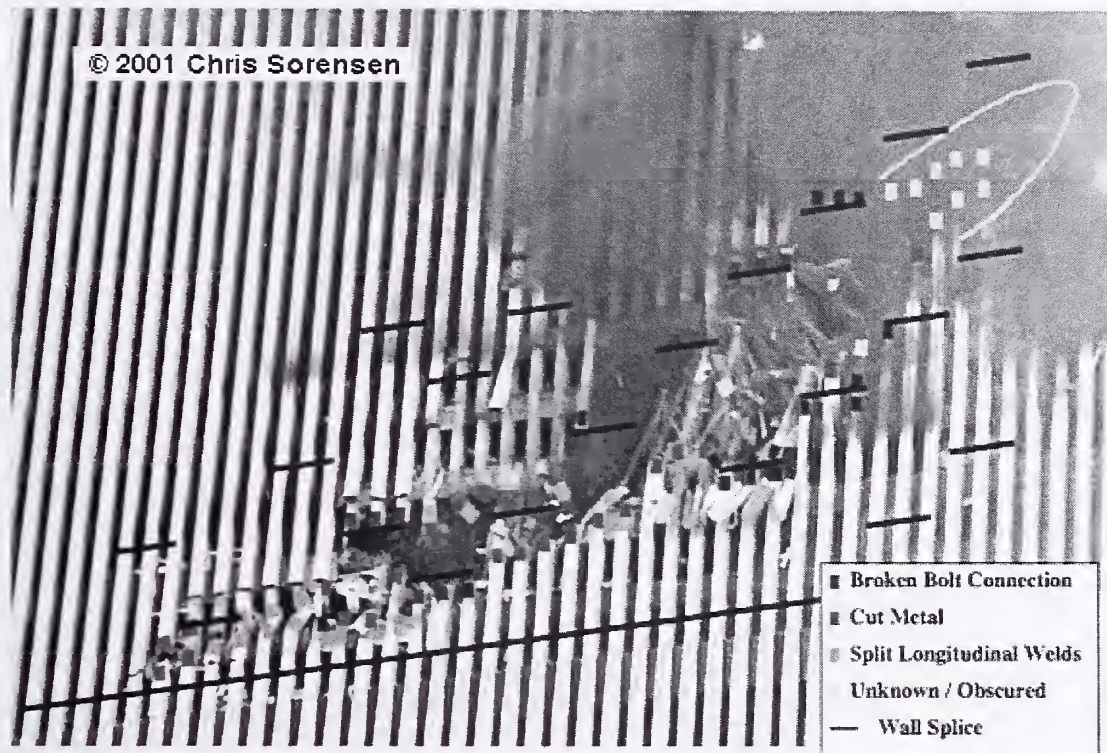
Figure 2–30. Image from Fig. 2–29 with black lines showing the location of bolted vertical column connections between panels.

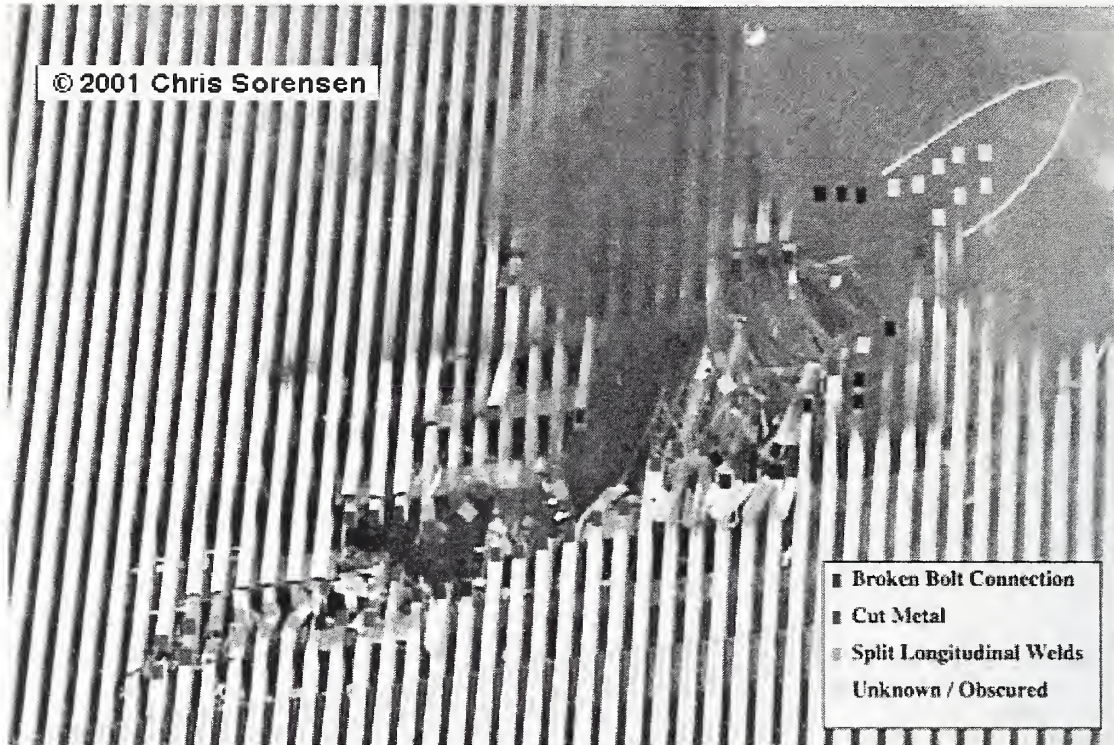
Figure 2–29. Image from Fig. 2–28 with indications of location and type of localized damage. Red designates cut metal components, blue indicates broken vertical column connection bolts, green indicates locations of failure of longitudinal welds in the box columns, and yellow shows regions that could not be identified from any photographic evidence.

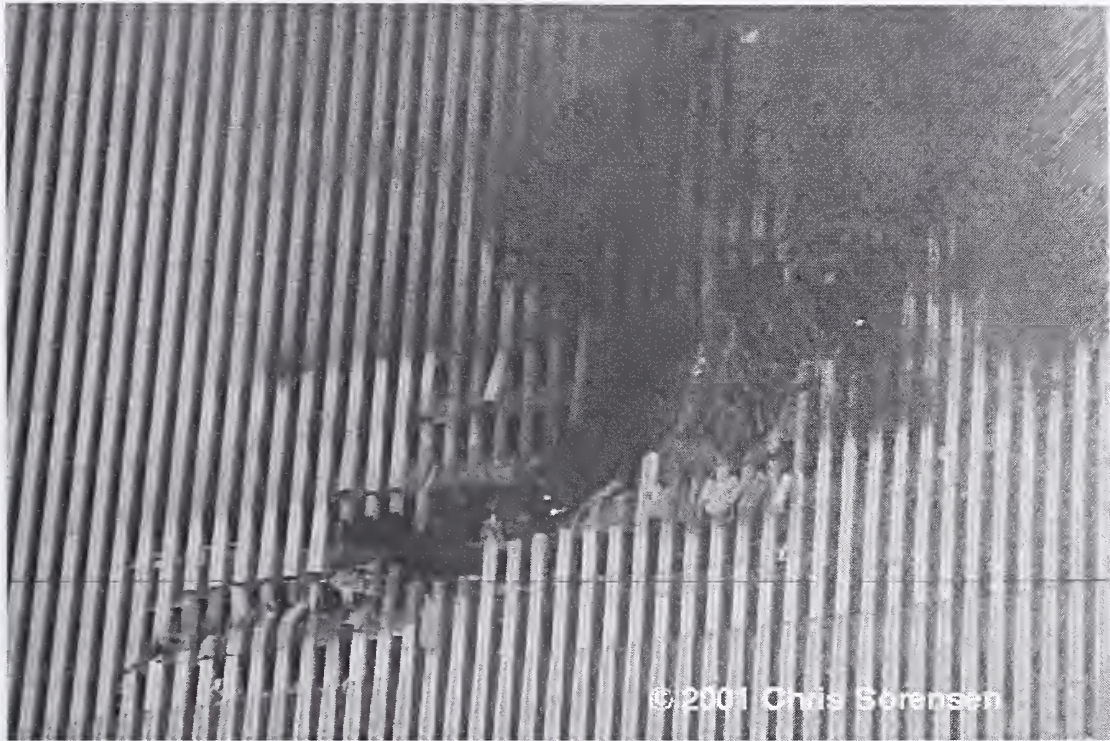
Figure 2–27. Un-enhanced frame from “Sorensen 4 at 1-44-21.jpg” showing the impact hole in the south face of WTC 2.

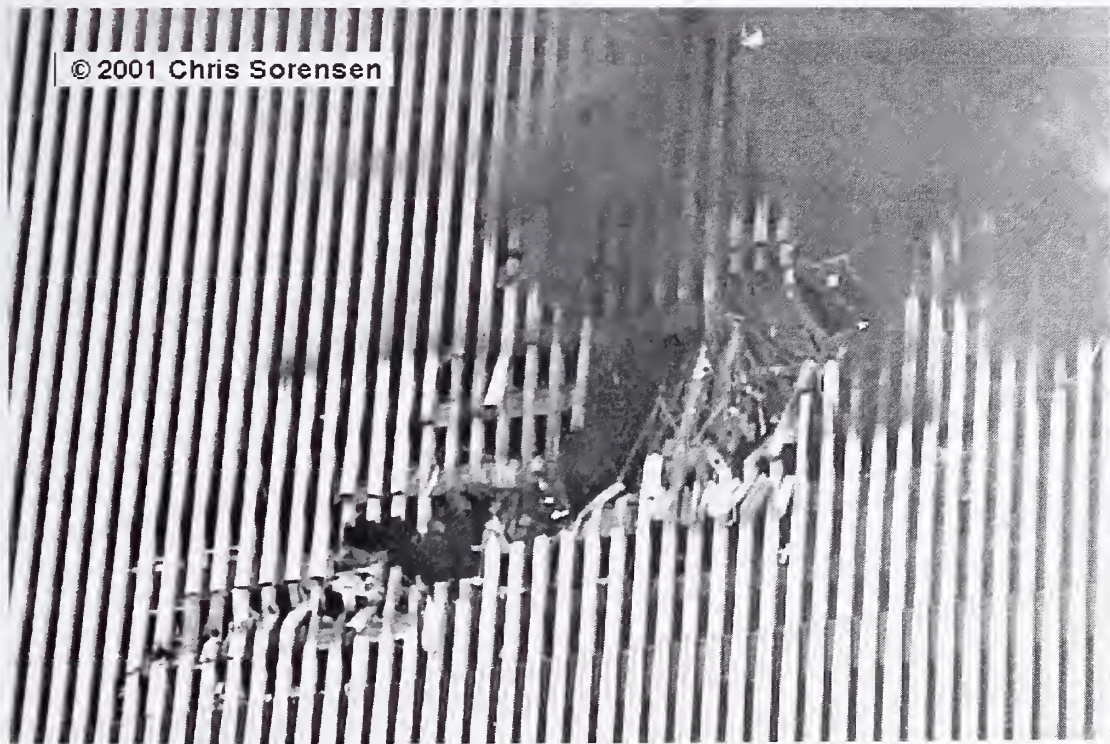
Figure 2–28. Image from Fig. 2–27 computer image enhanced for maximum visibility of damage to exterior wall panels.

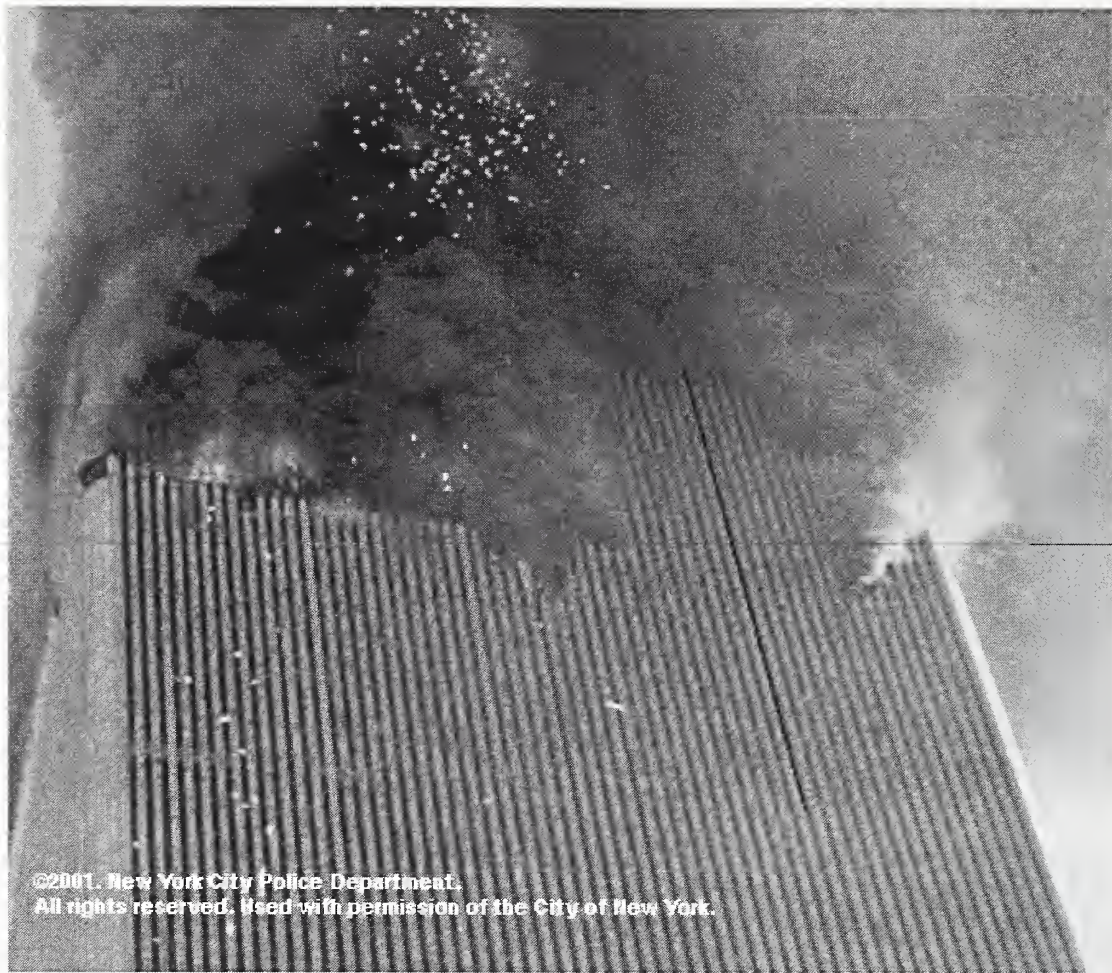
Figure 2–26. South face of WTC 1 58 min after (9:25 a.m.), showing no bowing in the outer columns.

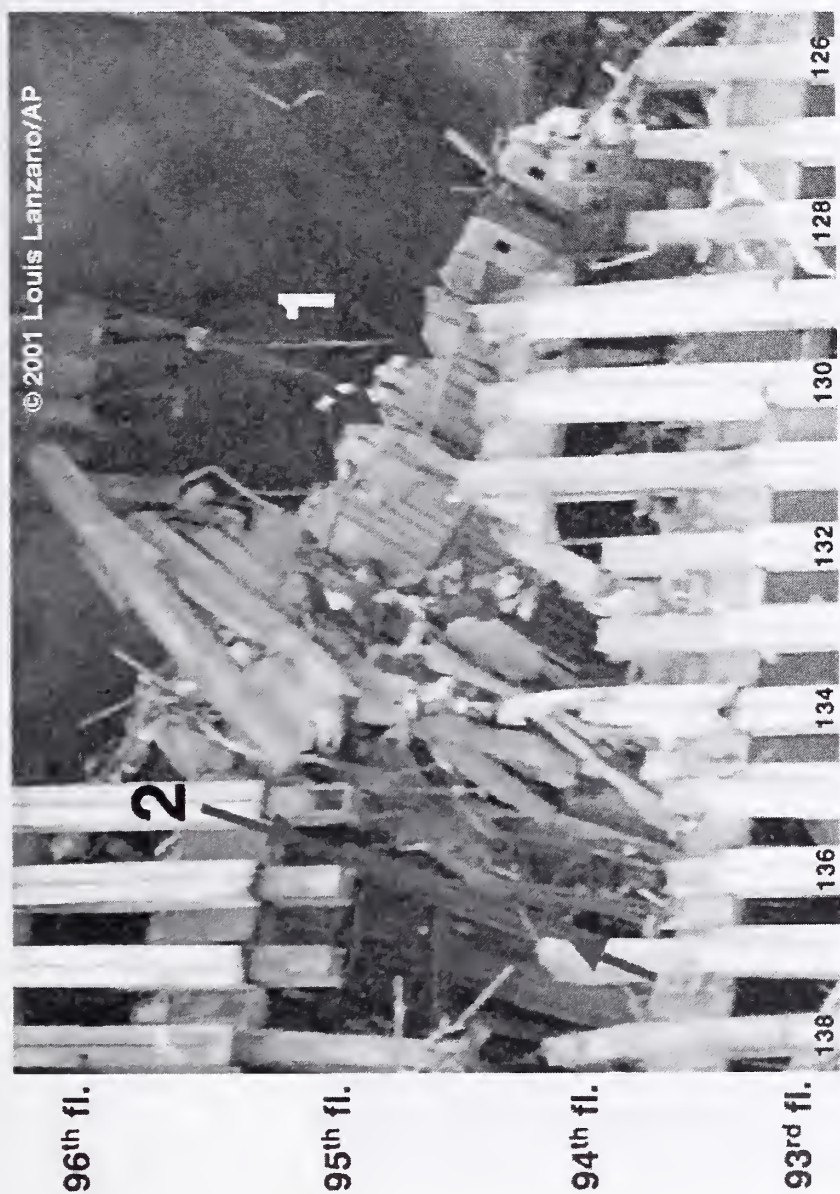
Figure 2-23. Image showing missing sprayed fire-resistive material on floor trusses that fell into impact hole on north face of WTC 1. The arrows labeled “1” are three trusses where you can see the lower or upper chords, and can distinguish the line that separates the two angle iron components. The arrows labeled “2” lie at either end of a lower chord of a truss that fell farther inside the building, and is made up of 4 angle irons (a double truss). The red paint color being visible and the fact that the line between the angle iron can be seen indicated that the sprayed fire-resistive material was displaced.

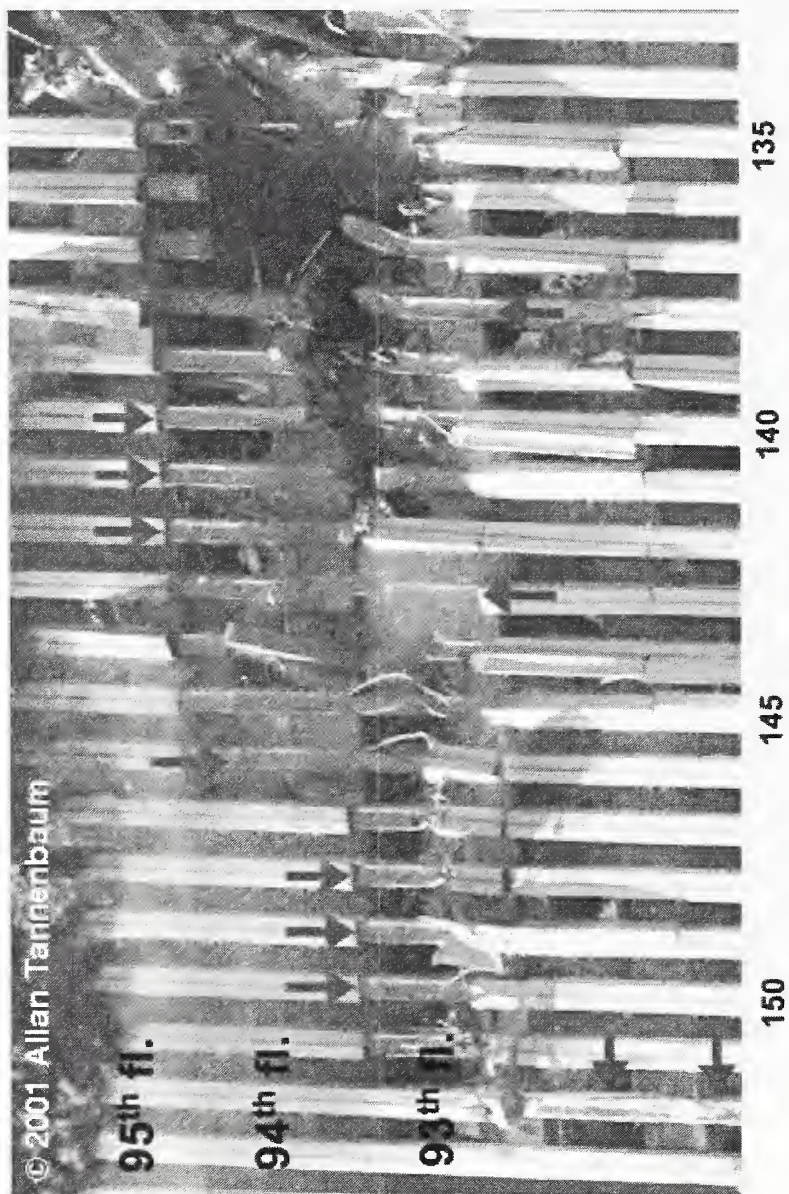
Figure 2-22. Port side of impact hole in north face of WTC 1 showing missing sprayed fire-resistive material. The red arrows indicate a few of the many instances of missing sprayed fire-resistive material around the impact hole. The region roughly approximated as the area where the aluminum panels were dislodge has been digitally enhanced for clarity.

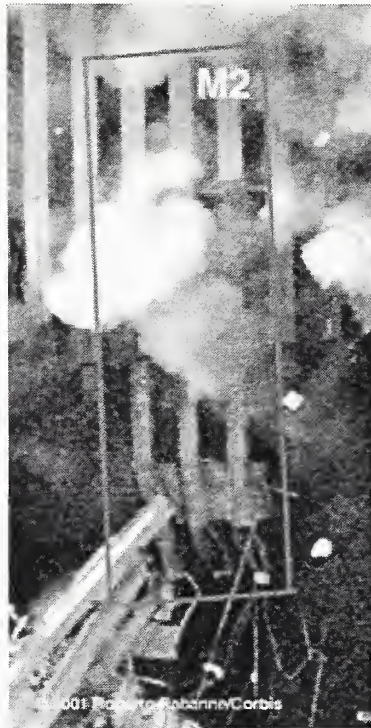
Figure 2-17. Close-up of pre-collapse condition of panel M-2 (A130: 96-99).

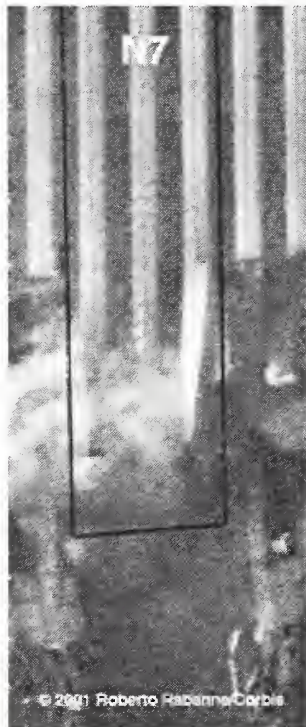
Figure 2-18. Close-up of pre-collapse condition of panel N-7 (A127: 97-100).

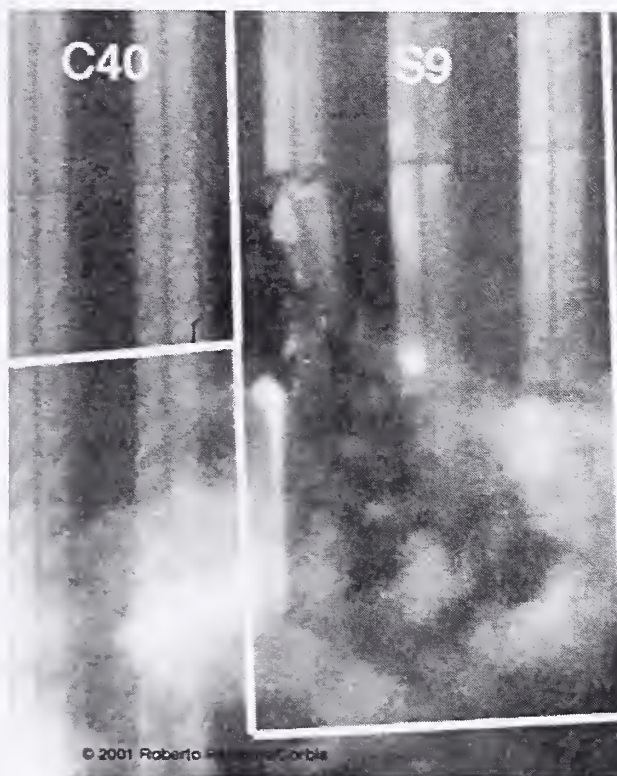
Figure 2–15. Close-up of pre-collapse condition of panel S-9 (A133: 97-100).

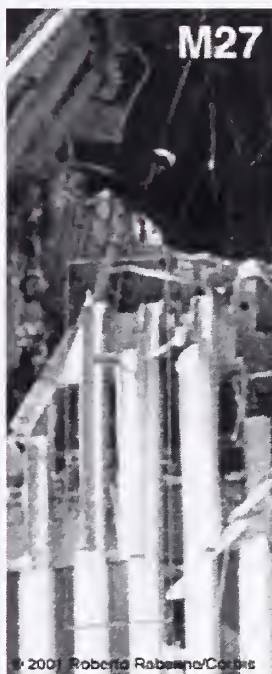
Figure 2–16. Close-up of pre-collapse condition of panel M-27 (A130: 93-96).
