NIST NCSTAR 1-3C

Federal Building and Fire Safety Investigation of the
World Trade Center Disaster

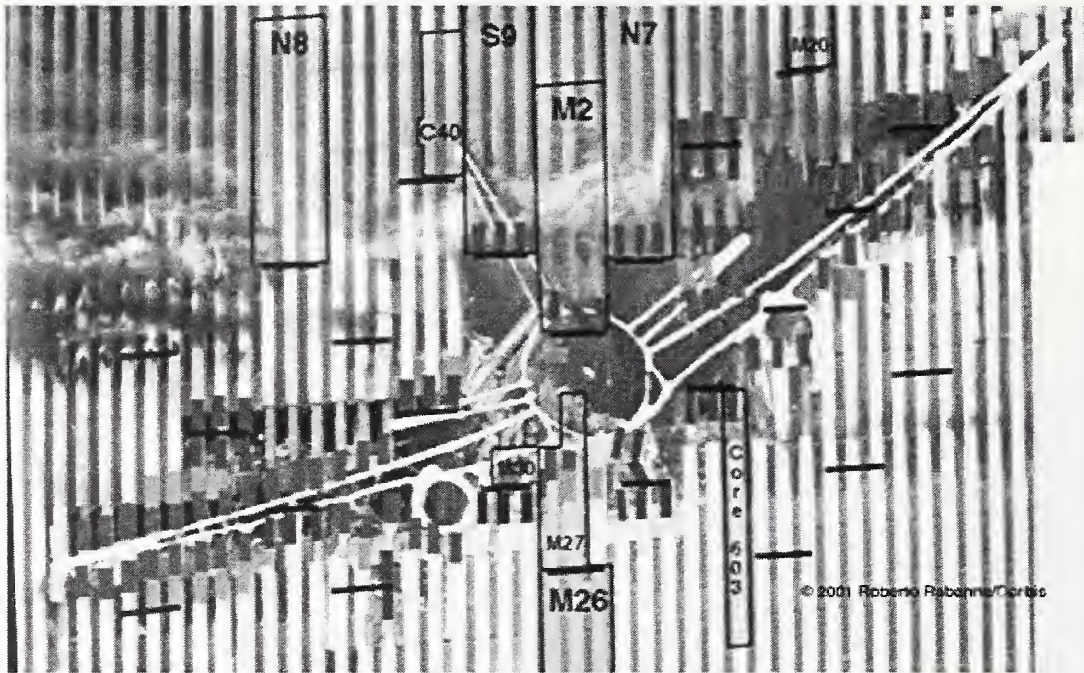
Figure 2–13. Image from Fig. 2–12 with shaded regions showing the locations of identified panels in NIST’s possession from around the impact hole in WTC 1.

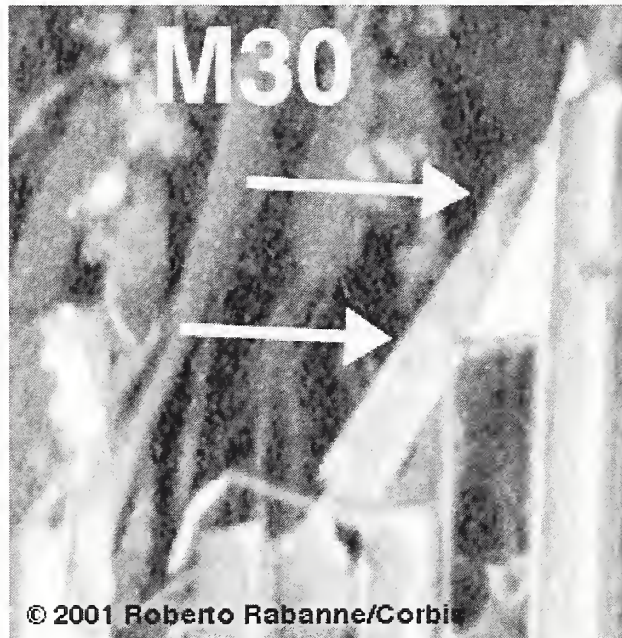
Figure 2–14. Close-up of pre-collapse condition of panel M-30 (A133: 94-97).

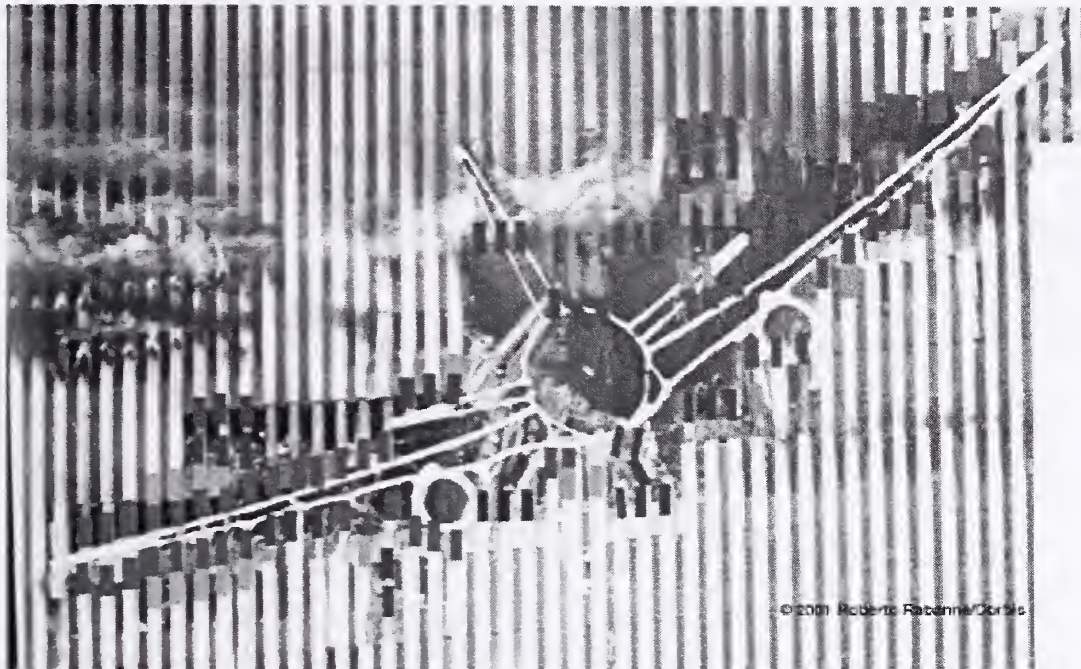
Figure 2–11. Image from Fig. 2–10 with indications of location and type of localized damage. Red designates cut metal components; blue, broken vertical column connection bolts; green, locations of failure of longitudinal welds in the box columns; and yellow shows regions that could not be identified from any photographic evidence.

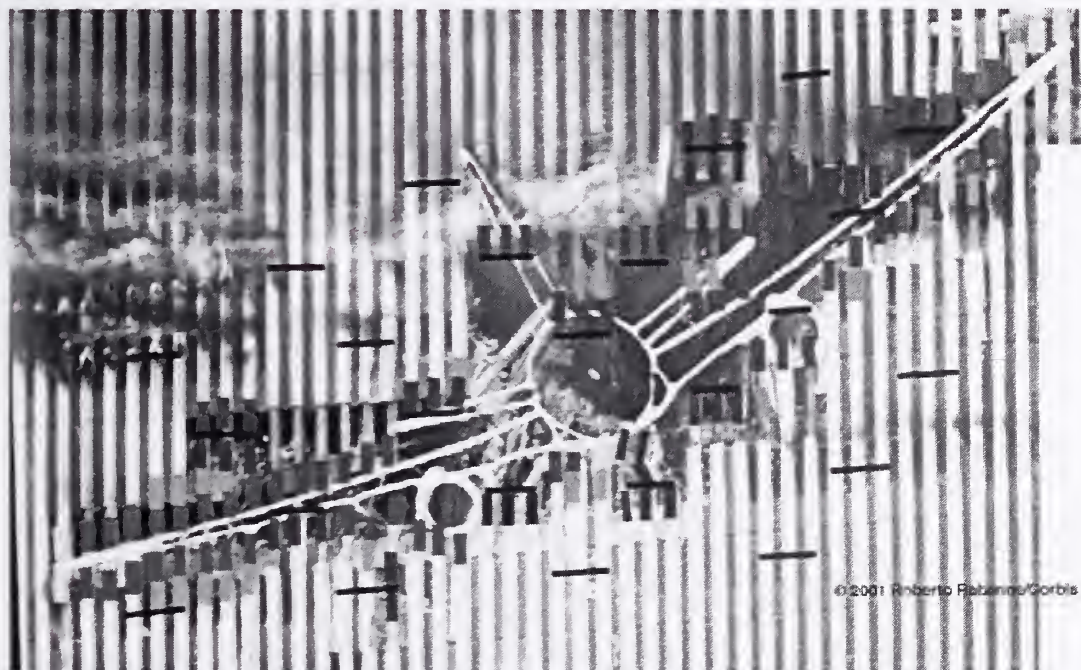
Figure 2–12. Image from Fig. 2–11 with black lines showing the location of bolted vertical column connections between panels.

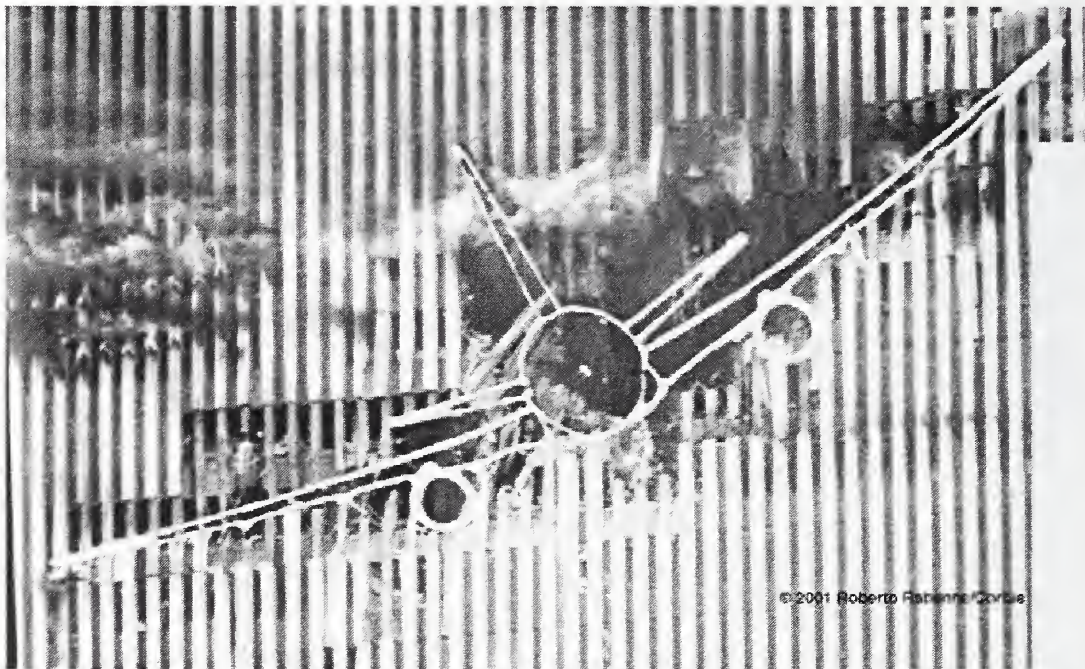
Figure 2-10. Image from Fig. 2-8 with overlay of the outline of a Boeing 767 that has been manually distorted in the computer to get a best approximate fit with damage to WTC 1.

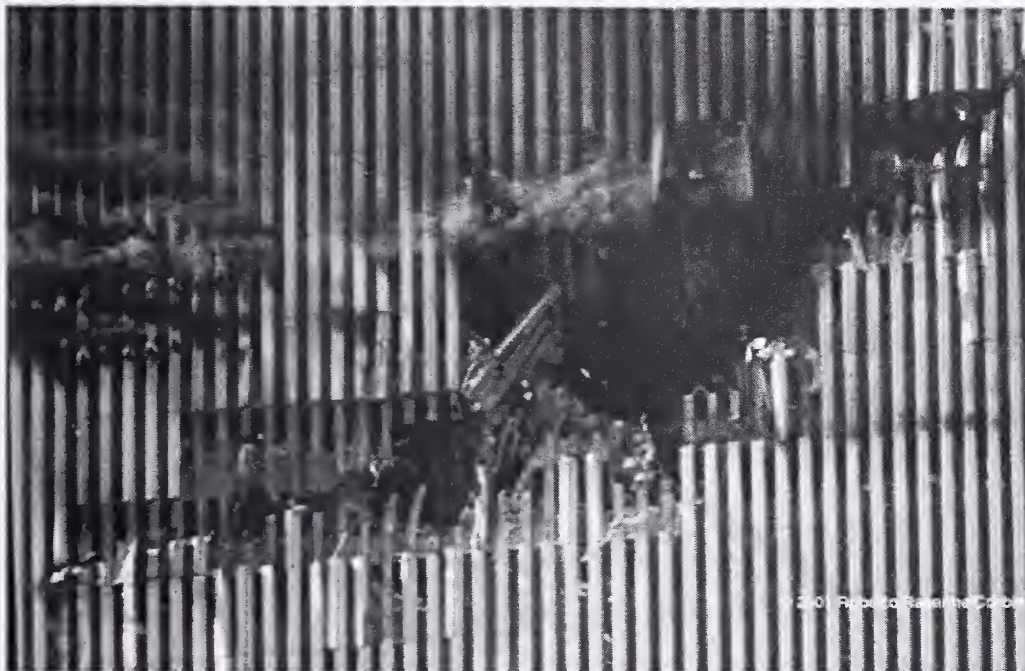
Figure 2–7. Unenhanced image Corbis_NRM161282 showing the impact hole in the north face of WTC 1.

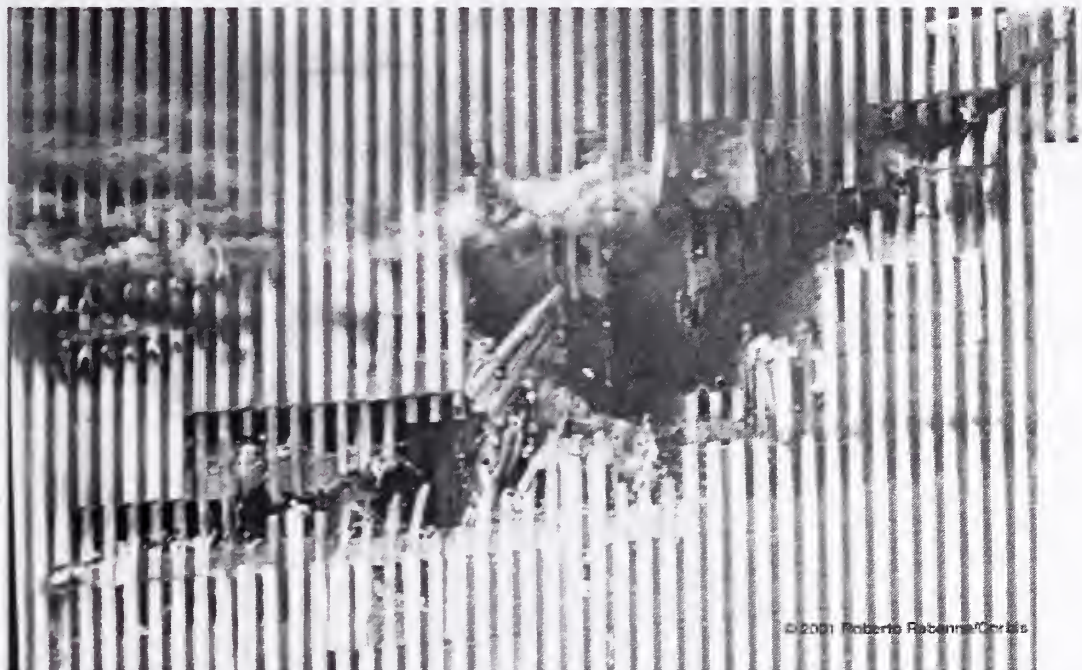
Figure 2–8. Image from Fig. 2–7 with addition of a small piece of image “7_1.jpg” (original photograph copyright Roberto Rabanne 2001), then computer image enhanced for maximum visibility of damage to exterior wall panels.

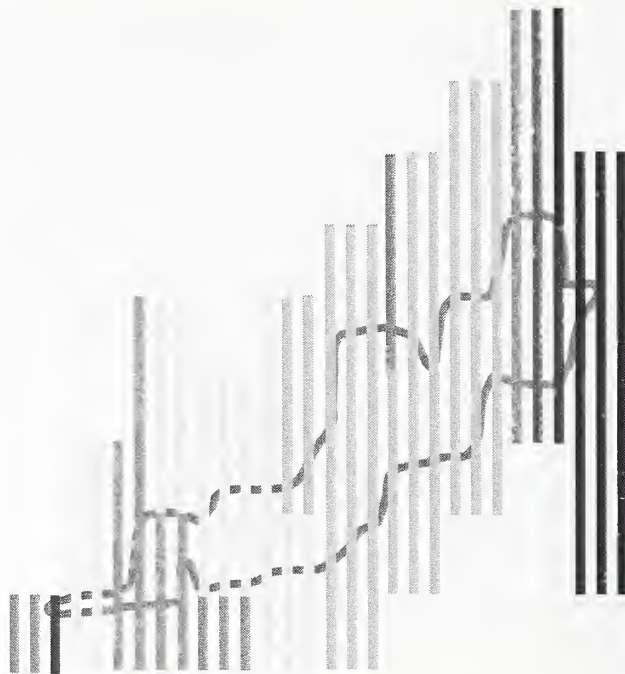
Figure 2-5b. The specified minimum yield strength of the exterior columns for WTC 2 shown in (a).

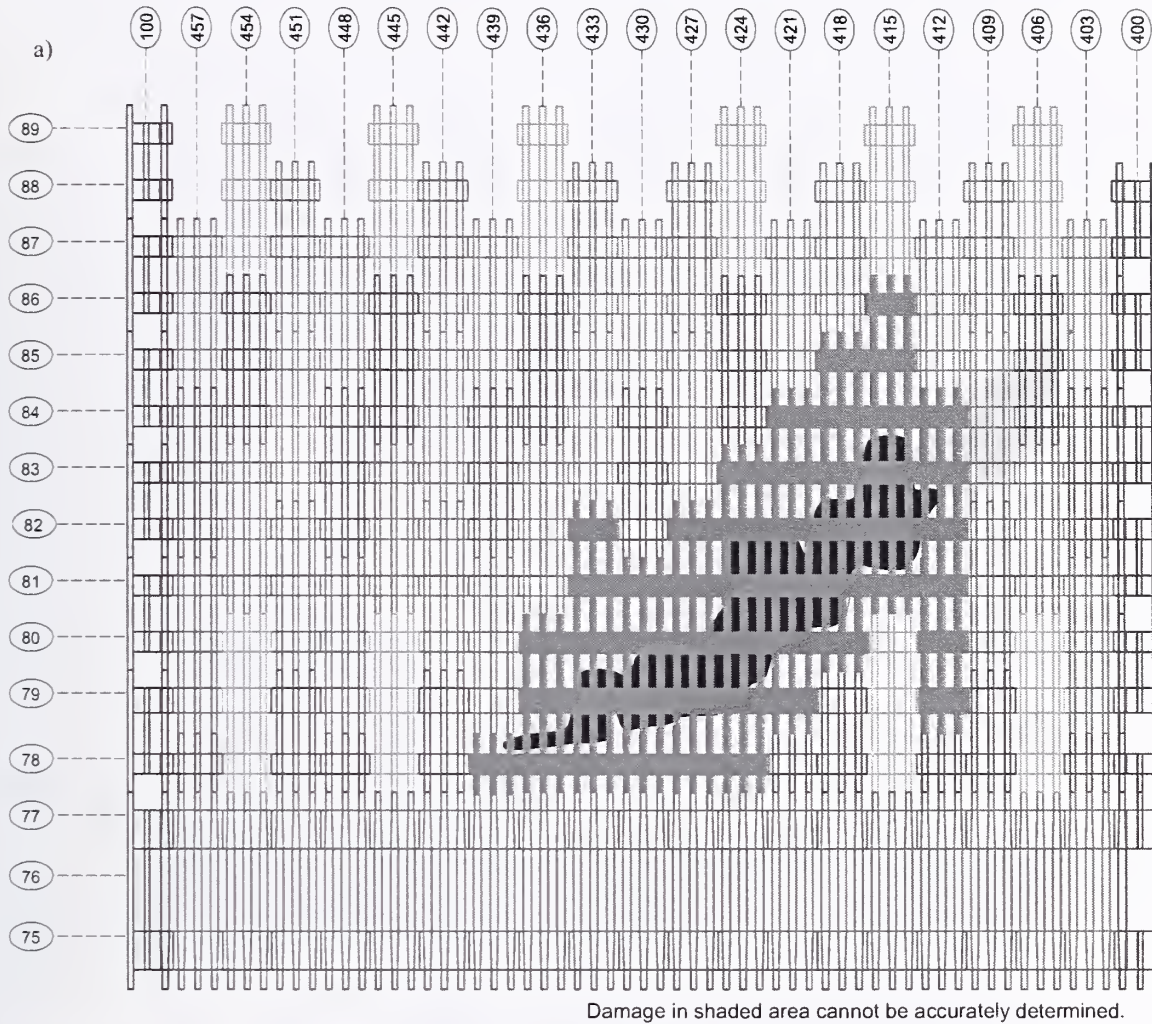
Figure 2-5a. Pictorial display showing the panels possibly damaged on the south face of WTC 2 around the airplane impact region.

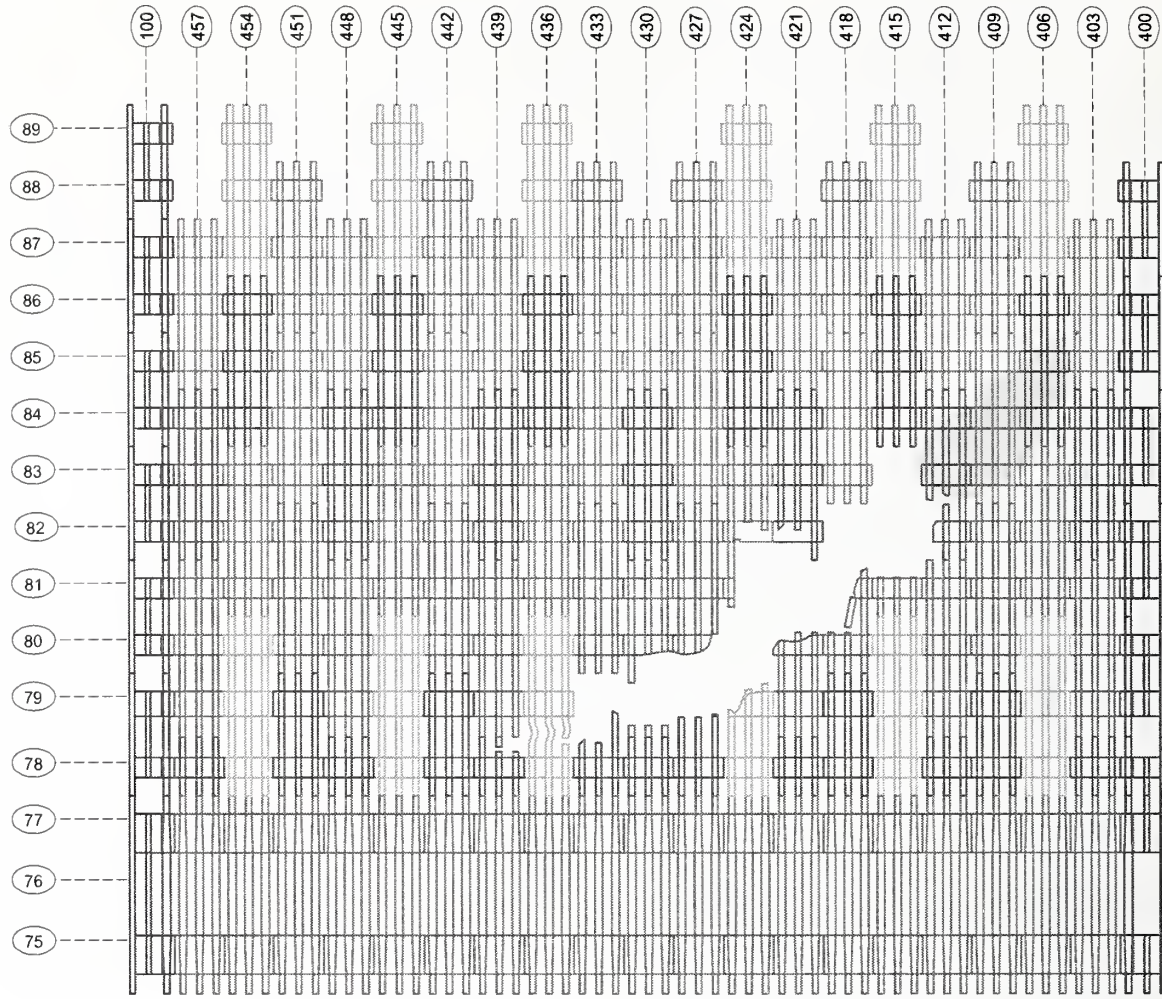
Damage in shaded area cannot be accurately determined.

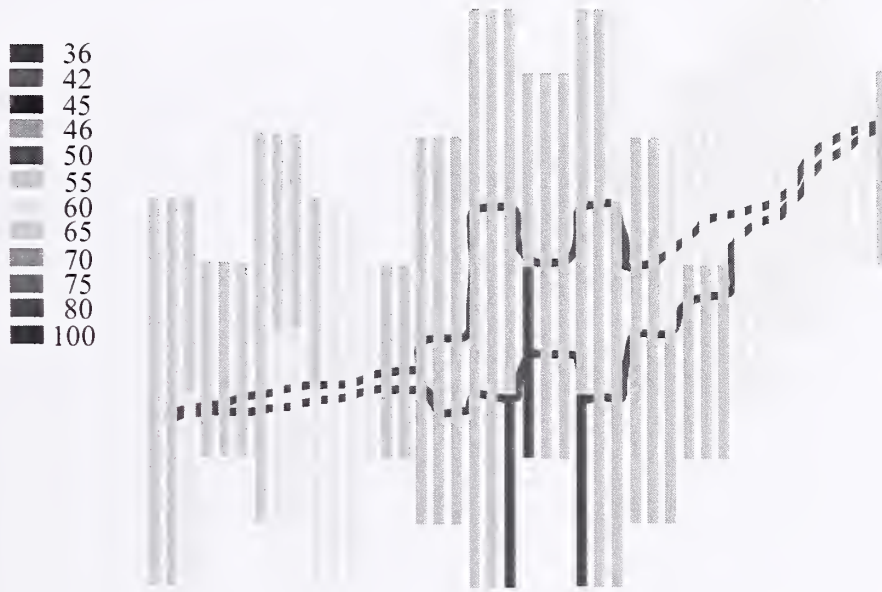
Figure 2-2b. The specified minimum yield strength of the exterior columns for WTC 1 shown in (a).

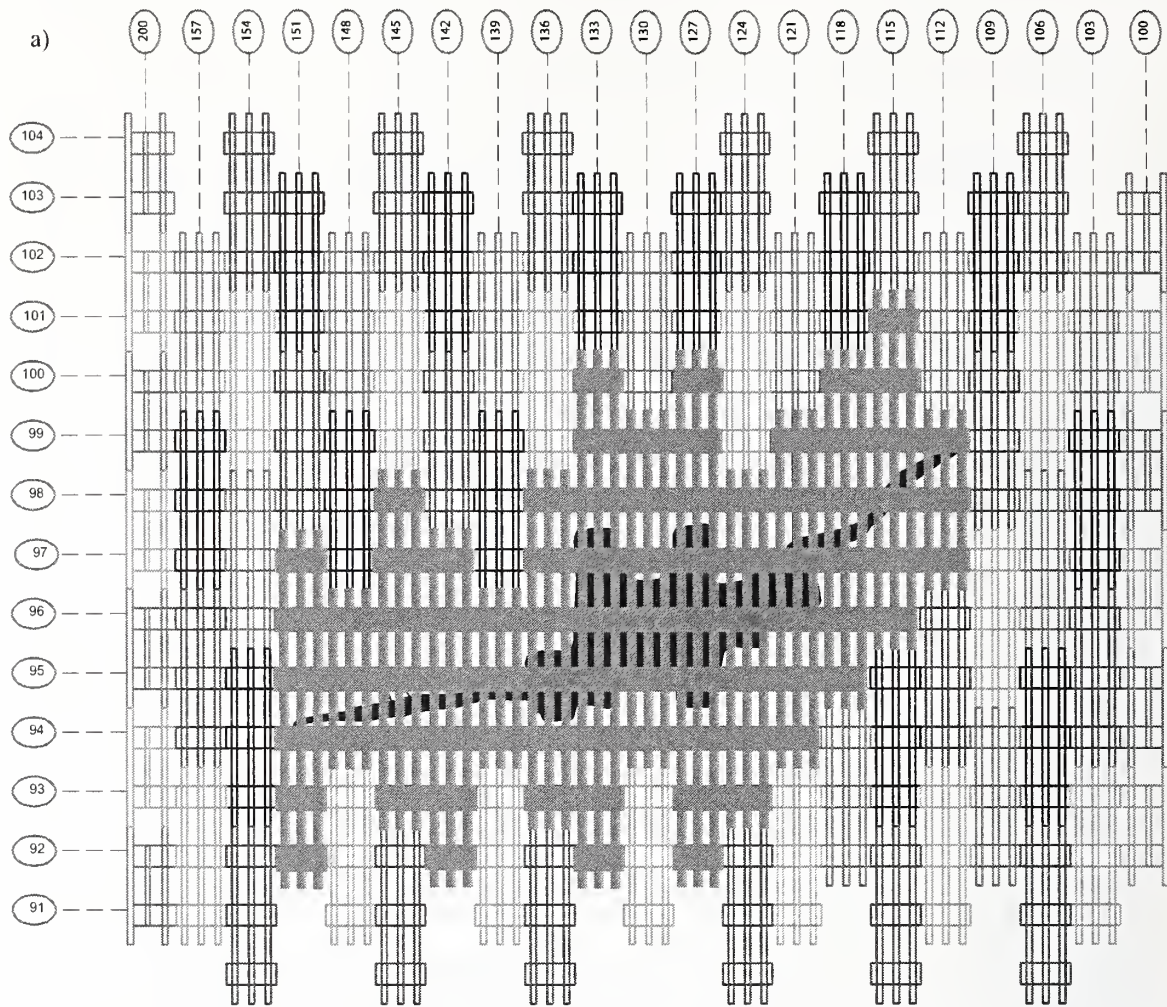
Figure 2-2a. Pictorial display showing the panels damaged on the north face of WTC 1 around the airplane impact region.

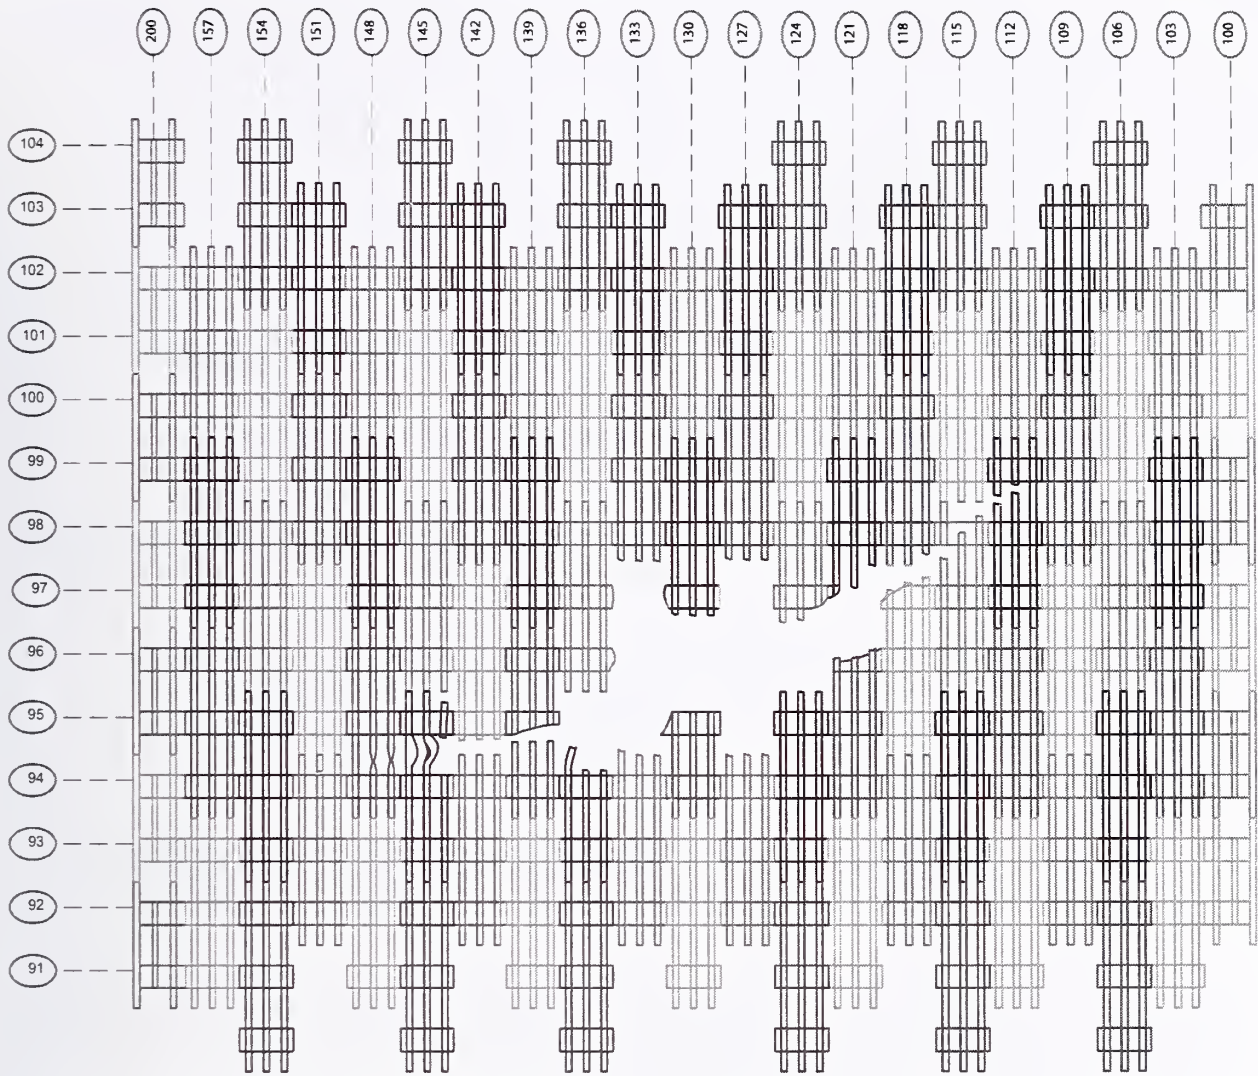
Figure 2–1. Estimated amount of damage to the north face of WTC 1, as determined by NIST.

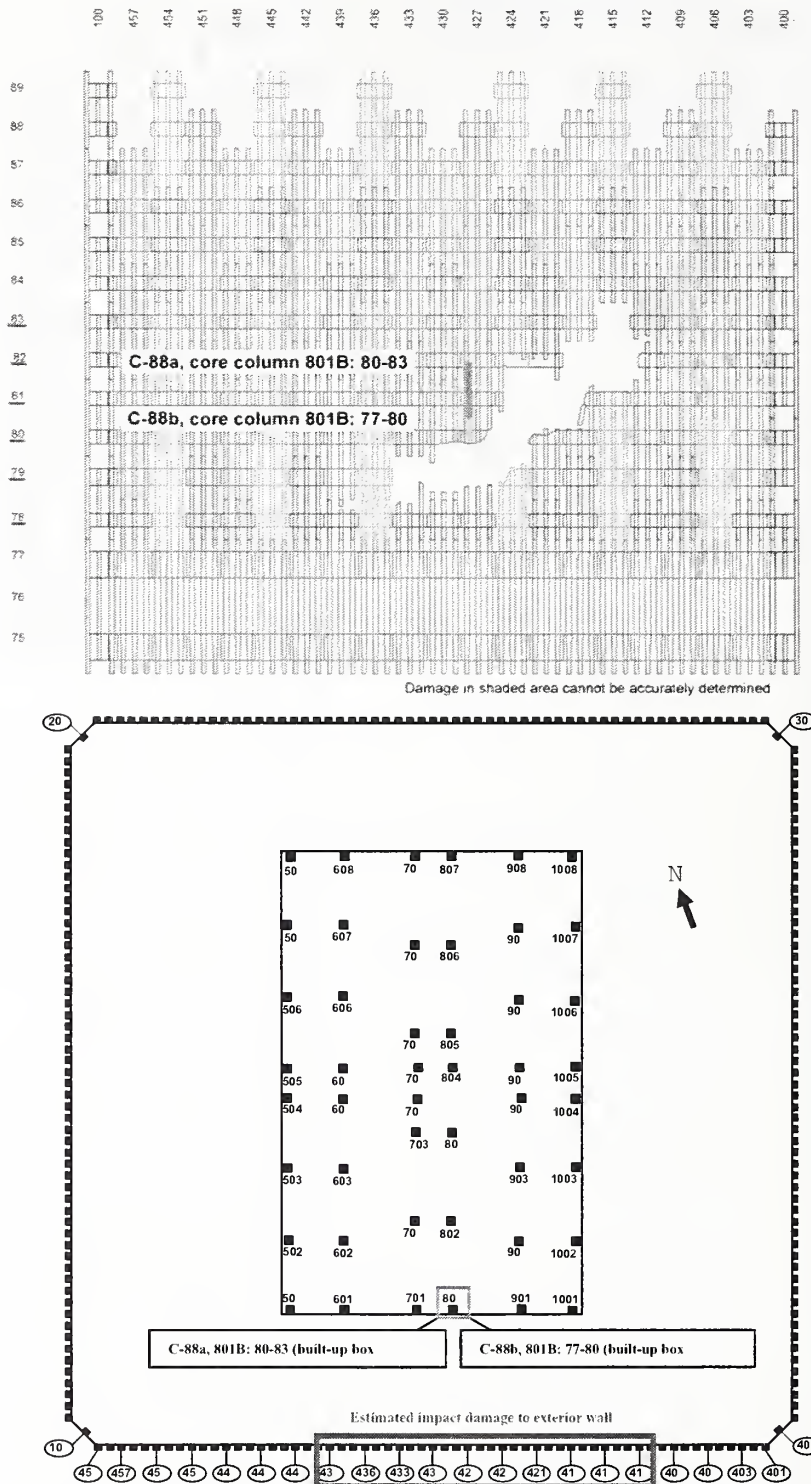
Figure 1–8. Impact damage location and recovered structural elements from WTC 2. Visual evidence of pre-collapse fires was observed on floors highlighted in red.

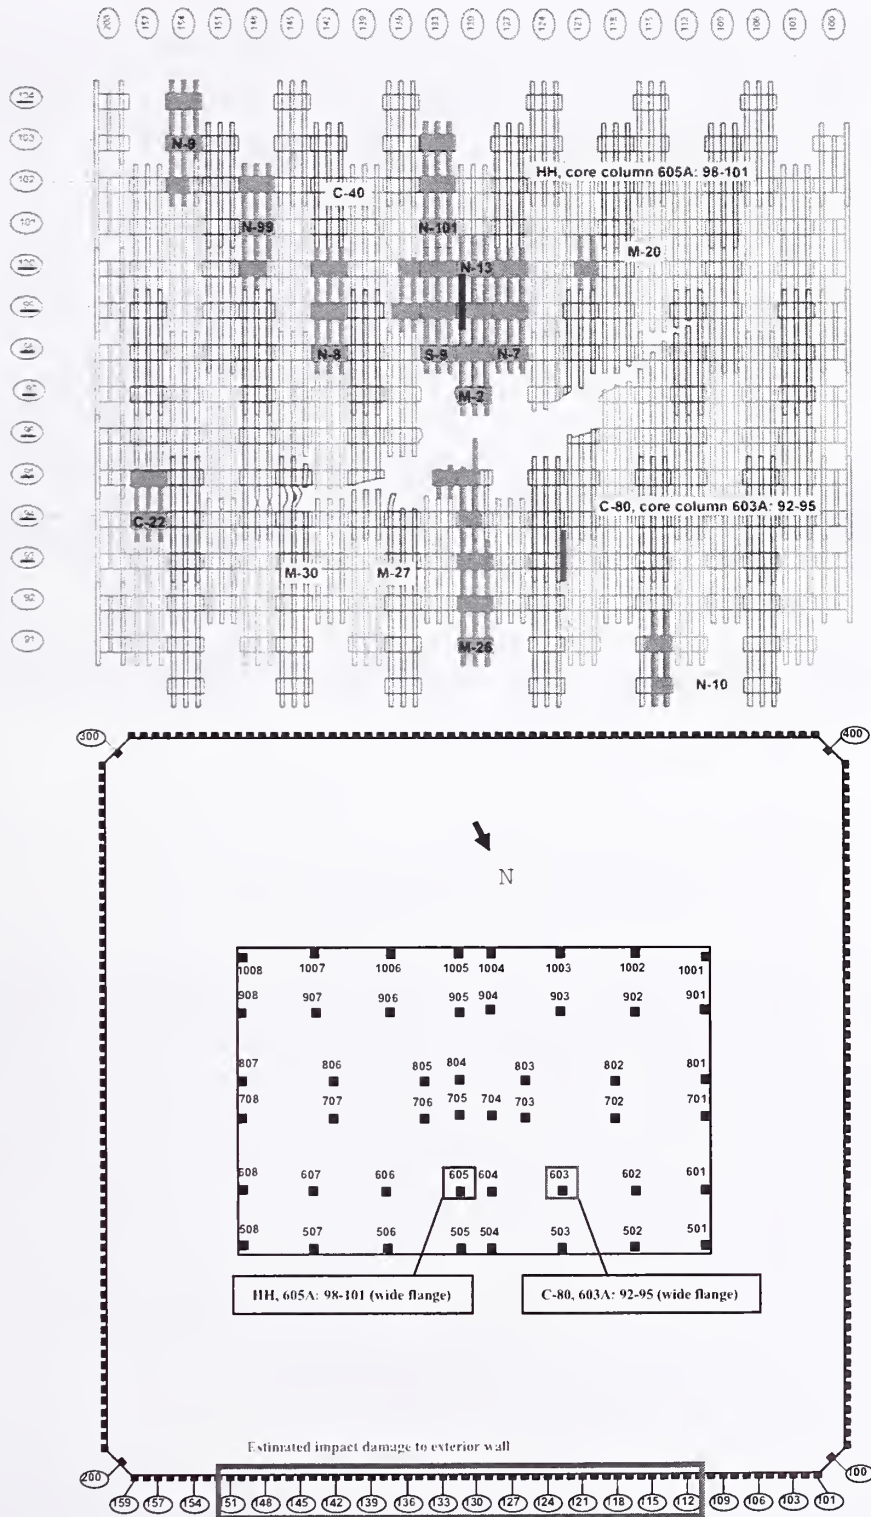
Figure 1-7. Impact damage location and recovered structural elements from WTC 1. Visual evidence of pre-collapse fires was observed on floors highlighted in red.

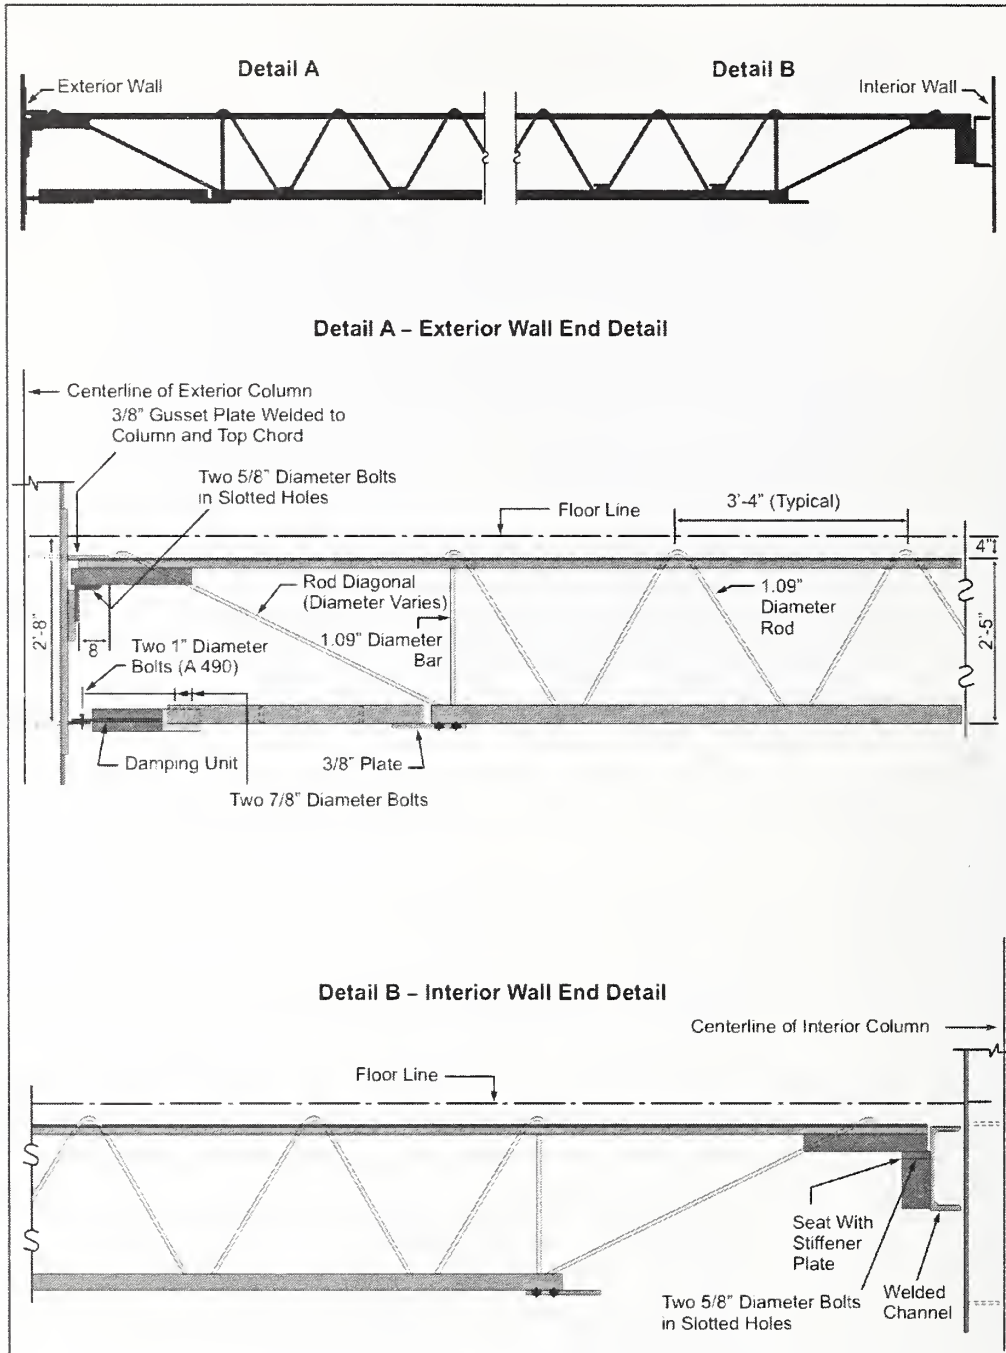
Figure 1-6. b) Schematic showing the attachment of the floor truss to the exterior wall and interior core columns.

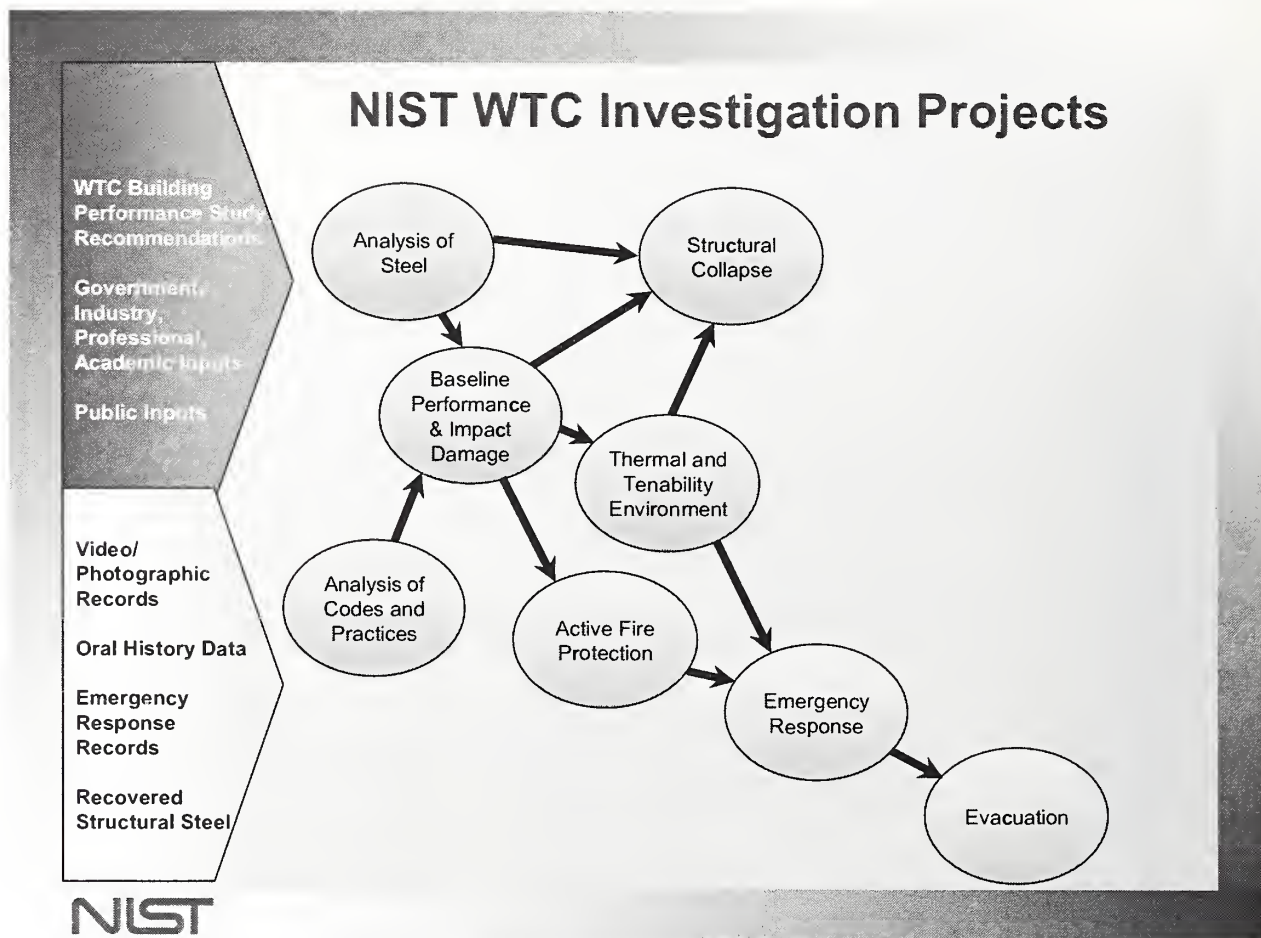
Figure P-1. The eight projects in the federal building and fire safety investigation of the WTC disaster.
