NIST NCSTAR 1-3C

**Federal Building and Fire Safety Investigation of
the World Trade Center Disaster**

Damage and Failure Modes of Structural Steel Components

(Appendices A-G)

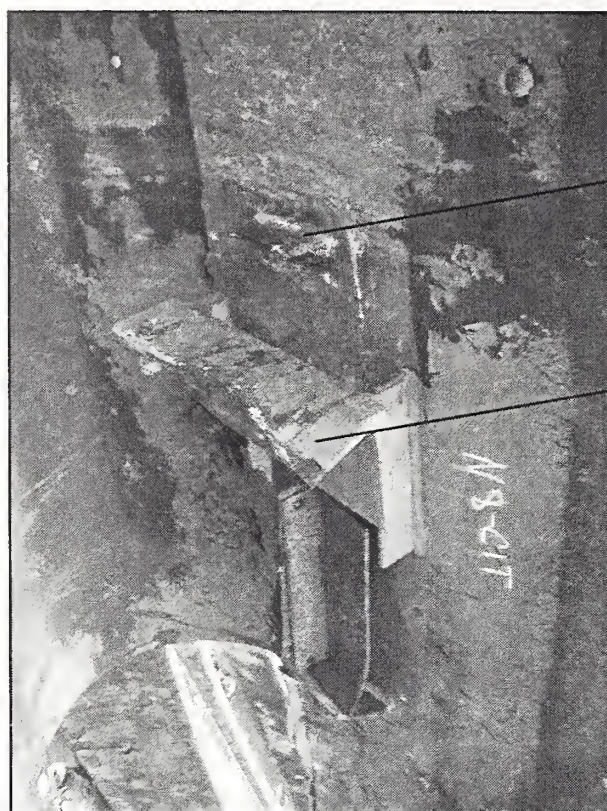
Connection N8-CIT

Portion of welded gusset plate with backing bar

Seat with 2 intact bolt holes for truss attachment

Figure A1a: Type A floor truss connector

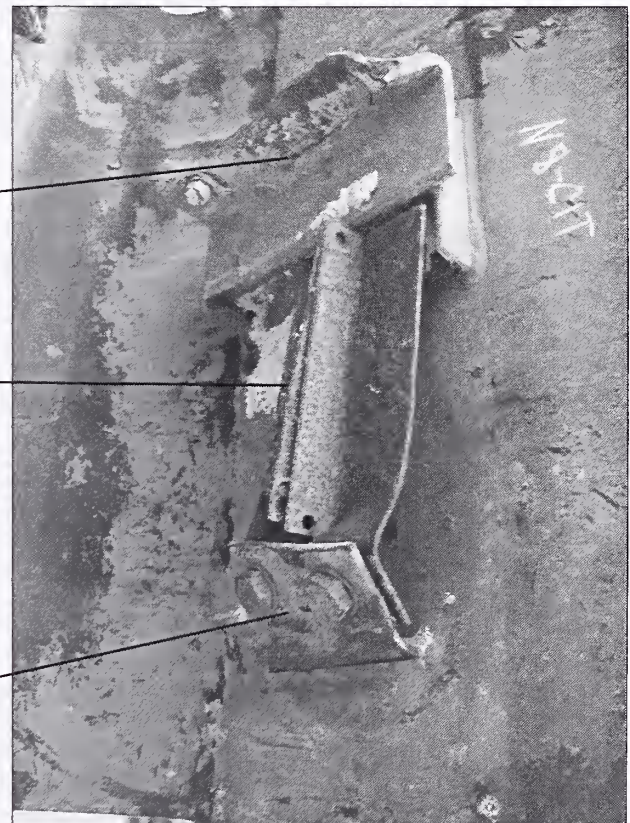
Connection N8-CIT

Damper unit with missing viscoelastic material

Gusset plate for viscoelastic damper unit attachment to column interior

Figure A1d: Type A floor truss connector

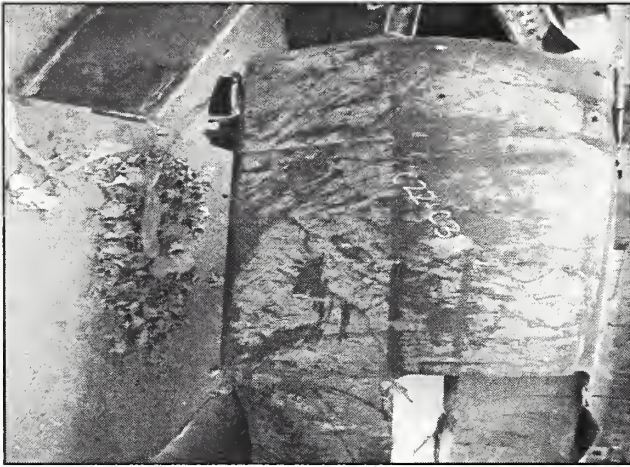
Seat 1: Both holes intact, one has bolt remaining, seat was bent

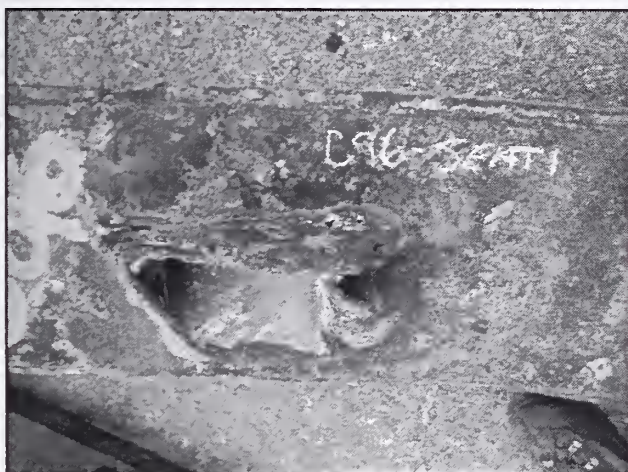
Seat 1: Both holes ripped out, seat appears corroded

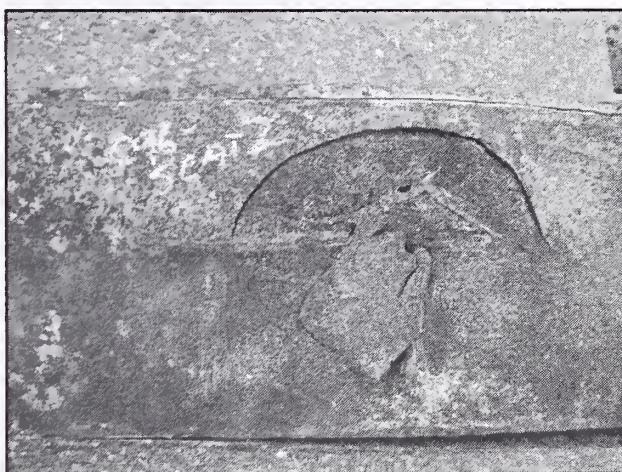
Seat 2: Seat ripped off at welds

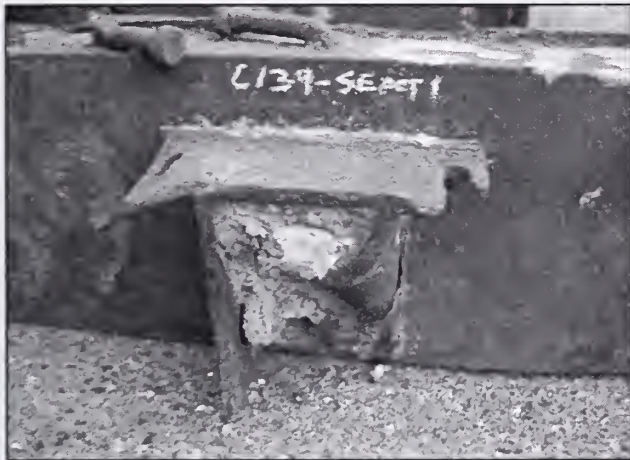
One seat with one hole intact, other ripped out, seat was damaged

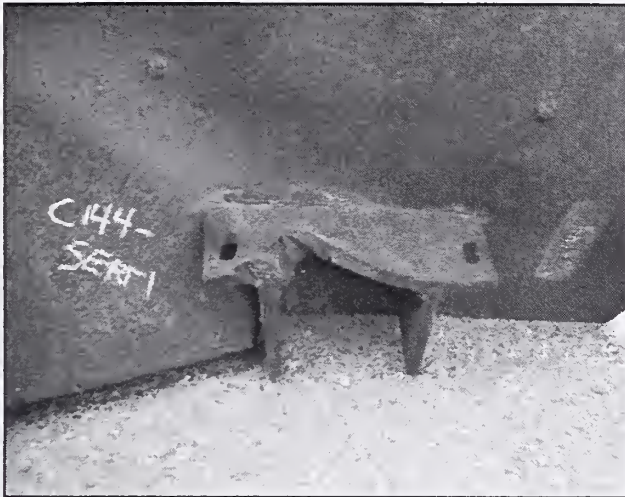
One seat with both holes intact,
seat was damaged

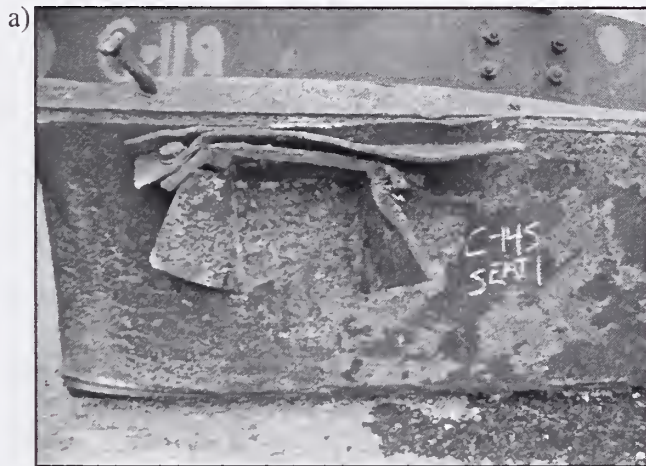
Seat 1: One hole intact with bolt
and angle attached, other ripped,
seat was damaged

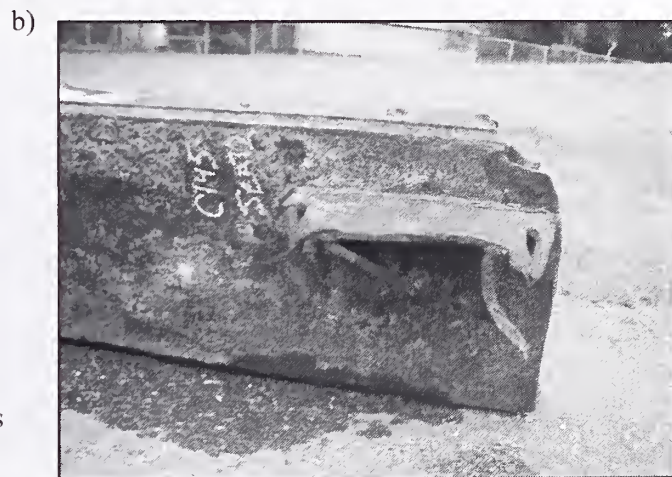
Seat 2: Both holes intact, seat was
bent

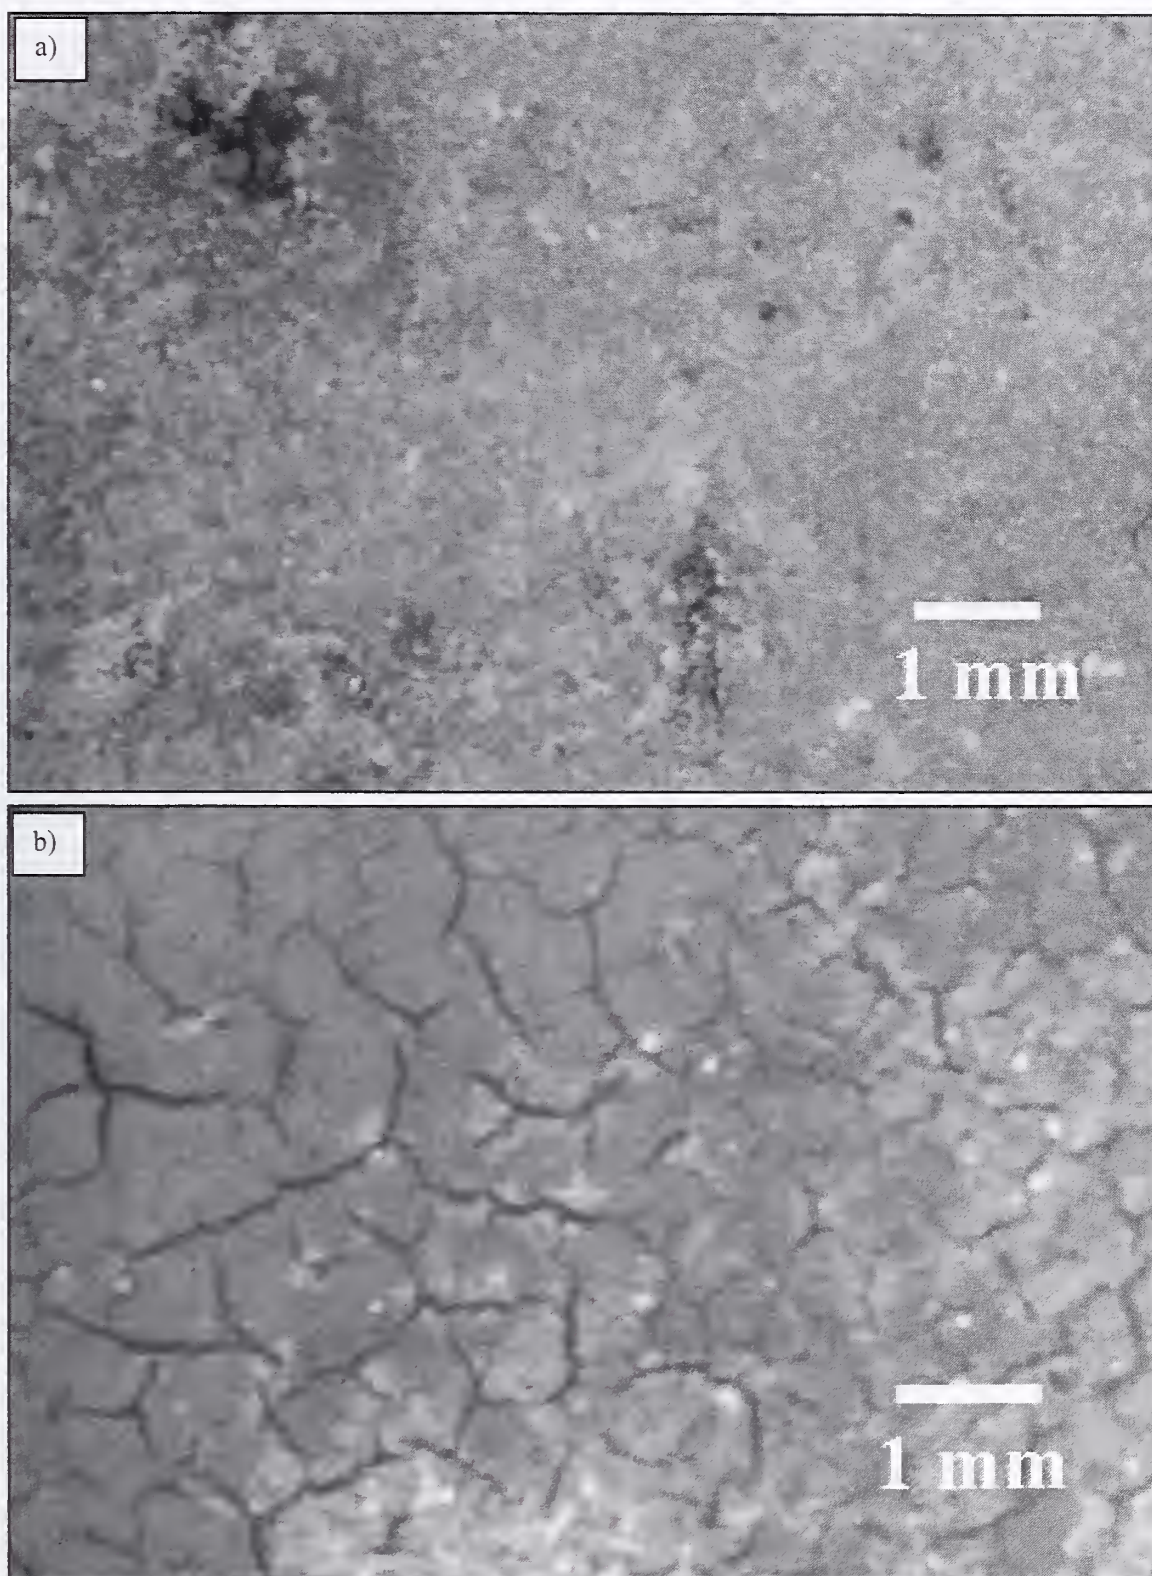
Figure D-1. Photographic images of the primer paint. a) paint in its original condition and b) mud cracking of paint after exposure at 250 °C for 1 h.

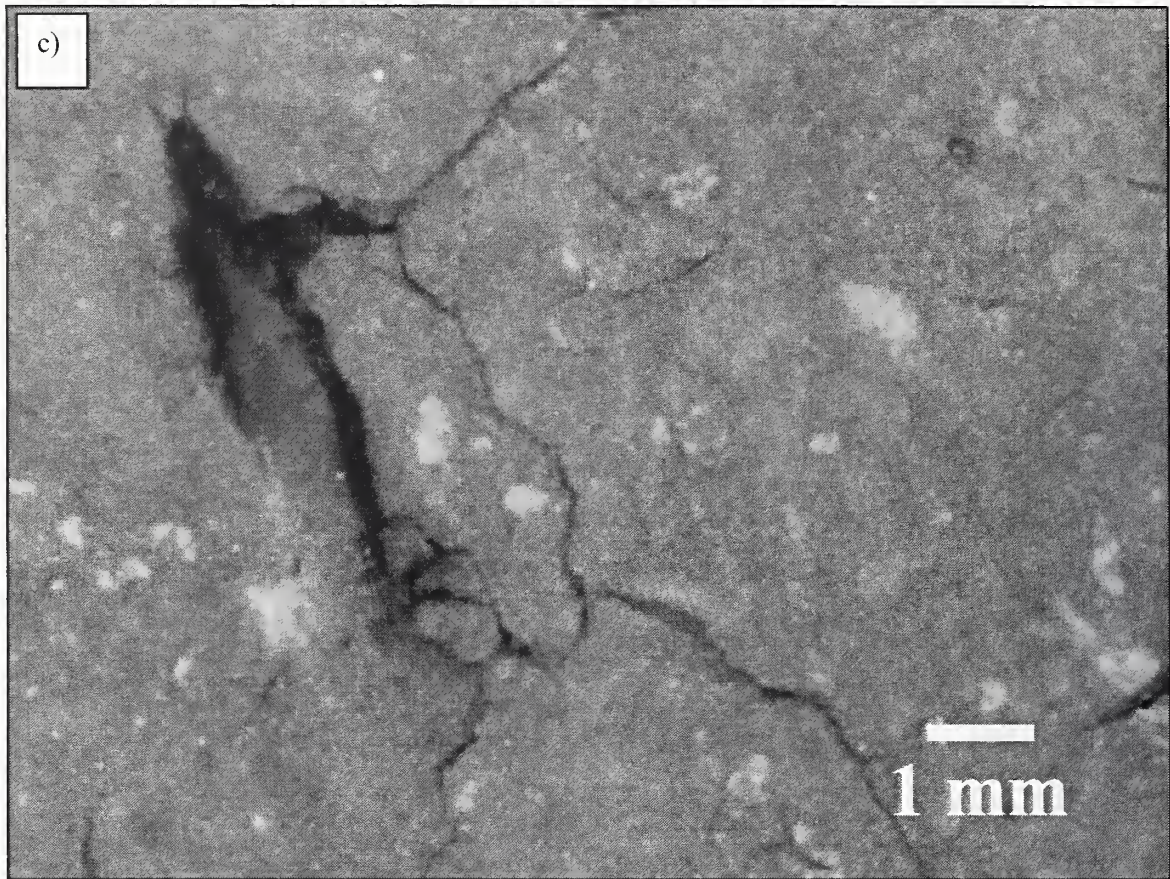
Figure D–2. Photographic images of the primer paint. c) mud cracking of paint after exposure at 650 °C for 1 h.

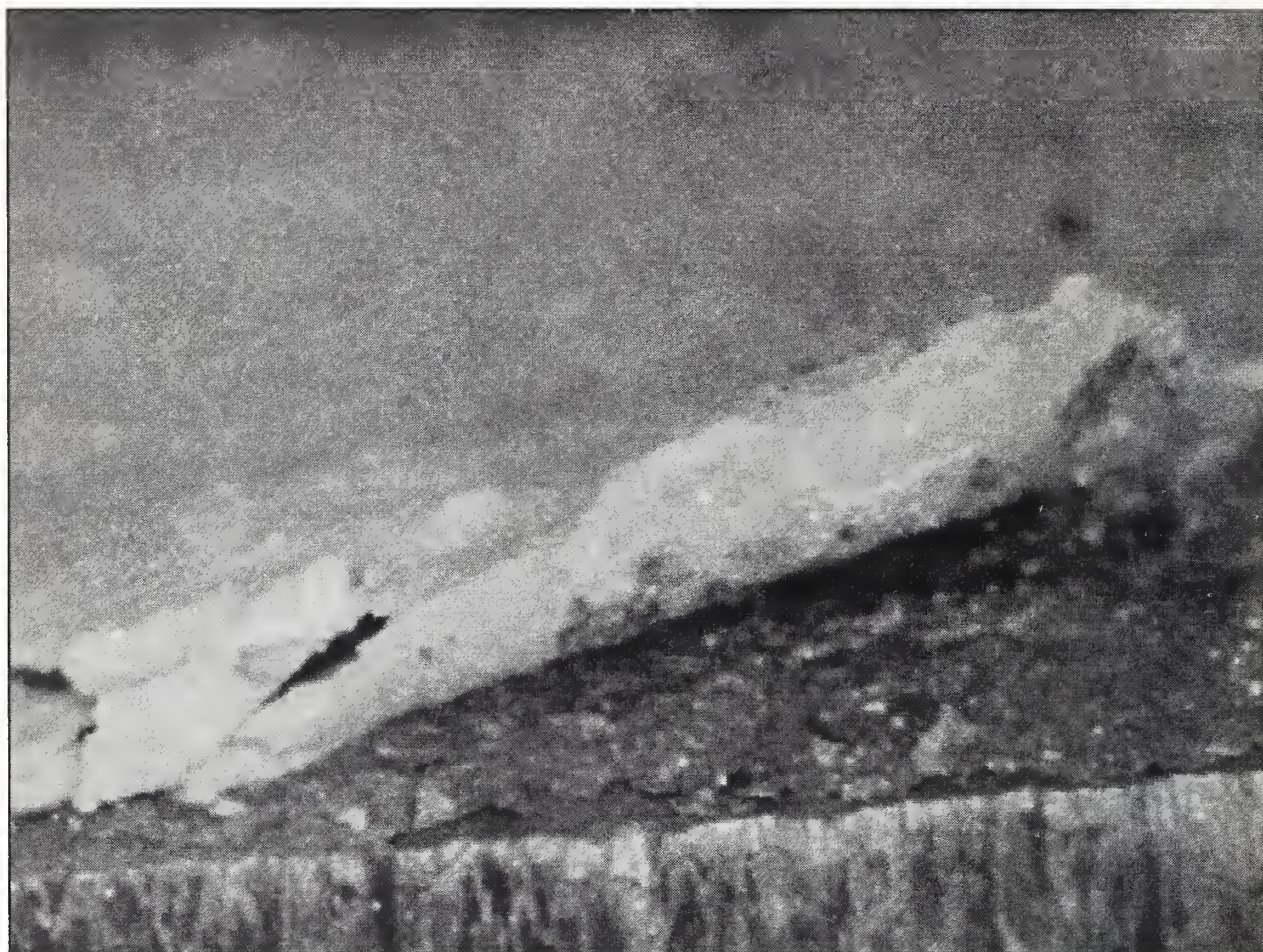
Figure D-4. Formation of a black scale between paint and steel after exposure greater than 650 °C. Paint readily spalled.

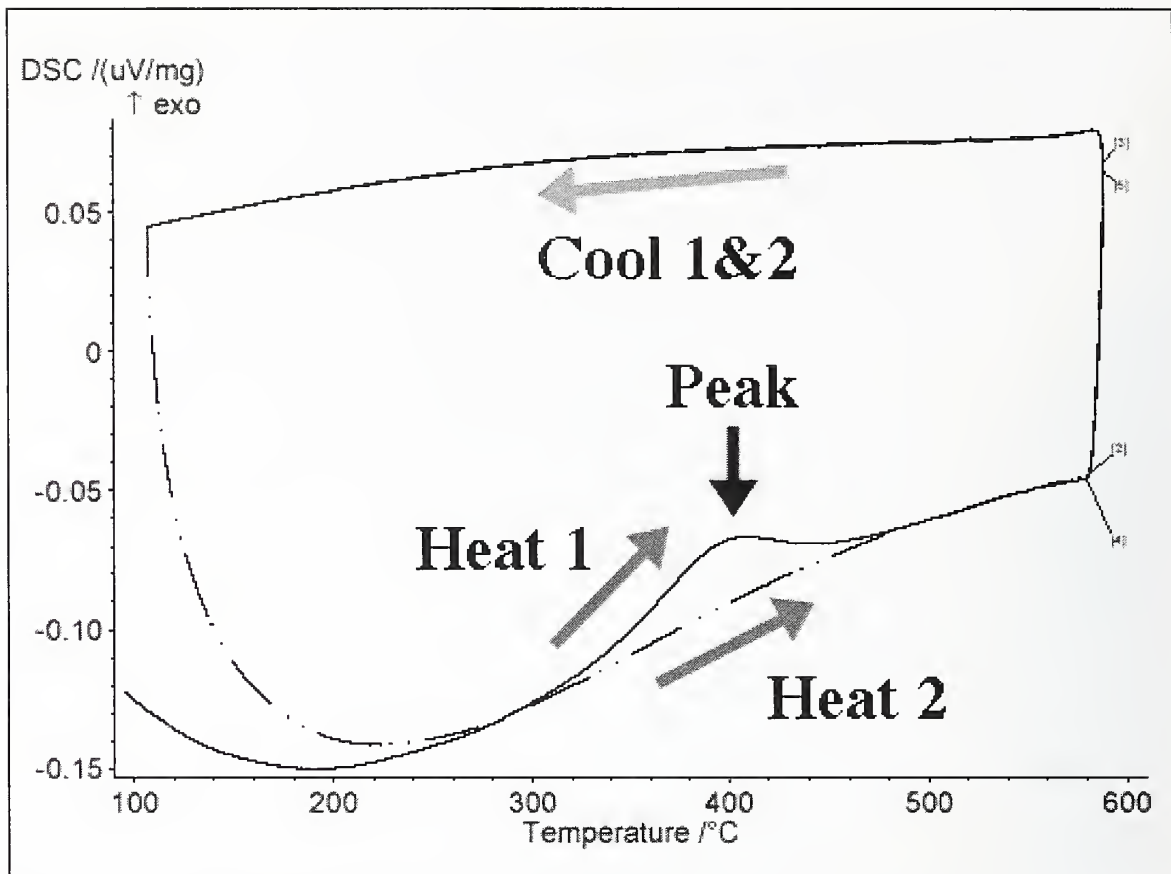
Figure D-6. DTA scans of weld metal taken from panel C-10 (A451: 85-88). First scan shows exothermic peak from non-equilibrium structure. Peak is missing in subsequent scan.

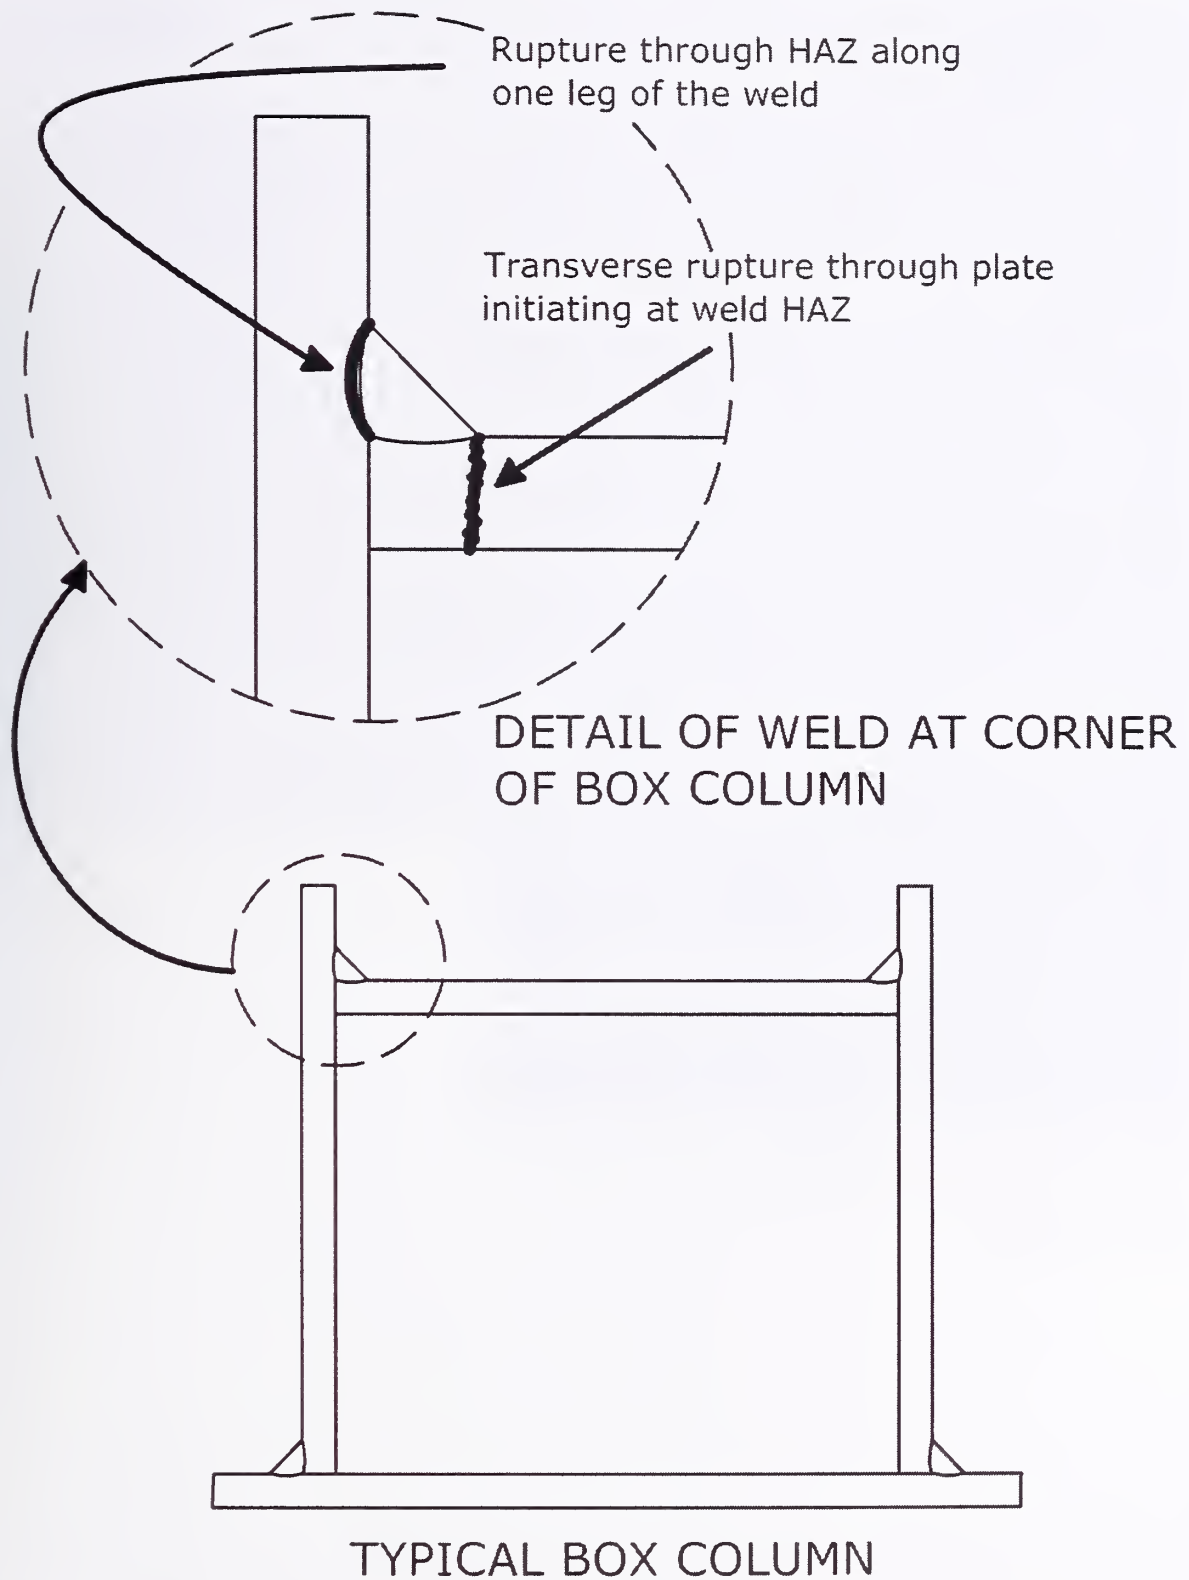
Figure 5. Schematic diagram illustrating fracture paths initiating at heat affected zone (HAZ) of weld.

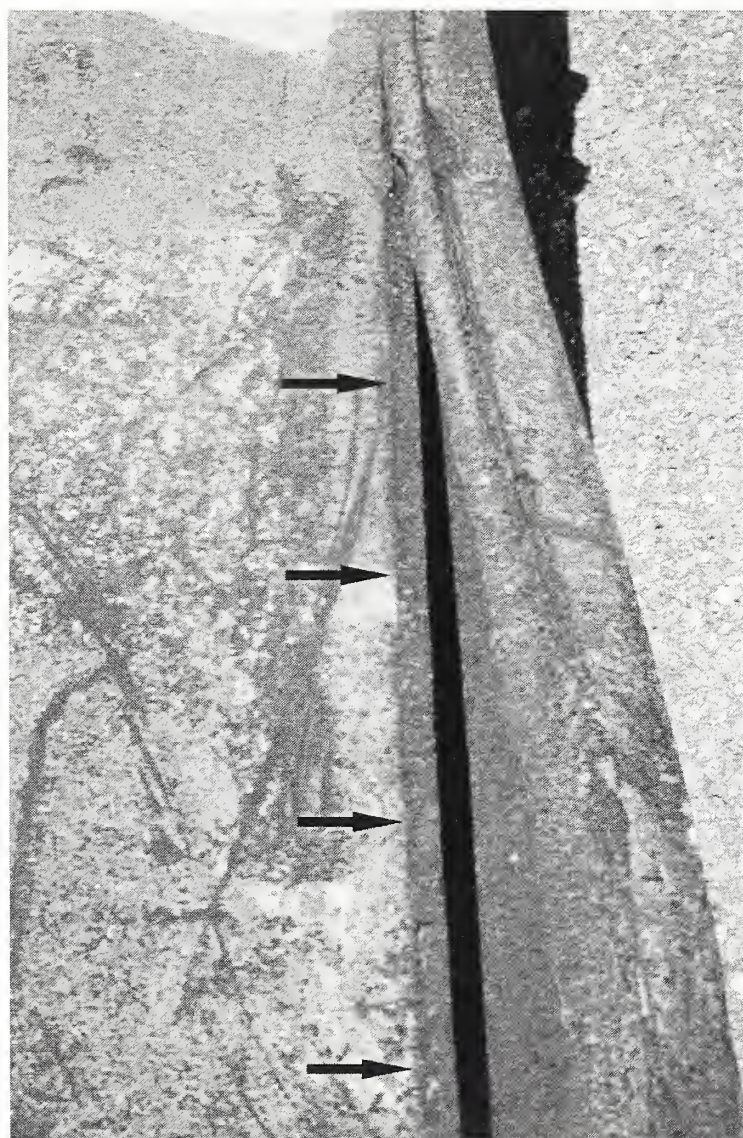
Figure 6. Close view of rupture of fillet weld through HAZ on parent material along a leg of the fillet. Arrows point to fracture surface in HAZ on parent material; the mating fillet weld is at the right.

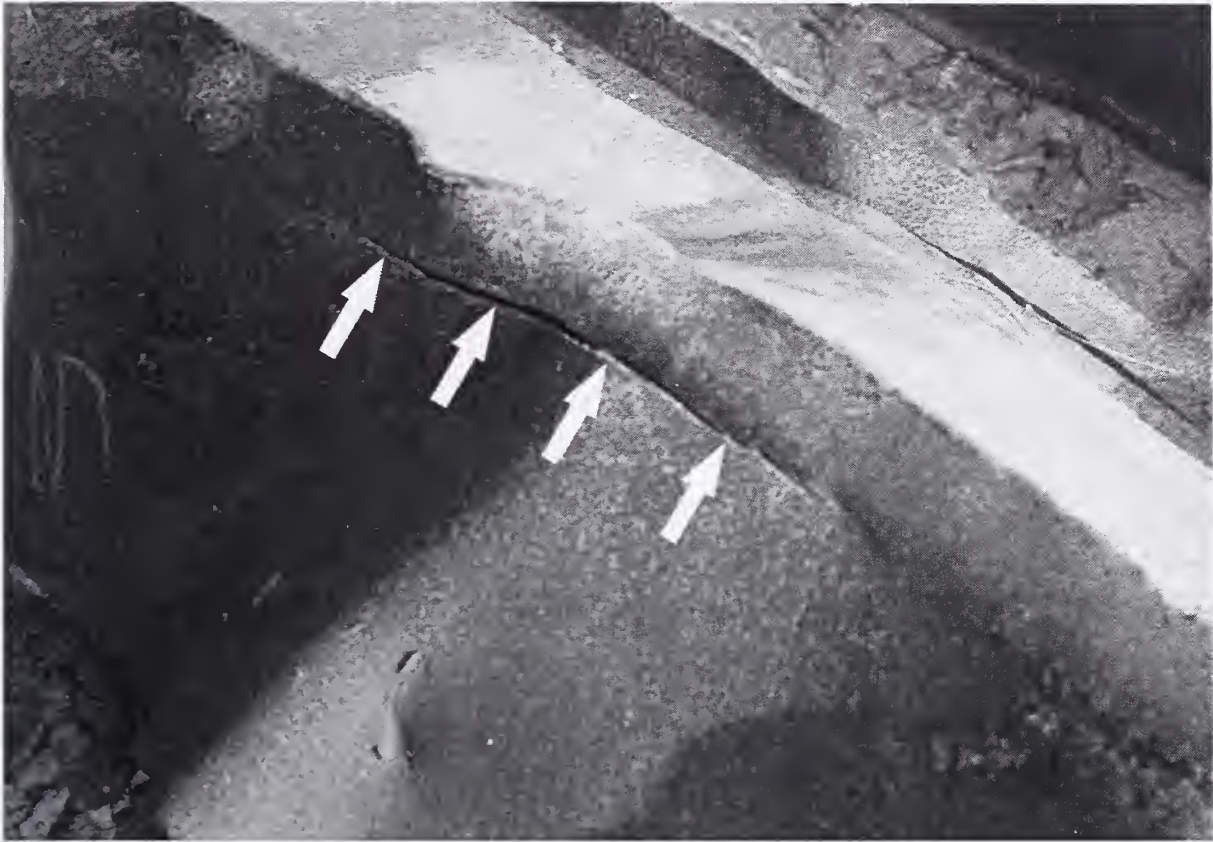
Figure 7. Transverse rupture through the thickness of the parent material, initiating in HAZ at toe of fillet welds

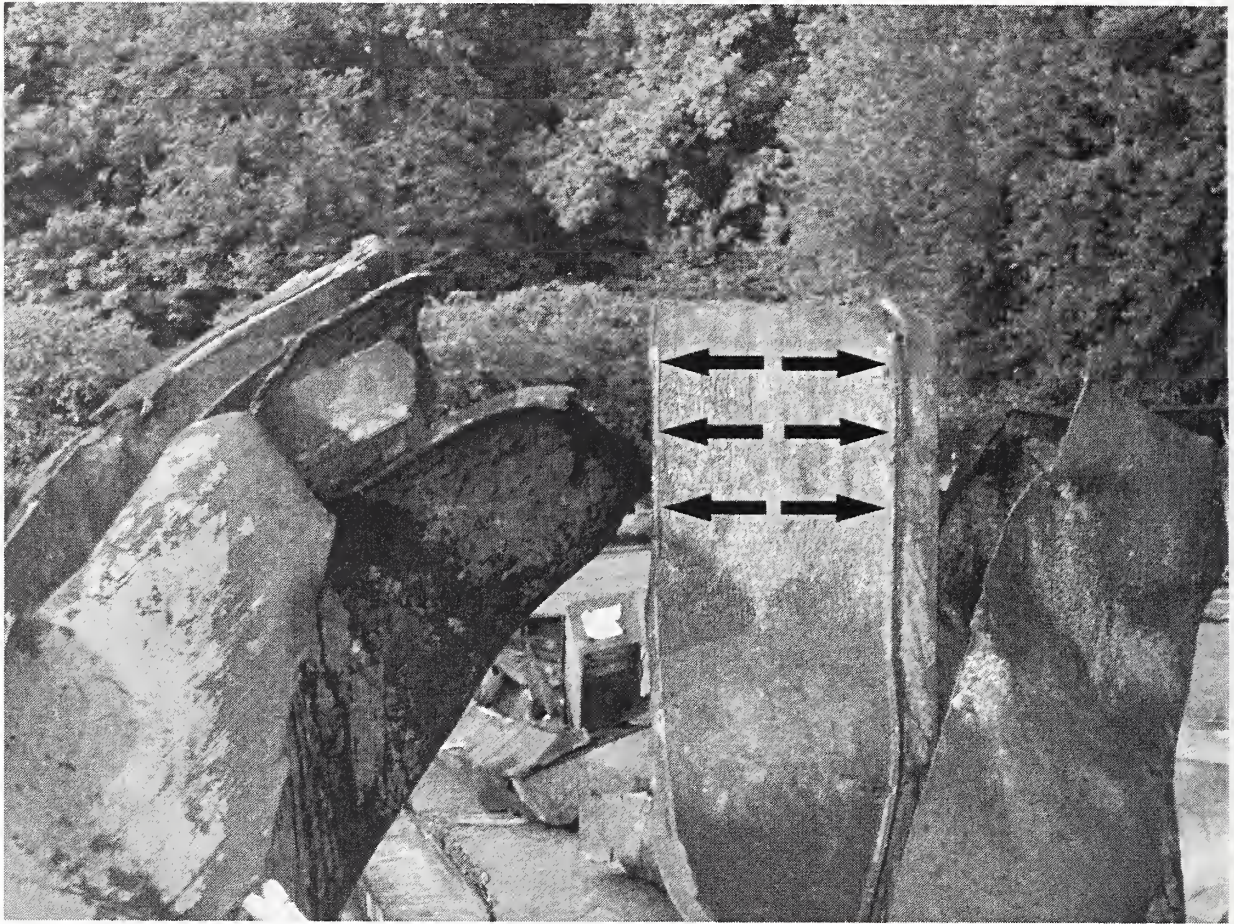
Figure 8. Ruptures of fillet welds through parent material HAZ on impact-effected region of Piece M-2

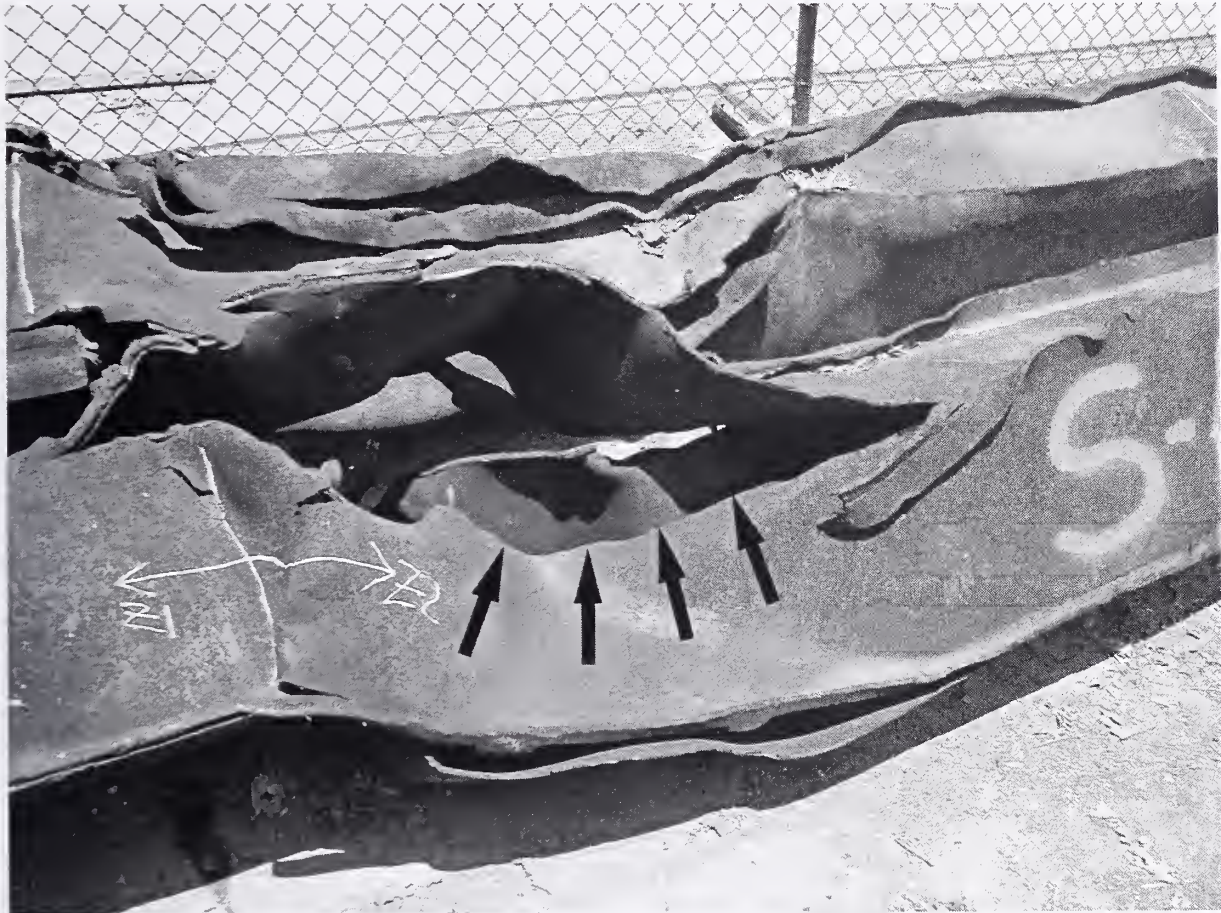
Figure 9. Ruptures of fillet welds through parent material HAZ on possible fire-effected region of Piece S-10

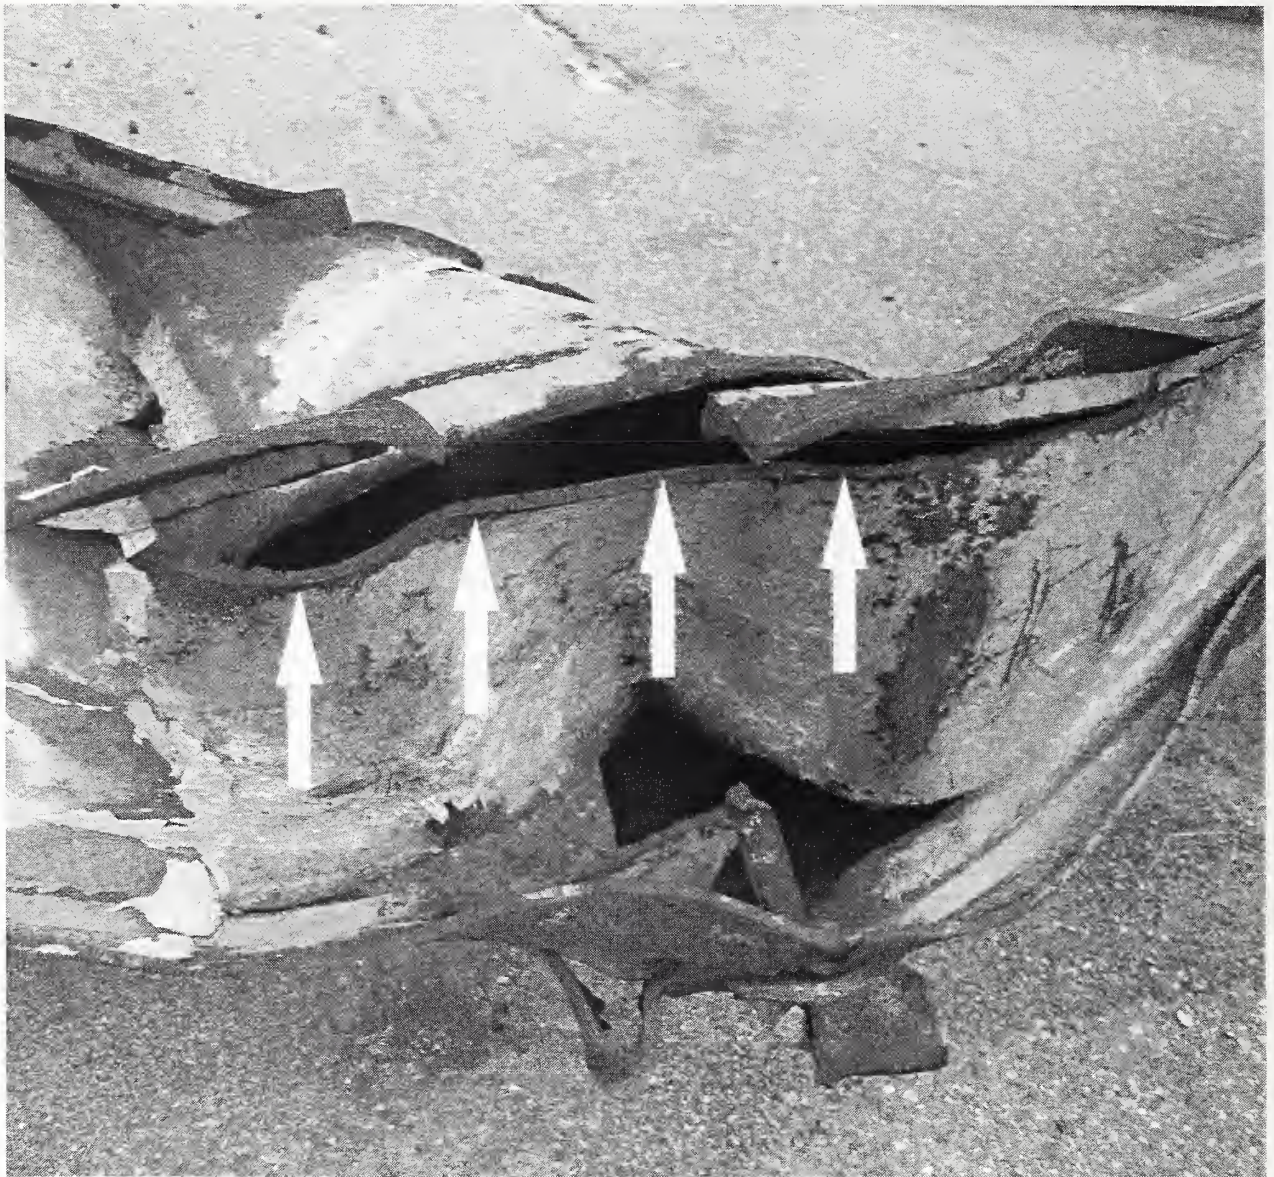
Figure 10. Ruptures of fillet welds through parent material HAZ (at arrows) on probable mechanically pinched zone on Piece C-40 (ruptures through parent material away from welds are also observable in the photo)

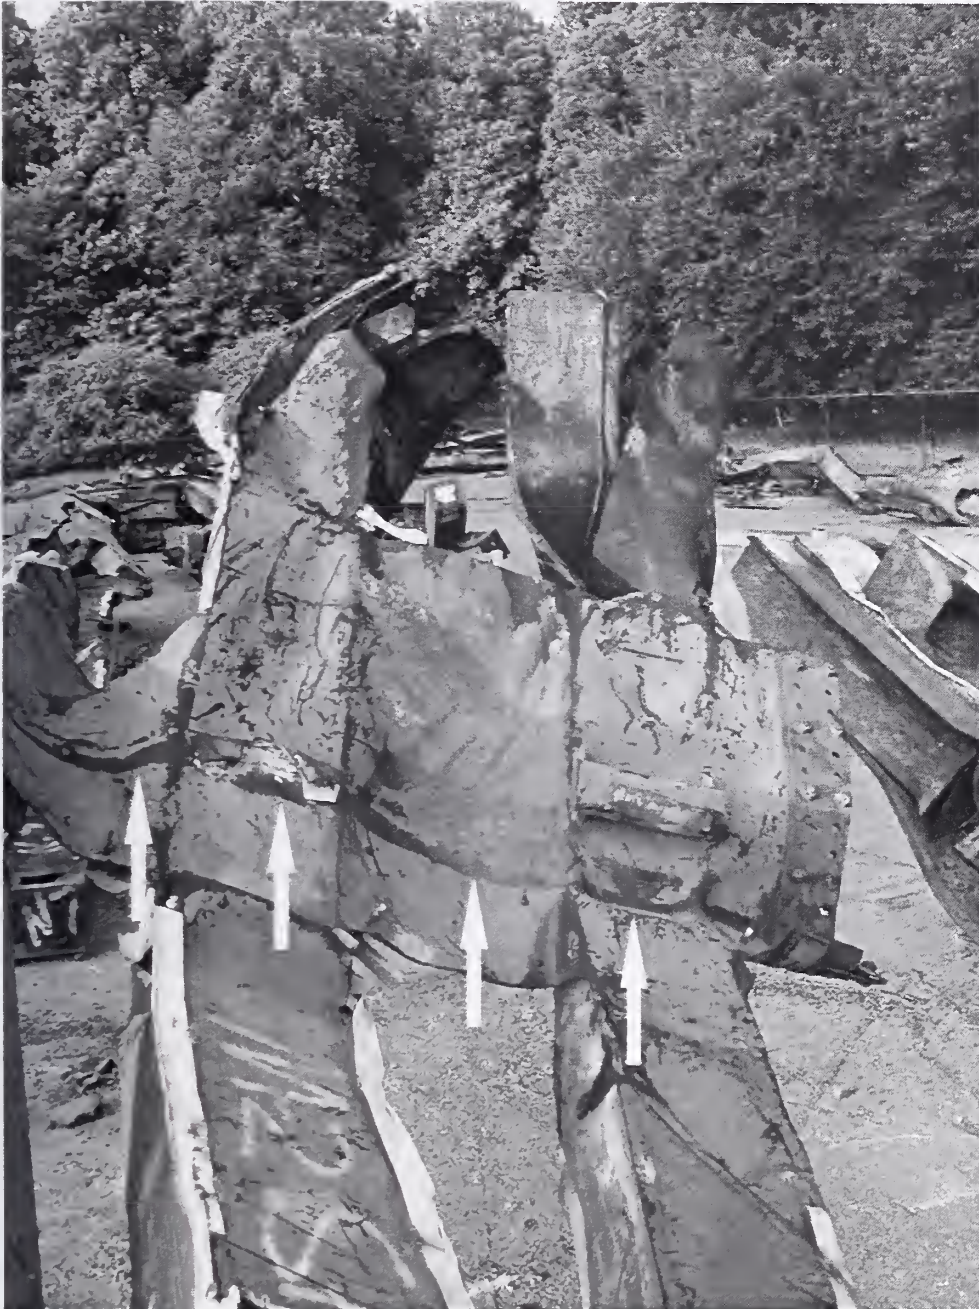
Figure 11. View of Piece M-2, showing inward bend of bottom of piece (at top of photo) about edge of the 97th floor slab (darkened line running left-to-right across spandrel plate, indicated by arrows)

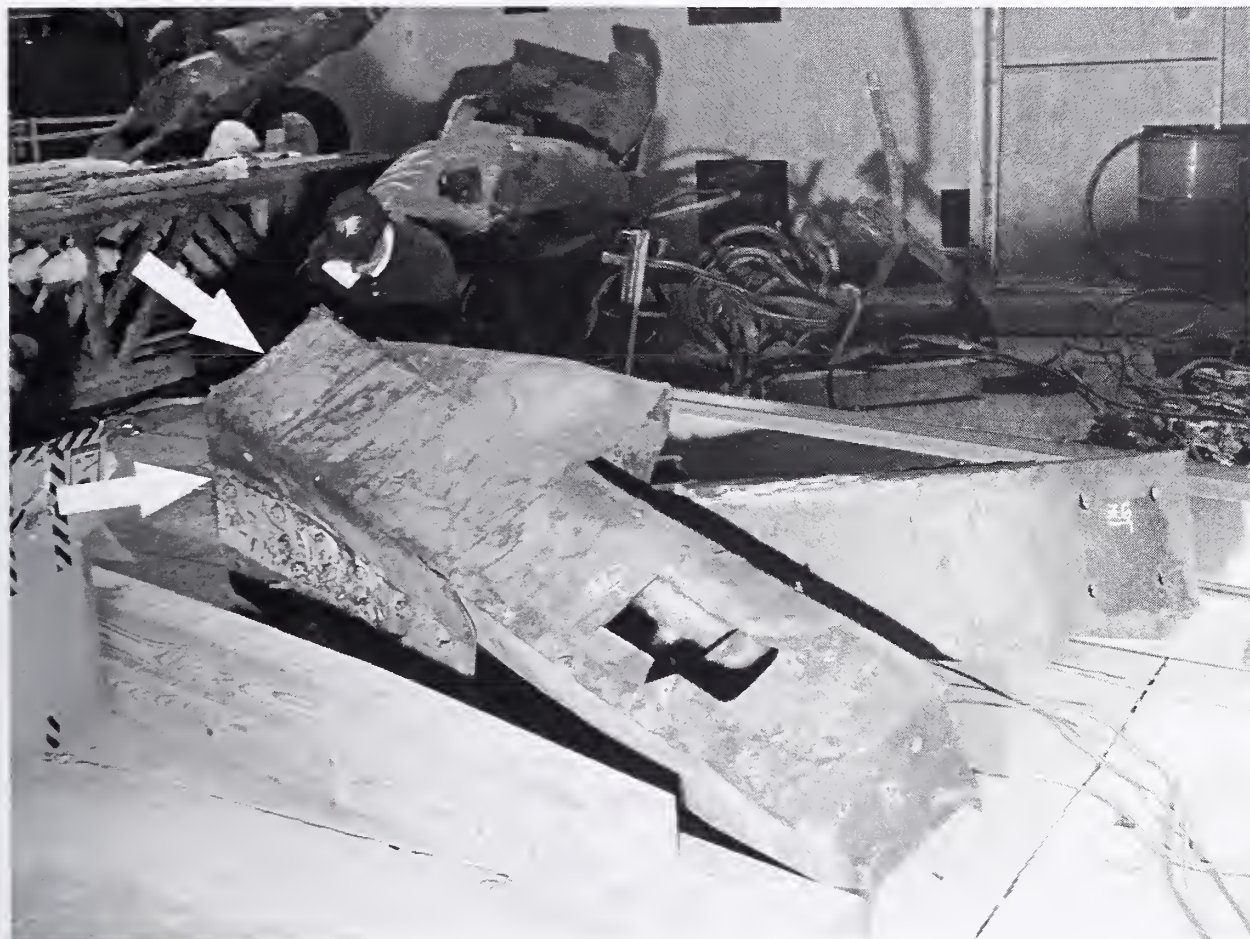
Figure 13. Severed column (at arrows) as observed on Piece M-30.

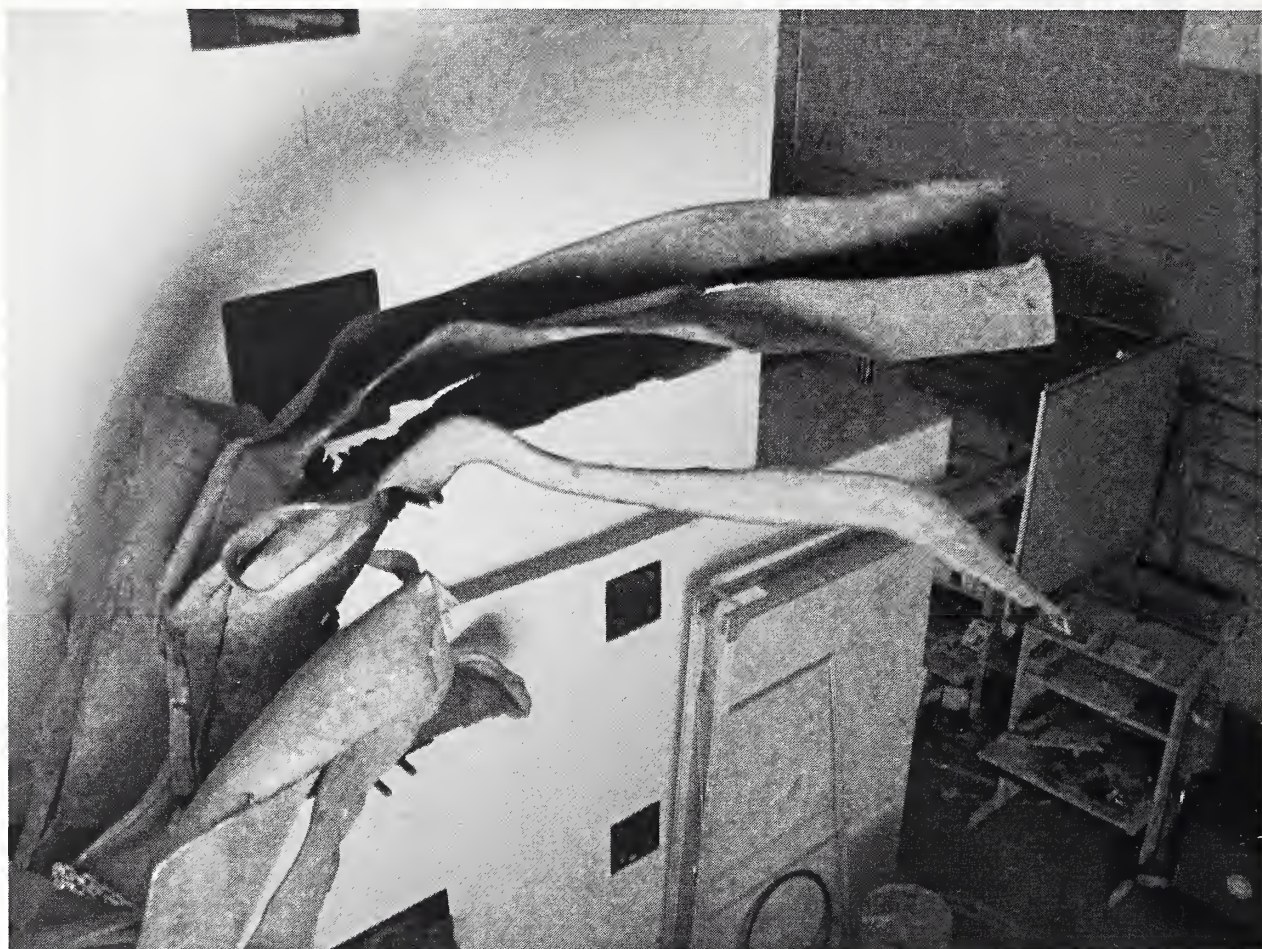
Figure 14. Column elements on Piece M-27 that have decomposed from closed box sections into ribbon-like slender plate elements as a result of the aircraft impact

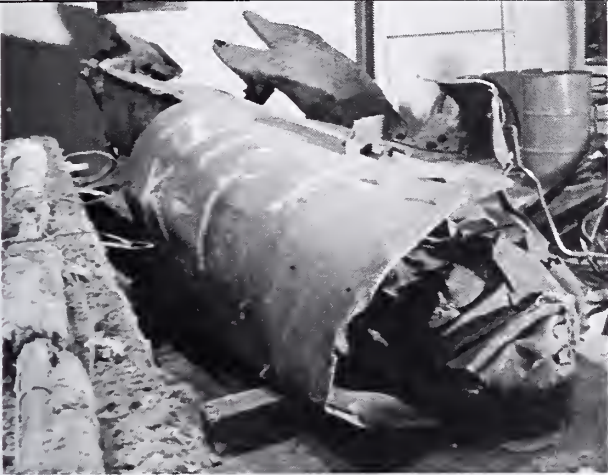
<p>Figure F-A-2a: Piece K-1 (also labeled K-13).</p>		<p>The piece is unique among the recovered steel in that Column 210 (the right-most of the three column, as viewed from inside looking out) has collapsed in compression in an accordion-like manner. No other similarly-collapsed piece is found among the recovered steel that was surveyed. The corresponding upper portions of Columns 208 and 209 are not attached to the recovered piece.</p> <p>While this piece is from floors in WTC 1 that were impacted by the aircraft, this piece is from the east building face (aircraft impact was on the north face). It is therefore unlikely that this piece has been directly impacted by aircraft.</p> <p>The accordion-like collapsed part of Column 210 remains in general concentric axial alignment with the lower portion of the same column, which is relatively undistorted even after salvage and recovery operations. It cannot be readily distinguished whether this failure took place at a high or low rate of loading, whether or not this failure occurred at about the time of collapse initiation; or if the observed condition is a result of impact as the piece fell to the ground. Further study of this piece in detail is needed in order to better understand how this type of collapse occurred.</p> <p>The lower portion of this piece is somewhat intact below the distorted portions of the columns. There are no significant visual indications of fire effects on the lower portion of this piece. However, given the sharp curvature of much of the bent steel in the collapsed portion of Column 3, there is the chance that that portion of Column 3 has been fire affected. Metallurgical examination can be used to determine whether or not the collapsed portion of Column 210 has been fire affected.</p>

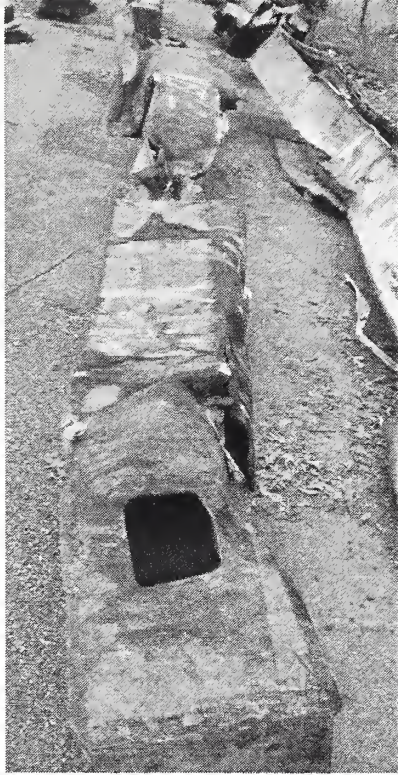
<p>Figure F-A-3a: General view of Piece K 2. Base of column is at bottom of photo.</p>		<p>Partial single column element from an exterior column panel on WTC 1. Piece recovered extends from column splice at 92nd floor to approximately base of windows opening at 94th floor. While this column is from floors where the aircraft impacted the structure, this column was not on the face of the building that was directly impacted by the aircraft.</p> <p>Distinct pattern of possible fire effects observed at windows at floors 92, 93 and 94 (loss of paint; significant section distortion), along with apparent protection of steel from fire effects at spandrels at floors 93 and 94. Pinching of column at 93rd floor window opening (Figure A-8) is most likely a result of post-collapse handling and recovery.</p>

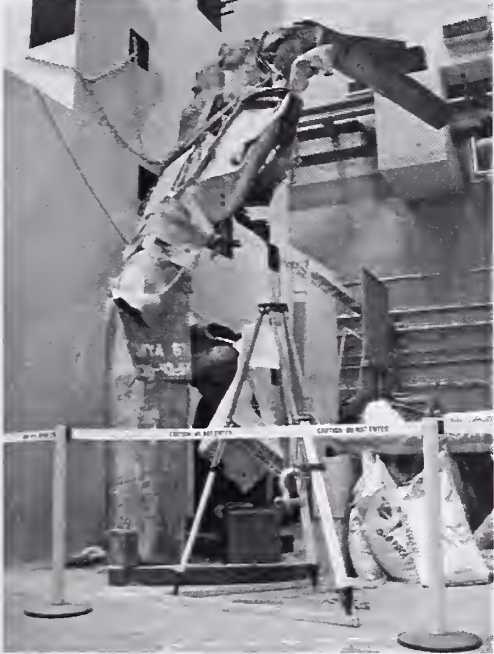
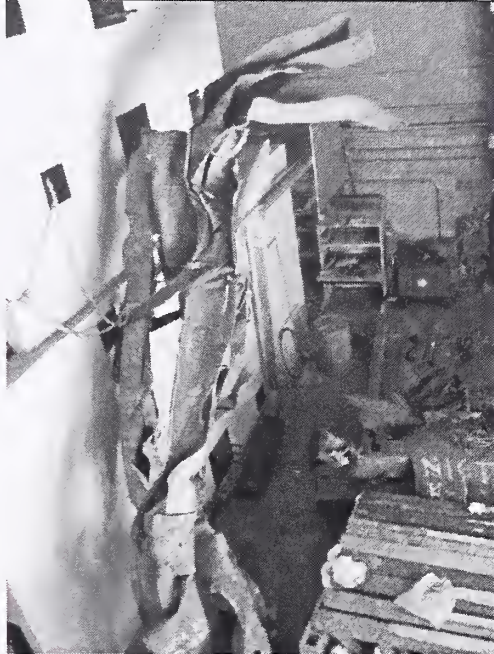
<p>This exterior column panel from WTC 1 was directly impacted by the aircraft at its upper end. In the impact-affected area, the column elements have typically decomposed from their original four-sided, closed rectangular box shape into four ribbon-like, thin rectangular plate elements. It is likely that the welds at the corners of the box shape, originally joining the four face plates together, ruptured as a result of the aircraft impact. The rupture of these welds likely took place at a high rate.</p> <p>The middle column in the panel has been sheared off at the line between the top of the 95th floor window and the bottom of the 96th floor spandrel element. The fractures at the severed ends of the plates that make up this column element would likely have happened at a high rate of loading as a result of aircraft impact.</p>

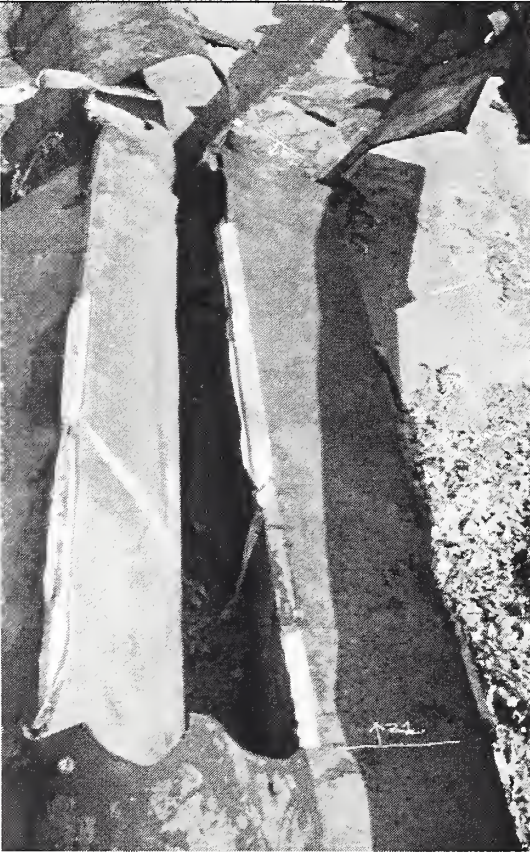
<p>Figure F-A-9b: Fracture at column edge in 95th floor spandrel plate.</p> <p>While this piece is from the floors in WTC 1 that were impacted by the aircraft, this piece is from the building face to the left side (orientation of aircraft travel direction) of the impact face. It is unlikely that this piece has been directly affected by aircraft impact.</p> <p>The paint is missing from approximately the upper two-thirds of the inside faces of the columns adjacent to the 94th floor window openings. (The 94th floor window openings have been marked as Zone Z1.) This loss of paint is consistent with flames of an interior fire exiting through the window openings. Given proximity of this piece to the aircraft impact, it is likely that the observed loss of paint is due to fire following impact.</p> <p>Near the top of the window openings, the columns are severely distorted (marked as Z2 on the piece), suggesting a local buckle or local failure in the column at this location. The corner welds that join the column face plates together have typically ruptured at this distorted region.</p> <p>Similar patterns of loss of paint at window openings and probable local buckles in column elements at the top of window openings were also observed adjacent to the 93rd floor window openings. (The piece has become folded in half at the top of the 93rd floor window openings.) The 92nd floor, however, does not exhibit these patterns.</p> <p>The 95th floor spandrel plate was fractured vertically along the edge of the middle column. Fracture is through the parent material but has likely initiated at the heat affected zone of the weld. Fracture probably occurred during collapse.</p>
