NIST NCSTAR 1-3C

**Federal Building and Fire Safety Investigation of
the World Trade Center Disaster**

Damage and Failure Modes of Structural Steel Components

(Appendices A-G)

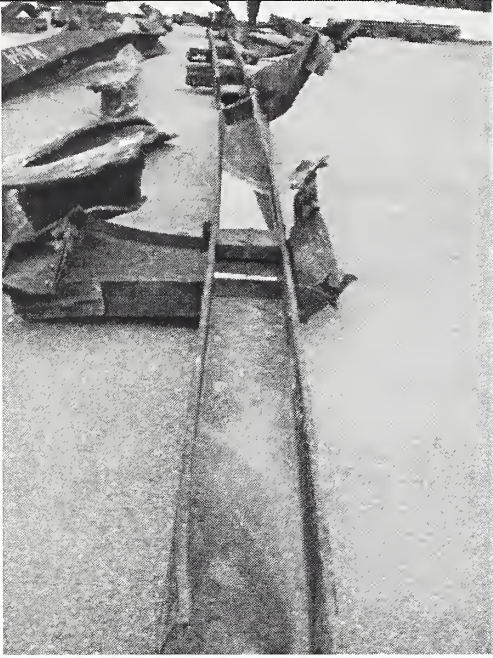
<p>Figure F-C-2a: Piece C-42.</p>		<p>Two-story wide flange column piece probably from a structure other than WTC 1 or WTC 2.. The column piece itself exhibits a twist about its longitudinal axis. This column piece exhibits generally more distortion than other pieces reported in this appendix.</p> <p>The connections at the free ends of the beam stubs that frame into the column exhibit bolt tear-out failures. The bolt tear-outs are generally directed parallel to the longitudinal axes of the beam stubs, suggesting that the beam stubs were in axial tension at the time of tear-out.</p> <p>The outstanding ends of the beam stubs exhibit probable fire effects as evidenced by the character of the distortions at the outstanding ends.</p>

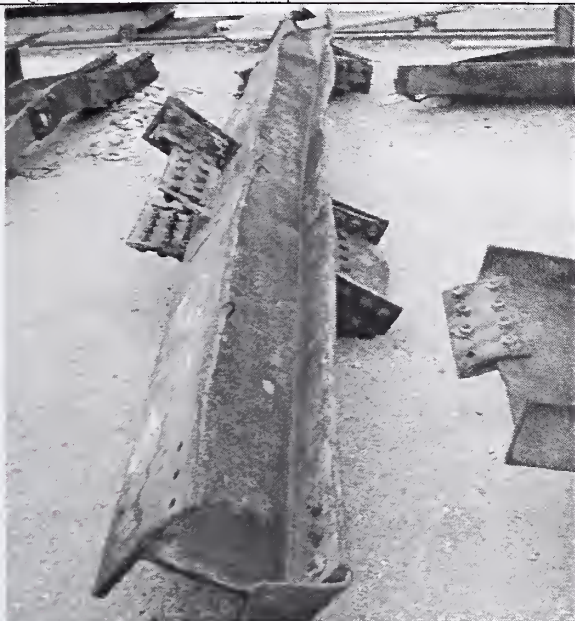
<p>Figure F-C-3a: Piece C-72 overall view.</p>		<p>Wide flange shape believed to be a two-story column probably from a structure other than WTC 1 or WTC 2..</p> <p>Remnants of wide-flange beams frame into strong axis side of the column. On one side of the column, the beams appear to have deflected downward and have fractured in block shear through web and top flange. Bottom flange connection plate has been torn out at weld of connection plate to face of column.</p> <p>The connections on the opposite side of the column appear to have fractured in net tension, with the line of fracture passing through the net section at bolt holes in the beam flanges. This fracture is consistent with a fracture in direct tension.</p> <p>This piece was not visually assessed for fire effects.</p>

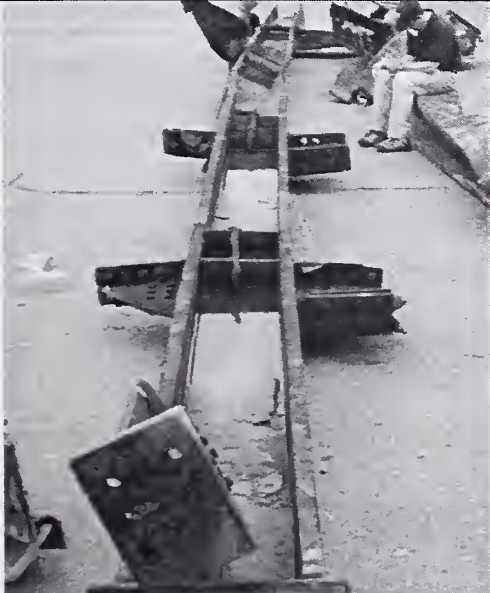
<p>Figure F-C-5a: Overall view of Piece C-85. (Note: Piece C-66 lies beyond Piece C-85 at top of picture.)</p>		<p>Wide flange shape probably from a structure other than WTC 1 or WTC 2.</p> <p>Remnants of probable diagonal or lateral braces frame into weak axis plane of the column.</p> <p>Remnants of wide-flange beam stubs frame into strong axis side of the column. On one side of the column, the beams appear to have deflected downward and have fractured in net tension through top flange at bolt holes and have torn out through web. Bottom flange connection plate has torn out in tension at weld of connection plate to face of column.</p> <p>The connections on the opposite side of the column require further study. While these beams appear to have fractured in tension, the line of probable fracture passes through the gross section, not the net section through bolt holes in the beam flange. This probable fracture is not consistent with a fracture in direct tension that would be expected to pass through the net tension sectional area.</p> <p>The column base connection plate has fractured in half, probably as the column deflected out-of-plane (weak axis bending plane) during collapse. A fragment of probable floor deck concrete remains in place just above the column base connection plate.</p> <p>Did not visually assess for fire effects.</p>
