NIST NCSTAR 1-5

Federal Building and Fire Safety Investigation of the World Trade Center Disaster

Reconstruction of the Fires in the **World Trade Center Towers**

September 2005

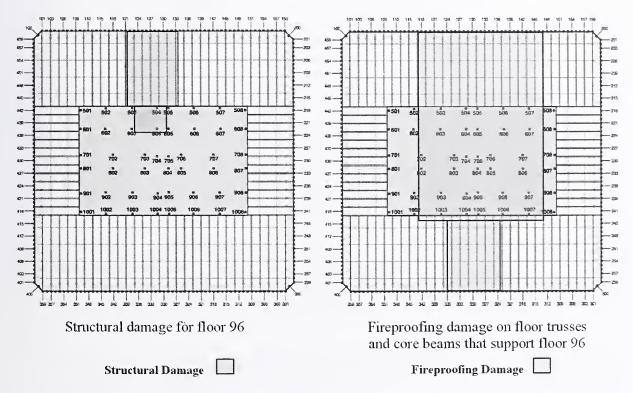
Figure E-3. Structural and insulation damage to floor 96 of WTC 1, Case B.

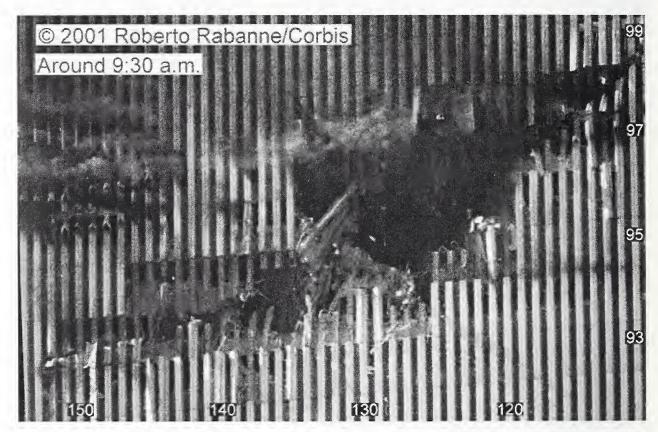
Figure 2–2. Photograph of the north face of WTC 1 around 9:30 a.m. showing the area damaged by the aircraft strike.

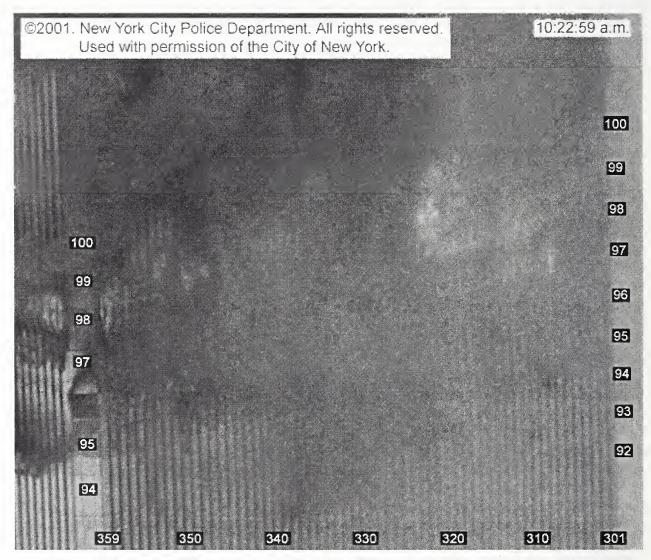
collapse, the line of fire on the 98th floor continued to burn vigorously. The fire on the 99th floor appeared to intensity and move towards the east, eventually reaching a location more than half way between the center of the face and the east edge. When WTC 1 began to collapse, a large amount of flame was pushed from openings on the south face with flames appearing to come from three separate locations. The first was from the vicinity of the intense fire burning on the east sides of the 98th and 99th floors, the second was from the fire burning on the western edge of the 94th floor, and the third came from around the center of the face near the 94th floor.

Figure 2–3. View of the south face of WTC 1, cropped from a photograph shot from a helicopter at 10:22:59 a.m. It has been enhanced by adjusting the intensity levels, and column and floor numbers have been added.

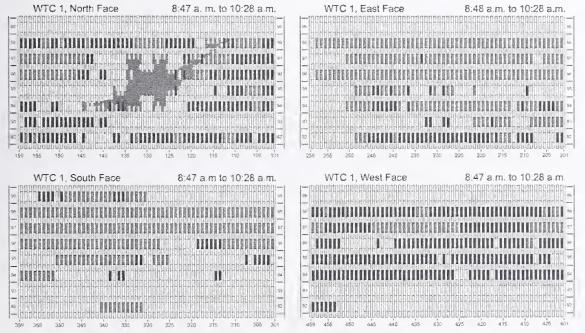
Fire growth and spread in WTC 1 was extensive during the 102 min between the aireraft impact and collapse of the tower. Figure 2–4 shows the results for the four faces of integrating the fire observations over the entire event. Extensive fires were observed from the 92nd to 99th floors. (Note that fires were also present on higher floors, including the intense fire on the south side of the west face of the 104th floor.) Fire seems to have spread over almost all of the 96th to 98th floors, while unburned areas were still present on lower floors. The largest unburned areas seem to have been on the 93rd and 95th floors.

Note: Color coding—white, no fire; yellow, spot fire; red, fire visible inside; orange, external flaming.

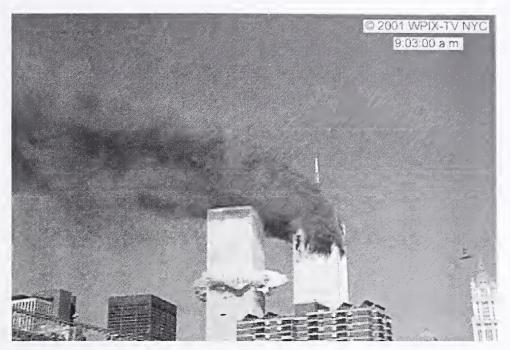
Figure 2–5. The nascent fireballs and dust clouds formed on WTC 2 1.2 s after the aircraft struck WTC 2.

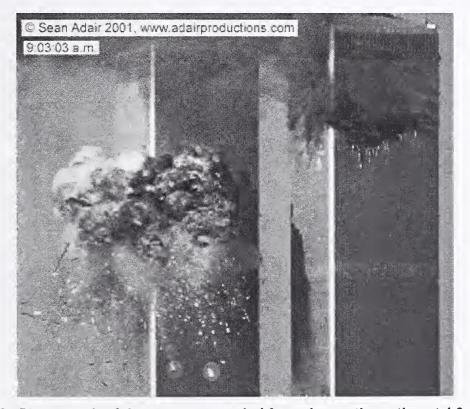
Figure 2–6. Photograph of the towers recorded from the north-northeast 4.3 s after the aircraft struck WTC 2.

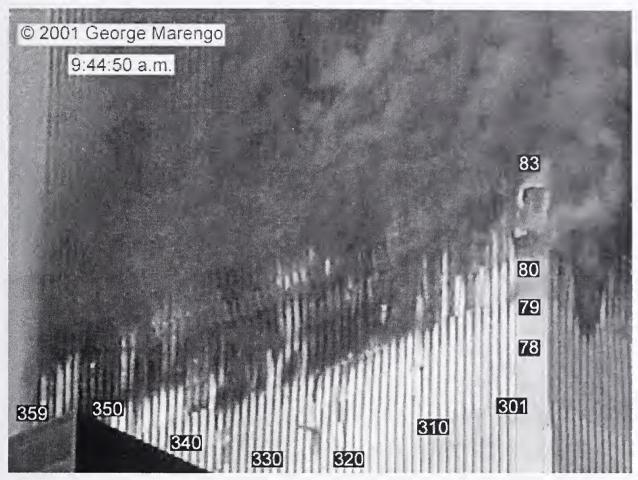
down and that some intermediate portions had disappeared from view. The windows where the object first appeared below the 83rd floor spandrel had moved further toward the edges of the tower on both the north and south ends. Figure 2–10 shows a photograph of the east face taken just before 9:45 a.m. during a period when there was very little smoke flow from the face. Closer inspection reveals that the columns near the center of the east face on the 80th and 81st floors were bowed inward. Similar bowing was identified in other images starting as early as 9:22 a.m.

Figure 2–10. Photograph was shot from the northeast, showing east face of WTC 2 at 9:44:50 a.m. The original intensity levels have been adjusted, and column and floor numbers have been added.

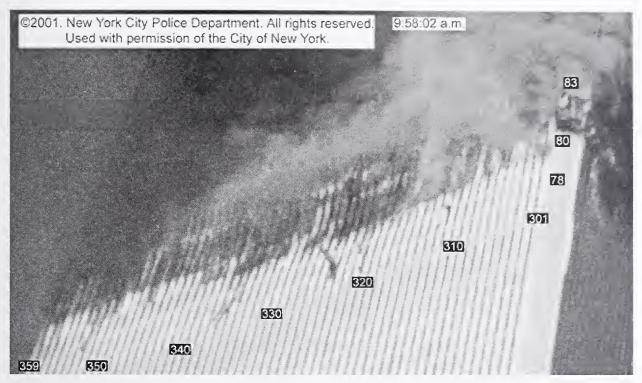
windows on the 82nd floor moved again, with the northernmost window where it first became visible shifting slightly to the north. A prominent feature on the east face during the period was the inward bowing of the outer wall. This can be seen clearly over the 79th to 82nd floors in Figure 2–11, which was taken less than a minute before the collapse started. During the 20 s prior to the collapse a large number of pieces of debris fell from the northern sides of the 80th and 81st floors. The falling debris coincided with a heavy flow of molten metal from the north face. When WTC 2 collapsed very little flame was expelled from the east-face windows. Based on observations elsewhere on the two towers, regions of intense burning would have been expected to generate short-lived jets of flames. Their absence suggests that large fires were not burning near the face at the time of collapse.

Figure 2–11. Cropped photograph of the east face of WTC 2 at 9:58:02 a.m. The intensity levels have been adjusted, and column and floor numbers have been added.

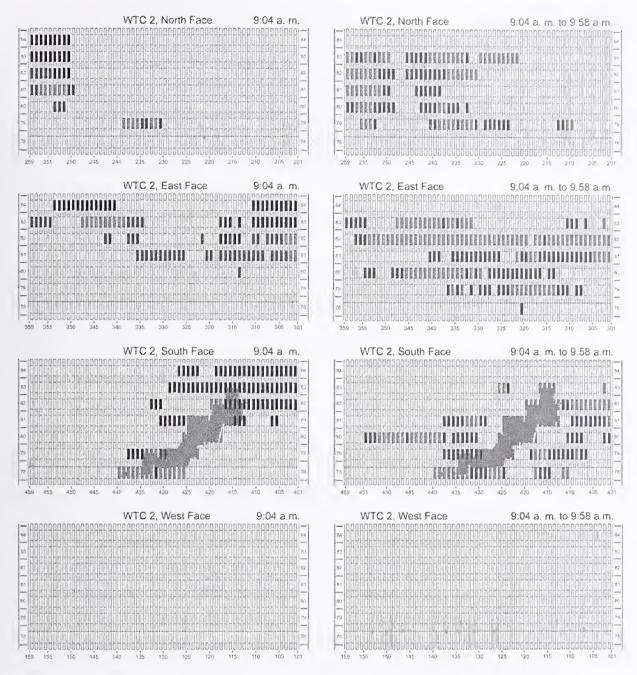
A curious aspect of the fire behavior in WTC 2 was the presence of the cold spot on the north face, which covered three floors over a length equal to one-sixth of the face width. The existence of the cold spot implies that little fuel was available in the immediate vicinity to support burning. A number of possible explanations were considered for the absence of fuel. One is that the area was vacant and that there was limited fuel present prior to the aircraft impact. NIST is unaware of any information that supports such a conclusion. A second possibility is that the fireballs that exited through the area were so intense that they pushed most available fuel in the area to the sides or out through the opened windows. A third possibility is that the floor slabs, particularly on the 81st and 82nd floors, in the immediate area collapsed during the aircraft impact and fireballs, in effect, creating a cavity behind the cold spot. The available visual evidence both supports and argues against all three possibilities. NIST has concluded that insufficient information is available to allow a likely formation mechanism for the cold spot to be postulated.

Note: Blue represents windows where observations were not possible.

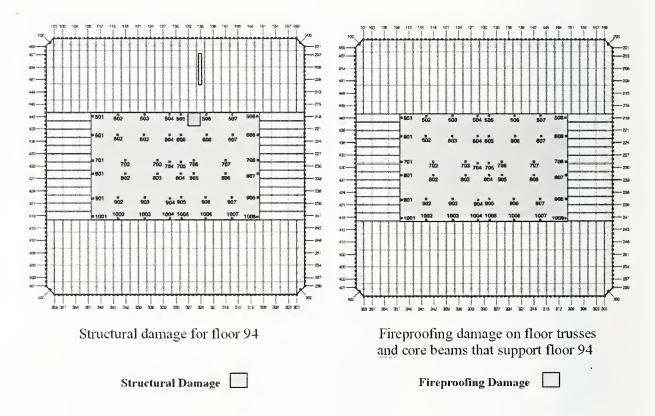
Figure 6–45 shows the structural and insulation damage to floor 94.

Figure 6–45. Structural and insulation damage to floor 94 of WTC 1, Case A.

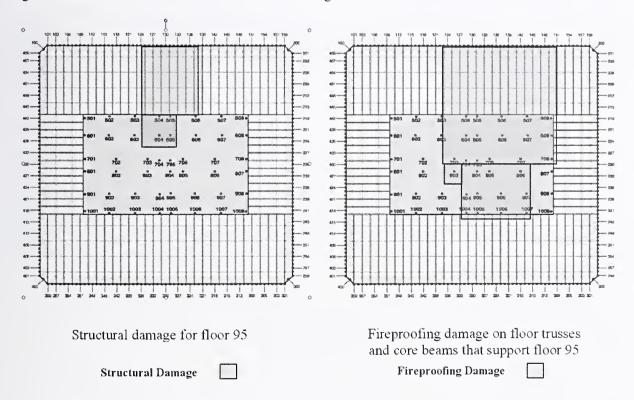
Figure 6-46. Structural and insulation damage to floor 95 of WTC 1, Case A.

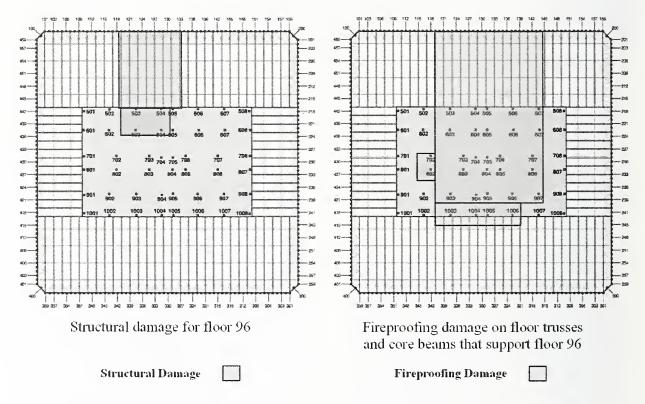
Figure 6-47. Structural and insulation damage to floor 96 of WTC 1, Case A.

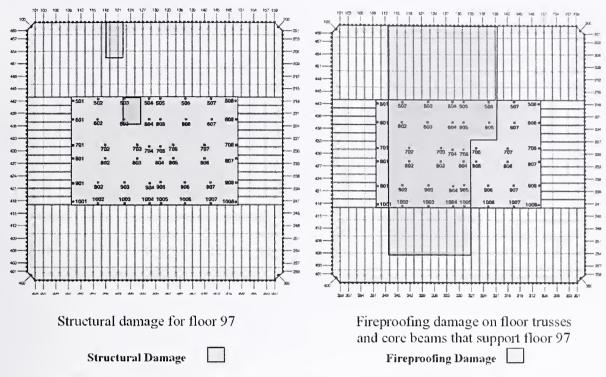
Figure 6-48. Structural and insulation damage to floor 97 of WTC 1, Case A.

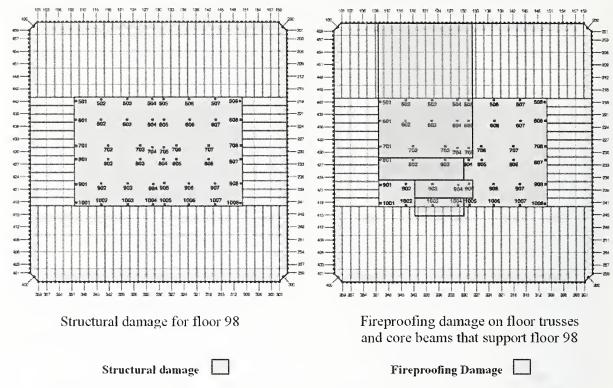
Figure 6-49. Structural and insulation damage to floor 98 of WTC 1, Case A.

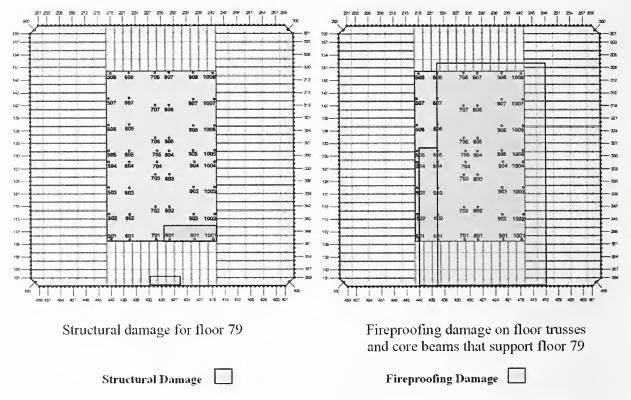
Figure 6-60. Structural and insulation damage on floor 79 of WTC 2, Case C.

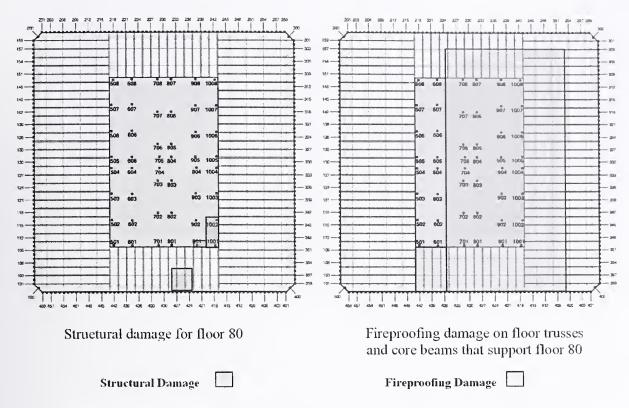
Figure 6-61. Structural and insulation damage on floor 80 of WTC 2, Case C.

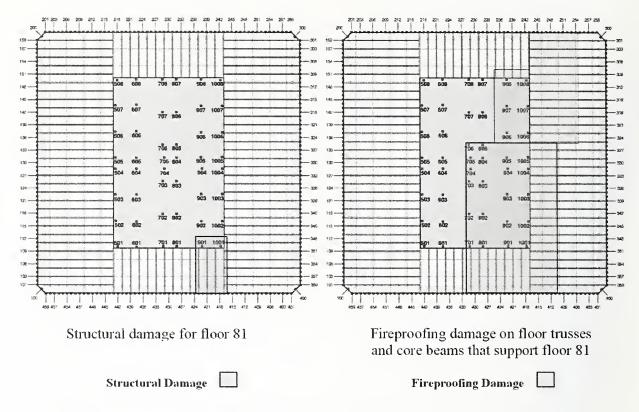
Figure 6-62. Structural and insulation damage on floor 81 of WTC 2, Case C.

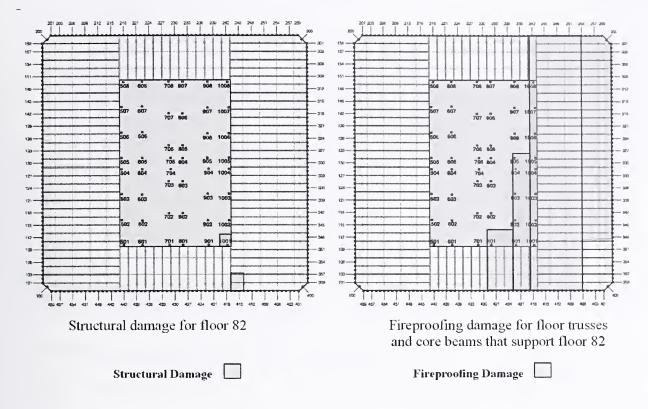
Figure 6-63. Structural and insulation damage on floor 82 of WTC 2, Case C.

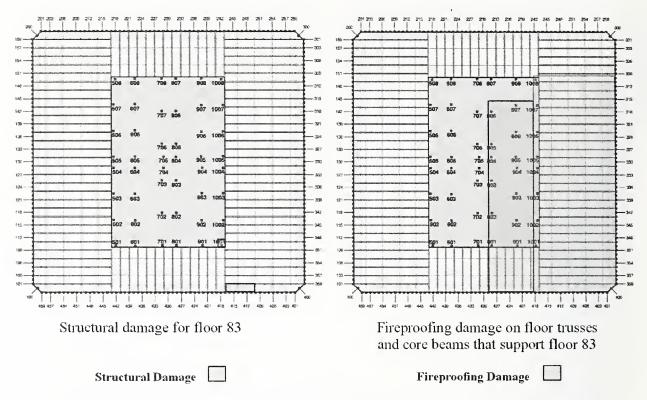
Figure 6-64. Structural and insulation damage on floor 83 of WTC 2, Case C.
