NIST NCSTAR 1-5D

**Federal Building and Fire Safety Investigation of the
World Trade Center Disaster**

**Reaction of Ceiling Tile Systems to
Shocks**

September 2005

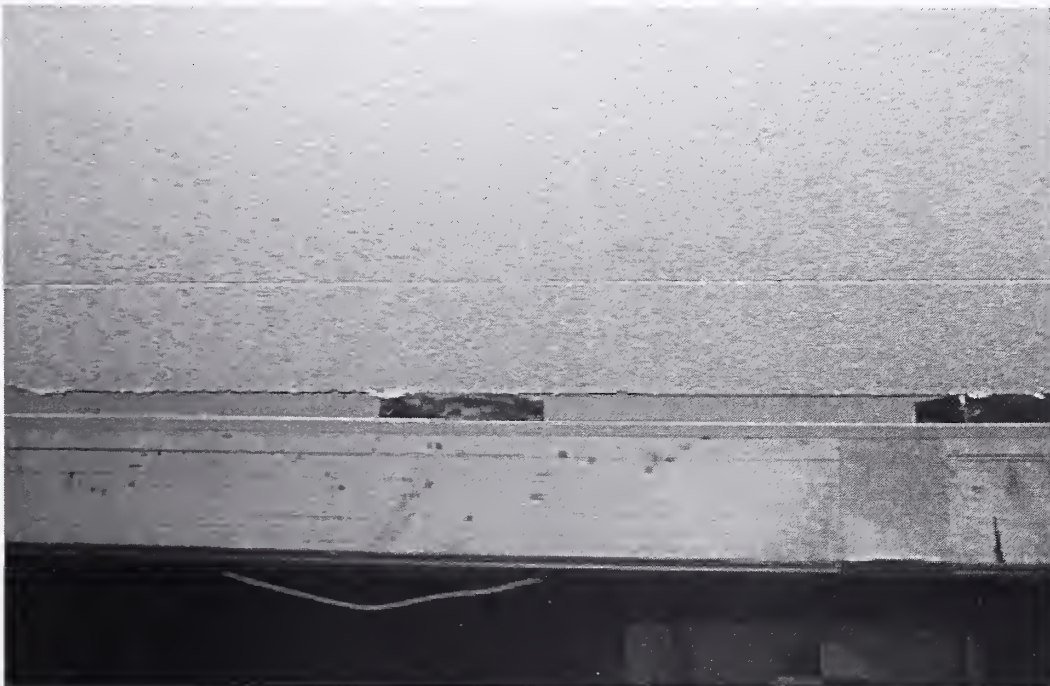
Figure 3-1. Displacement of perimeter tiles over perimeter spring clips following Test 20 for ceiling system CS1.

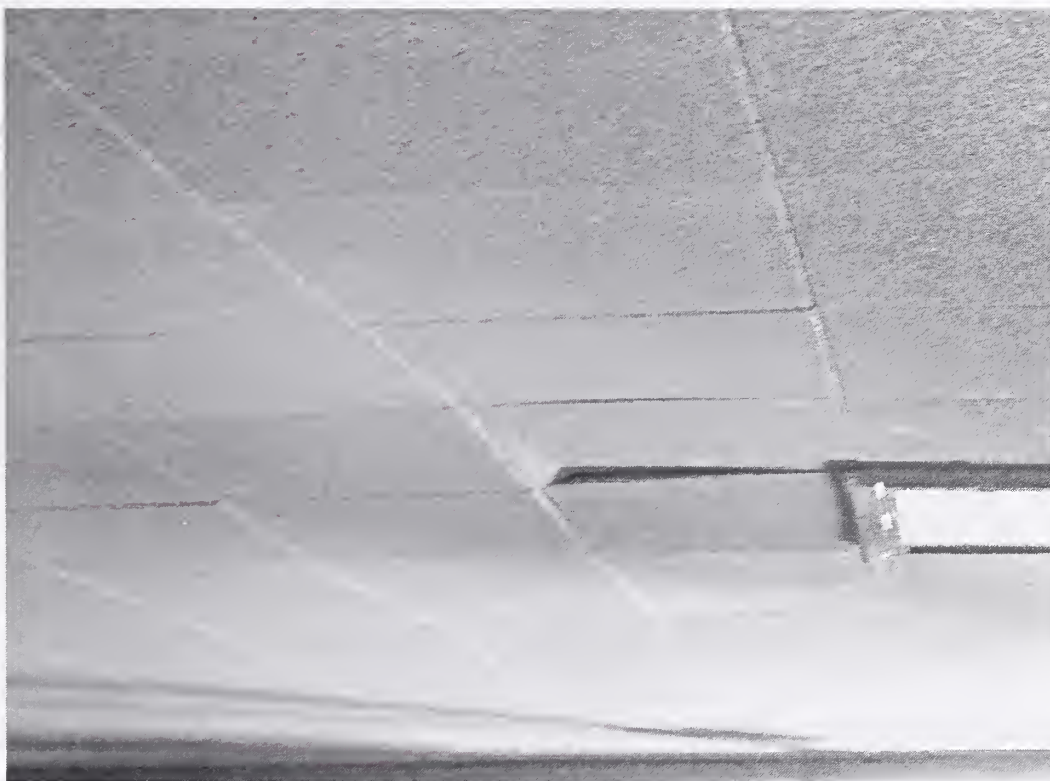
Figure 3-2. Bottom view of damage to ceiling system CS1 following Test 20.

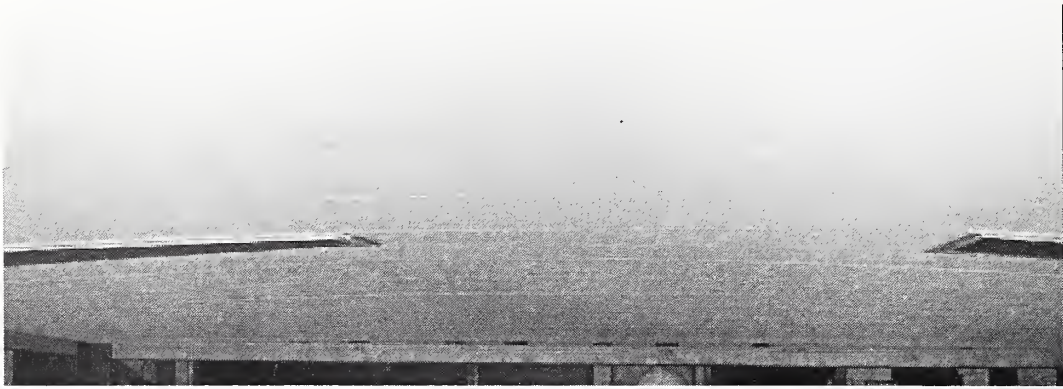
Figure 3–3. Bottom view of damage to ceiling system CS1 following Test 20.

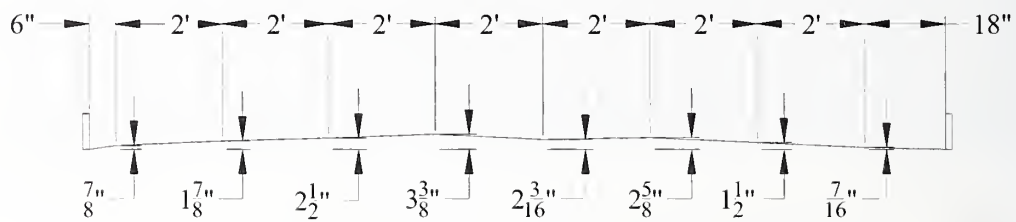
Figure 3–4. Permanent vertical displacements of Z-bars in the east-west direction following Test 20 for ceiling system CS1.

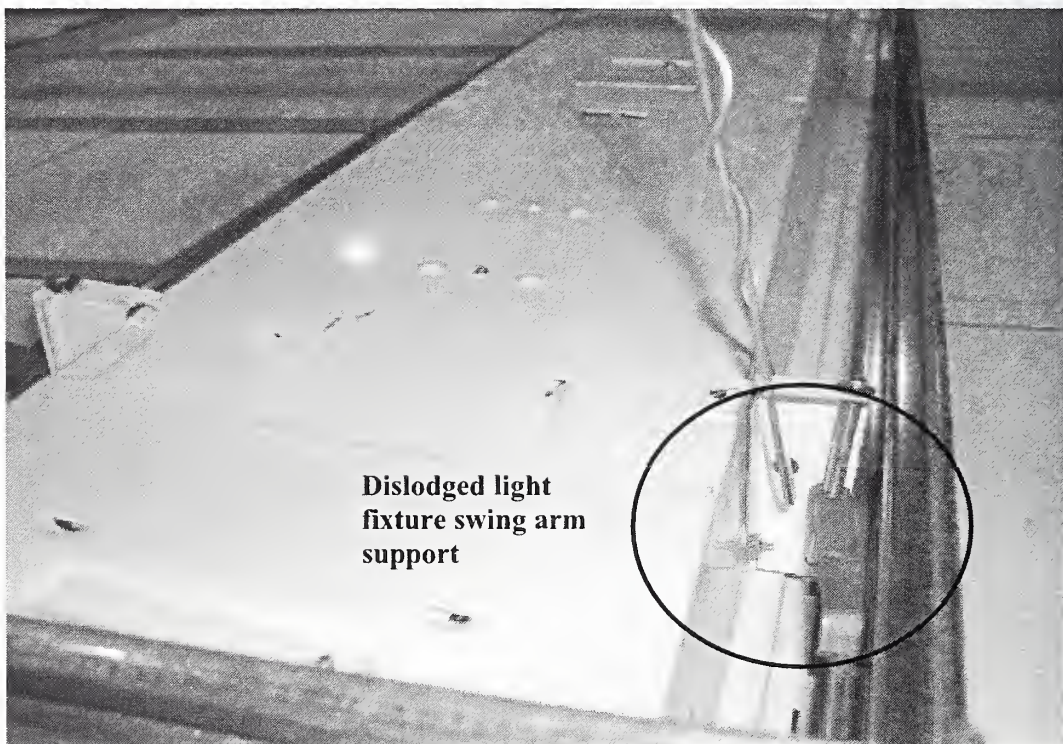
Figure 3–5. Light fixture swing arm support dislodged following Test 21 for ceiling system CS1.

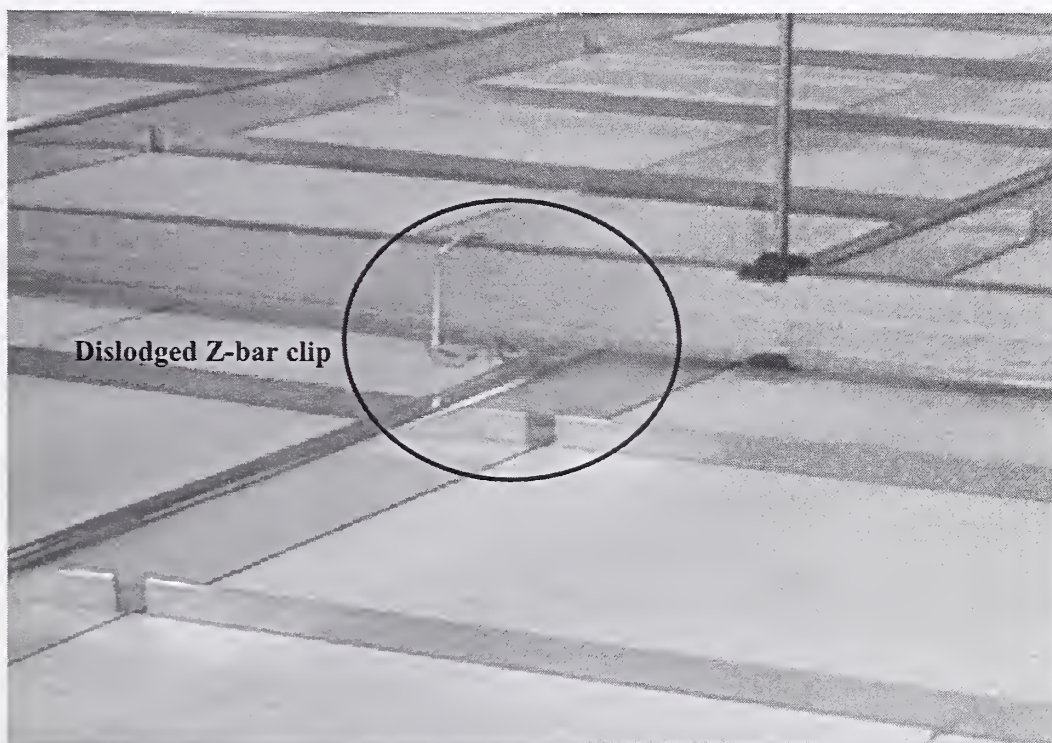
Figure 3–6. Dislodged Z-bar clip in ceiling system CS1 following Test 21.

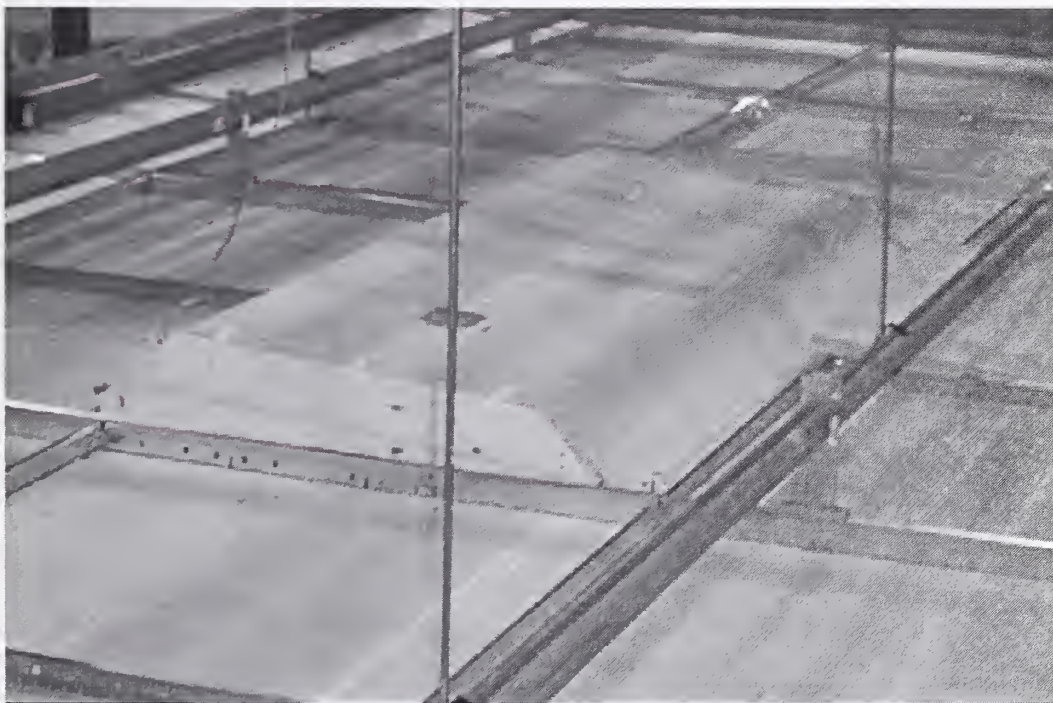
Figure 3–7. Dislodged southern light fixture corner in ceiling system CS2 following Test 14.

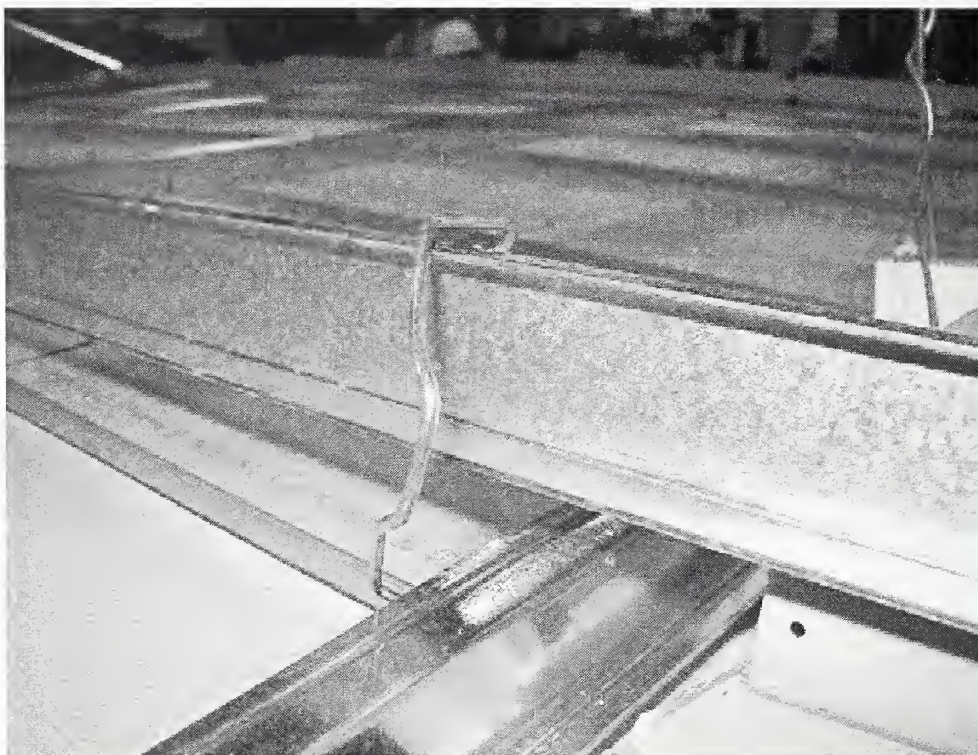
Figure 3–8. Stretching of Z-bar clips located at northern light fixture corner in ceiling system CS3 following Test 20.

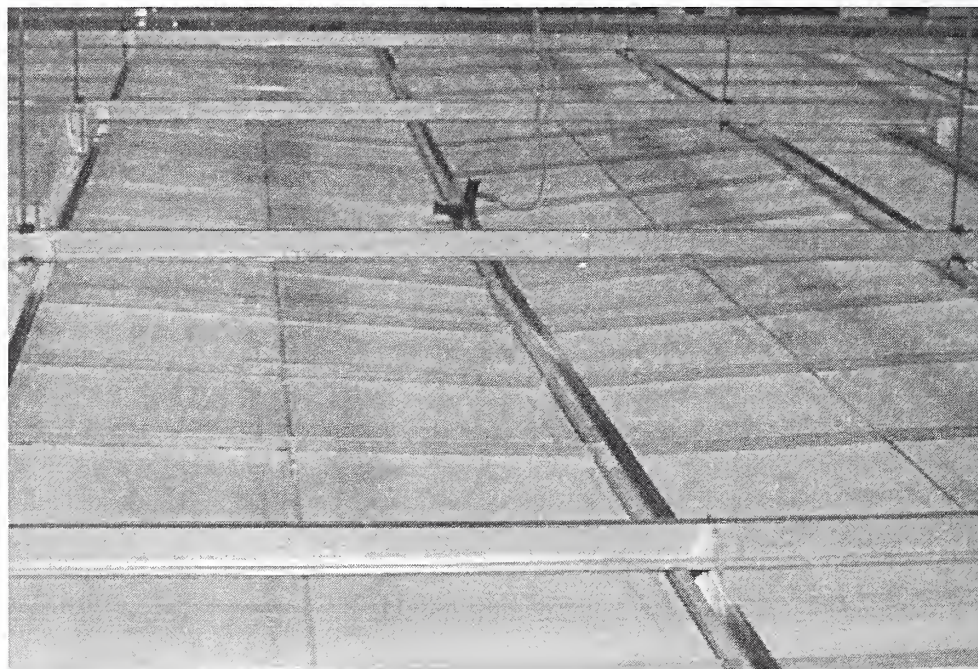
Figure 3–9. Damage to the center of ceiling system CS3 following Test 20.

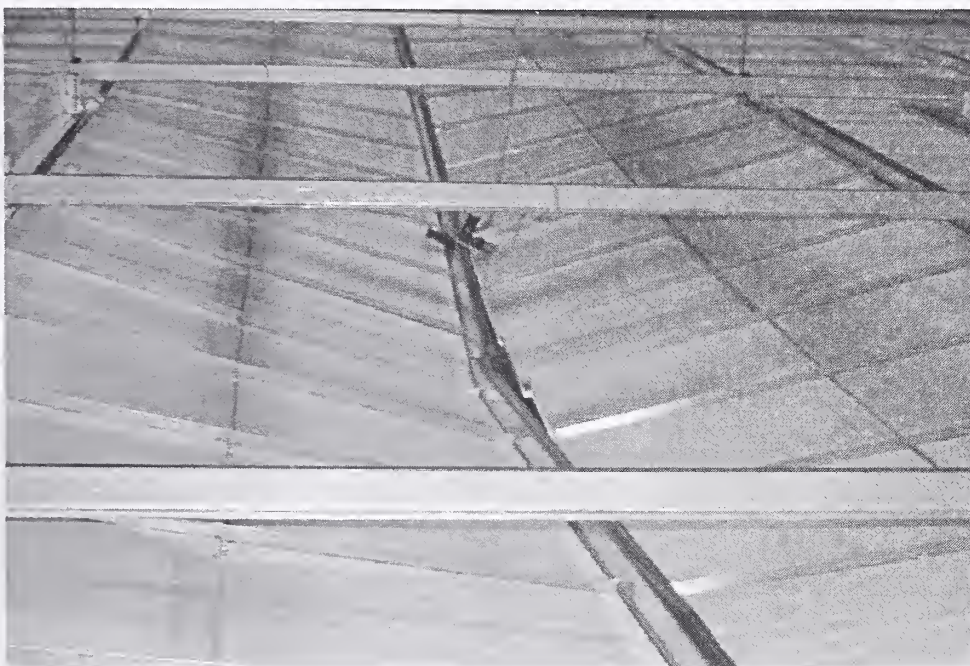
Figure 3–10. Damage to the center of ceiling system CS3 following Test 23.

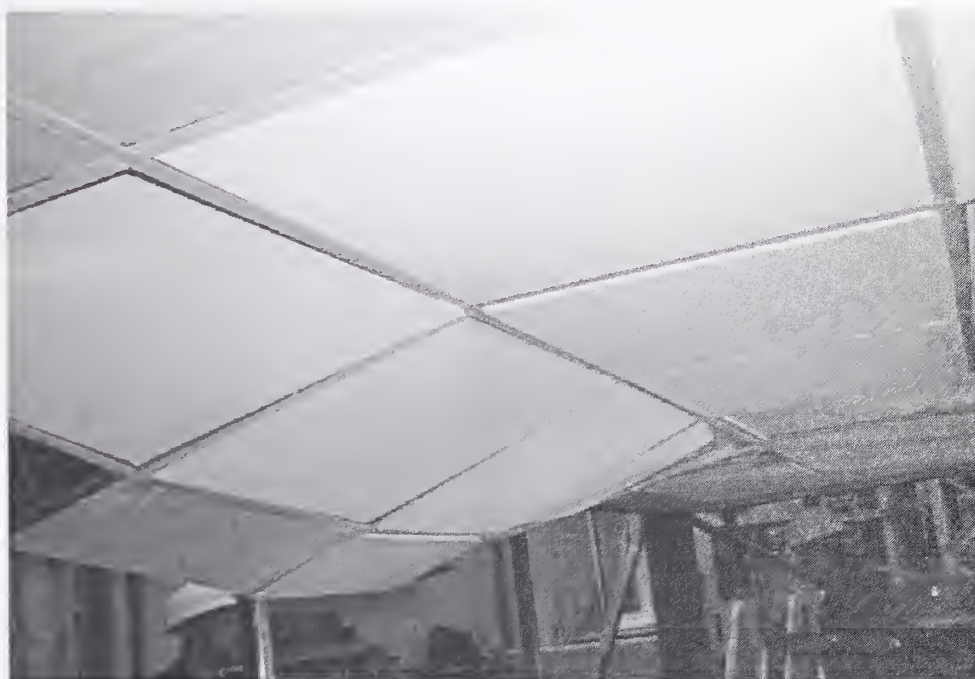
Figure 3–11. Damage to the northern perimeter of ceiling system CS4 following Test 23.

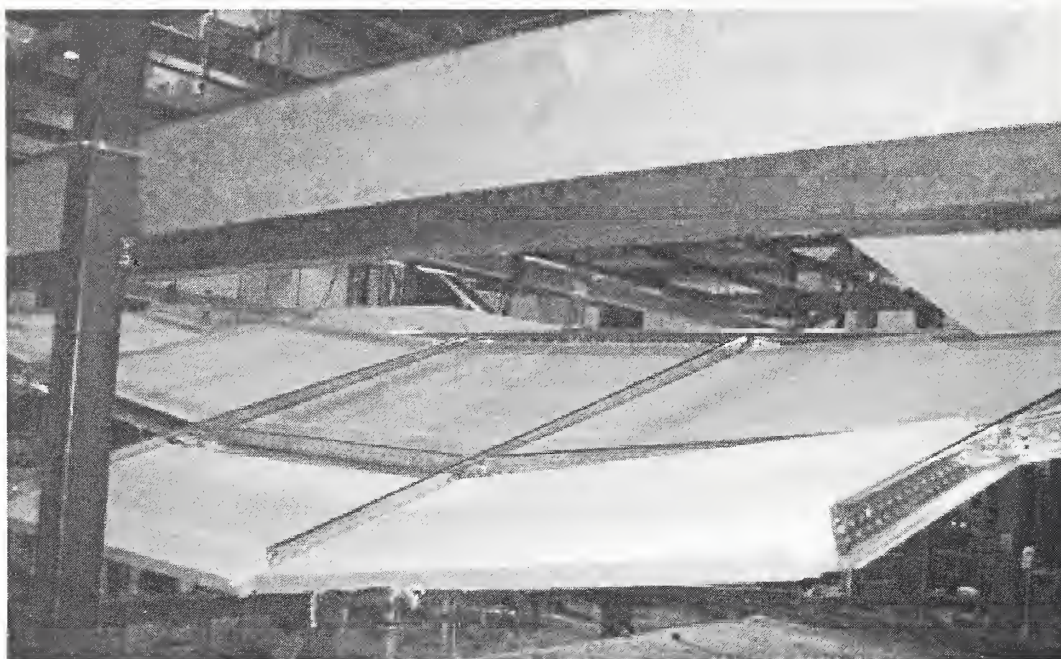
Figure 3–12. Damage to the northern perimeter of ceiling system CS4 following Test 23.

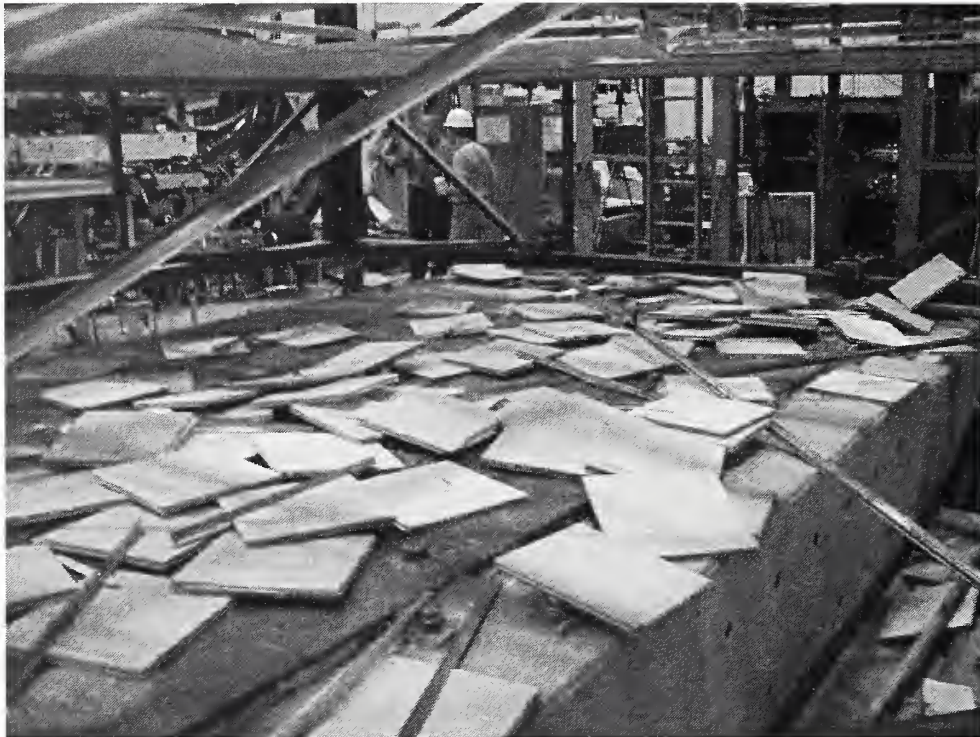
Figure 3–13. Collapse of ceiling system CS3 after 2.5g earthquake excitation.

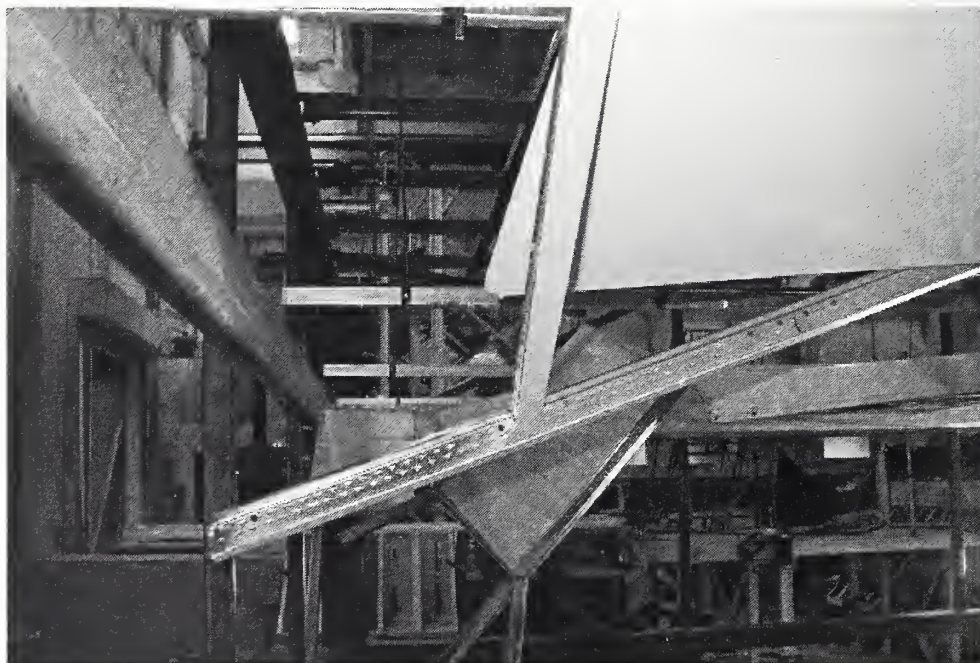
Figure 3–14. Damage to north perimeter of ceiling system CS4 after 1.75g earthquake excitation.

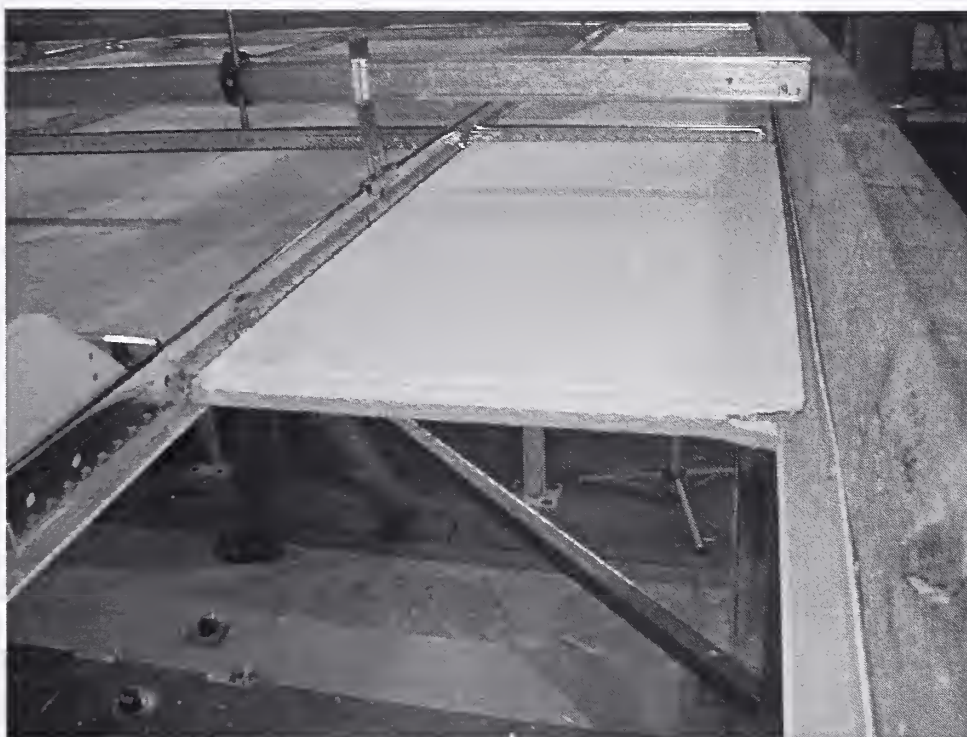
Figure 3–15. Damage to south perimeter of ceiling system CS4 after 1.75g earthquake excitation.
