FAILURES IN WIRE BASKETS OF URETERAL STONE DISLODGERS

B. W. Christ

C. H. Brady

Engineering Metallurgy Section
Metallurgy Division

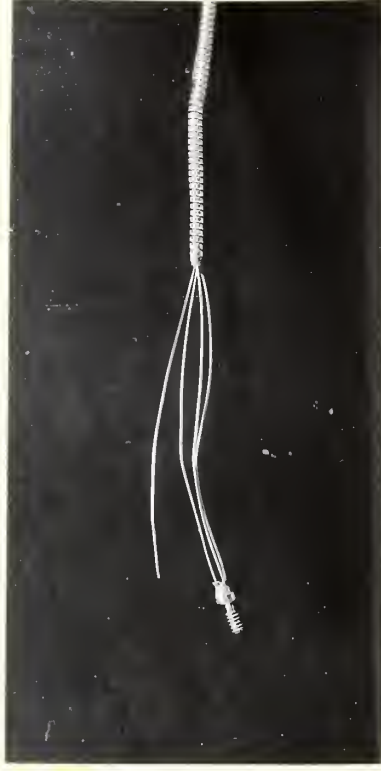
It is reported¹ that the majority of repair items are returned because of basket failure. Typical stone dislodgers which have failed appear in Figures 1b and 1c. One can see that failure in these cases is a matter of the wire basket having come apart near the connectors. Other failures related to the plastic filiform tip have also been reported², but these will not be discussed in this report. The purpose of this report is to identify possible metallurgical causes of the type of failure appearing in Figures 1b and 1c, and to recommend procedures for minimizing the frequency of such failures.

Evidence presented in the preceding section shows that the cause of the typical wire basket failures shown in Figures 1b and 1c is fracture of individual basket wires, in contrast to the possibility that basket wires are pulling free of the soldered joint. Failure is caused by application of loads beyond the fracture strength of individual wires comprising the basket.

(b) IX
Used stone dislodger which has failed. Unit produced by Greenwald Surgical Co. for C. R. Bard, Inc.

1. Since the analysis presented in this report shows that cumulative damage to basket wires during re-use eventually leads to fracture, the most obvious recommendation to make is to minimize the re-use of individual stone dislodgers. Ideally, a stone dislodger should have its basket wires replaced after a reasonable number of cycles of use. A definition of what represents "a reasonable number of cycles of use" will have to be provided by individuals having a day-to-day familiarity with the use of stone dislodgers.

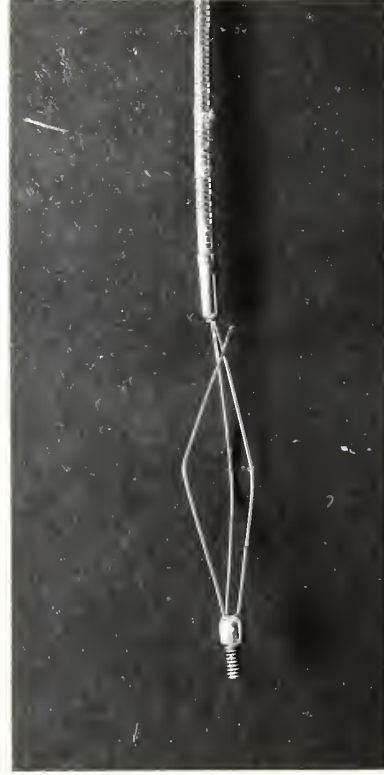
(c) IX
Used stone dislodger which has failed. Unit produced by American Cystoscope Makers, Inc.

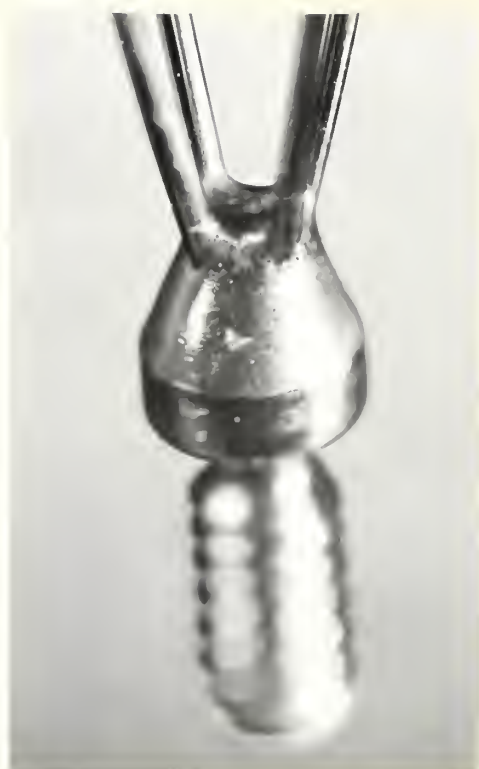
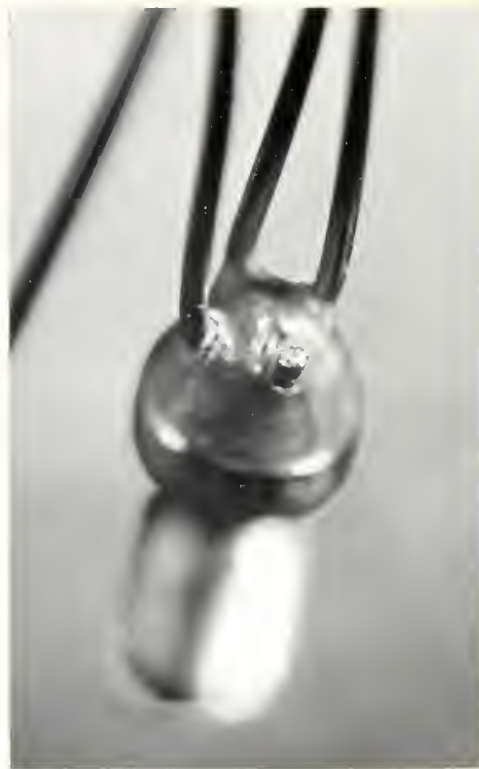
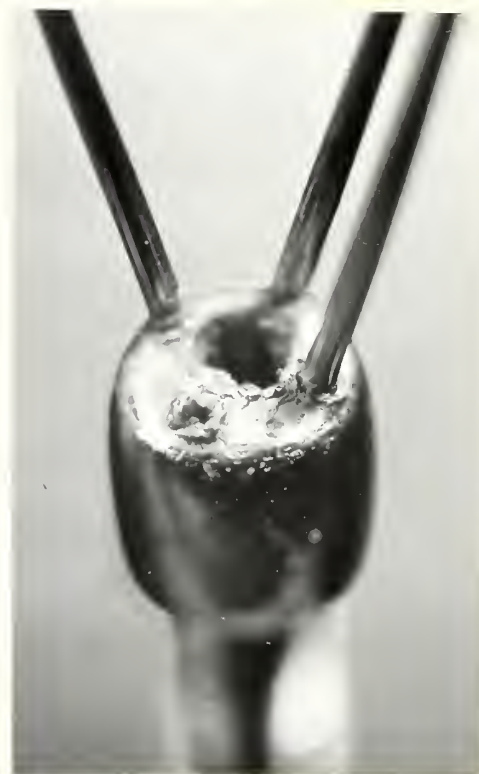
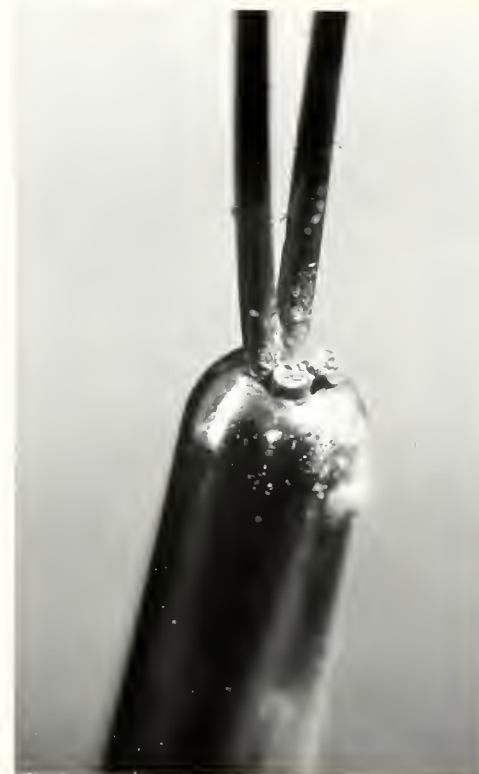
Figure 2. Exterior Views of Soldered Joints.

Examination at magnifications of 10-250 times provides information which serves to identify the possible causes of the typical basket failures appearing in Figures 1b and 1c. For example, Figure 2 shows exterior views at 12X of the soldered joints between basket wires and connectors. Figure 2a shows an intact joint. Figures 2b and 2c show that wires at the filiform connector have fractured. Similarly, Figure 2d shows that wires at the flexible cable connector have fractured. These observations suggest that the cause of wire-basket failure is fracture of the basket wires themselves, and not rupture of the soldered joints.

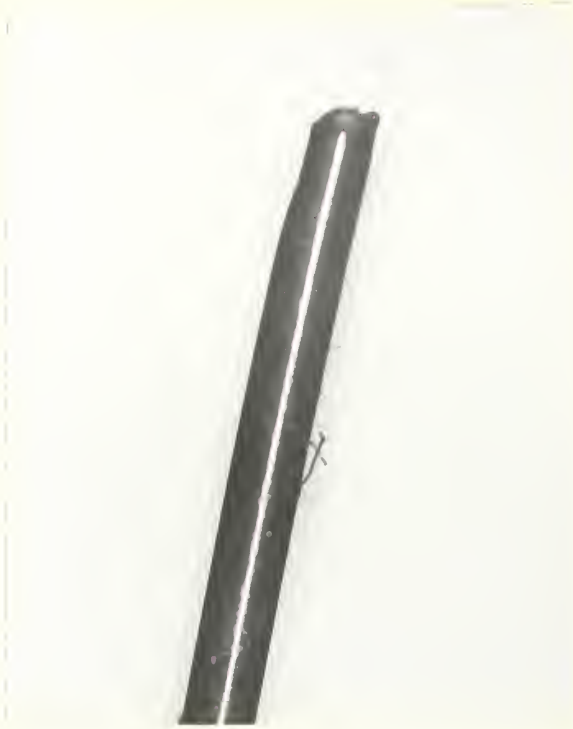
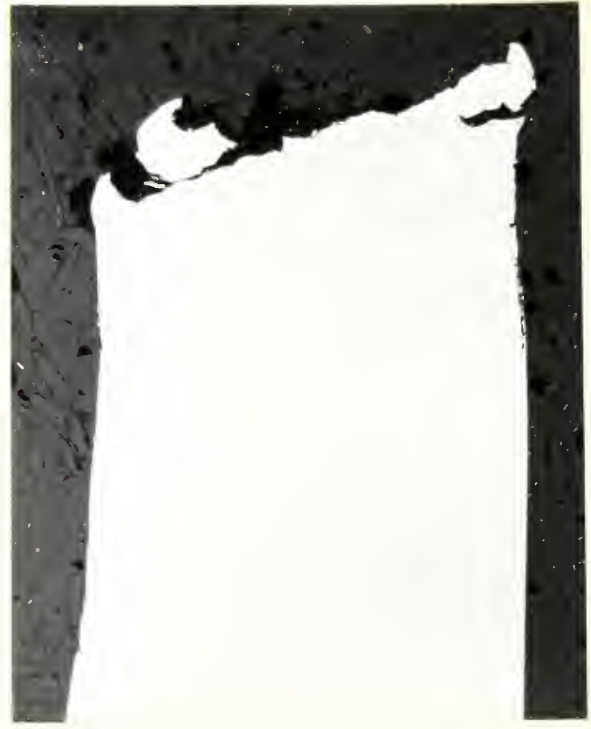
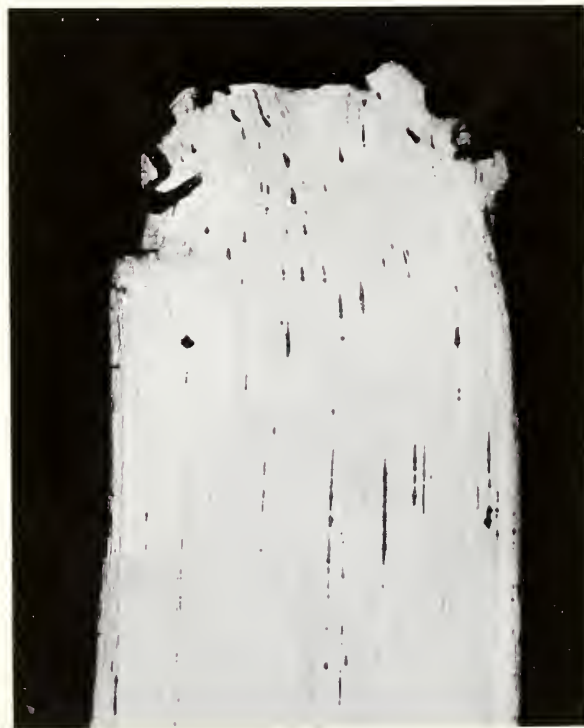
Figure 3. Tip of Fractured Basket Wire Appearing in Figure 1b.

Views of two fractured basket wires appear in Figures 3 and 4. A view at a magnification of 27X appears in Figures 3a and 4a. Close-up views (at 200X magnification) of the fractured tips of these wires are shown in Figures 3b and 4b. These wires have fractured primarily by shear after a small amount of plastic flow. Evidence of a shear failure is the fact that the fracture surface is inclined to the longitudinal axis of the basket wire. Evidence of plastic flow are the shape distortion of the wires themselves and the rounded features of the fracture surface itself. The cracks penetrating the surface of the basket wire shown in Figures 4b originate in the nickel-plated surface layer. The wire shown in Figure 3b does not exhibit such cracks because the wire was not nickel plated.

When sample surfaces such as those appearing in Figures 3b and 4b are etched with 20% HCl-5% HNO₃, features of the metallurgical structure are revealed. For example, after etching, two failed basket wires appear as in Figures 3c and 4c. The layer of nickel plate and its associated microcracks show up clearly in Figure 4c. It can also be seen in Figure 4c that the microcracks are not restricted to the nickel layer; the microcracks actually propagate into the basket wire itself.

Both Figures 3c and 4c show a typical structure for "spring temper" material, i.e., a fibrous appearance with the fiber direction parallel to the longitudinal axis of the wire. For comparison with Figures 3c and 4c, the fibrous appearance of a basket wire from an unused stone dislodger appears in Figure 5. Shape distortion is also apparent in Figures 3c and 4c. These further observations support the viewpoint that the cause of wire-basket failure is fracture of the basket wires themselves, and not rupture of the soldered joints.

In view of the abundant evidence that plastic flow occurs in basket wires, e.g., shape distortions as in Figures 3b, 4b, 7 and 8, it is not likely that metal fatigue is an important contributor to basket wire failure.

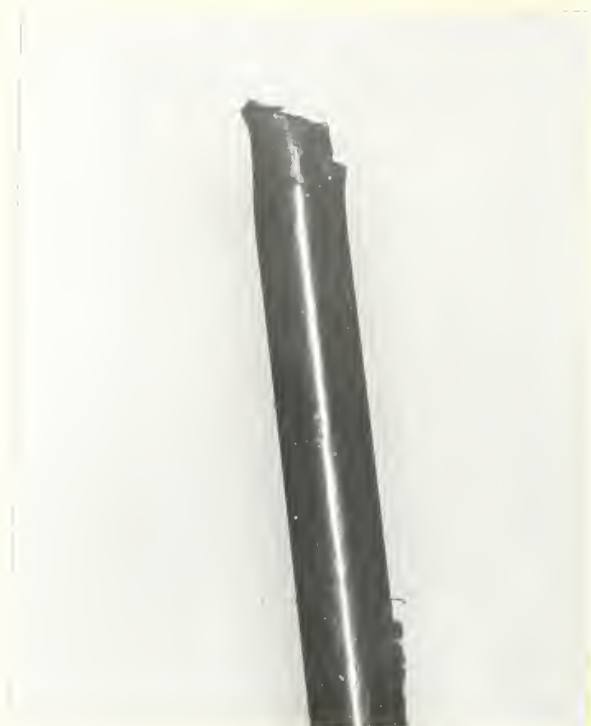
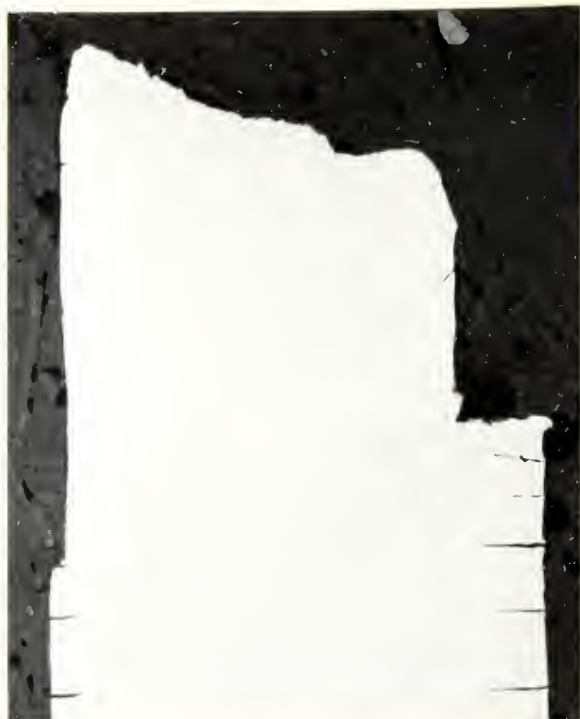
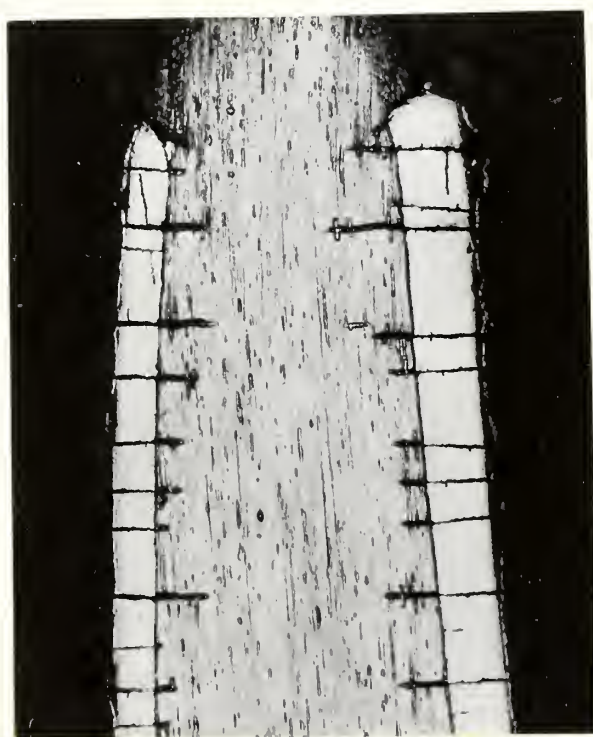
Figure 4. Tip of Fractured Basket Wire Appearing in Figure 1c.

The layer of nickel plate applied to one manufacturer's stone dislodger contributes to weakening, and probably to fracture, of basket wires. This is illustrated in Figures 4b and 4c, where it is seen that the nickel plated wire exhibits surface cracks which penetrate the basket wire itself. These cracks act to decrease the effective cross-sectional area of the basket wire, thereby decreasing its load-carrying capacity. The reason that cracks originate in the nickel layer is not known with certainty. One plausible cause is the difference in average coefficients of thermal expansion of stainless steel and nickel, 9.3×10^{-6} in./in.-°F and 7.4×10^{-6} in./in.-°F, respectively. At typical autoclaving temperatures, an 0.016-inch diameter stainless steel wire expands radially about 372×10^{-7} inches, whereas a 0.0004-inch hoop of nickel expands radially about 7.4×10^{-7} inches. Another possible cause of cracks originating in the nickel layer is that the metallurgical structure of the plated layer is inherently brittle. This is sometimes the case for electroplated metals. Since fractures have been reported for both unplated and plated basket wires, cracks originating in the nickel layer cannot be the sole cause of basket wire failure. However, they represent a potential cause of fracture which should be eliminated.

4. The nickel-plated layer on stone dislodgers produced by one manufacturer acts as a source of cracks which contribute to the fracture of basket wires. It may be desirable to eliminate the nickel plating operation altogether. Stainless steel has an intrinsic corrosion resistance which makes it unnecessary to apply a nickel layer for corrosion resistance. Elimination of the nickel layer would also avoid the problem of flaking associated with the nickel layer, as shown in Figure 10.

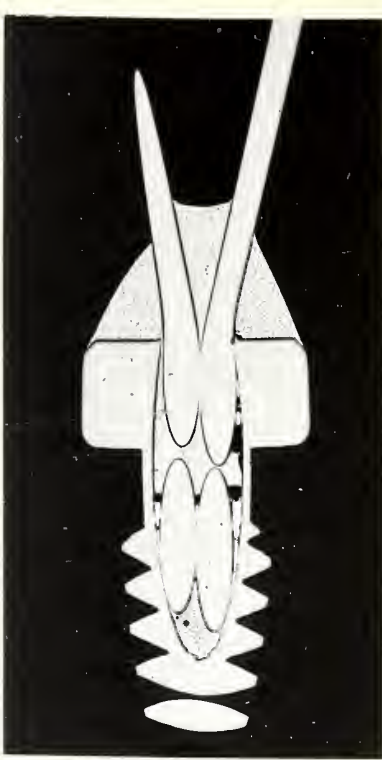
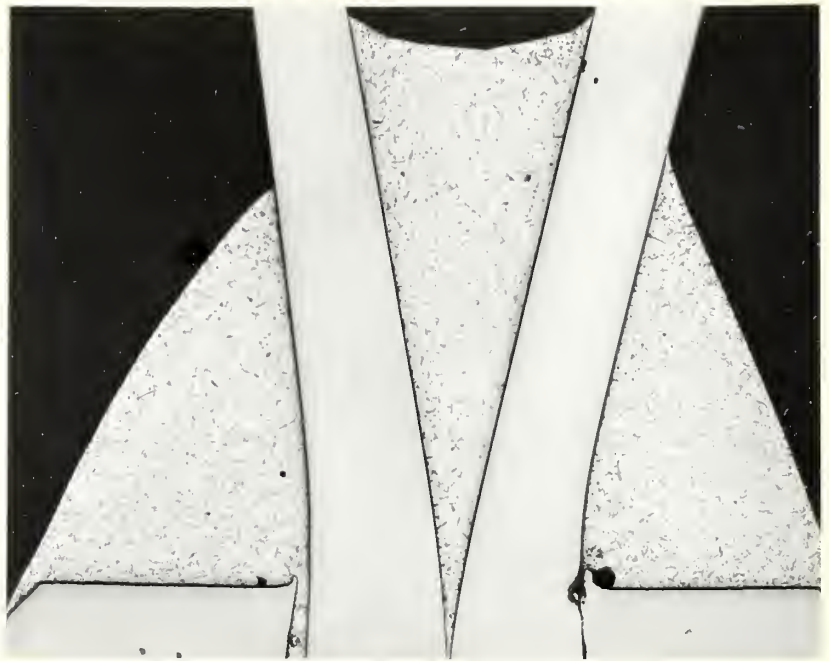
Figure 6. Cross-sectional view of soldered joint within filiform tip. Sample taken from unused stone dislodger appearing in Figure 1a.

The primary feature to be noted in Figures 6 to 8 is the degree of soundness of the soldered joint. It can be seen in Figure 6, obtained on an unused stone dislodger, that although solder has bridged within the body of the connector and created at least seven small pores, there is still a good deal of solder surrounding the basket wires. The bead of solder on the surface of the filiform tip connector, Figure 6, exhibits no pores and completely surrounds the basket wires.

6. Although soldered joints do not seem to be a primary cause of failure, features of the soldered joints noted earlier are worth some discussion:
 - a) Maximum mechanical strength of the basket-wire-to-connector joint is achieved if the basket wires pass entirely through the connector, as in Figures 6a and 7a. Purely from the standpoint of maximum achievable mechanical strength, the joints in Figures 6a and 7a have an intrinsically better design than the joint in Figure 8a.

- b) Bridging of solder within the connector, as in Figures 6a, 7a and 8a, should be minimized by applying sufficient flux and heat during the soldering operation.

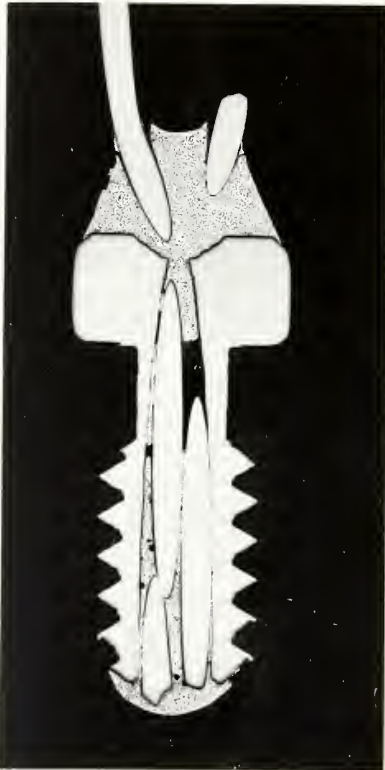
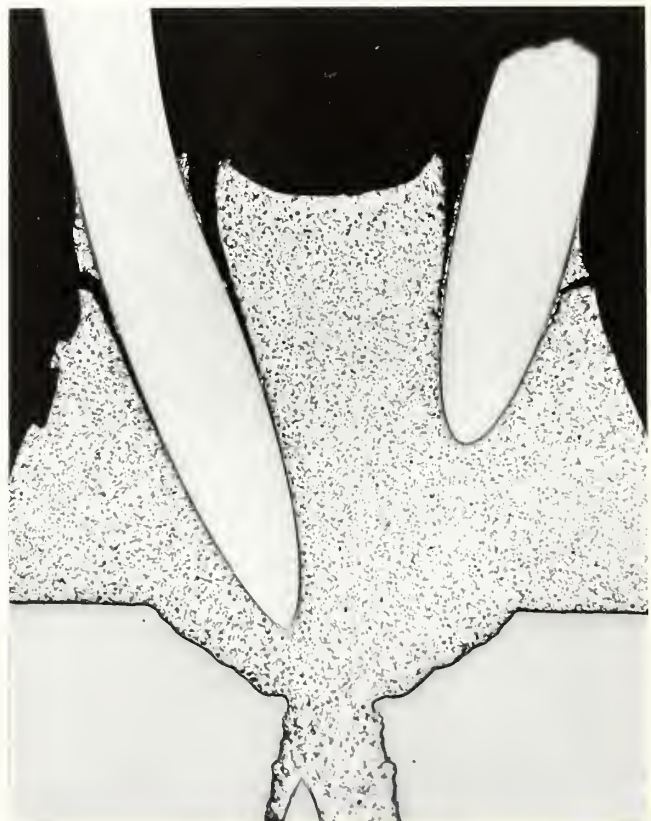
Figure 7. Cross-sectional view of soldered joint within filiform tip. Sample taken from used stone dislodger appearing in Figure 1b.

The used stone dislodger shown in Figure 7 shows the features pointed out in Figure 6. In addition, it shows some separation between the basket wire and the bead of solder on the surface of the filiform tip. The extent of this separation is likely to increase with increased frequency of use of the stone dislodger. The significant point to note in Figure 7, however, is that the basket wire fractured before the separation between wire and solder increased to the point where the wire could pull free of the soldered joint.

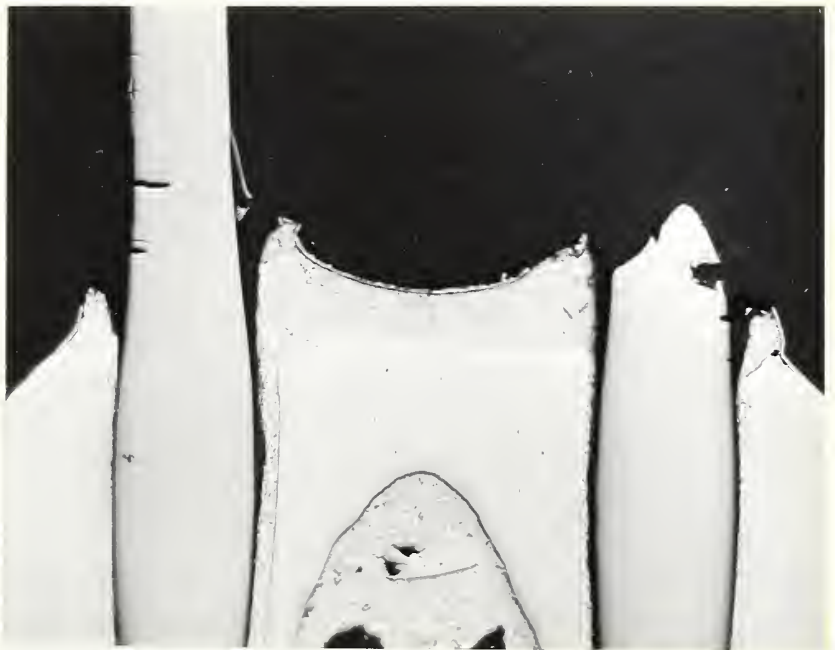
Figure 8. Cross-sectional view of soldered joint within filiform tip. Sample taken from used stone dislodger appearing in Figure 1c.

The used stone dislodger appearing in Figure 8 shows a filiform tip connector with somewhat different geometry than those connectors appearing in Figures 6 and 7. Furthermore, the central hole in the filiform tip of Figure 8a does not penetrate the full length of the tip, as is the case in Figures 6a and 7a. These small differences in design are also illustrated by comparing Figures 1c and 1b. The sectioned filiform tip in Figure 8a is the same as that appearing in Figure 1c, whereas the tip shown in Figure 7a is the same as that in Figure 1b.

Since the sectioning plane is sharply inclined to the longitudinal axis of the filiform tip shown in Figure 8, the cylindrical central hole is somewhat obscured. Nevertheless, some bridging of the solder in the central hole can be seen. Moreover, some separation between solder and basket wires appears. Only a small bead of solder on the surface of the filiform tip surrounds the basket wires at this point. (Compare the solder bead size in Figure 8a with that appearing in Figures 6a and 7a.) As in Figure 7, the important point to recognize in Figure 8 is that the basket wires distorted and fractured before the soldered joint failed.

Yield and tensile strengths of the types of stainless steels used for basket wire, as described in Table I, are tabulated in Table II. If a tensile load causes a stress which exceeds the yield strength of a basket wire, shape distortion such as that which appears in the case of the left-hand basket wire in Figure 8a will occur. Loads resulting in stresses which exceed the ultimate tensile stress will cause fracture, as in the case of the right-hand basket wire in Figure 8a.

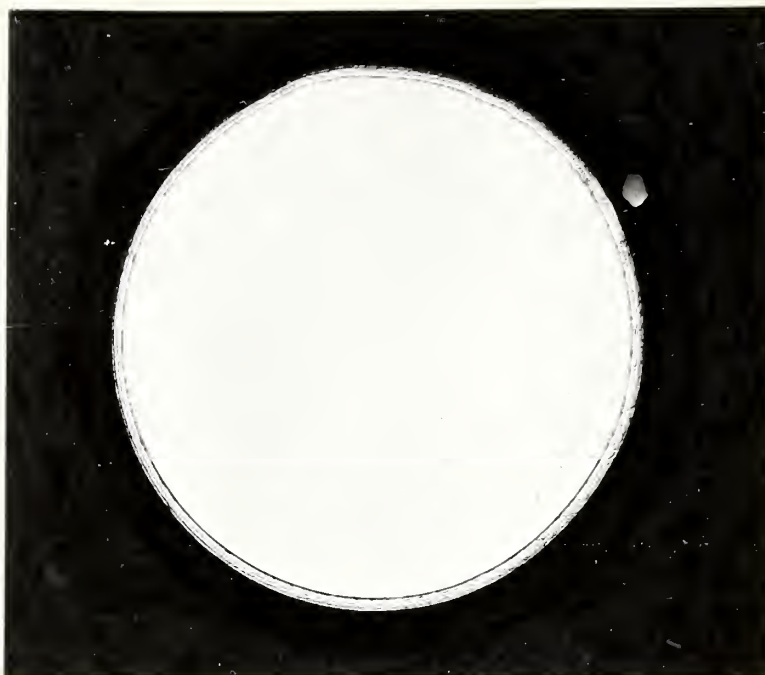
Figure 9. Transverse Sections of Basket Wires.

Some interesting aspects of the nickel-plated basket wires appear in Figures 9 and 10. A transverse section of an unetched nickel-plated wire shown in Figure 9a reveals a sound, reasonably uniform film of nickel completely surrounding the wire. The average thickness of the nickel film is 0.0004 inches. For comparison, an unplated wire appears in Figure 9b.

(9a) 160X
 Nickel-plated basket wire. Sample taken from stone dislodger shown in Figure 1c. The nickel layer shows up as the annular ring surrounding the basket wire. Wire diameter-0.016 inches. Thickness of nickel layer-0.0004 inches.

(9b) 160X
 Unplated basket wire. Sample taken from stone dislodger shown in Figure 1b. Wire diameter-0.014 inches.

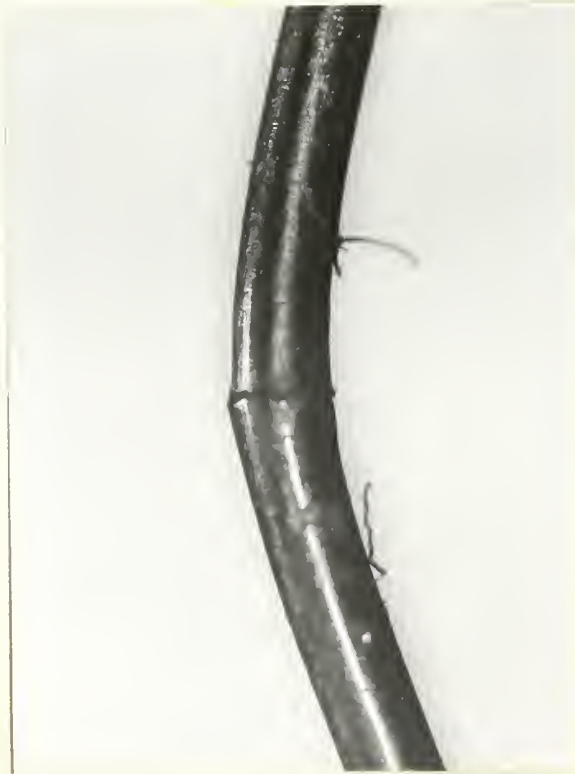
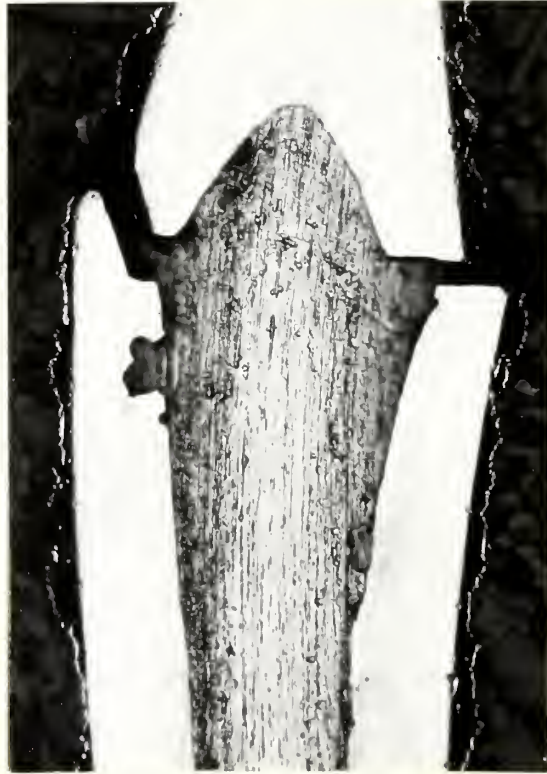
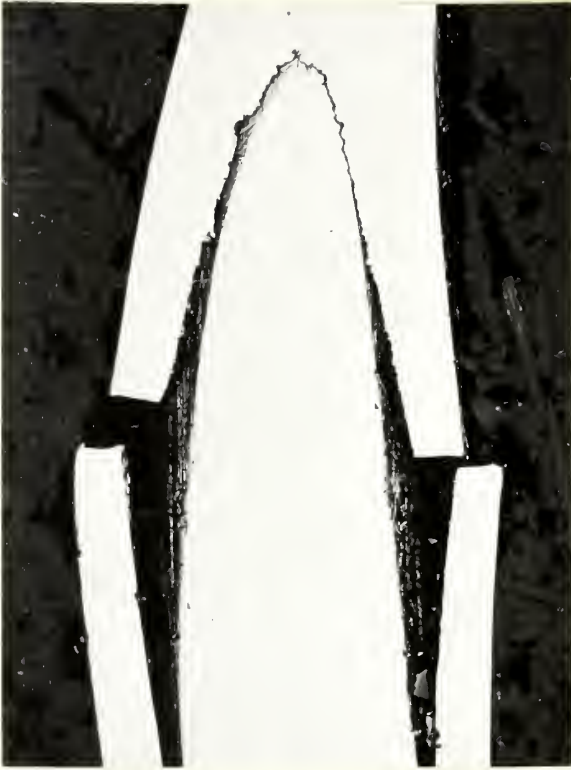
Figure 10. Views of Bent Basket Wire Appearing in Figure 1c.

Longitudinal views of a used basket wire with its nickel plate flaking off appear in Figure 10. These views are close-ups of the sharply bent wire appearing in Figure 1c. Figure 10a reveals a circumferential crack in the nickel layer. (The threads appearing on either side of the crack in Figure 10a are simply dust particles and have no relationship to the crack.) Views of surfaces at the top of the bend in Figure 10a appear in Figures 10b and 10c. Figure 10b is taken at a slightly different section level than that of Figure 10c. Separation of the nickel layer from the basket wire due to poor bonding is obvious in Figure 10b. The soundness of the stainless steel basket wire beneath the flaking nickel plate is attested to in both Figures 10b and 10c.

(10c) 250X
View of top of bend in wire appearing in Figure 10a, at a different level than that shown in Figure 10b. Etched in 20% HCl, 5% HNO_3 .

(10b) 250X
View of top of bend in wire appearing in Figure 10a. Separation of nickel layer from basket wire is evident.

5. Examination for flaking nickel layers on basket wires, and elsewhere, is desirable for stone dislodgers presently in use. This could be accomplished simply by looking at stone dislodgers after each use under a low-power binocular microscope. A magnification of 27X, as in Figure 10a, would be appropriate.
