NATIONAL BUREAU OF STANDARDS REPORT

10 164

TEST AND EVALUATION OF THE PREFABRICATED LEWIS BUILDING
AND ITS COMPONENTS
PHASE I PART 2
FULL-SCALE BUILDING TESTS

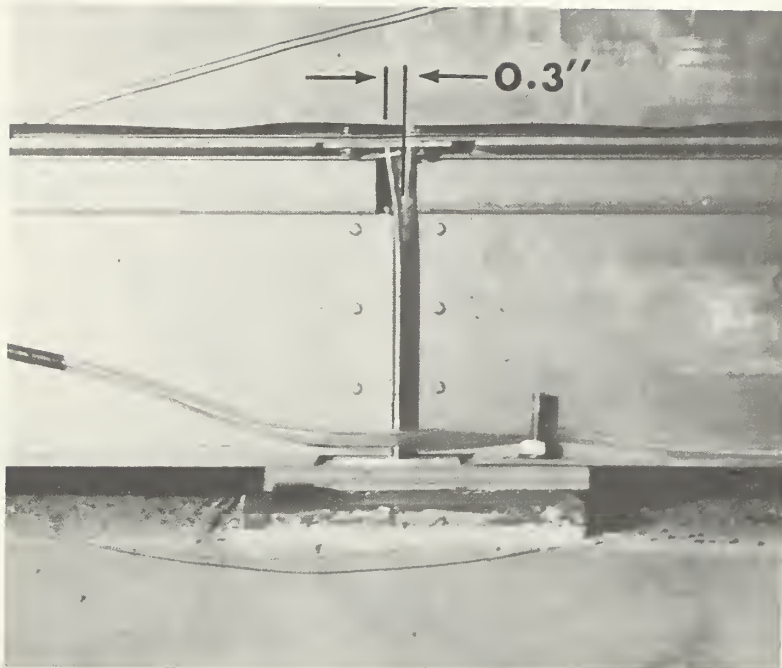
Figure 2.18 Horizontal movement of
building on foundation, racking
test No. 1

The panels were attached to the foundation beams by aluminum tie-down bolts placed only in the longitudinal beams, as called for on the building plans. The lack of connection between the transverse foundation "Eye" beams and floor panels permitted free movement of the floor panels with respect to the transverse beams. Because of this the

longitudinal beams had large shear forces applied at the top flange, hence the deflected shape shown in figure 2.18. After unloading, eight 1/4 in tie-down bolts were used to attach the floor panels at the two ends of the building to each of the four exterior transverse foundation "Eye" beams for a total of 32 additional bolts (eight equally spaced bolts per beam). These bolts, which were not called for on the building plans, were in place for all subsequent tests. These bolts increased the lateral load capacity of the foundation by about 6.3 times. The additional bolts also decreased the shearing load causing twisting in the longitudinal beams by transmitting some load into the transverse beams. It is shown in section 4.4 that the relative deflection of the top of the wall with respect to the base was not significantly affected by the large base movements during this test.

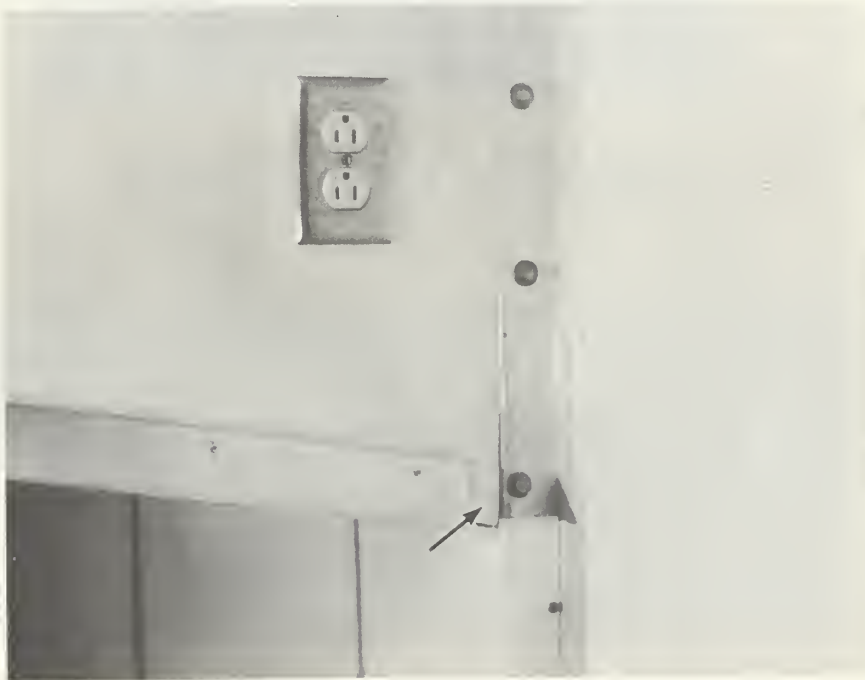
damaged areas are shown in figures 2.24b, c, and d. Inspection of the interior of the building indicated that the west longitudinal ridge beam between the transverse beam and south end wall slipped down at the connection to the transverse beam (about 1/4 in relative to the transverse beam and roof), pulling the screws out of the roof panels near the center of the building as shown in figures 2.24c and d. Slight buckling of the transverse beam aluminum skin at the transverse beam to wall connection was also observed; this is shown in figure 2.24b.

(b) Damage area No. 1, Buckle
at beam to East wall connection

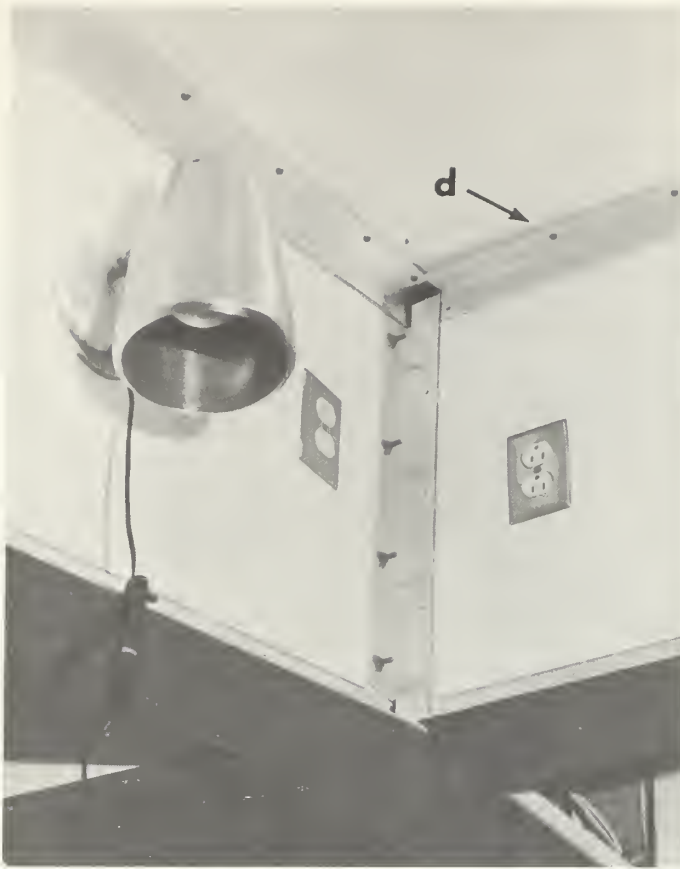
The roof was loaded as shown in figure 2.25. The ridge beams must transmit a large reaction from the roof load through the connection into the transverse beam. Close examination after all testing was complete showed that the rivets connecting extrusion A to the ridge beam had been sheared. Although this was not found until after all testing was completed, it accounts for the observed failure. The failure pattern is shown in figure 2.25b. As the rivets sheared, the reaction was transferred from the connection into roof panel P by means of the screws connecting ridge beam B to roof panel P. These screws could not carry the load so they pulled loose from the roof skin as shown in figures 2.24d and 2.25b.

(c) Damage area No. 2, Screws pulled of roof panel at ridge beam to transverse beam connection

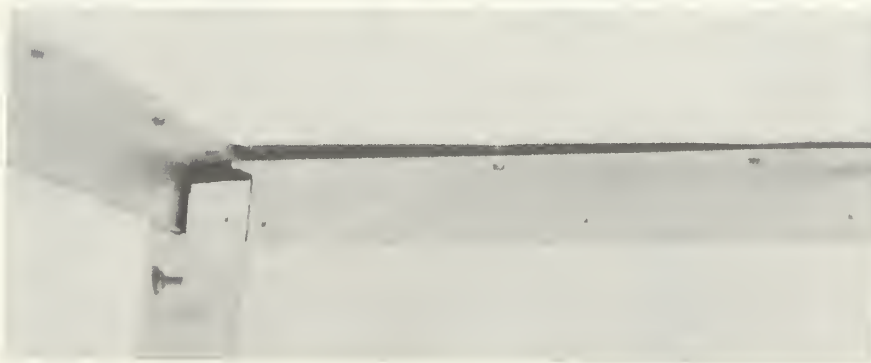
(d) Closeup of separation at damage area No. 2

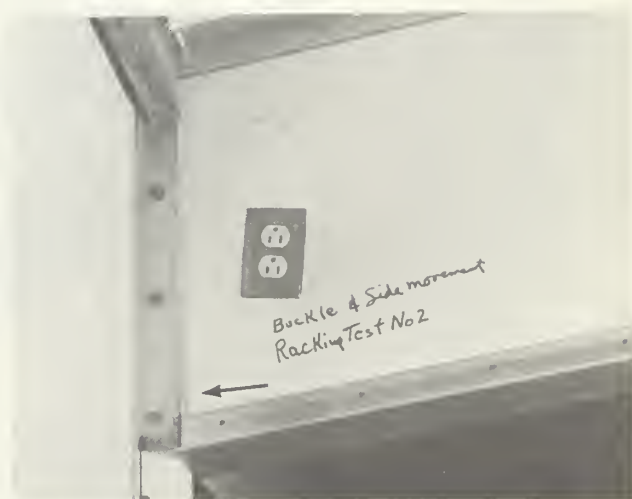
(c) Damage area No. 2,
Buckle at transverse beam to
West wall connection

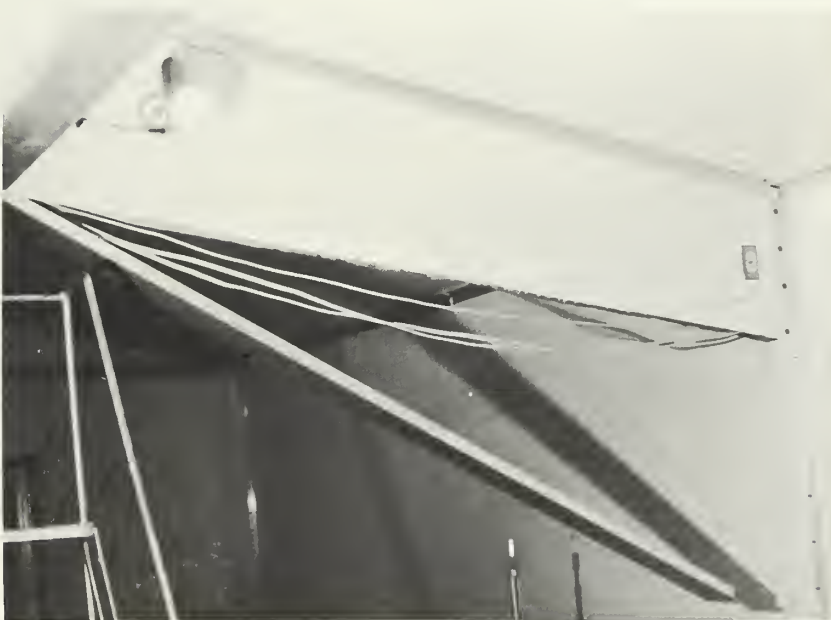
Most of the load in the transverse beam is carried by the extrusions in bending. After the rivets sheared, the load was transferred into the aluminum skin which fractured due to stress concentration at the corner of the cut out. The fracture of the beam reduced the stiffness of the roof system and probably accounts for the flexible load-deflection relationship shown in figure 2.36 for racking test No. 3.

(b) Closeup of damage area

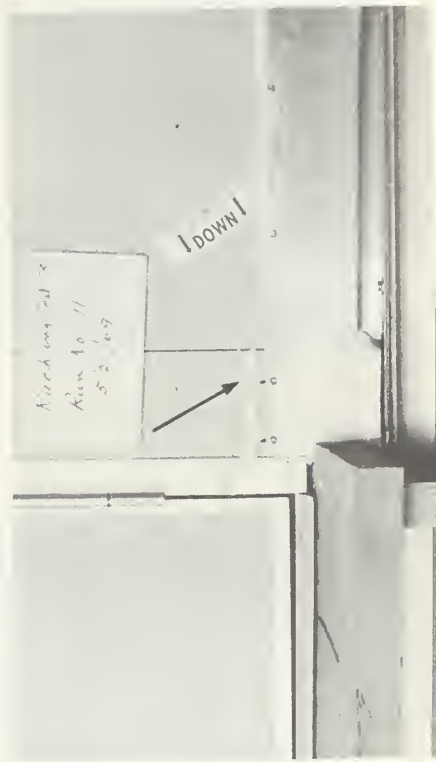
(c) Lower right hand side of South door

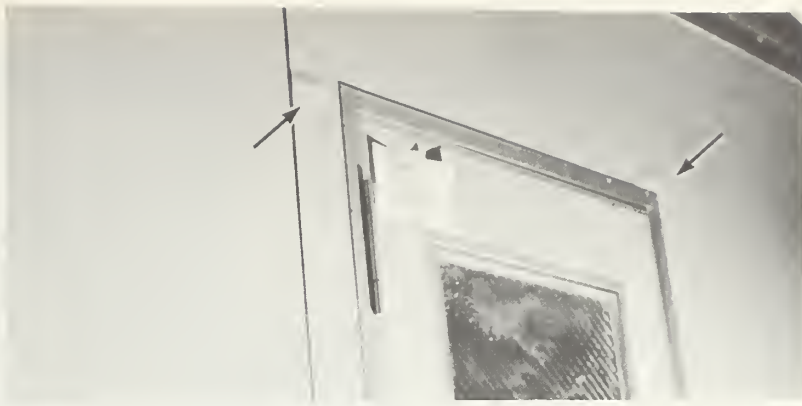
Exterior damage is shown in figure 2.38. Much of this damage was concentrated around the doors of the north and south end of the building. Damage around the north door is shown in figures 2.38d and e. Both faces of the skin on the panel containing the door wrinkled immediately above the door as shown in figure 2.38d. The screws connecting the door panel to the bottom extrusion tore through the skin on the tension uplift side of the door panel as shown in figure 2.38e. Similar damage is shown around the south end door in figures 2.38b and c. The screws shearing through the door panel skin had relative movement on the order of $5/8$ in. Typical panel to panel buckling of two end wall panels is shown in figure 2.38f. Damage of the

(d) Buckling at top of North door

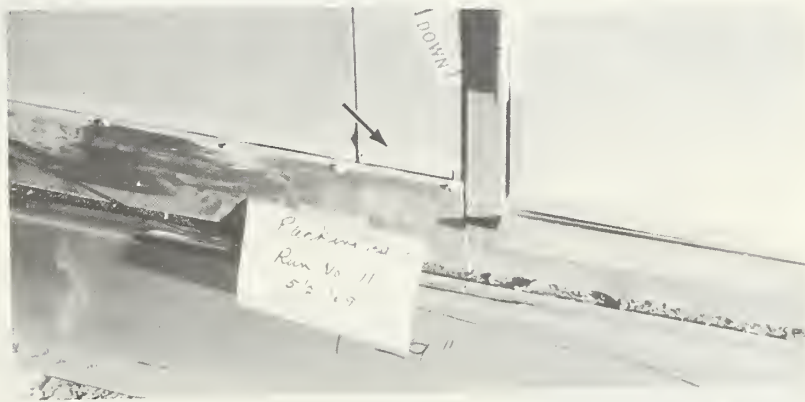
(e) Bottom of North door

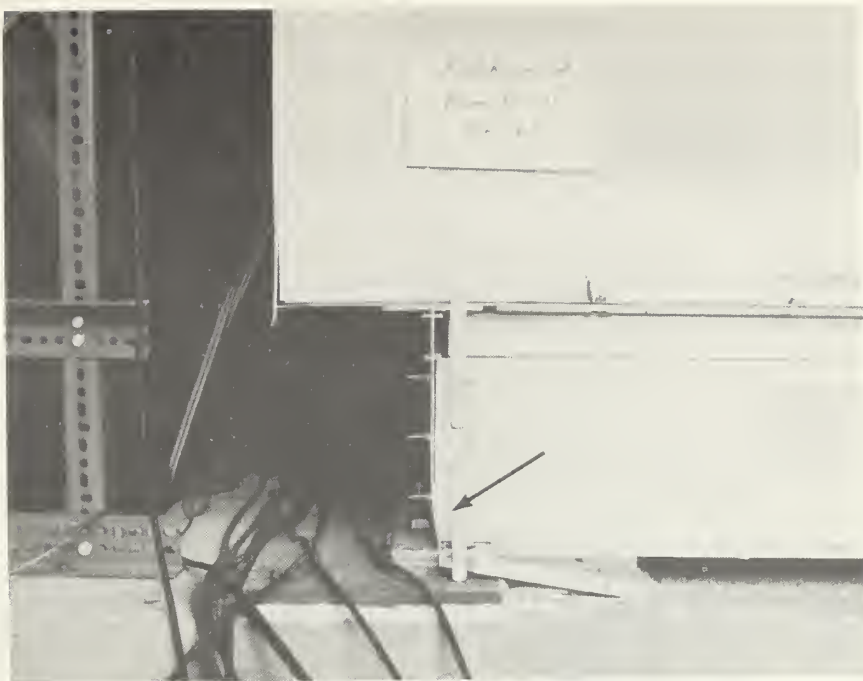
(g) Sheared web of longitudinal beam
at Southwest corner

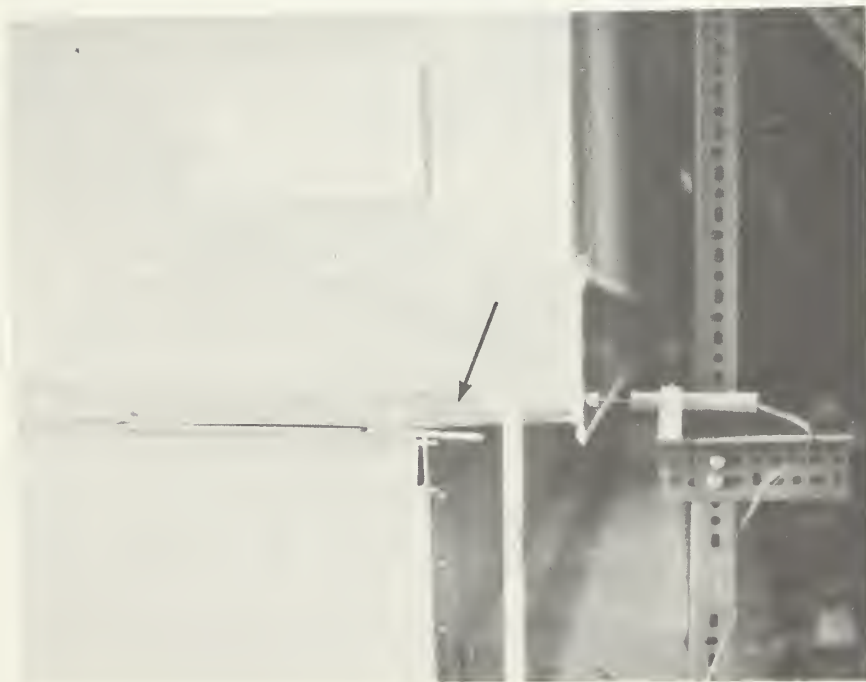
(h) Uplift at Southeast corner
