# NATIONAL BUREAU OF STANDARDS REPORT

10263

## REPORT ON THE INVESTIGATION OF CERTAIN DEFECTS AND DEFICIENCIES IN TRAILER-TYPE HOUSES ON KWAJALEIN ATOLL MANUFACTURED BY NORTHLAND CAMPS, INC.

Department of the Army  
Honolulu District, Corps of Engineers  
Fort Armstrong  
Honolulu, Hawaii

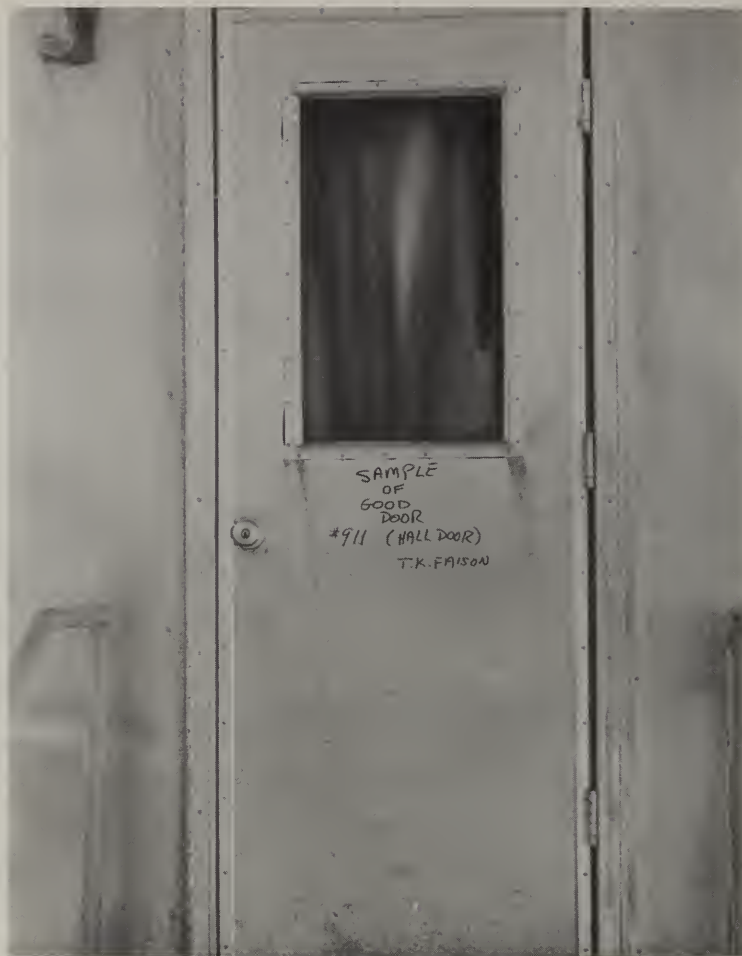
The doors were examined for delamination (see Table 1). In cases where delamination was evident, the cause appeared to be the field application of the screwed-on weather stripping flange added subsequent to original installation. The screws were just long enough to penetrate through the  $1/4$  inch hardboard to which the aluminum skin was bonded. It appeared that the screws caused the cracks between the hardboard and the solid wooden frame member.

Two sample doors, one shown in figure 5, were selected during the field investigation to be returned to NBS for laboratory study. Sample #1 was taken from house 911 and was a door having the least amount of warpage for the original type doors observed,  $1/8$  inch at both points of measurement. Sample #2, taken from house 894 was the most warped,  $7/16$  inch along the diagonal.

Figure 5 . Exterior door taken as sample. Note weatherstripping added after installation at door perimeter.

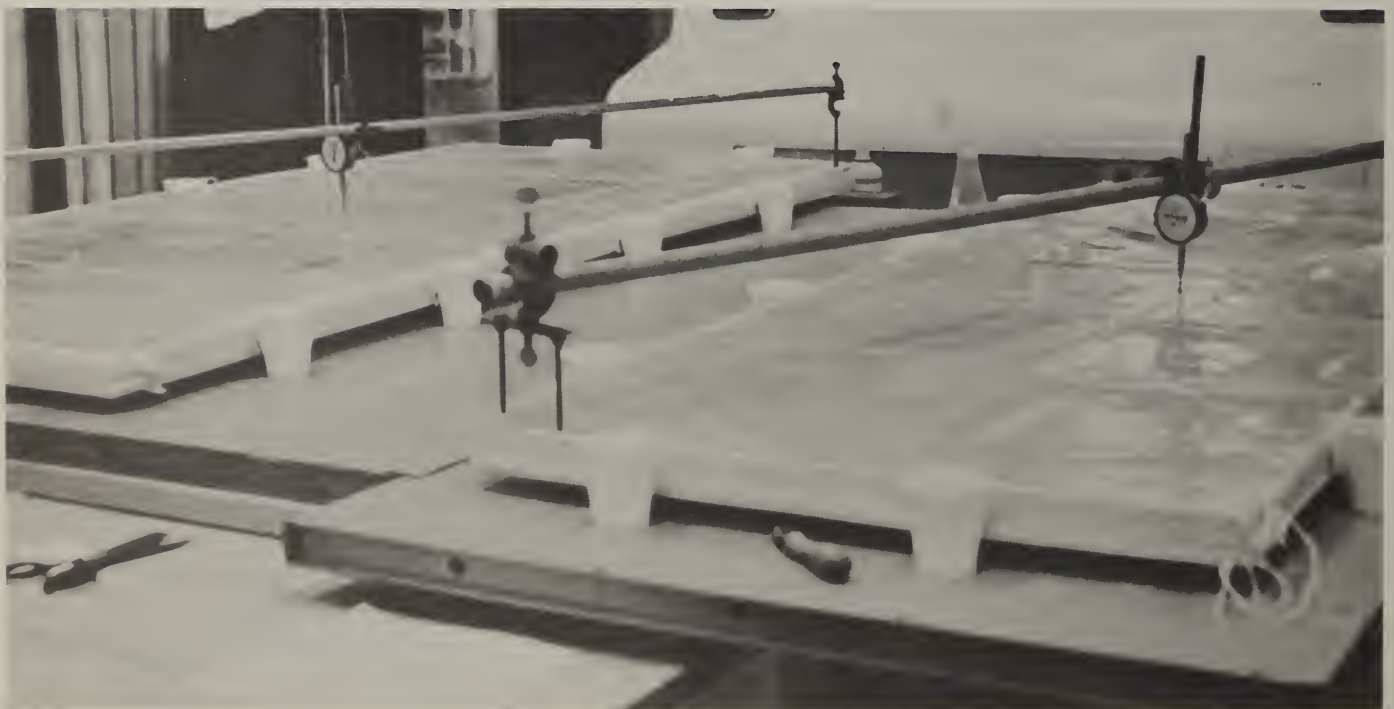
In the laboratory the two samples were mounted horizontally on metal pads and were supported at four points. This test set-up is illustrated in figure 6. Deflection gages sensitive to 0.001 inch were mounted to indicate the relative changes in deflection caused by warpage. The doors were subjected to temperature gradients encountered in normal conditions and were exposed to moist conditions to determine the warpage reaction.

Under these conditions, Sample #1 although erratic at the start of the test settled down to a rate of change of approximately 0.003 inch per day deflection along the diagonal. The other sample, #2, was more responsive at 0.007 inch per day. The warpage in both cases was in the same direction as was observed in the field, convex with respect to the interior surface. These short term tests were conducted in a three week period. Over an extended time (90 days or more), changes at the indicated rate could produce significant dimensional changes (.5 inch).

Figure 6 . Laboratory tests for warpage of doors.

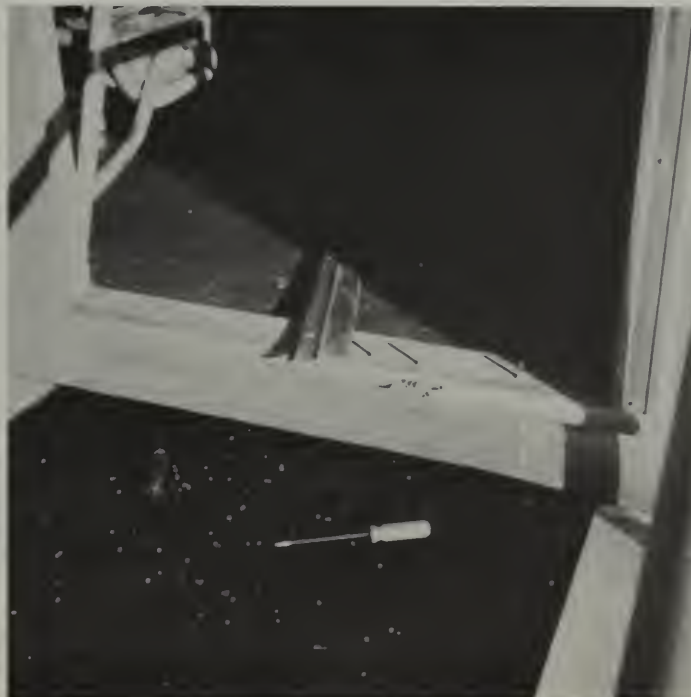
The exterior doors and jambs were manufactured with tongue-and-groove metal weather stripping members around the inside perimeter of the door. Wind-driven rain could penetrate to the weather stripping thus allowing the door edges to be wetted at the joint between the door and jamb. In some cases, because of door warpage, which was accelerated by the edge wetting, the weather stripping did not adequately perform its intended function. As the warpage became increasingly large, the mating of the weather stripping members was not accomplished and water leakage into the house interior resulted. The location of the weather stripping with respect to the threshold also contributed to water leakage. The vertical weather stripping was positioned near the center of the ends of the threshold plate which, as designed, allowed water to drain to the interior of the house rather than providing positive direction to the outside. Figure 7 shows construction of the weather stripping at house 811 and its position in relation to the threshold plate. Water which ran down the weather stripping could also leak to the interior through the uncaulked end joint between the threshold and jamb. Lack of caulking under the threshold plate also contributed to leakage of rain water to the interior of the house. Construction of the threshold plate from house 887 is shown in figure 8.

Figure 8. Components of the threshold assembly.

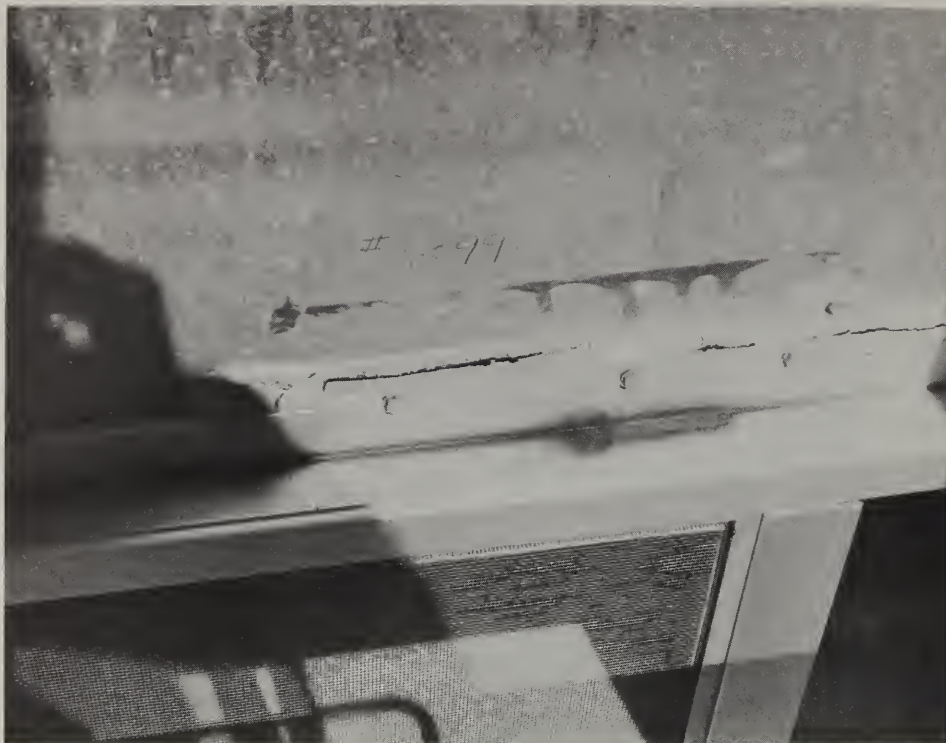
Figure 9. Cracks in the caulking above the window frame.

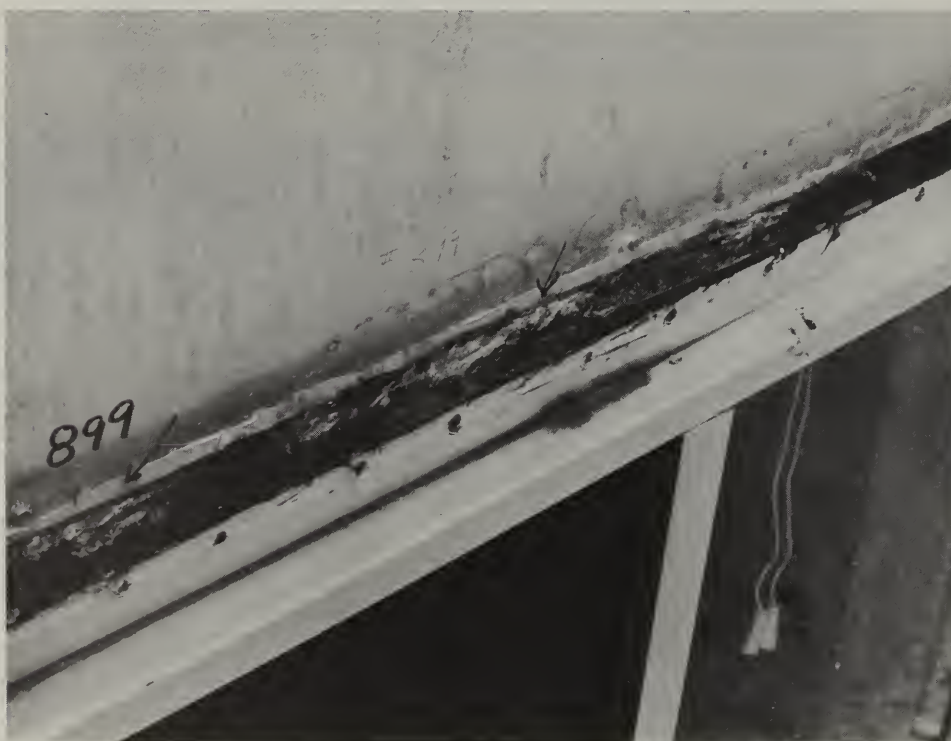
In two cases there was damage to the window sill material. Severe leakage was observed in house 899. The window above the kitchen sink was streaked and the sill material discolored. This window was selected for removal and inspection. After loosening the retaining screws and prying the window frame away from the aluminum house surface, the path of leakage was very evident. A white deposit could be traced from a crack in the caulking material through the butyl rubber type gasket of the window in house 899. The crack in the caulking and the path through the gasket material is evident in figures 9 and 10. The gasket was very tacky as shown in figure 11 and resisted the removal of the frame. The gasketing of the joint between the aluminum skin and the window frame appeared to be of adequate design but there was, as evidenced by leakage, inadequate bonding at one point. It was observed in all houses inspected that the spacing of the screws around the frame perimeter was irregular. With thin framing material and excessive spacing between

Figure 10. Window assembly pulled away from the opening.

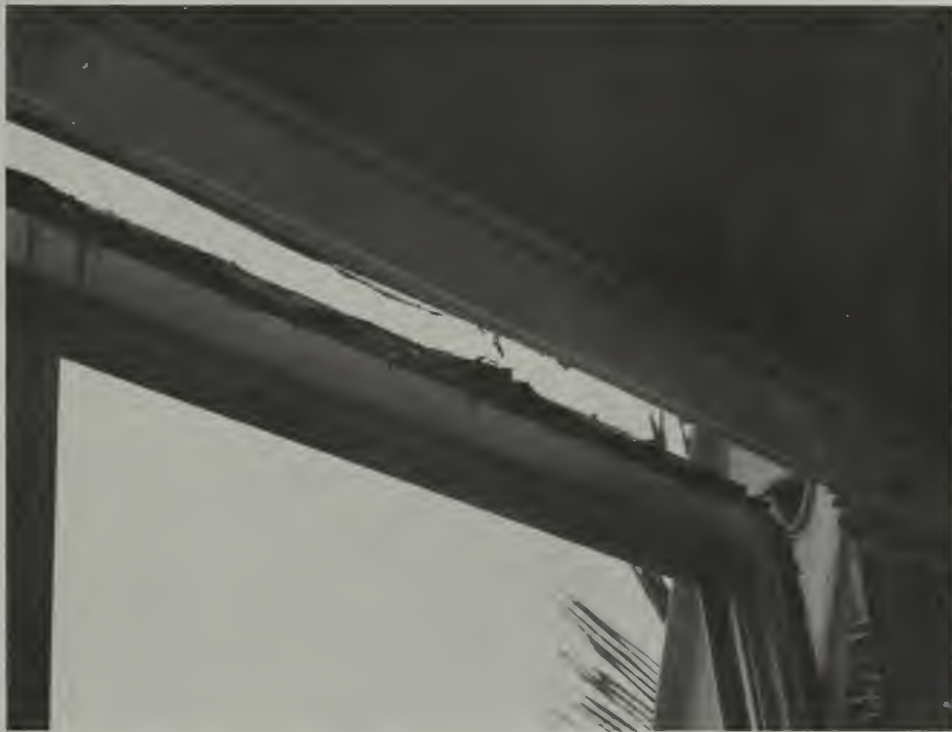
screws, the gasket material might not be compressed sufficiently for gasket bonding between the aluminum skin and window frame. Placement of the gasket over improperly prepared surfaces could also be a cause for leakage, such as occurred in house 899.

Figure 11. View of the window assembly and gasket material from inside the housing unit.

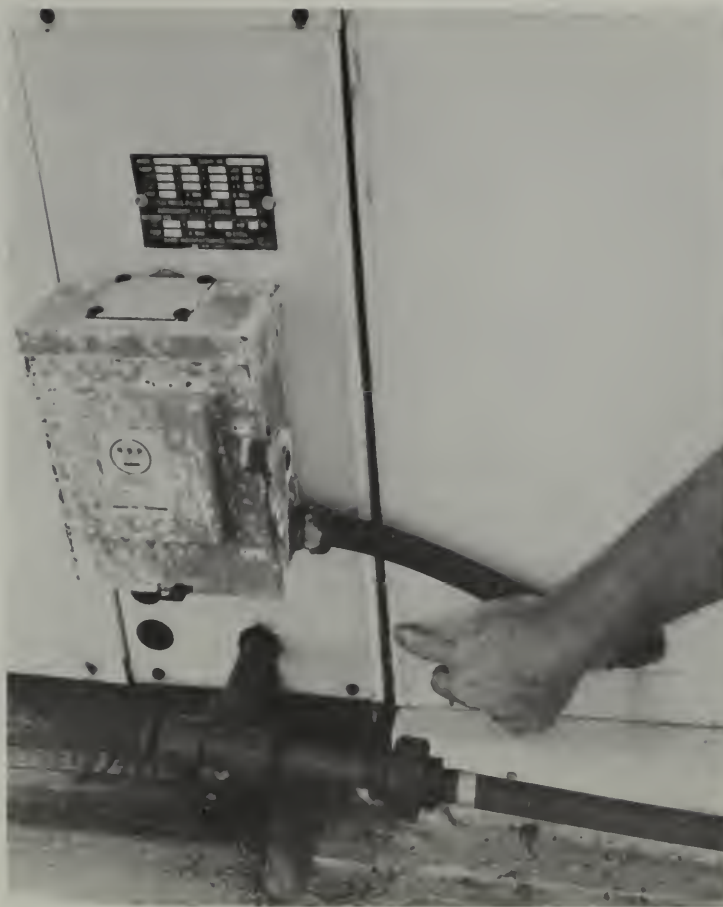
A terminal switch box as shown in figure 14, was mounted on the exterior of each of the air conditioner cabinets and could have contributed to the leakage problem. The power lines, prewired at the factory and placed in the air conditioning duct work, were run from either the supply or return opening through the side of the plenum cabinet to the switch box. A flexible conduit (vinyl) was used to make the connection between the plenum and the switch box. The connection between the conduit and the cabinet may have provided a path for water to enter the plenum.

Figure 14. Vertical joint between plenum and air conditioner cabinets showing joint width.

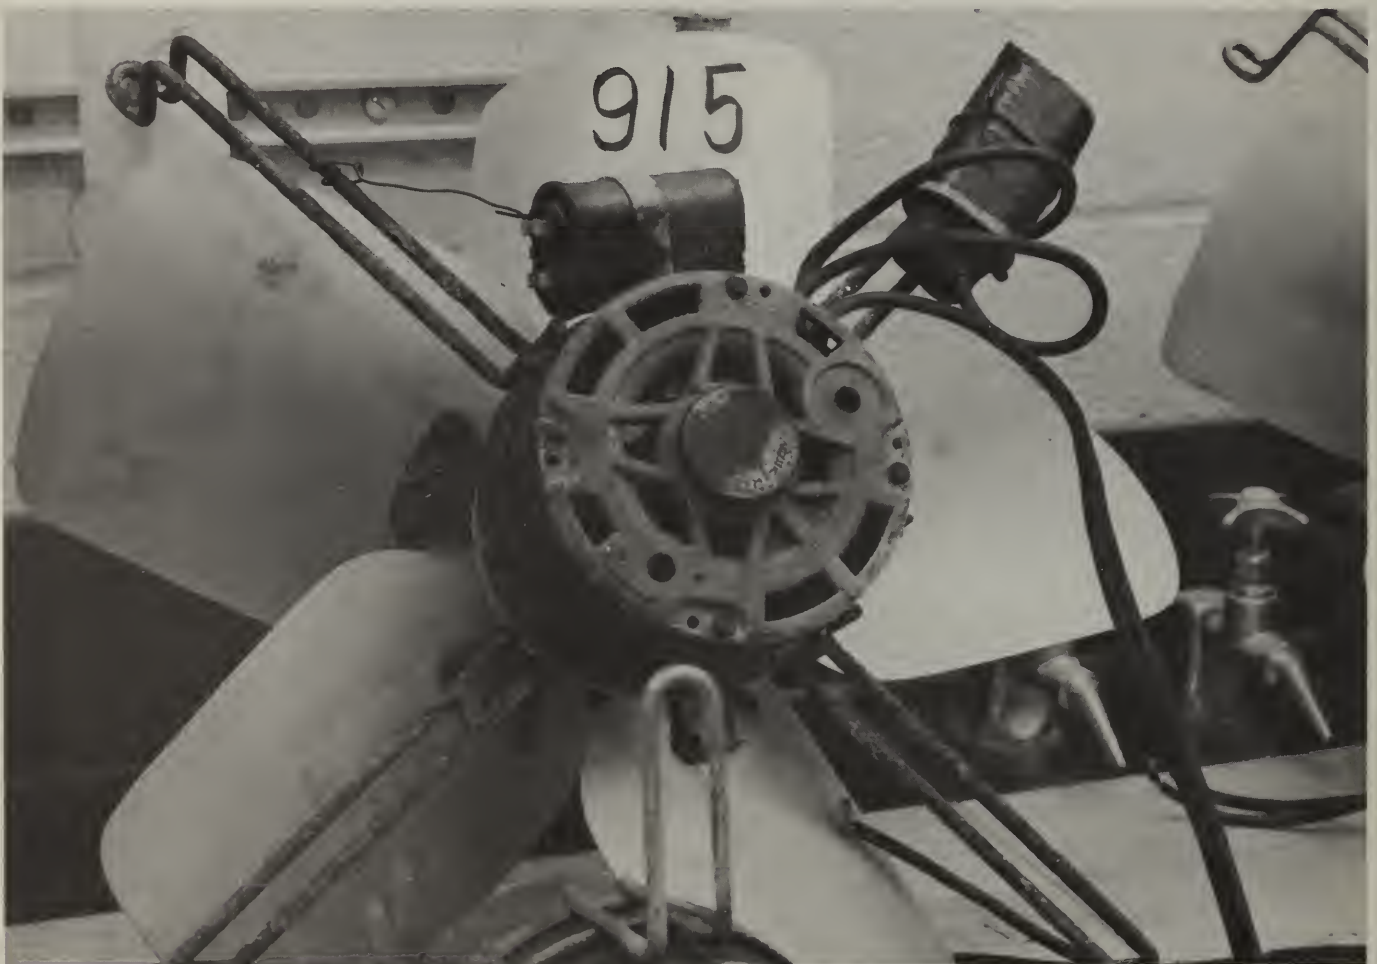
It became evident during our inspection that failure of the starting capacitor for the condenser fan motor was a major, and probably the principal, factor in the subsequent damage to the motor. It was observed that, as originally assembled, the capacitor for the condenser fan motor was mounted in such a way that the capacitor leads were held against the end of the capacitor. Abrasion rapidly wore holes into the capacitor and in the wire insulation, with resultant shorting of the capacitor, and grounding of the wire against the capacitor. Figure 27 shows this problem on the motor removed from house 853. Figure 21 shows how replacement capacitors have been positioned to avoid this problem.

Figure 21. Condenser fan and motor removed from house number 915. Note motor bearing end cap on which model number was stamped and placement of original (left) and replacement capacitors.

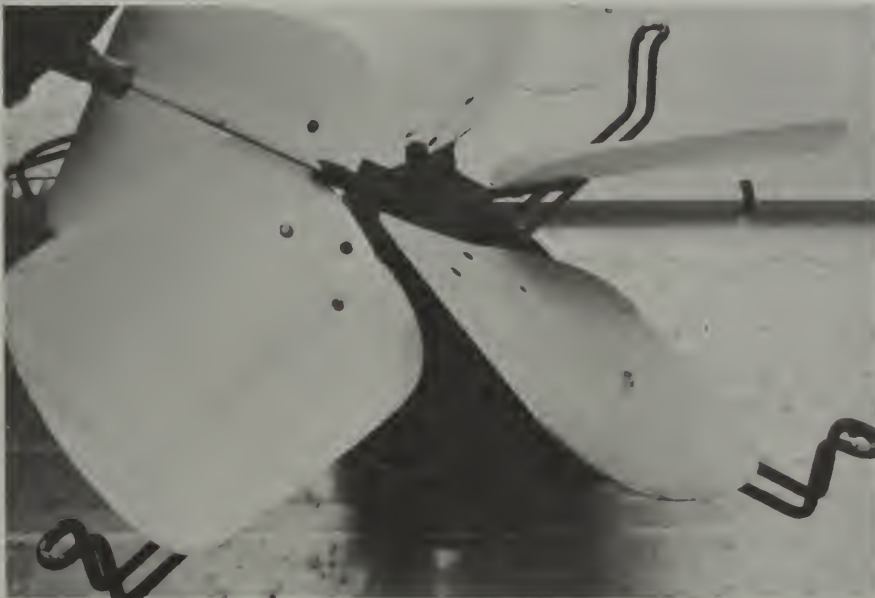
It was not possible to determine in every case whether the motors inspected were original or replacement. In some cases replacement motors could be identified by the length of the shaft. The original shaft length was 3 inches. To facilitate subsequent fan removal the shafts of the replacements, according to Global Associates maintenance personnel, were cut off so as not to extend beyond the fan hub. Figure 23 shows the original shaft length and where the shaft was cut for replacement motors.

Figure 23. Condenser fan motor showing original length of shaft.

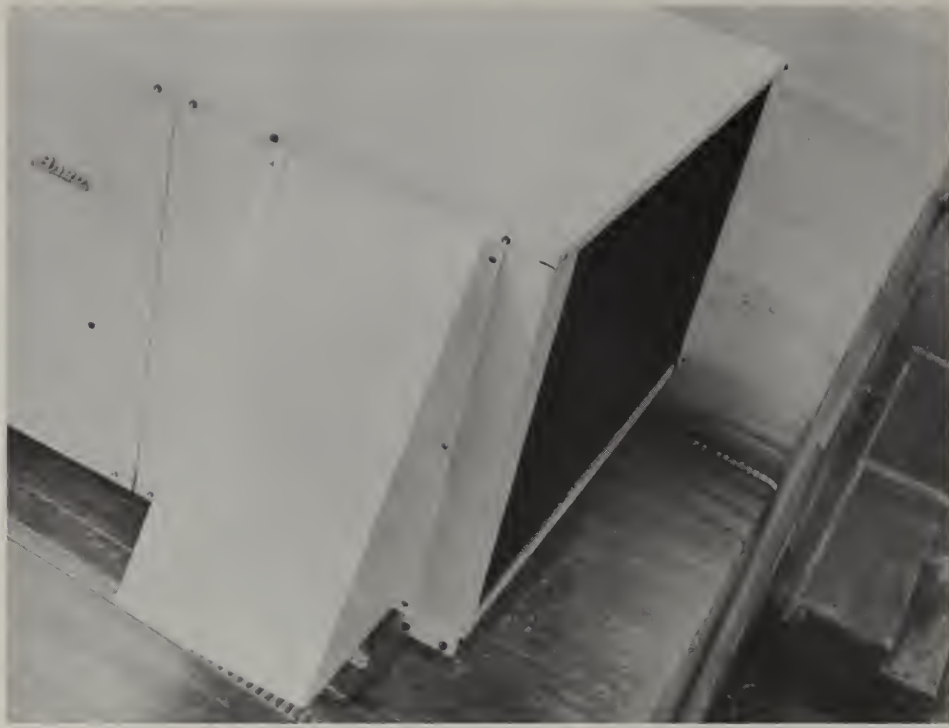
It was noted that, subsequent to original installation, shields had been fabricated and installed (in place of original grilles) over the condenser air inlet openings on each side of each air conditioner. See figure 24. The stated purpose for this addition was to reduce windmilling of the condenser fans.

Winds were moderate, probably less than 20 mph, during most of the inspection. Some windmilling was observed. Where the wind entered directly into the condenser face (normal fan motion forces air out) the windmilling was about the same whether the shields were in position or removed. This was observed during the inspection at house 896. The wind direction was SE, gusty and estimated between 20 and 25 mph. Reverse windmilling, estimated at about 100 rpm, was overcome by the normal starting torque of the fan motor with longer-than-normal high current starting time. Performance of a condenser fan and motor under various starting conditions is discussed under the laboratory test part

Figure 24. Modification of the air conditioner unit by the addition of wind shields for the condenser fan section.

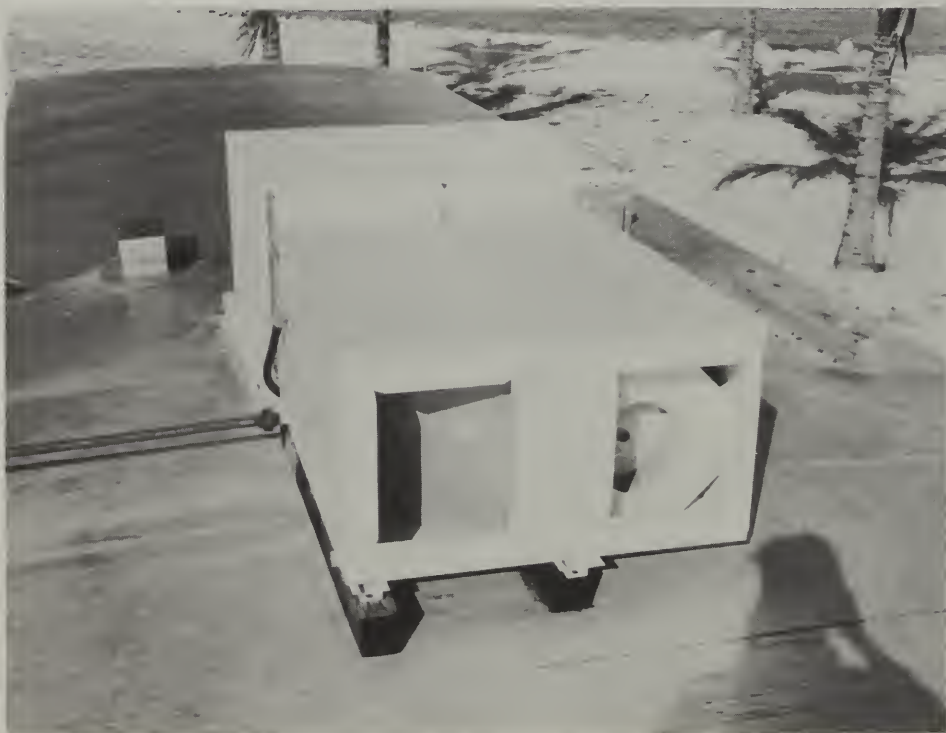
Figure 25. Replacement air conditioning unit on house 892 showing a blower type condenser assembly.

Centrifugal blowers, as required in Military Specification MIL-A-21261, would have minimized, if not eliminated, both the wind-milling and excess power effects of winds. An example of a blower used for condenser air cooling is shown in figure 25 which is a replacement unit installed on house 892.

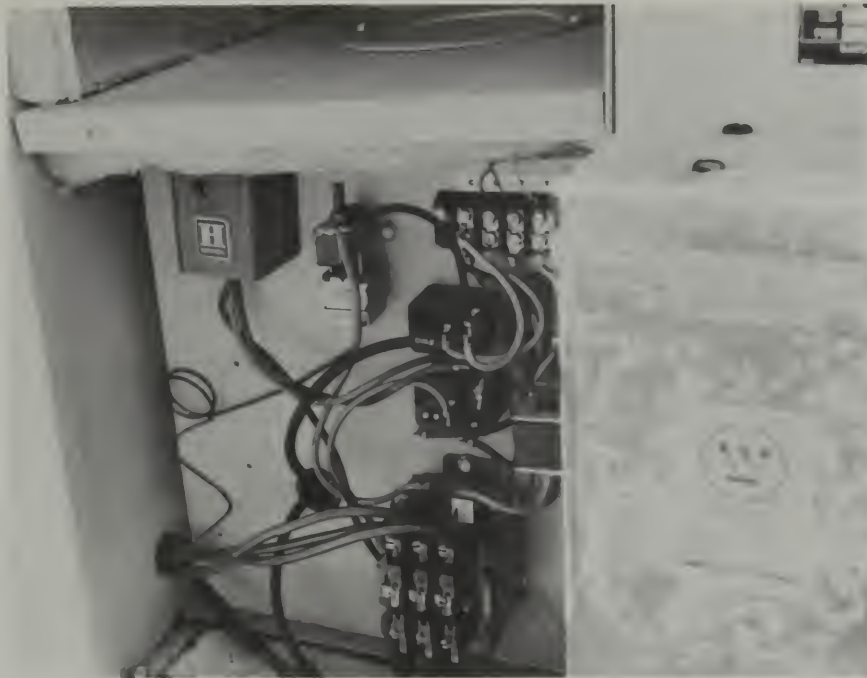
As shown in Table 3 it was observed in at least 15 of the 31 houses that the compressor high pressure limit switch was shunted by attaching both wires to the same terminal. The shunting is illustrated in figure 26 which shows the control panel of house 883. The limit switch is at the top center of the panel. It was assumed that this shunting was done to minimize service calls to reset the high-pressure control which would trip when erratic condenser fan operation occurred. The practice of shunting the high pressure switch is not recommended because of deleterious effects on motor components. Shunting causes the compressor to cycle on its internal thermal overload mechanism in the event of high discharge pressures and is accompanied by undesirable high motor winding temperatures and accelerated wear of the internal switch.

Figure 26. Air conditioner control panel showing shunted pressure switch at top center on house 883.

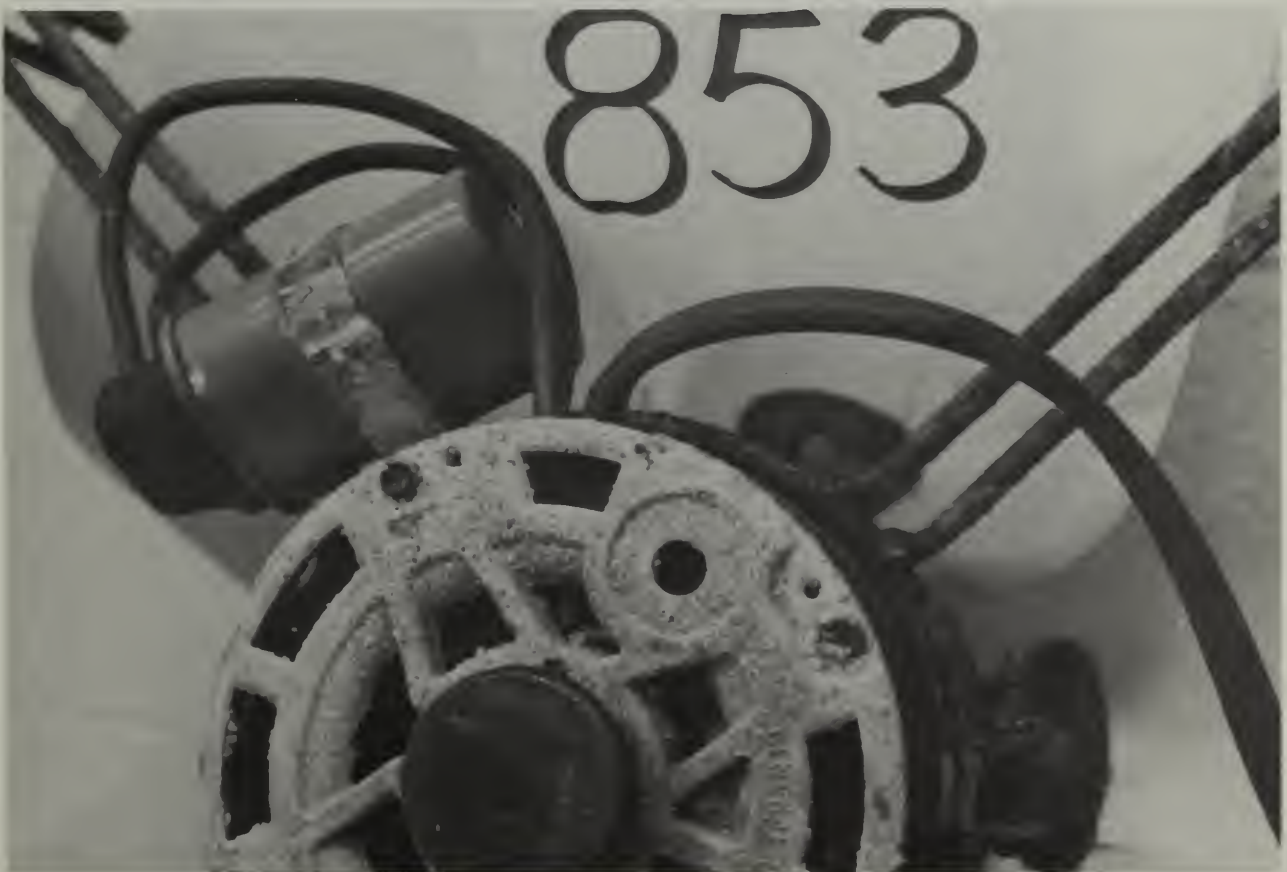
With a shorted capacitor, it was observed that the motor would run in the proper direction but at reduced speed, had higher-than-normal starting torque, and much higher current (7.2 amps) than the motor could tolerate for more than a minute or so. Under this condition, even though the internal temperature limit switch would open the circuit in about 2 minutes, the case temperature would continue to rise for a period of time after the switch would open. Off-time before the switch would reset was observed to be five or more minutes.

Figure 27. Air conditioner condenser fan motor showing capacitor lead wires resting against the case of the capacitor. Arc pits shown at the end where the case and wires have shorted.

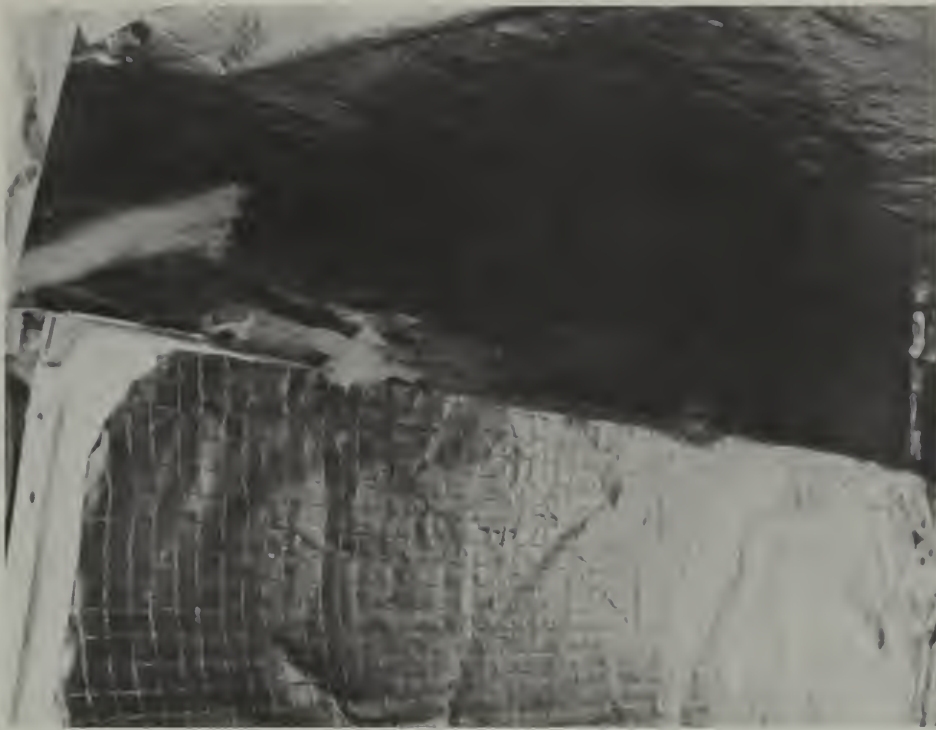
Figure 29. Detachment of insulation in supply duct of plenum on house 899.

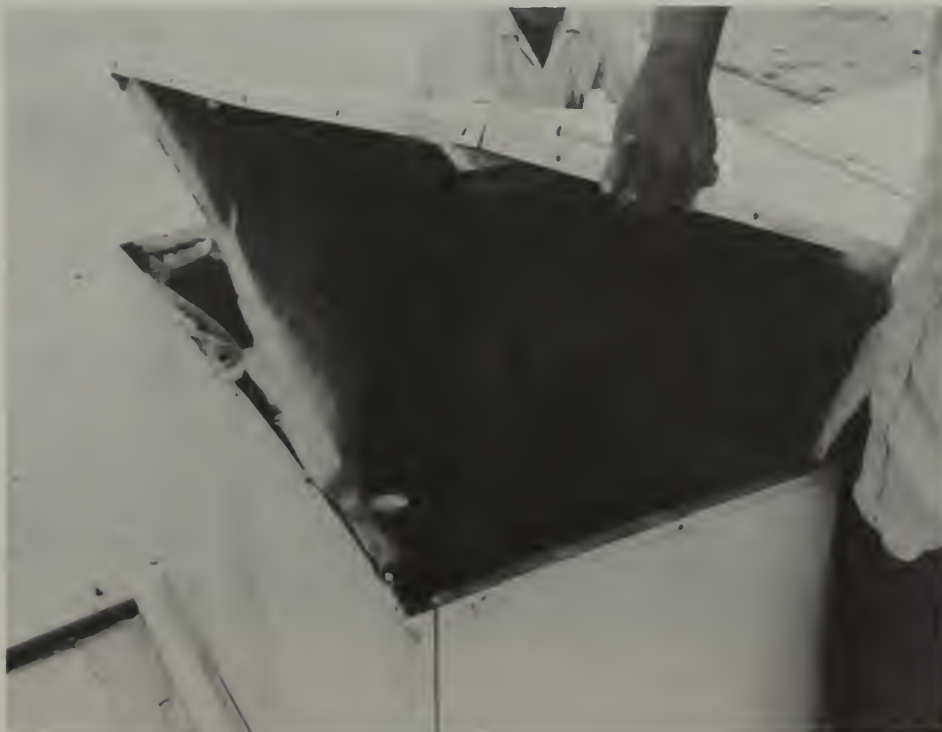
Figure 30. Detachment of insulation in supply duct of plenum on house 808.

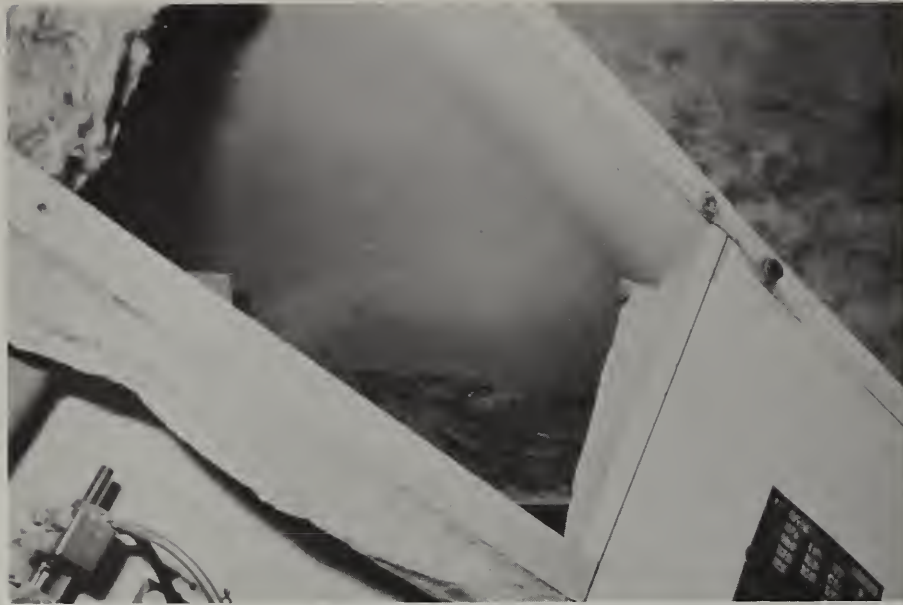
Figure 31. Photograph showing the unit portion of the supply plenum. Note that insulation is missing.

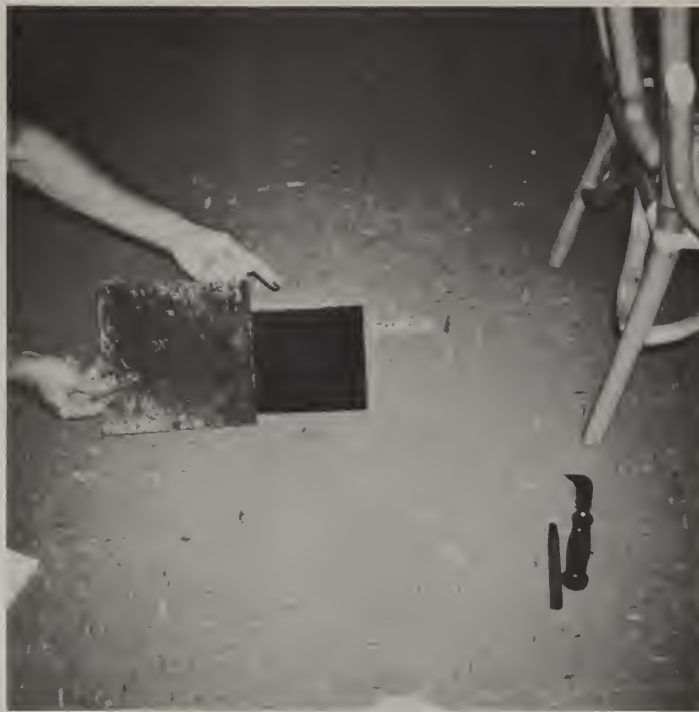
Figure 34. Typical oily characteristic of floor tile adhesive, which was easily transferred to finger with slight rubbing.

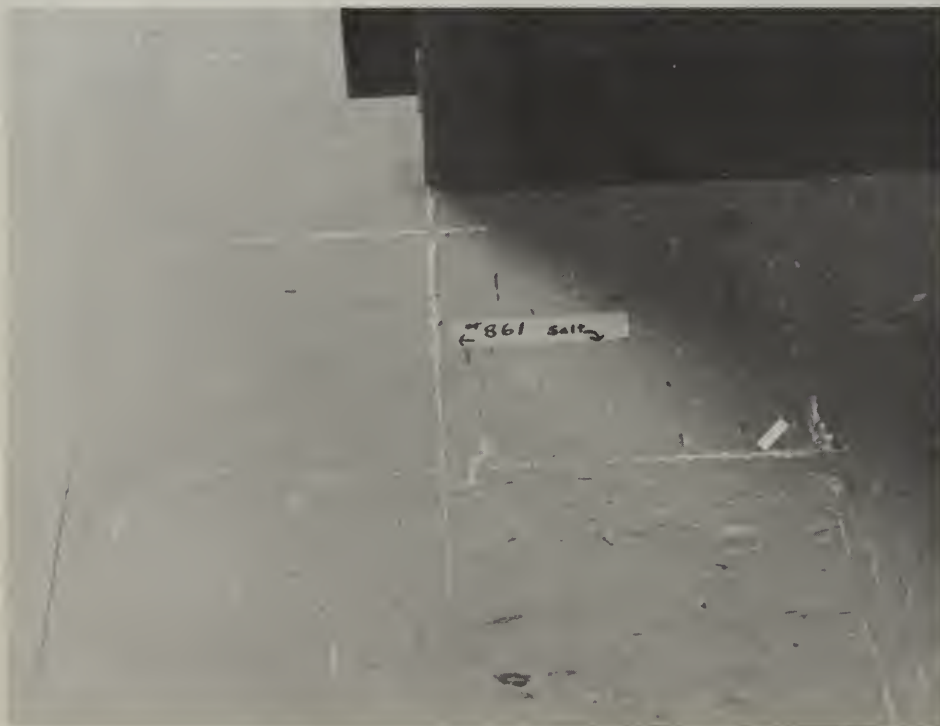
Figure 35. Mineral deposits at the tile joints in the master bedroom of house 861.

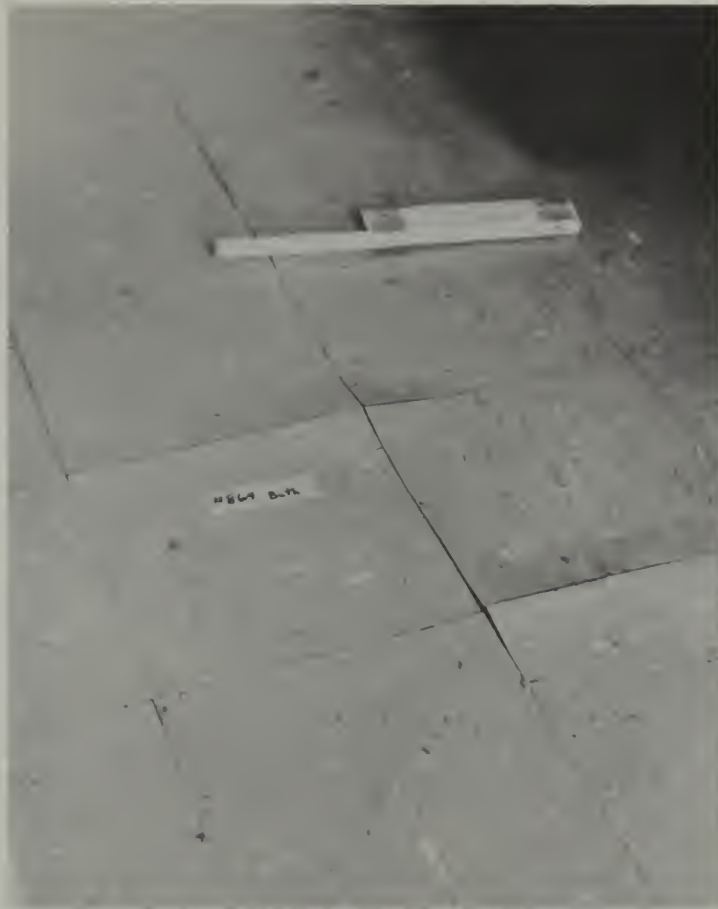
Figure 36. Buckling of the tile in the bathroom of house 864.

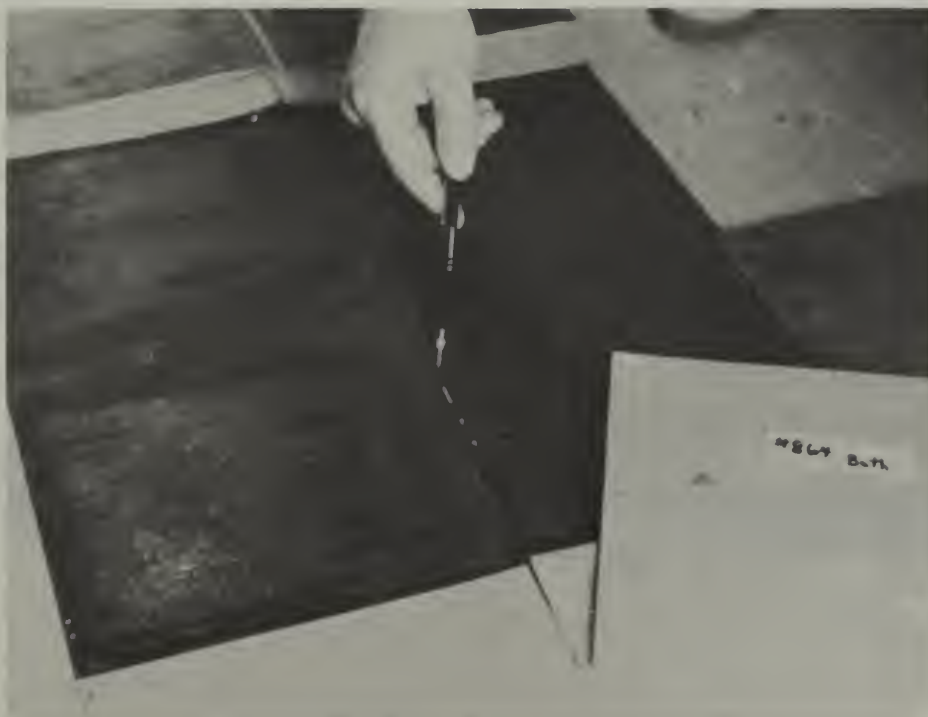
Figure 37. Water beneath the tile near the tile joints in the bathroom of house 864.

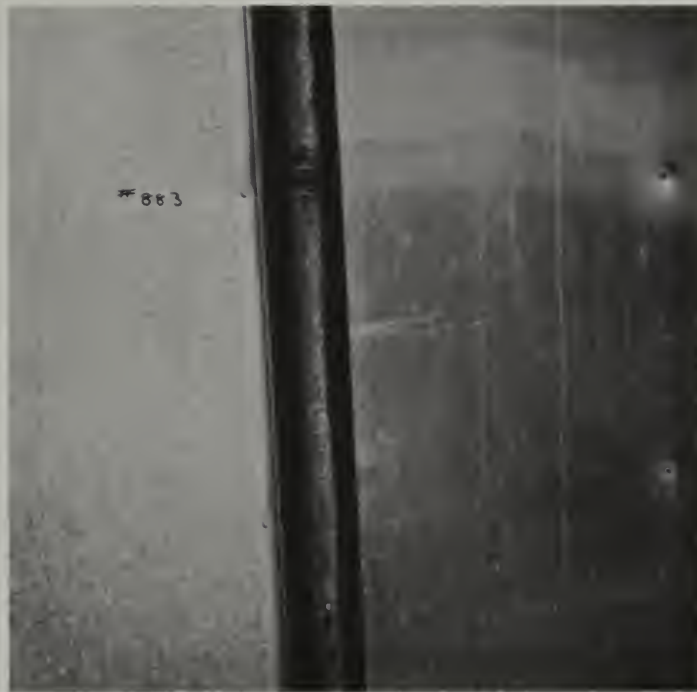
Figure 39. Corrosion on windward side of the main electrical service riser.

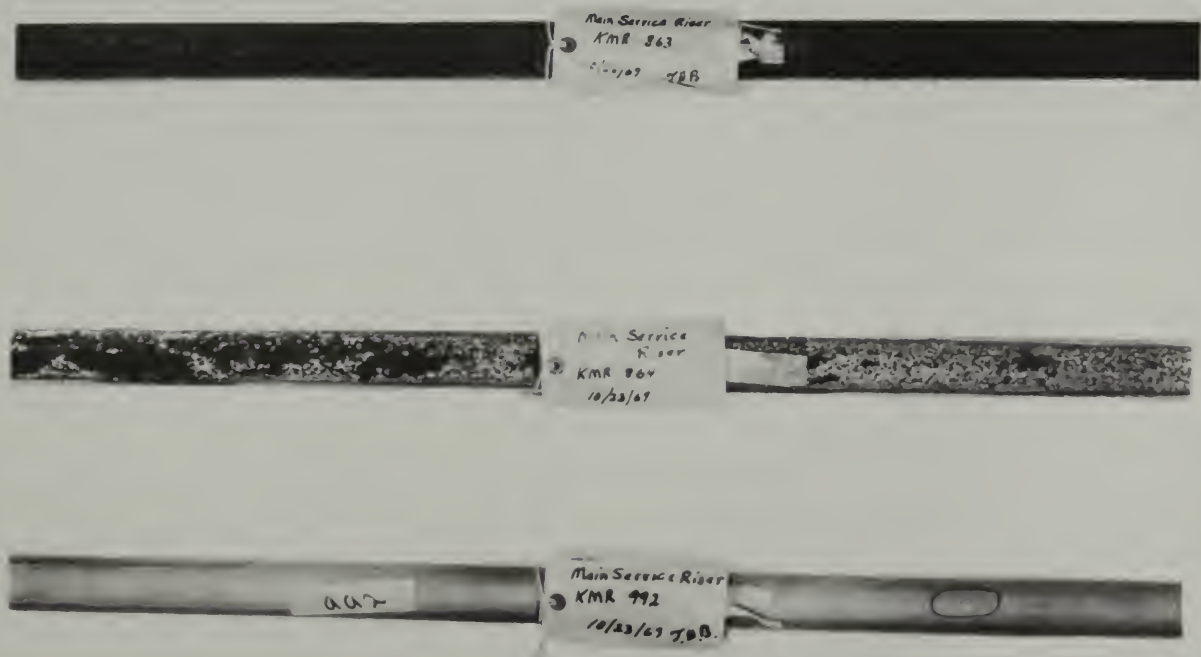
Figure 40. Comparative conditions of three sample service risers examined at NBS.

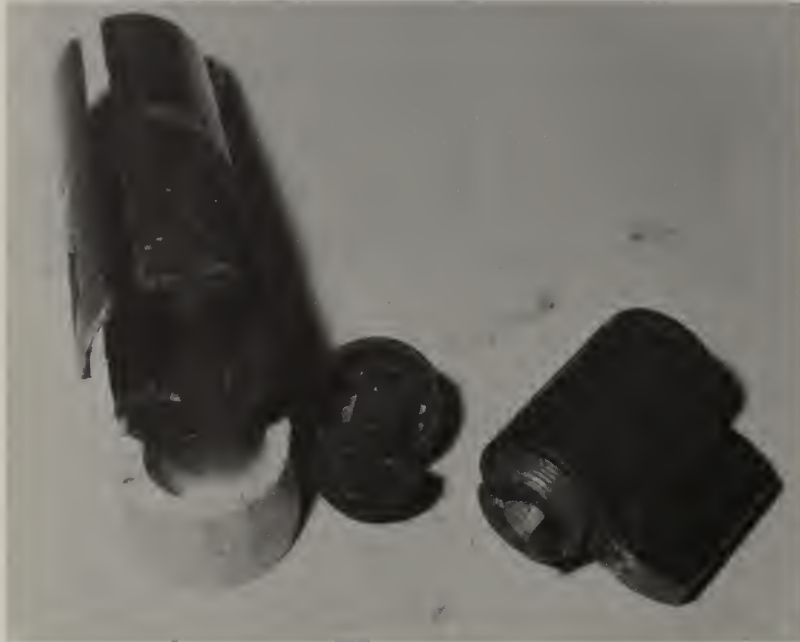
Figure 41. Lock-set cylinder assembly showing rusted components.
