FIRE ENDURANCE TESTS OF EXTERIOR WALL AND ROOF/CEILING CONSTRUCTIONS FOR SINGLE FAMILY HOUSE

January 28, 1972

Prepared for:
Department of Housing and Urban Development

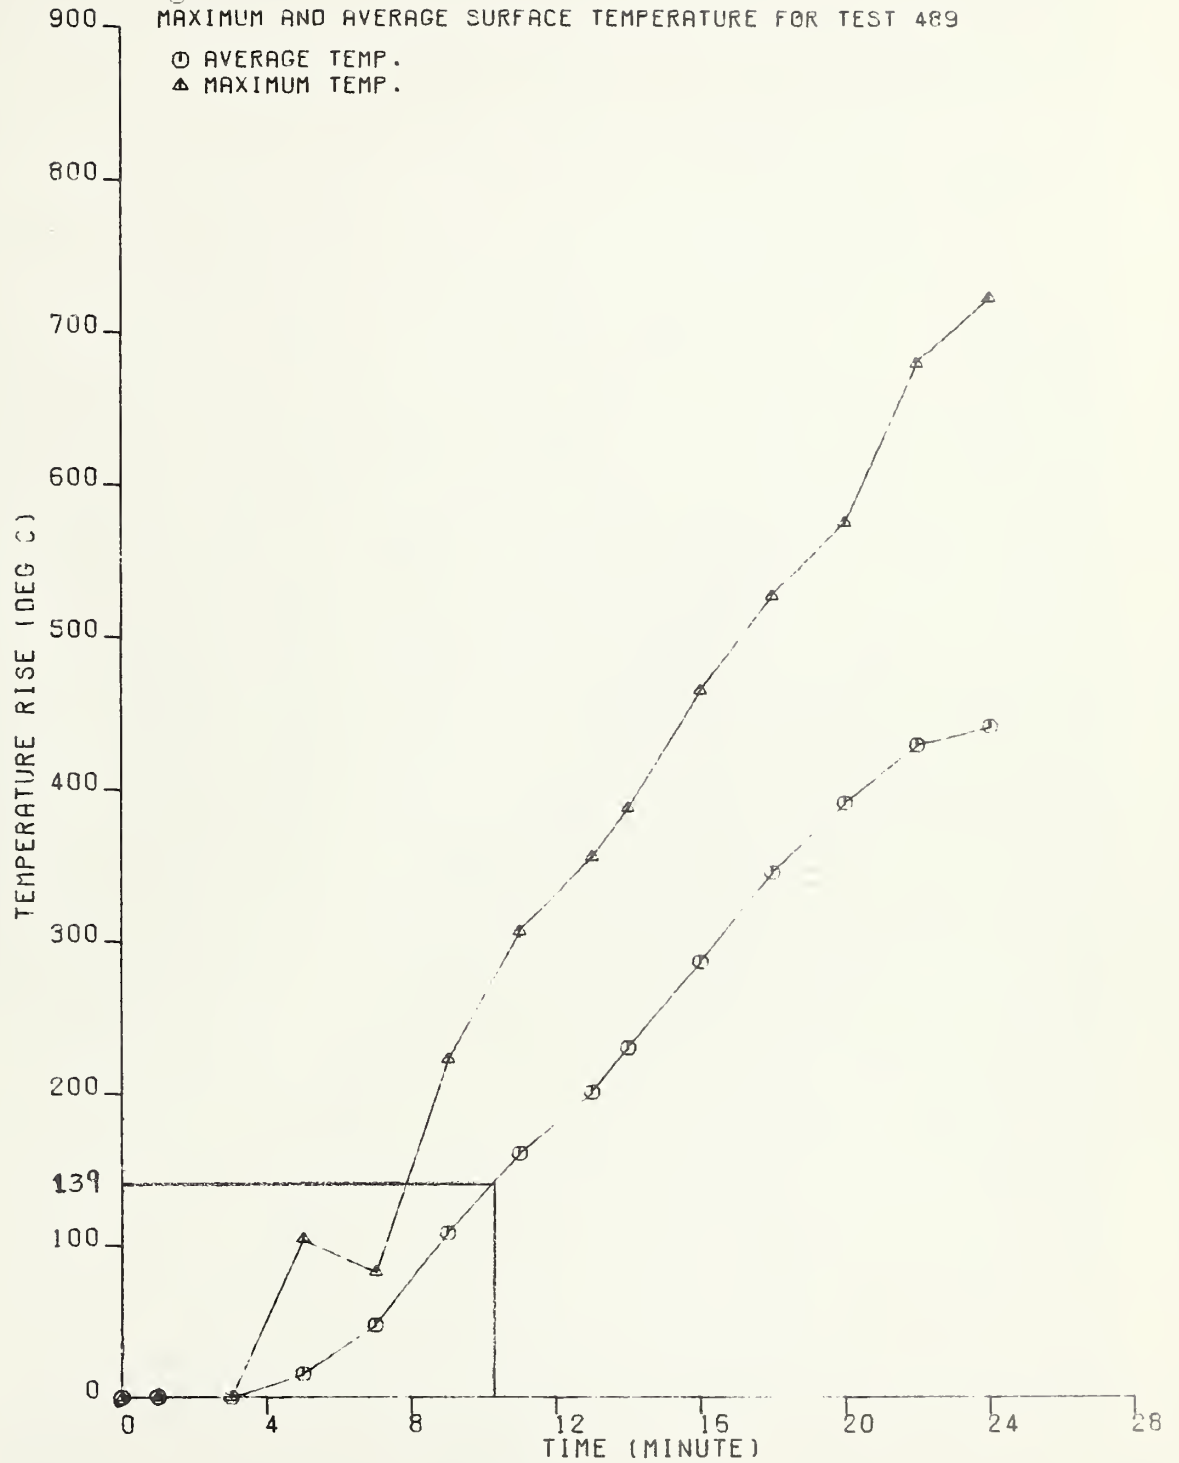
Figure 4

A log of the test observations is given in Appendix 1. The failure of the panel due to an average temperature rise of 139 C above its initial temperature on the unexposed surface was observed at 9 minutes. (See figure 4). The corrected time of failure, according to the standard correction formula in ASTM E119-69 based on the comparison of areas under the actual time-temperature curve and the standard curve, was 8 min: 20 sec. Load failure due to inability to maintain the load occurred at 23 min., and was followed by flame through at 26 min. on the south most joint.

The fire endurance of the wall assembly was 8 min:20 sec. This does not meet the 20 minute requirement in Criterion E 4.1.1.1 Volume III of the "Guide Criteria" for systems when the proximity is over 10 ft but less than 30 ft from a parallel exterior wall. The mode of failure was an average temperature rise of 139°C above its initial temperature on the unexposed surface.

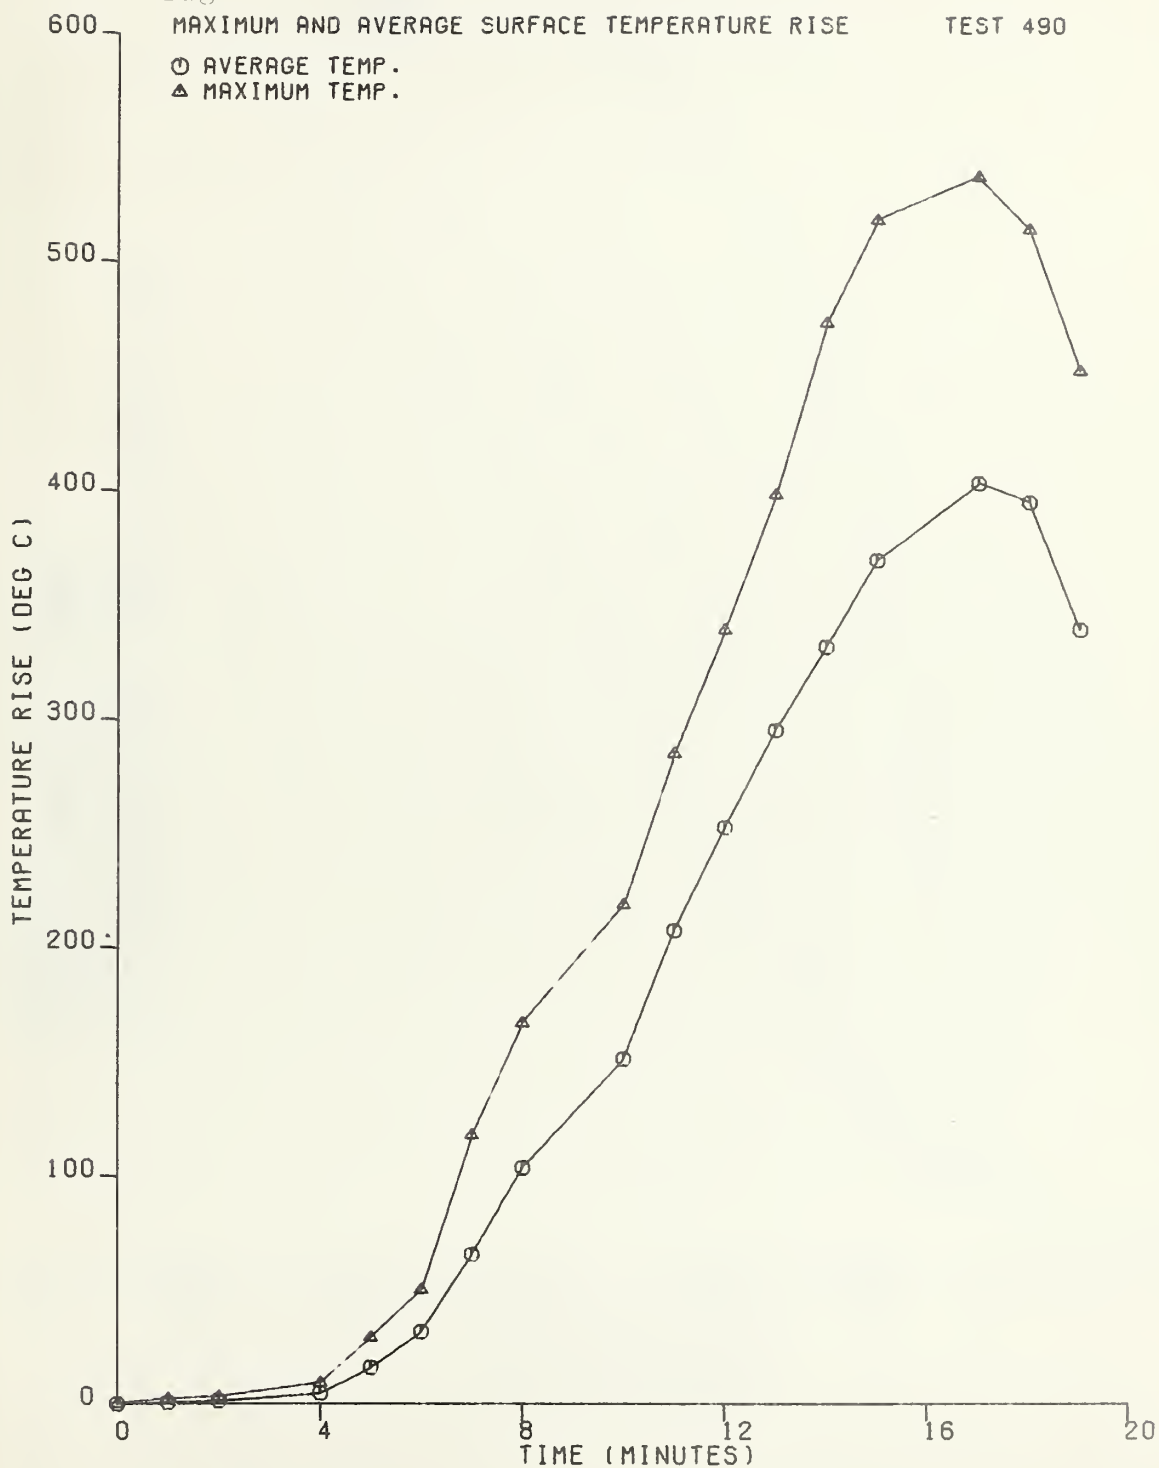
Figure 10

A complete log of the test observations is given in the Appendix I. The failure of the panel due to an average temperature rise of 139°C above its initial temperature on the unexposed surface was observed at 9 min:30 sec. as shown in figure 10. The corrected time of failure in accordance with the formula given in ASTM E119-69 was 10 min:09 sec.

The fire endurance of the roof/ceiling assembly was 10 min:09 sec. This does not meet the 20 minute requirement in Criterion A.4.1.1 Volume III of the "Guide Criteria" for a roof/ceiling in a single family housing system.

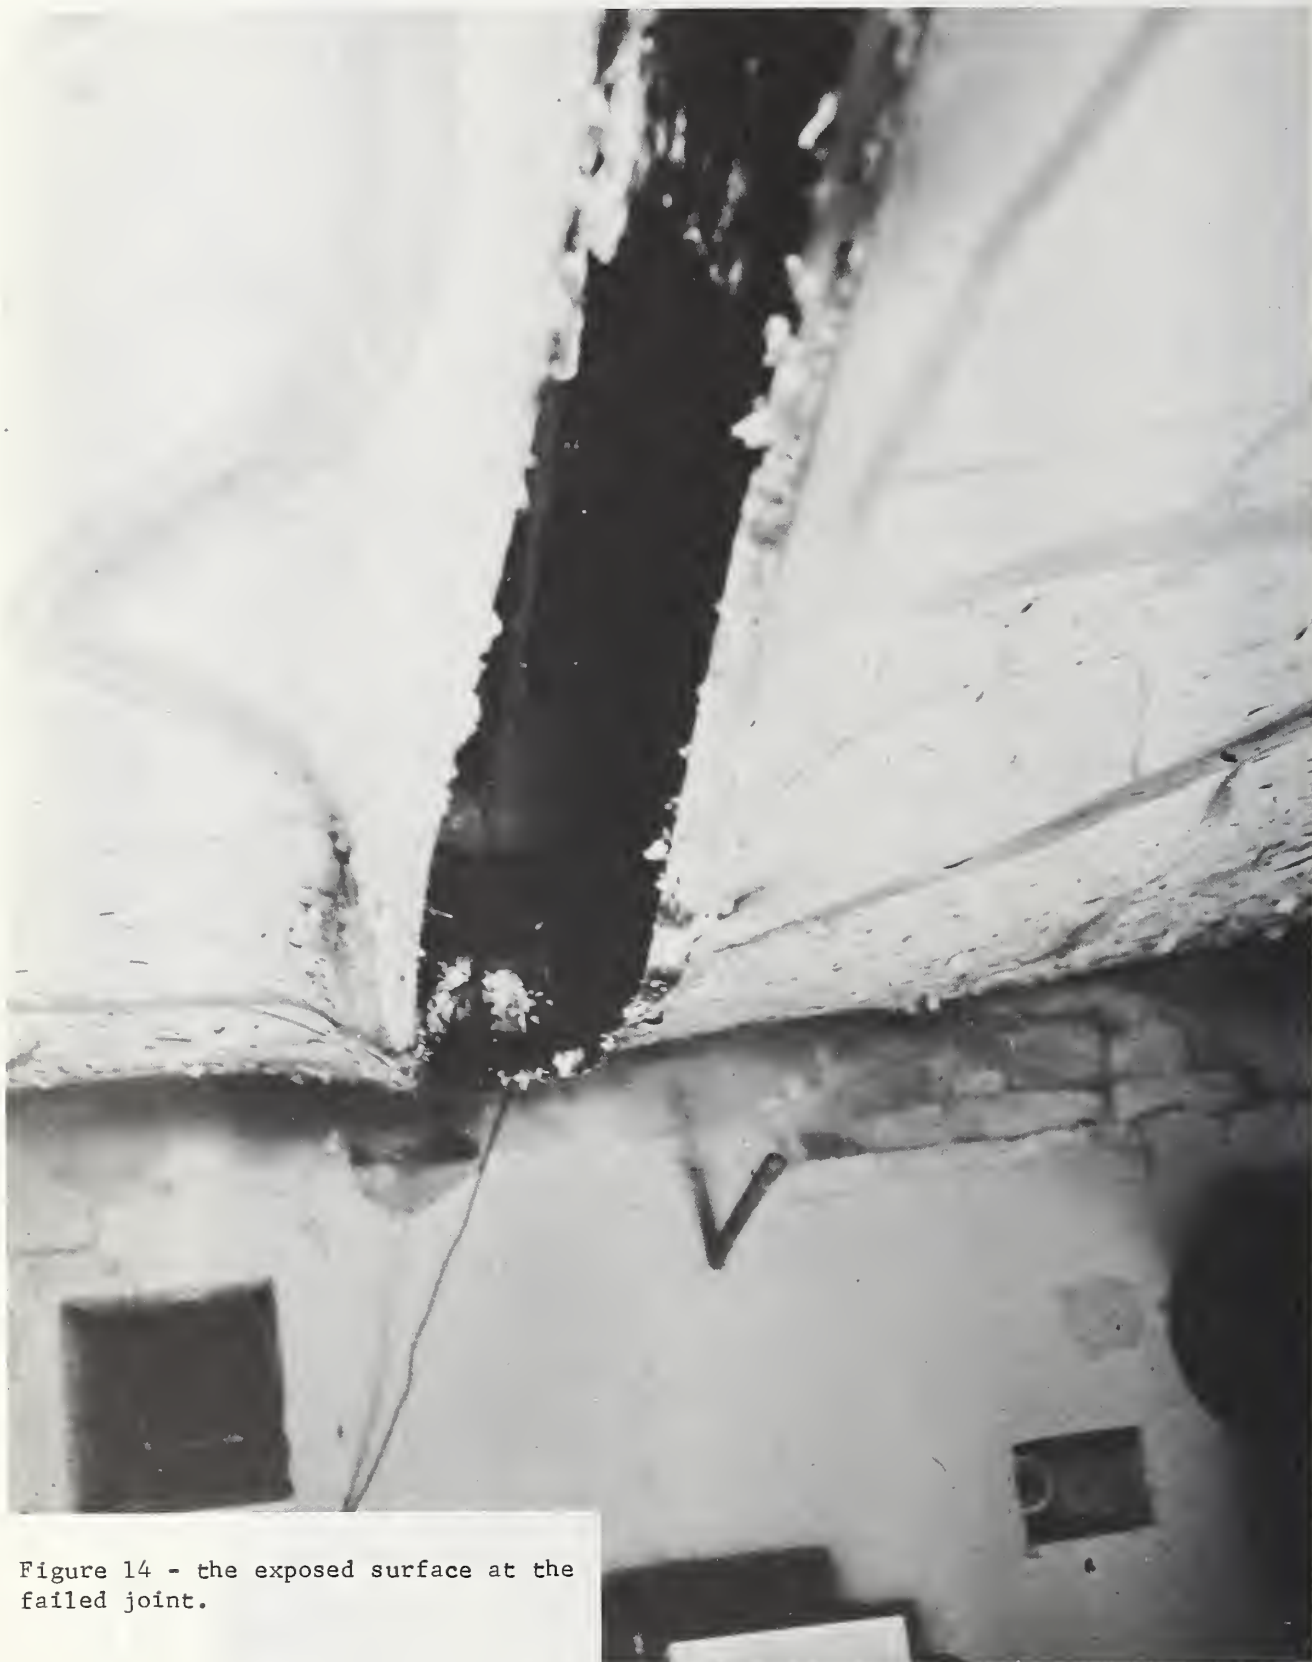
The photographs in figures 13 and 14 show the unexposed surface of the panel after the loading rigs were removed at the end of the test and the exposed surface at the failed joint. Most of the wood members and polyurethane foam were consumed except a few pieces around edges of the assembly. The paper honeycomb seemed to keep its shape, but it charred and delaminated from the bottom surface as shown in figure 15.

Figure 13 - the unexposed surface of the loading rigs were removed at the end of the test.
