NATIONAL BUREAU OF STANDARDS REPORT

10 677

FIRE ENDURANCE TEST OF AN INTERDWELLING WALL

The Gypsum Association

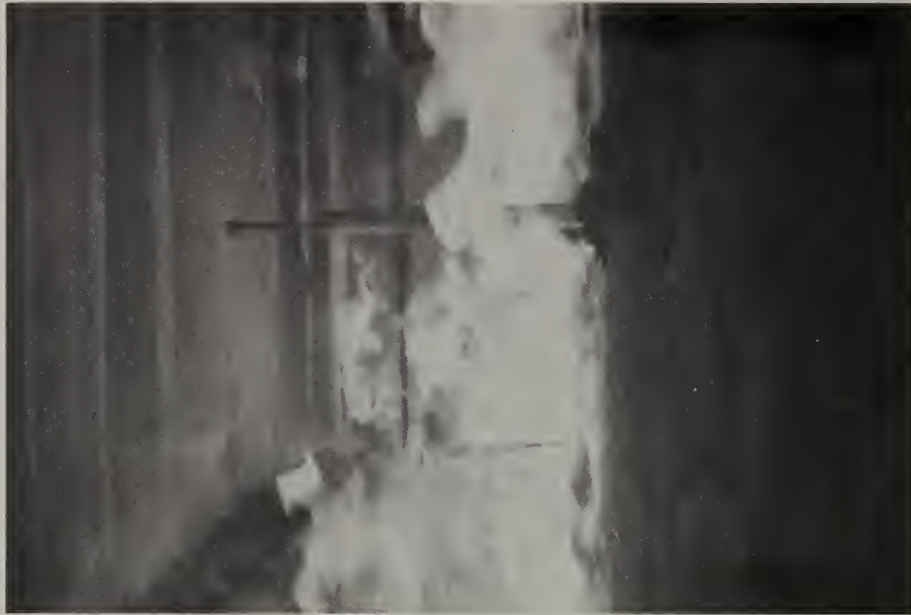
<u>min:sec</u>	<u>Observations</u>
00:00	Start Test
01:05	Paper on the exposed face ignited (Fig. 6).
03:00	Flame spread over the entire exposed face.
04:00	Paper tape used to reinforce the joint compound beginning to fall off (Fig. 7).

Figure 6. Ignition of the paper near bottom of the south corner on the exposed surface at 1 min:05sec.

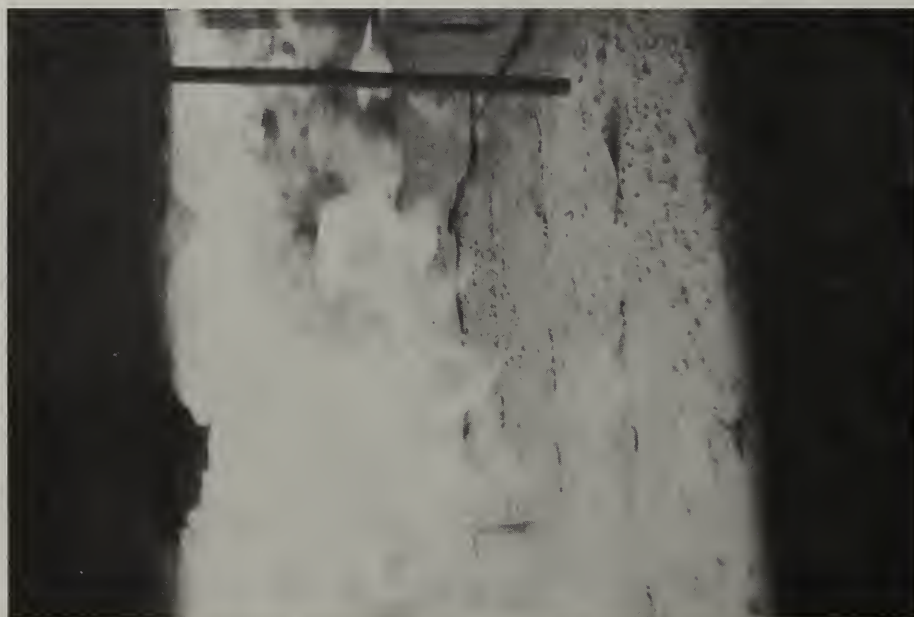
Figure 7. Paper Tape on the exposed surface beginning to fall off at 4 min.

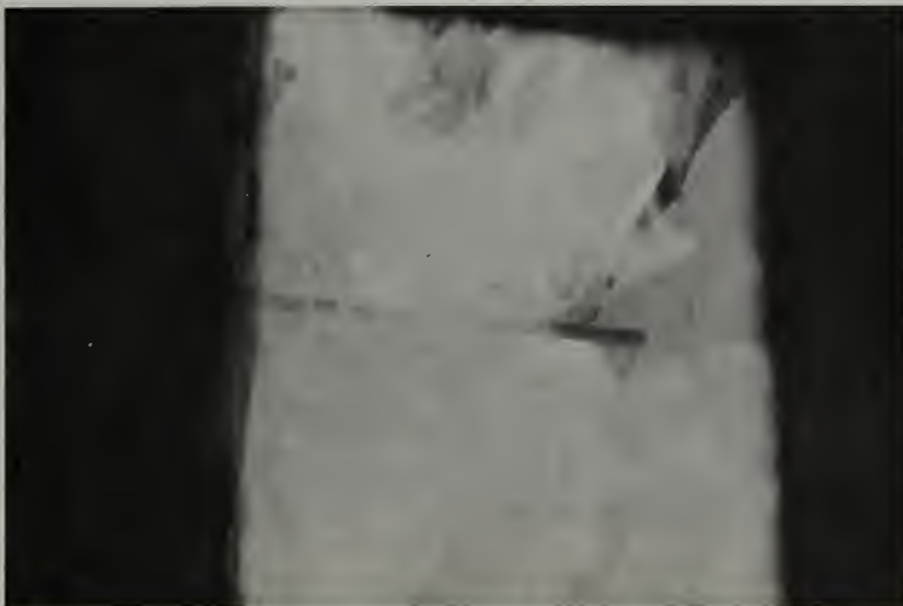
30:00	Joints on the exposed face beginning to open up.
35:00	Small flames from the combustion of the wood stud were coming through the joint opening.
40:00	On the exposed face, the individual gypsum boards were buckling between the joint line. (Fig. 8)

Figure 8. The individual gypsum boards on the exposed surface were buckling at 40 min.

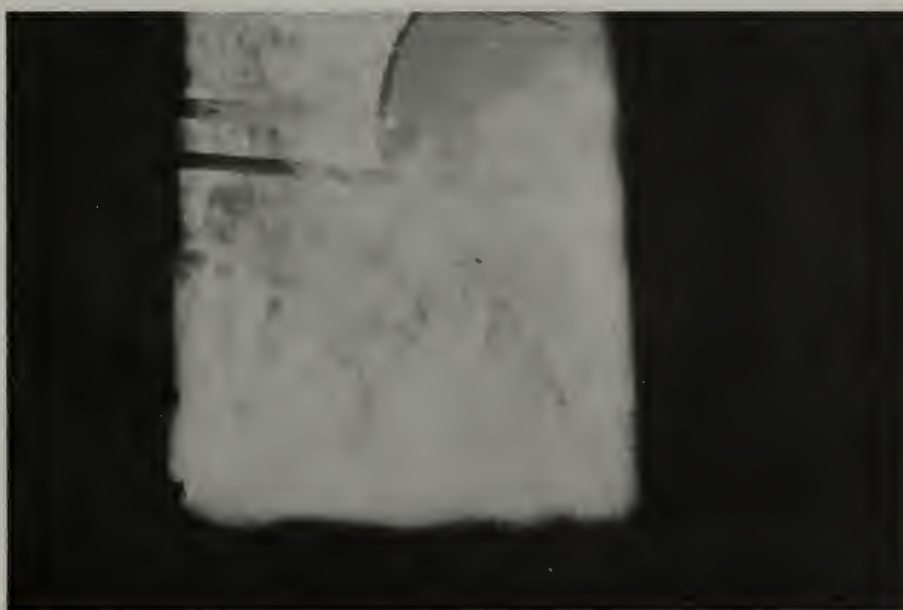
62:00	The horizontal gypsum joints opened wide and bowed out and the gypsum boards at the joints appeared ready to fall down. (Fig. 9)
63:00	Pieces of the exposed face falling down. (Fig. 10)

Figure 9. Gypsum boards bowed out and ready to fall down at 62 min.

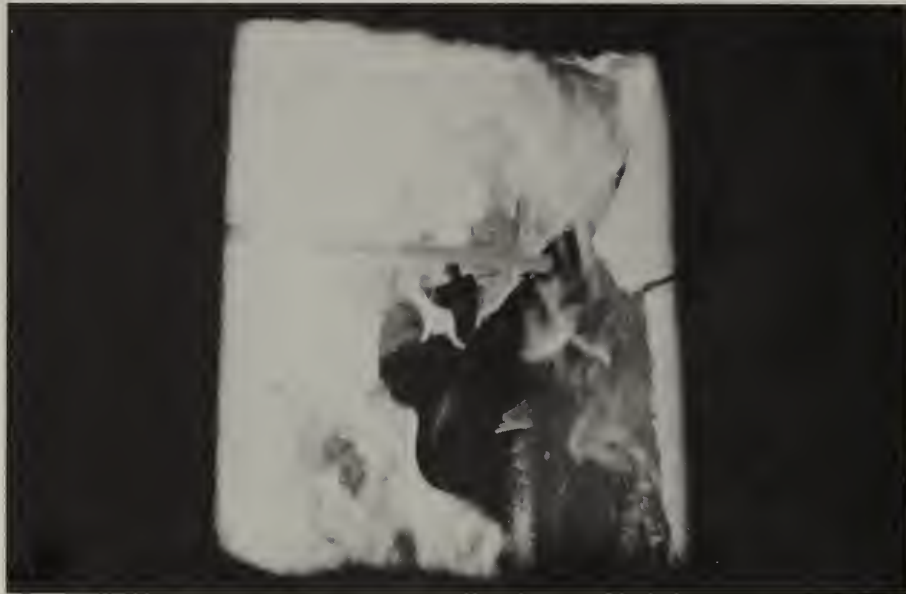
Figure 10. Pieces of the exposed face falling down at 63 min.

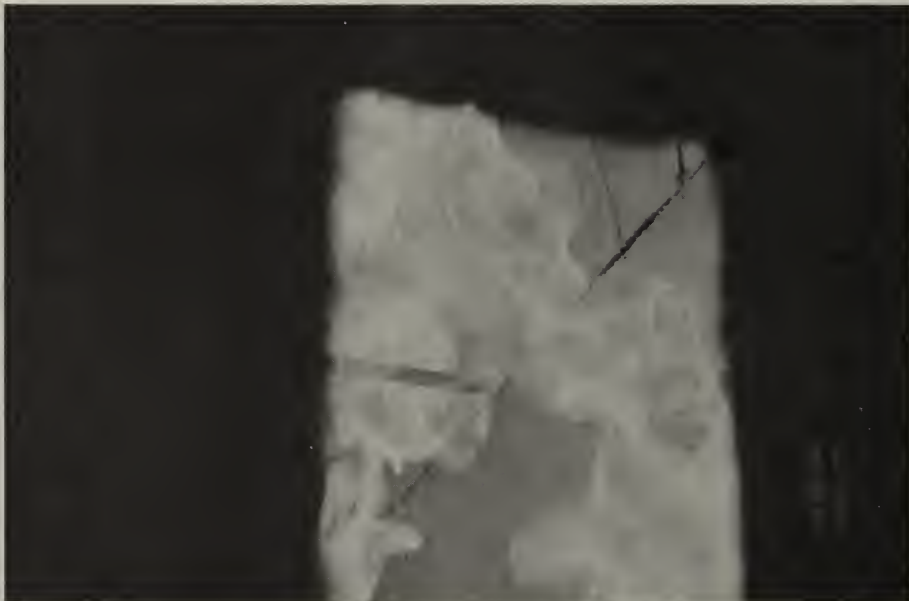
90:00	Most of the first wall had fallen into the furnace. The horizontal joint on the exposed gypsum face of the second wall beginning to blacken and open up. (Fig. 11)

Figure 11. The exposed gypsum face of the second wall at 90 min.

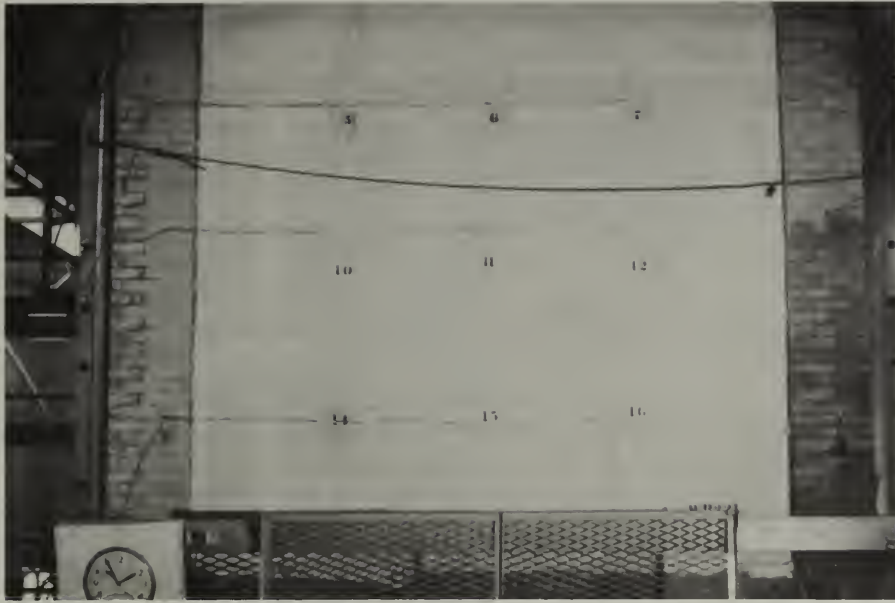
115:00	The unexposed side still appeared sound. (Fig. 12)
118:00	Load failure followed by flame through at the resultant crack formed at mid-height near the north quarter point of the assembly. (Fig. 13)
	End of Test

Figure 12. The unexposed side of the assembly at 115 min.

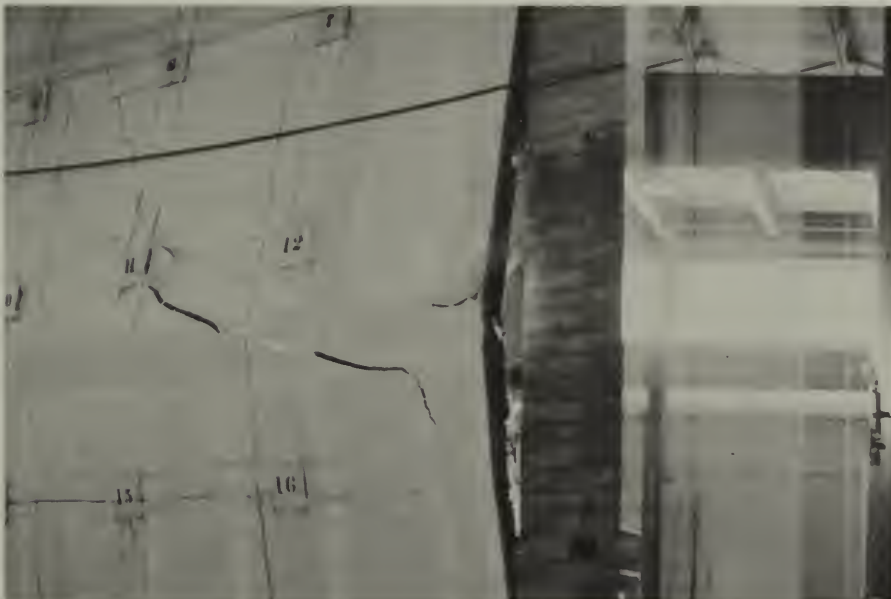
The structural failure of the second wall occurred at 1 hour: 58 minutes of test time and was followed by flame through. Figures 13 and 18 are photographs showing the front view of the unexposed surface and the view of the north end after test. Note the large crack that formed on the unexposed gypsum board face at the north end of the panel. Fig. 19 shows the condition of the fire side of the assembly (the first gypsum face of the second wall panel) after it was removed from the furnace and before the application of water from a fog nozzle. All the gypsum joints were open, the boards were buckled and the surface was blistered.

Figure 13. The resultant crack formed at mid-height near the north quarter point of the assembly.

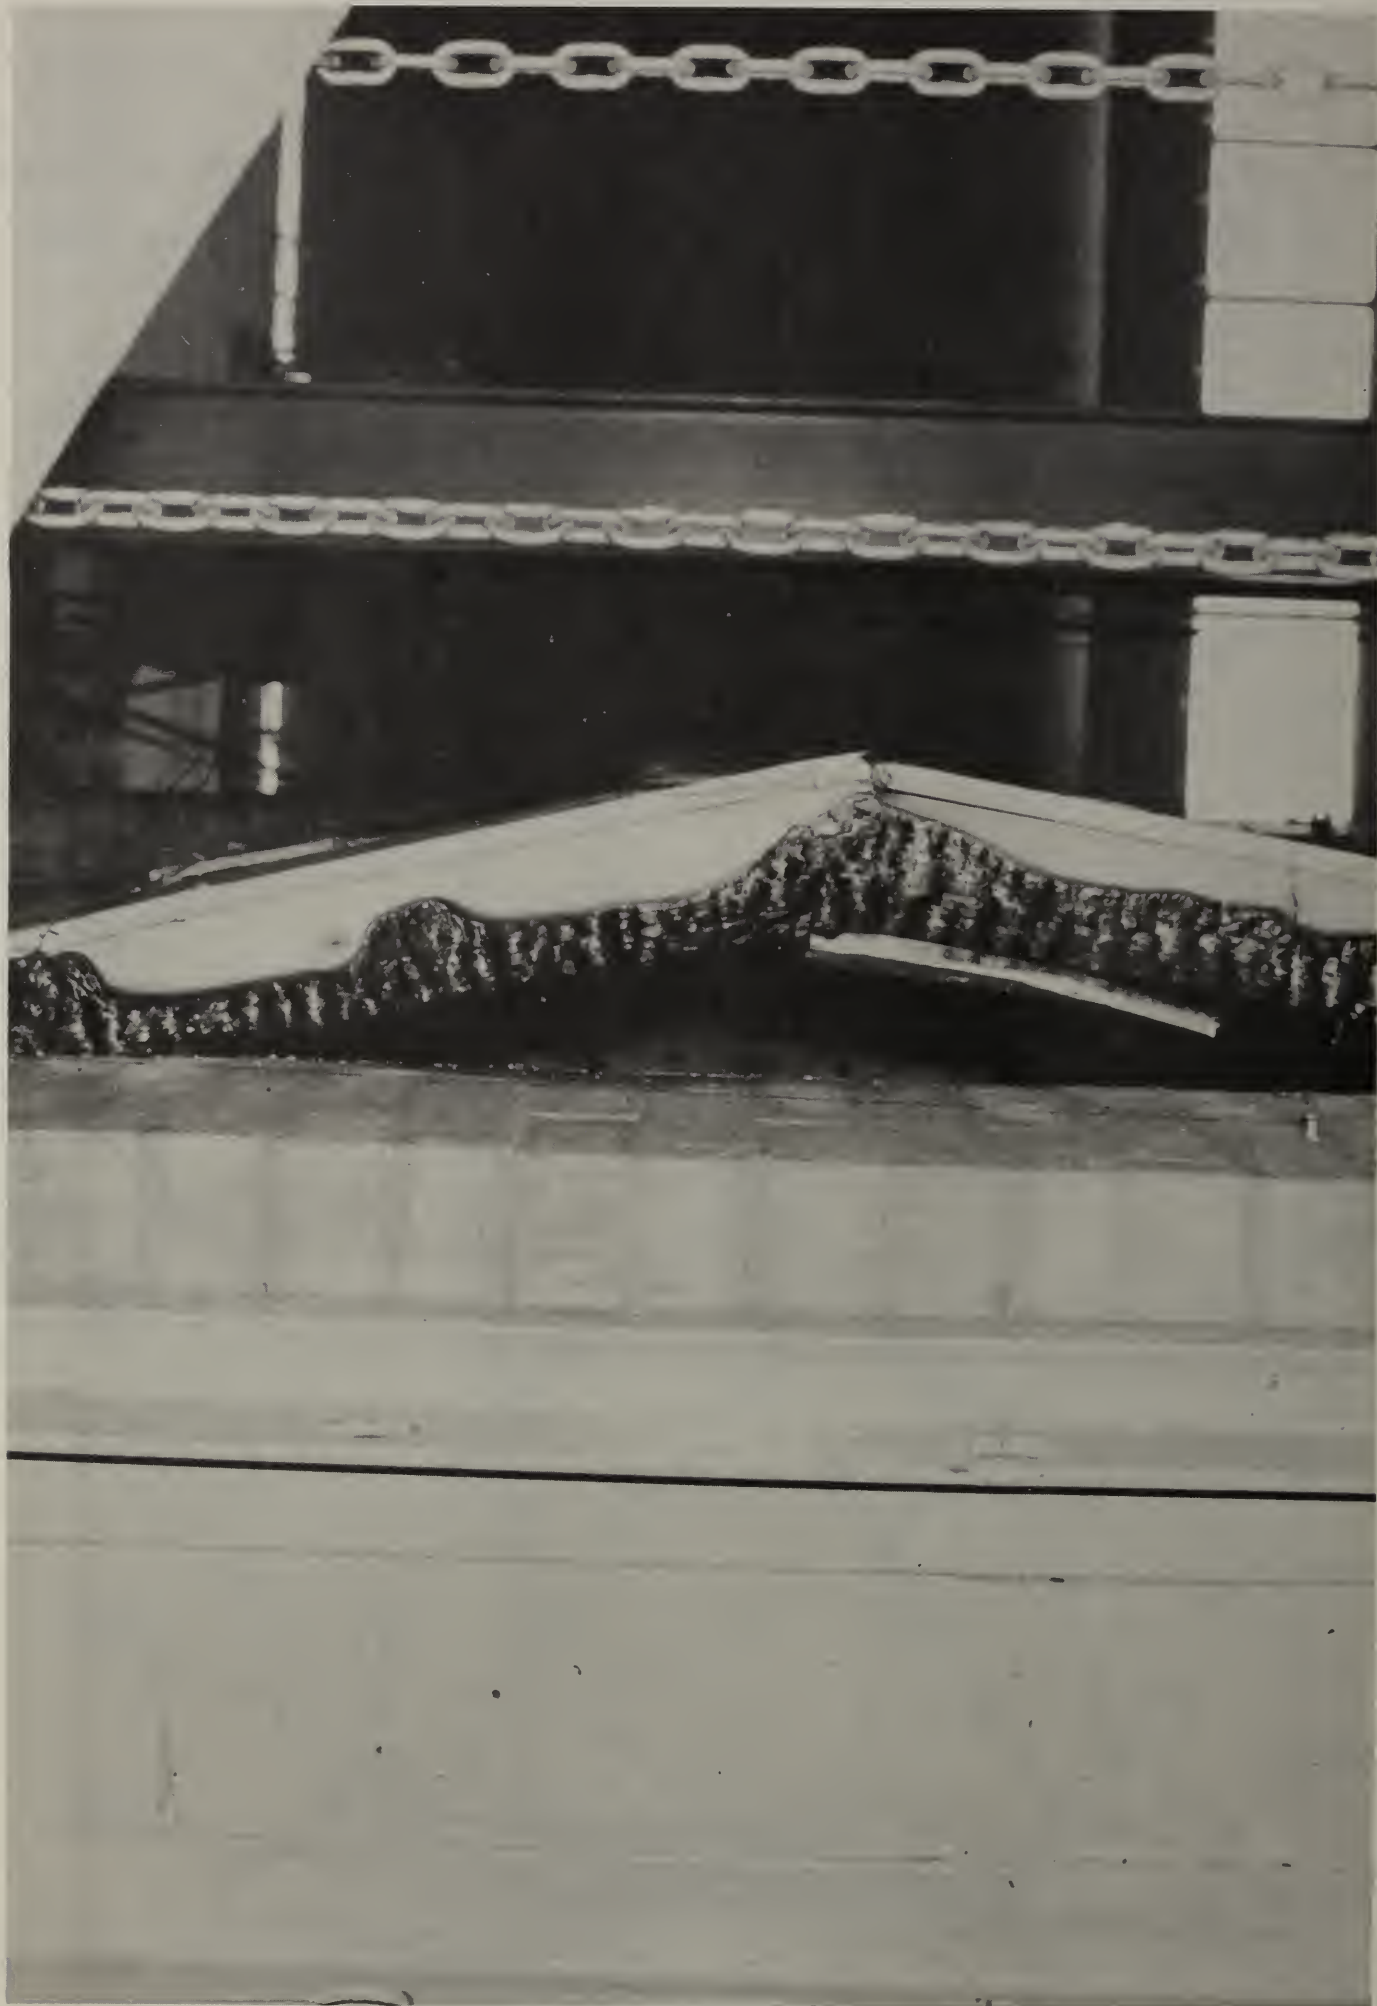
Figure 18. The view of north end near
the resultant crack after test.

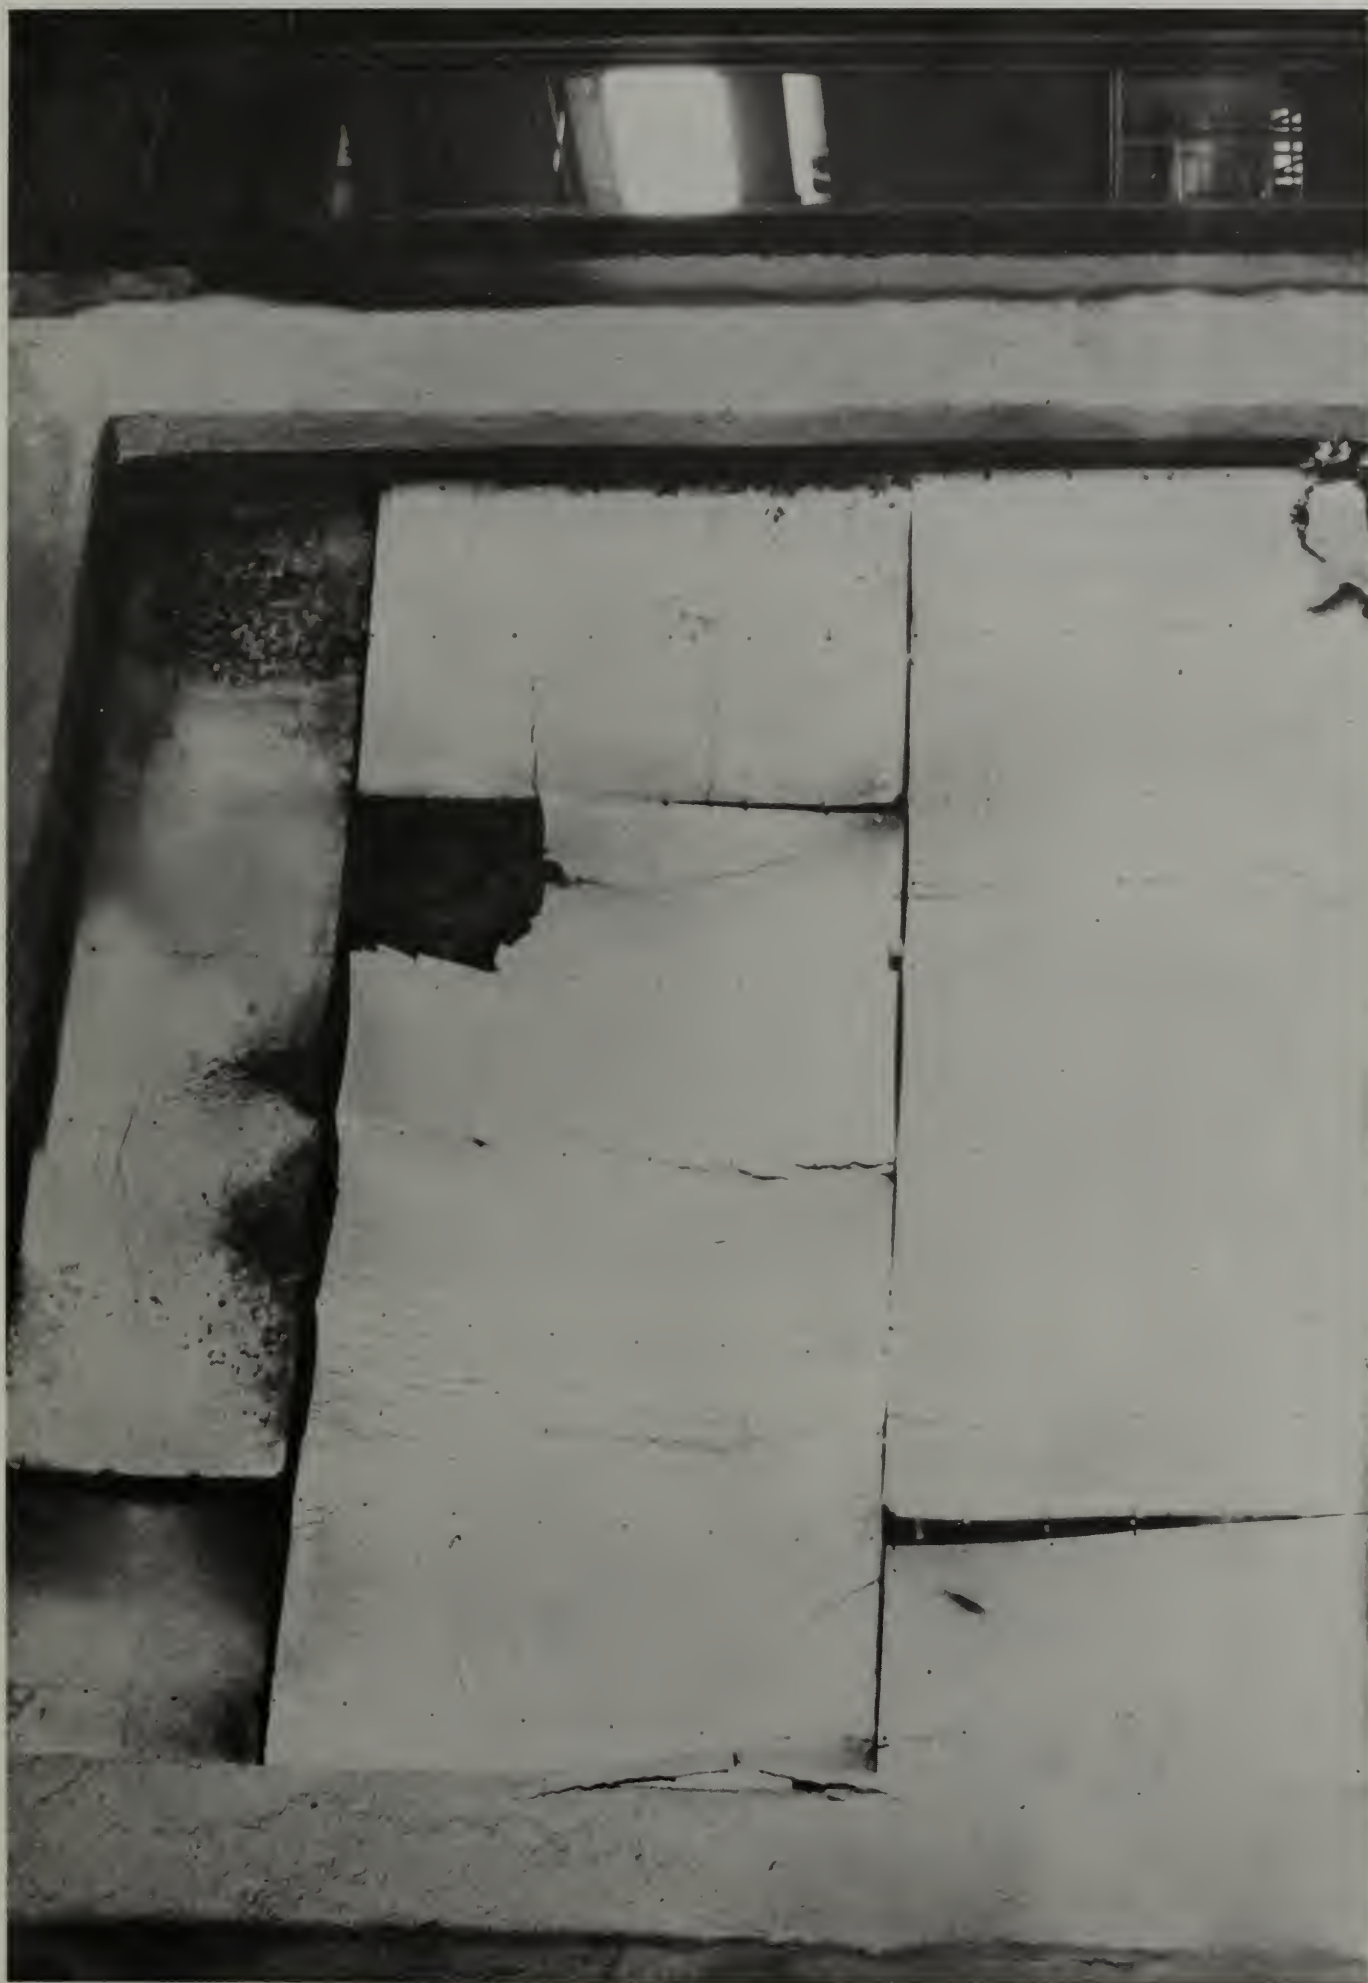
In the second panel most of the wood studs were either charred or consumed and had lost their structural strength. A photograph of three wood studs from the center and quarter points near the mid-height of the panel is shown in Fig. 20. This picture shows that the wood stud at the north quarter point was more severely burned than those at the center and south quarter point. This occurred when the lower vertical joint, on the second wall, near the north quarter point opened up during the test. See Fig. 19.

Figure 19. The fire side of the assembly after it was removed from the furnace.

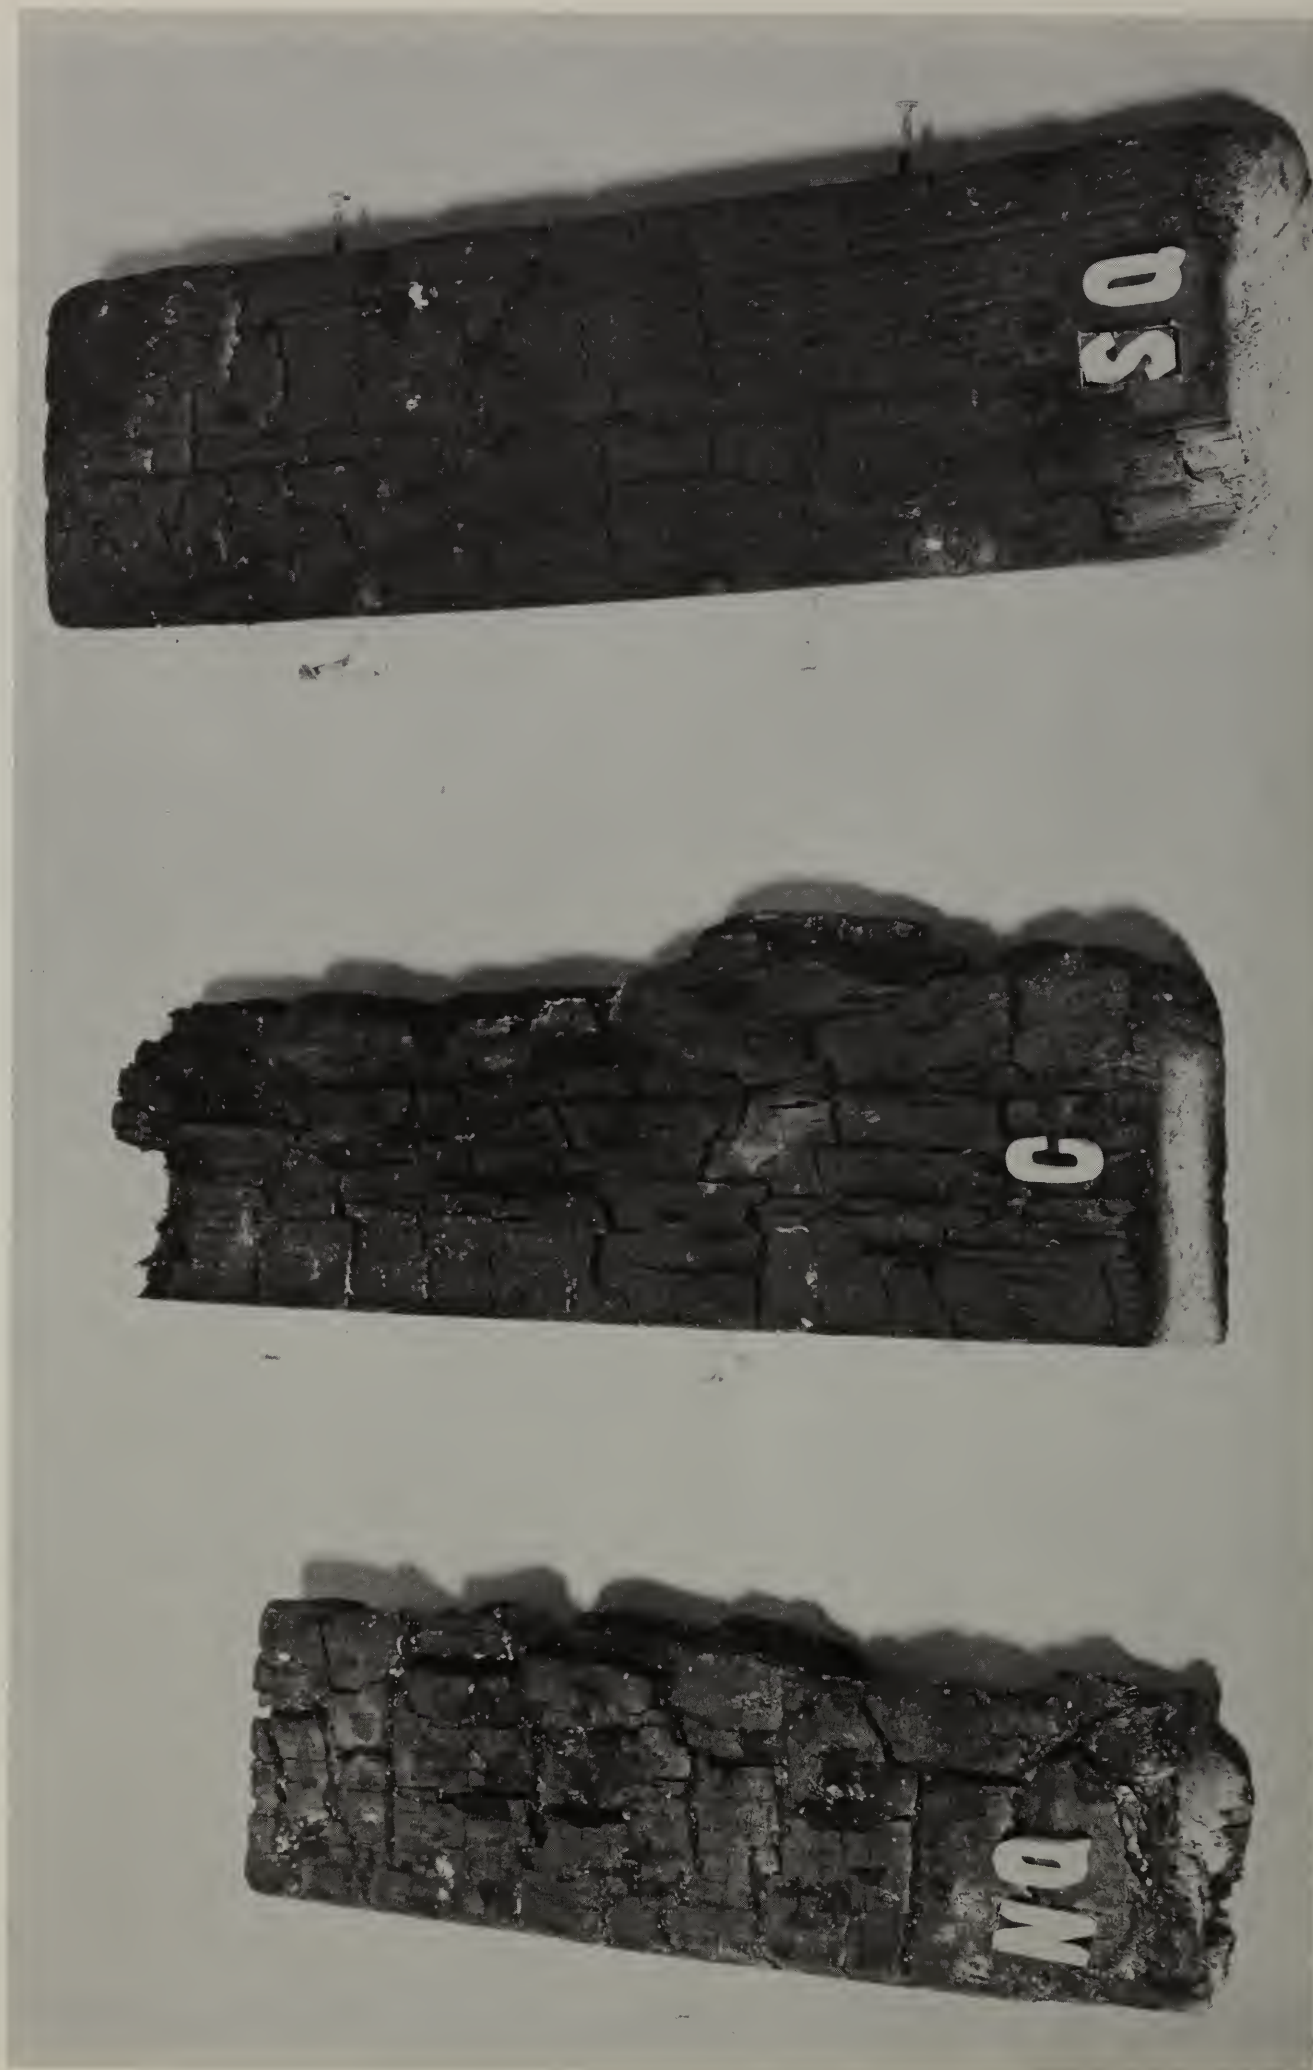
Figure 20. Three wood studs collected from the center and quarter points near the mid-height of the second panel after test.
