**NATIONAL BUREAU OF STANDARDS REPORT**

2585

June 19, 1953

REPORT OF  
INSPECTION OF PLASTER WORK AT  
ALASKA NATIVE SERVICE HOSPITAL  
AND TESTS FOR QUALITY AND  
CHARACTERISTICS OF PLASTER MATERIALS

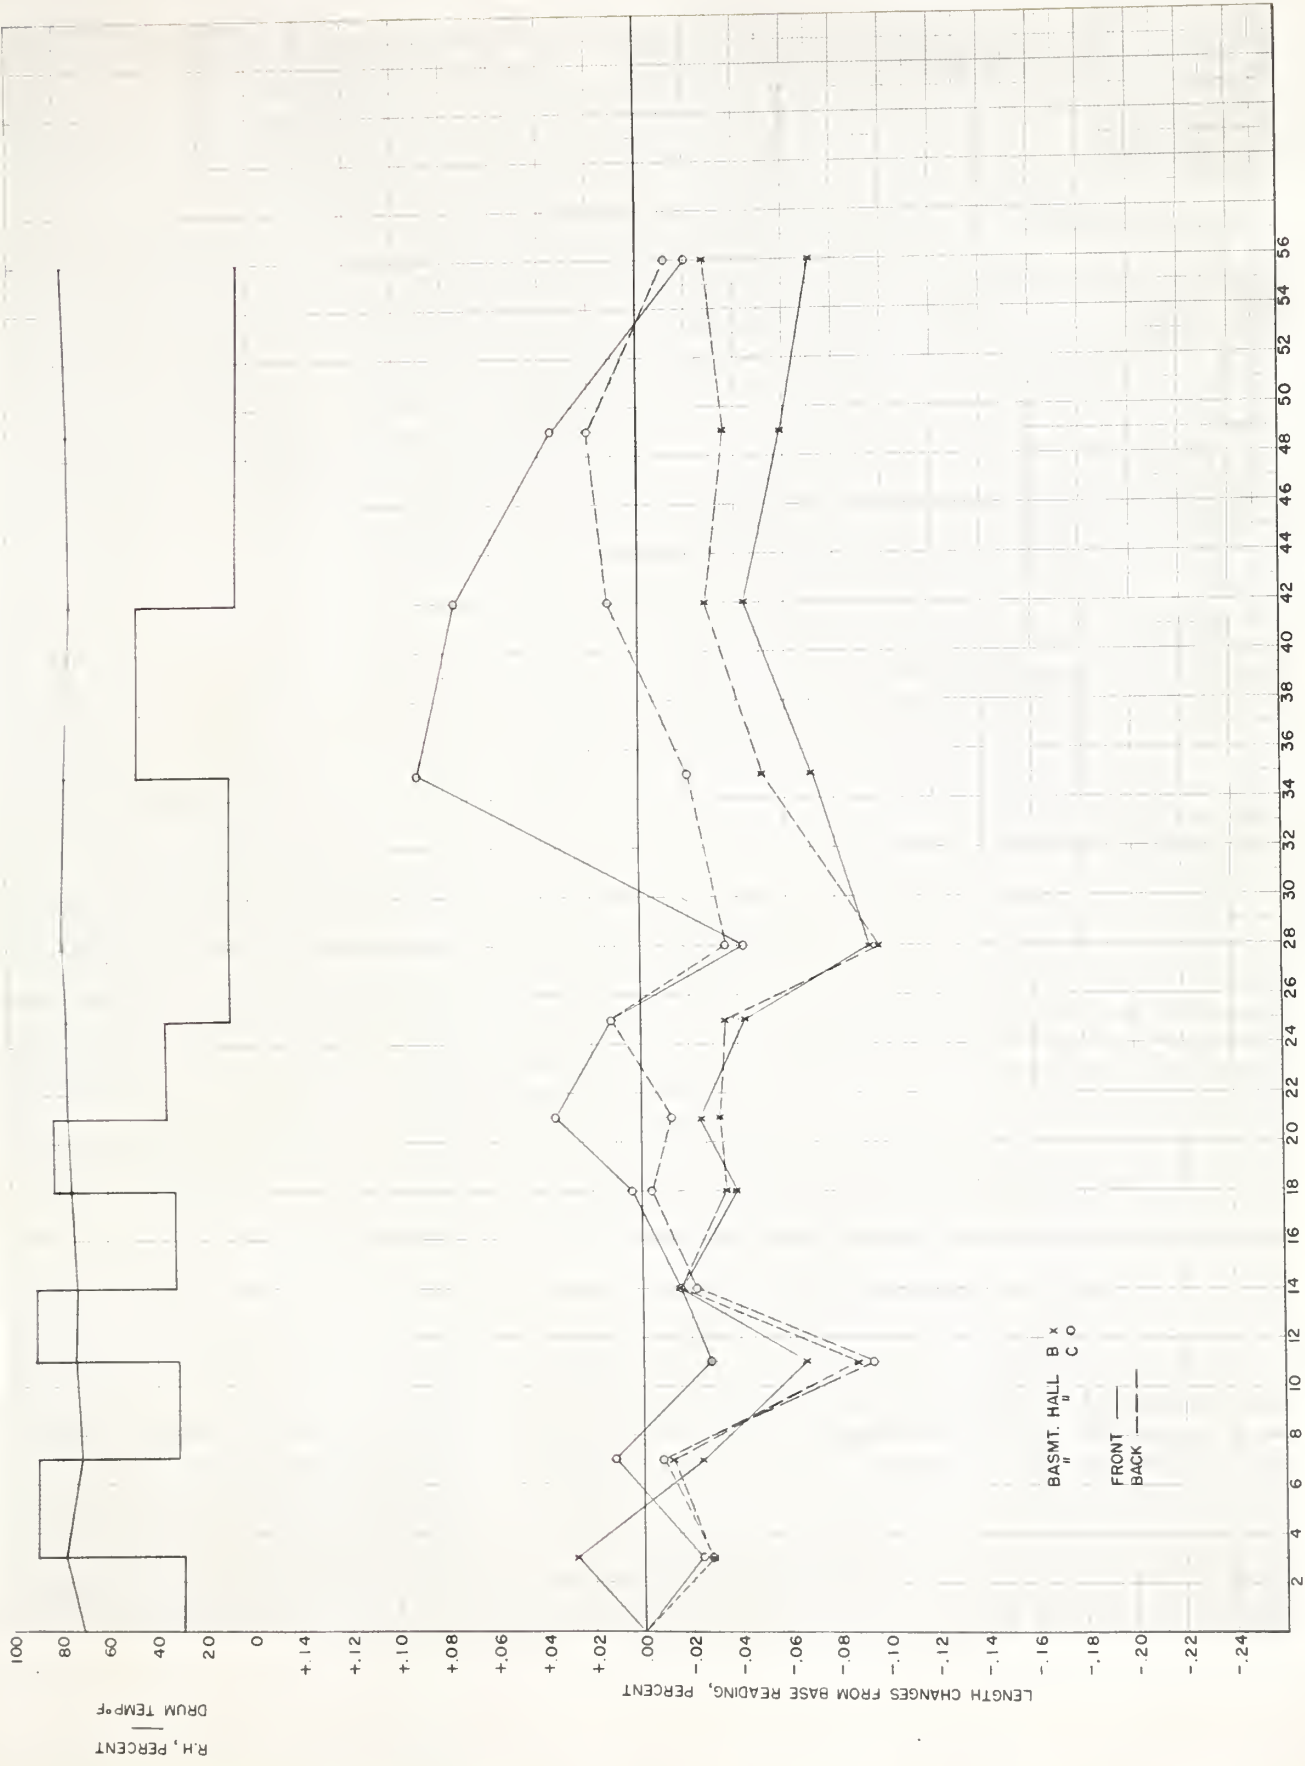
The changes of length of the specimens in terms of percentage of the 10-inch gage length are shown in figures 1 and 2. These are typical of the behavior of the twenty-two specimens subjected to the tests. In some instances there appeared to be evidence that the expansion of the plaster caused flexing of the lath, thus producing marked or anomalous differences in the lengthening or shortening of the gage length of the specimens during the period in which it was subjected to a constant humidity. Some of these anomalies have been attributed to cracking of the base-coat plaster or both the base-coat plaster and the white-coat finish, thus allowing the metal lath, already strained by the shrinking plaster, to regain its length to the extent that the strain from shrinkage of the plaster had been relieved.

Figure 1. Changes in length of specimens of lath and plaster from basement corridor in percentage of a 10-in. gage length when subjected to changes in humidity.

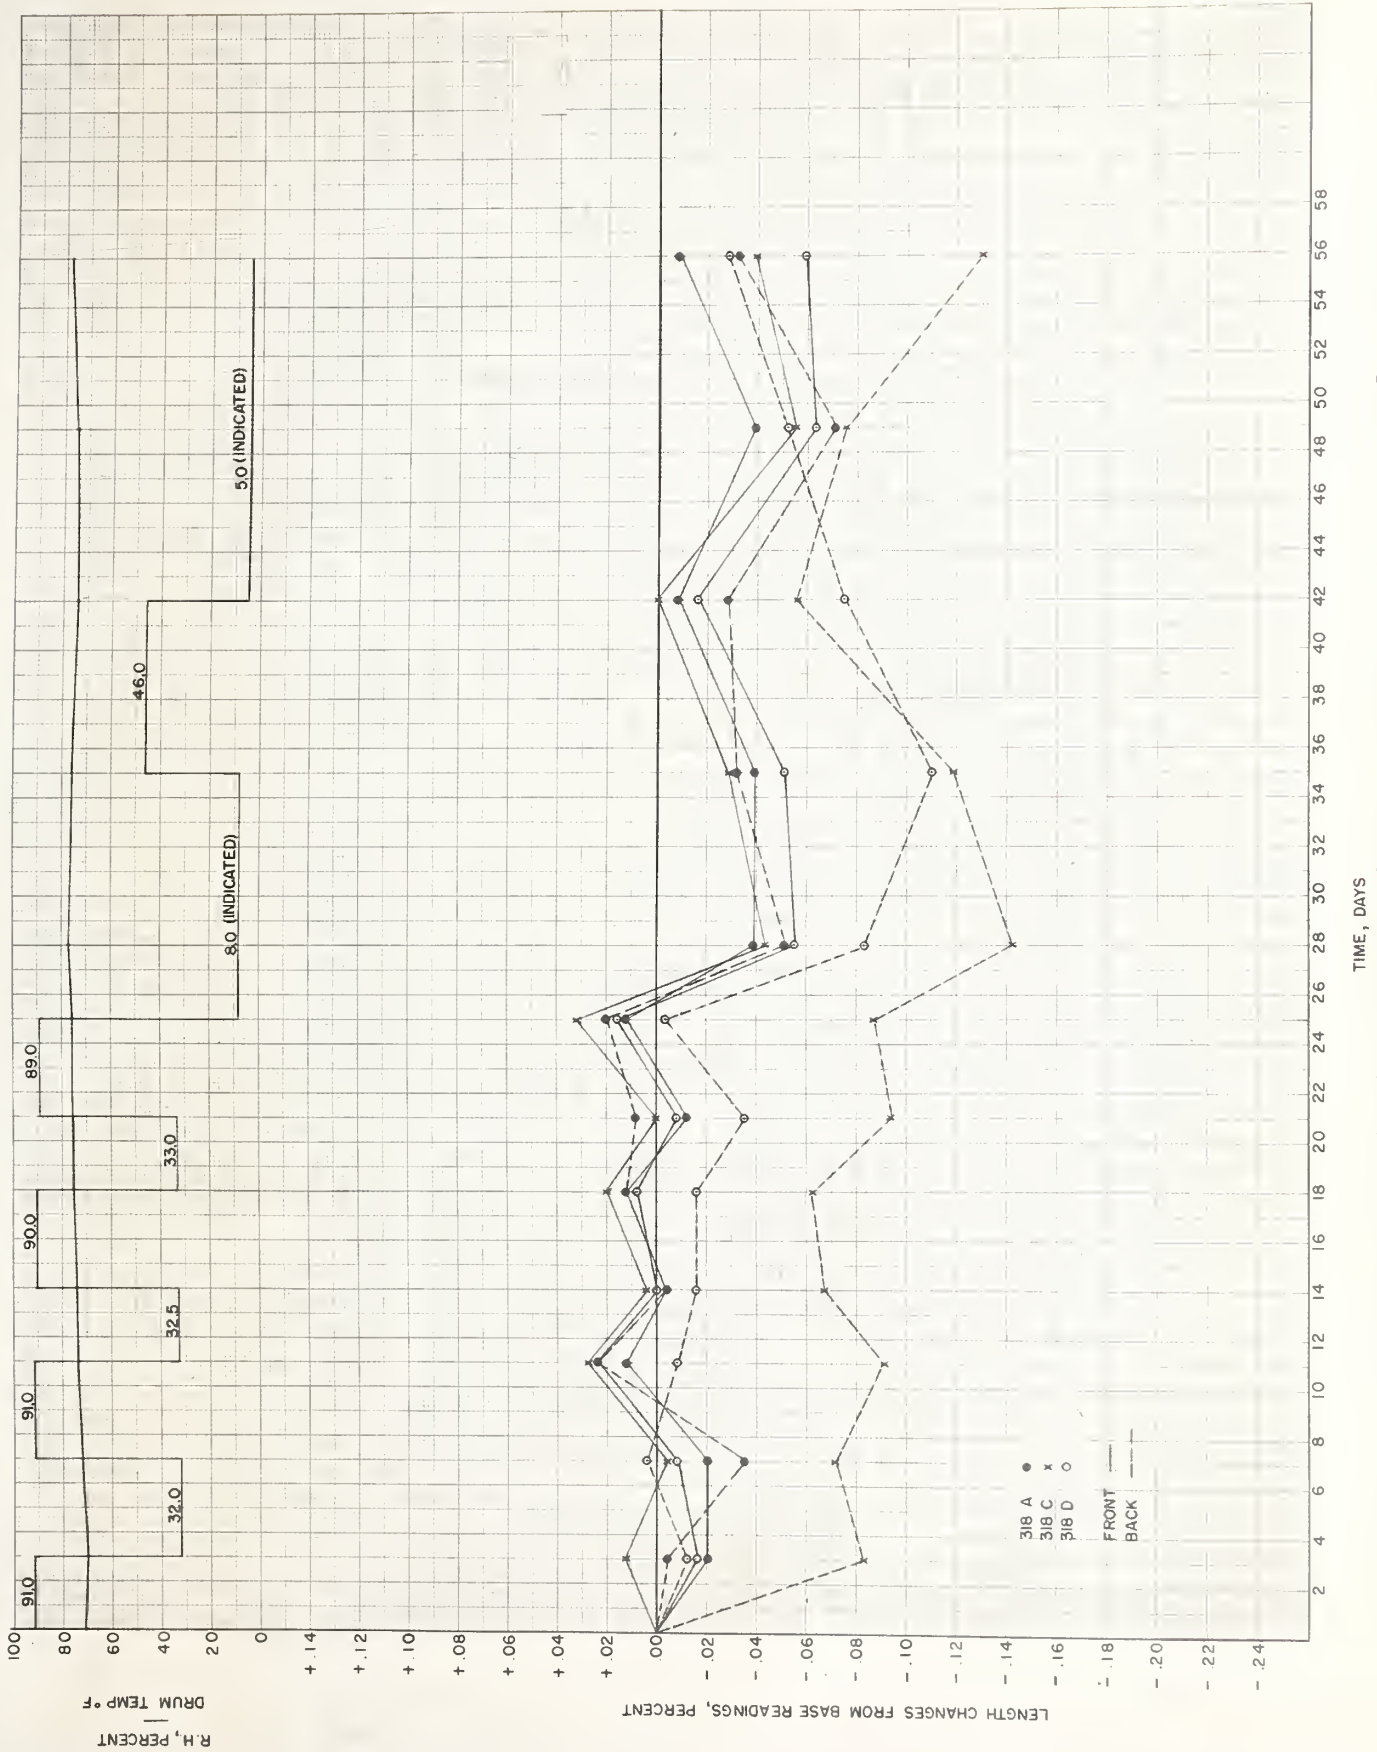
Figure 2. Changes in length of specimens of lath and plaster from room 318 in percentage of a 10-in. gage length when subjected to changes in humidity.
