NATIONAL BUREAU OF STANDARDS REPORT

3353

TEST OF PRECAST PANEL FRAME NO. 1

Report to
Bureau of Yards and Docks
Department of the Navy

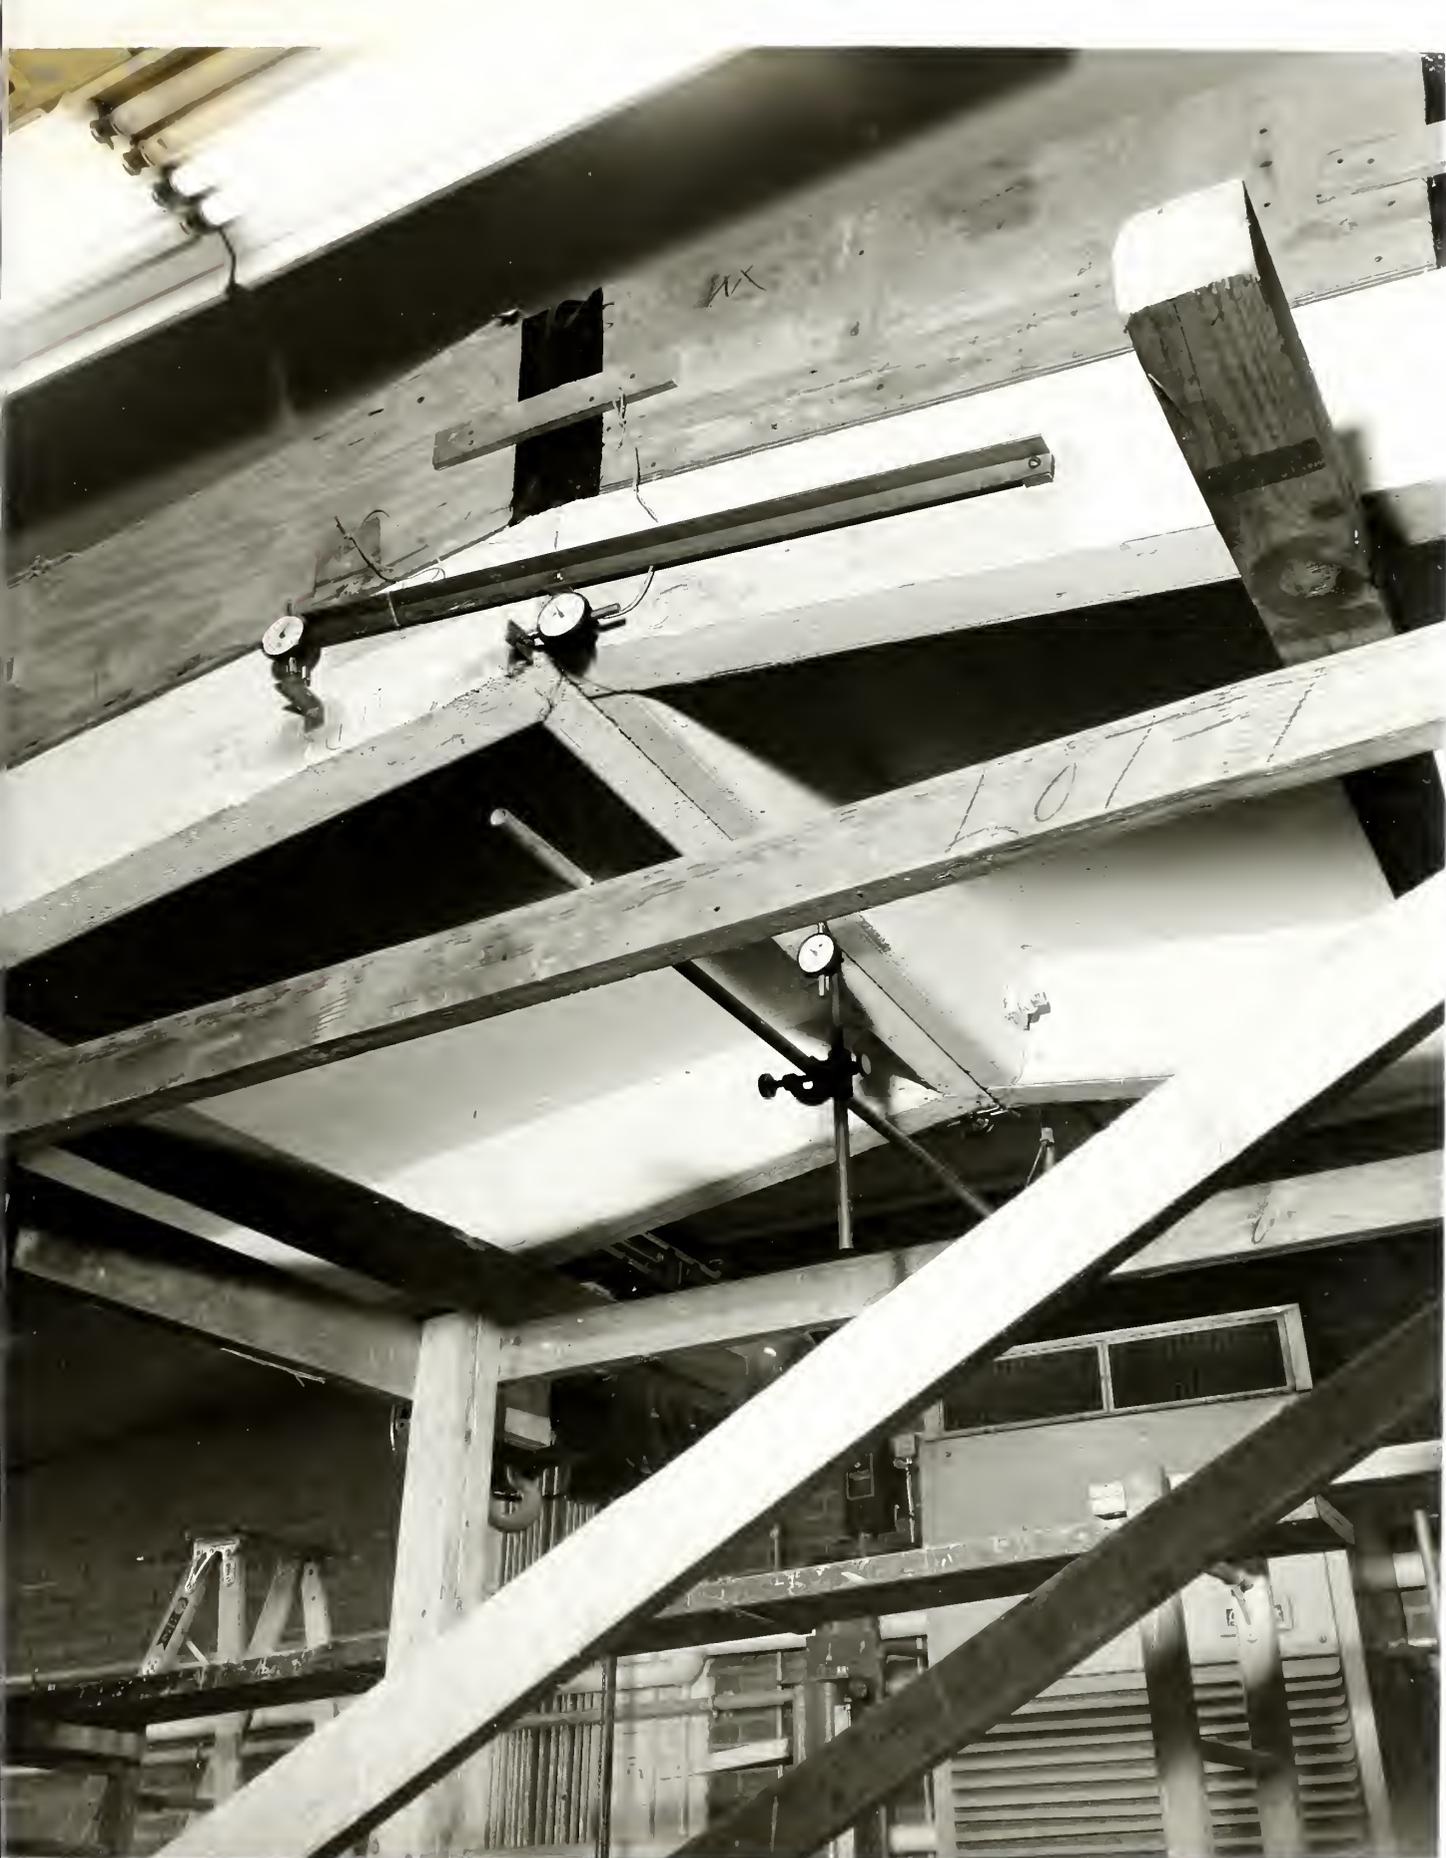
Fig. 14 - Cracking at center joint (load = 80 psf)

The first visible cracks occurred at the inside intersection of the wall with the footing at a load of 30 psf both at the north and south ends. No further cracking was observed until a load of 40 psf was applied at which time cracking was observed at the intersection of the transverse ribs and longitudinal legs of the roof panels at the crown. Cracks occurred at each of the four intersections and were the most prominent to appear throughout the test. These cracks are clearly visible in figure 14.

It is recalled that the reinforcing bars in the transverse ribs terminated at the midplanes of the longitudinal edge beams. Had the reinforcement in the transverse ribs been extended into the edge beams, the width of the cracks at the corners would have been considerably less, and the opening at the bottom of the crown joint would have been less pronounced.
