NATIONAL BUREAU OF STANDARDS REPORT

June 24, 1951

Fire Endurance Tests of Prefabricated Exterior Wall Panels

Test Report No. T610219-53; 673286

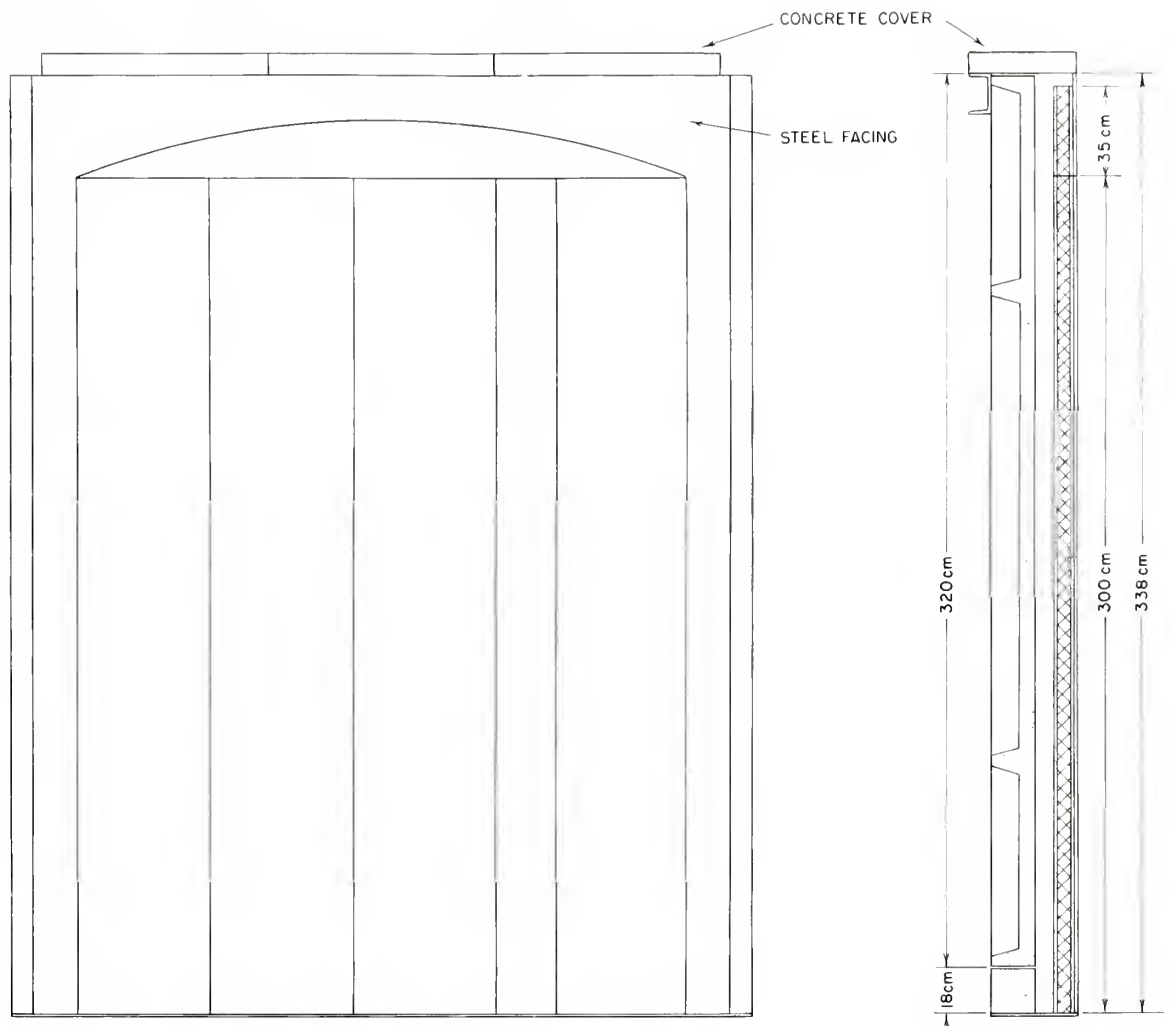
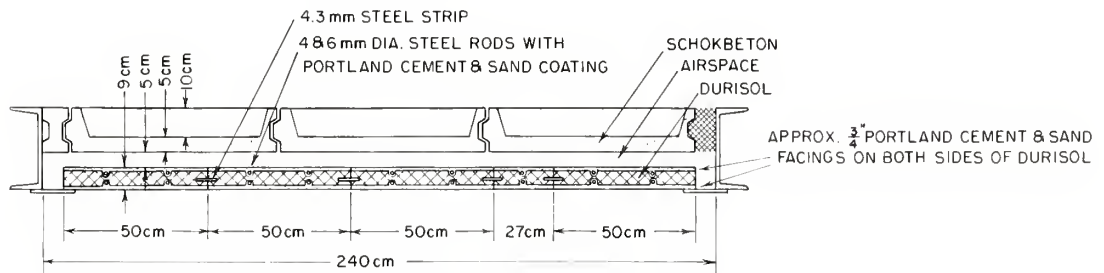
FIG. 1 CONSTRUCTION DETAILS OF TEST PANEL NO. 1

Test 1. A hollow wall with an air space of about 2 in. (5 cm) between the inner and outer faces. The outer face consisted of precast high density concrete channel slabs with transverse ribs. Each slab was 10 ft. 6 in. (320 cm) high, 2 ft. 5 1/2 in. (75 cm) wide, about 2 in. (5 cm) thick through the web and about 5.9 in. (15 cm) thick through the channel flanges and transverse ribs. The exterior sides of the flanges were forced to fit the flanges of the adjoining slabs in a tongue-and-groove system. The slabs were cast in form on a shock table and shocked repeatedly to obtain the high density. The inner face consisted of a pressed board of wood shavings bonded with portland cement which was coated on both sides with about 3/4 in. of a portland cement and sand mixture, giving an overall thickness of about 4 in. The total thickness of the test specimen was about 12 in. The details are shown in figure 1.

Test 1. The inner face would have to be replaced after a standard 2 hr. fire exposure or equivalent and the outer face panels should be patched out could be used again.

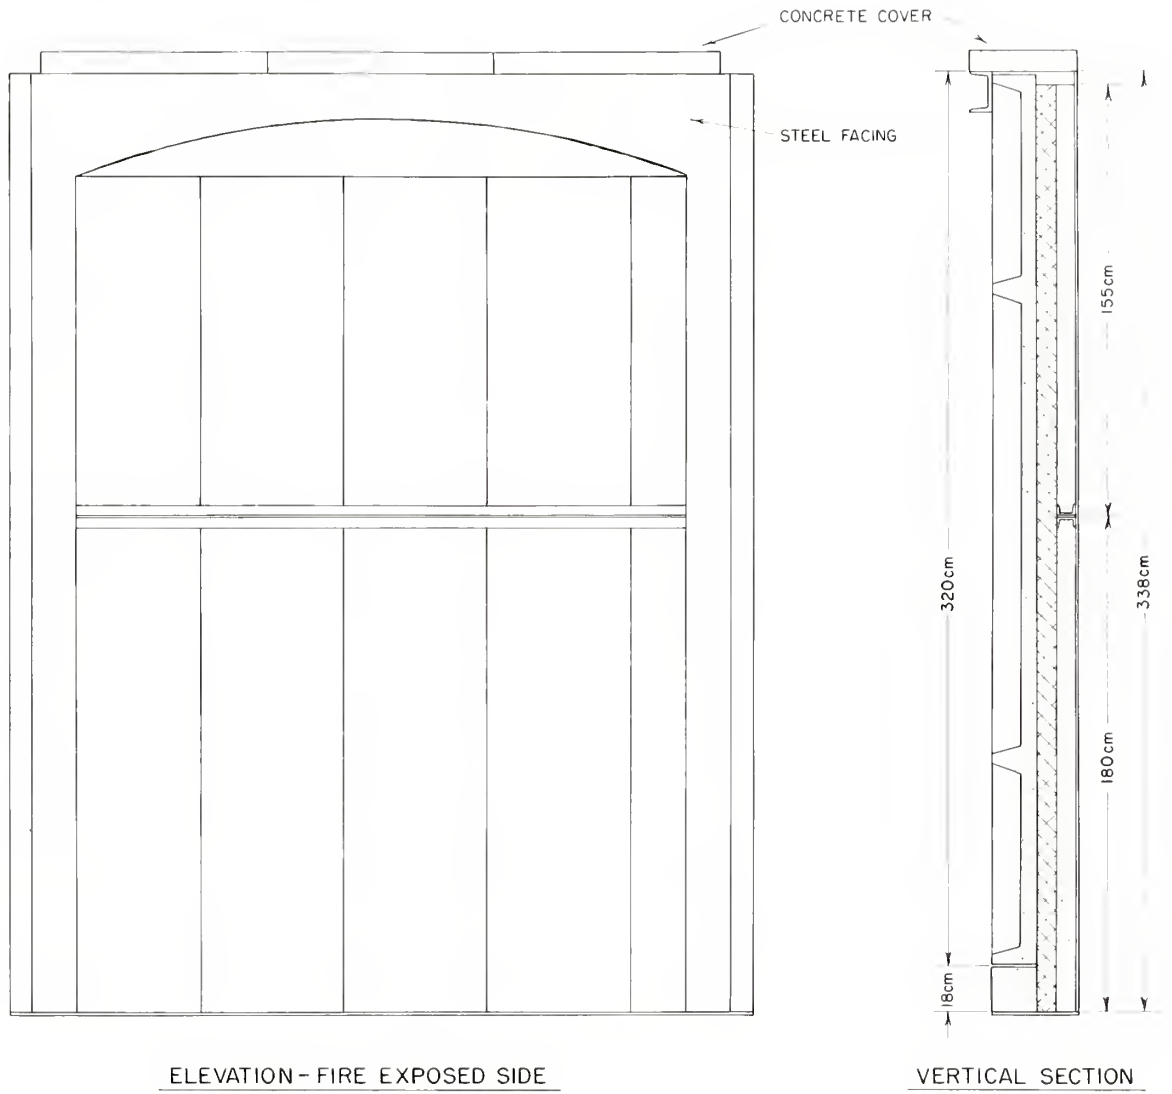
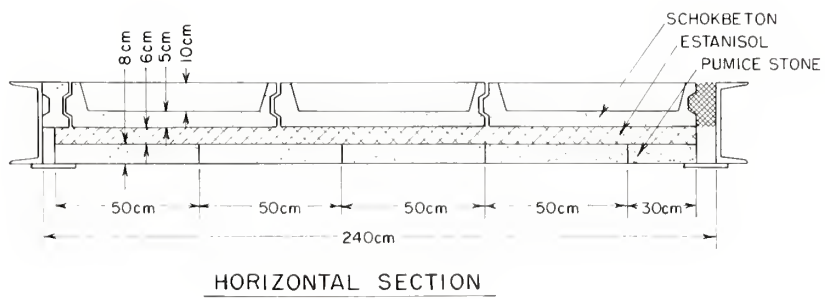
FIG. 2 CONSTRUCTION DETAILS OF TEST PANEL NO.2

Test 2. A sandwich wall with 2 in. of mineral wool insulation between the inner and outer faces. The outer face was of the same type materials and design as that in test 1. The inner face consisted of pumice concrete slabs 4 in. thick. The details are shown in figure 2.

Test 2. The inner face and the material which built up between the faces would have to be replaced but the outer face panels would probably be maintained after a standard 3 hr. fire exposure, or its equivalent.

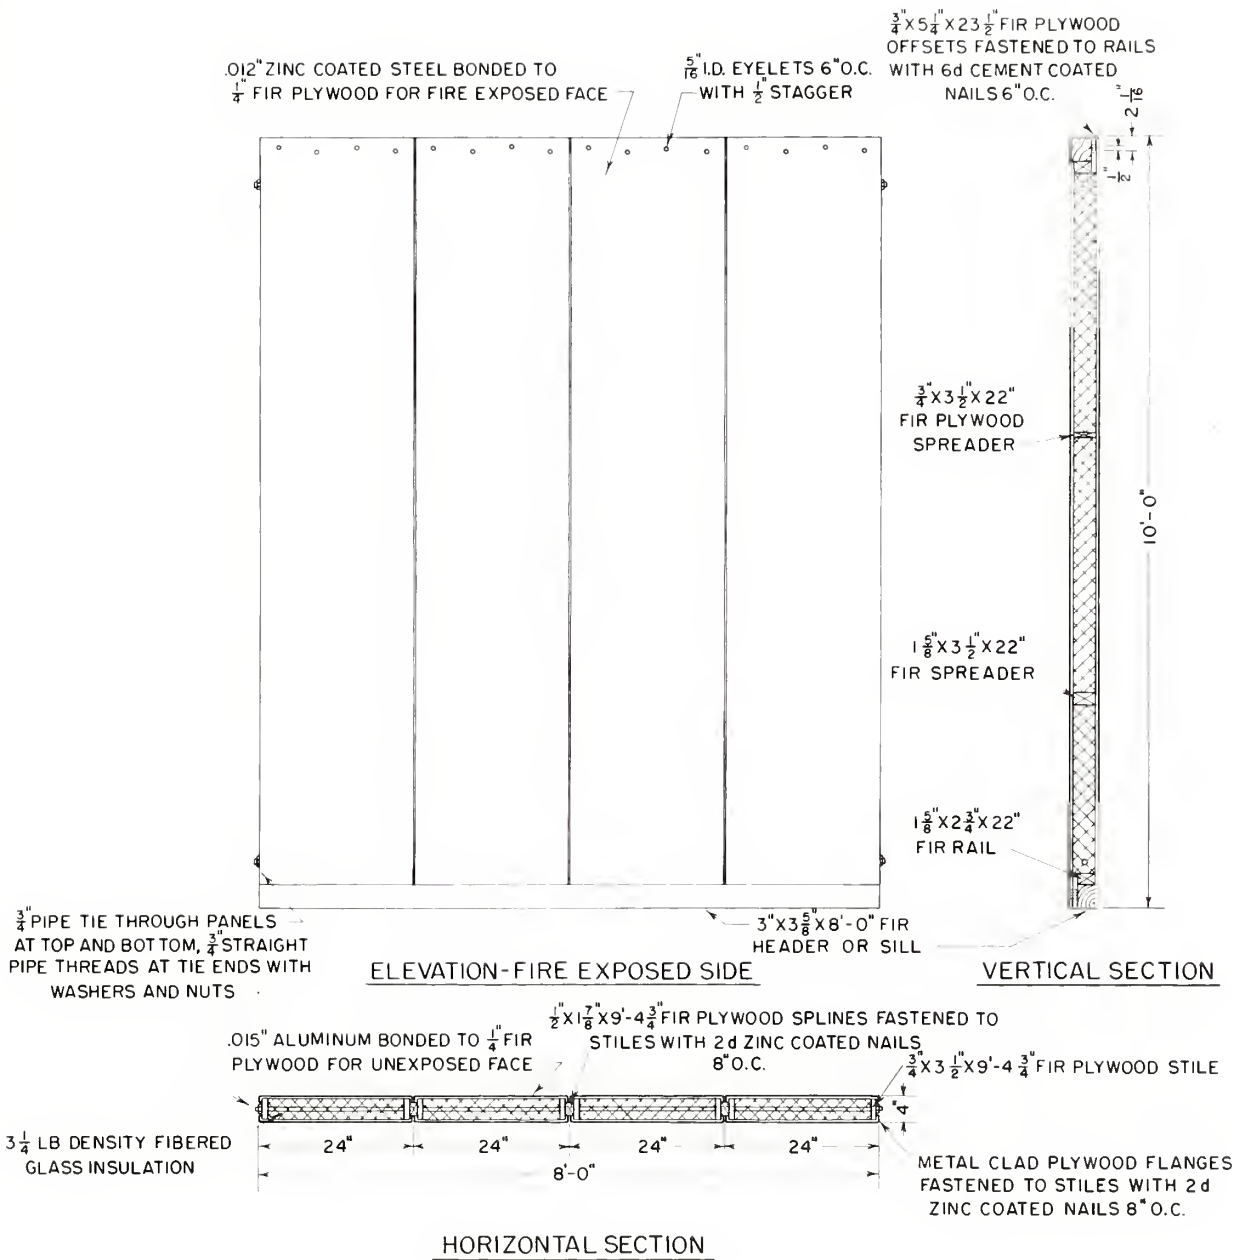
FIG. 4 CONSTRUCTION DETAILS OF TEST PANEL NO. 4

Test 4. A wall consisting of four prefabricated panels, each of which was 10 ft. high, 4 ft. wide, and $\frac{1}{2}$ in. thick. Each panel consisted of a wood frame 9 ft. $\frac{3}{4}$ in. high by 1 ft. 11 $\frac{1}{2}$ in. wide by $\frac{3}{8}$ in. thick which had been faced on the interior side with $\frac{1}{2}$ in. plywood clad with zinc coated steel and on the exterior side with $\frac{1}{2}$ in. plywood clad with aluminum. The facings had been backed with asbestos paper and the space between facings filled with a glass fiber insulation. The interior face projected $3\frac{5}{8}$ in. above the wood frame and the exterior face $3\frac{5}{8}$ in. below, each backed with $\frac{3}{4}$ in. additional plywood. These projecting lips had predrilled holes and eyelets for lag screws by which the panels were secured to 3 by 3 $\frac{5}{8}$ in. transverse sills at top and bottom during erection. All the surfaces of the wood components had been coated with a fire retardant paint except the metal clad faces of the plywood. The panels were tied together at erection by the sills and by $\frac{3}{4}$ in. pipes which went through all four panels parallel to the faces near the top and bottom. The details are shown in figure 4.

Test 4. The complete wall panels would have to be replaced after a 3/4 hr. standard fire exposure, or equivalent.

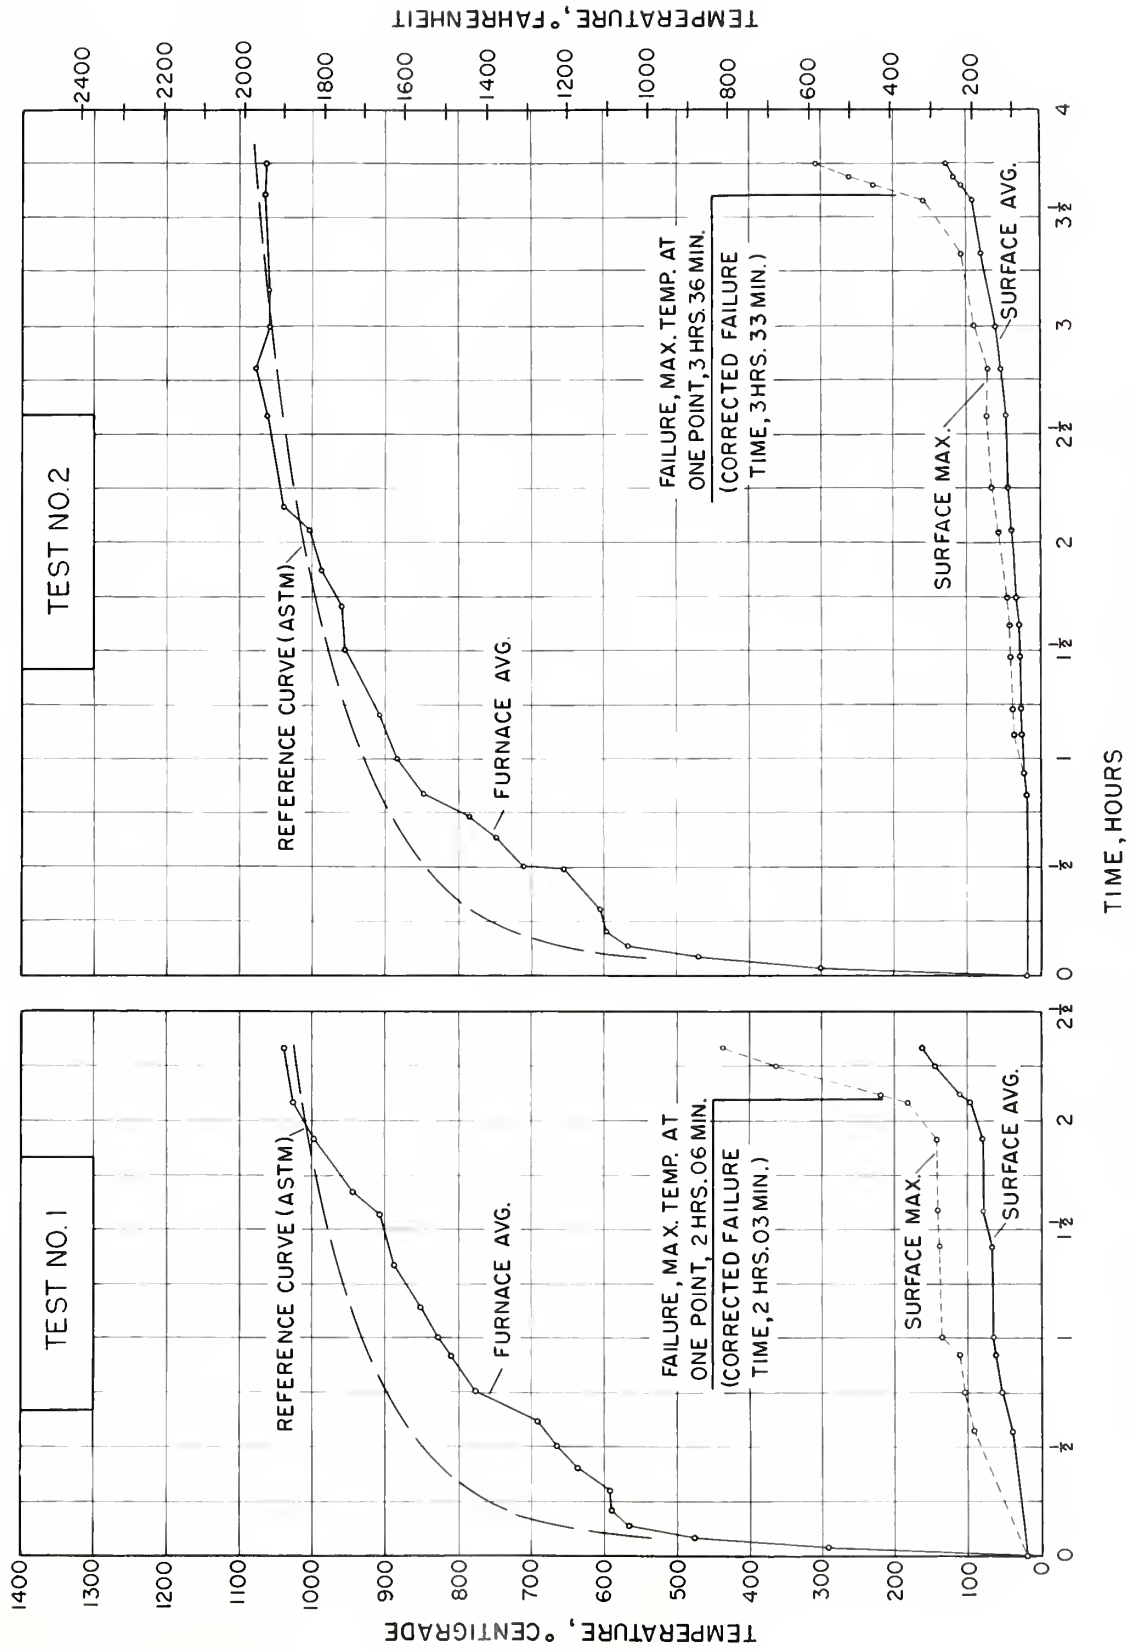
FIG. 6 TIME-TEMPERATURE CURVES FOR TESTS NO.1 AND 2

The control of the furnace temperature was such that the exposure severity was 89 percent of standard. The fire endurance limit was determined by temperature rise of 325 degrees F at one thermocouple on the unexposed surface at 2 hr. 6 min. The thermocouple was on the face of the center panel. If the correction formula in M119 is applied to the temperatures indicated by the bare thermocouples, the correction is minus 3 min. Therefore, the corrected fire endurance is 2 hr. 3 min. The temperatures measured during the test are shown in figure 6.

The control of the furnace was such that the fire exposure severity was 96 percent of standard. The fire endurance limit was determined at 3 hr. 36 min. by temperature rise of 325 degrees F at one thermocouple located on the unexposed face of the center panel in the upper half. If the correction formula in M119 is applied to the temperatures as indicated by the bare furnace thermocouples, the correction is minus 3 min. Therefore, the corrected fire endurance is 3 hr. 33 min. The temperatures measured during the test are shown in figure 6.

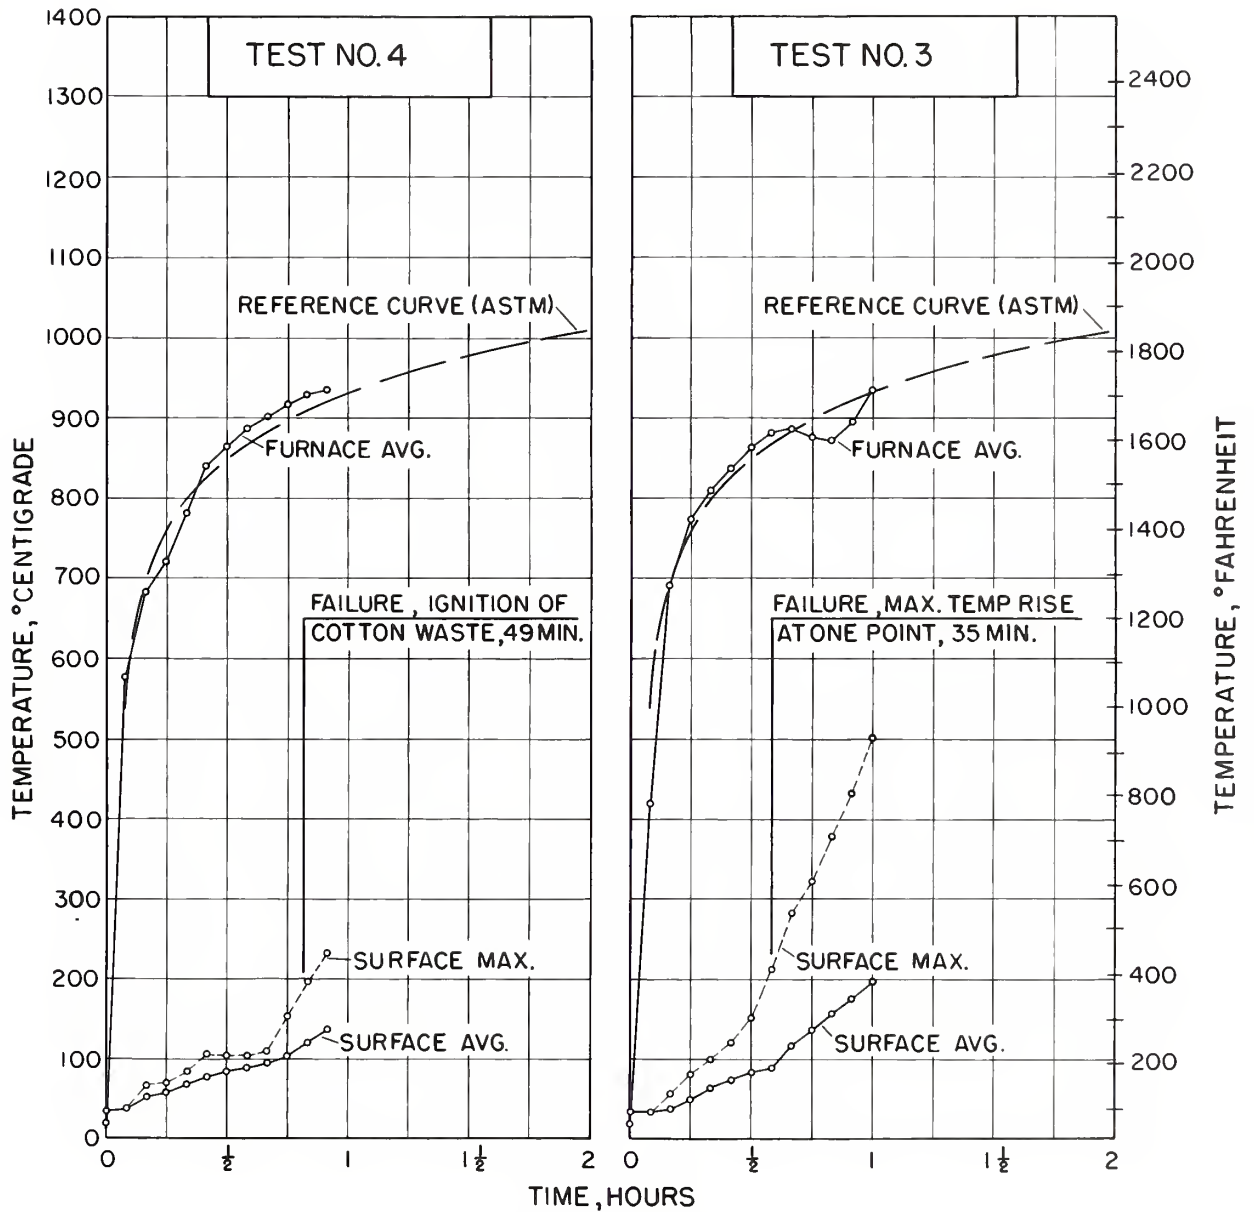
FIG. 7 TIME-TEMPERATURE CURVES FOR TESTS NO. 3 AND 4

The furnace control was such that the fire exposure severity was 98.8 percent of standard. The fire endurance was limited to 35 min by 325 degree F temperature rise at one thermocouple on the unexposed surface. This thermocouple was located on the cover strip of one of the joints between panels. The applicable correction was minus 1 min. making the corrected fire endurance 34 min. The temperatures measured during the test are shown in figure 7.

The furnace control was such that the fire exposure severity was 101.2 percent of standard but an correction was applicable to the fire endurance which was limited to 49 min. by the ignition of cotton waste on the exposed surface over the joint between panels. The temperatures measured during the test are shown in Figure 7.

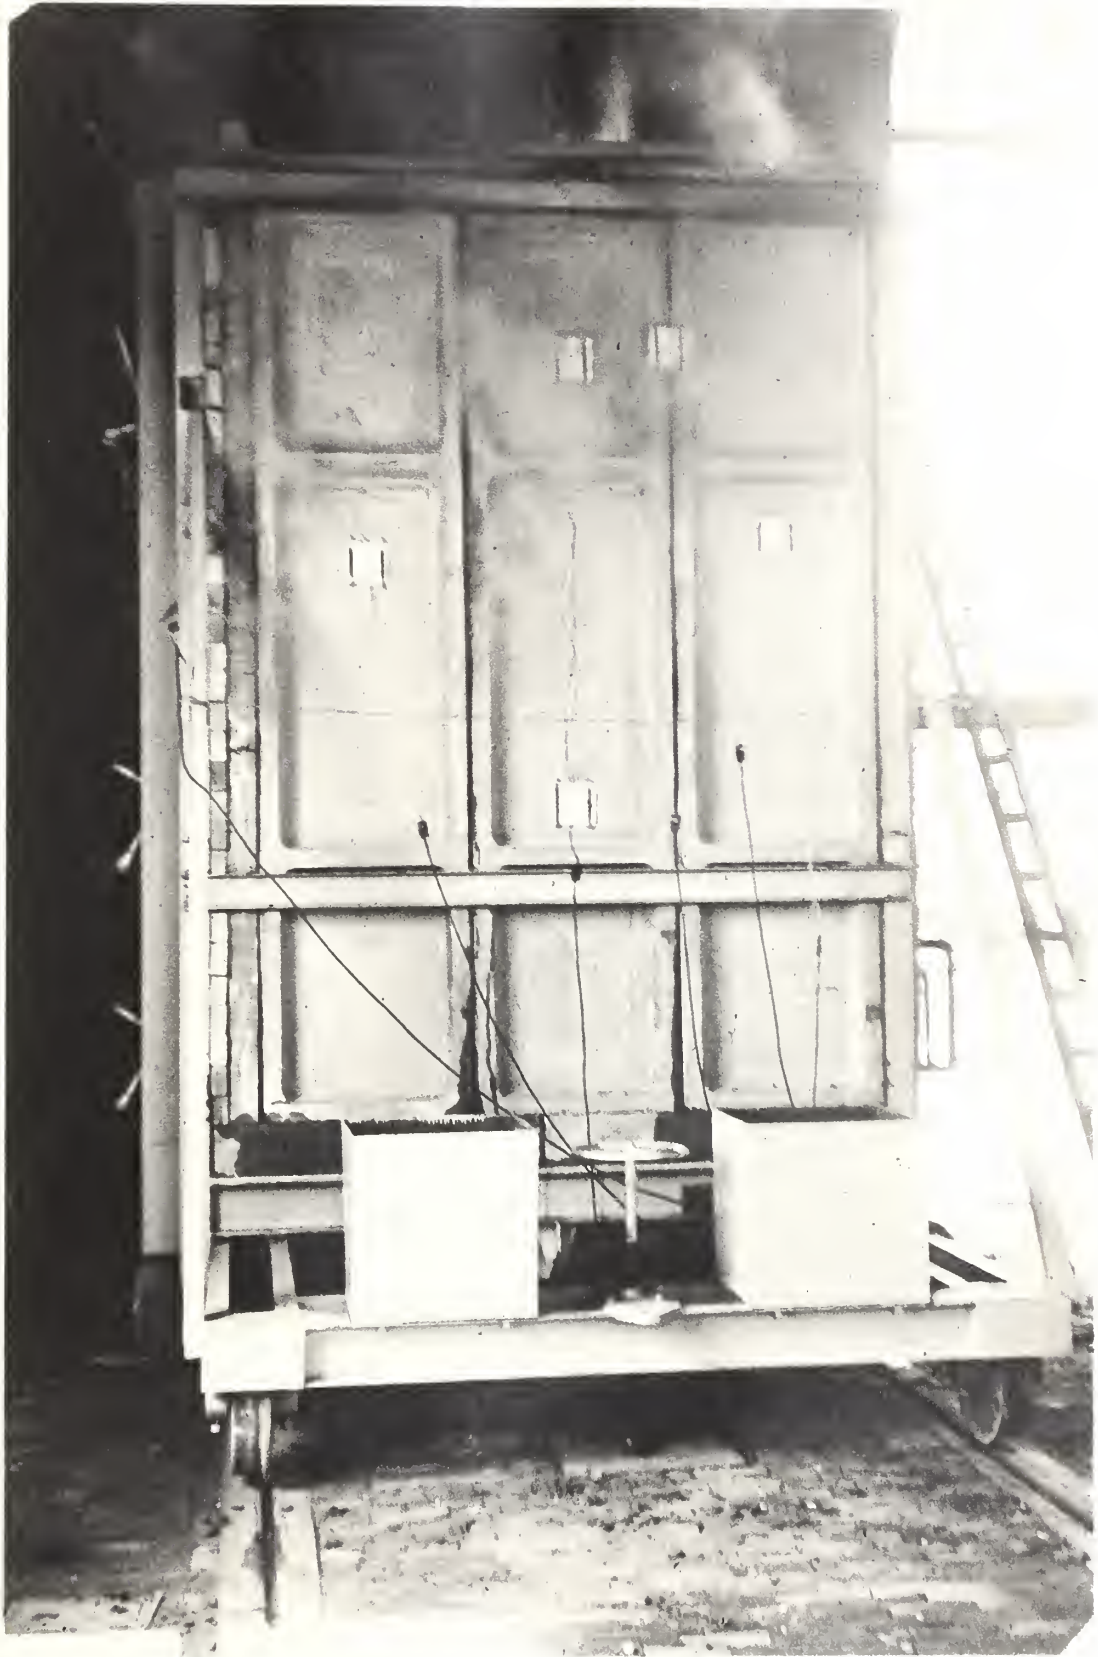
Immediately after the gas was turned off, the test specimen and frame were removed from the furnace. The insulating inner face panel in the center and portions of those on either side had fallen into the furnace chamber. The only damage to the concrete outer face was a spalled spot about $\frac{1}{2}$ in. deep and 6 in. diameter in the center of the upper section of each panel. Collections of the outer face were negligible.

Fig. 9. Exposed surface of specimen immediately after end of test 1.

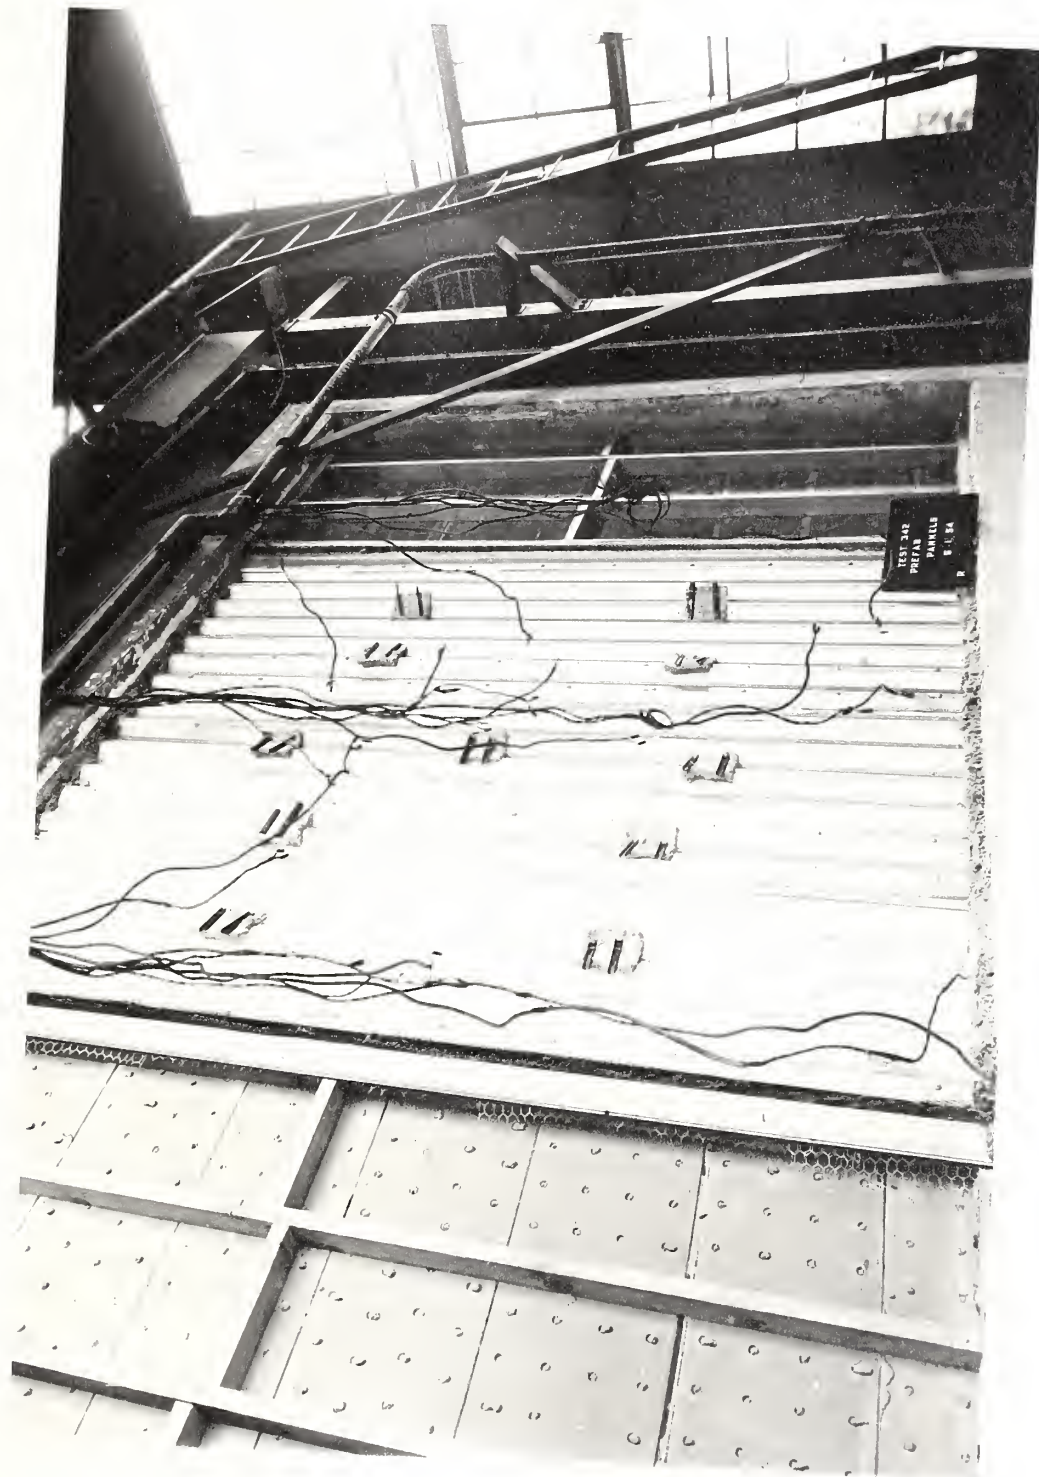
Fig. 11. Unexposed surface of specimen at 43 min in test 3.
