National Bureau of Standards

SUGGESTED METHOD FOR REPAIR OF ROOF SLAB
GENTILE AIR FORCE BASE

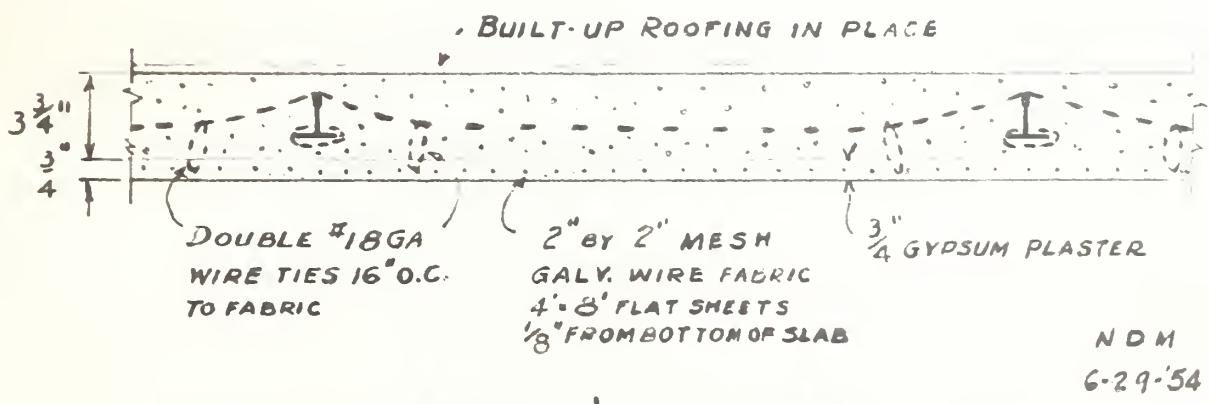
Inasmuch as any of the older cracks are either new or long side of the tee iron slab will it is recommended that the grooving of the crack should be deep enough to expose some of the wire fabric or in other words the bottom flanges of the tee iron. This would permit the plaster filling the crack to engage the wire fabric in a manner to support the fire roofing of the slab.

A method for the repair of panels which show signs of disintegration is suggested by the sketch herewith. Holes would be drilled into the slab from below at 16 in. centers so as to expose 1 in. strands of the wire fabric reinforcement. No. 14 gauge galvanized tie wires would be doubled and looped over the strands of the reinforcement, or in lieu of ties No. 12 bare wire hooks. Two-by two-in. mesh wire fabric would be tied to the effect of the damaged slab and furred down at least 1/8 inch to provide for embedment of the wire fabric in plaster. Three fourths inch thick sanded gypsum plaster applied to the bottom of the deck slab, when so reinforced by wire fabric, will be sufficient to support the weak perlite gypsum concrete and provide cover to the tee irons to give two-hour rating for the assembly. The plaster mix should be 1 part gypsum cement extra fibered to 2 parts by weight of clean sharp sand. The scratch coat should be applied as thick as will adhere. The second coat should be applied as soon as it will stay in place, preferably before the scratch coat has set and given a sand float finish.

It is suggested that the perlite-gypsum concrete of the roof deck be dried until it contains not to exceed 10 percent by weight of free water before repairs are begun. The drying might be expedited by the use of artificial heat and mechanical air circulation. Precautions must be taken to prevent the temperature of automatic sprinklers exceeding 110°F at any time and should not exceed 100°F for any extended number of days. If blasts of warm air from heating equipment are to be directed toward sprinklers the ratings of such sprinklers should be intermediate (212°F) or hard (237°F).
