NATIONAL BUREAU OF STANDARDS REPORT

1003-10-4881

November 7, 1955

SUPPLEMENTARY TESTS ON THE EFFECTS OF HEATING AND COOLING A GILSULATE ENVELOPE

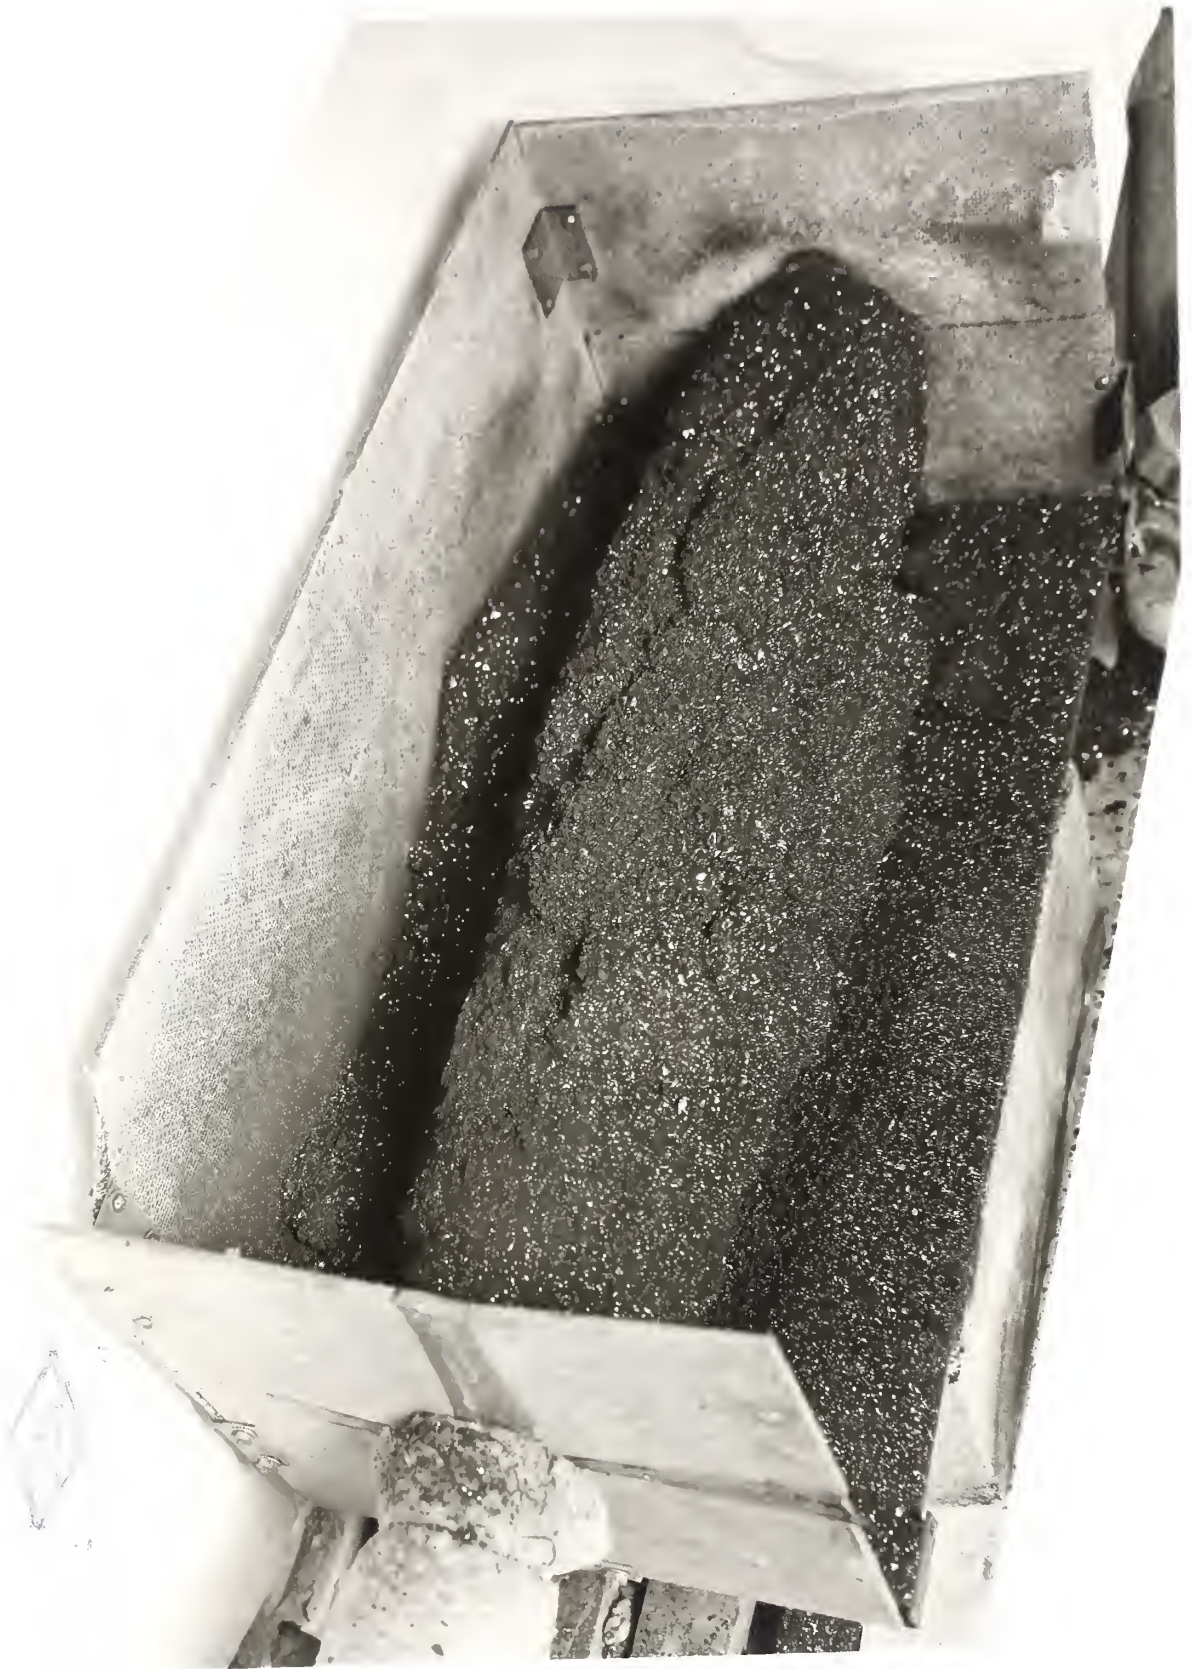
FIG. 1

The inspection after cycle 10 is illustrated with Fig. 1 and Fig. 2. Fig. 1 shows the sintered core after the removal of the unconsolidated material and reveals a large longitudinal crack on the top. Fig. 2 shows that the sintered material came off the top half in well-defined pieces of coke-like material and with no adhesion to the pipe. The lower half of the core consisted of a sintered outside layer and an inner layer of a stiff gummy consolidated material adhering to the pipe. The adhesion can be seen below the center line of the pipe in Fig. 2.

Repeated heating and cooling of the Gilsulate conduit for a cumulative heating period of 203 hours showed different results at the top and bottom of the pipe. The top half showed numerous thin cracks that did not heal upon reheating. The inside surface was hard and free from the pipe. The lower half of the core adhered to the pipe after 203 hours of heating with some of the consolidated layer being softened
