NATIONAL BUREAU OF STANDARDS REPORT

5223

SUMMARY REPORT - VAPOR BARRIER INVESTIGATION

Thule and Sondrestrom Air Force Bases, Greenland

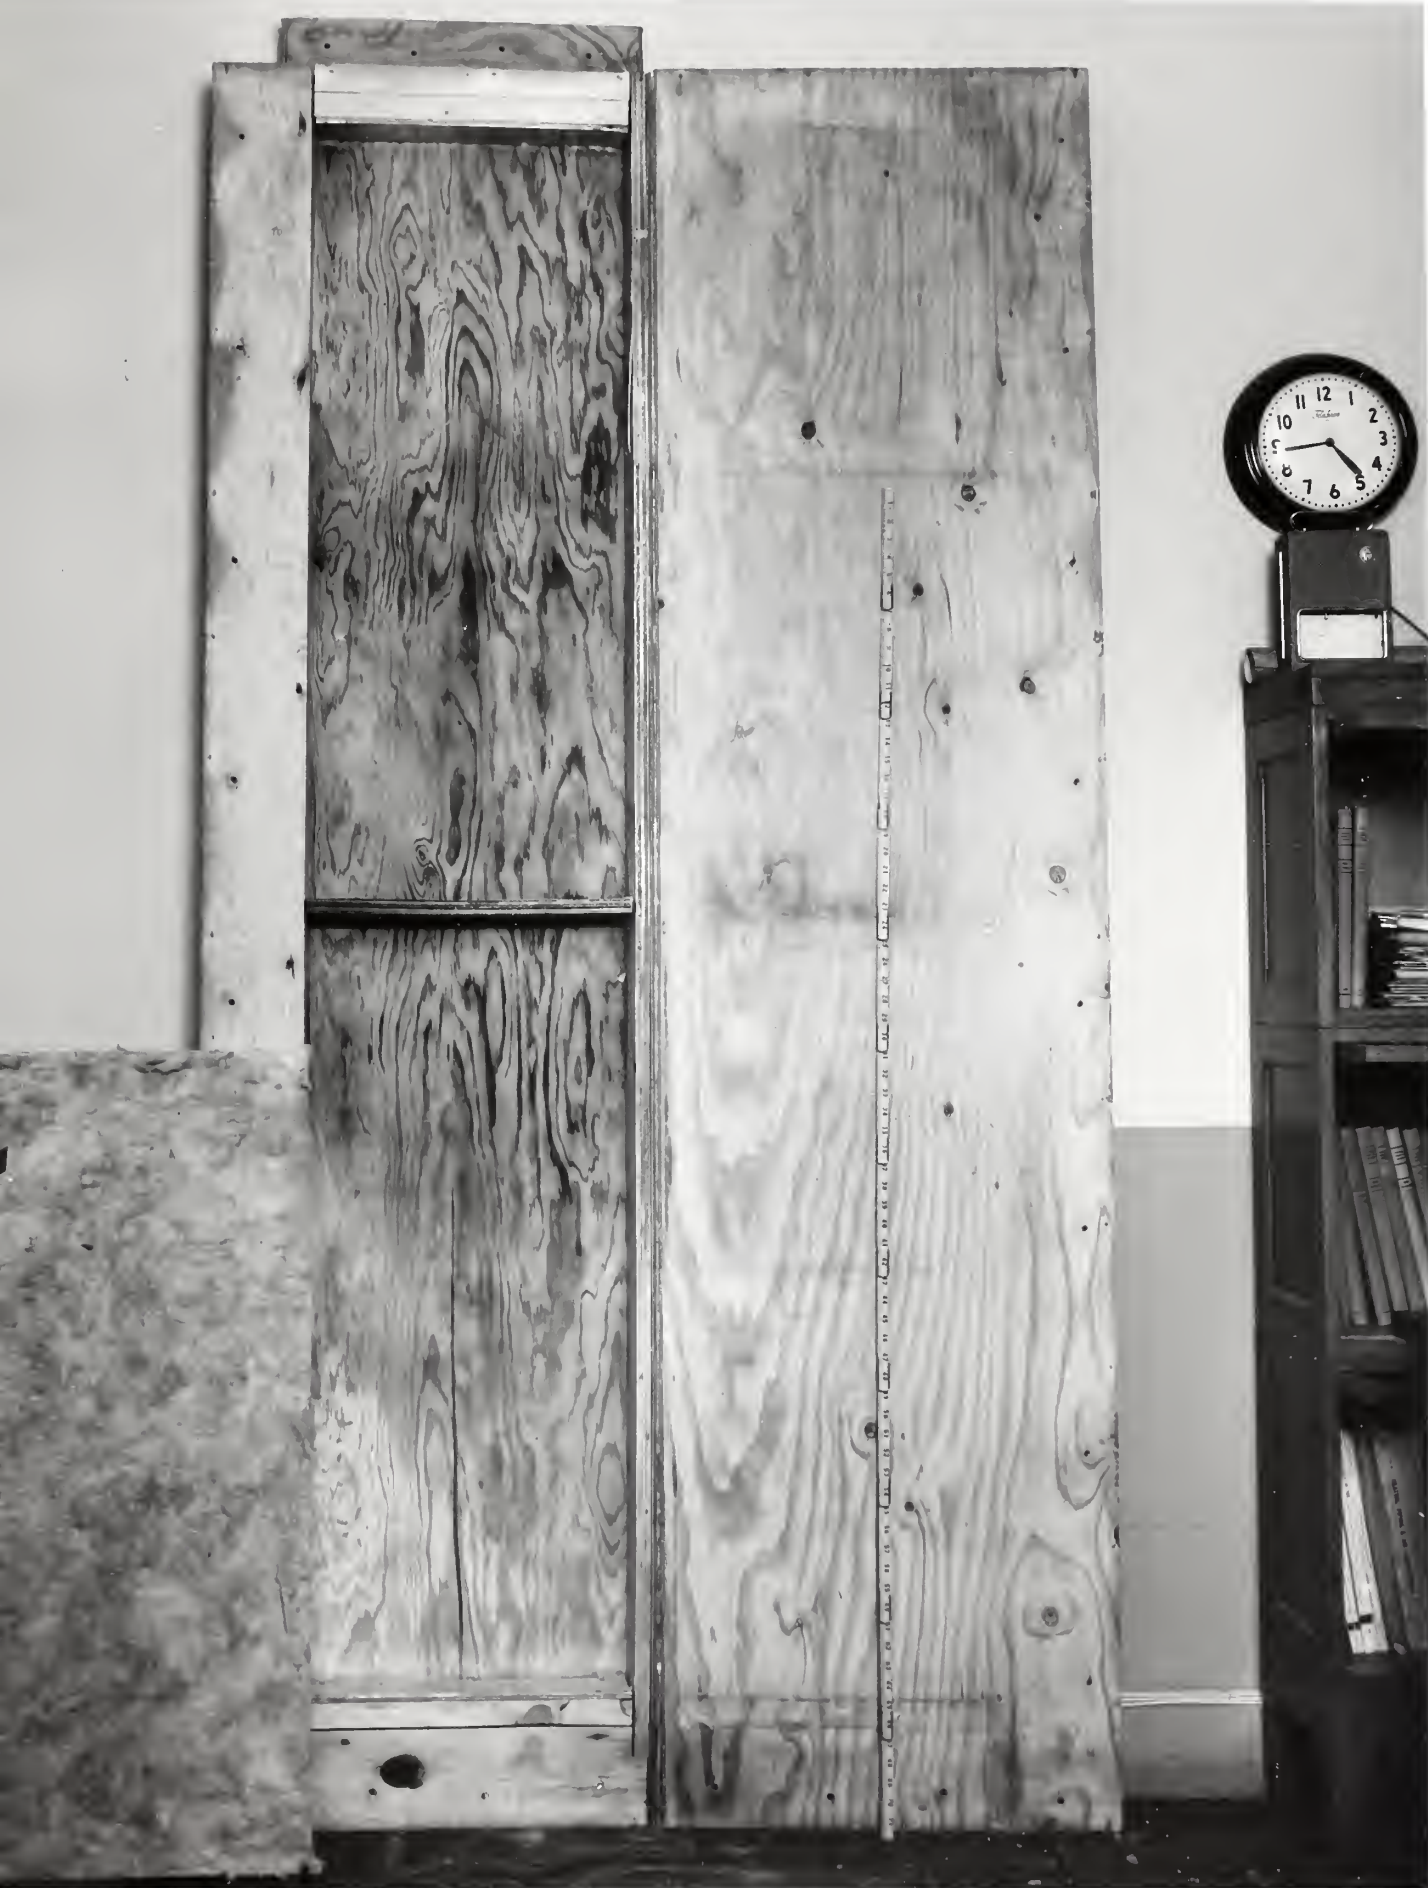
Figure 5

The larger panel (Figure 5) was 18 inches wide (insulated space), approximately eight feet high, and was probably of recent construction. This panel, generally, was in good condition. Considerable moisture-staining and wet areas were noted on the interior plywood. A small amount of delamination occurred on this sheet. Moisture concentrated near the central 3/4-inch plywood divider (Figure 5) and at the edges of the panel. The wood members of the remainder of the panel were sound. The insulation was damp on the indoor surface and did not appear so moist as in the smaller panel. Both interior and exterior aluminum skins were well bonded to their respective sheets of plywood except for the wet areas near the center of the interior sheet; at this point, the aluminum was separated from its backing sheet of plywood.
