NATIONAL BUREAU OF STANDARDS REPORT

6205

AN INTERIM REPORT ON BOILING TESTS OF INSULATION FOR UNDERGROUND HEAT DISTRIBUTION SYSTEMS

Selden D. Cole and Paul R. Achenbach
Air Conditioning, Heating, and Refrigeration Section
Building Technology Division

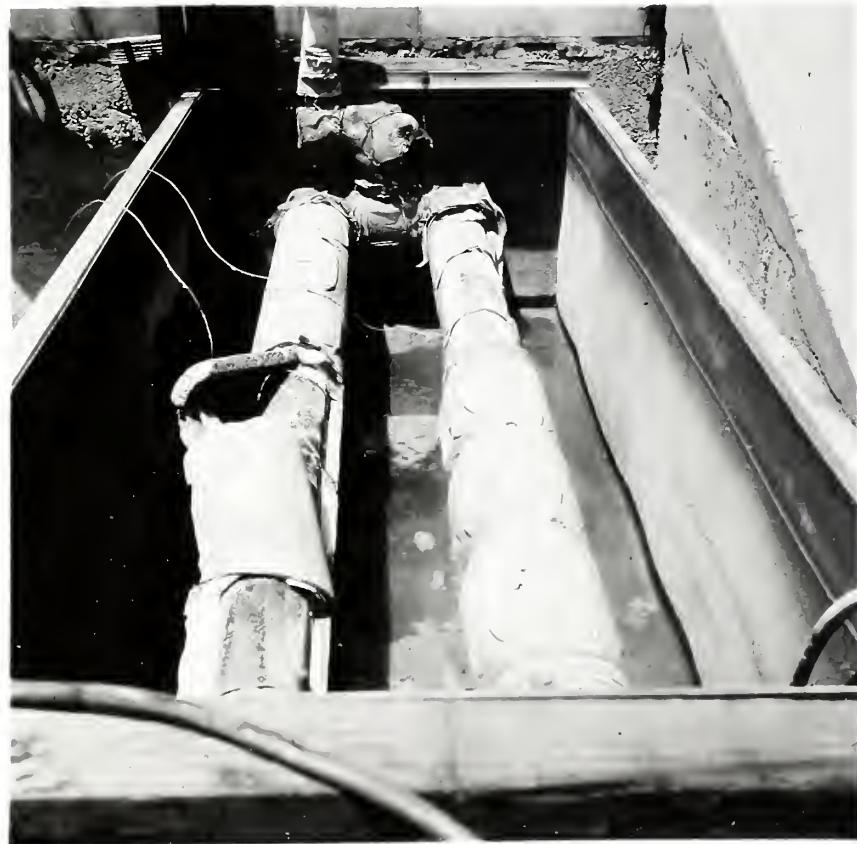
Figure 3

Amount fallen from pipe: Top half of 1st section fell off.
Bottom half dropped down and resting
on straps. 2nd section intact.

Fig 3 shows 1st section gone after
72 hours; right specimen.

Cracks and ruptures: Insulation cut by wires on 2nd section and broken into pieces. Top half of 2nd section dislocated. See Fig 3; left specimen.

Fig 3 shows rupture of 2nd section as it appeared after 72 hr of boiling; left specimen.

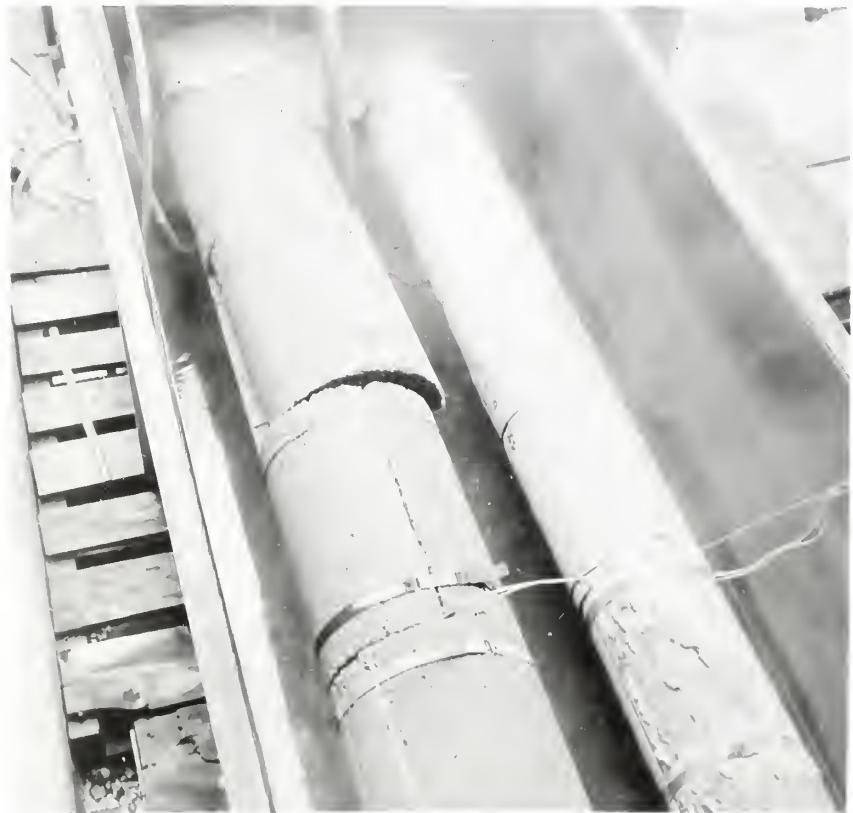
Figure 4

Cracks and ruptures: Vibration of fourth section caused it to cut into insulation, but it was not severed. See Fig 4; left specimen.

Fig 4 shows appearance after 7½ hr boiling. Dislocation of 4th section from cutting by wires shown in left specimen.

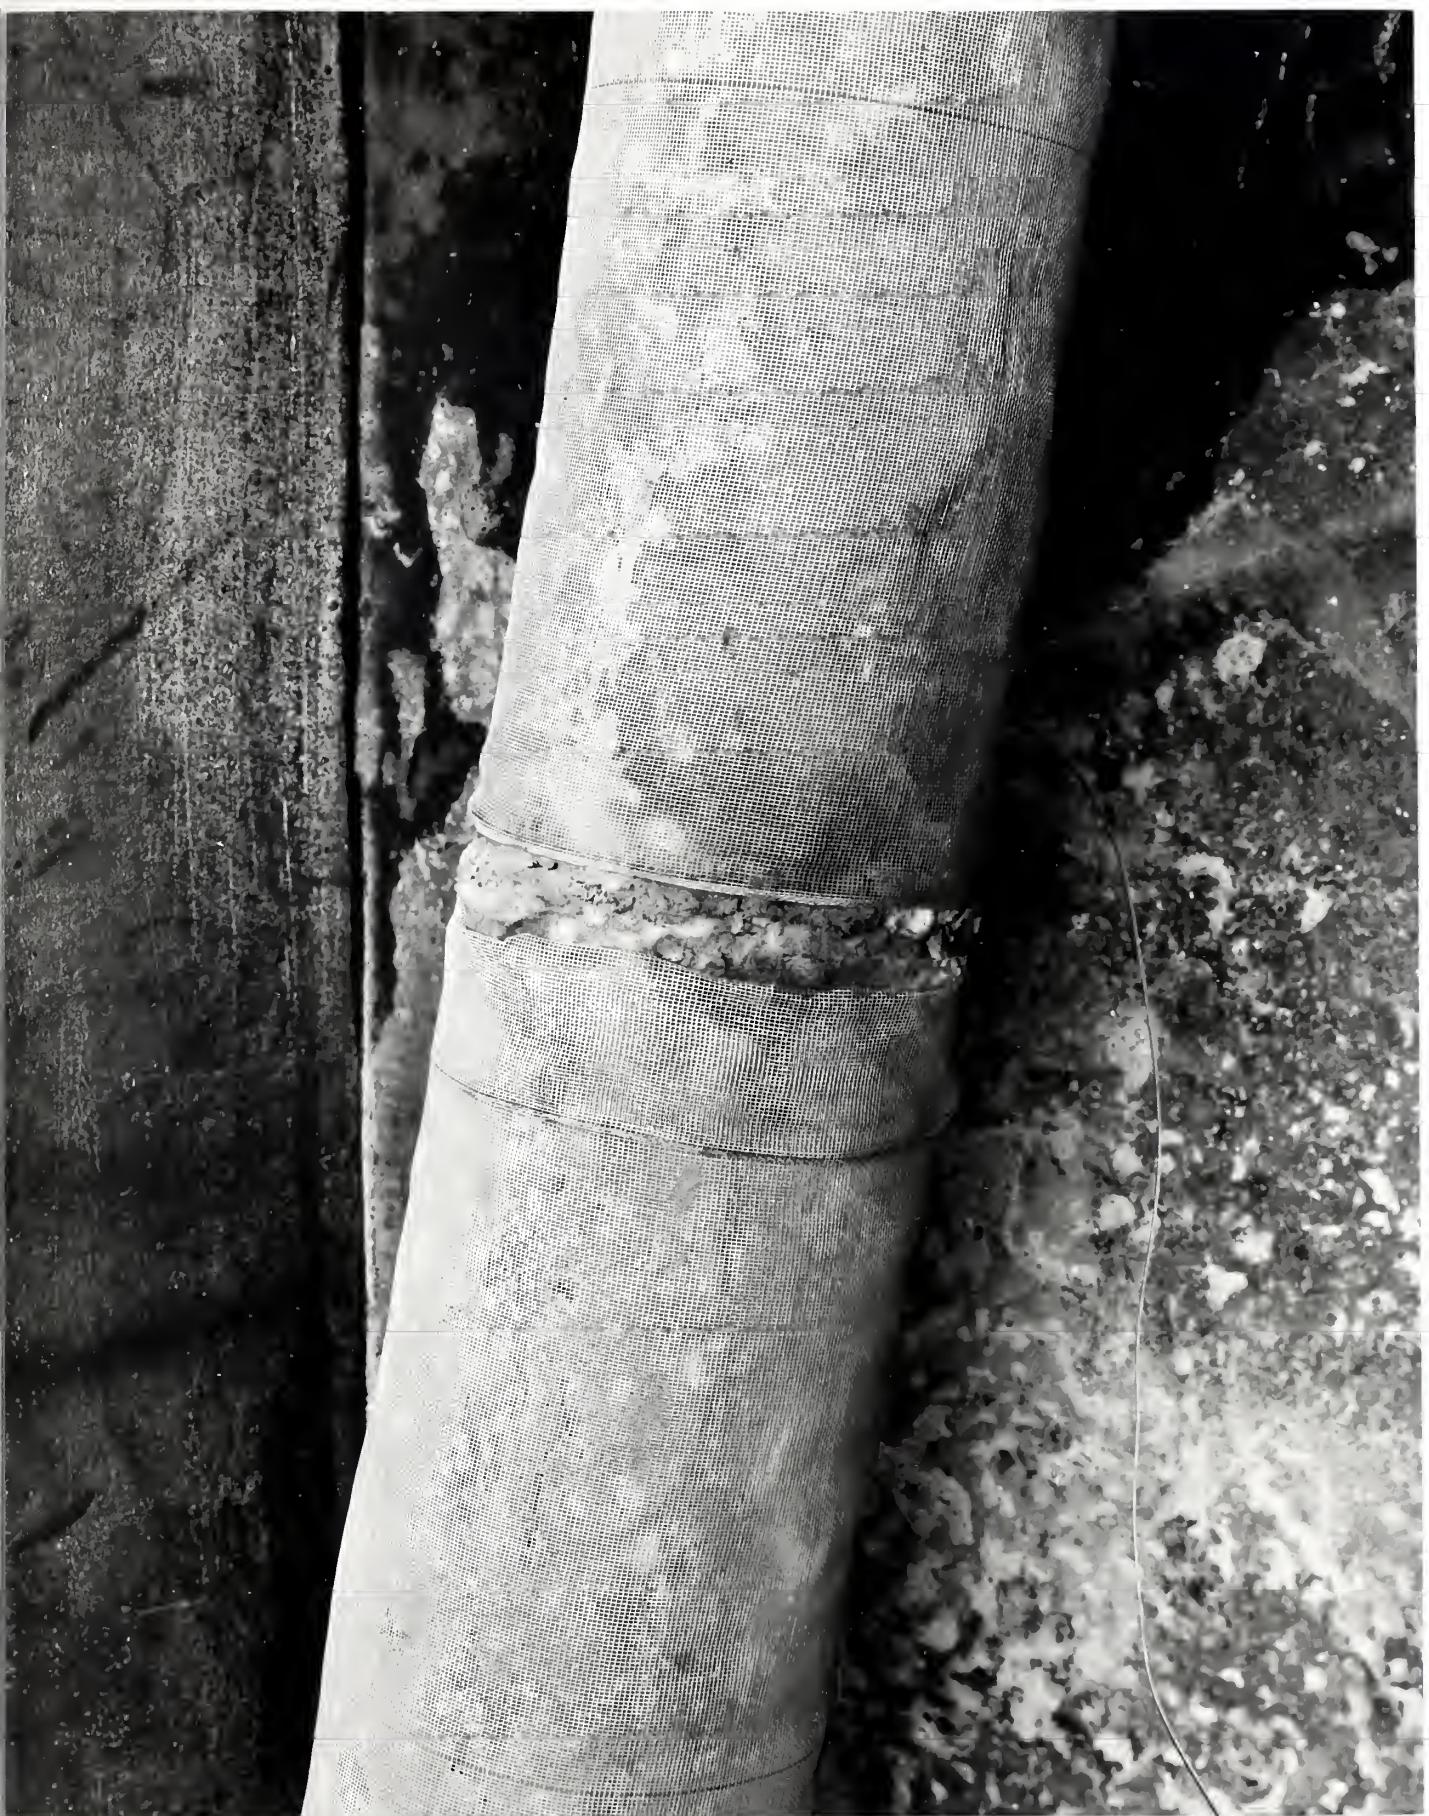
Figure 6

Fig 6 - butt joint uncovered to show negligible loss of wool

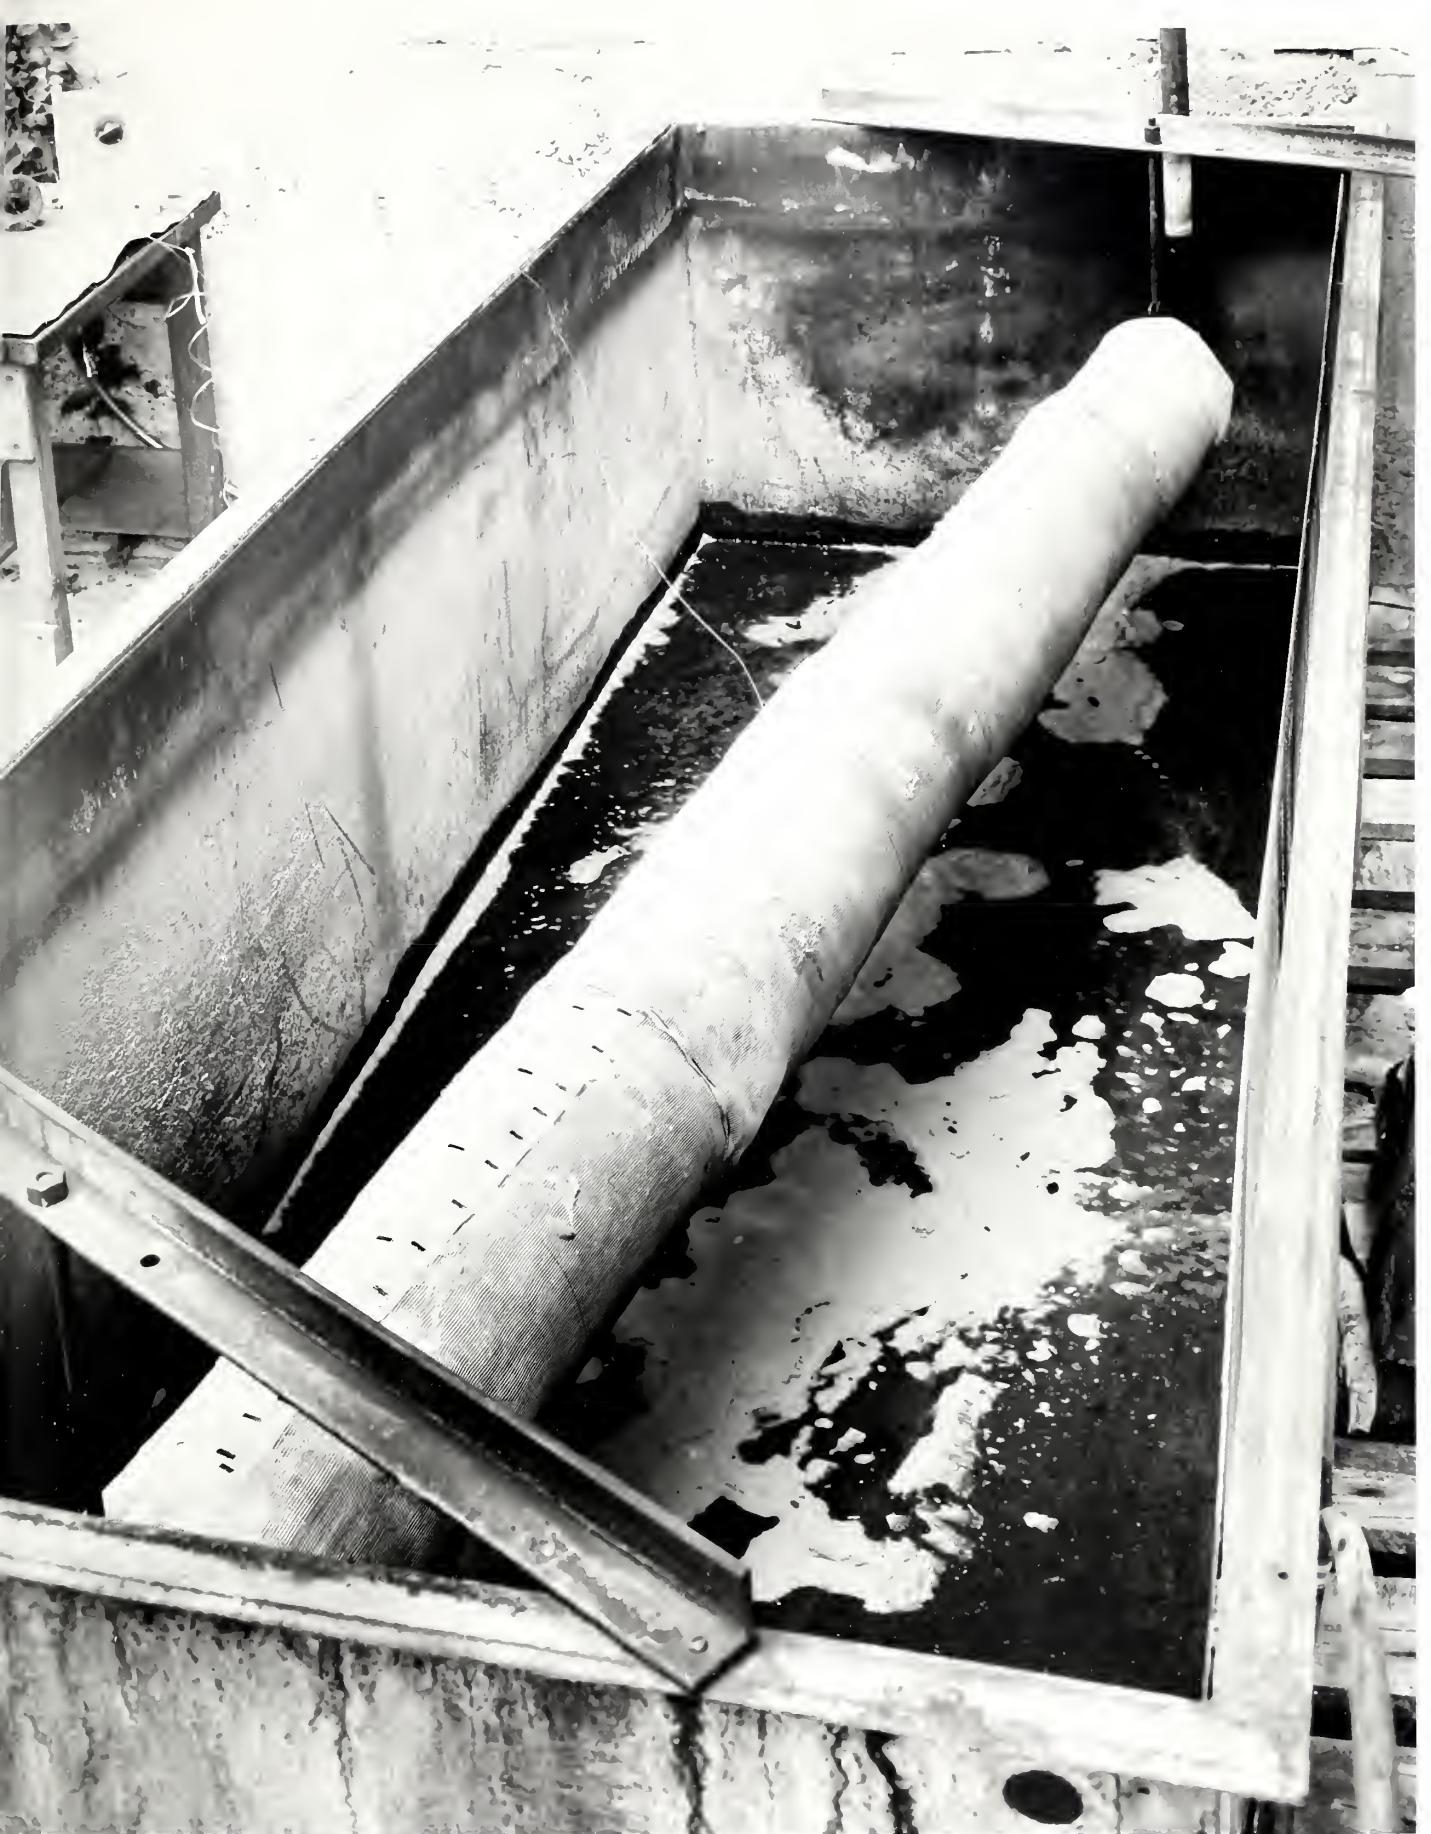
Figure 7

Other damage: Plastic covering brittle after 144 hrs.

Fig 7 - after 144 hrs boiling shows some loss of Fiberglas wool

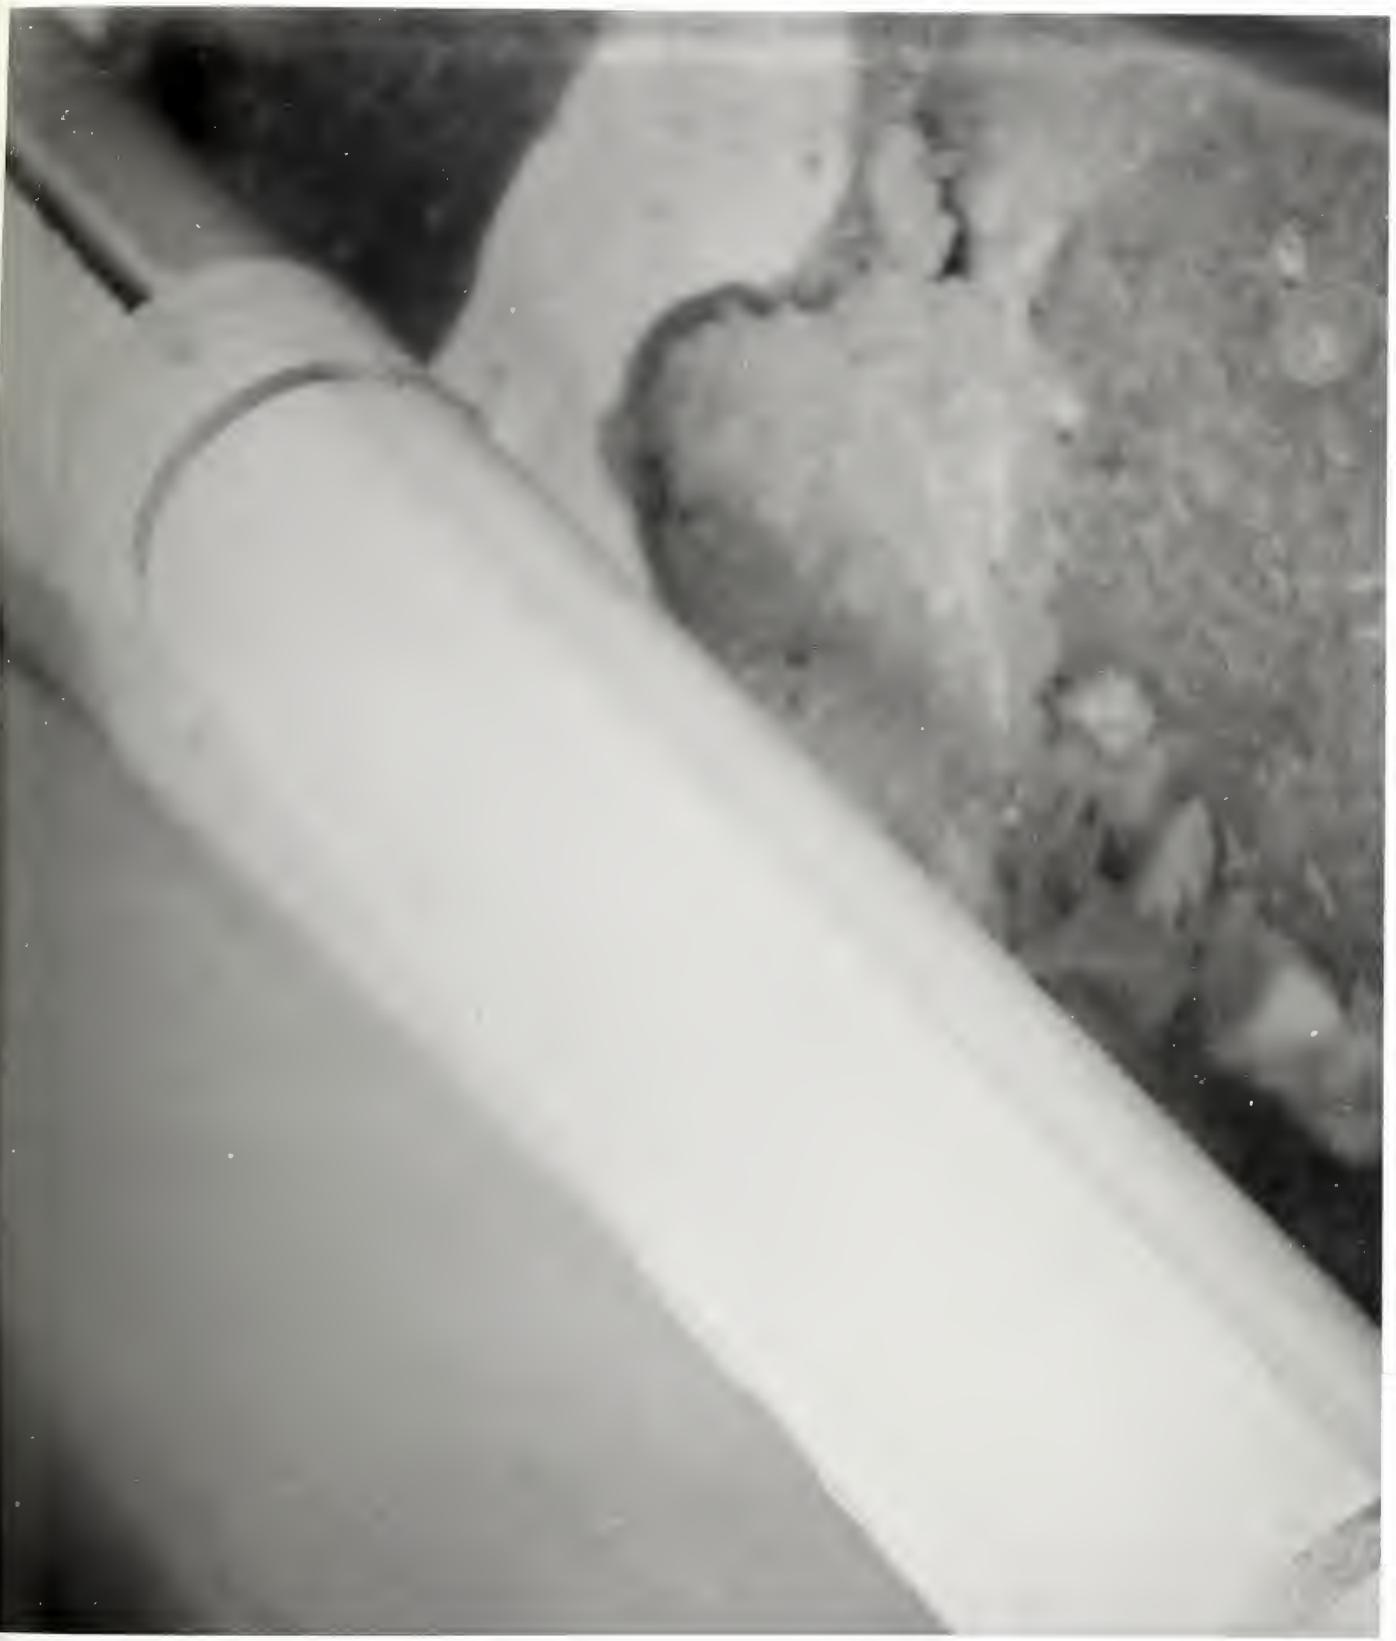
Figure 14

- Amount fallen from pipe: 1st section fell off in less than 24 hrs when aluminum straps sheared.
1st section replaced and steel straps used.
1st section off again after 48 hours boiling. Replaced and boiled for an additional 72 hours with one piece breaking off.
- Cracks and ruptures: At 72 hours, seams of mesh-covered sections had opened about 2 in. 2 straps were added to the second section and after 72 hours of additional boiling, the seam opening had not increased in the second section but had in the short unstrapped section.
- Other damage: Some erosion at joints after 144 hours of boiling.
- Moisture retention (percent): Not measured
- Reference to photographs: Fig 14 shows condition of mesh-covered section after 144 hours of boiling.

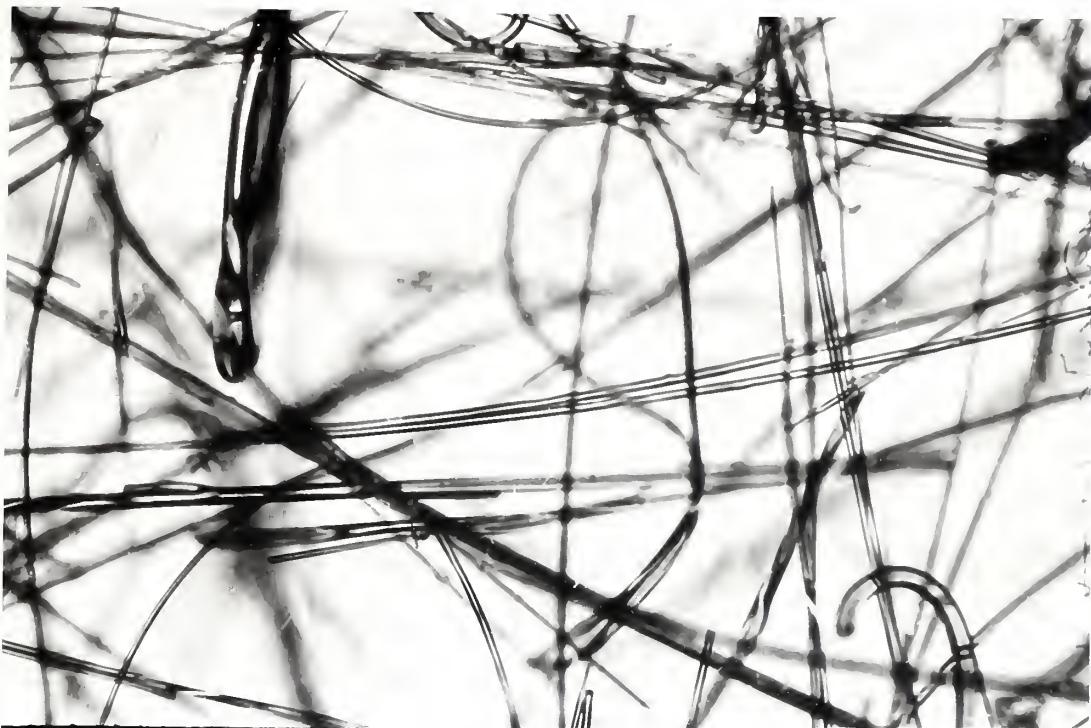
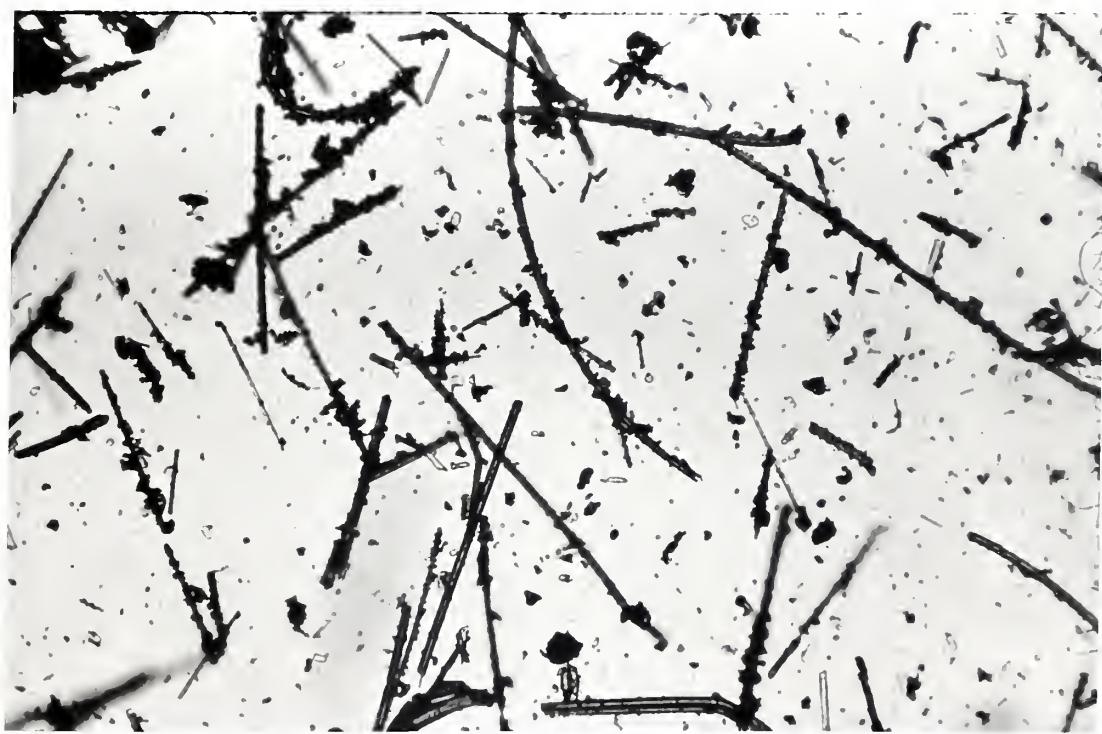
Microscopic Examinations of Insulation: Samples of insulation were taken from the specimen at several locations after the test for microscopic examination. Microphotographs were taken of the glass fibers before and after boiling. Fig 16a shows the smooth, transparent, cylindrical appearance of the fibers when new. Fig 16b shows the appearance of the material near the surface of the envelope after boiling. It was broken into many short pieces, and appeared brown to the naked eye (perhaps the effect of the boiling water and steam on the oil treatment of the original material). Fig 16a and 16b are about 400 to 1 magnifications.

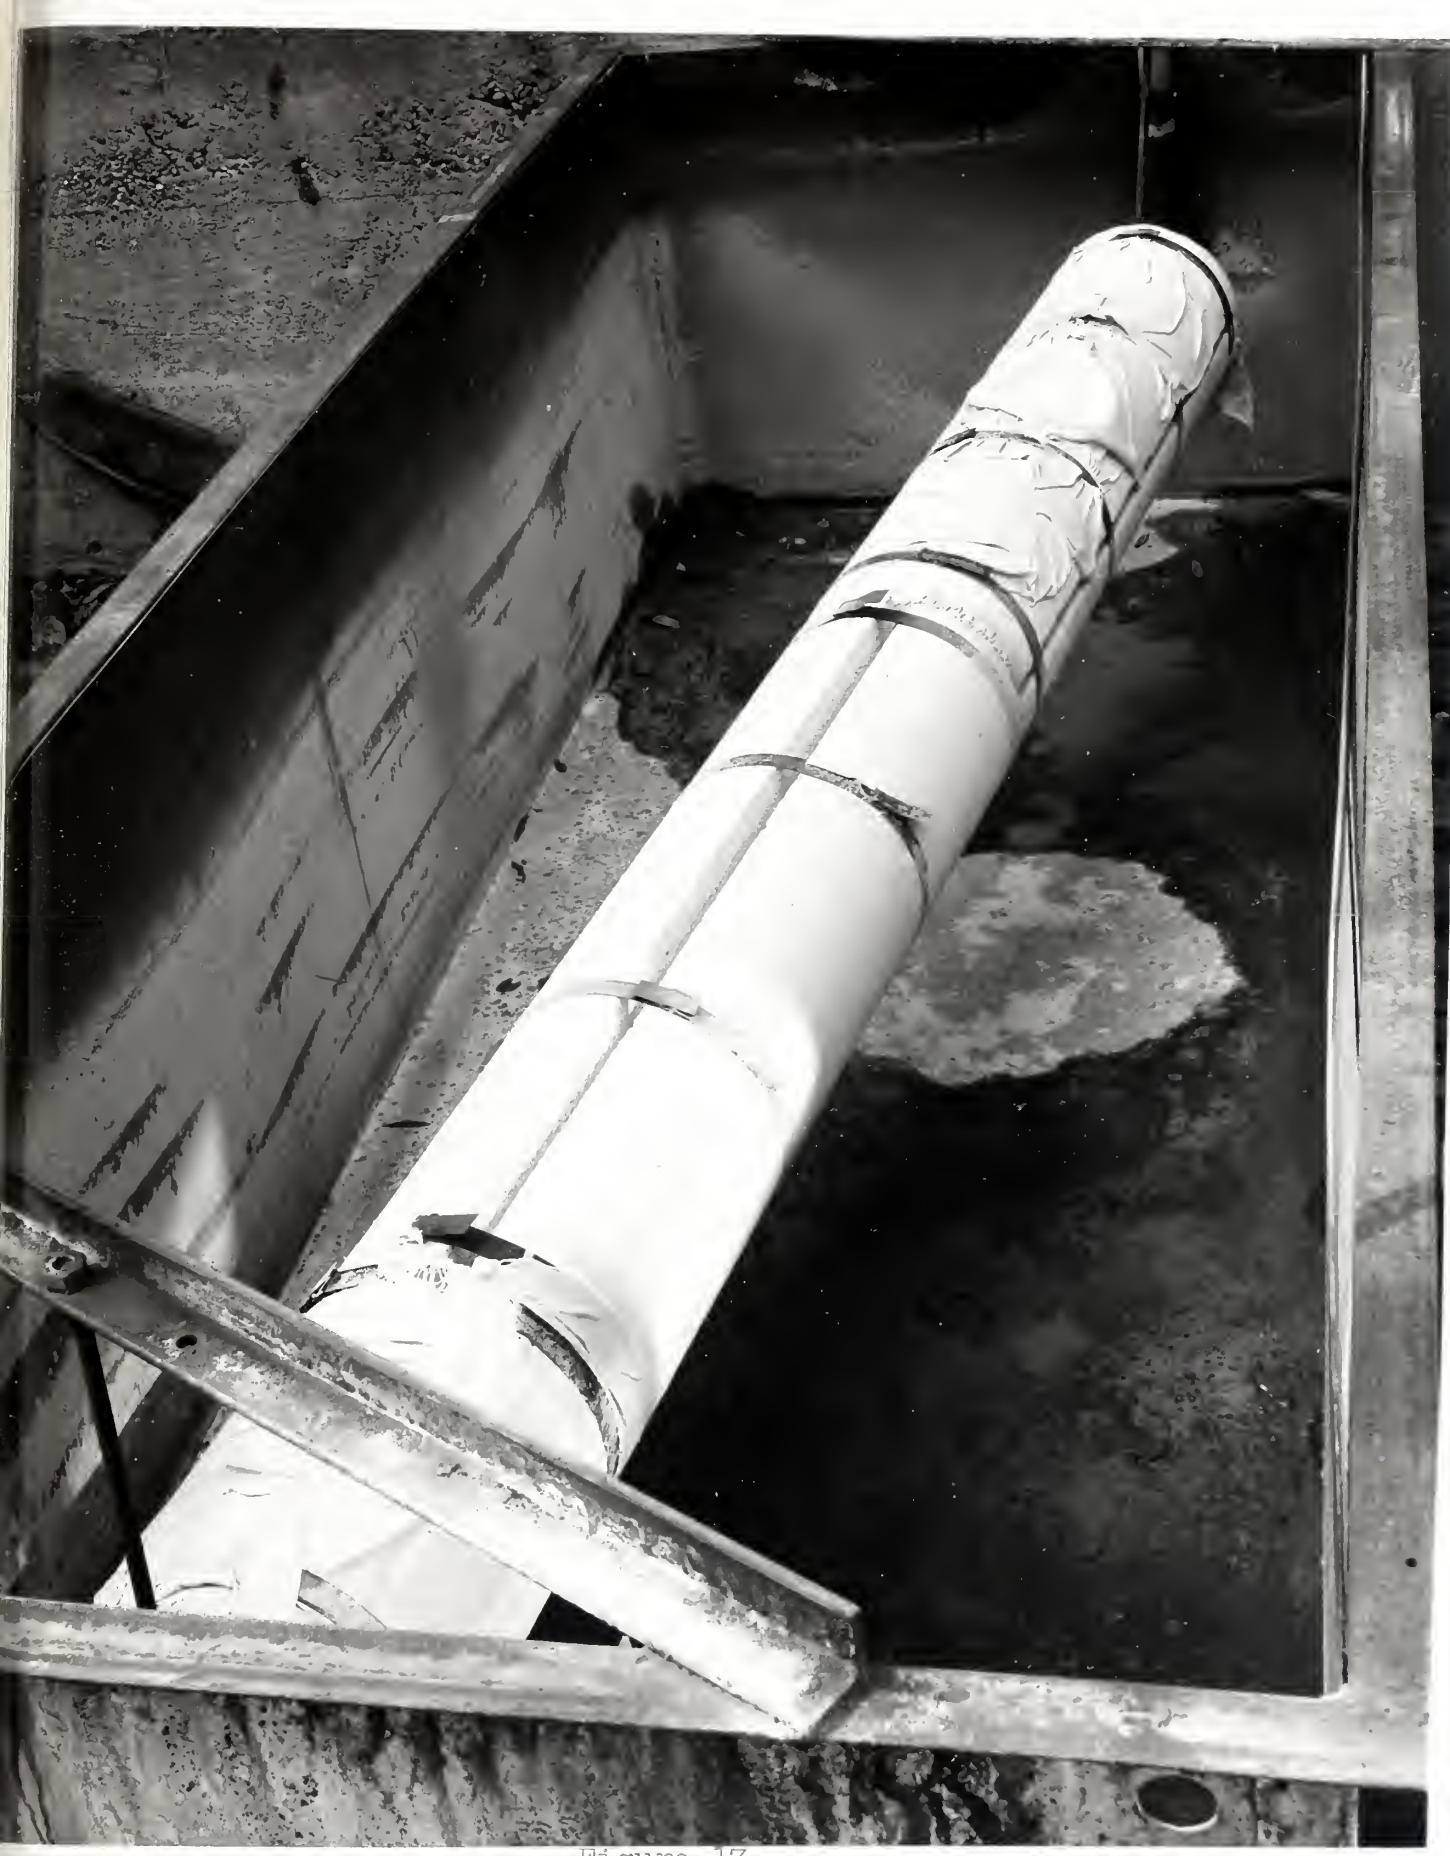
Figure 17

Erosion: Edges of vertical joints eroded so that circumference of two half sections lost about 1 in. after 144 hours boiling.

Reference to photographs: Fig 17 shows appearance after 72 hours boiling

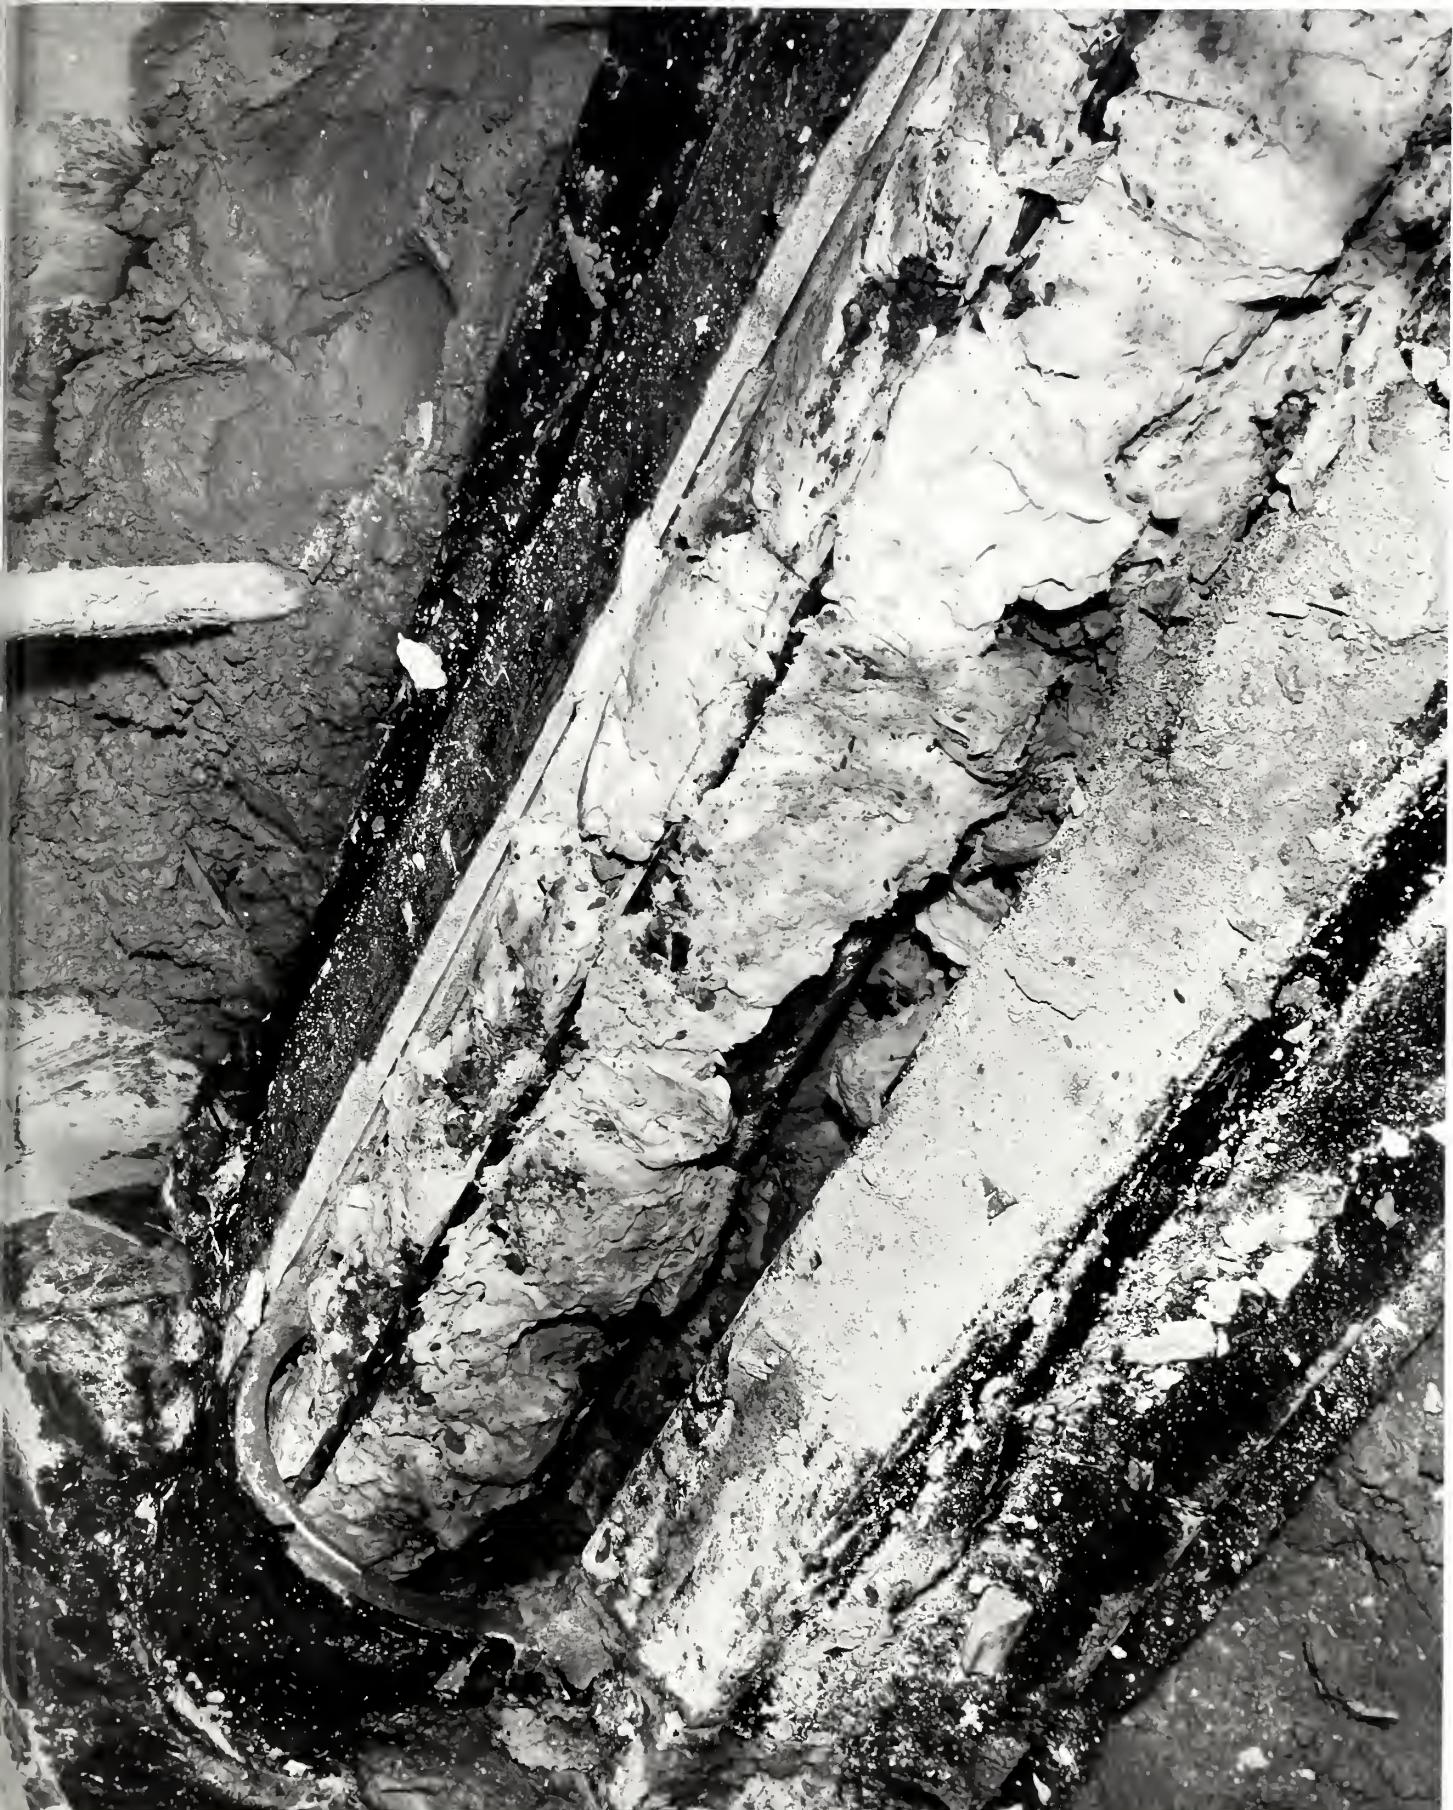
Figure 20

Fig 20 shows the appearance, at the downstream end, of the insulation. The 4 in. pipe is exposed for about 1/2 of its circumference on the lower side. There was considerable loss of insulation only near the outlet end for a distance of about 3 ft. A small amount was also lost at the inlet end. Apparently the insulation was carried out of the vertical vent pipes by the surging water and steam. Some pulverized glass fibers were found in the vent pipe at the end of the test. Except for the loss indicated above, there was little evidence of any voids in the remainder of the insulation.
