NATIONAL BUREAU OF STANDARDS REPORT

6837

FIRE ENDURANCE AND HEAT TRANSFER
TESTS OF PREFABRICATED PANELS

FIRE ENDURANCE AND HEAT TRANSFER TESTS OF PREFABRICATED PANELS

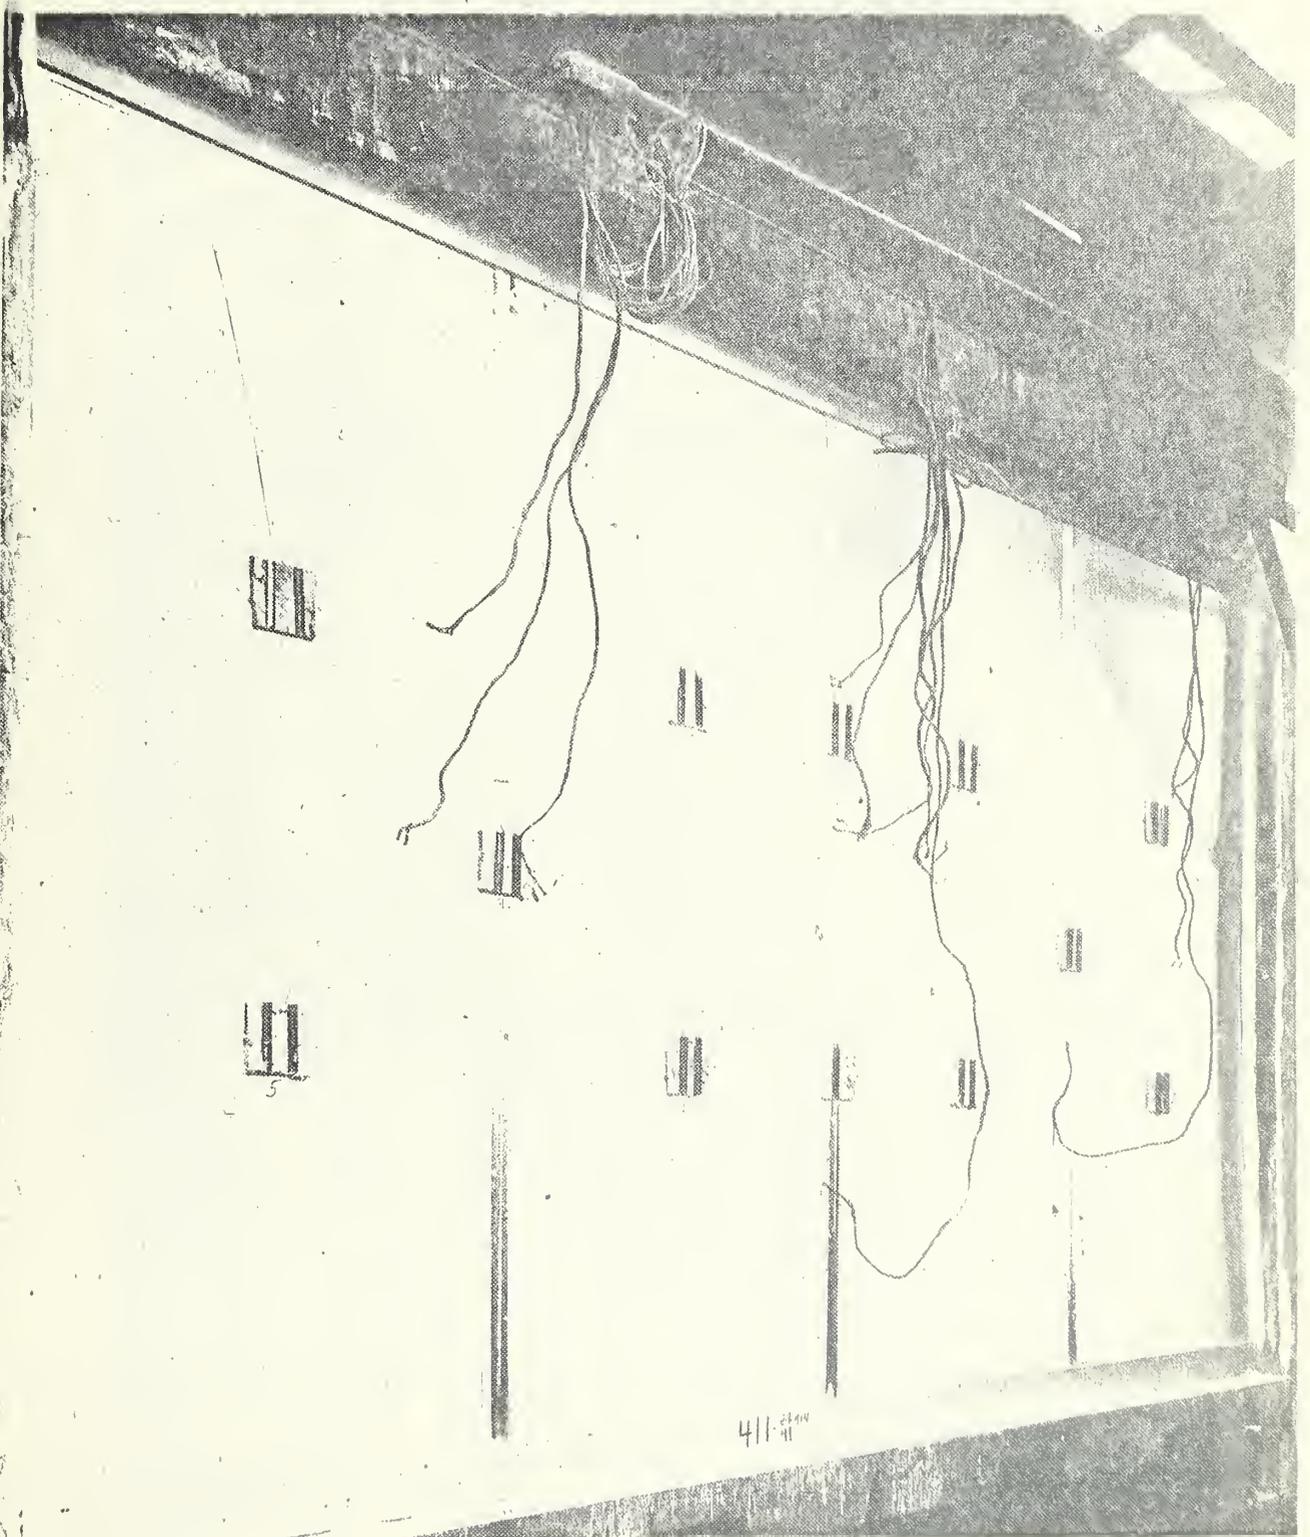
There was no observable lateral deflection as a result of the application of load just before the start of the test. There were intermittent flames on the exposed surface in the first 6 min. The unexposed surface of the south-center panel was wrinkled at 13 min. At 17 min, about 1/2 sq ft of gypsum board fell from the south-center panel; the extra metal liner on the exposed surface of the south panel was warped and bulging. By 28 min, there were flames from the exposed surface along all the joints plus several cracks in the gypsum board. At 31-1/2 min, about 8 sq ft of gypsum board fell from the north-center panel. By 35 min, this had increased until about half the gypsum board was down from the north-center panel plus about 8 sq ft from the south-center panel with an equal area leaning on a furnace thermocouple pipe. By 40 min, about 2/3 of the gypsum board had fallen from the north-center and south-center panels and the exposed metal was buckled. The condition of the unexposed surface at 41 min is shown in Figure 3. At 51 min, smoke was coming through the center joint and about half the gypsum board had fallen from the north panel. At 58 min, the unexposed surface of the south-center panel was discolored. At 1 hr, there appeared to be an offset of about 1/2 in. along the joints on each edge of the north-center panel. Flames came through the center joint at 1 hr 3 min and the north joint at 1 hr 3-1/2 min; see Figure 4. The test was stopped at 1 hr 5 min. The interior of the specimen continued to burn. The frame and specimen were removed from the furnace and the flames extinguished. Temperature and deflection data are summarized in Figure 1. Figure 5 shows the exposed surface at removal from the furnace.

Figure 3. Unexposed surface of perlite-filled wall at 41 min.

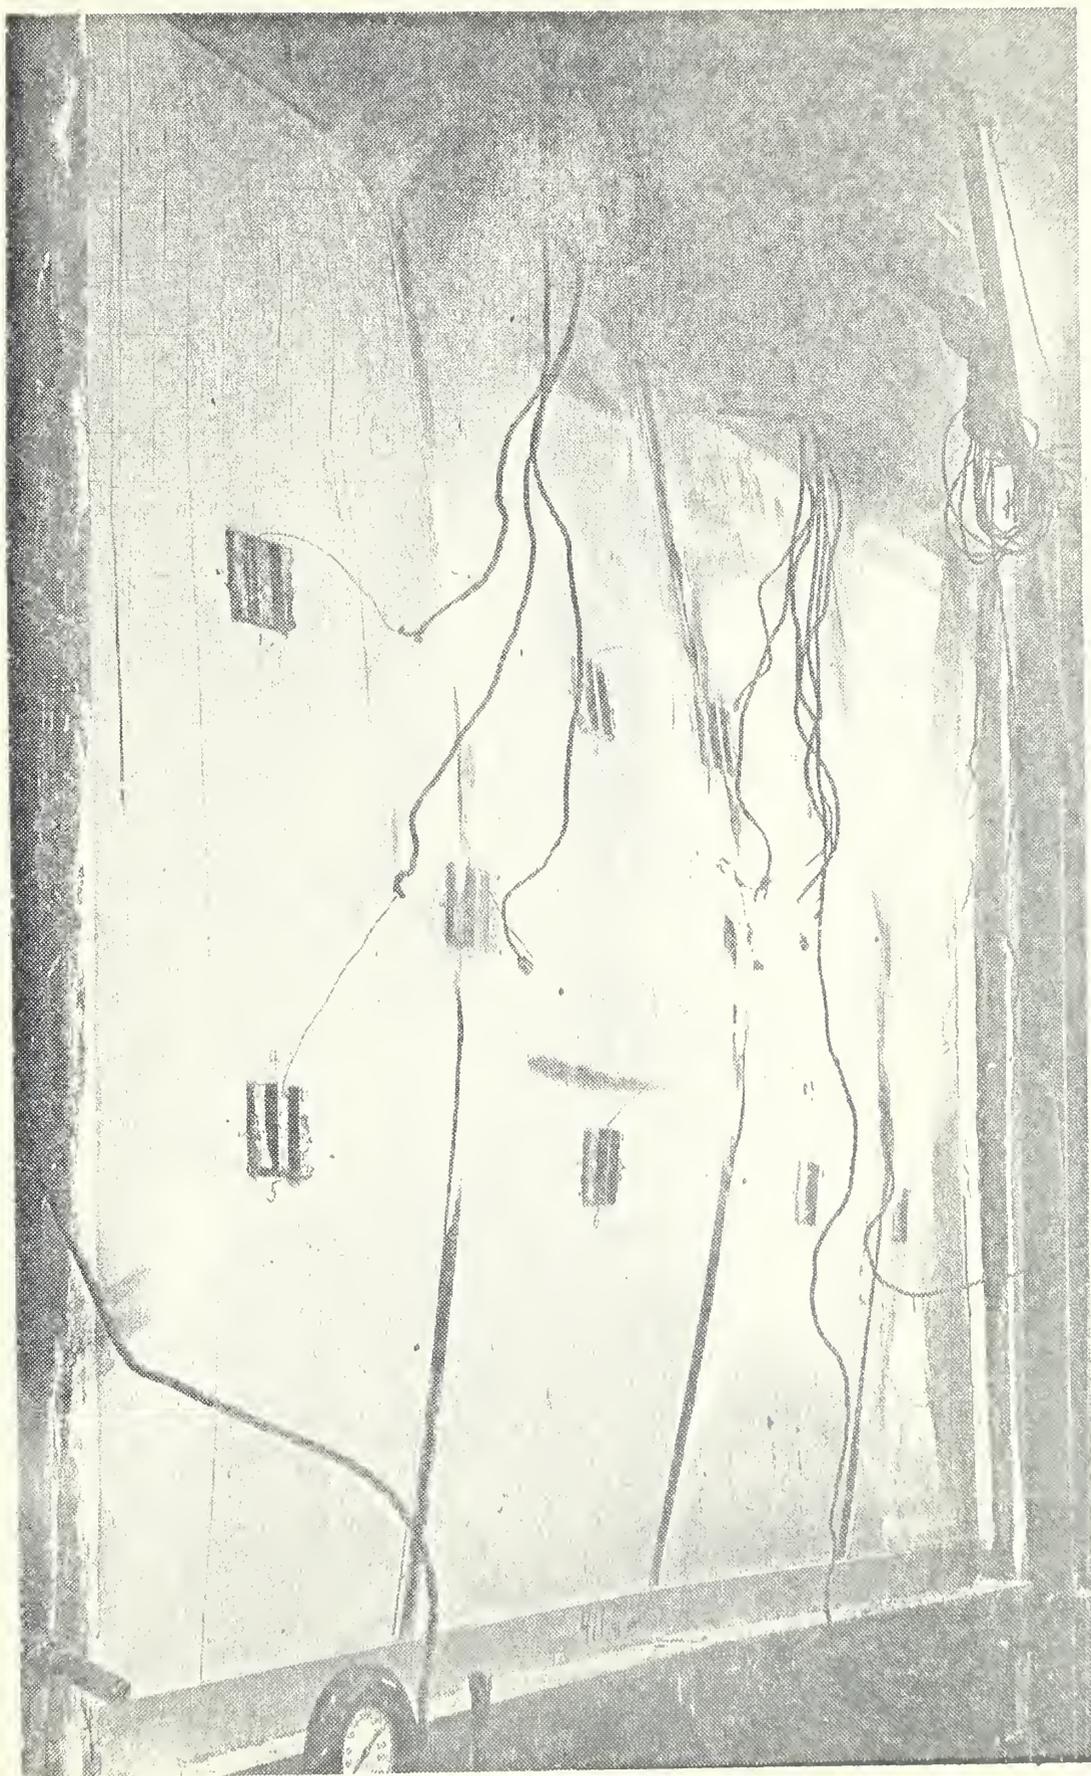
The fire endurance of the specimen was limited by 325°F rise above initial temperature at each of two thermocouples on the unexposed surface at 1 hr 2 min. The correction for actual furnace temperatures reduced this to 1 hr 1 min. The specimen continued to support the applied load until it was removed after the first breakthrough of flames at 1 hr 3 min.

Figure 4. Unexposed surface of perlite-filled wall as flames broke through north joint, 1 hr 33 min.

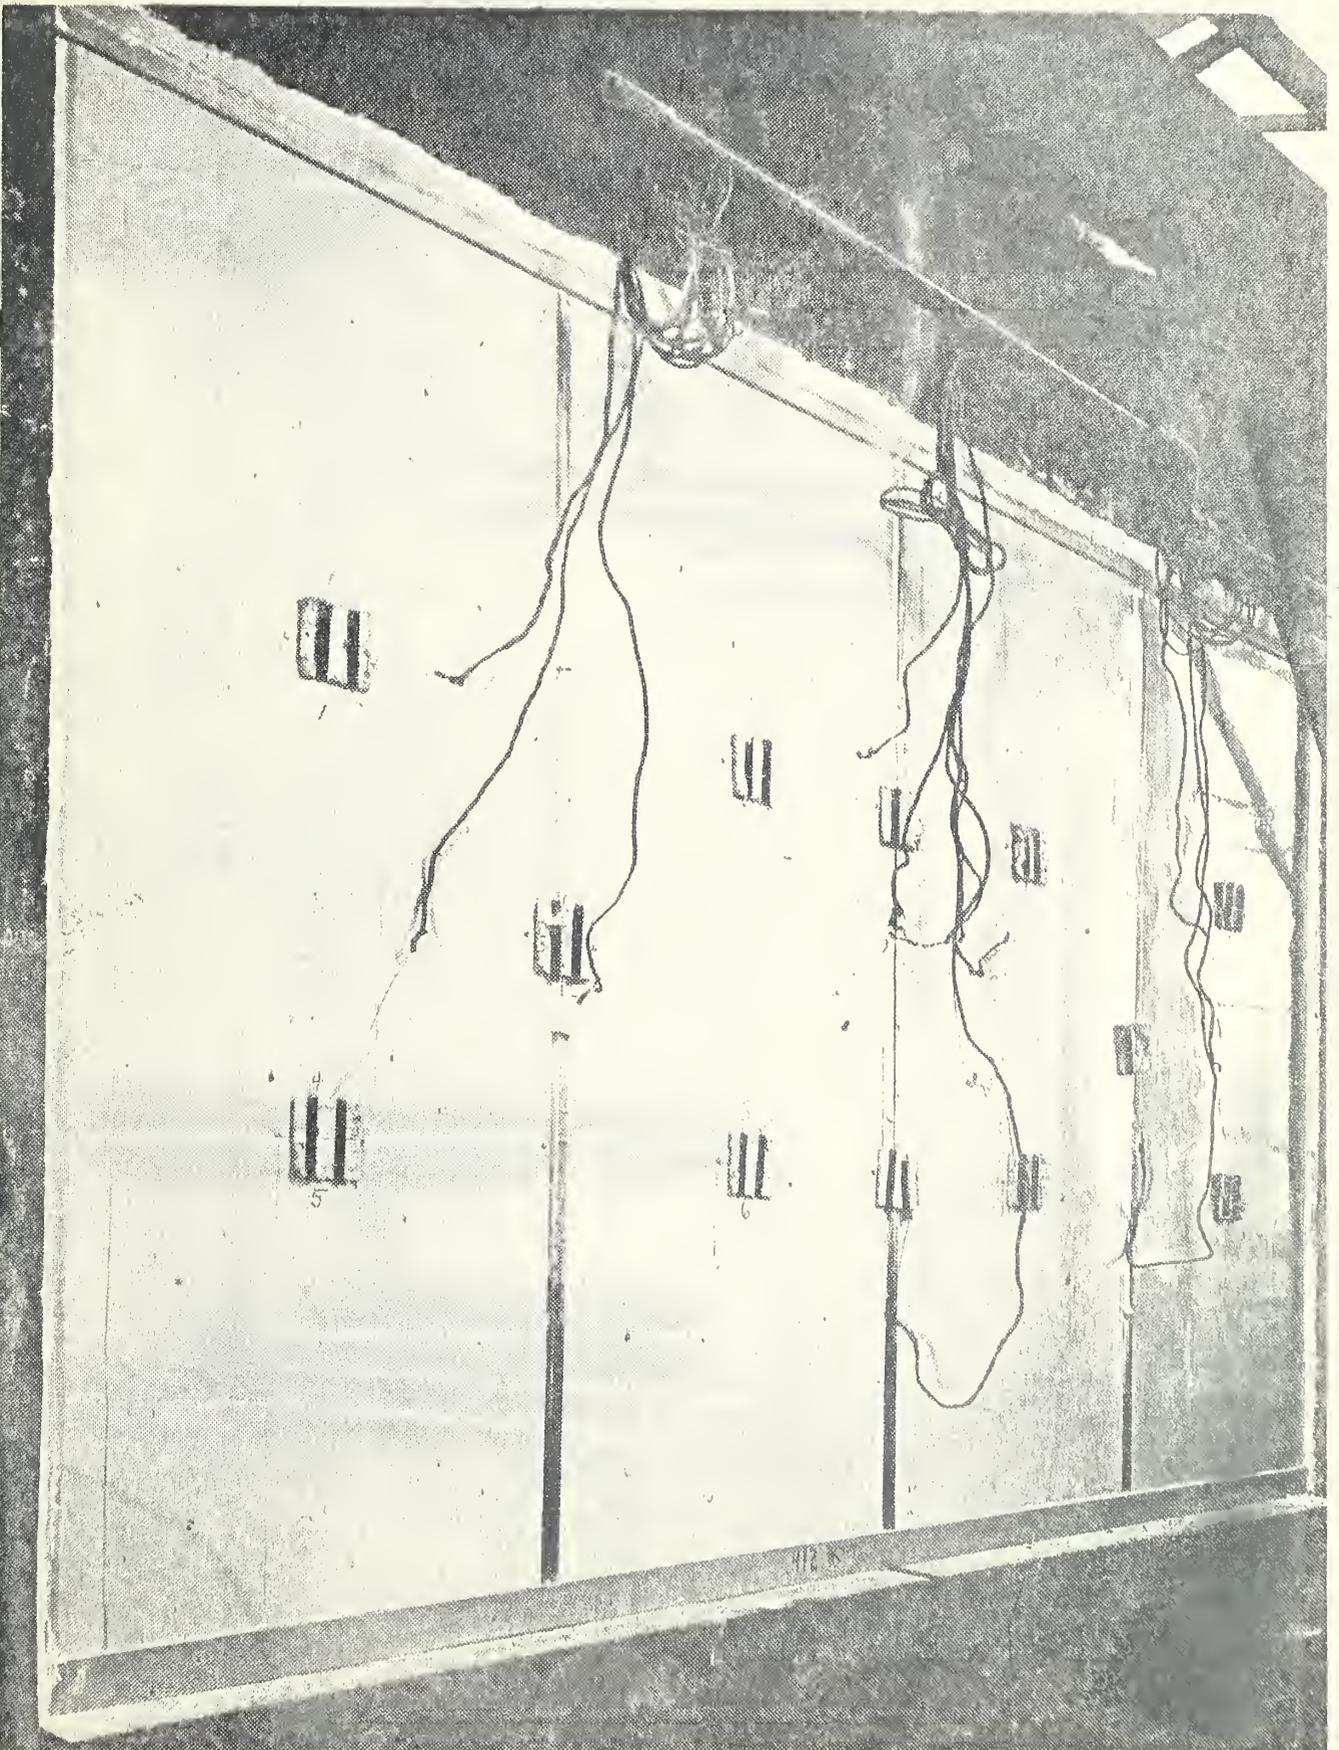
Figure 6. Unexposed surface of wall without perlite fill at 40 min.

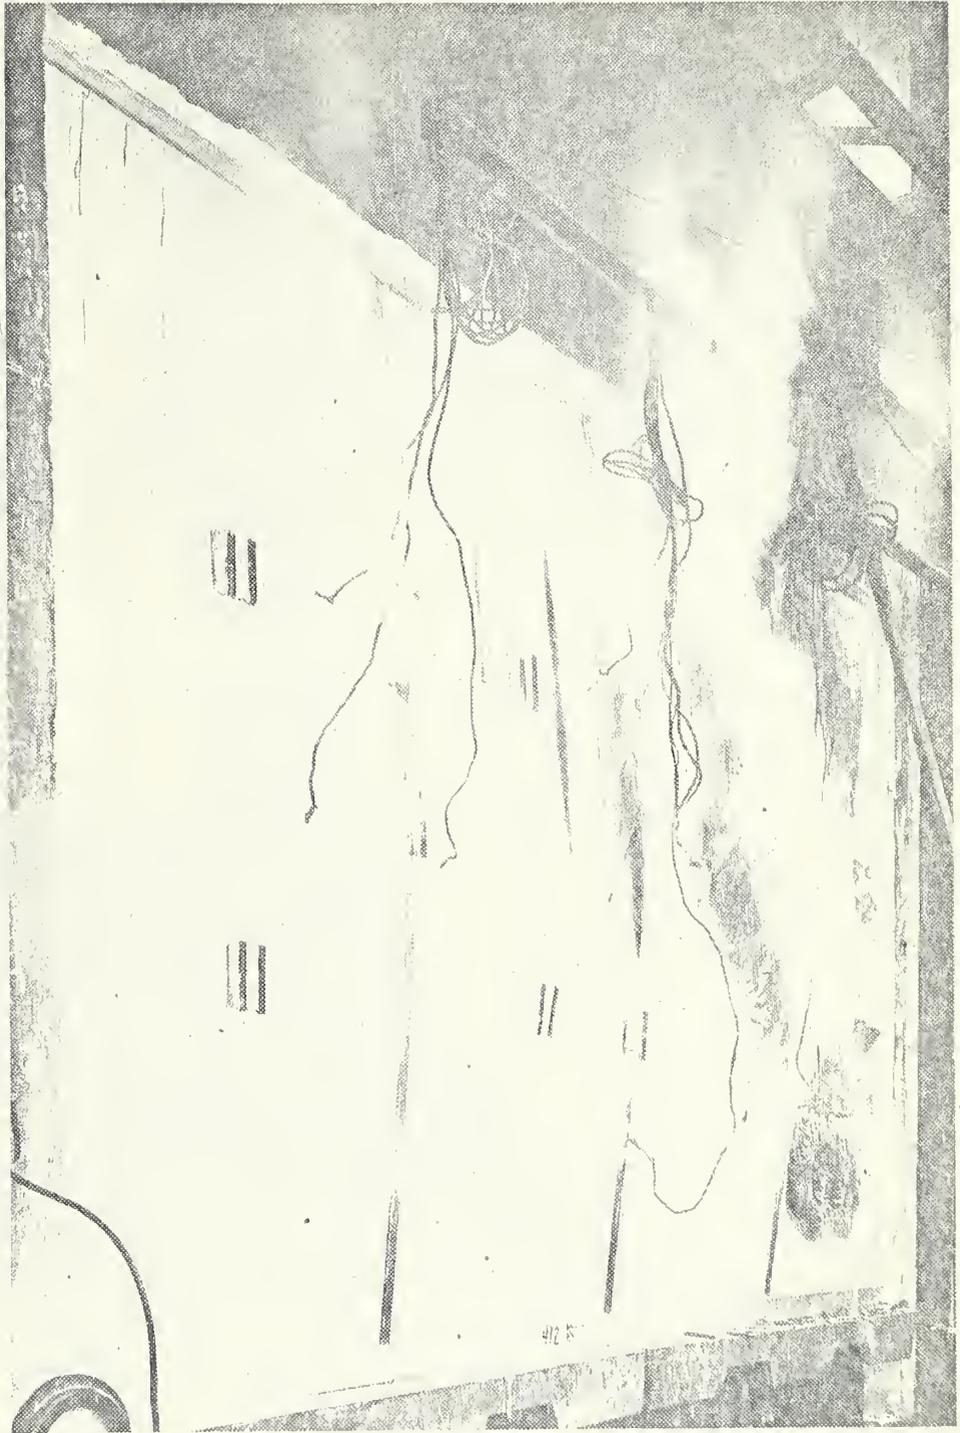
There was no observable lateral deflection of three of the panels as a result of the application of load just before the start of the test. The fourth panel deflected about .05 in. By 3 min, there were flames over the entire exposed surface, but these were reduced to a few intermittent flames by 6 min. The extra metal liner on the exposed surface of the south panel was warped by 11 min. At 21-1/2 min, there were small flames from the exposed side of the center joint and from a crack in the north panel. By 28 min, there were flames from the exposed side of all joints plus smoke from a seam in the unexposed surface of the north-center panel. By 32 min, the flaming from the joints was heavy. At 38 min, the south edge of the north panel was open on the exposed side and heavy flames were issuing from within the panel. The condition of the unexposed surface at 40 min is shown in Figure 6. At 41 min, smoke was issuing from under the thermocouple pad on the north joint. At 45 min, the unexposed surface of the north panel was turning black. At 47-1/2 min, most of the gypsum board on the north panel fell. At 50 min, about half the unexposed surface of the north panel was blackened and the paint on the upper half of the north-center panel hung in a single large blister. The paint on the north panel burst into heavy flaming about 51-1/2 min. At 54 min, about half the gypsum board on the north center panel fell. The test was stopped at 55 min. Figure 7 shows the unexposed surface at 55 min, just after flames broke through the north joint.

Figure 7. Unexposed surface of wall without perlite fill at 55 min.

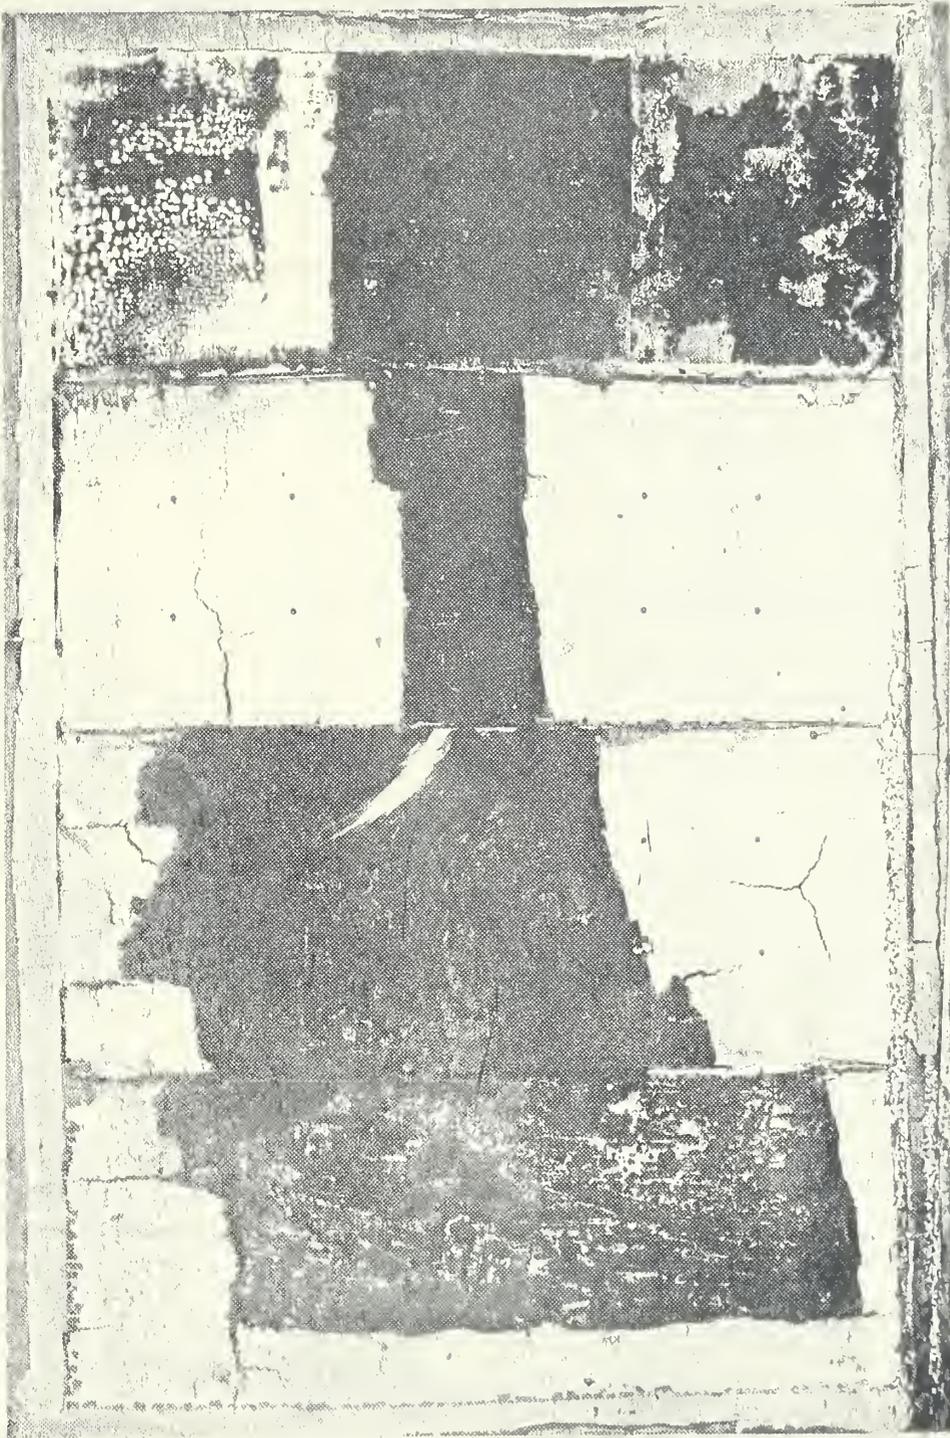
The fire endurance of the specimen was limited by 325°F rise above initial temperature at one thermocouple on the unexposed surface of the north panel at 44 min. The correction for actual furnace temperatures increased this to 45 min. The specimen continued to support the applied load throughout the test. The gypsum board on the north-center and south-center panels, supported by the addition of sheet metal screws and washers as described in 2.1.1, remained in place for all but the last minute of test. About half of it remained in place through the vibration incident to removal of the frame from the furnace. See Figure 8.

Examination after test showed that the glue joint between honeycomb and exposed surface metal skin was broken in all panels; but the joint between honeycomb and unexposed surface metal was intact. The honeycomb was charred full depth throughout and an appreciable amount washed away under the stream of water (from a garden hose) used to quench the interior flames. The wood framing of the panels had been completely charred and most of it had been dislodged.

Figure 8. Exposed surface of wall without perlite fill immediately after test. Extra screws and washers in two center panels only; extra metal liner on right panel only.

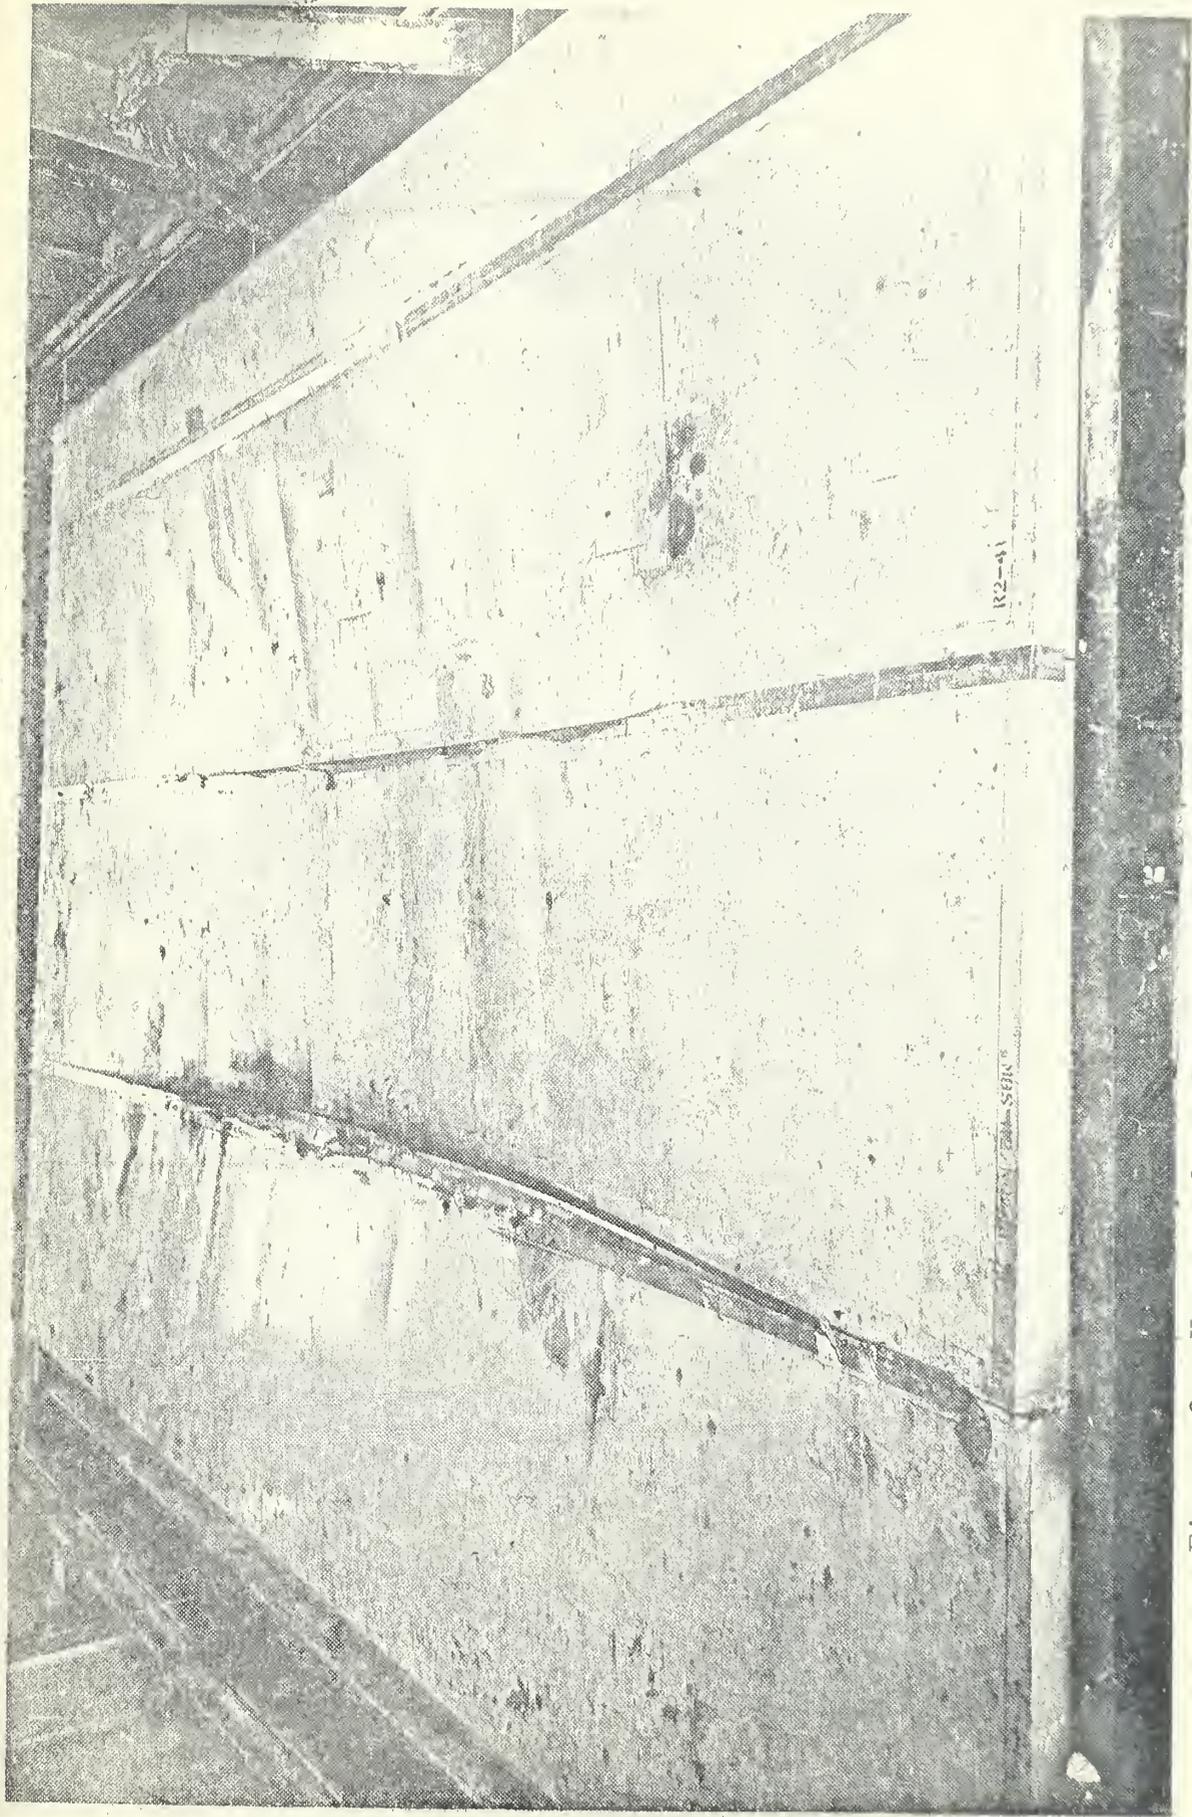
The fire endurance of the specimen was limited by 325°F rise above initial temperature at one thermocouple over the west joint, and by flaming through the west joint, both at 28 min. The applicable correction for furnace temperatures increased this to 29 min. The specimen supported the load until after the temperature rise and flame penetration limits had been reached. However, the magnitude of deflections and the rate at which they were increasing made it obvious that load failure would have occurred within the next 1-1/2 minutes. Even with the load removed, the specimen had sagged until it was resting on furnace thermocouple pipes at the end of the test. Figures 9 and 10 show the unexposed and exposed surfaces, respectively, after test and removal of the loading apparatus and instrumentation.

Figure 9. Unexposed surface of roof specimen after test and removal of loading equipment.

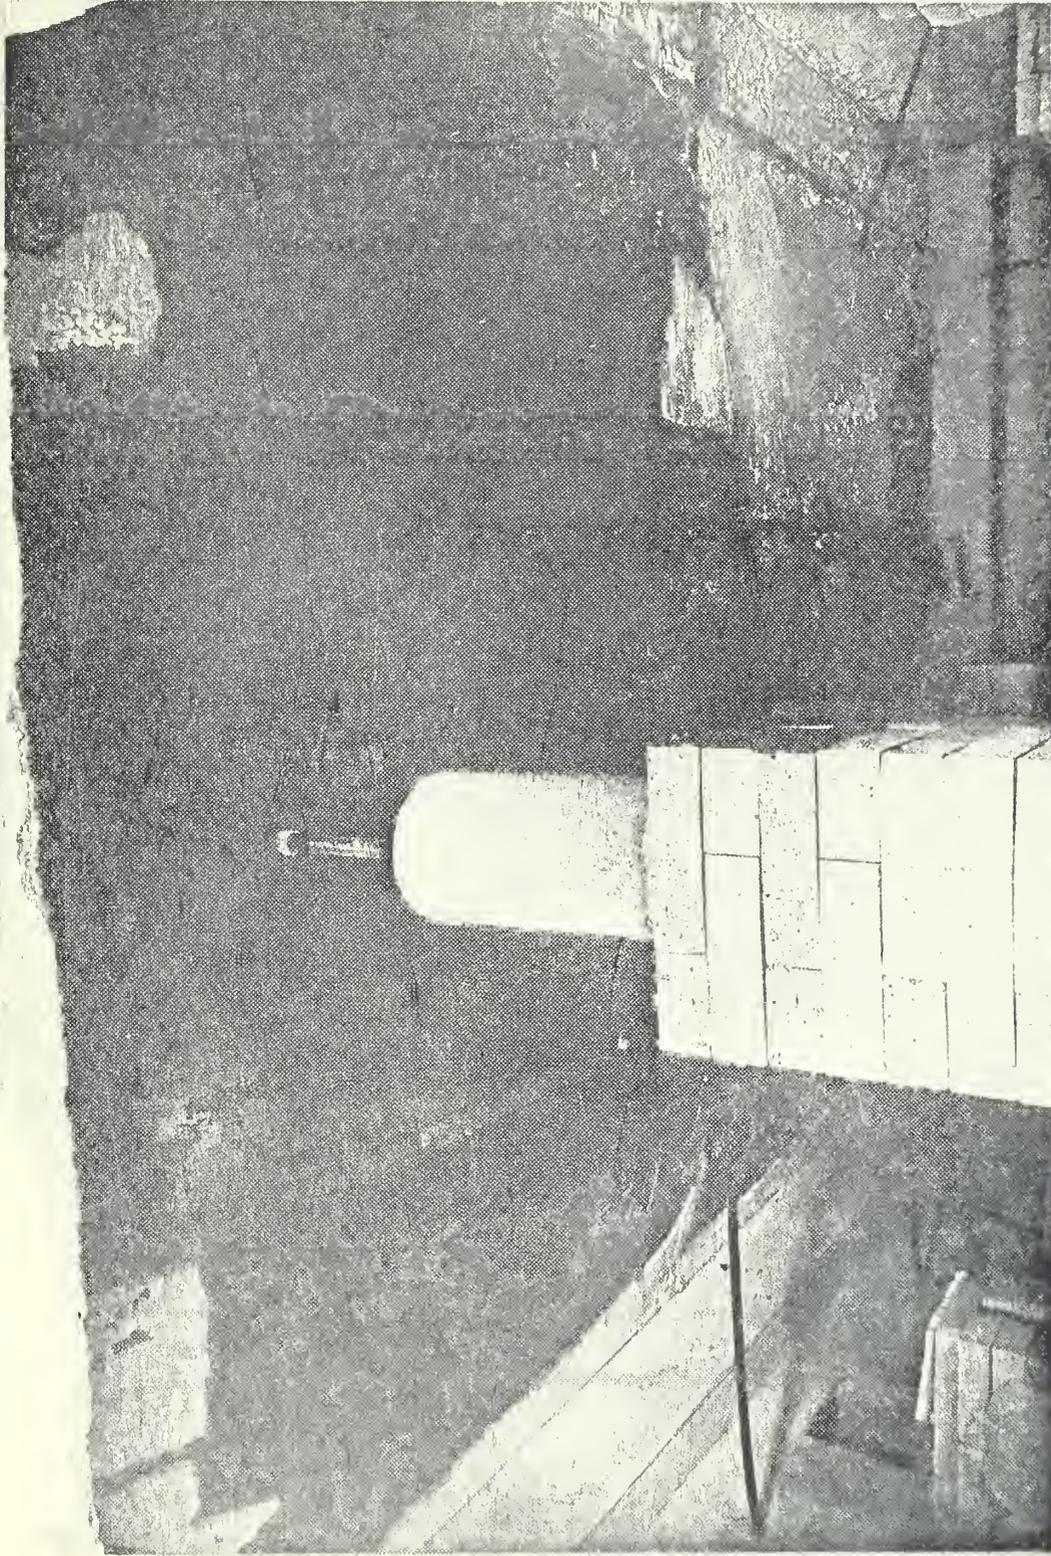
Examination after test showed that the glue joint between the honeycomb and exposed surface metal skin was broken in all panels; but that the joint between honeycomb and unexposed surface metal skin was intact. The perlite had fallen from the honeycomb cells. The honeycomb was charred to its full depth along the edges of the individual panels. The wood framing was charred to full depth where the edges of the panels had opened during the test. The gypsum board given additional support by cap head sheet metal screws fell shortly after the end of the test, but that given additional support by the same screws plus 3/4 in. o.d. washers remained in place.

Figure 10. Exposed surface of roof specimen after test. Extra screws in near end of right panel; screws and washers in far end of same panel.
