7489

PERFORMANCE OF ROOFING IN PUERTO RICO

20 April 1962

The survey of roofing was conducted on March 20 through March 24, 1962, primarily in the vicinity of the cities of San Juan and Ponce, Puerto Rico. The following Military Installations were included in the survey:

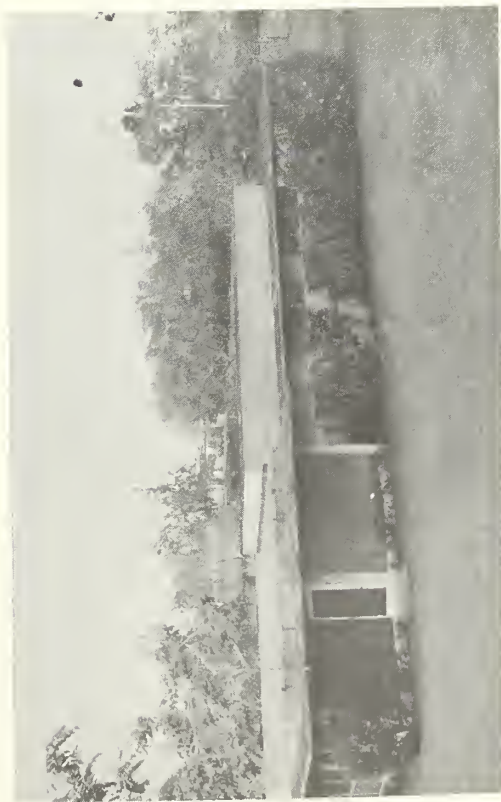
7

The built-up roof was also used to repair exposed concrete when it became uneconomical to isolate and repair cracks in the deck. A typical structure employing such a roof is shown in Figure 7.

Built-up roofs used to render cracked slabs waterproof were also observed on residential buildings at the N.C.S., Sabana Seca, P.R., illustrated in Figure 7. The membranes were applied in 1961 to the main roof sections, as shown in Figure 20. The roofs were in excellent condition and were watertight. However, some leakage was still apparent in the interior. It, no doubt, resulted from cracks observed at the angles formed by the intersection of the roof slab with vertical surfaces.

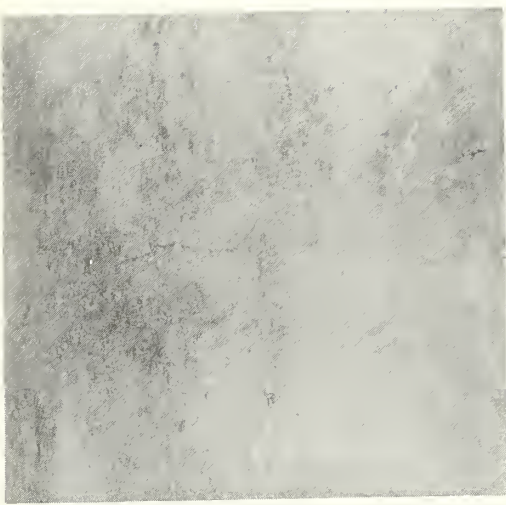
8

Protective coatings of various types were observed on many of the exposed slabs. These materials were, in many cases, employed for aesthetic reasons, but were primarily used to reduce temperatures by reflecting solar energy and, therefore, were pigmented white, aluminum, or other pastel shades. The use of these coatings apparently had little effect on the waterproofness of the slab. However, it was obvious that the light-colored coatings exerted a dominate influence on the temperatures attained by the slab. There is a tendency to think of unpainted concrete slabs as white in color, but this is not true in Puerto Rico where exposed slabs are quite dark due to biological growths, as illustrated in Figure 8.

- (5) In the warm, humid climate of Puerto Rico, concrete slabs become quite dark due to biological growths on the surface and, therefore, reflective coatings should be employed to reduce thermal movements in the slab.

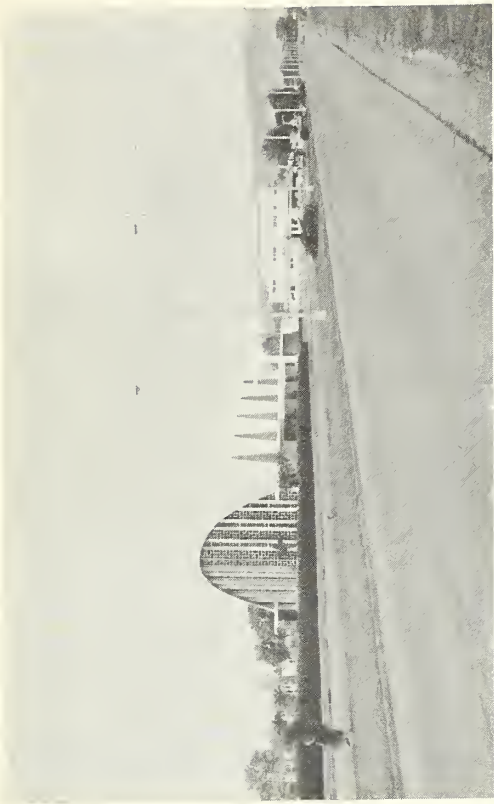
6

The performance of an elastomeric type of coating identified as "Hypalon" (a chlorosulfonated polyethylene roofing solution) was observed on the parabolic roof of the Santa Maria Reina Cathedral in Ponce, P.R., shown in Figure 6. The roof consisted of a 3-inch reinforced concrete shell supported by a series of 54-foot span catenary arches and had an area of about 240 squares. It was reported that two coats of "Hypalon" were applied by conventional pressure pot-spray equipment in January 1957. Our observations indicated the material had weathered quite well and no obvious defects were observed after 5 years exposure. A general view showed a somewhat mottled appearance indicating either unequal coverage or unequal weathering. It was felt that an additional application of the material should be applied in the near future.

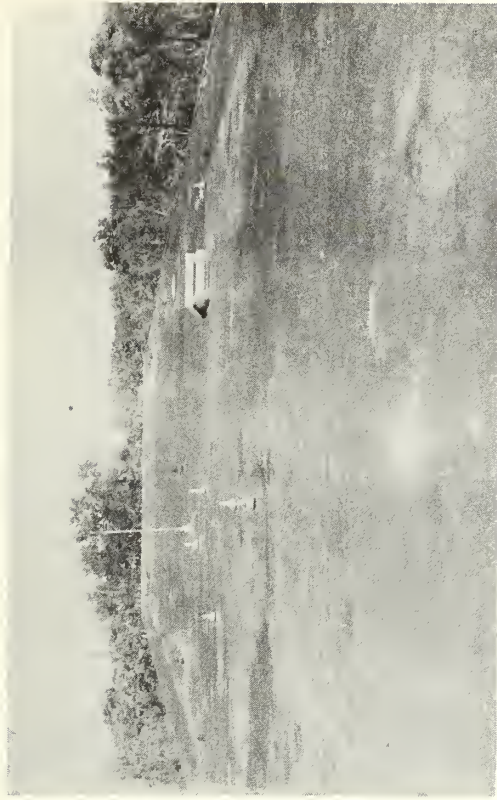
10

The exposed slab of one relatively large structure (EM Barracks, NCS, Sabana Seca, P.R.), illustrated in Figure 10, was relatively free of cracking and the occupants reported it to be watertight. This two-story structure was of reinforced concrete construction and was built in 1952. The roof slab had a broom finish. A biological growth, common to the exposed roofs in Puerto Rico, contributed to the dark roof surface, as shown in the photograph.

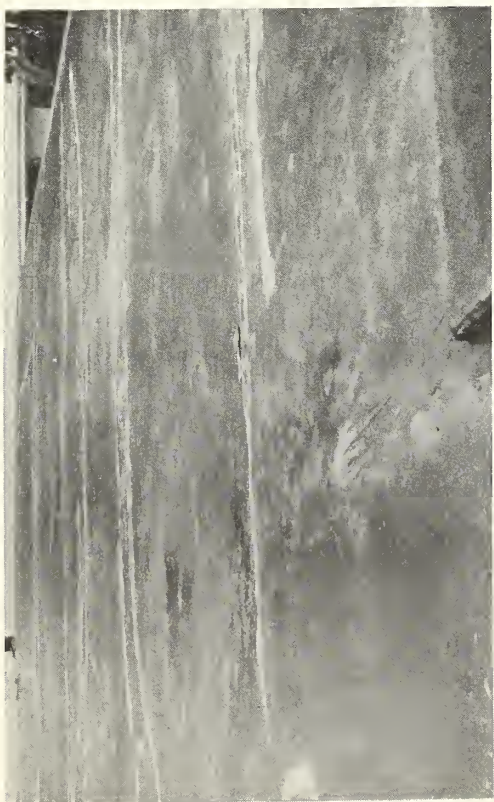
13

This method consisted of applying a cement grout directly over the crack, as illustrated in Figure 13. Our observations indicated that this method was not effective due to the poor adhesion to the dense concrete deck. On the other hand, if proper adhesion was obtained it is predicted that the crack in the substrate would soon be transferred to the patching compound due to its relatively poor elasticity.

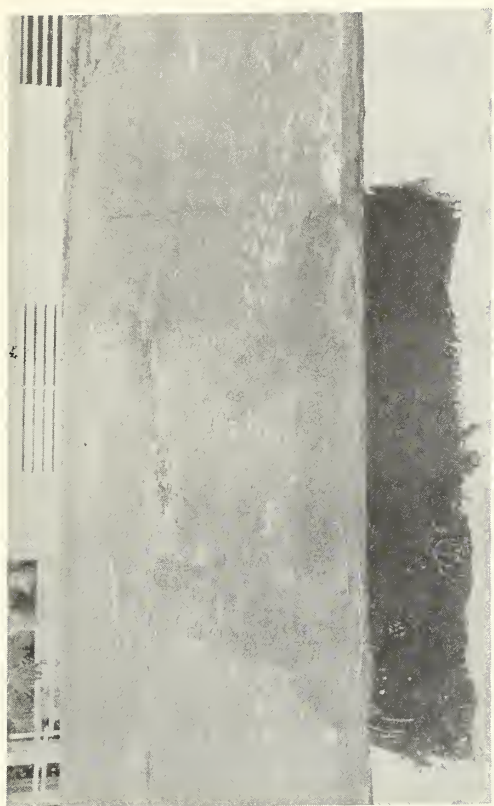
14

The repair method consisted of applying a mastic (bituminous emulsion, asphalt plastic cement, or proprietary materials of similar viscosity) over the crack and extending 4 to 6 inches on both sides of the crack. A reinforcing strip (generally woven glass fabric or glass mat) was embedded in the mastic and coated with a similar material. A typical roof employing such a system is illustrated in Figure 14.

This method of crack repair has proven the most successful of the many methods tried. However, it has many limitations. Our observations indicated that movements in the deck at the crack due to expansion and contraction sometimes resulted in a break in the system over the crack. In addition, poor adhesion between the fabric and the deck was observed, indicating poor preparation of the surface.

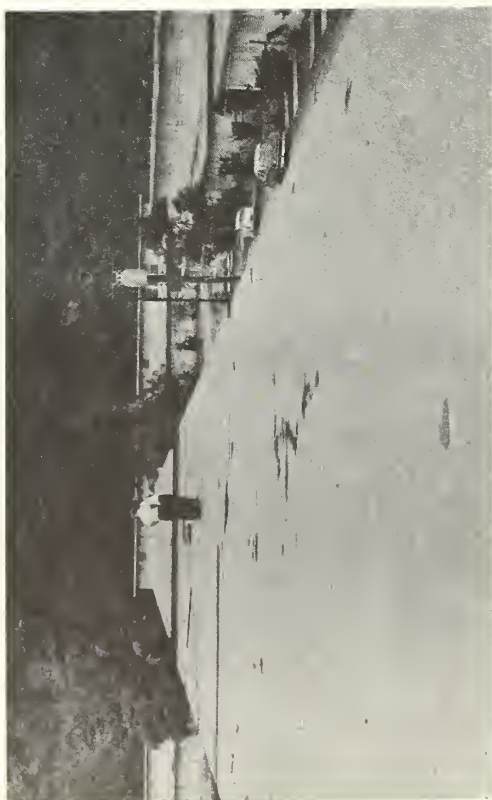
Our observations indicated the condition of the membrane was good after five years exposure, as shown in the general view in Figure 15. Two deficiencies were noted in the system. Ruptures of the membrane, as illustrated in Figure 16, were observed in two areas. However, these cracks were not typical of the irregular cracks generally found in the exposed decks. Therefore, they were attributed to other causes. In addition, many blisters were observed which ranged from a few inches in diameter up to 15 inches or more, as shown in Figure 17. The blisters apparently occurred between the deck and the membrane and were possibly caused by poor preparation of the surface prior to the application of the membrane. The blisters have caused no particular problems and, therefore, no action to eliminate them is indicated at this time.

The aluminum coating had weathered to a dull finish exposing the bituminous material in some areas and its condition after 5 years exposure indicated that additional coatings are warranted.

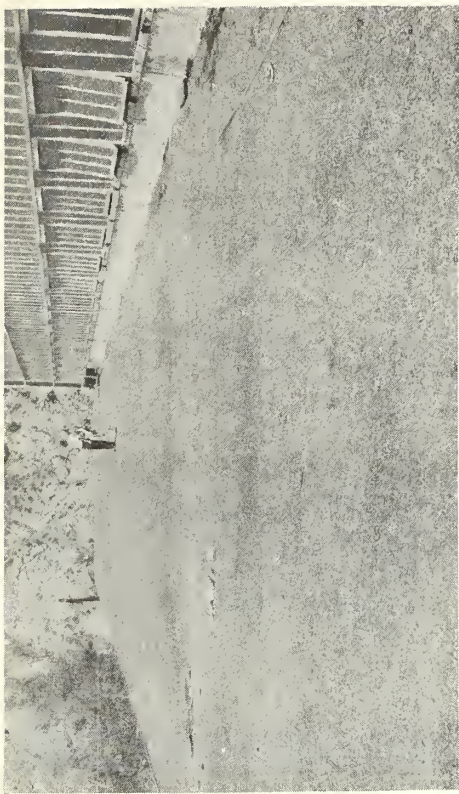
18

The appearance of this roof was good after about 20 years exposure, as shown in Figure 18. An examination of the asphalt showed it to be very hard and brittle even at the high temperature of the roof. However, there were no other signs of deterioration and it was apparently performing its basic function. The only defects observed were a number of bare areas where the felts were exposed. Some 41 leaks were reported in this roof. However, our observations indicated that most, if not all, of the leaks resulted from defective flashings, as shown in Figure 19. Obviously such deficiencies could be prevented by adequate and timely maintenance.

In our opinion, this roof could be expected to perform for another 10 years with adequate repair and maintenance procedures. The performance of this roof compares favorably to the performance of similar roofs in the continental United States.
