# NATIONAL BUREAU OF STANDARDS REPORT

8339

## PERFORMANCE OF FLOORING MATERIALS IN MILITARY KITCHENS

30 April 1964

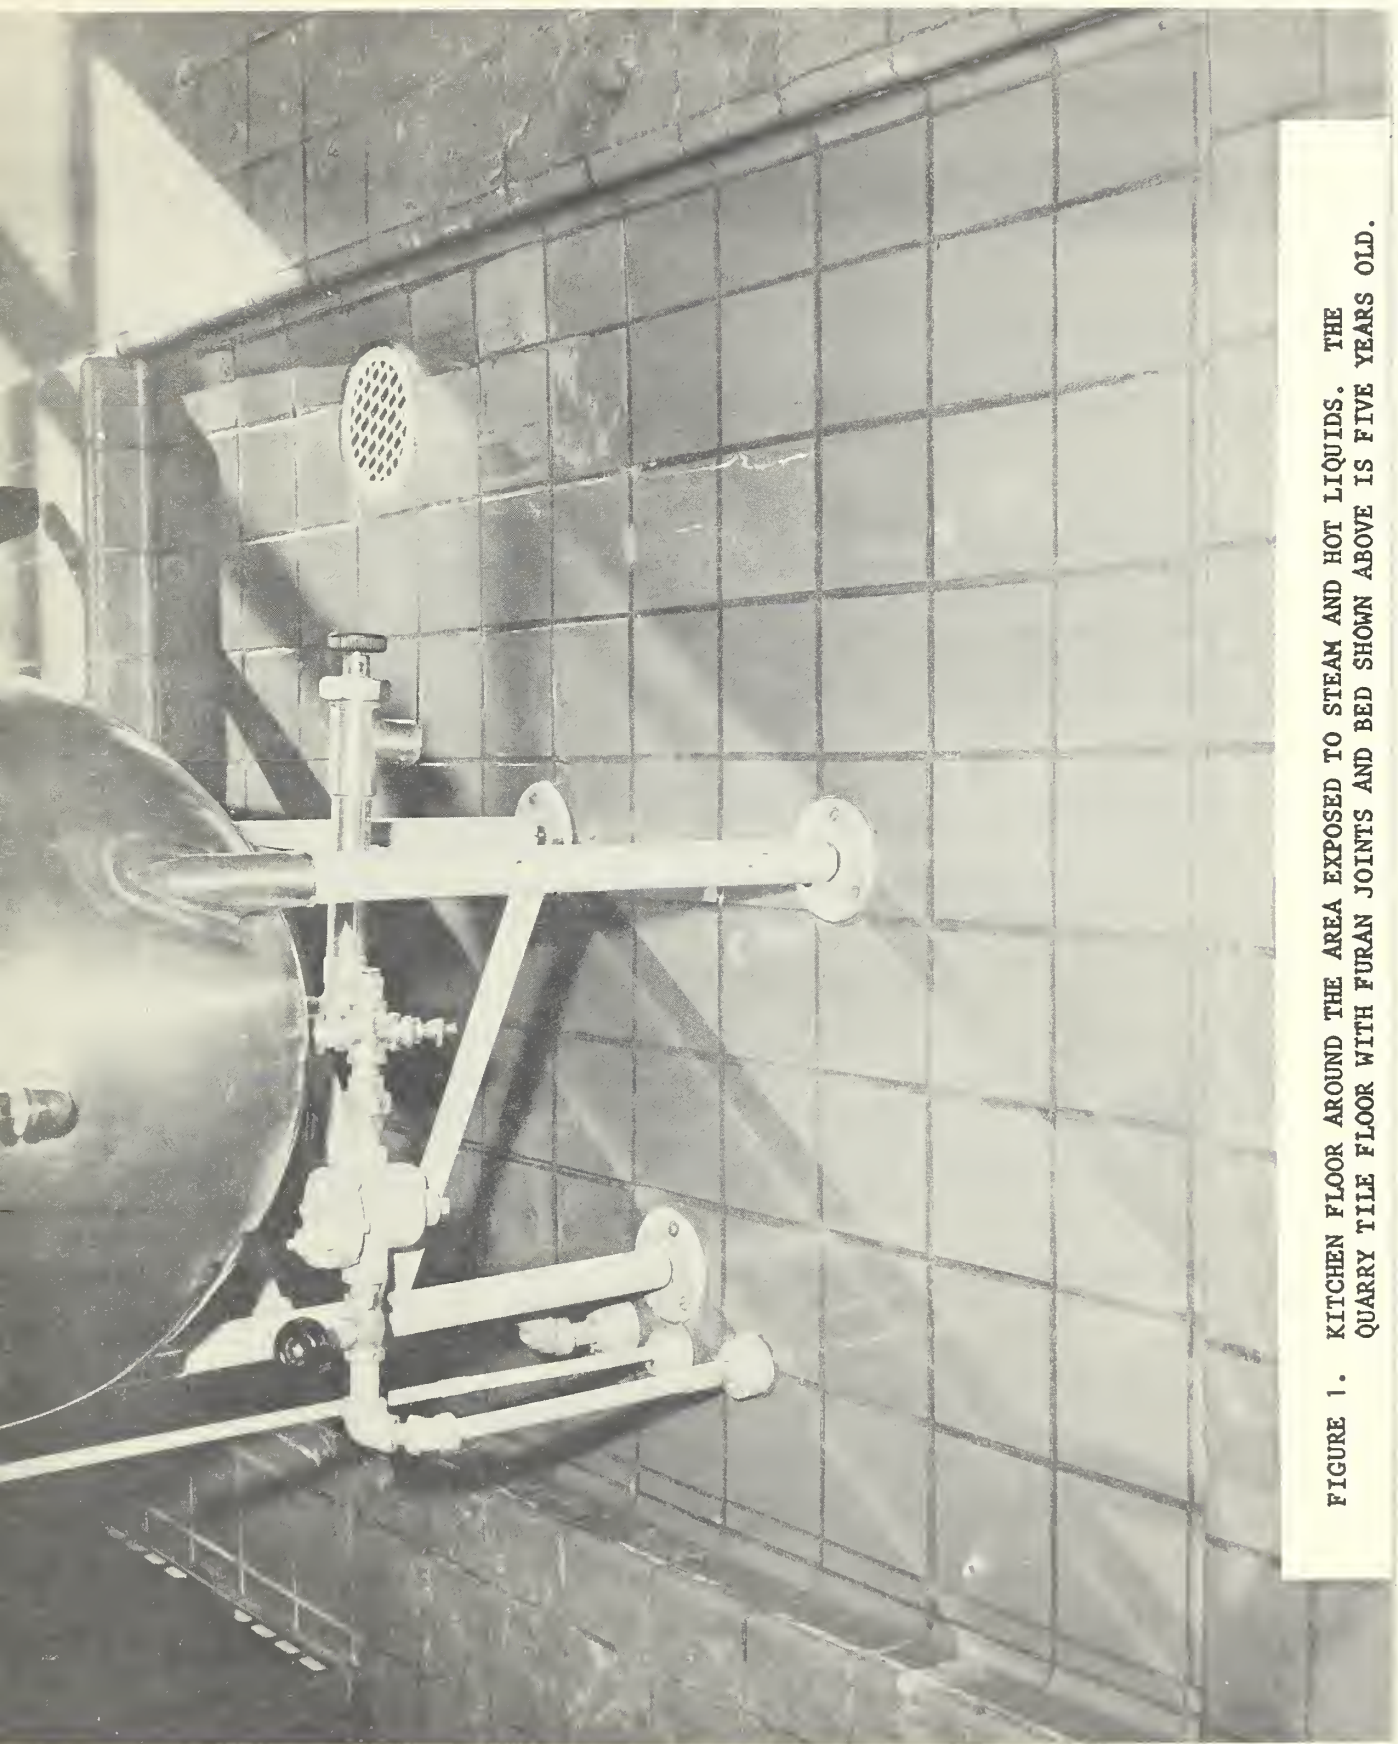
FIGURE 1. KITCHEN FLOOR AROUND THE AREA EXPOSED TO STEAM AND HOT LIQUIDS. THE QUARRY TILE FLOOR WITH FURAN JOINTS AND BED SHOWN ABOVE IS FIVE YEARS OLD.

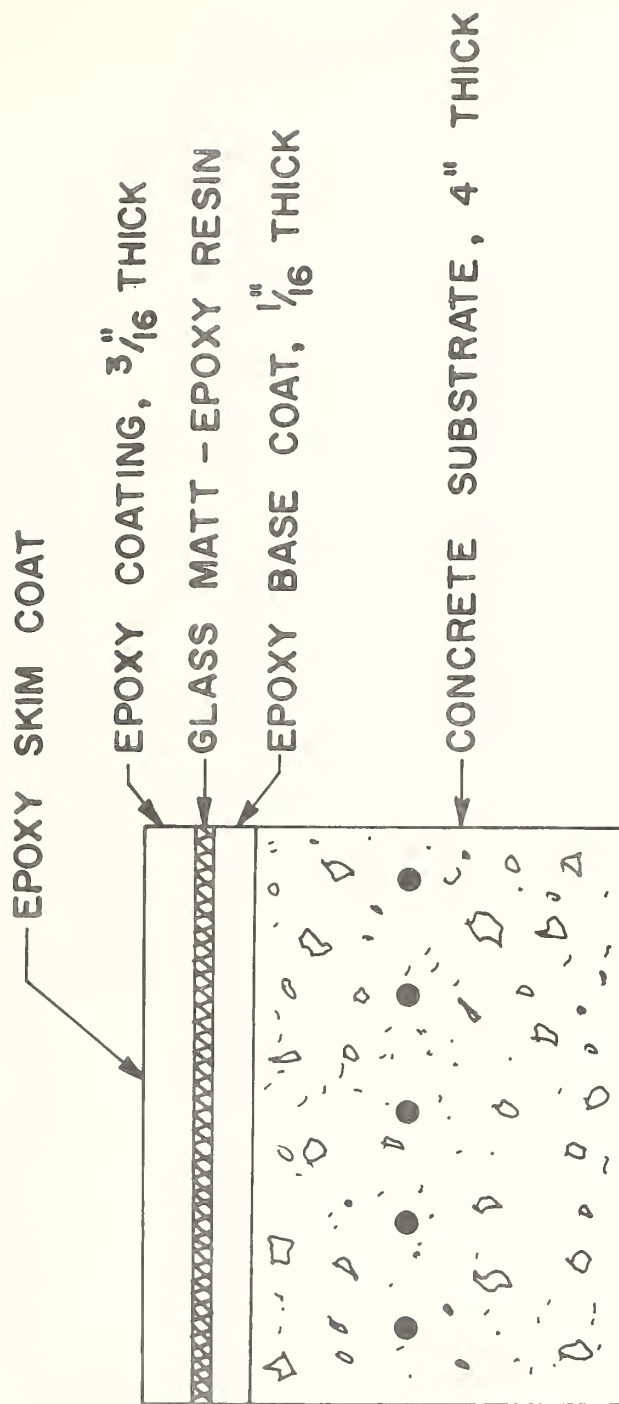
The concrete base of floor number 7 was cleaned with a hydrochloric acid solution, scrubbed, thoroughly rinsed with water, and dried. This installation was placed in August 1959, under the same conditions and temperatures as floor number 6. An epoxy sandfilled base coat was placed 1/16-inch thick with a glass matt overlay. A non-filled epoxy was worked into the top surface of the matt. Over this was placed two coats, a 3/16-inch filled coating and a high resin content skim coat (see Figure 2). The building was not occupied for 20 days.

- (1) bond failure between base epoxy and concrete at areas near ranges,
- (2) separation of skim coat from the body of the epoxy around the floor drain area,
- (3) numerous indentation spots caused by impact of food serving trays and garbage cans.

By the fall of 1960, this floor had completely failed. Large sections had delaminated, other sections had broken away from the concrete.

FIGURE 2. SCHEMATIC DIAGRAM OF TEST FLOOR NUMBER 7, MULTI-LAYER EPOXY COATINGS.

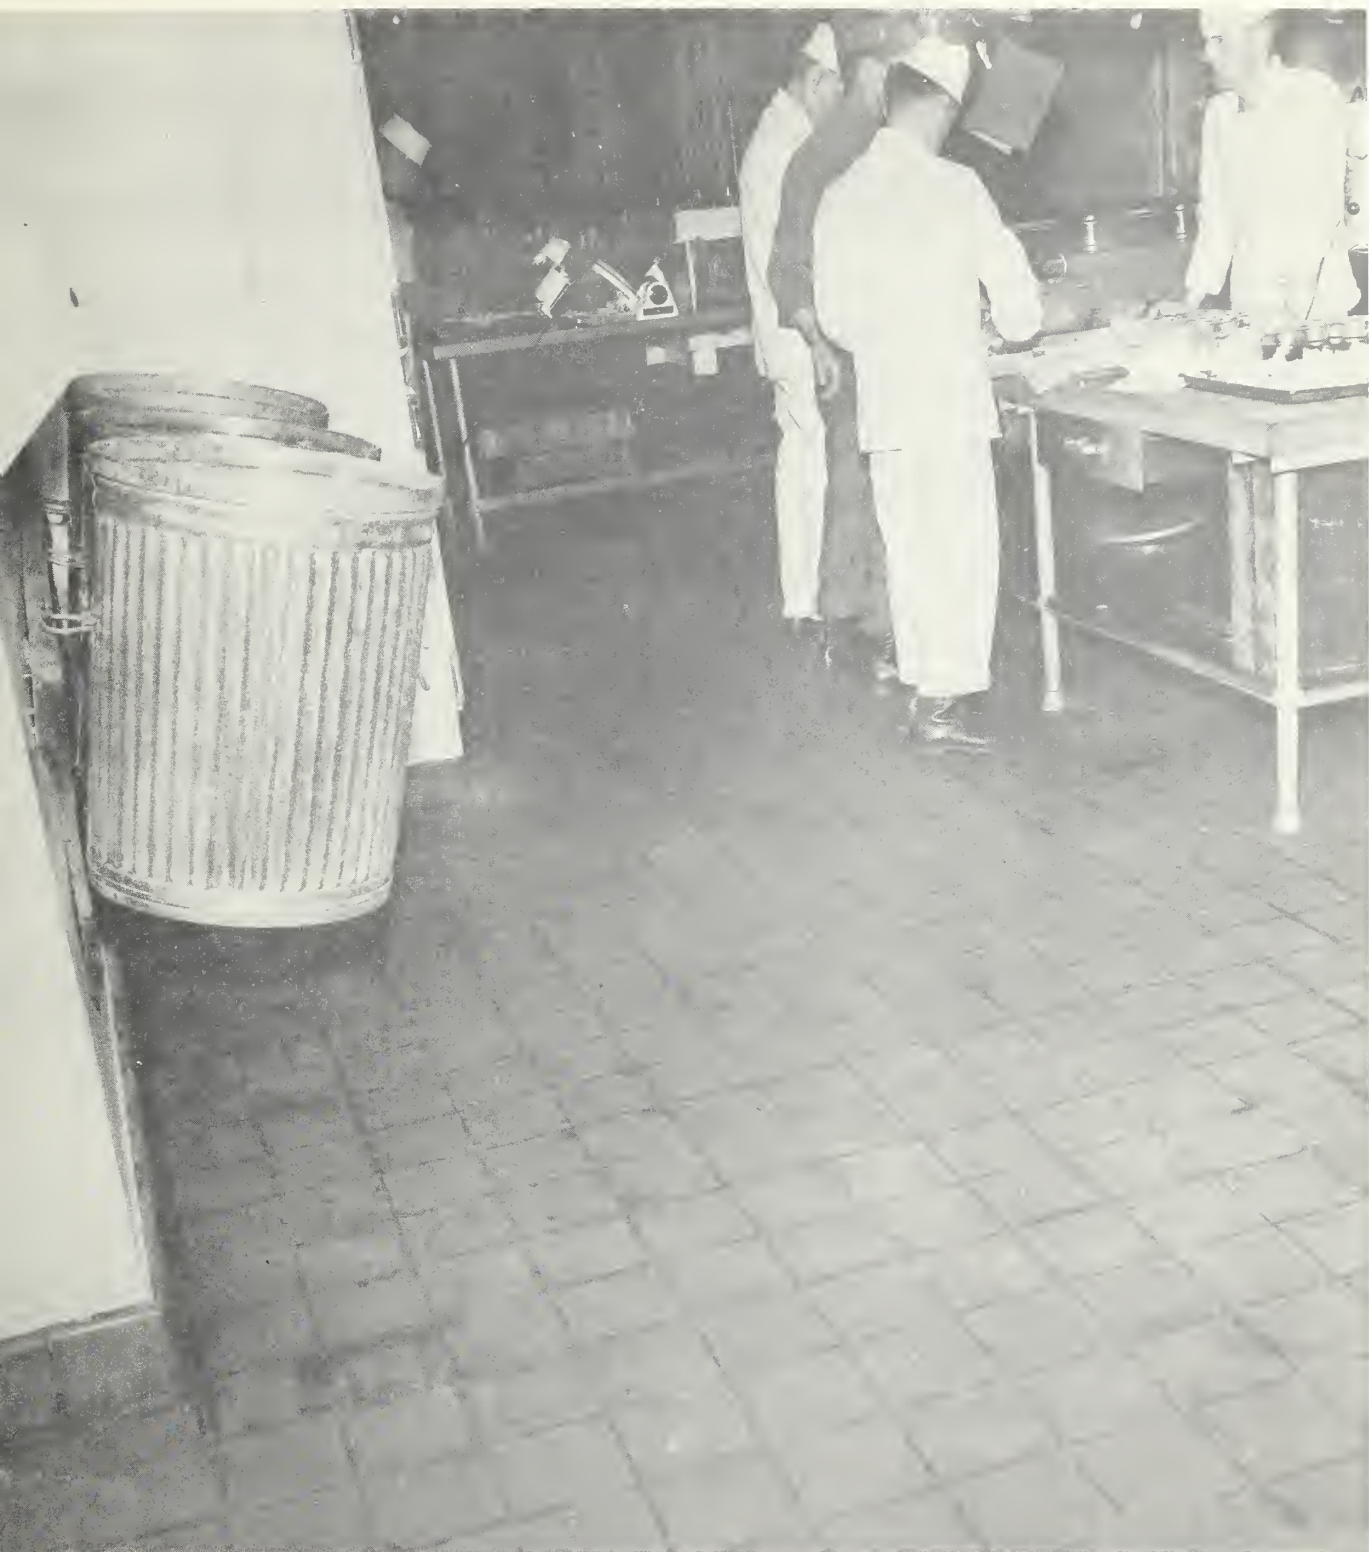
This floor was installed in the winter of 1954-55 by tile setters inexperienced at working with thermosetting resin mortars. Difficulty was encountered in mixing the compound, in obtaining a completely cured floor, and in cleaning the tile surface.

With the exception of a few hairline cracks in the joints and a small amount of tile impact damage this floor has performed very satisfactorily for 9 years (see Figure 4). Many other military kitchen floors of furan and quarry tile have also performed satisfactorily since 1958.

**FIGURE 4.** TEST FLOOR NUMBER 10, QUARRY TILE WITH FURAN JOINTS AND BED. WITH THE EXCEPTION OF A FEW HAIRLINE CRACKS IN THE JOINTS AND A SMALL AMOUNT OF TILE IMPACT DAMAGE THIS FLOOR HAS PERFORMED VERY SATISFACTORILY FOR NINE YEARS.
