NATIONAL BUREAU OF STANDARDS REPORT

8352

PERFORMANCE OF ROOFINGS ON GUAM, M.I. AND OKINAWA, R.I.

20 May 1964

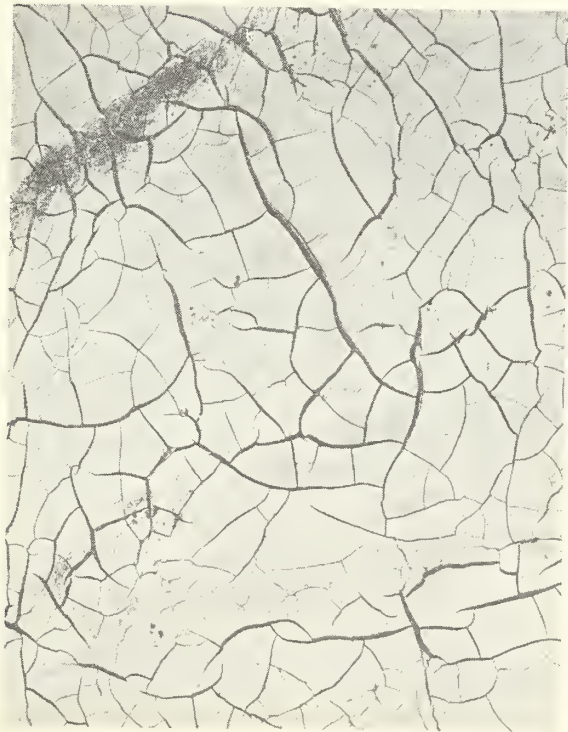
FIGURE 1. WEATHERING PATTERN, ASPHALT-SURFACED ROOF ON GUAM OBSERVED IN 1954.

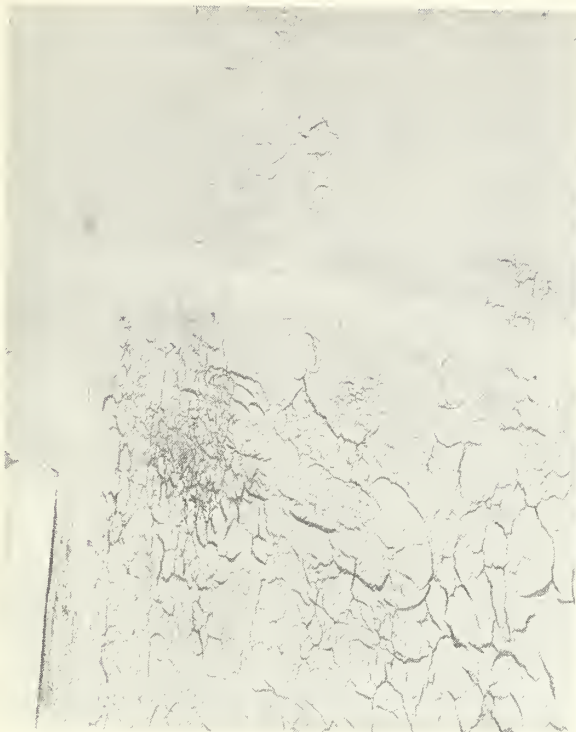
FIGURE 2. DIFFERENCE IN WEATHERING ATTRIBUTED TO USE OF INSULATION.

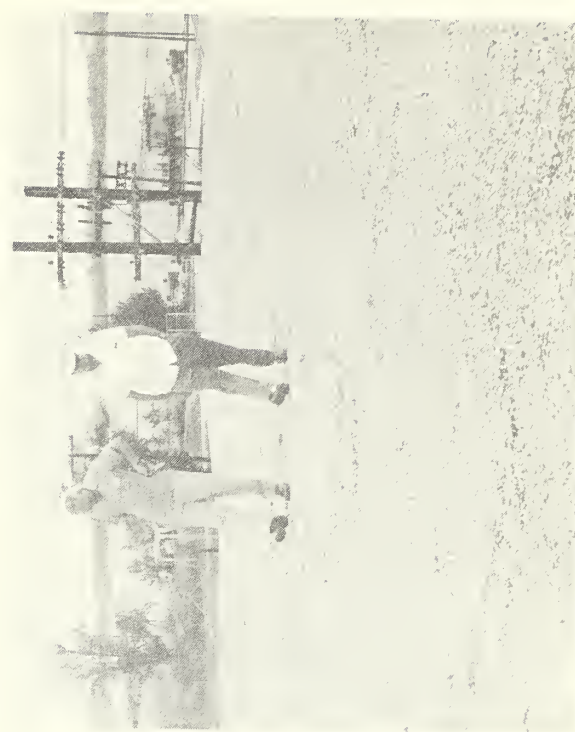
FIGURE 4. CORAL-SURFACED BUILT-UP ROOF, OROTE POWER PLANT, GUAM. AGE: 10 YEARS.

surfaced built-up roofs on the Orote Power Plant, the U. S. Naval Hospital, and the Fleet Laundry which have served very satisfactorily after 10, 8, and 7 years, respectively. However, it was observed that each of these roofs required immediate preventive maintenance as exemplified by the area shown in Figure 7. Figure 8 shows the gradation of the manufactured coral aggregate and the excellent coverage obtained with this material on the hospital roof. Similar service was obtained from surfaced built-up roofs observed on the Commissary Building and the CE Shops Building at Anderson Air Force Base.

The good performance of these roofings was attributed to the use of mineral surfacing, to the elimination of insulation from the top of the deck, and to the use of a softer asphalt.

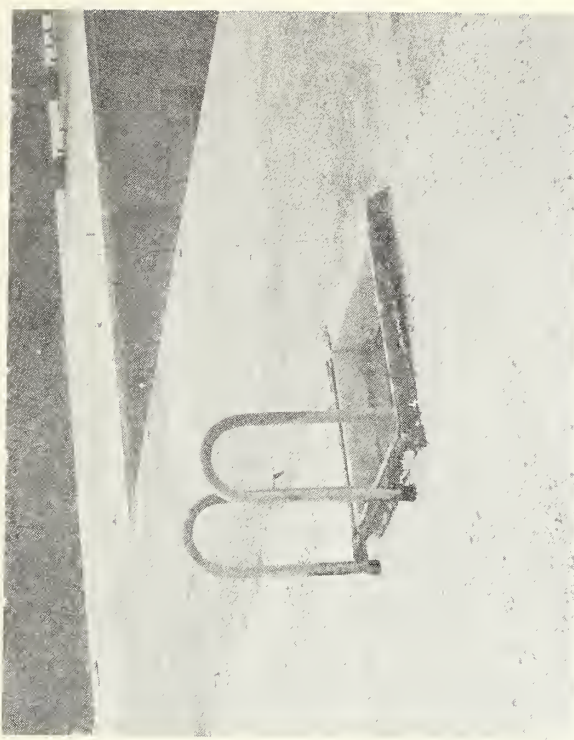
FIGURE 6. CORAL-SURFACED BUILT-UP ROOF,
FLEET LAUNDRY. AGE: 7 YEARS.

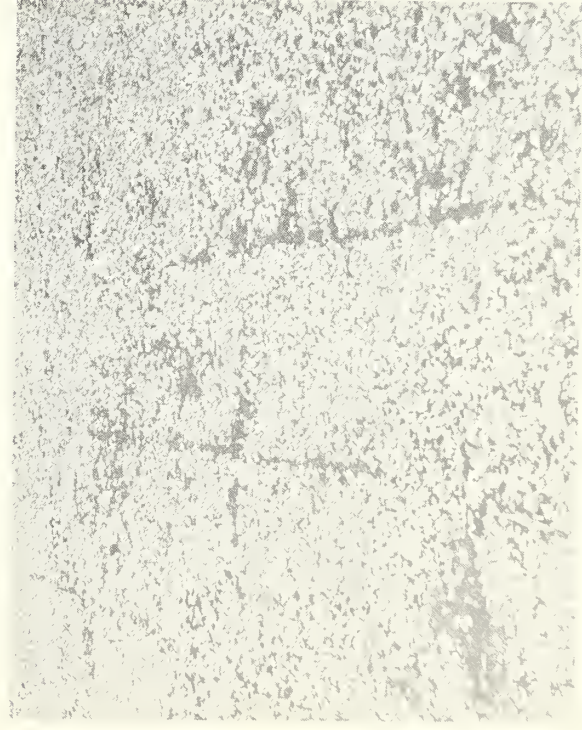
FIGURE 7. EXPOSED FELTS WHICH INDICATE
NEED FOR PREVENTIVE MAINTENANCE. OROTE
POWER PLANT.

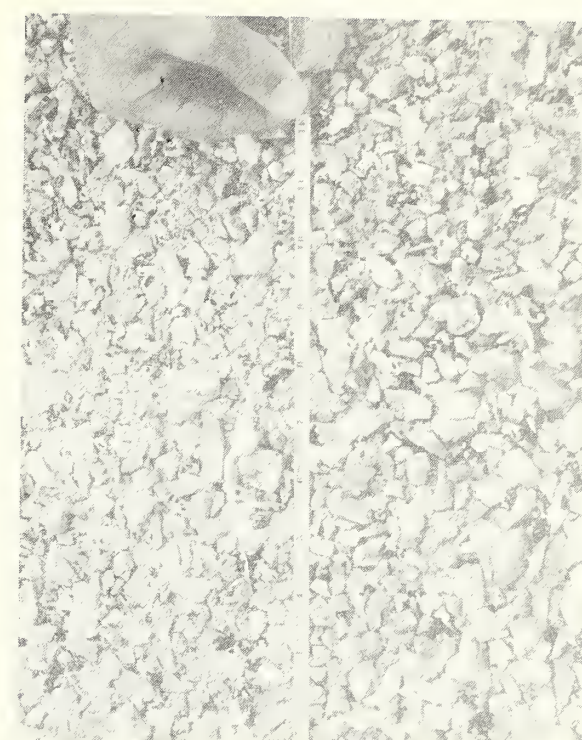
FIGURE 8. EXCELLENT COVERAGE PROVIDED
BY MANUFACTURED CORAL AGGREGATE.

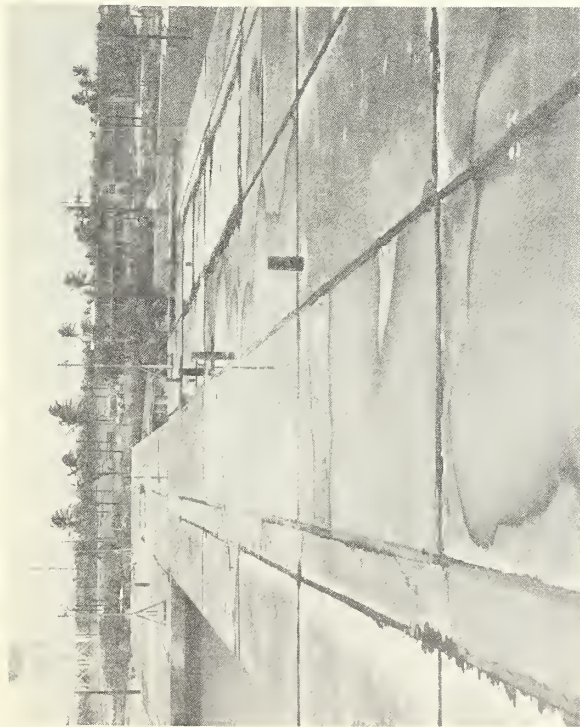
joint sealer (Federal Specification SS-S-164) approximately three years ago. It was reported that extreme care was exercised to prepare the concrete surface at the joint in order to obtain good adhesion. The satisfactory results are illustrated in Figures 9 and 10, which show both a general and close-up view, respectively. An examination of the interior revealed no water penetration despite the ponding water shown in Figure 9.

FIGURE 9. TREATMENT OF INTER-PANEL OF
PRECAST DECK WITH HOT-POURED JOINT
SEALER. AGE: 3 YEARS.

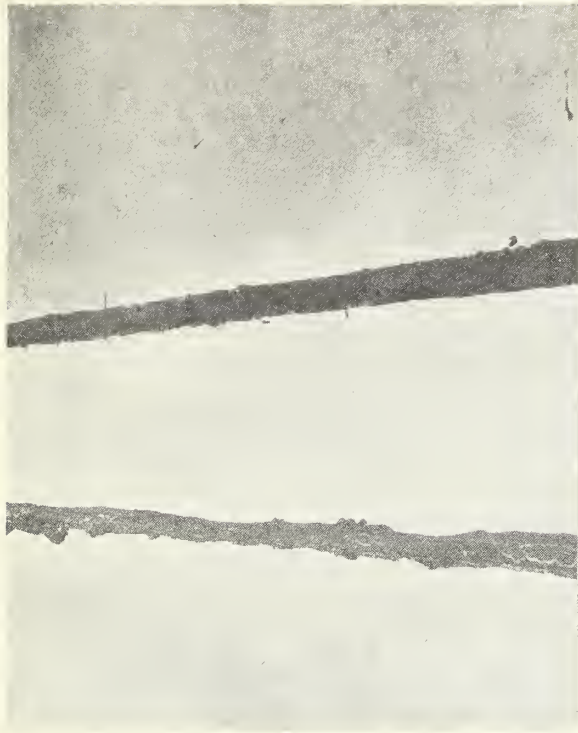
FIGURE 10. CLOSE-UP OF JOINT SHOWN IN
FIGURE 9.

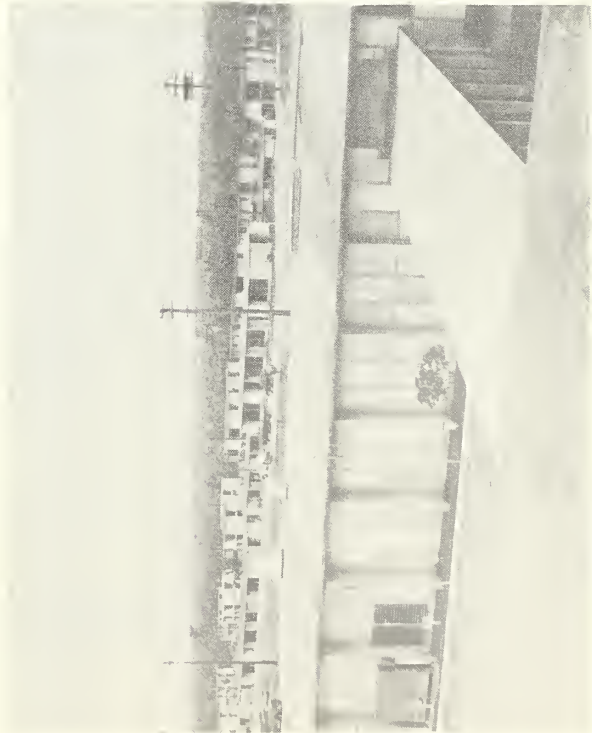
The poured-in-place slabs have two advantages over their pre-cast counterparts in that they have fewer joints to treat and are of greater thickness. Consequently, they have performed very satisfactorily as exposed decks for at least 10 years on Guam Island. Observations of typical slabs indicated no leakage or seepage had occurred except where structural or shrinkage cracks were evident. Figures 11 and 12 illustrate typical poured-in-place slabs which have given maintenance-free service on structures at the Naval Communication Station, Finegayan. The dark appearance of the roof on the house shown in Figure 12 resulted from a biological growth which is common to warm and humid areas.

FIGURE 11. EXPOSED POUR-IN-PLACE CON-
CRETE DECK, BOQ, NCS, FINEGAYEN, AGE:
3 YEARS.

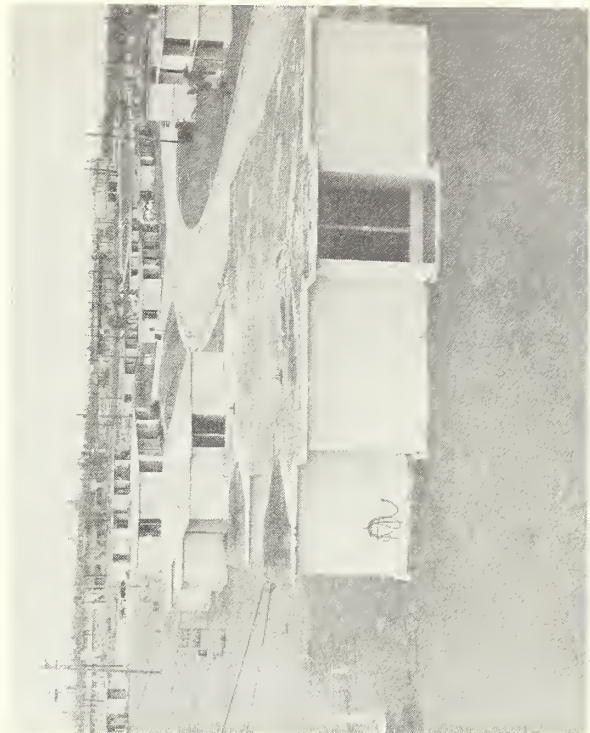
FIGURE 12. POUR-IN-PLACE CONCRETE
DECK. AGE: 10 YEARS.

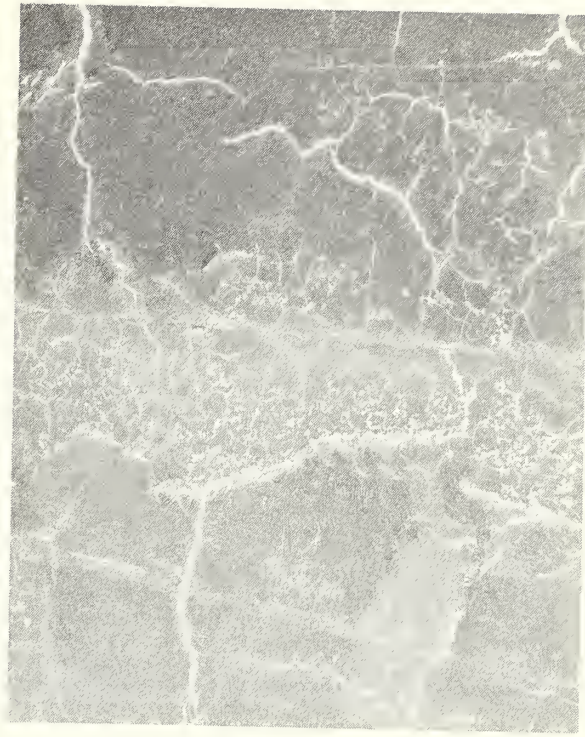
FIGURE 16. SURFACE DETERIORATION OF
BUILT-UP ROOFING AFTER 2 YEARS
EXPOSURE.

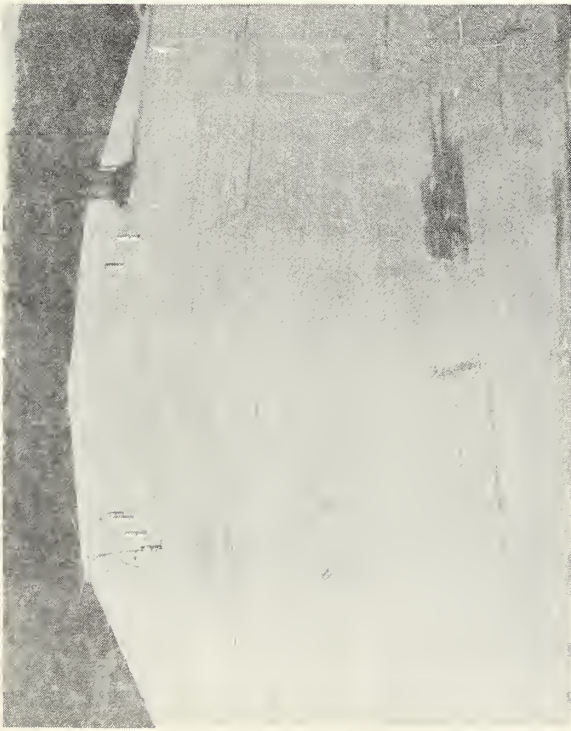
believe that it did not substantially contribute to premature failures. Examples of this defect were observed at Fort Buckner as illustrated in Figure 19 after 9 years exposure and on the built-up roof of the prototype barracks building (Figure 20) located at Camp Butler as evidenced by the numerous repaired areas shown in Figure 21.

FIGURE 21. ALUMINUM-SURFACED BUILT-UP ROOFING APPLIED 1957.

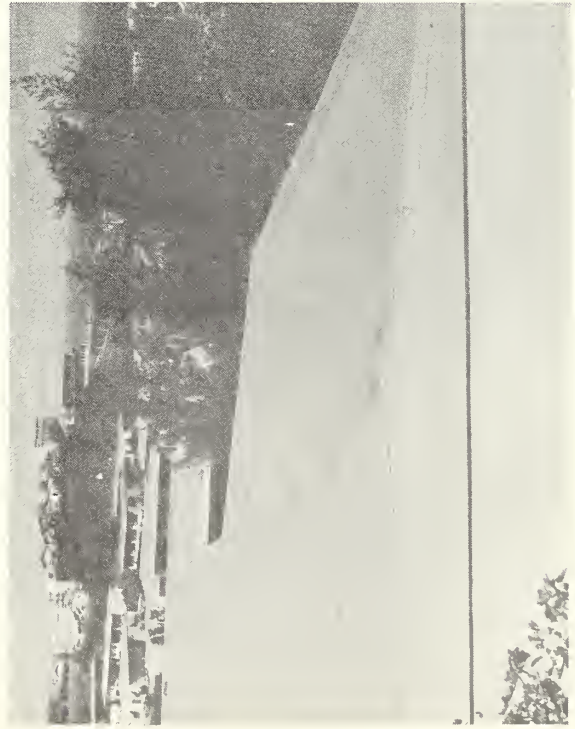
FIGURE 23. ASPHALT EMULSION-GLASS FABRIC ROOFING AFTER 11 YEARS EXPOSURE.

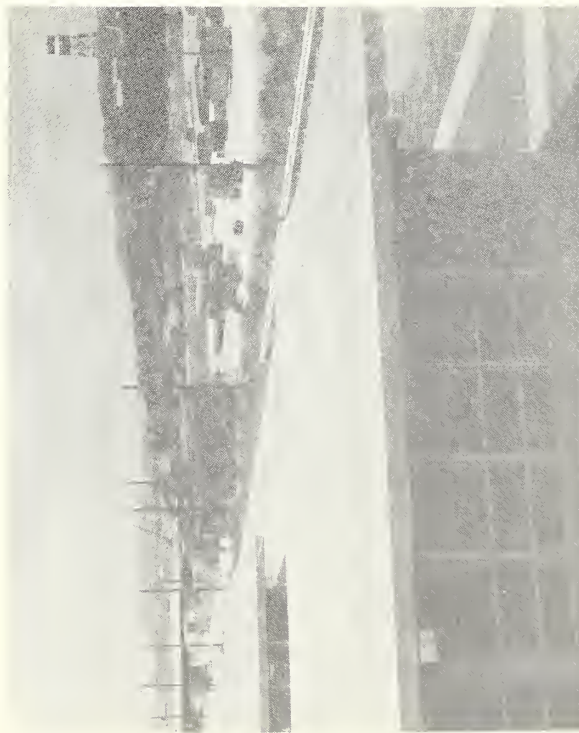
FIGURE 27. TREATMENT OF INTER-PANEL JOINTS ON PRECAST DECK, CAMP HANSEN.
