EVALUATION OF NEW ROOFING SYSTEMS ON GUAM, M.I.

30 June 1964

William C. Cullen
Organic Building Materials Section
Building Research Division

Office of the Chief of Engineers
Department of the Air Force
Bureau of Yards and Docks

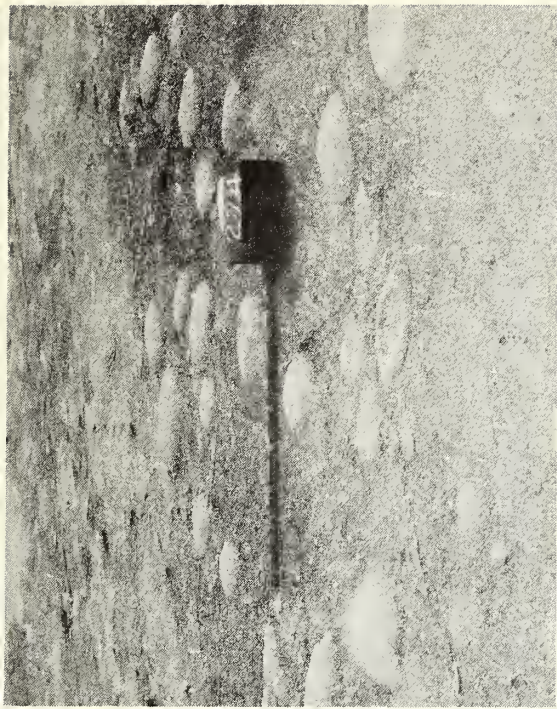
Generally the coatings in this group declined in their ability to waterproof the concrete roof deck with exposure. The prime factors contributing to the decline were blistering, cracking, embrittlement, loss of adhesion to substrate and a general deterioration. Typical examples of failures in the mastic coatings are shown in Figures 2 and 3.

FIGURE 2. SEVERE BLISTERING OF A
MASTIC TYPE MATERIAL. AGE 45 MONTHS.

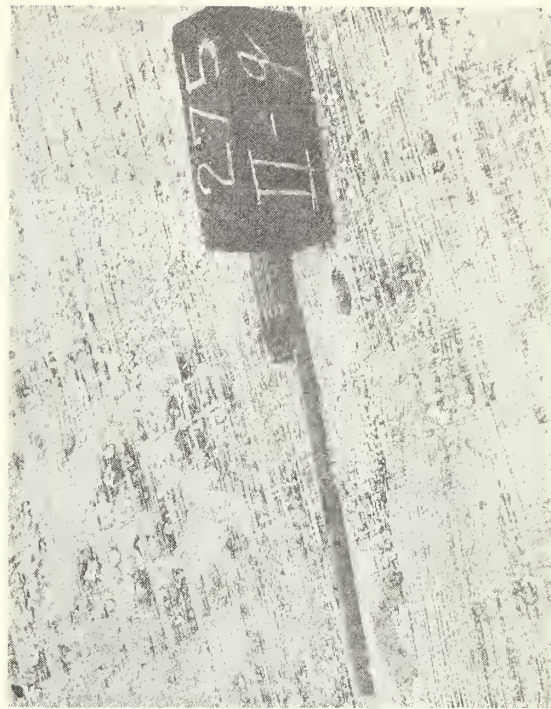
In some cases the materials included in this class initially failed to waterproof the concrete slab due to poor coverage at the high spreading rates recommended for these materials. The remaining materials failed to perform due to peeling, blistering, flaking, and in their ability to bridge even small structural or shrinkage cracks which developed in the concrete deck. Typical examples of failures which were common to coatings of this class are shown in Figures 4 and 5.

FIGURE 4. EROSION OF A PAINT TYPE
COATING. AGE 45 MONTHS.

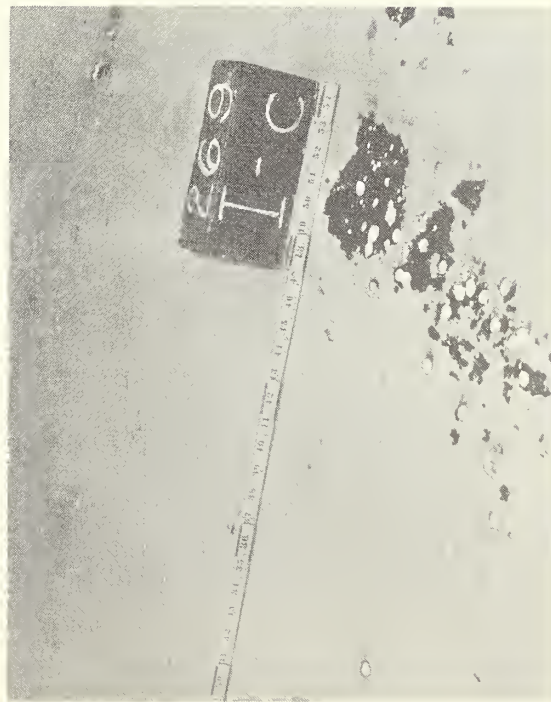
FIGURE 3. GENERAL DETERIORATION OF AN
ALUMINUM COATING. AGE 38 MONTHS.

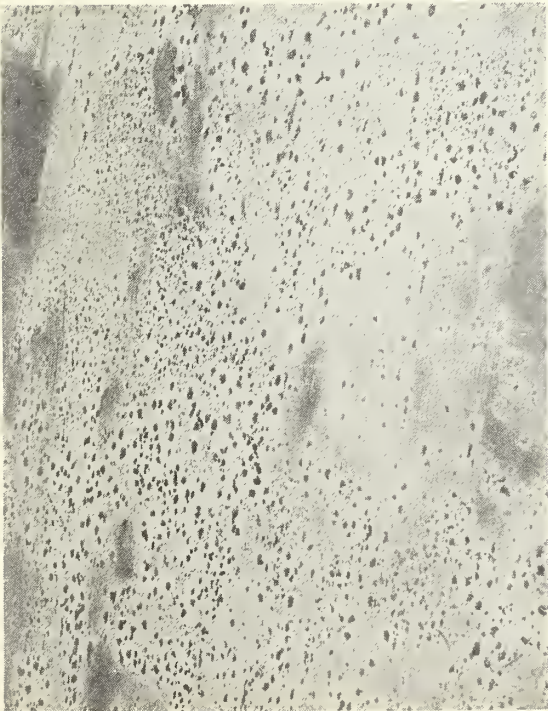
FIGURE 5. FAILED PAINT TYPE COATING.
AGE 45 MONTHS.

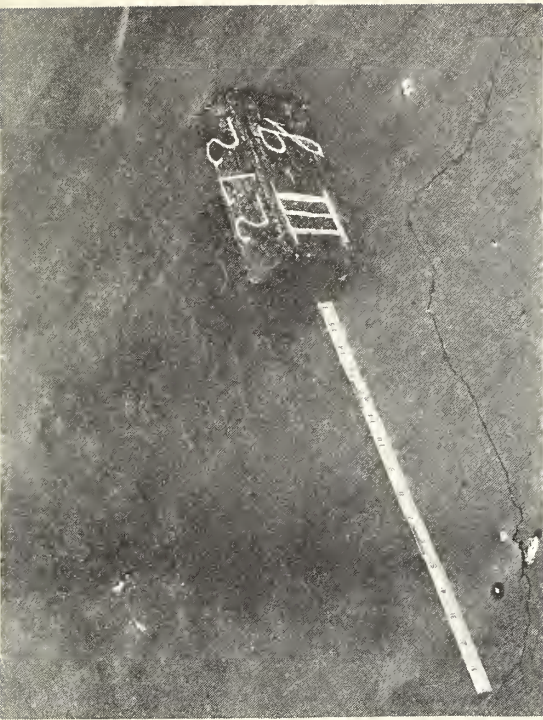
As expected, the bituminous emulsions indicated good weather resistance which is characteristic of this class of coatings. However, they declined rather rapidly in their ability to waterproof the slab due to other factors as: erosion, cracking, and in one case, blistering. Figures 6 and 7 show examples of defects observed.

FIGURE 6. CRACKING AND FLAKING OF AN
EMULSION TYPE COATING. AGE 45 MONTHS.

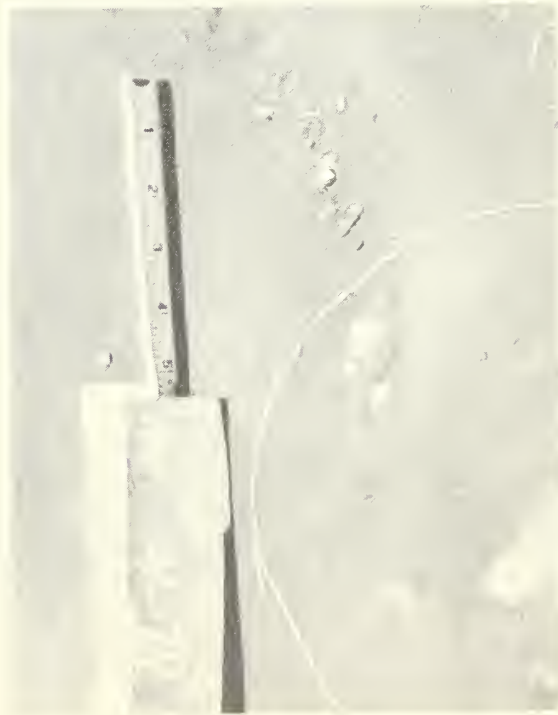
FIGURE 7. BLISTERING AND SALT DEPOSITS
ON EMULSION COATING. AGE 45 MONTHS.

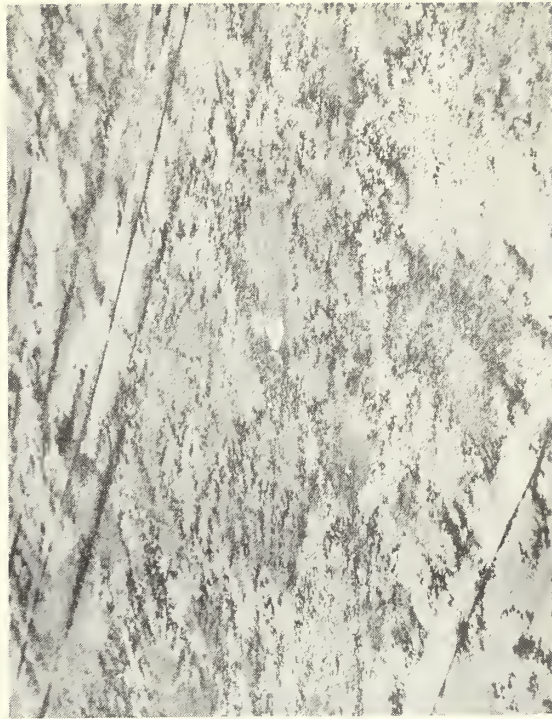
The emulsion-glass felt and the epoxy-glass fabric combinations performed quite satisfactorily, but were rated as failed after 10 years exposure. The former exhibited breaks and small blisters, while the latter indicated erosion of the top coating and an accumulation of mildew as shown in Figure 8.

FIGURE 8. CONDITION OF REINFORCED
MEMBRANE SYSTEM SHOWING MILDW GROWTH.
AGE 75 MONTHS.

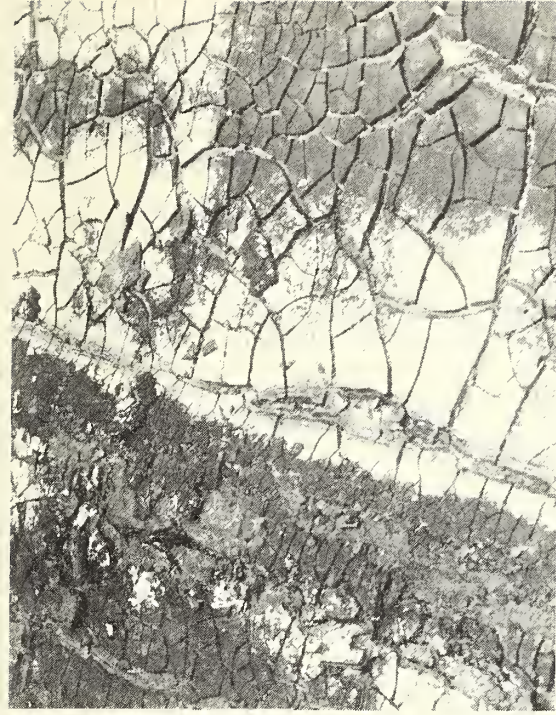
FIGURE 10. CONDITION OF WEATHERED
BITUMINOUS ROOFING BEFORE REMOVAL.

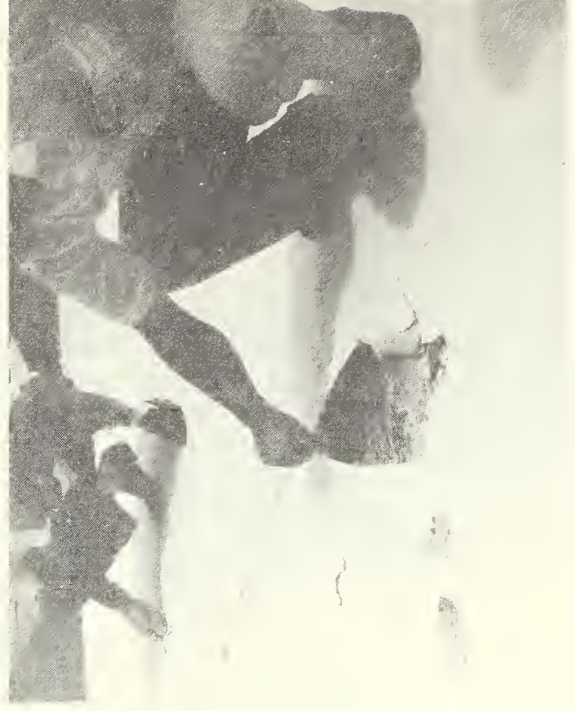
Our observations of the neoprene-chlorosulfonated polyethylene roofing systems and the asphalt emulsion-chopped glass systems which had been exposed in excess of 2 years indicated that both possessed good weathering properties under certain conditions. The former performed well when applied to a clean substrate, but exhibited wrinkling and poor adhesion when applied to a contaminated surface, as shown in Figure 16. The latter performed satisfactorily once it was cured in place. However, "wash offs" were experienced with emulsion type coatings from the action of frequent unexpected showers on these materials whose drying was delayed by exposure to the high humidities experienced on Guam.

FIGURE 16. DEFECTS IN FLUID-APPLIED SYSTEM ATTRIBUTED TO POOR PREPARATION OF CONCRETE DECK

In light of the experience, we are of the opinion that the fluid-applied systems should be used only on roof decks which have not been previously covered. It is not considered economical to attempt to clean a used deck to such a condition that will provide an acceptable surface. Further, we believe that emulsion-type systems (not including easily-dried surface coatings) should be applied only during dry seasons when relative humidities are low and the chance of unexpected showers is minimal.
