PERFORMANCE OF ROOFINGS IN COLD CLIMATES

William C. Cullen

30 June 1965

Office of the Chief of Engineers
Department of the Air Force
Bureau of Yards and Docks

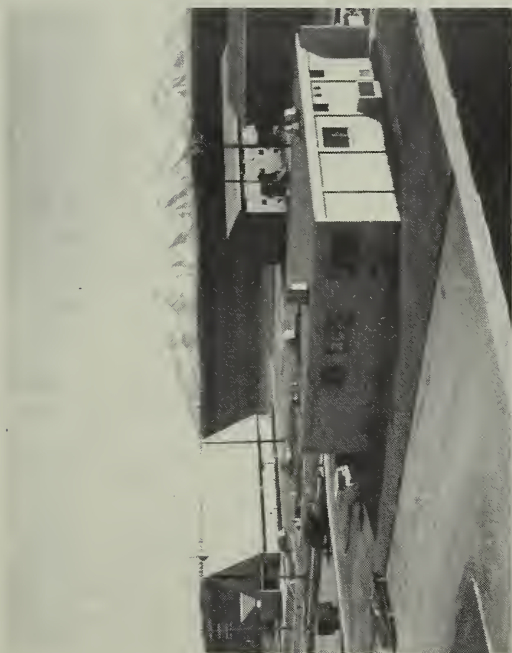
Various and sundry roofing materials and systems, both conventional and unconventional, were observed at each installation. These included bituminous built-up systems and fluid-applied elastomeric systems for flat decks, as well as metallic and composition roofings for sloping decks. A view showing the miscellaneous types of roofings which were observed on one installation is shown in Figure 1.

FIGURE 1. TYPICAL ROOFING SYSTEMS USED IN ALASKA.

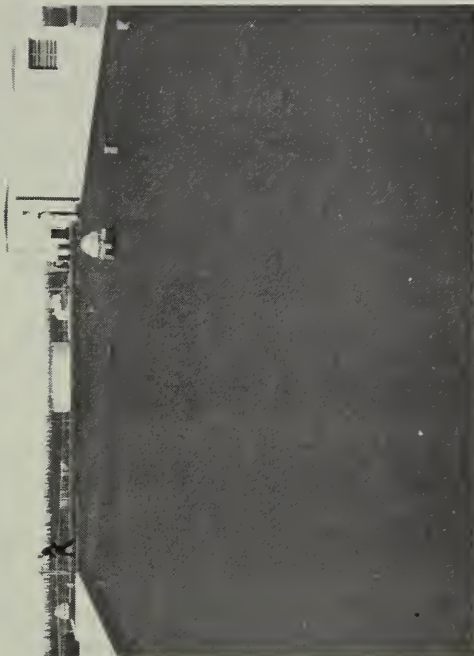
Concrete decks, both poured and precast, have been used frequently as the structural platforms for roofing systems on low slopes. Wood decks, both plywood and T & G planks, have also been used to a large extent especially on family housing units. In many cases a wood deck was constructed over an existing flat concrete deck to provide a sloping surface. A case in point is shown in Figure 2 which proved to be most successful.

FIGURE 2. WOOD DECK APPLIED OVER A FLAT CONCRETE DECK TO PROVIDE A POSITIVE SLOPE.

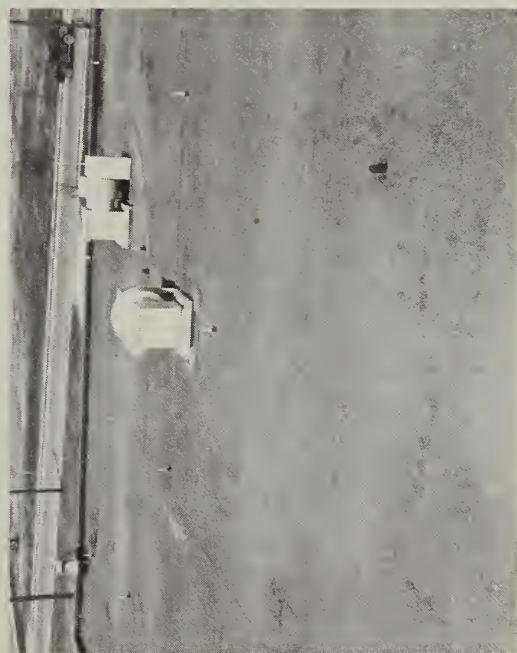
The moisture in the system contributed to premature failure of the waterproof membrane which was evidenced by blistering, wrinkle formation and subsequent cracking. Figure 3 shows the early indication of this type of deficiency. In addition, an appreciable accumulation of moisture in the insulation results in a reduction of its thermal efficiency.

FIGURE 3. GRAVEL SURFACED ROOF SHOWING EFFECTS OF MOISTURE ENTRAPMENT IN THE ROOF SYSTEM.

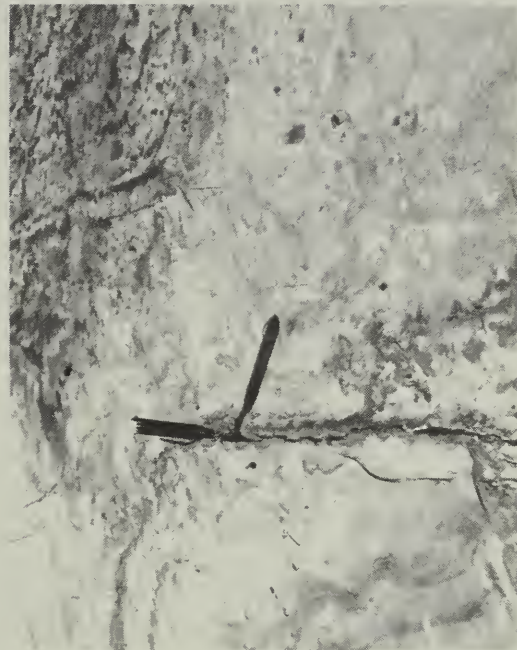
Investigations, by the author, of roofing failures in cold climates over a period of many years have revealed that membrane shrinkage has been an important factor in both membrane and flashing failures. It was therefore anticipated that this factor would be a frequent cause of roofing failures in Alaska. However, our observations indicated that thermal shrinkage was of minor concern when compared to other factors. In fact, only three cases were observed in which thermal shrinkage was suspect. Figure 4 shows a serious failure attributed to thermal shrinkage in the form of a roof split which was observed on a cold storage warehouse. Figure 5 shows a repaired area which is again showing signs of a splitting failure due to thermal movement.

FIGURE 4. ROOF MEMBRANE SPLIT ATTRIBUTED TO THERMAL SHRINKAGE.

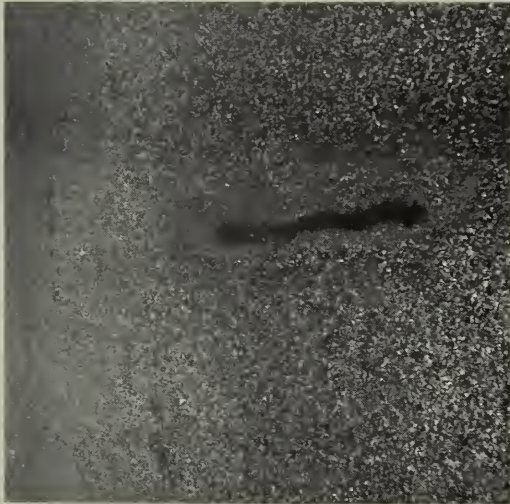
FIGURE 5. UNSUCCESSFUL REPAIR OF A MEMBRANE RUPTURE ATTRIBUTED TO THERMAL SHRINKAGE.

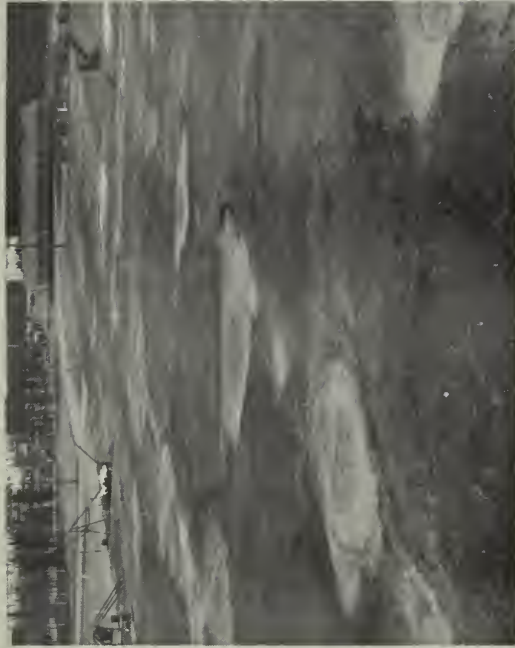
The ponding of water in low areas on roofs definitely contributed to premature failure and resulted in specific problems such as the chemical degradation of the bitumen, physical deterioration of any exposed felts and frequently the disintegration of the cellular glass insulation. These factors were observed on most level roofs and in particular on those unprotected with gravel surfacing. Figure 6 illustrates the many areas of one roof where water collected and stood. Many of these areas exhibited evidence of early membrane failure. Invariably the roof drains when present were located at high areas on the roof and, of course, contributed to the ponding of water.

FIGURE 6. EFFECTS OF PONDING WATER ON DEAD LEVEL ROOF. NOTE LOCATION OF DRAIN ON HIGH AREA (ARROW).

Roof drainage systems should be designed so that drains are located at low areas of the roof.

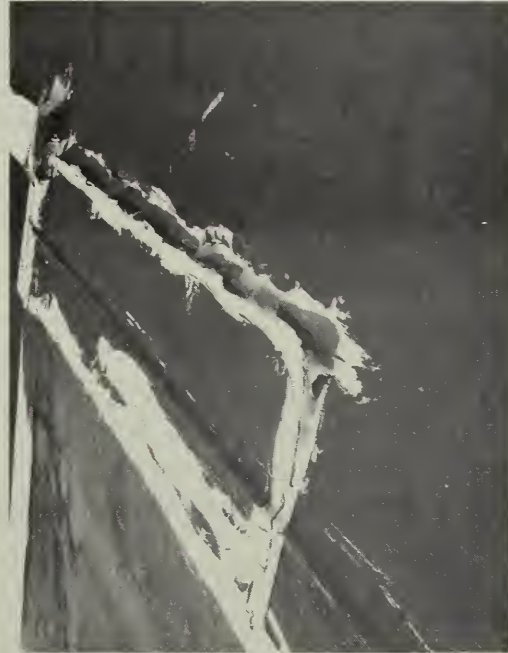
Inadequately designed, improperly installed and defective flashings were observed on roofs located at each installation. In our opinion, these deficiencies accounted for a large percentage of the reported failures. Figure 7 shows a serious failure which is typical of such a design at the flashing of an earthquake joint, which resulted in leakage. This was the only failure on a roof which otherwise provided good service for over 5 years. We believe this to be a poorly designed flashing system for an expansion joint.

FIGURE 7. DEFECTIVE FLASHING AT EARTHQUAKE JOINT AFTER UNSUCCESSFUL ATTEMPTS TO REPAIR.

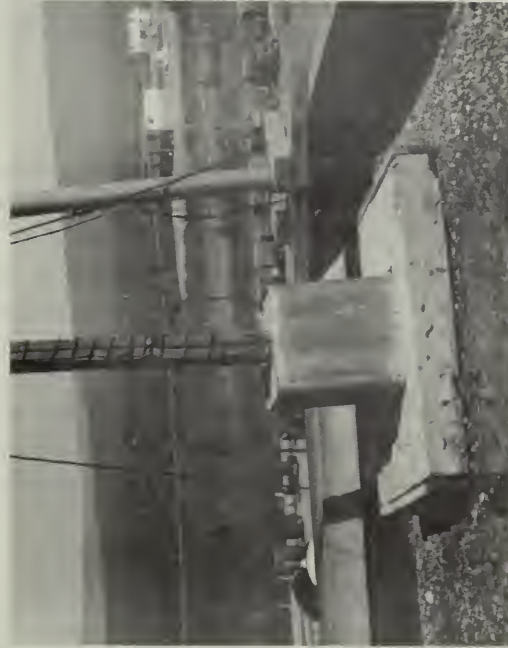
The unauthorized installation of antennae have also been the cause of leakage in many roofing systems. Figure 8 illustrates an extreme case where coping, roofing and flashing were punctured.

FIGURE 8. UNAUTHORIZED INSTALLED ANTENNAE WHICH RESULTED IN COPING, FLASHING AND MEMBRANE FAILURES.

Antenna installation should be made under the supervision of the post engineering personnel.

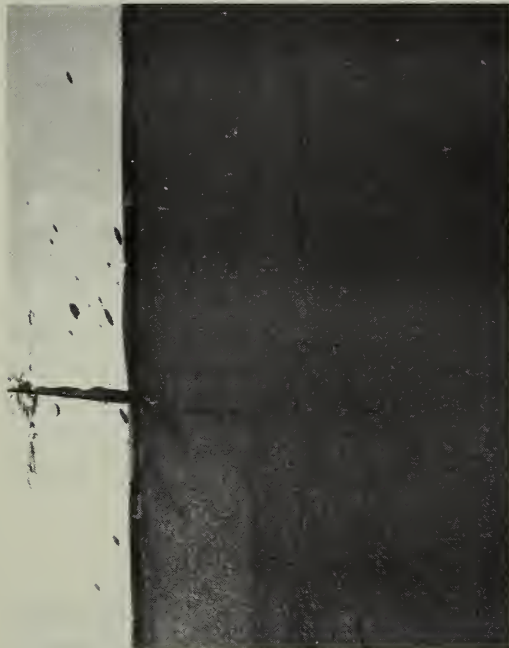
Metal to bituminous transitions in flashing systems should be avoided whenever possible and should never be allowed beneath the standing water line. Figure 9 shows a typical failure at an edge flashing, while Figure 10 is an architectural drawing of the condition. We observed this type of failure more than any other single failure during the survey. The seriousness of this defect when it occurs below the standing water line is readily apparent.

FIGURE 9. COMMON FAILURE OBSERVED AT
EDGE FLASHING WHERE A TRANSITION
OCCURRED BETWEEN METAL AND BITUMINOUS
MATERIALS.

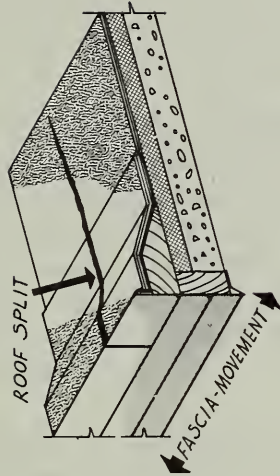
FIGURE 10. SCHEMATIC SKETCH OF FAILURE
SHOWN IN FIGURE 9.

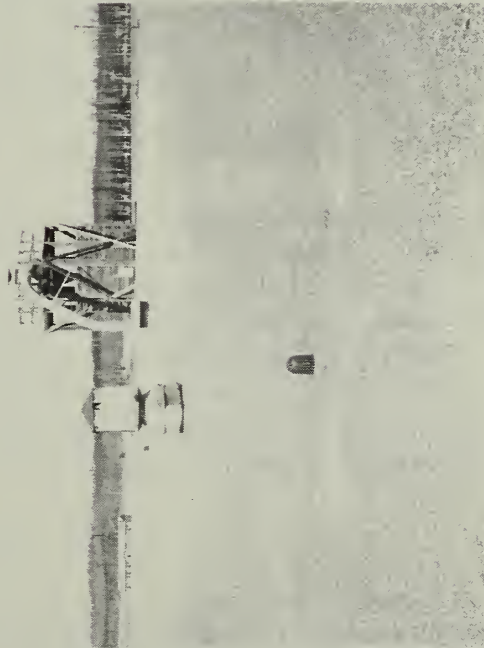
FIGURE 11. GRAVEL SURFACED ROOF AFTER
14 YEARS SERVICE, ANCHORAGE, ALASKA.

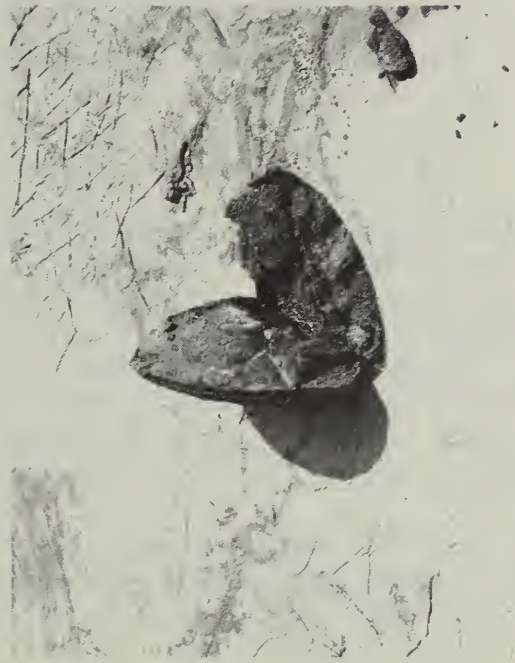
Various types of insulations were used in the Alaska area prior to 1957. However based on the recommendations of the Alaska Roofing Board, the cellular glass type has been used in the majority of installations since that time. In general, this material has performed adequately in service although some deficiencies were brought to our attention. The relatively poor resistance to wind uplift of the paper-backed type contributed to serious wind damage in one location. It was reported that the failure occurred at the interface of the cellular glass and its paper cover. In three cases, we observed indications of the disintegration of cellular glass extending down as much as 1/2 inch from the surface. In each case water had penetrated the membrane and we believe the repetitive freezing and thawing action of the water resulted in this disintegration. Figure 12 shows an area where this deficiency was observed.

FIGURE 12. DISINTEGRATION OF CELLULAR
GLASS INSULATION (EXTENDING 1/4 TO 1/2
INCH FROM SURFACE) ATTRIBUTED TO FREEZING
AND THAWING ACTION OF ENTRAPPED WATER.

We have seen no evidence to warrant the continued use of cellular glass on an exclusive basis for "on the deck" installations. Other insulating materials such as fibrous glass, mineral board, fiber-board, etc., will also give adequate service when properly installed in an adequate roofing system.

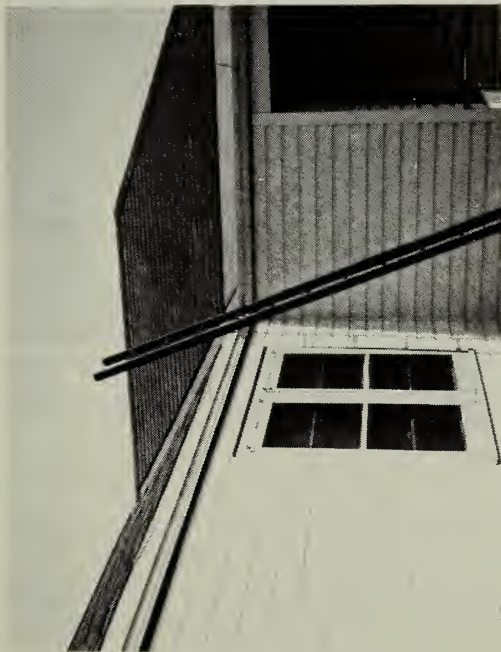
There was complete agreement that roofing systems on steep slopes have a history of excellent service in Alaska regarding watertightness and durability. Figures 13, 14, 15, and 16 show roofings which are typical of those which have served well. These include asbestos-cement, asphalt shingles, roll roofings, metallic shingles, and various other metal roofings. In fact, copper shingles which were observed in the Fairbanks area were still giving adequate service after 24 years service. This is considered excellent service for any roofing material in any climate.

FIGURE 13. ASPHALT SHINGLES ON A 6-INCH IN 12-INCH SLOPE IN EXCELLENT CONDITION AFTER 17 YEARS EXPOSURE.

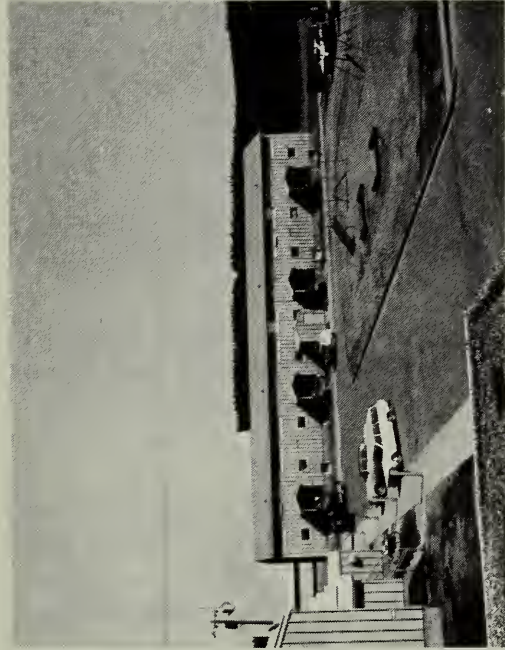
FIGURE 14. ASPHALT SHINGLE ROOF ON FAMILY HOUSING BUILDING.

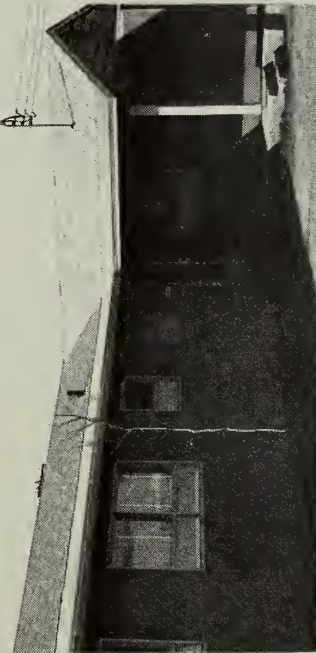
FIGURE 15. ASPHALT SHINGLES, SPOT-CEMENTED, ON FAMILY QUARTERS AFTER 5 YEARS EXPOSURE. NOTE METAL EAVE STRIP.

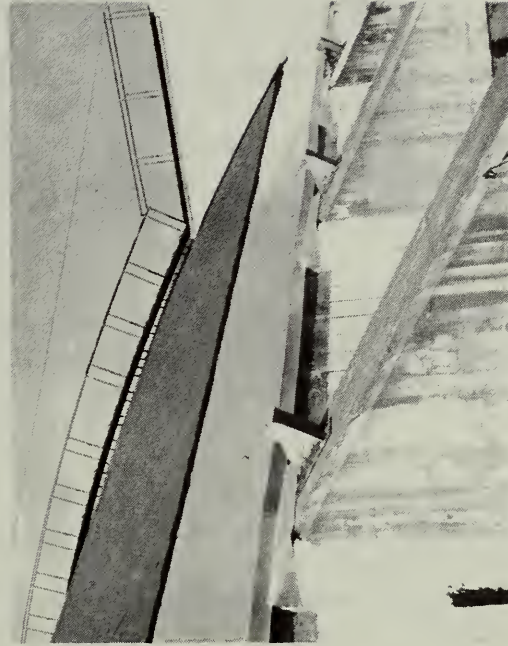
FIGURE 16. MINERAL-SURFACED ROLL ROOFING ON HANGAR ROOF AFTER 7 YEARS EXPOSURE. NOTE THE WIDE METAL EAVE STRIP USED TO SHED ICE AND SNOW.

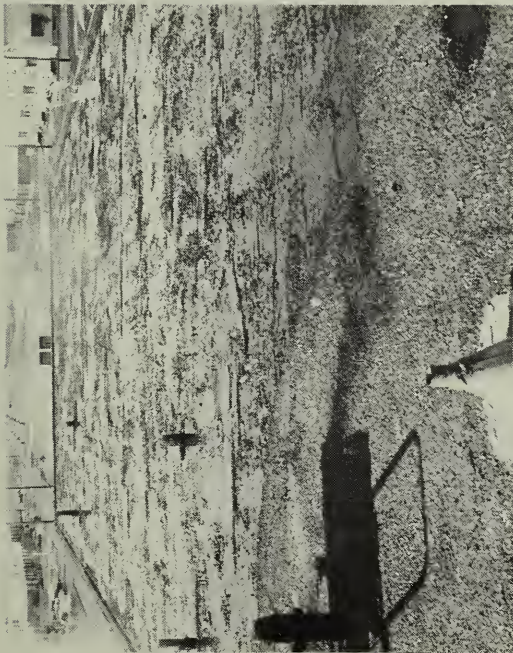
Figure 17 illustrates the condition of a roof selected for the application of a repair membrane prior to a failure. Figure 18 shows a roof of a similar structure after repair was accomplished. We believe that this procedure will extend the useful life of the roof for many years. On the other hand, unconventional maintenance techniques were also observed. These in many cases compounded the failure rather than corrected it. Figure 19 shows the results of applying a glass fabric over a gravel-surfaced roof without removing the surfacing. Figure 20 illustrates cracking failures resulting from the use of thick surface coatings without the protection of gravel surfacing.

FIGURE 17. BUILT-UP ROOF IN INITIAL STAGES OF REPAIR AFTER 13 YEARS EXPOSURE.

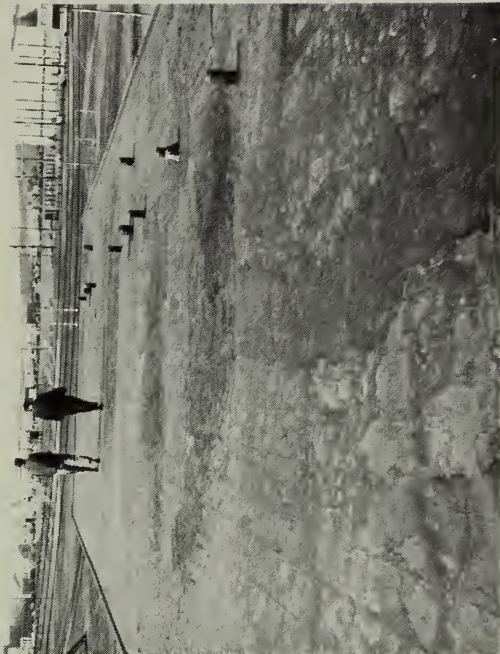
FIGURE 18. BUILT-UP ROOF, SIMILAR TO THAT SHOWN IN FIGURE 17, AFTER REPAIR MEMBRANE WAS INSTALLED.

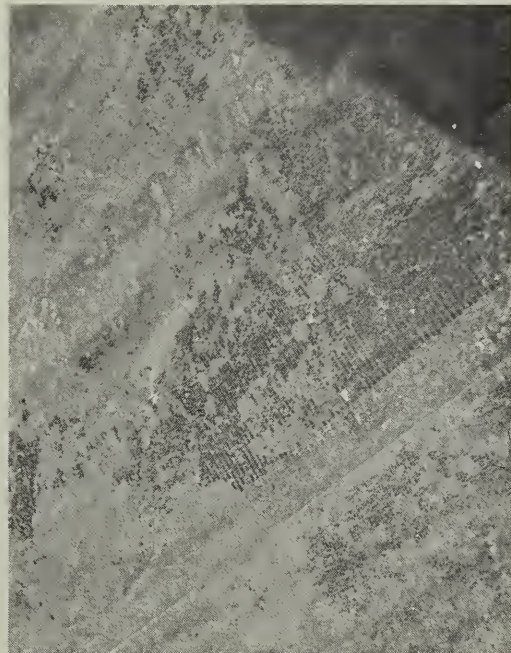
FIGURE 19. EXPOSED GLASS FABRIC WHICH WAS USED AS IN A REPAIR MEMBRANE OVER A GRAVEL-SURFACED BUILT-UP ROOF.

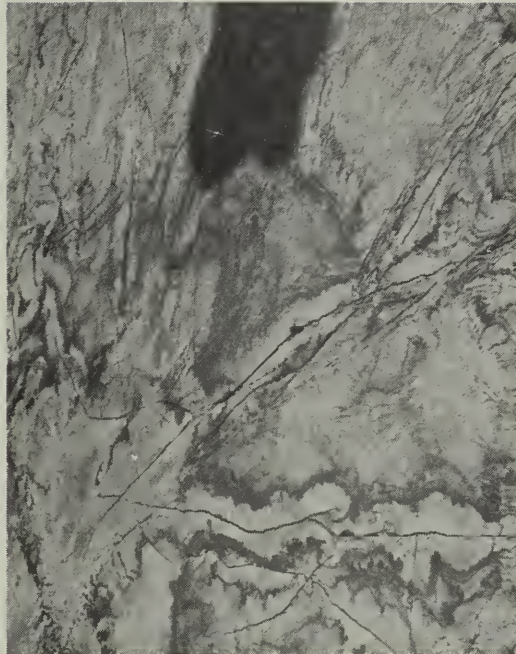
FIGURE 20. SURFACE CRACKING OF AN ASPHALT EMULSION ROOF COATING APPLIED OVER A THICK COATING OF HOT ASPHALT.
