NATIONAL BUREAU OF STANDARDS REPORT

DWELLING UNIT BURNOUT TESTS

PRATT INSTITUTE TEST BUILDING

January 5, 1966

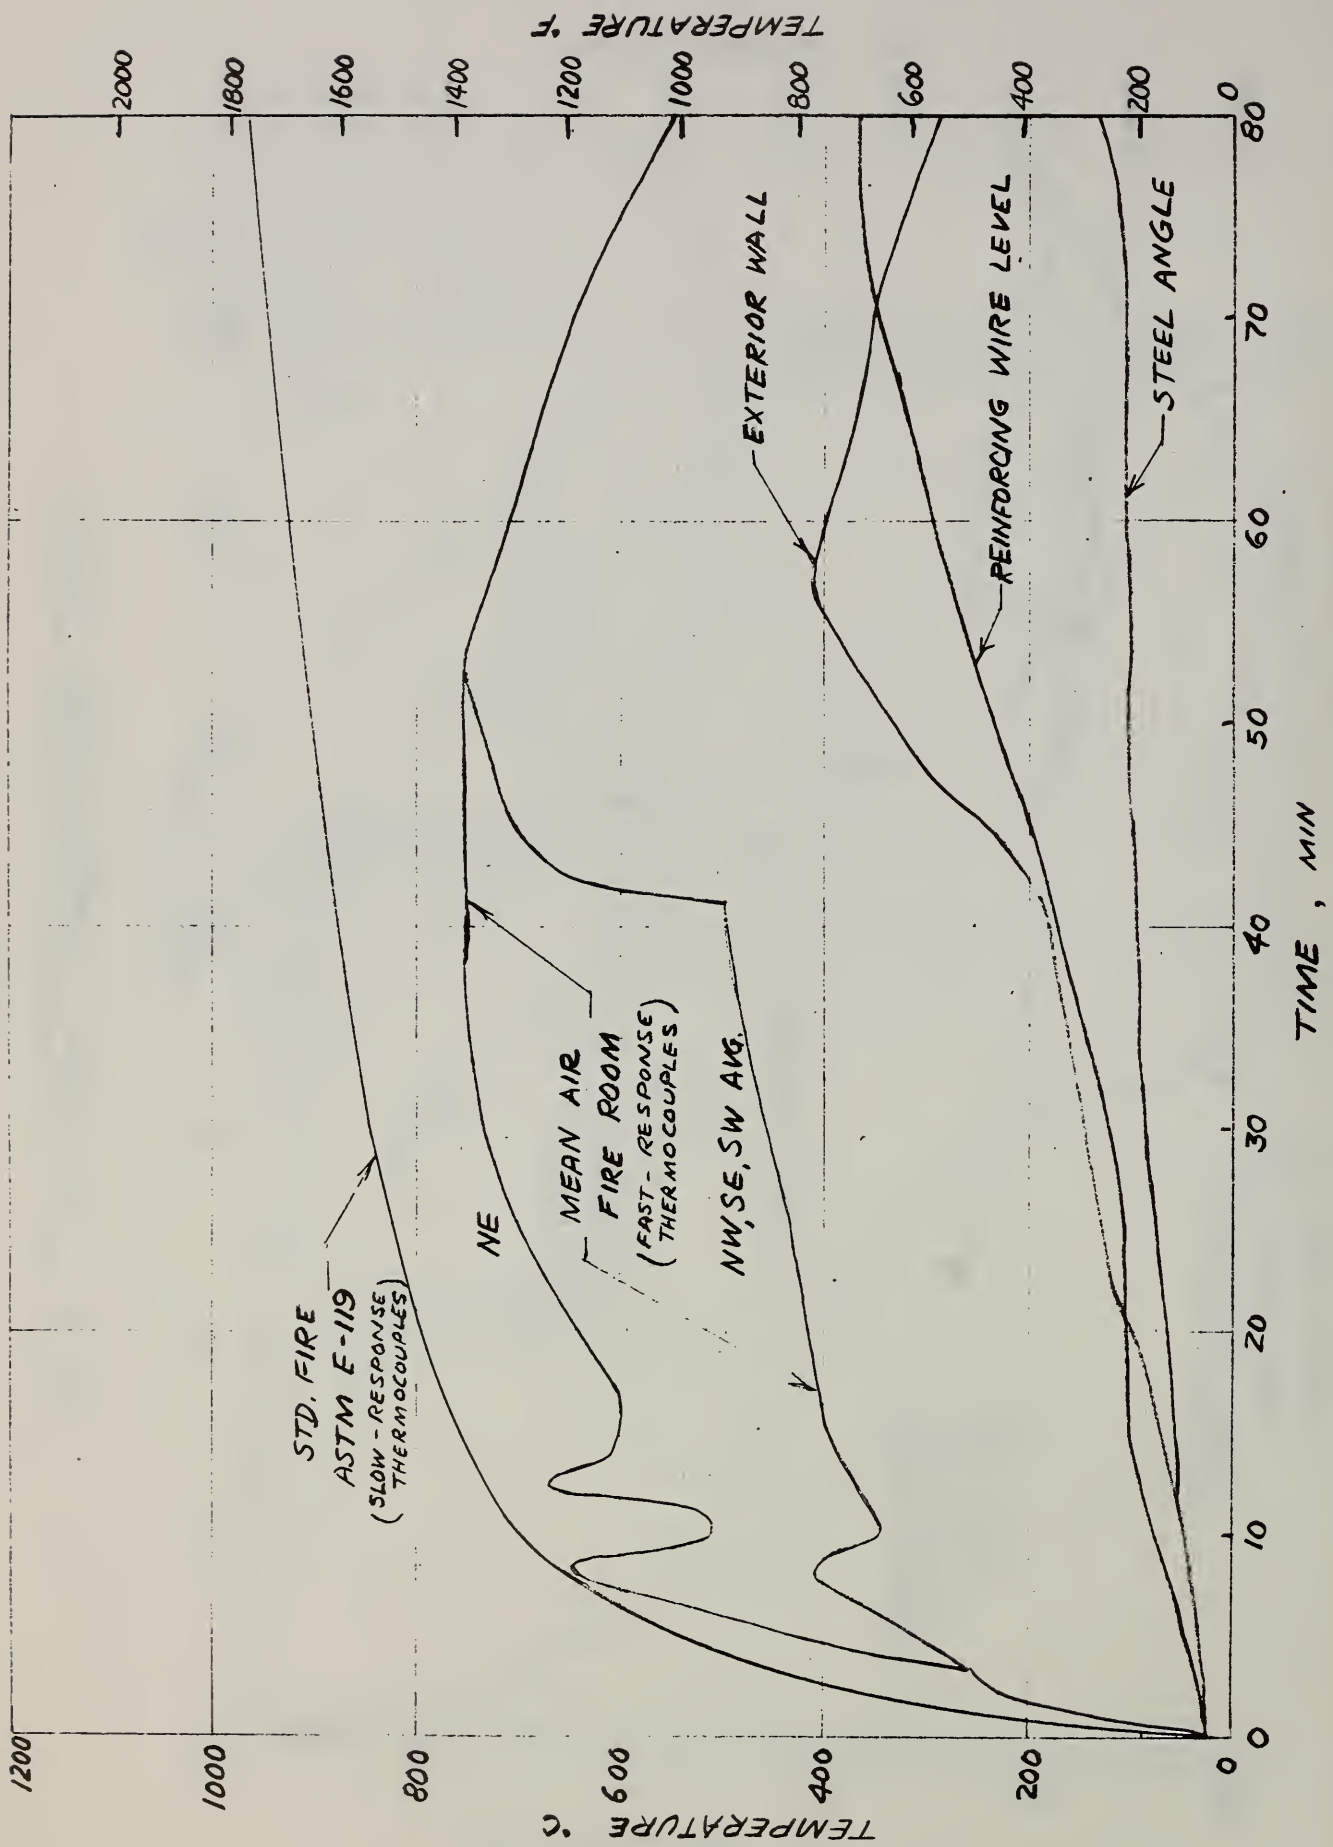
FIG. 7 SELECTED TEMPERATURES , TEST 2

The failure of all five cribs comprising the fire load to ignite simultaneously prevented the rapid and uniform buildup in temperature in the fire room. As shown in Fig. 7, the temperature measured by the NE thermocouple, situated above the burning crib, was considerably above the average of the three other thermocouples until after 41 minutes when complete window dropout and intense burning occurred. Because of the cooling effect of the southerly wind and fire room temperatures only slightly above the melting point of aluminum (660°C , 1220°F), the aluminum sandwich panel remained in place. The temperature on the exterior face of the aluminum sandwich panel under an asbestos pad reached a maximum of 410°C (770°F) at 55 minutes.

The temperature in the second floor slab above the fire at the level of the lower reinforcing wires is shown by a typical curve in Fig. 7. The maximum temperatures at six locations varied from 350°C to 380°C (635 to 716°F) and occurred at approximately 80 minutes. At two other locations, moisture evaporation endotherms limited the temperature to 100°C (212°F) for extended periods and the maximum temperatures reached were 127° and 185°C (260 and 365°F).

A typical curve of temperature on the steel supporting angles is also shown in Fig. 7. At these east and west wall-ceiling joints, the migration (presumably through the hollow cores) and subsequent condensation of moisture, tended to hold the temperature at the steam point (100°C) for extended periods. The maximum temperatures recorded on the steel angles ranged from 138° to 172°C (280 to 341°F) at about 100 minutes. In the grout joint along the north wall, a temperature of about 230°C (446°F) was measured during the period of 70 to 140 minutes.

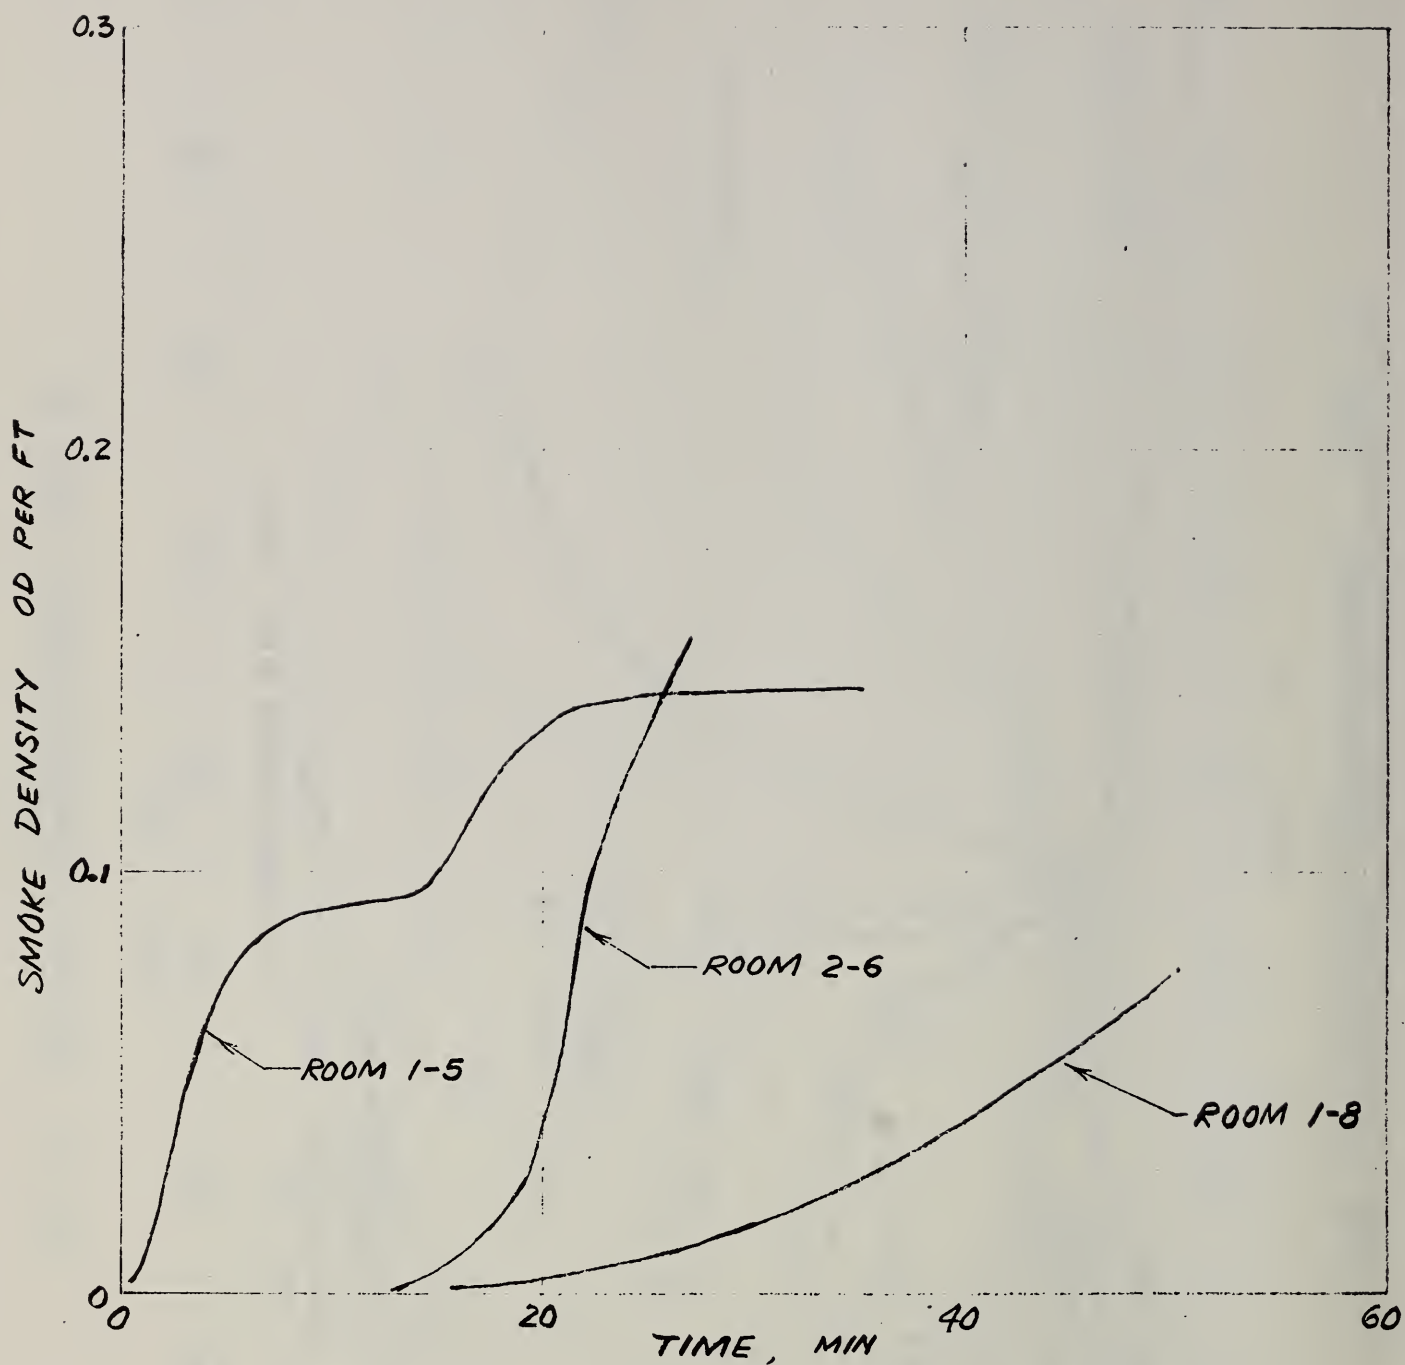
FIG. 9 SMOKE DENSITY, TEST 1

The attenuation of light due to smoke (and water vapor) accumulation was measured in terms of percent of initial light transmission (T). Readings were converted to optical density per foot, $1/L (\log_{10} 100/T)$, where L, the optical path length was two times the smoke meter-to-ceiling height, approximately 14 feet. No corrections were made for possible slight drift in the phototube circuits, for the moisture or soot deposits on the lenses and mirrors, or for the scattering of daylight by the smoke. The results are plotted in Figs. 9, 10, and 11.

These results represent the accumulated or total smoke concentration in the various rooms adjacent to the fire room as measured over a vertical path, and are essentially independent of smoke stratification effects. In a typical fire situation, smoke stratification could alter the time period prior to the onset of impaired visibility. Decreasing values following a maximum may be due to smoke settling or agglomeration, loss through openings, etc., but in the case of Tests Nos. 2 and 3, was principally due to the condensation of the moisture vapor portion of the "smoke" aerosol.

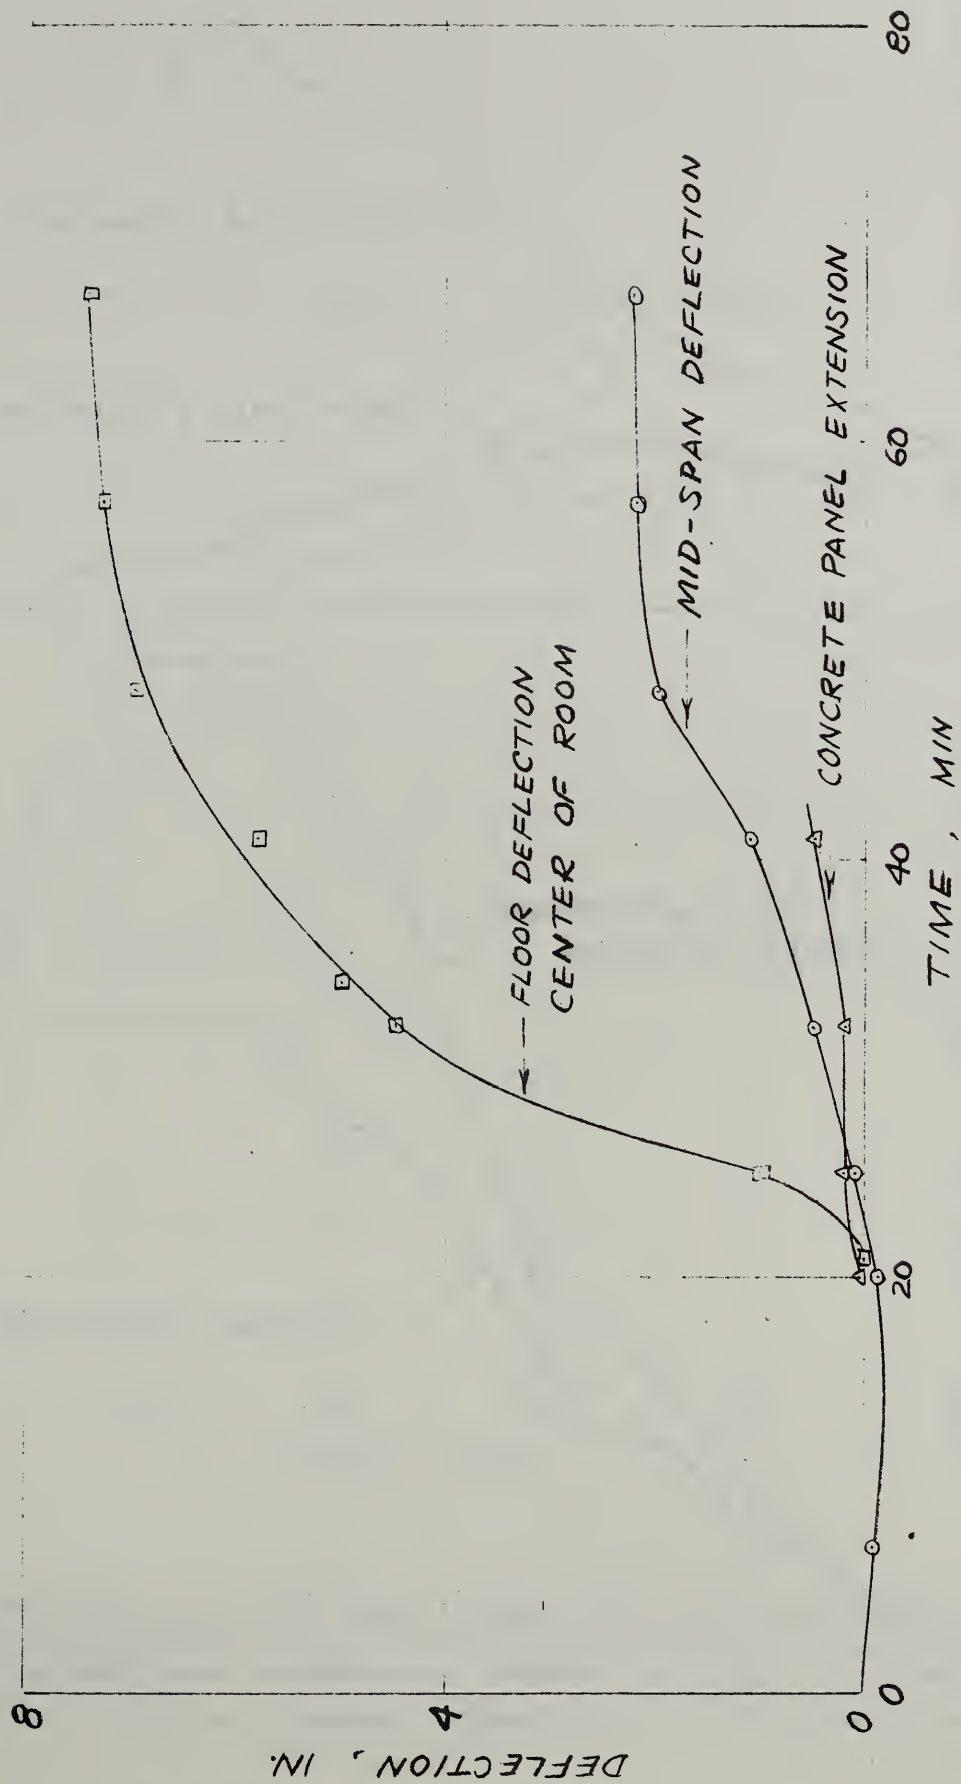
FIG.12 DEFLECTIONS , TEST 1

Vertical and lateral deflection measurements are shown in Fig. 12. Rapid deflection of the floor at the center of the room followed shortly after the ceiling dropped and all structural members became directly exposed to fire. The maximum deflection observed was 7.4 in., with a permanent sag of about six in. after cooling. At the mid-span of the joists, the maximum deflection observed was 2-1/4 inches.
