NATIONAL BUREAU OF STANDARDS REPORT

9513

The Stress Corrosion and Galvanic Behavior of
17-4 PH Fasteners in Marine Environments

Materials Division
Air Systems Command
Department of the Navy

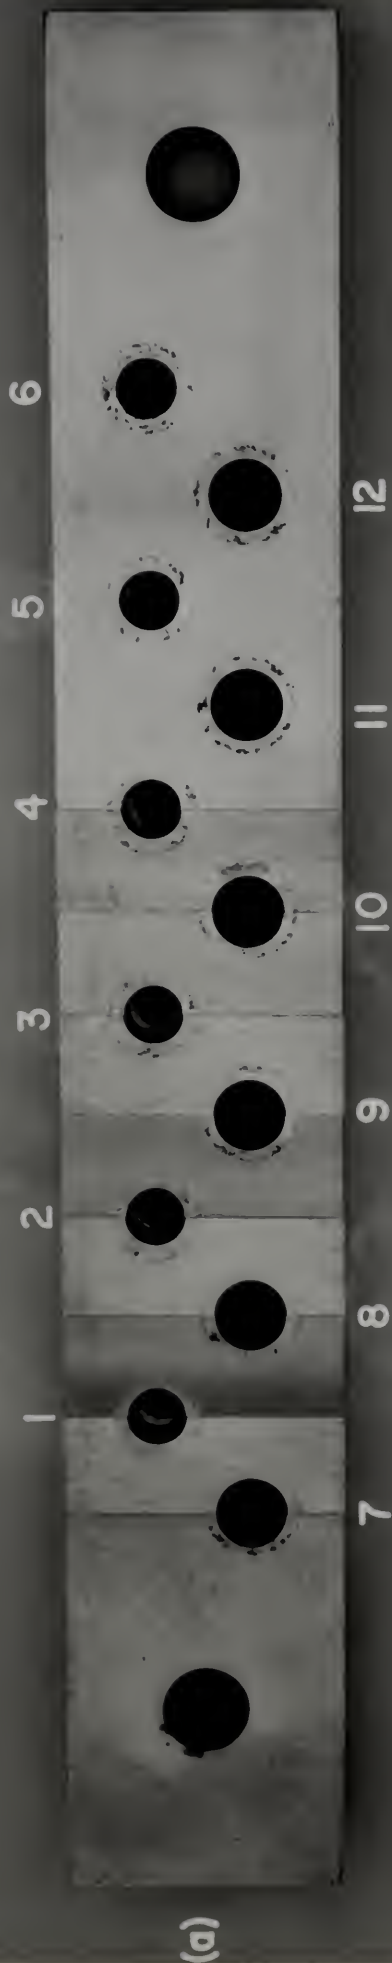
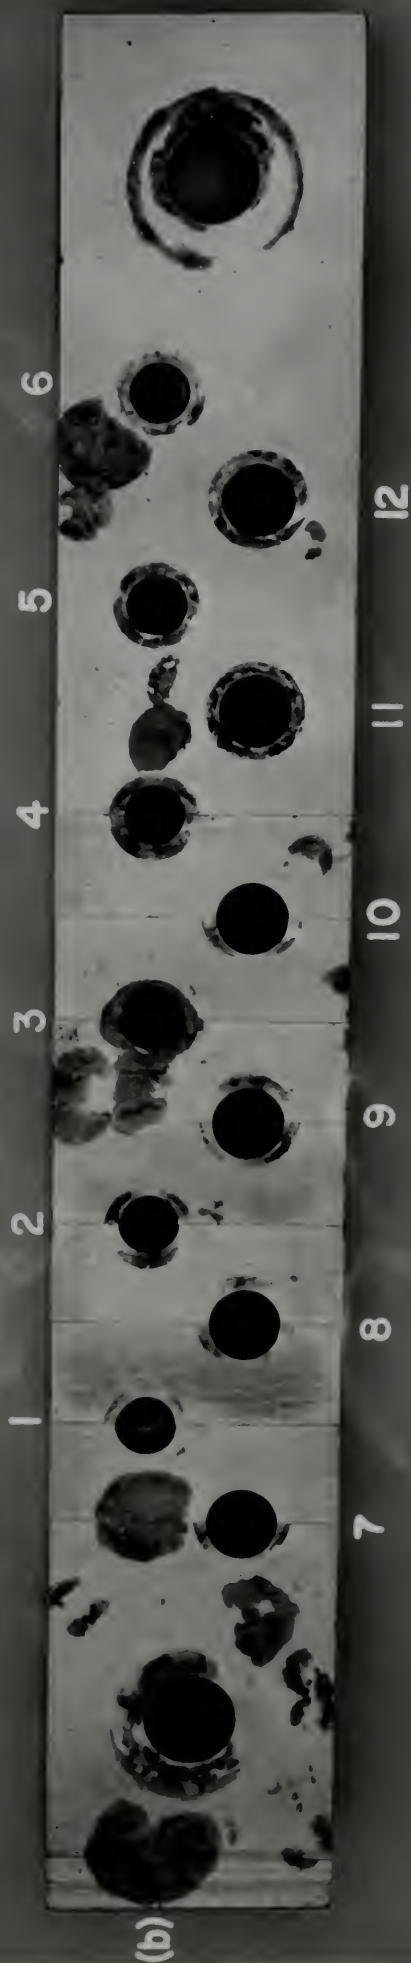
Results: There were no stress corrosion failures of the 17-4 PH stainless steel alloy bolts after 39 1/2 months exposure in either test environment. Localized corrosion, attributed to the formation of oxygen concentration cells, at the bolt and block interface areas and at areas where marine organisms had attached themselves, was observed on the seawater exposure assembly. Similar effects from oxygen concentration cells, but to a lesser degree, were also observed at the bolt and block interface areas on the marine atmosphere exposure assembly. The effects on both assemblies and fasteners are shown in Figures 2, 3 and 4.

Figure 2. Photograph of the 17-4 Ph threaded blocks after disassembly and cleaning; showing oxygen concentration cell effects at bolt-block interface areas on (a), specimen exposed in the marine atmosphere, and on (b), specimen exposed in the sea water in the tidal zone. Note also effects of marine organism attachment on (b). X1

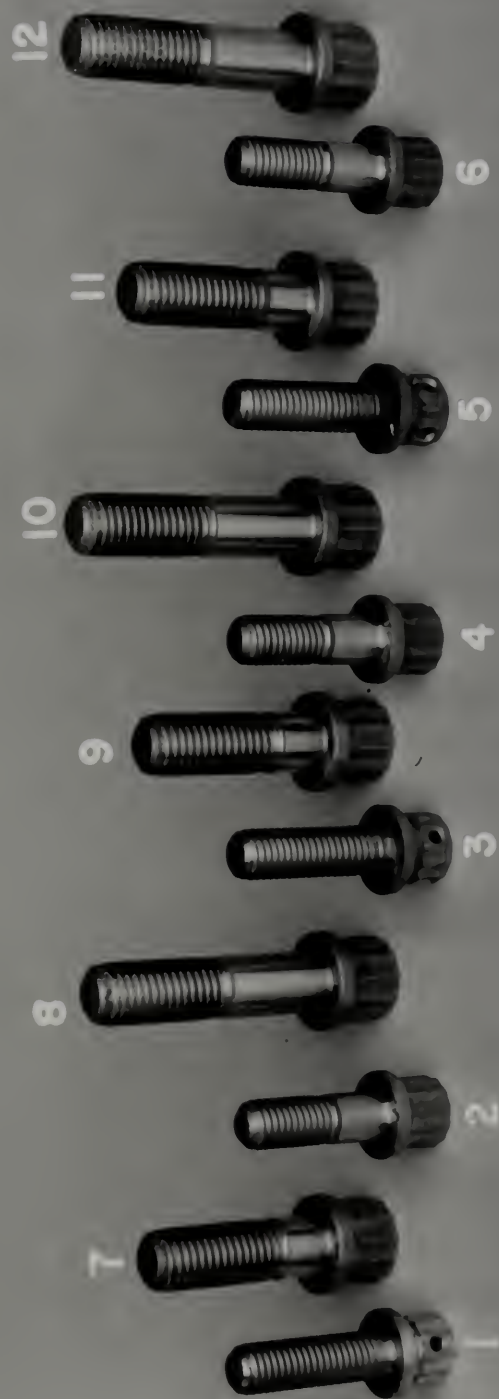
Figure 3. Appearance of 17-4 PH stainless steel alloy bolts removed from the marine atmosphere test assembly. Bolts are shown after cleaning. Note pitting effects from oxygen concentration cell corrosion at areas on the bolt washer faces. X1

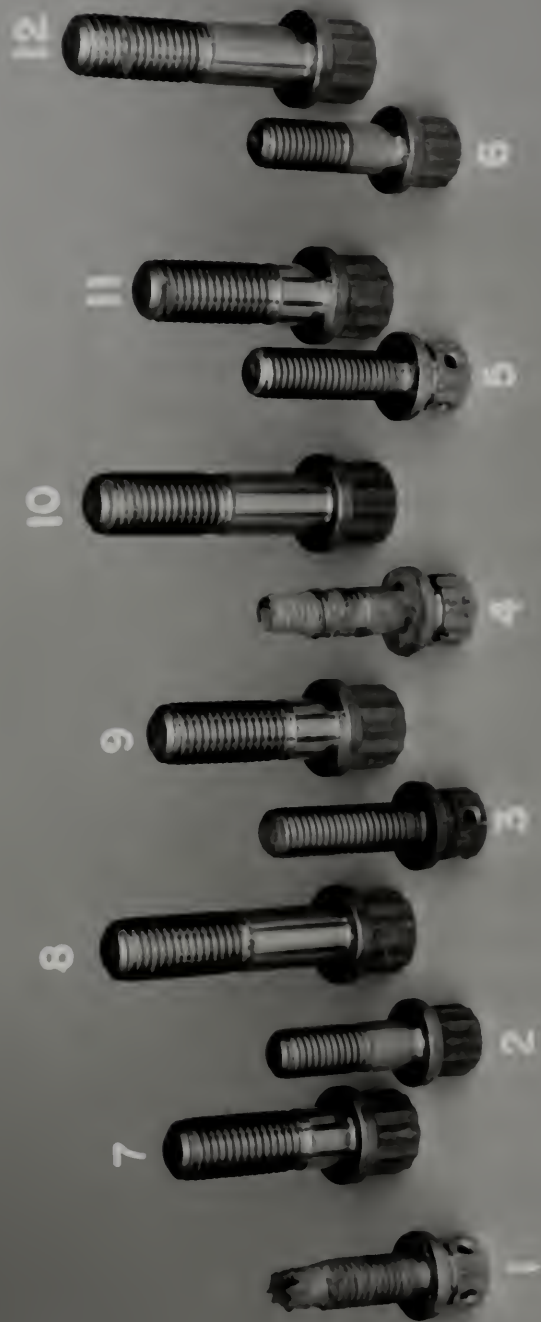
Figure 4. Appearance of 17-4 PH stainless steel alloy bolts from seawater test assembly. Bolts are shown after cleaning. Note pitting corrosion on the washer face of the bolts and corrosive effects from marine organism attachment on the heads of bolts 1, 4 and 11. Corrosion on the shank areas of bolts 1 and 4 was due to marine organism attachment at areas within the threaded hole of the block. Corrosion is attributed to the formation of oxygen concentration cells. X1

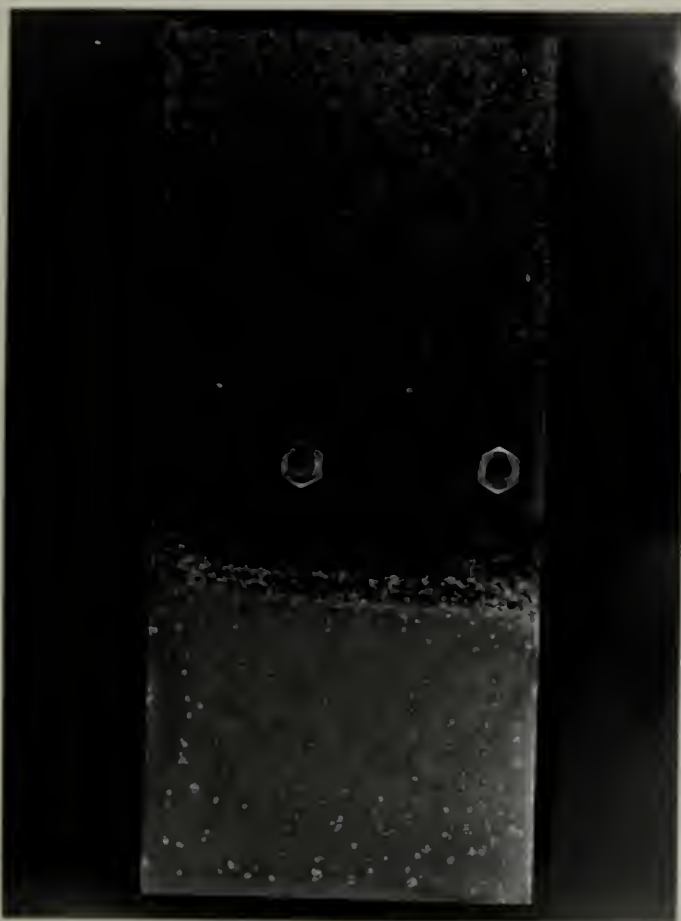
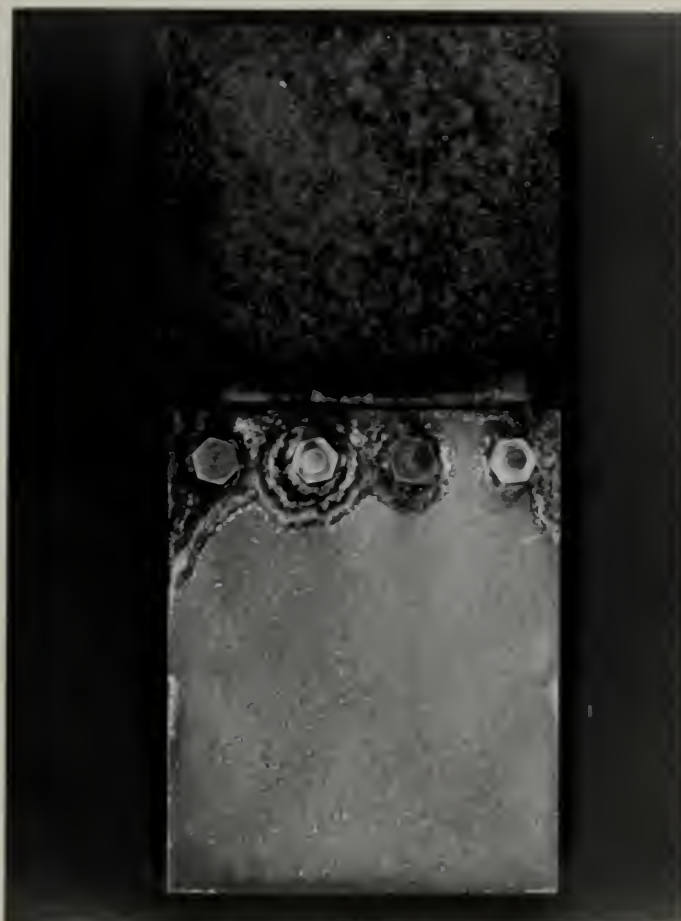
Figures 6, 7 and 8 show before disassembly, the cadmium plated steel members that were coupled respectively with the types 410, 302 and 321 stainless steel alloy members. The most severe corrosion on the cadmium plated steel was indicated

by adherent rust colored corrosion products (darker areas) at the fastener areas and at areas immediately adjacent to the faying surface. When these couples were disassembled, it was noted that the corrosion products beneath the bolt heads and at the faying surfaces were gray to grayish white indicating the presence of sufficient cadmium at these areas to provide protection for the fasteners and coupled members. No corrosion was observed at the contact areas of any of the fasteners coupled with the cadmium plated steel members.

Figure 6. Appearance of dissimilar metal couple after 39 1/2 months exposure in the marine atmosphere at Kure Beach, N.C. In each photograph top panel component is type 410 stainless steel alloy and bottom panel component is cadmium plated SAE 4130 steel alloy. Corrosion products (dark areas) on cadmium plated steel at the faying surface and around the bolt holes were rust colored. After disassembly it was noted that the corrosion products on the faying surface and beneath the bolt heads were gray to grayish white in color. X 1/2

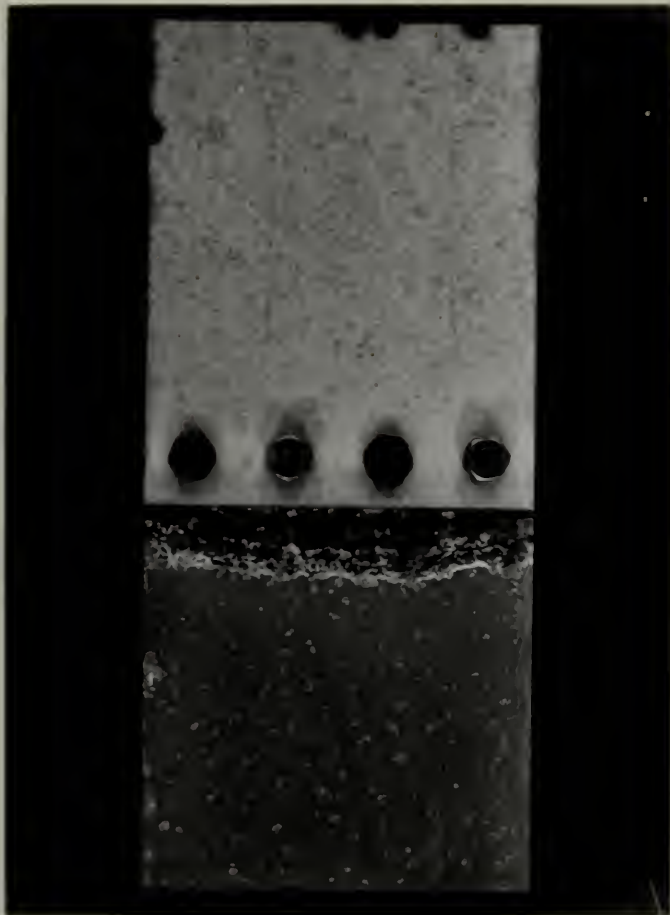
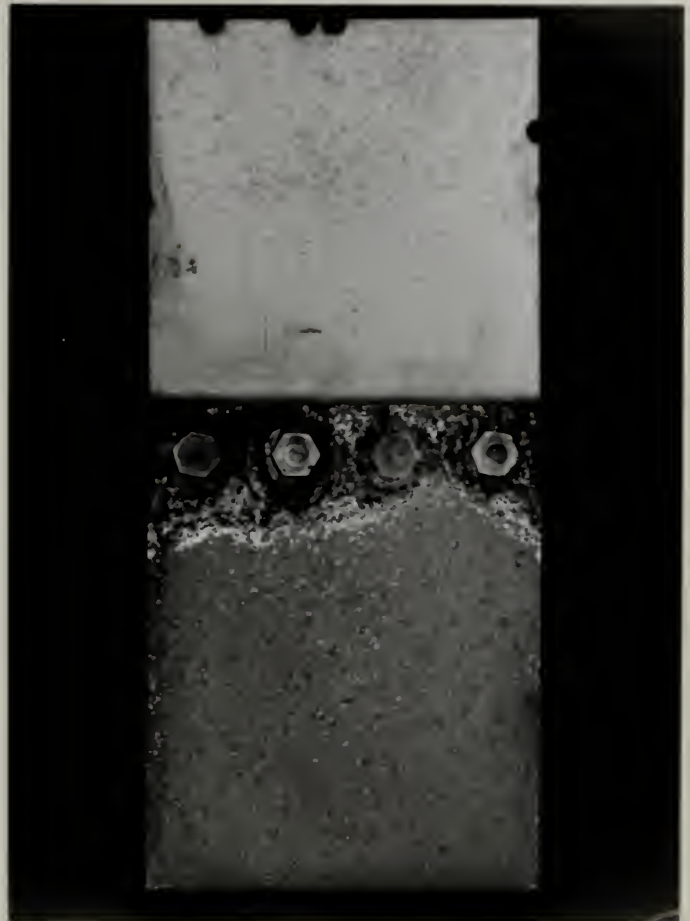
Figure 7. Dissimilar metal couple after 39 1/2 months exposure in the marine atmosphere at Kure Beach, N.C. In each photograph top panel component is type 302 stainless steel alloy and bottom panel component is cadmium plated SAE 4130 steel alloy. Corrosion products (dark areas) on cadmium plated steel at the edge of the faying surface and around the bolt holes were rust colored. After disassembly it was noted that the corrosion products on the faying surface and beneath the bolt heads were gray to grayish-white in color. X1/2

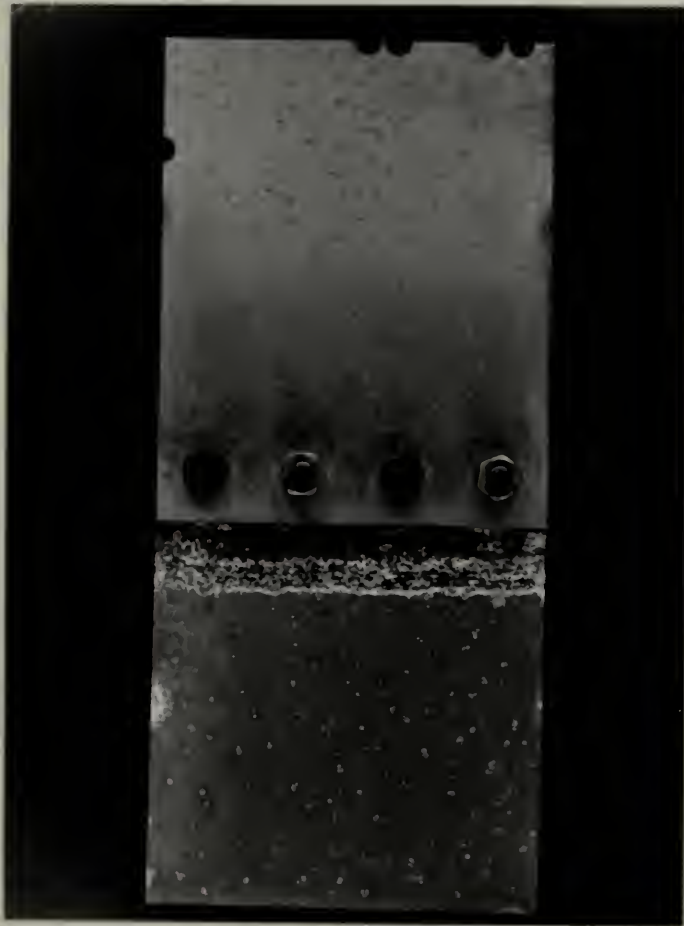
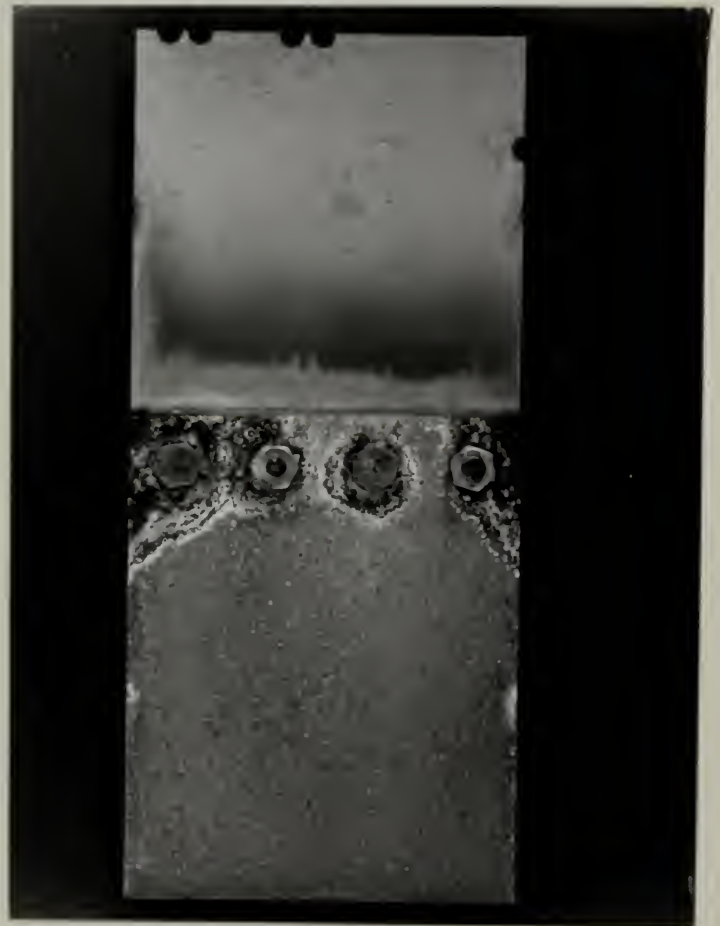
Figure 8. Dissimilar metal couple assembly after 39 1/2 months exposure in the marine atmosphere at Kure Beach, N.C. In each photograph top panel component is type 321 stainless steel alloy and bottom panel component is cadmium plated SAE 4130 steel alloy. Corrosion products (dark areas) on cadmium plated steel member at the faying area and around the bolt holes were rust colored. After disassembly it was noted that the corrosion products on the faying surface and beneath the bolt heads were gray to grayish white in color. X 1/2.

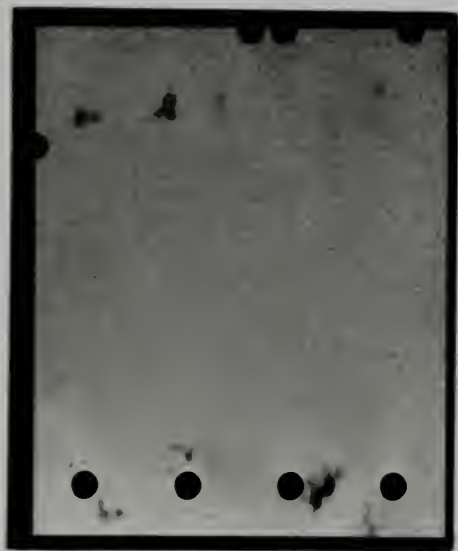
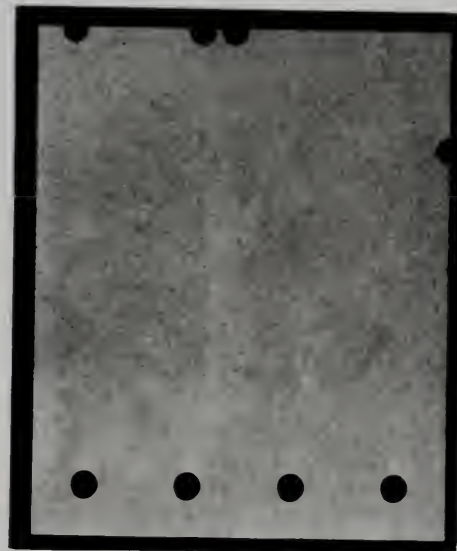
Figures 9, 10 and 11 show, respectively, after cleaning, the surfaces of the types 410, 302 and 321 stainless steel members that had been coupled to the cadmium plated steel members. There was no corrosion at the fastener contact areas of any of the stainless steel members or at the faying surfaces of the types 302 or 321 steel specimens. The type 410 steel was slightly etched at the faying surface. No corrosion was found at the washer face contact areas on any of the fasteners coupled with the type 410 steel member or on the type 18-8 stainless steel nuts that were coupled with the types 302 and 321 steel members. However, shallow pits were found on the washer face of the 17-4 PH steel fasteners that were coupled with the types 302 and 321 steel members.

Figure 9. Photographs of the surfaces of the type 410 stainless steel alloy specimen that had been fastened to a cadmium plated SAE 4130 steel alloy member. Specimen is shown after 39 1/2 months exposure and after disassembly and cleaning. Note that the corrosion is uniform on both surfaces except at fastener contact areas on the skyward exposed surface (a) and at the faying area of the earthward exposed surface (b). Faying surface area was slightly etched. Dark patches at bolt hole areas and in upper left corner of (a) are rusted areas that appeared after cleaning before the specimen could be photographed. X 1.2

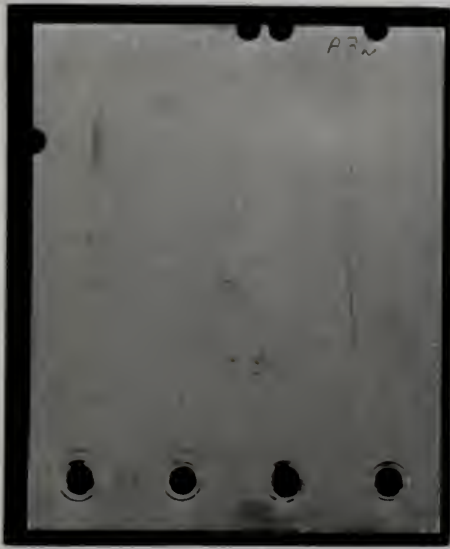
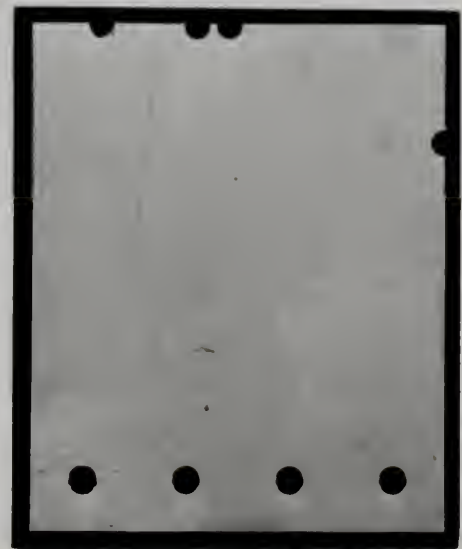
Figure 10. Photographs of the surfaces of the type 302 stainless alloy specimen that had been fastened to the cadmium plated SAE 4130 steel alloy member. Specimen is shown after 39 1/2 months exposure in the marine atmosphere and after disassembly and cleaning. There was no corrosive attack at the fastener contact areas on the skyward exposed surface (a) or the faying area on the earthward exposed surface (b). Rings around bolt holes are scoring marks introduced by the bolt and nut washer faces and by tools used to remove the fasteners. Darkened areas at bolt holes are from lighting used in photographing the specimen. X 1/2

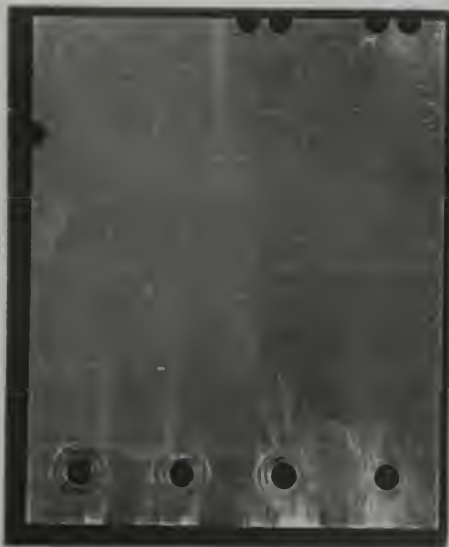
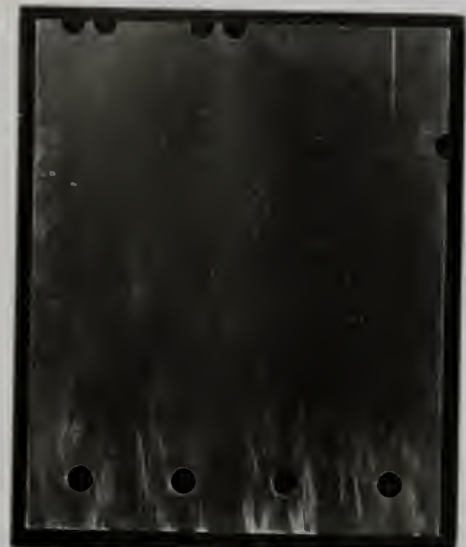
Figure 11. Photographs of the surfaces of the type 321 stainless steel alloy specimen that had been fastened to the cadmium plated SAE 4130 steel alloy member. Specimen is shown after 39 1/2 months exposure in the marine atmosphere and after disassembly and cleaning. There was no corrosive attack at the fastener contact areas on the skyward exposed surface (a) or at the faying area on the earthward exposed surface (b). There was scattered pin-point attack at other areas on the exposed surfaces. Rings at bolt hole areas are scoring marks introduced by the bolt and nut washer faces and by tools used to install and remove the fasteners.

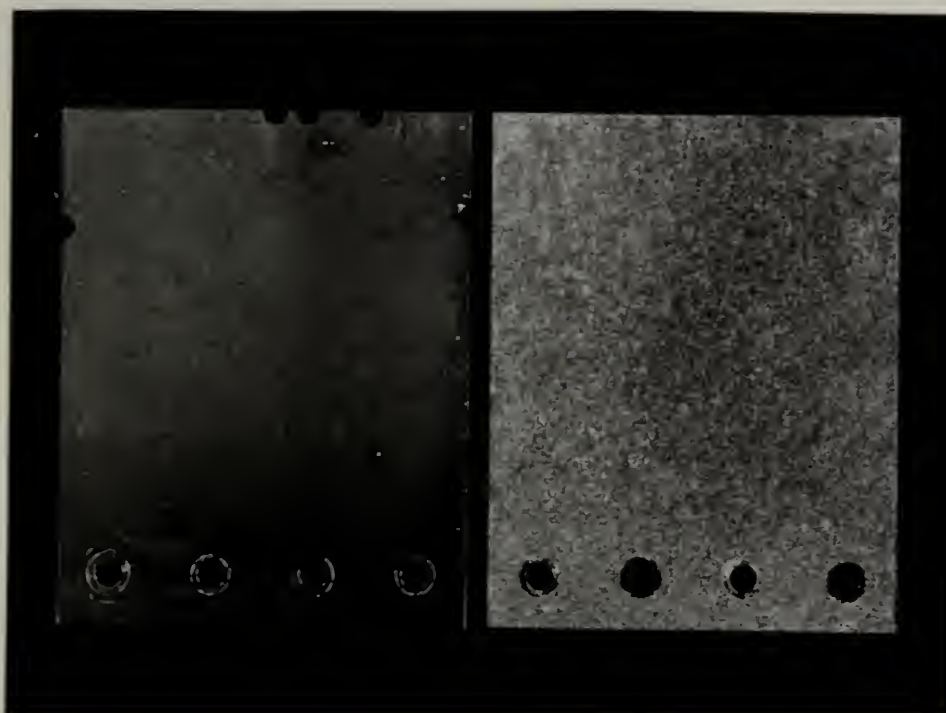
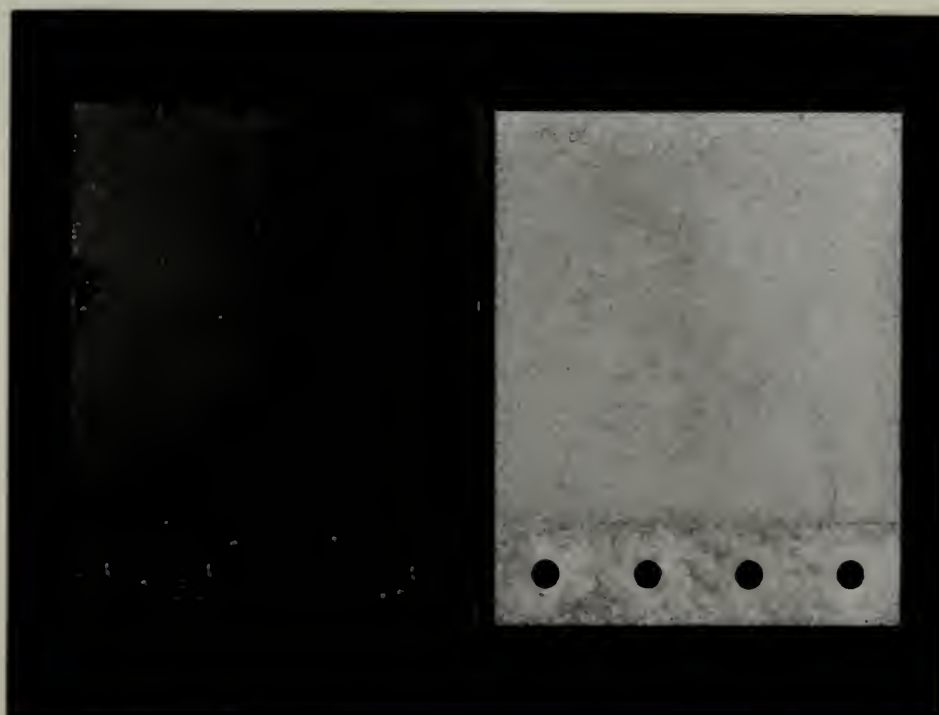
Figure 12 shows the extent of corrosion on the types 321 and 410 steels that were coupled together. There was no corrosion at the fastener contact areas on the type 321 steel member, but there was some slight pin hole attack at the faying surface. There was pitting corrosion at the fastener contact areas on the type 410 steel specimen which was more severe where the type 18-8 stainless steel nuts made contact than where contact was made with the 17-4 PH steel bolts. Pitting was more severe at the faying surface on this member than at the exposed surfaces.

Shallow pitting was noted on the contact surfaces of the 17-4 PH steel fasteners coupled with the type 321 steel member. The 17-4 PH steel fasteners coupled with the type 410 steel were stained at the washer face contact areas. No corrosion was observed at the contact areas of the type 18-8 stainless steel alloy nuts.

Figure 12. Surface appearance after 39 1/2 months exposure in the marine atmosphere and after disassembly and cleaning of types 321 and 410 stainless steel alloy specimens that had been coupled together. (a) and (b) are the skyward and earthward exposure surfaces, respectively, of the type 321 steel specimen and (c) and (d) are the earthward and skyward exposure surfaces, respectively, of the type 410 steel specimen. There was no corrosion at the fastener areas on the exposed surface of the type 321 steel, but there was some slight pin hole surface attack at the faying areas. Rings at bolt hole areas are scoring marks introduced by the bolt and nut washer faces and by tools used to install and remove the fasteners. Corrosive effects were noted at the fastener contact areas on the type 410 steel specimen. This attack in the form of pitting was more severe at the 18-8 stainless steel nut contact areas than at the 17-4 PH steel bolt contact areas. Pitting occurred generally at the faying surface and was more severe here than on the exposed surfaces. X 1/2

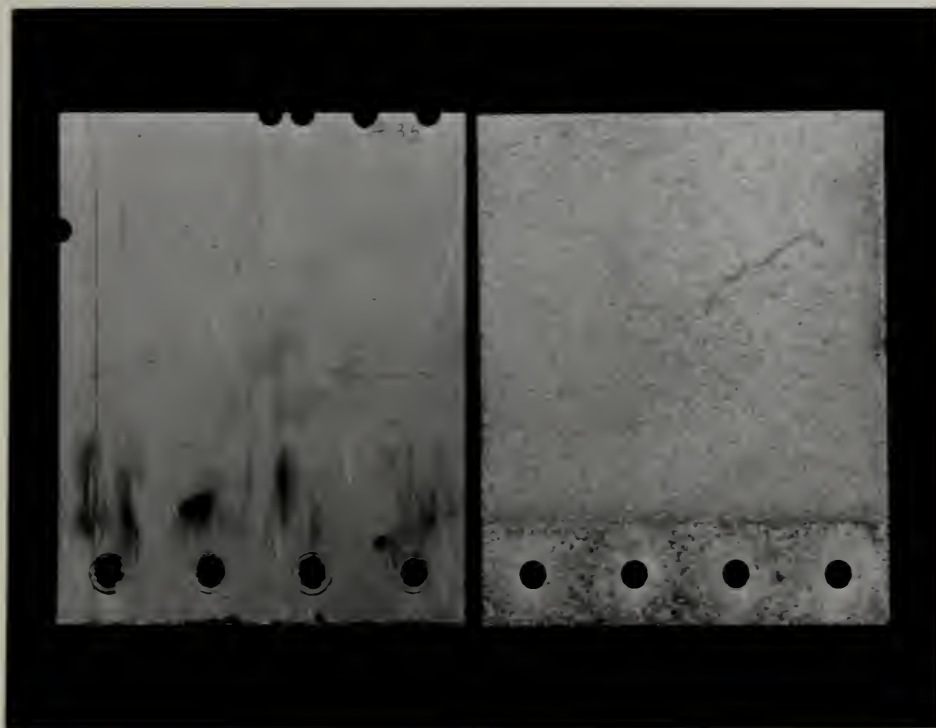
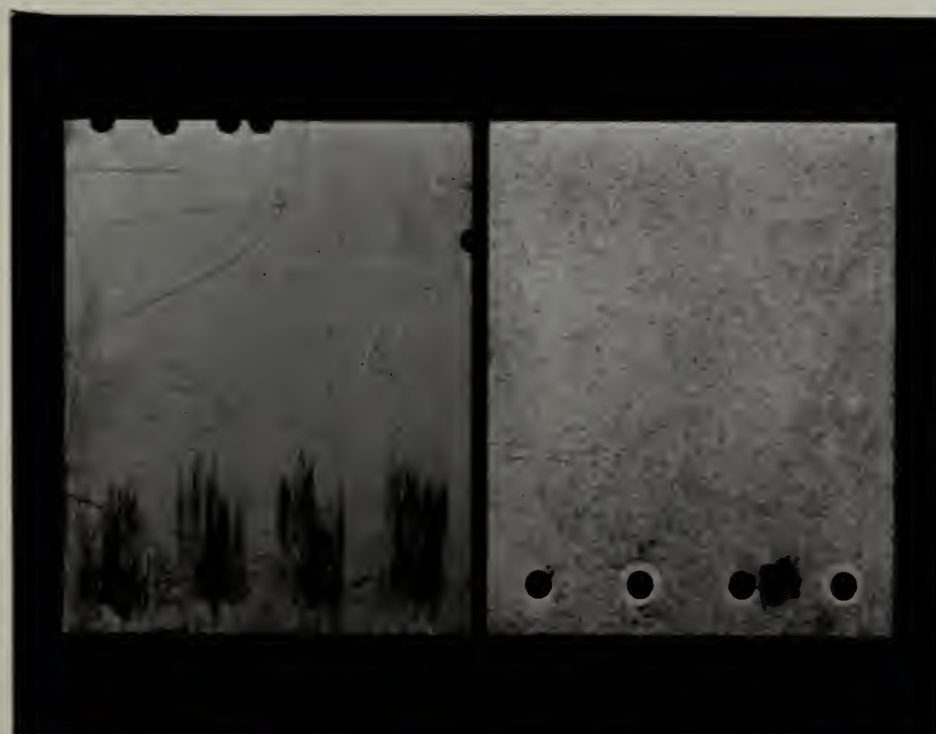
Figure 13 shows the surface appearance of the types 302 and 410 steel specimens that were coupled together. There was no corrosion at the fastener contact areas on either member. However, there was some local pitting at the faying surface of the type 302 steel member and severe attack at the faying surface of the type 410 steel member. The attack at the faying surface on the type 410 steel

member was more severe than at exposed areas.

Shallow pitting at the washer face contact areas was noted on the 17-4 PH steel fasteners that were coupled with both the types 302 and 410 steel members. The pitting was of a more general nature than that observed on the other fasteners previously cited. There was no corrosion damage on any of the type 18-8 steel nuts coupled with either member.

Figure 13. Surface appearance, after 39 1/2 months exposure in the marine atmosphere and after disassembly and cleaning, of types 302 and 410 stainless steel specimens that had been coupled together. (a) and (b) are the skyward and earthward surfaces, respectively, of the type 302 steel and (c) and (d) are the skyward and earthward exposure surfaces, respectively, of the type 410 steel member. There was no corrosion at the fastener contact areas on the exposed surface of the type 302 steel specimen, but there was some pitting attack at the faying area. Rings at fastener contact area are scoring marks introduced by the bolt and nut washer faces and by tools used to install or remove the fasteners. There was no pitting corrosion at the fastener contact areas on the type 410 steel. The faying surface of the type 410 steel was pitted more severely than the exposed surfaces. X 1/2

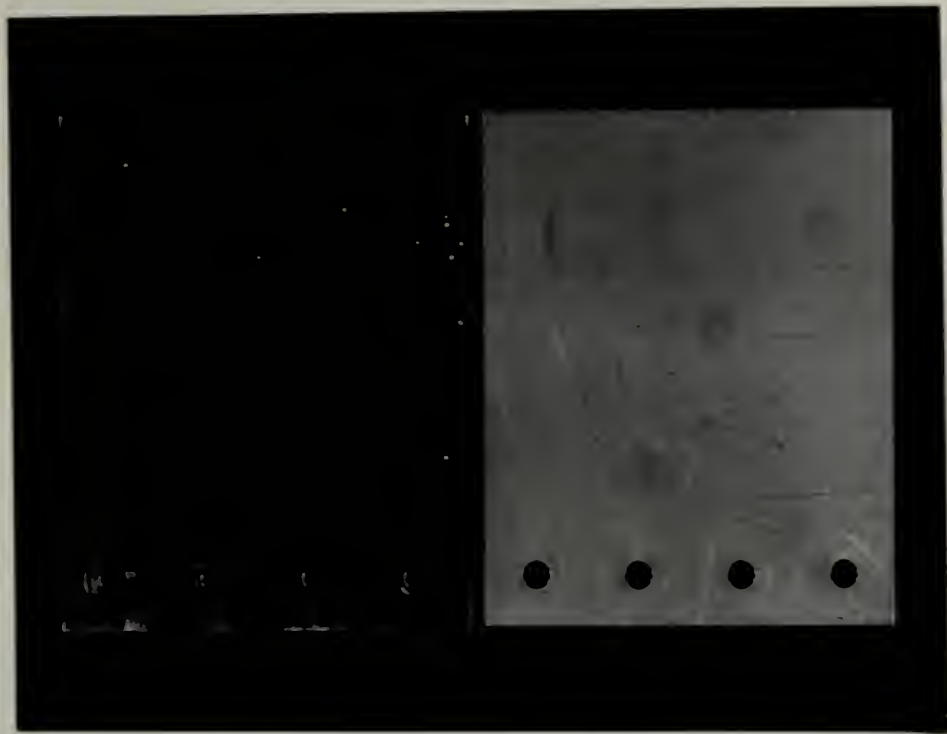
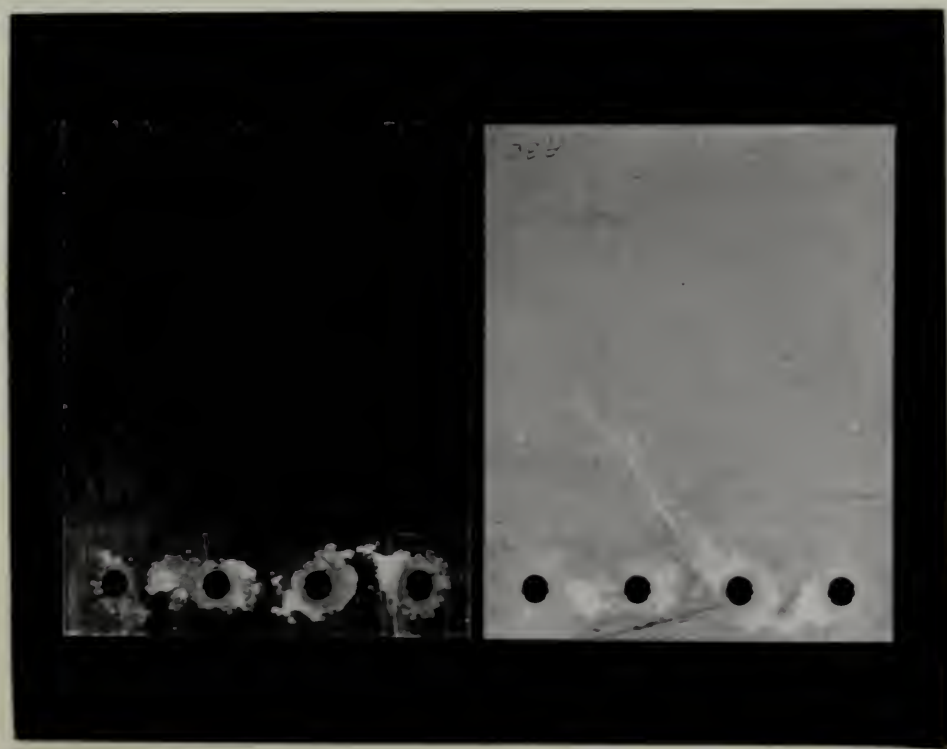
The surface appearance of the types 321 and 302 steel members that were coupled together is shown in Figure 14. There was no corrosion at the fastener contact areas on either member. Evidence of concentration cell corrosion was noted at the bolt hole areas on the faying surfaces of both specimens. The attack was more severe on the type 321 steel specimen in that surface cracking was noted in these areas. One of these areas is shown in Figure 15. The path of the cracking at the surface was in a direction that was predominantly concentric with the bolt holes and 1/8 to 3/16 inches from the bolt hole base.

Figure 14. Surface appearance, after 39 1/2 months exposure in the marine atmosphere and after disassembly and cleaning of types 321 and 302 stainless steel specimens that had been coupled together. (a) and (b) are the skyward and earthward exposure surfaces, respectively, of the type 321 steel and (c) and (d) are the earthward and skyward exposure surfaces, respectively, of the type 302 steel member. There was no corrosion at the fastener contact areas on either specimen. Rings at bolt hole areas are scoring marks introduced by the bolt and nut washer faces and by tools used to install or remove the specimens. Evidence of concentration cell corrosion was noted at the bolt hole areas at the faying surfaces of both specimens. The attack was more severe on the type 321 steel specimen in that surface cracking was noted in these areas. X 1/2

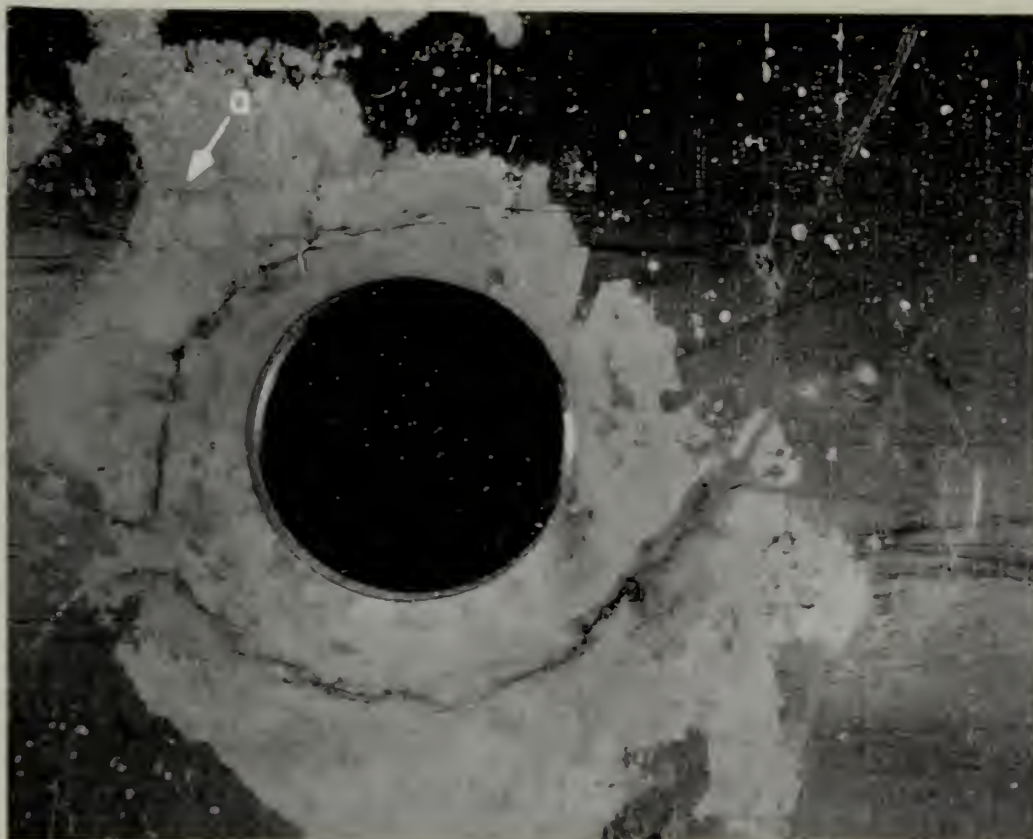
Other areas on the type 321 steel specimen, one of which is shown at arrow a in Figure 15, showed evidence of the metal surface erupting from corrosion below the surface.

Figure 15. Example of surface cracking observed at the bolt holes on the faying surfaces on the type 321 steel specimen that was coupled with a type 302 steel specimen. Arrow a denotes area where an eruption at the surface was noted. X5

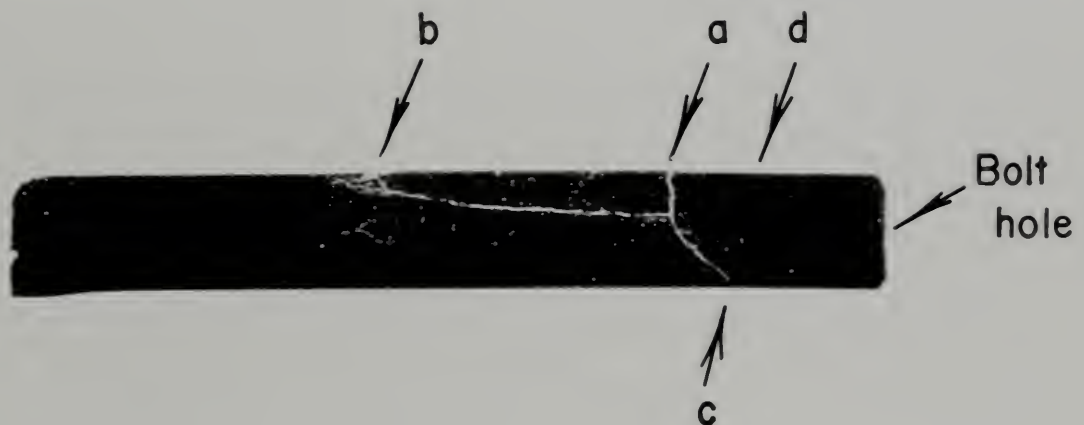
Metallographic examination of a section cut from one of the bolt hole areas, that included both modes of cracking, revealed that the concentric cracking propagated from a pitted area on the surface, arrow a, Figure 16, to a depth of approximately 0.02 inches at which point it branched. One branch progressed in a direction nearly parallel with the surface, and then curved back toward the surface, emerging at the area designated by arrow a in Figure 15 and by arrow b in Figure 16. The propagation of the other branch was in a direction toward the opposite surface (exposed surface) to a point which was nearly coincidental with the periphery of the type 18-8 stainless steel nut washer face (arrow c in Figure 16). However, this crack did not penetrate to the surface. Additional surface cracks were noted at the area designated by arrow d in Figure 16. These faying surface cracks were directly opposite the periphery of the type 18-8 stainless steel nut washer face on the exposed surface.

The nature and paths of the cracks observed indicate the presence of high tensile stresses at areas on the faying surface adjacent to similar areas at the periphery of the fastener washer faces on the exposed surface. The stresses were most likely induced by the pressure exerted from the exposed surface when the fasteners were tightened prior to exposure. The entrapment of salt laden moisture from the atmospheres at the faying surface and the apparent cathodic nature of the type 302 steel member of the couple resulted in the formation of a galvanic cell which initiated local pitting corrosion. The combination of high surface tensile stresses and the corrosive effects at the faying area resulted in the surface cracking or stress corrosion failure observed..

Figure 16. Photomacrograph of a section cut from the bolt hole area of a 321 stainless steel alloy specimen that had been coupled with a 302 stainless steel alloy specimen. Arrow a denotes the pitted area where circumferential cracking occurred adjacent to the bolt hole. Arrow b shows the area at arrow a in Figure 6 where eruption of the surface occurred and arrow c is at the periphery of the bolt or nut washer face. Arrow d denotes area where other cracks were observed. Unetched. X10

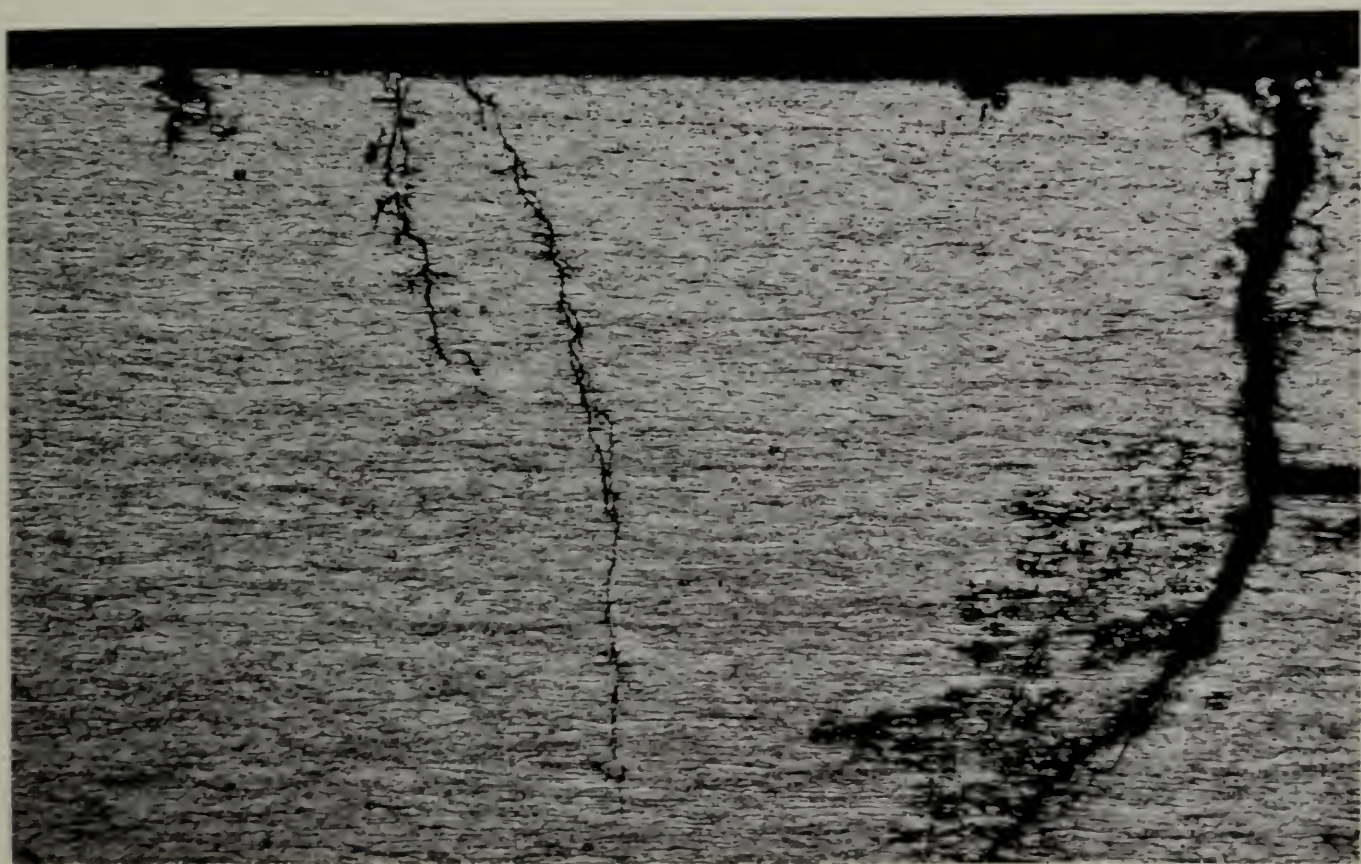
Metallographic examination of the section after repolishing and etching showed that the cracks were predominantly transgranular, Figure 17.

Figure 17. Photomicrograph of a portion of the section shown in Figure 16. Large cracks on right hand side are those whose origin were at arrow a in Figure 16. Tighter cracks toward center are those whose origin were at arrow d in Figure 16. Cracking is predominantly transgranular. Reversal of this photograph is due to the nature of the metallograph used. Etched with HCl and FeCl₃. X100
