NATIONAL BUREAU OF STANDARDS REPORT

9588

Examination of
A Cracked 4¢ Lincoln Stamp Printing Plate

Electrolytic Section
Bureau of Engraving and Printing

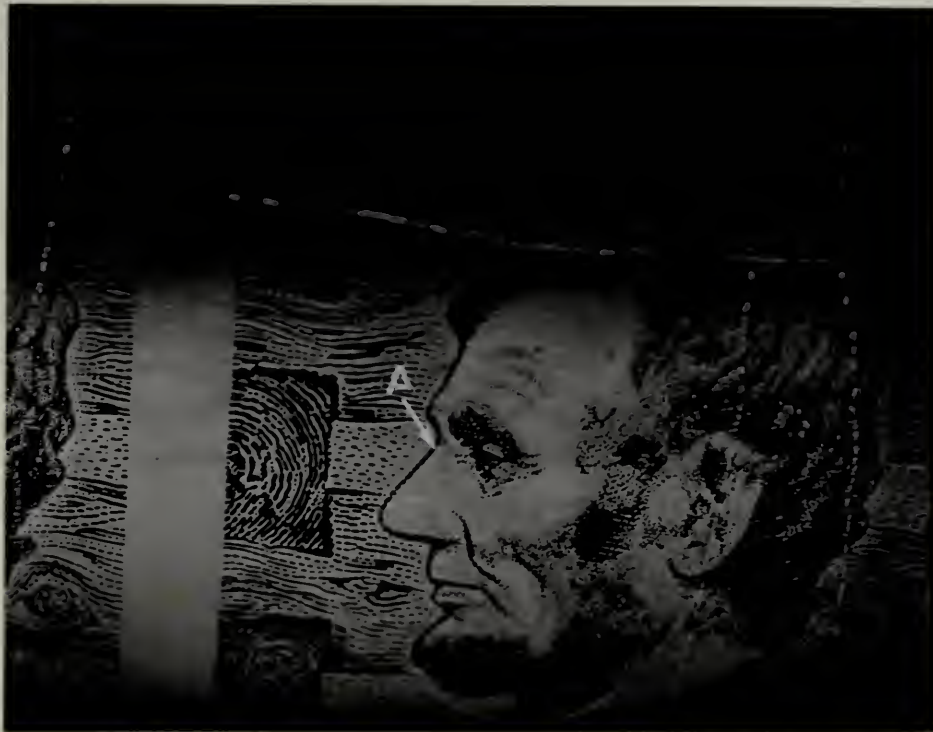
On April 12, 1967 a portion of a 4¢ Lincoln stamp plate was submitted to the Metallurgy Division, National Bureau of Standards for examination. This plate contained a number of fine cracks, barely visible to the unaided eye. A magnified view of one area containing these cracks is shown in figure 1. Additional magnification, figure 2, indicates that the cracks started in the small depressions which form the contours of the Lincoln image.

Figure 1. Surface of the plate in the cracked area. X 5.
Location of one crack is indicated by A.

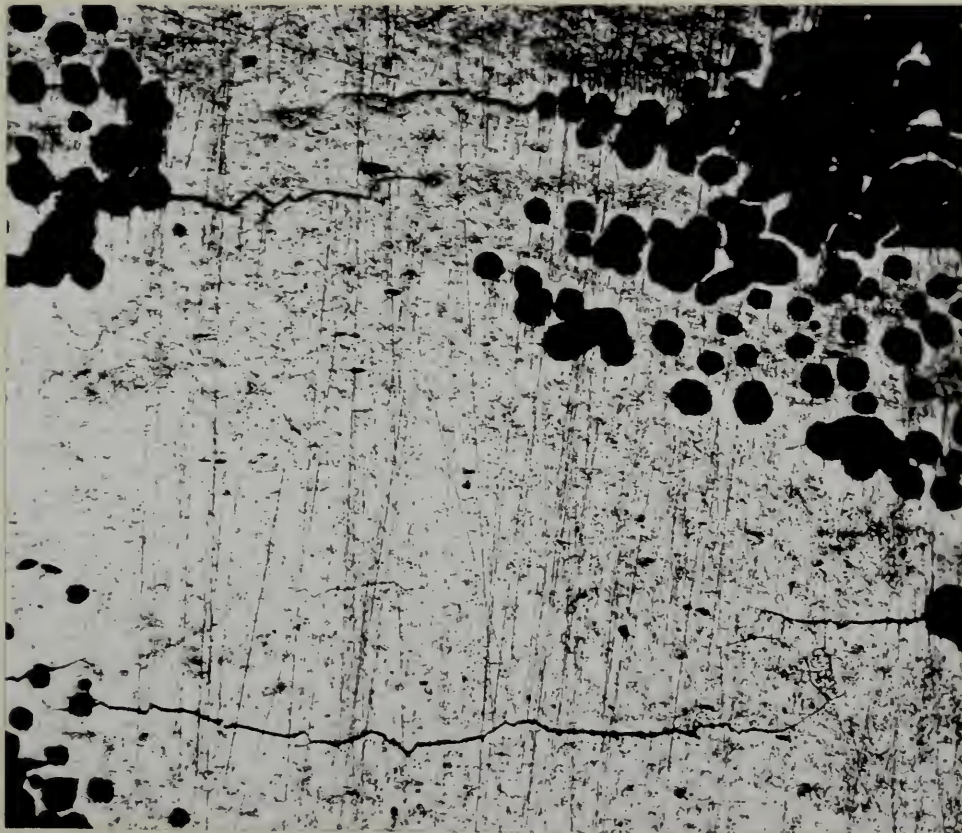
Figure 2. Surface of the plate showing cracks. X 50.

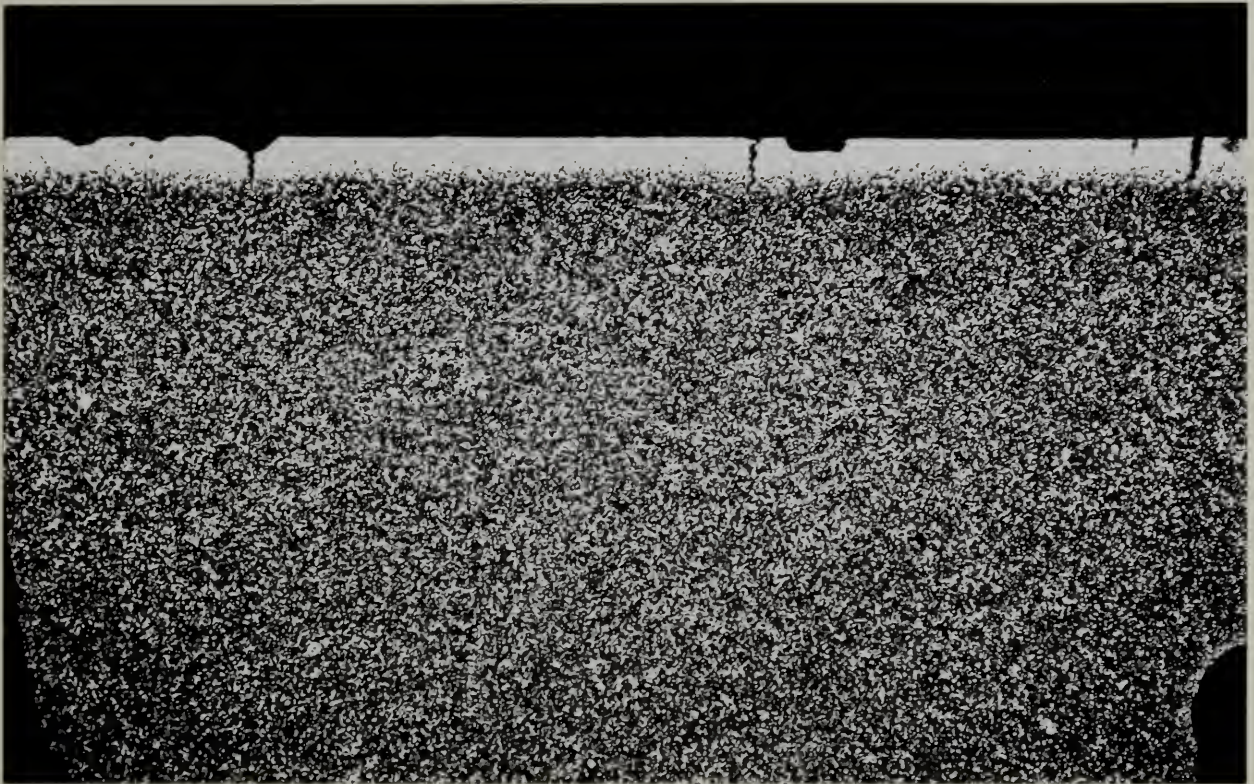
Another section containing cracks, designated area 1, was removed and prepared for metallographic examination in cross section. The area selected, figure 3, shows one crack starting at or propagating through a small depression and two other cracks in a flat area of the plate. The white layer shown in figures 3 and 4 is essentially all martensitic and very hard, the underlying black and white area is a softer slack quenched structure containing pearlite and some martensite. This duplex structure is normal for case hardened steels of this type and has been observed many times in past investigations. It is interesting to note that the cracks penetrated into the plate only as far as the slack-quenched structure, where the superior ductility of this softer structure provided an effective barrier.

Figure 3. Microstructure of plate showing cracks in martensitic case. X 50.

The slightly high hardness found in the cross section of the plate away from the gripper slots indicates a lower degree of ductility and higher notch sensitivity than may be desirable. This condition could contribute to cracking either during fitting or during the printing operation. It is hoped that this type of failure is an isolated case which will not occur again. If it should, steps should be taken in the heat treating process to lower the final hardness levels. This could be done by adjusting either the hardening or tempering procedure.

The high hardness encountered in the areas of the gripper slots was unexpected but can be explained as being due to the faster cooling rates on quenching experienced in the areas of reduced plate thickness. Any bending of these areas after hardening would be particularly subject to cracking, and should be avoided wherever possible. It would not be practicable to reduce the hardness in the slotted areas to that of the over-all plate, but the same treatment applied to the entire plate to reduce hardness slightly would be beneficial in the gripper slot area also.

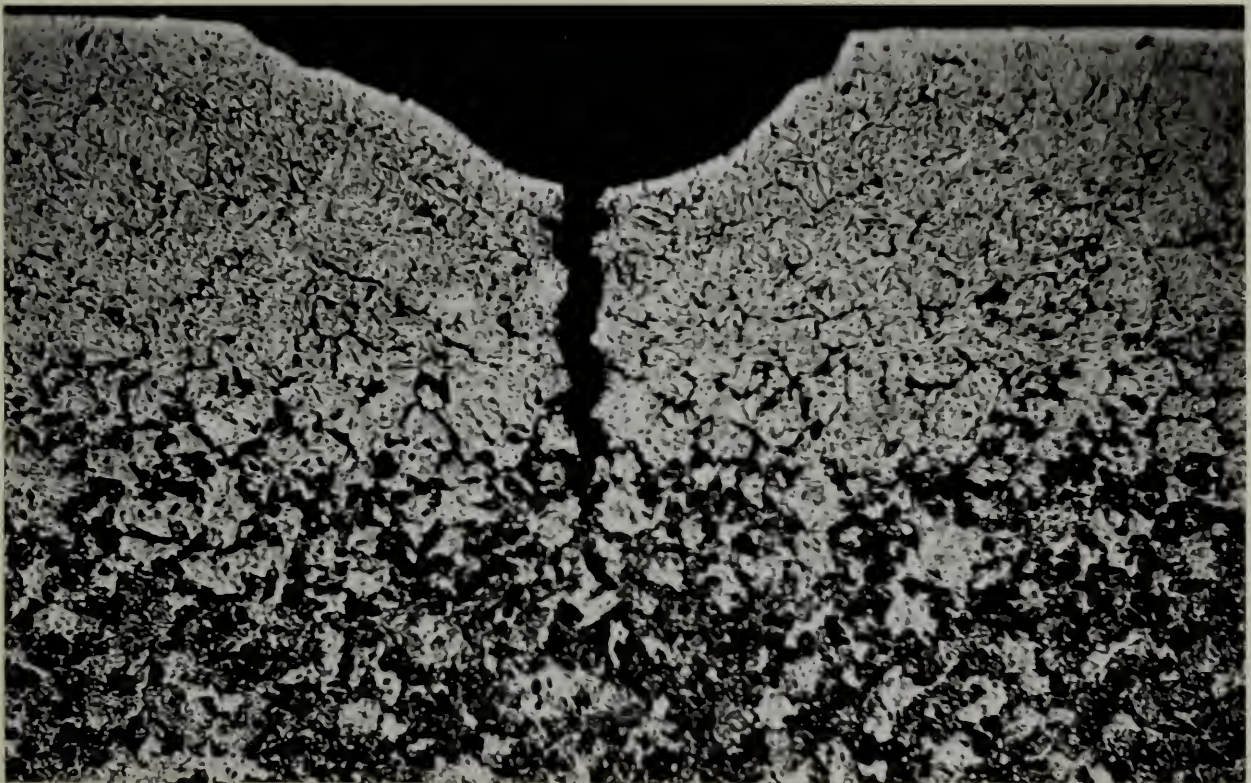
Figure 4. Microstructure of plate showing crack in martensitic case. X 500.
