NATIONAL BUREAU OF STANDARDS REPORT

9829

EXAMINATION OF STOCK POD SECURITY CHAIN

W. F. Gerhold
Engineering Metallurgy Section
Metallurgy Division

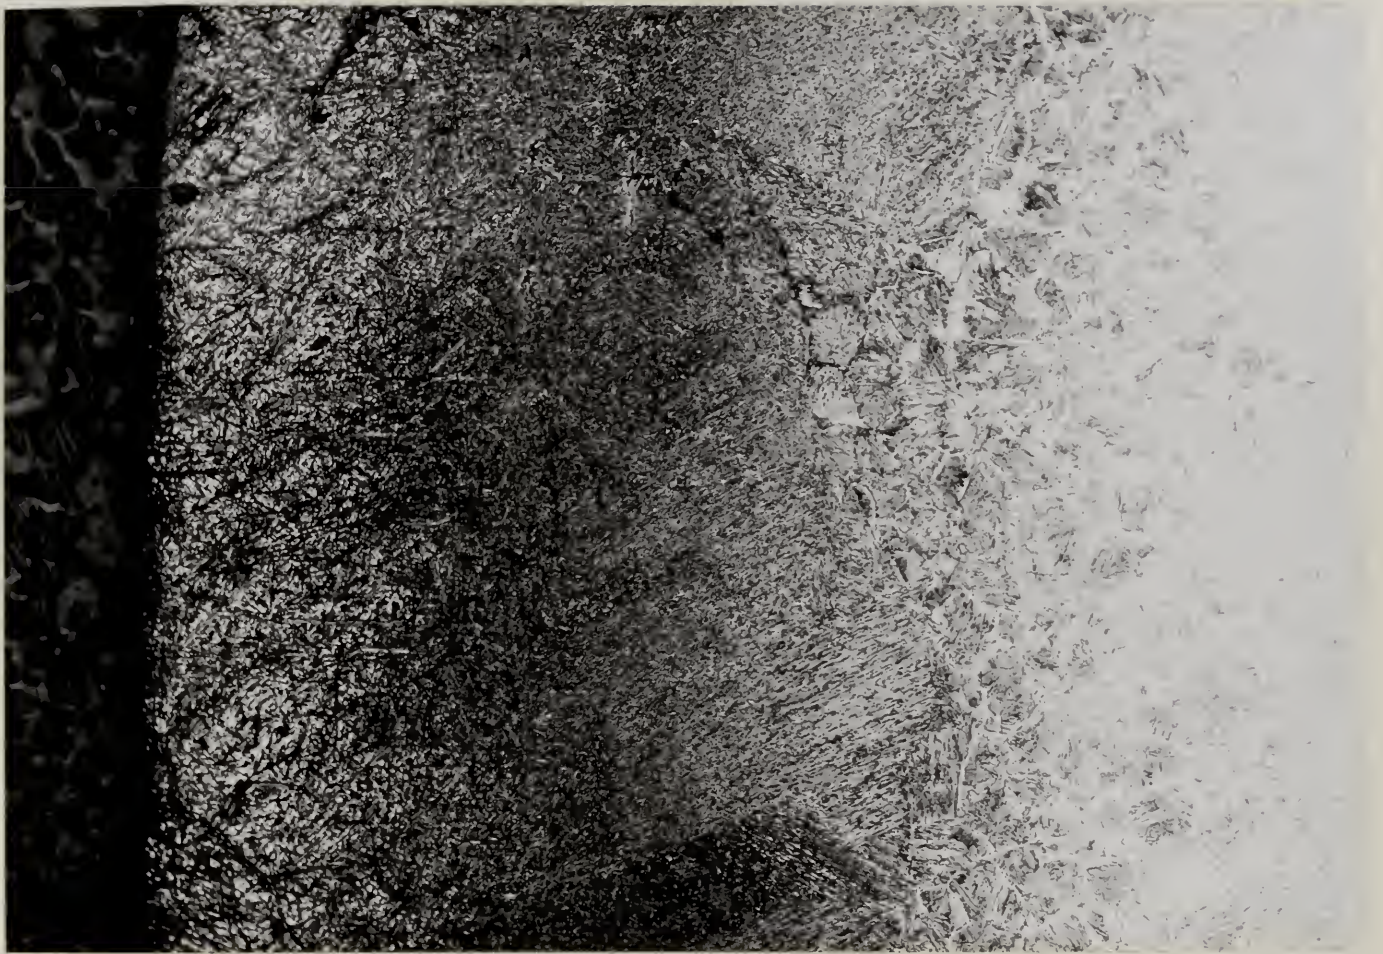
Metallographic Examination and Hardness Tests: One link was sectioned and prepared for metallographic examination. The depth of the carburized case was found to be approximately 0.04 inch. Figure 1 shows the gradation of the carbon penetration from the outer edge, where it is at a maximum, to the core where it approaches the carbon content of the carbon steel used in the fabrication of the chain. Examination of the microstructure at a higher magnification (figure 2) revealed the following microstructural conditions:

Figure 1. Microstructure of a section from a stock POD security chain link. Carburized case is approximately 0.04 inch thick. Photomicrograph shows the gradation of the carbon penetration from the outer edge (darker area) where it is at a maximum to the lighter etching core area where it is at a minimum approaching the carbon content of the core. Etched with nital. X 100.

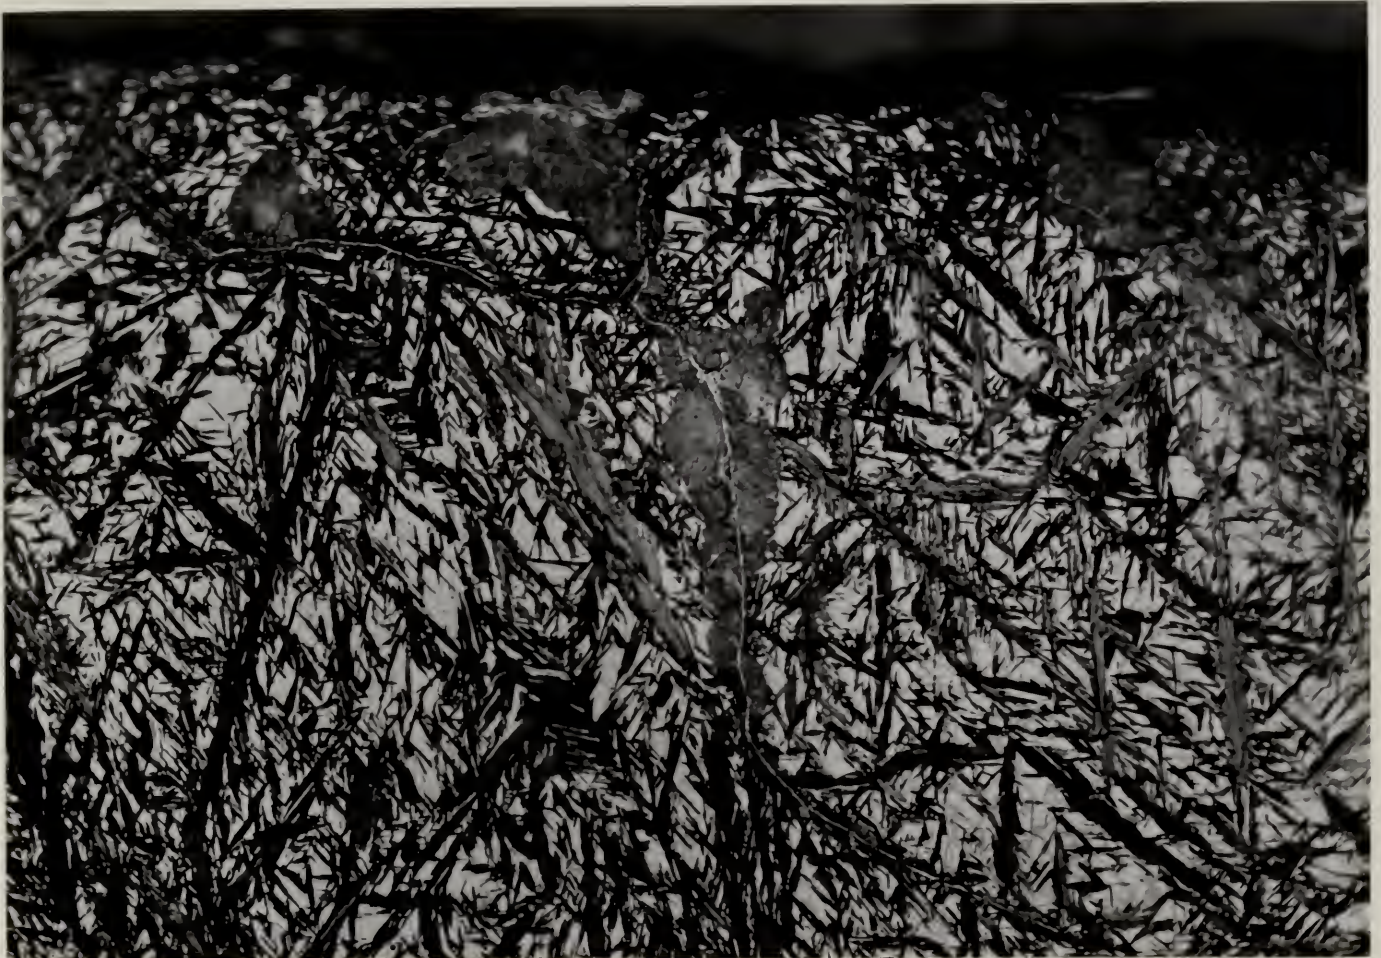
- a. Tempered martensite plates (dark needlelike structures).
- b. Untempered martensite (light gray areas).
- c. Nodular pearlite (dark gray areas).
- d. Cementite at the grain boundaries.
- e. Large prior austenitic grain size as indicated by the size of the tempered martensite plates and the boundaries outlined by cementite.

This structure, because of conditions b, d, and e above, would tend to be brittle. We believe it was produced by quenching the chain directly from the carburizing temperature without a subsequent tempering treatment. The long length of time or high temperature required to carburize to a 0.04 inch depth would have produced the large austenite grains. A delay in quenching or cooling at a rate less than the critical cooling rate could produce cementite boundaries and pearlite. The darkened martensite plates indicate that the initial martensite was formed at high temperatures and was tempered during the cool down, rather than during a subsequent tempering treatment. The fact that the smaller martensitic areas appear untempered indicates that no adequate tempering treatment was applied after cool down.

Figure 2. A portion of the area shown in Figure 1 showing the following conditions: (a) tempered martensite plates (dark needlelike structures), (b) untempered martensite (light gray areas), (c) nodular pearlite (dark gray areas), (d) cementite at the grain boundaries and (e) large prior austenitic grain size as indicated by the size of the tempered martensite plates and the boundaries outlined by cementite. Etched with nital. X 500.

However, it was determined that the stock chain was susceptible to failure due to the extreme brittleness of the carburized case. In order to improve the ductility without decreasing the hardness, it is recommended that the chain be given an additional heat treatment after carburization. This should consist of reheating to a temperature of 1425°F, holding at this temperature for one-half hour and then quenching immediately in water. Care should be taken to prevent surface decarburization. Hardening should be followed by tempering at 350°F for 1 1/2 hours.

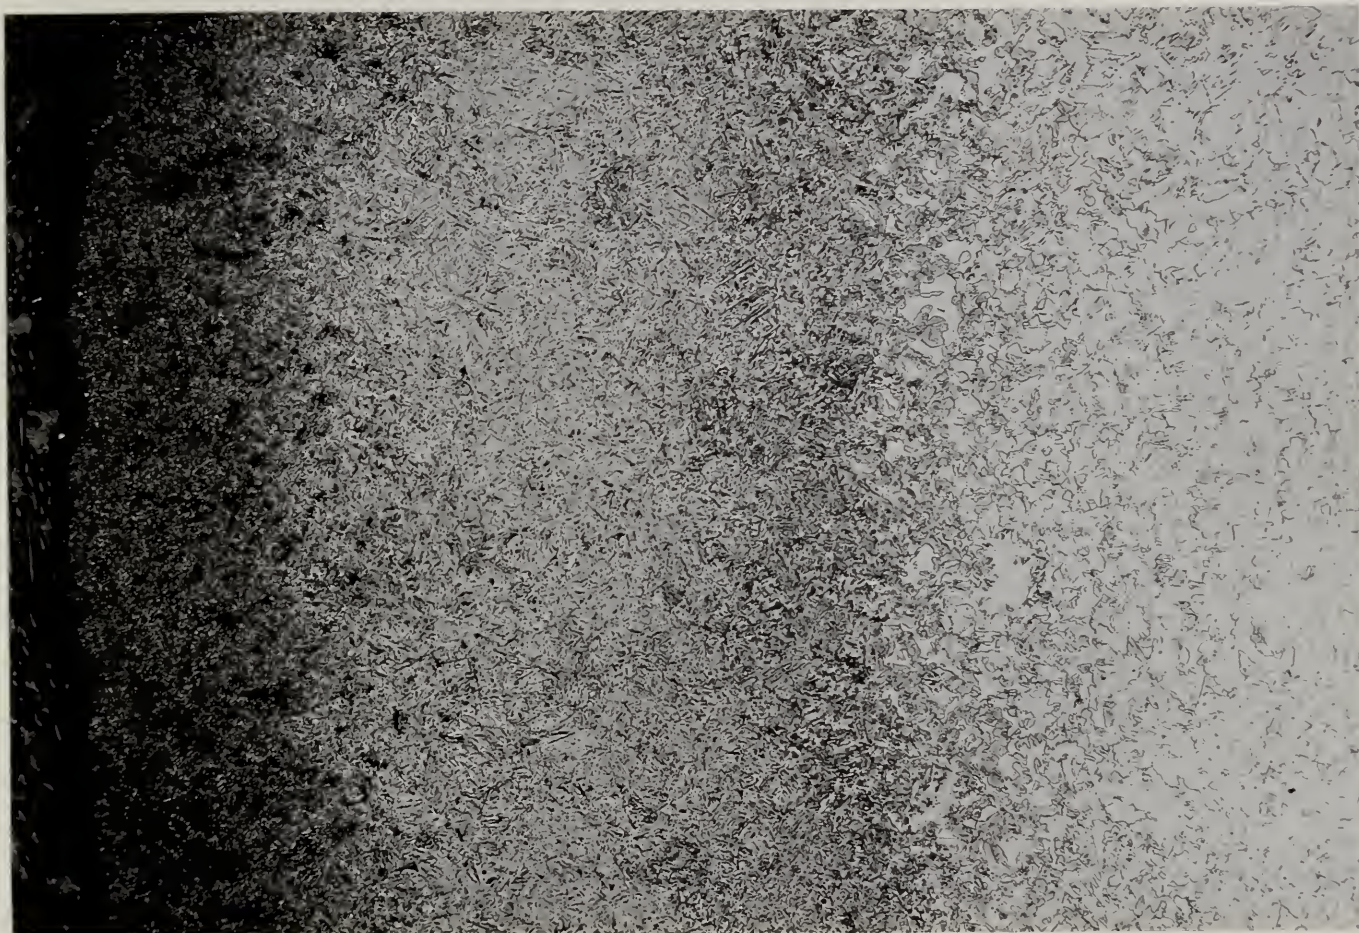
Metallographic examination of the case in a section cut from one of the specimens (figures 3 and 4) revealed that the grain had been refined considerably, with the result that all martensite present had fine plate size. There was no evidence of cementite at grain boundaries; instead it was dispersed as fine spheroids. Nor was there any trace of pearlite. All of the martensite appeared uniformly tempered. A comparison of figures 2 and 4, both at the same magnification, strikingly reveals the improvement brought about in the structure by this heat treatment. Microhardness determinations were obtained for comparison with those obtained for the stock POD security chain. The hardness at the surface was R_C 63-64. This is sufficiently hard to resist the abrasive action of a file.

Figure 3. Microstructure of stock POD security chain after (1) reheating to 1425°F for 20 minutes and water quench and (2) tempering for 1 1/2 hours at 350°F and air cool. Matrix of carburized case is tempered martensite with some small particles (not visible at this magnification) of Fe₃C. Core matrix is ferrite with some pearlite. Etched with nital. X 100.

Reheating, Hardening and Tempering: Since the results obtained from the above tests and examinations showed that the carburized case was excessively brittle, an experiment was conducted to determine if additional heat treatment would improve the ductility of the case without significant decrease in hardness. Specimens were stripped of the zinc coating by immersion in a 1:1 hydrochloric acid solution, rinsed and dried. They were then heated to 1425°F for 20 minutes, quenched in water, tempered for 1 1/2 hours at 350°F and air cooled.

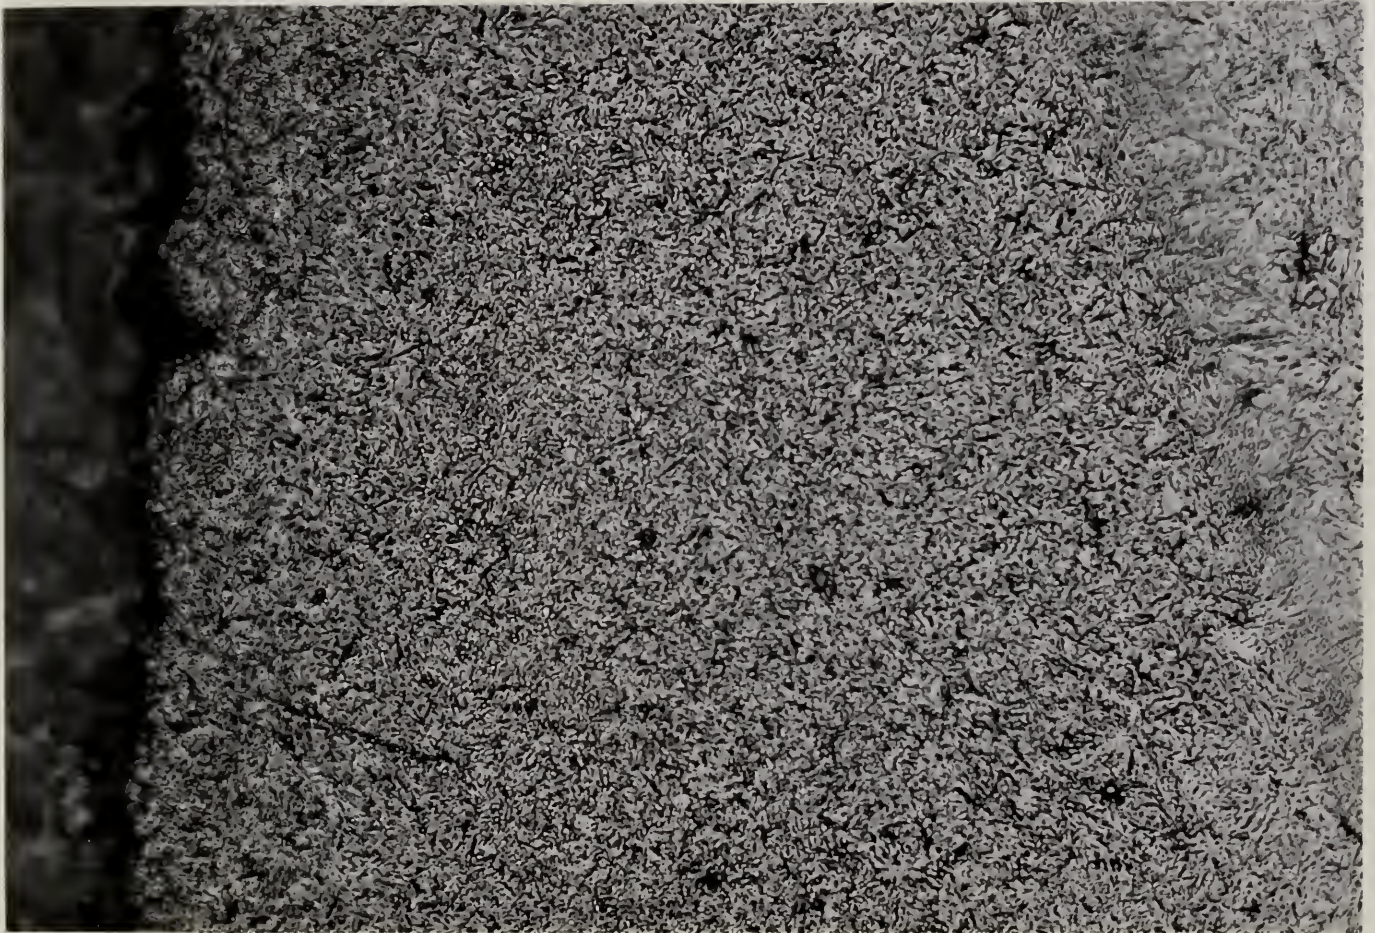
Figure 4. Portion of carburized case area of stock POD security chain after additional heat treatments noted in Figure 3. Grain size is very fine. Spherodized particles of Fe_3C are scattered throughout the martensite matrix. Etched with nital. X 500.
