EXAMINATION OF FAILURE OF  
PRINTING PLATE, NO. 29724

I. J. Feinberg  
Engineering Metallurgy Section  
Metallurgy Division

Electrolytic Section  
Bureau of Engraving and Printing  
Washington, D. C.

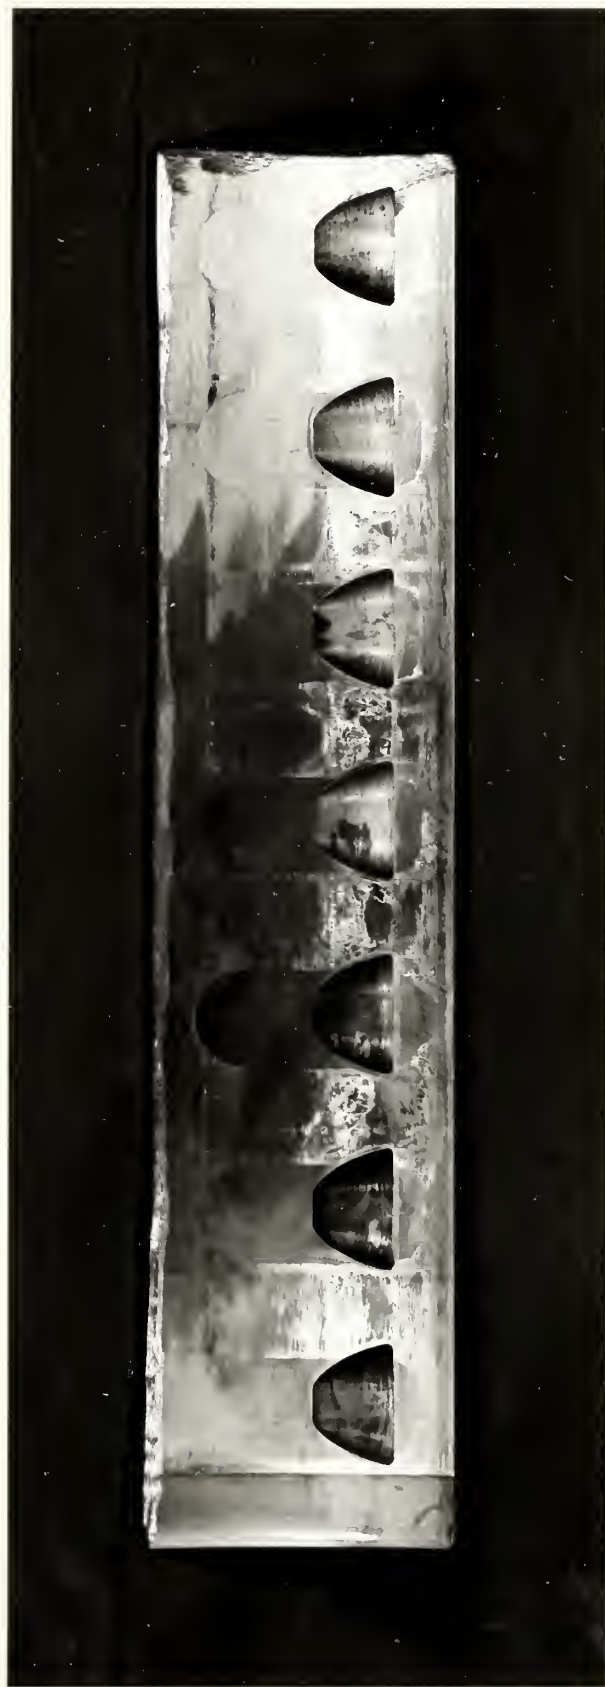
1. The chafing of the plate adjacent to the cracks (Figures 1 and 2) indicates cyclic stressing that could have been caused by improper seating of the plate on the drum in this area. The stressing involved repeated bending along a line parallel to the base of the gripper slots.
2. The deep tool marks in the gripper slots and the sharp corners of the gripper slots (Figures 1 and 2) are objectionable features. They are heterogeneities creating stress concentration and could be sites for crack initiation and/or propagation.
3. The hardness of the reverse surface of the plate ( $R_C$  47) and of the case adjacent to the crack ( $R_C$  44-48) are slightly high. This is based on a review of the hardness of previously examined plates that had a lower hardness and were satisfactory.

Figure 1. Reverse of plate section cut from plate no. 29724. X 1

3. Feather edges of the gripper slots all-around and avoid leaving deep tool marks in the slots and on the over-all reverse face of the plates.
4. Ensure close fitting of the plate on the printing drum to reduce bending or cyclic stressing during rotation of the plate.

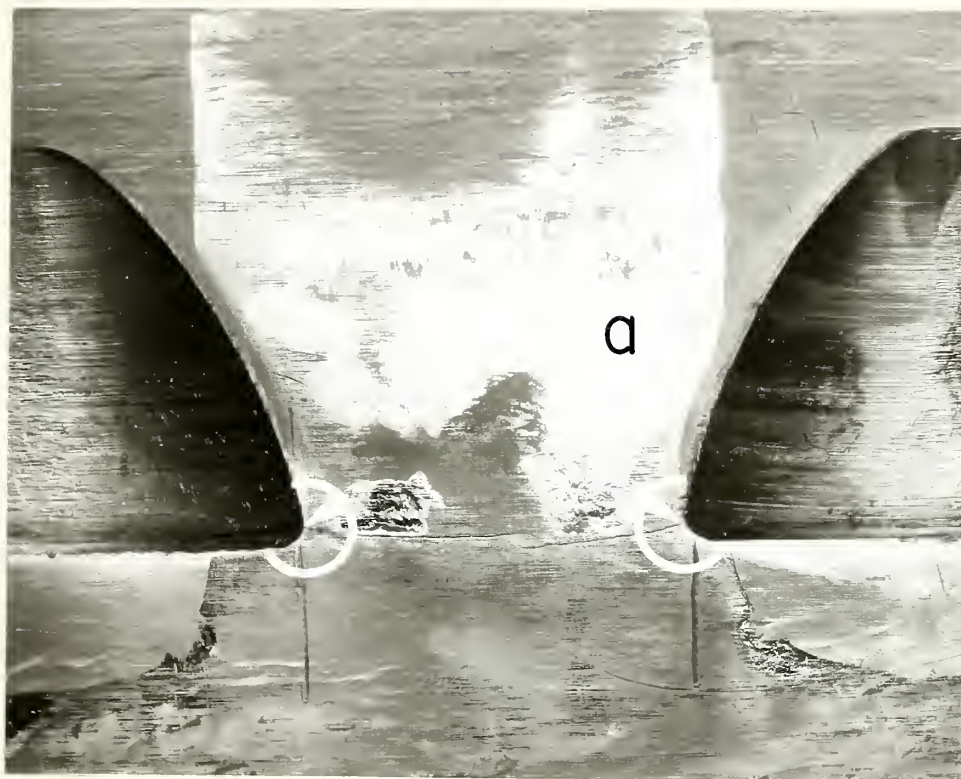
Cracking of the subject plate resulted from fatigue fractures apparently initiated at the slot corners which had a "built-in" notch. It appears that the hard case combined with the sharp corners of the slots was an immediate factor in crack initiation. It is well known that a hard case has low plastic properties and is particularly notch sensitive. Fatigue cracks were initiated in the case as the result of cyclic bending stresses that

Figure 2. Enlarged view of a section of the plate sample shows cracks propagating from slot corners. Arrows point to probable crack origin. Area a, is a highly reflective surface resulting from chafing of the plate on the drum. Note the deep tool marks in the gripper slots and the sharp edges of the slots adjacent to the cracks. Grinding generous fillets in the encircled slot corners to reduce possibility of crack initiation at these points is recommended. X 4

1. Gripper slot separation, size, and depth in future plates should be the same as that in plates that proved to be satisfactory.
2. Introduce fillets at the corners of the base of the gripper slots (encircled areas, Figure 2). These fillets may be made by first drilling 3/16 inch diameter holes to a depth of approximately 0.075 inch in the reverse face of the plates where the slot corners are to be located, or by other suitable techniques. All sharp edges resulting from drilling and subsequent machining of slots should be removed.

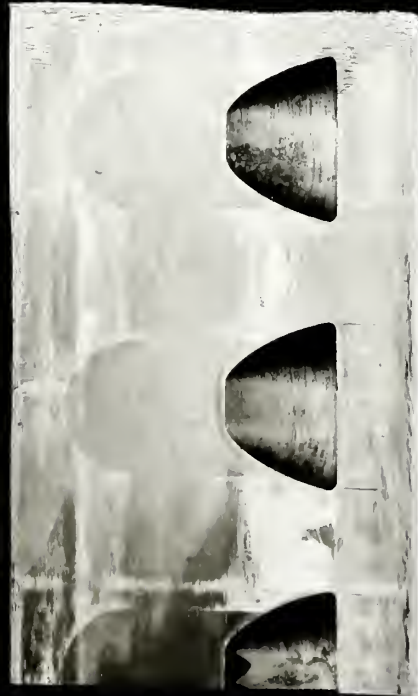
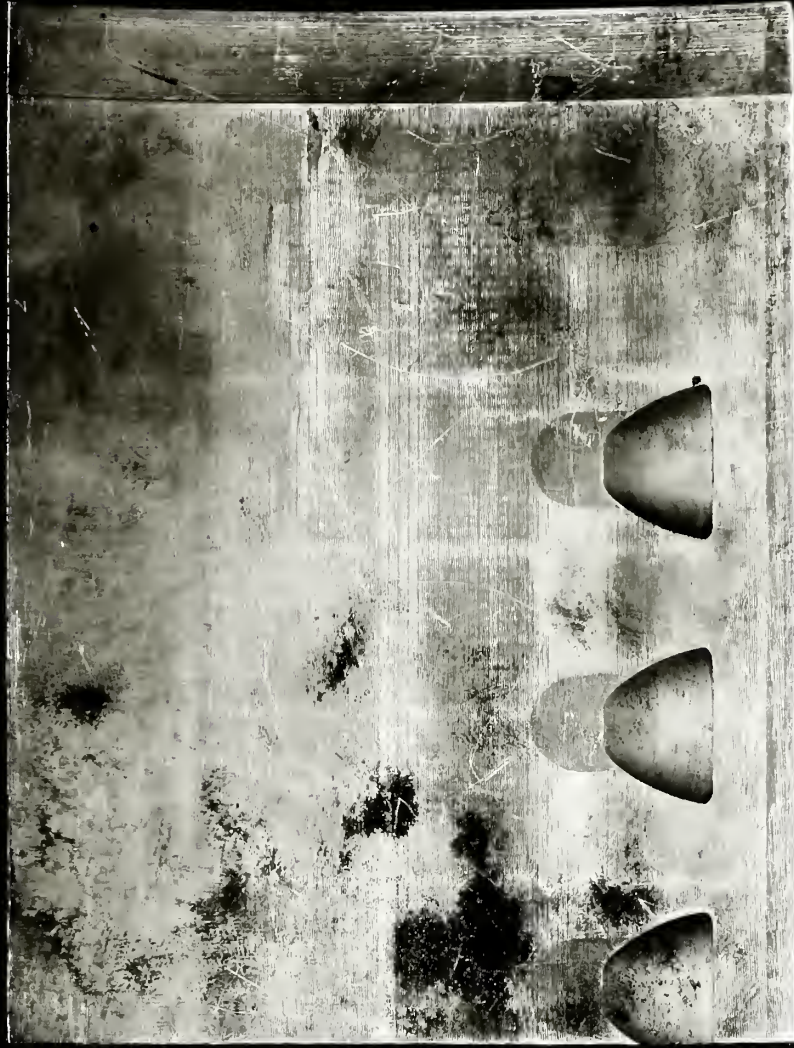
These dimensions show appreciable deviations from intended slot separation and from intended slot base length in both plates. As a result of these deviations and because the Roosevelt plate is thinner, the net material section area between slot corners is approximately 8 per cent less in the Roosevelt plate. The Roosevelt plate is also approximately 10 per cent thinner in the slot areas. Interestingly, the Lincoln plate did not crack at the slot corners as did the Roosevelt plate. Because the overall thickness of the Roosevelt plate is less than the Lincoln plate, and the steel under the gripper slots is substantially thinner, the cooling rate during a quench from 1550°F would be greater in the Roosevelt plate. This would produce a slightly higher hardness than previously observed in other plates, and in particular, the hardness in the vicinity of the gripper slots would be higher. Less available material to resist cyclic bending and higher hardness at the notch corners could produce an unfavorable combination that would accelerate the formation of fatigue cracks.

In comparison with a previously examined plate that did not fail in service, gripper slot separation in the subject plate was found to be closer and slot walls thinner. These conditions weakened the plate. The first condition increased the unit stress in the area between slots under the loading imposed. The second condition created an area that became excessively hard in heat treatment.

Figure 3, a Section cut from subject Roosevelt 4 cent plate that did not crack in gripper slot area.

Figure 3, b Section cut from subject Roosevelt 6 cent plate that did not crack in gripper slot area.

Note that slot separation is less and that slot size and depth are greater in the Roosevelt plate. X 1

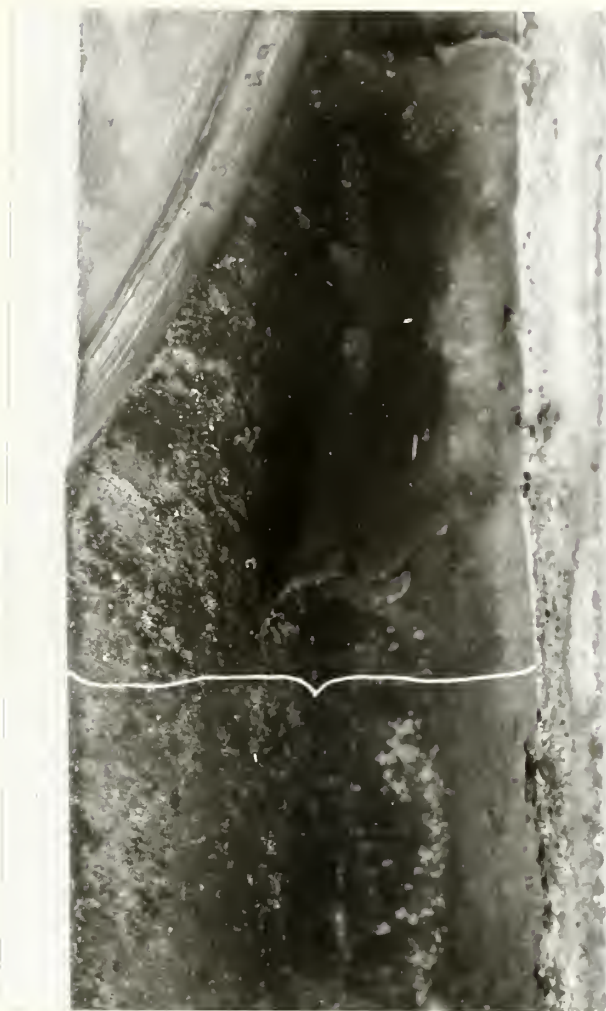
Figure 4 is a view of a typical fracture surface. This surface was revealed when a cracked section was opened. The thin bright fracture surface area resulted from completion of the fracture in the laboratory. The arrow in Figure 4 points to the apparent crack origin which is located at a point where there is a change in section thickness that could cause severe stress concentration. The dark area has a smooth portion adjacent to the origin and appears to be a fatigue fracture surface. This surface was darkened by corrosion products.

put the reverse face of the plate in tension. These bending stresses resulted from repeated loading and unloading occurring in rotation of the plate during printing. It appears that the tool marks in the slots contributed to crack propagation. Darkening of the fatigue fracture surface is evidence that corrosive oxidation also occurred.

Figure 4. Fracture surface of failed printing plate. Arrow points to apparent origin of crack and direction of propagation. The surface is typical of that resulting from fatigue. The depth to which the crack propagated is bracketed. X 4

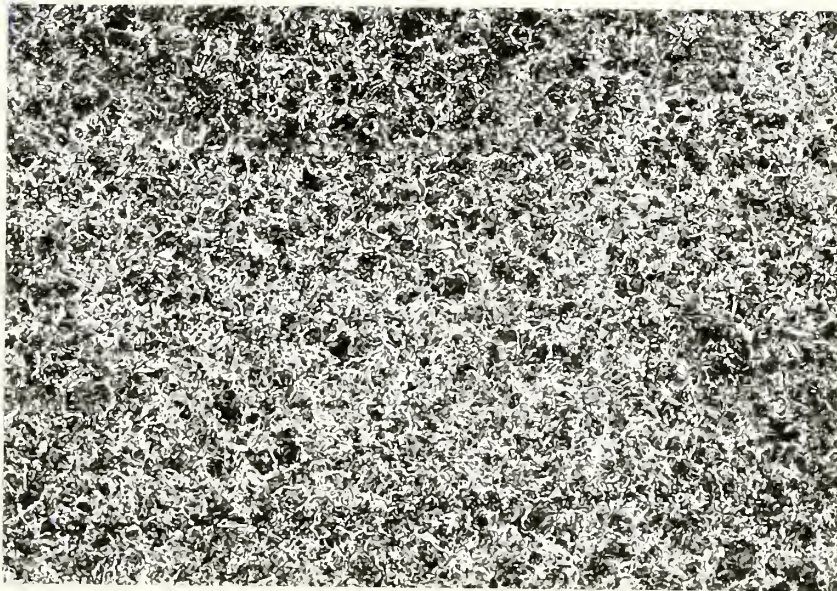
No evidence of ferrite banding was observed in a longitudinal section of a core area, Figure 6. The fine-grained structure exhibited has a grain size rating of 8 using ASTM Designation E 112 as a reference. Figure 7 shows the microstructure of a longitudinal section adjacent to the crack mouth. There are no indications of decarburization adjacent to the surface. The case shown is predominantly martensitic and is approximately 0.0015 inch deep. The core is composed of partially spheroidized carbides (dark) in a ferrite matrix (white).

Figure 6. Microstructure of sample. Shows no evidence of ferrite banding in longitudinal section. Etched with 2% picral. X 200

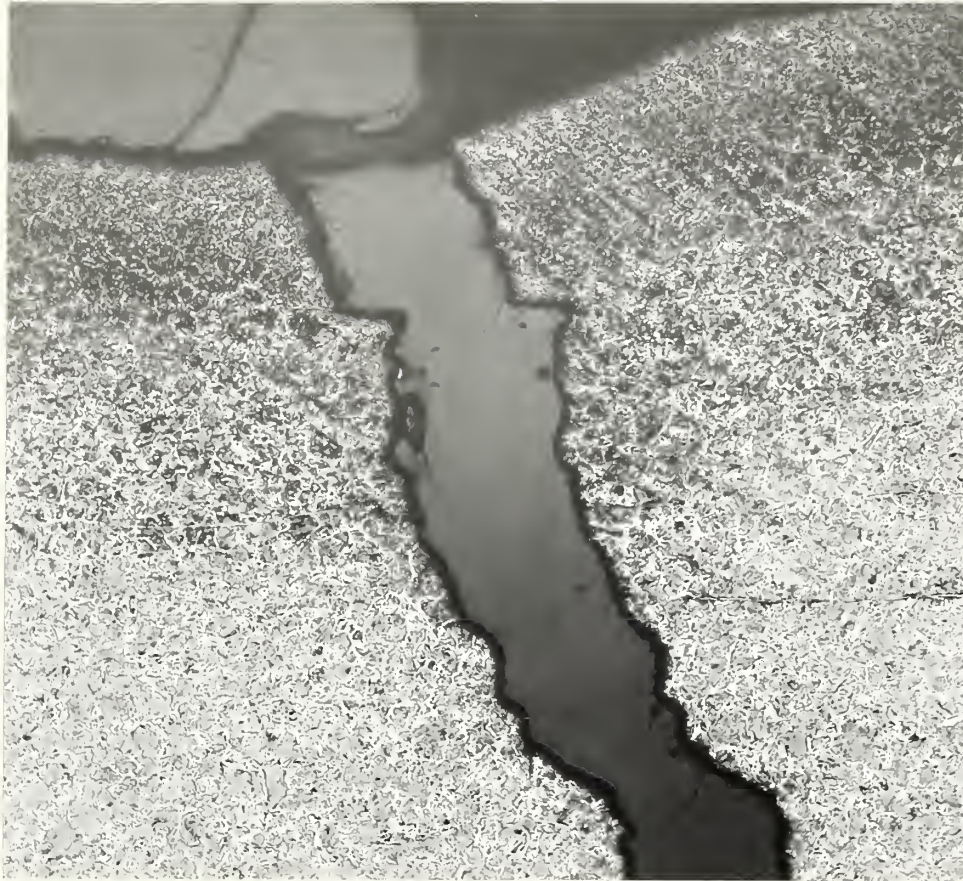
Depth of martensitic case  
approx. 0.0015 inch

**Figure 7.** Structure of longitudinal section of plate sample adjacent to fracture origin. Show no decarburization at plate surface. Martensitic case is approximately 0.0015 inch deep. Core is composed of partially spheroidized carbides (dark) in a ferrite matrix (white). Etched with 2% picral. X 500
