**EXAMINATION OF FAILURE OF
PRINTING PLATE, NO. 29812**

EXAMINATION OF FAILURE OF PRINTING PLATE, NO. 29812

I. J. Feinberg
Engineering Metallurgy Section
Metallurgy Division

Electrolytic Section
Bureau of Engraving and Printing
Washington, D. C.

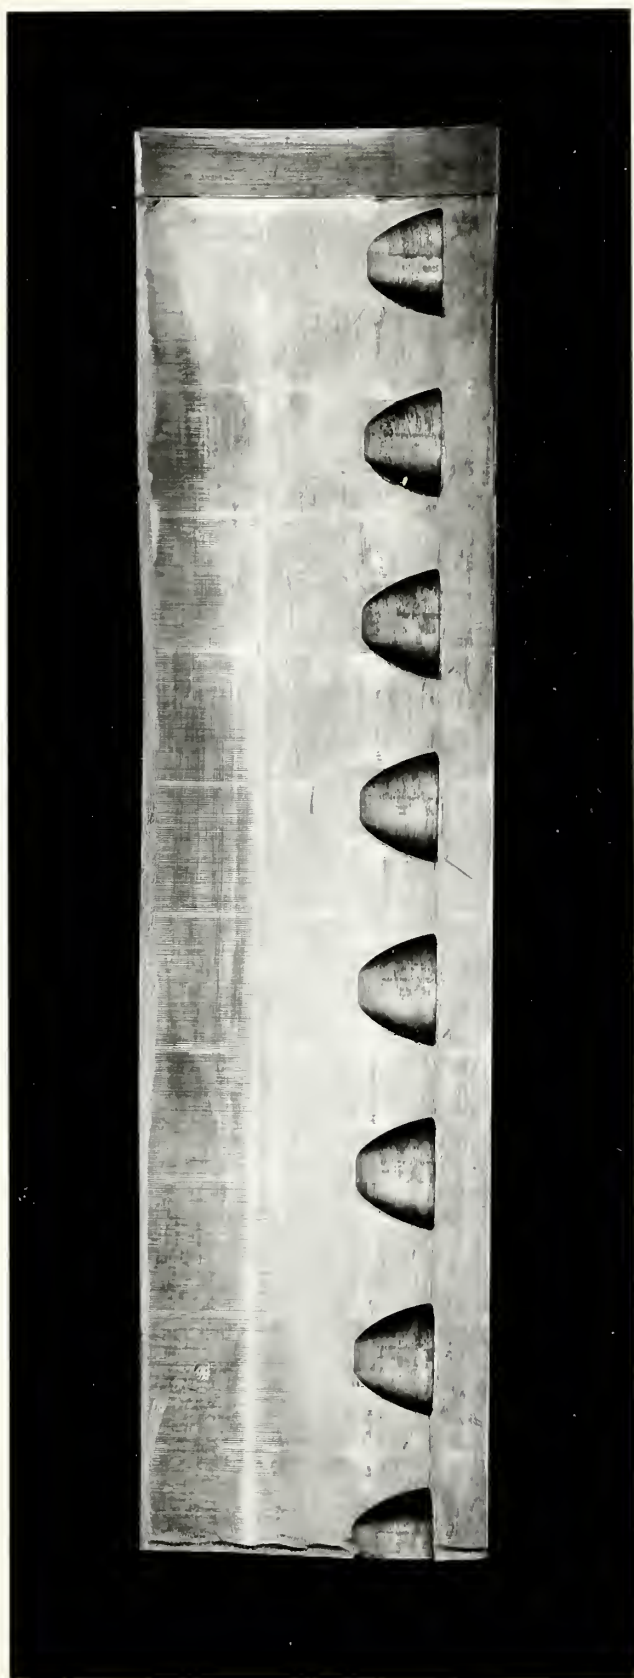
Visual Examination: Figure 1 shows the reverse face of the plate section. Tight cracks propagating from the corners of all eight of the gripper slots on the reverse face were observed. Figure 2 is an enlarged view showing cracks propagating from the corners of two of the slots. The plate section was chafed adjacent to the slots, a, Figure 2. The slot edges shown in this view are quite sharp; sharper than those found in the examination of plate no. 29724. However, the tool marks in the slots of the subject plate were not as deep.

1. The plate was chafed adjacent to the cracks (Figures 1 and 2) indicating that cyclic stressing could have been caused by improper seating of the plate on the drum in this area. The stressing involved repeated bending along a line parallel to the base of the gripper slots.
2. The sharp corners of the gripper slots are heterogeneities creating stress concentration and could be sites for crack initiation and/or propagation.
3. In comparison with a previously examined plate that did not fail in service, gripper slot separation in the subject plate was found to be closer and slot walls thinner. This condition weakened the plate by increasing the unit stress in the area between slots under the loading imposed.

Figure 1. Reverse of section cut from plate no. 29812. X 1

It is believed that faults stemming from fabrication and from fit of the plate on the drum are mainly responsible for this plate failure. The Bureau of Engraving and Printing has reported that an improvement in the service life of plates has resulted from introducing fillets at the base of gripper slots and feathering edges of the gripper slots all-around. It is suggested that adherence to these and the other remedial suggestions for printing plates listed in NBS Report 9838 be continued.

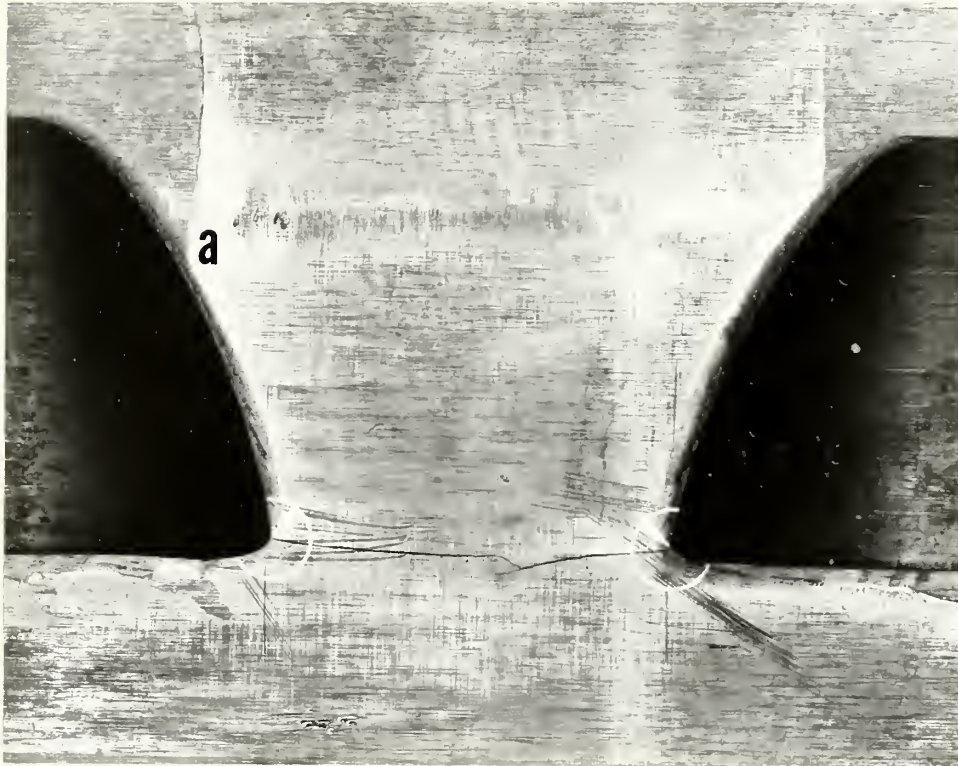
Figure 2. Enlarged view of a section of the plate sample shows cracks propagating from slot corners. Area a, is a highly reflective surface resulting from chafing of the plate on the drum. Note the sharp edges of the slots adjacent to the cracks. Feathering of the slot edges all-around and grinding generous fillets in the encircled slot corners to reduce possibility of crack initiation at these points is recommended. X 4.

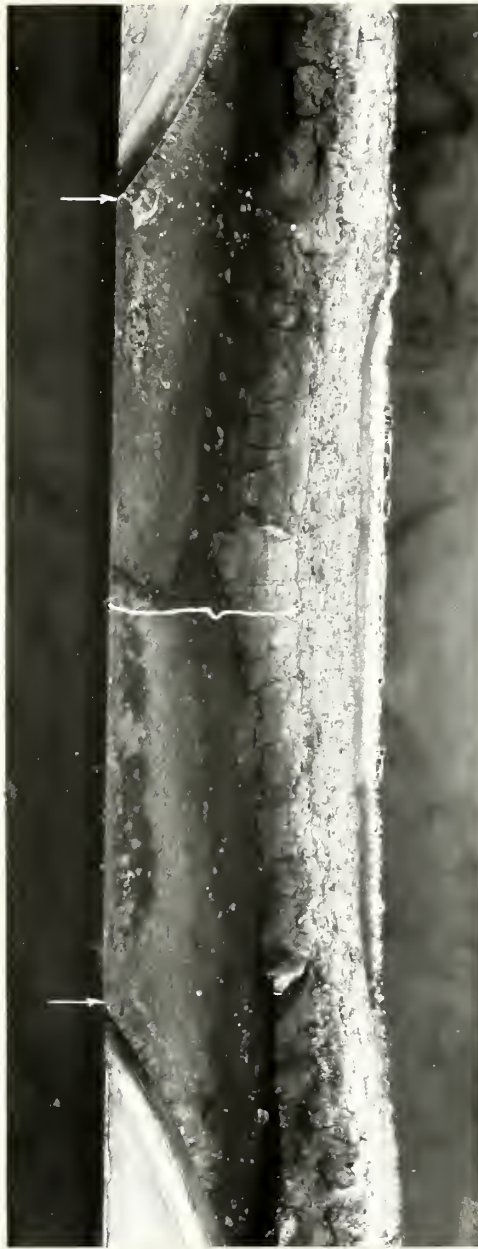
Figure 3 is a view of a typical fracture surface. This surface was revealed when a cracked section was opened. The bright fracture surface area resulted from completion of the fracture in the laboratory. The arrows in Figure 3 point to two apparent crack origins which are located at points where there is a change in section thickness that could cause severe stress concentration. The cracks propagated laterally from their individual origins and nearly merged. The dark area has a smooth portion adjacent to the origin and appears to be a fatigue fracture surface. This surface was darkened by corrosion products.

As in the case of plate no. 29724, cracking of plate no. 29812 resulted from fatigue fractures initiated at the slot corners which are in effect stress concentration notches. It is believed that the sharp slot corners locally harder than adjoining areas created a particularly notch sensitive condition that was an immediate factor in crack initiation. Cyclic bending occurring from repeated loading and unloading of the plate during printing put the reverse face of the plate in tension and provided tensile stresses of sufficient magnitude to initiate the cracks. It appears that inclusions in the material contributed to crack propagation. Darkening of the fatigue fracture surface indicated that corrosive oxidation also occurred.

Figure 3. Fracture surface of failed printing plate. Arrows point to apparent crack origins. The surface is typical of that resulting from fatigue. The depth to which the crack propagated is bracketed. X 8

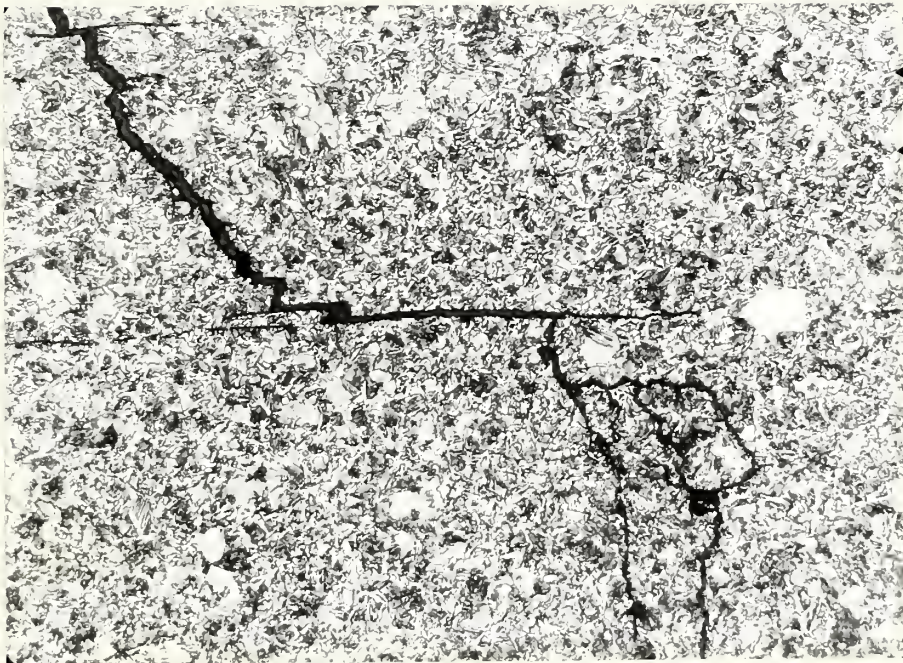
Metallographic Examination: The plate sample contained mixed stringer and globular inclusions. These are shown in Figure 4a. The inclusion rating using ASTM Designation E-45 as a reference is A-2 - A-3. The steel is not as clean as desired for this application. The inclusions acted as paths for crack propagation and probably accelerated the rate of crack growth, Figure 4b. Cleaner material (inclusion rating A-1 - A-2) would be more desirable.

Figure 4a. Mixed stringer and globular inclusions found in longitudinal section of sample. Unetched. X 100.

Figure 4b. Part of fatigue crack showing the crack propagating through stringer of inclusions at arrow. Etched with 1% nital. X 200.

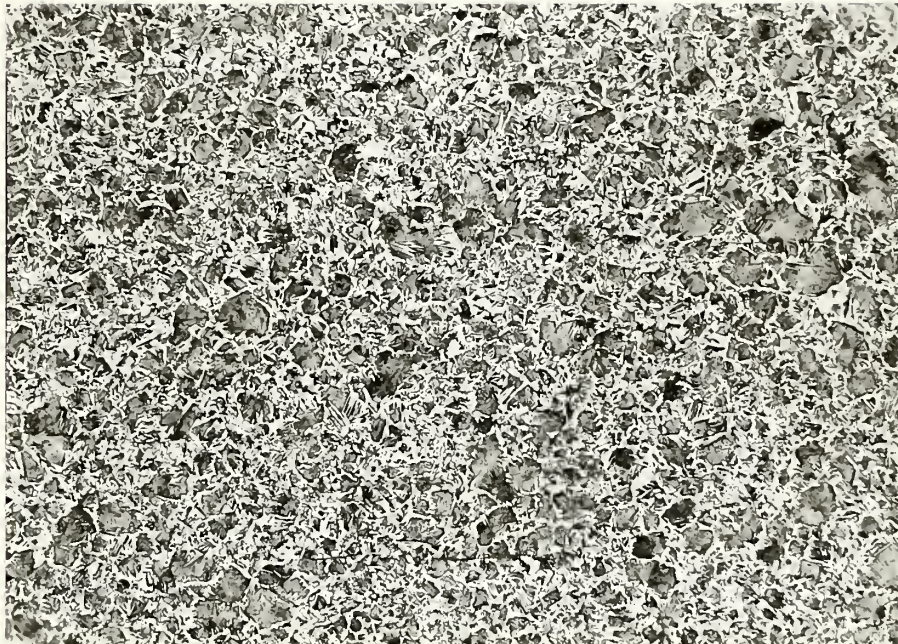
No evidence of ferrite banding was observed in a longitudinal section of a core area, Figure 5. The fine-grained structure exhibited has a grain size rating of 8 using ASTM designation E-112 as a reference. Figure 6 shows the microstructure of a longitudinal section adjacent to

Figure 5. Microstructure of sample. Shows no evidence of ferrite banding in longitudinal section. Etched with 4% picral. X 200.

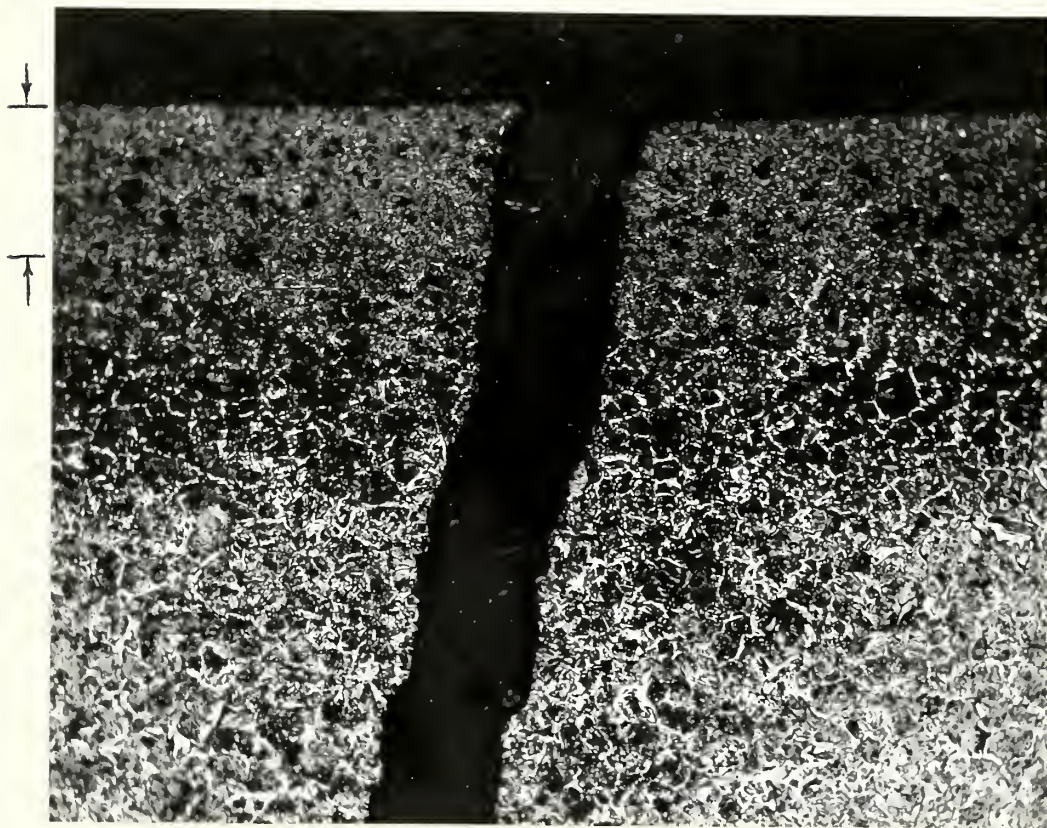
the crack mouth. There are no indications of decarburization adjacent to the surface. The case shown is predominantly martensitic and is approximately 0.003 inch deep. The core is composed of partially spheroidized carbides (dark) in a ferrite matrix (white).

Depth of martensitic case
approx. 0.003 inch

Figure 6. Structure of longitudinal section of plate sample adjacent to fracture origin. Martensitic case is approximately 0.003 inch deep. Core is composed of partially spheroidized carbides (dark) in a ferrite matrix (white). Etched with 4% picral. X 250.
