FRACTOGRAPHY OF A 7178-T6 ALUMINUM FAILED WING PLANK

NATIONAL TRANSPORTATION SAFETY BOARD

D. B. Ballard

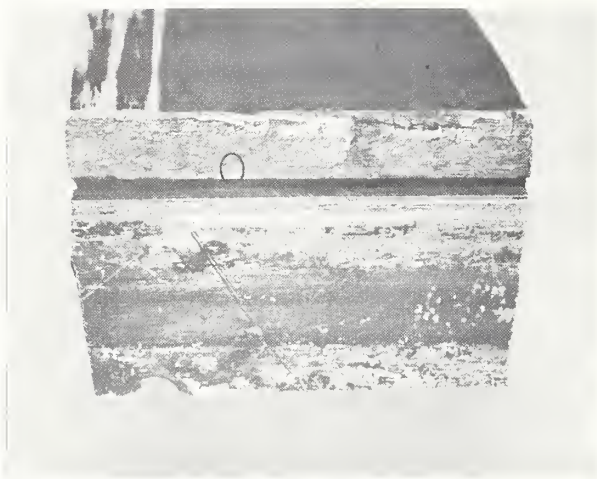
Fractographs of specimen (1-1) are shown in Figs. 9a thru 9f. The original magnification is indicated by the length of the micro meter mark included in each electron photomicrograph. The two photomicrographs 9a and 9b were taken adjacent to the fillet on the fracture surface. The general surface topography is typical of intergranular fracture which usually indicates stress corrosion cracking. Superimposed on the grain facets can be seen a fine dimple-like surface indicating low ductility fracture. There is a small increase in surface roughness in Fig. 9c which was adjacent to Figs. 9a and b but more distant from fillet edge. The first evidence of transgranular ductile fracture is shown in Fig. 9d as narrow bands of dimpled rupture parallel to the long axis of the fracture between areas of low ductility. These features are shown again in Figs. 9e and 9f and are typical of the fracture surface approximately 0.5 mm away from the edge of fracture.

Fig. 1. Fracture Section (1-1)  
Encircled area replicated for  
electron fractography. X2

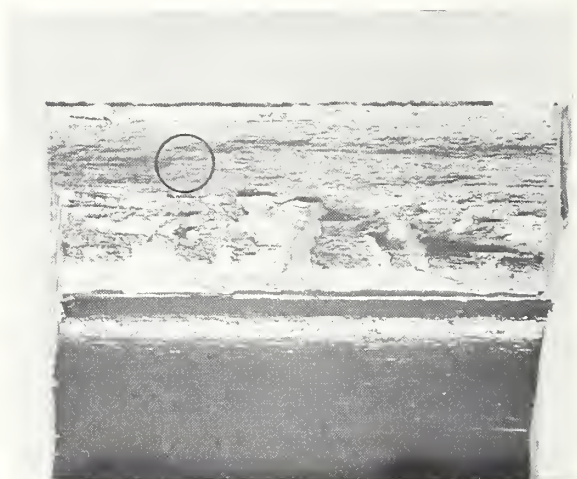
Visual examination of the section (1-2) showed that the fracture edge adjacent to the fillet was mechanically abraded and all original fracture surface was destroyed. Therefore an undamaged area was chosen at a location approximately half the distance across the fracture. Figures 10a through 10f show microstructure typical of this area. In general the surface shows an elongated transgranular fractured grains of low ductility bounded by narrow bands of dimpled rupture. The amount of dimpled rupture shows a significant increase of ductility over the fracture edge of (1-1).

Fig. 2. Fracture Section (1-2)  
X4

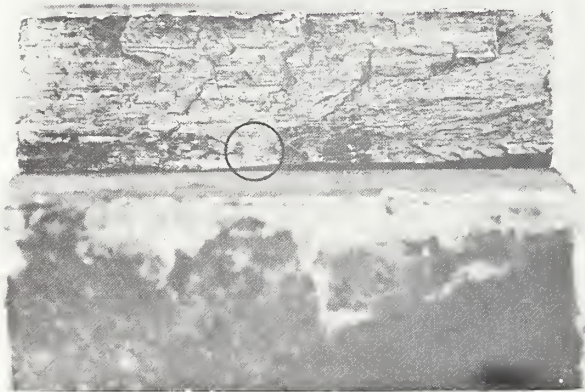
The surface of fracture section (1-3) was coated in places by a dark brown debris. This was removed by successive cleaning replicas until a clean metal surface in the area of interest was obtained. The outside exposed surface in the area of the fillet is shown in Figs. 11a and b. Identification of the lamellar structure is unknown. (It may be the partially corroded anodized coating). The fillet edge of the fracture is shown in Figs. 11c, d, e. Severe corrosion or oxidization has changed the surface and altered the original fracture surface features. A smaller amount of surface corrosion appears to have occurred on the areas shown in Figs. 11g and 11h. This surface area was approximately 1 mm distant from the fillet edge and appears to retain some of the original fracture topography. At a distance of 1.5 mm the surface appears as in Figs. 11k and 11l. Little or no corrosion is noted and the small amount of dimpled rupture is evident.

1. Dimpled rupture, as an indication of ductility, was found at the fillet edge of all fractures except fracture section (1-3). This section had evidence of severe corrosion at the fillet edge of fracture.

2. There is a possibility that a stress corrosion crack approximately 1.5 mm deep and of unknown length may have existed in section (1-3) prior to final overload failure.

Fig. 3. Fracture Section (1-3)  
X4

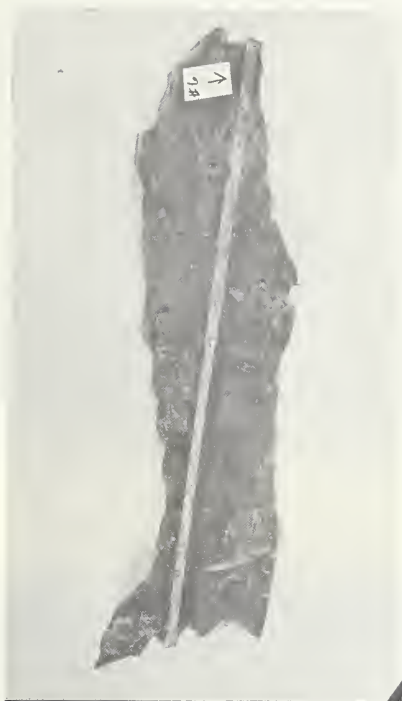
Fig. 5. Fracture location #6  
X1/5

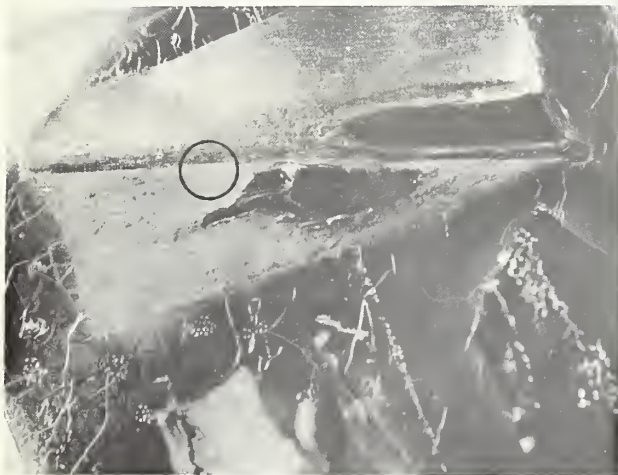
Fig. 7. Replica of fracture surface #5.  
The outside surface is in the lower  
sector of circle. X4

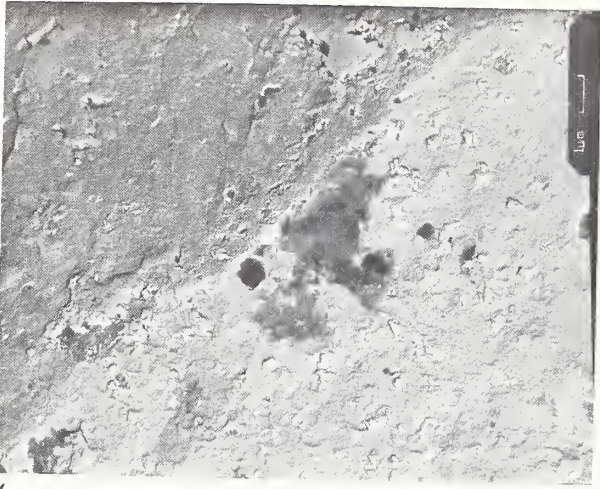
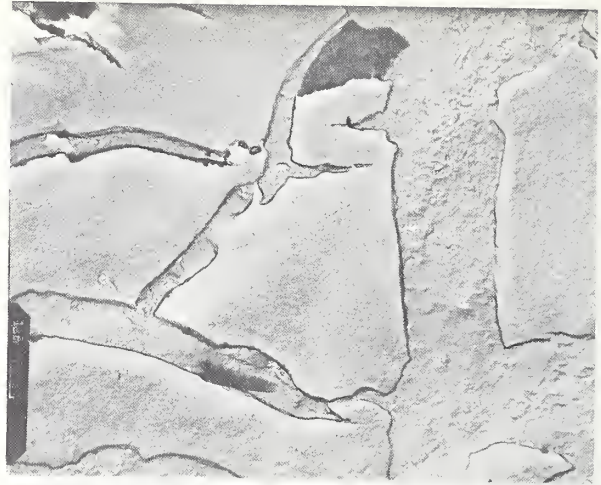
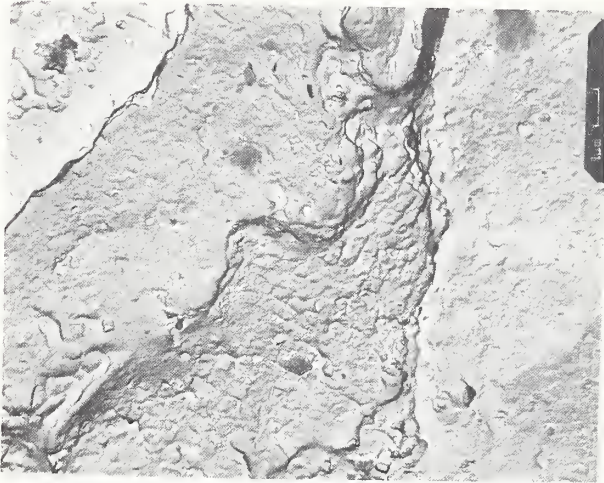
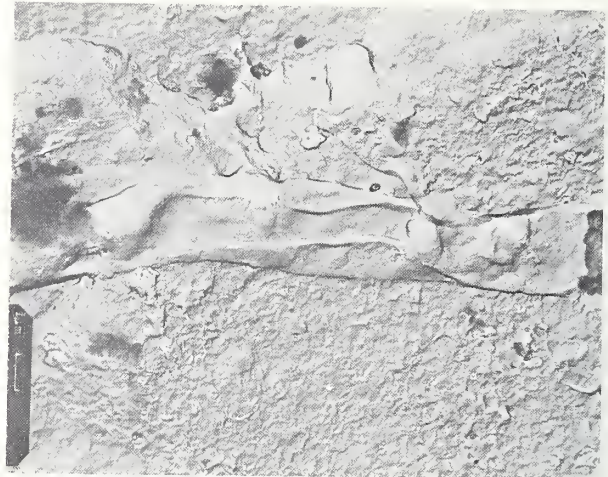
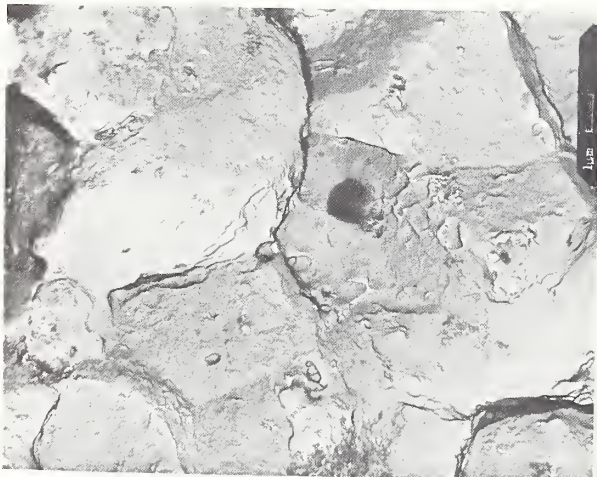
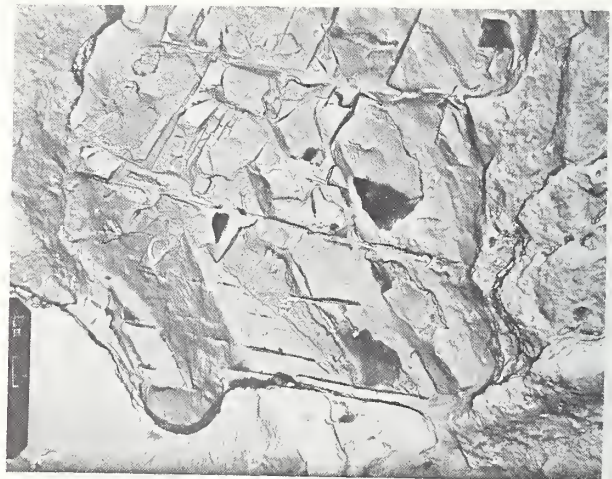
Fracture Surface #4

Fracture #4 was, by visual examination, similar to (1-3); that is, a flat semi lustre surface. The outside surface at the fillet is shown

in the upper left corner of Fig. 12a. The edge of fracture begins at the diagonal, progresses to lower right, and exhibits a flat surface with fine traces of corrosion. The large irregular shapes in Fig. 12b may be a thick oxide or surfaces which have been deeply corroded. A fine dimpled structure can be seen on all Figs. (a) through (f) indicating a low ductility fracture. An indication of intergranular fracture is shown in Fig. 12e. The mud crack pattern in Fig. 12f is probably the result of rapid corrosion of an exposed large second phase particle or an inclusion.

Fig. 12f. Corrosion on second phase, or inclusion.

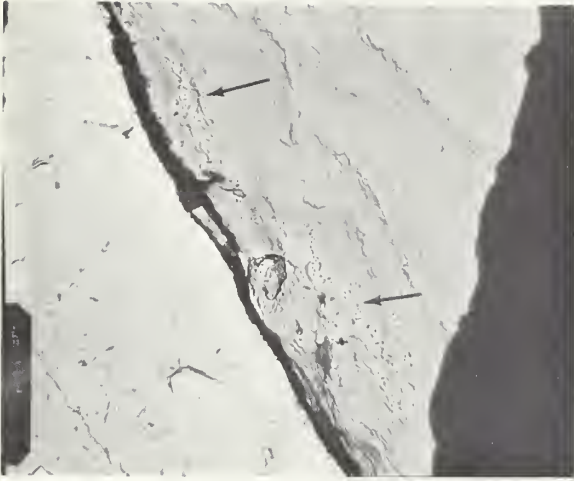
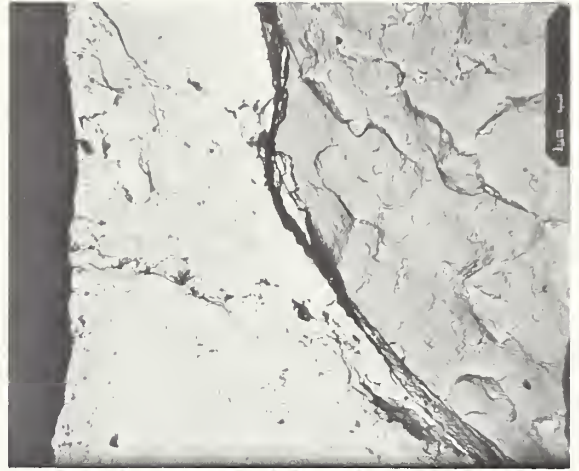
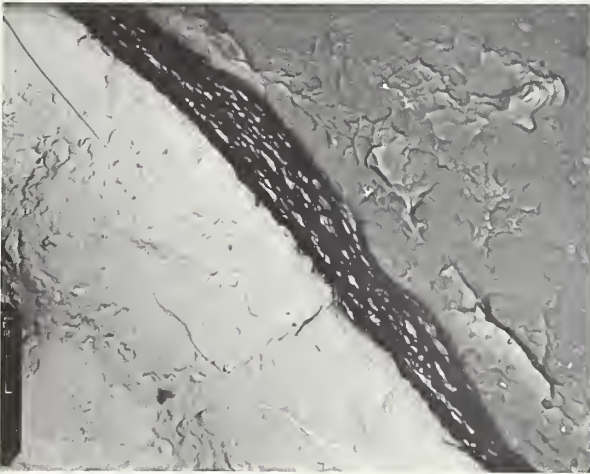
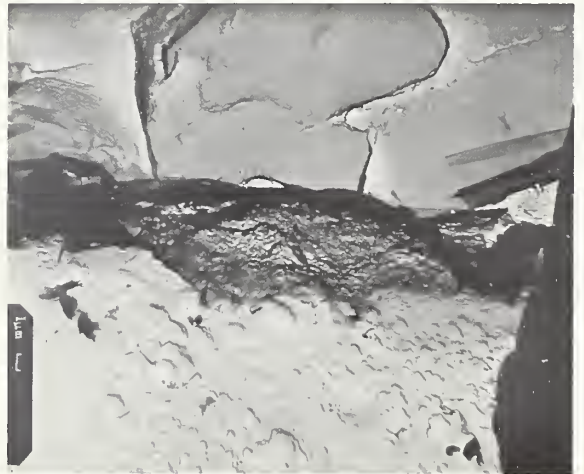
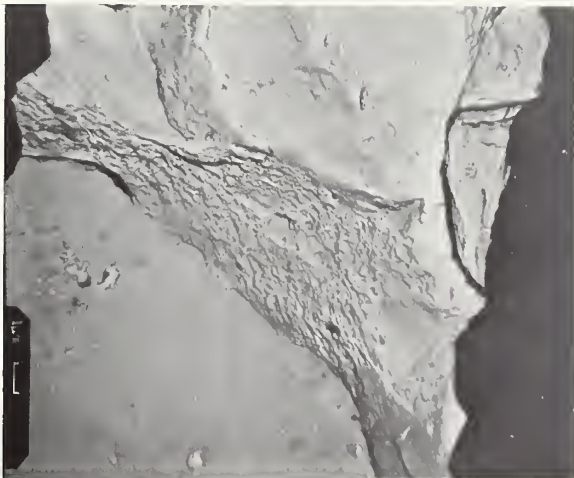
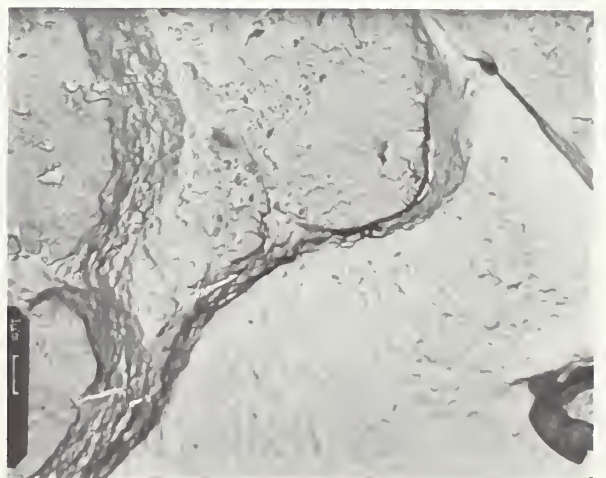
Fracture Surface #5

Macroexamination of fracture #5 revealed the presence of a small flat brittle region between the fillet and the fibrous woody fracture surface. Fractographs of this flat area and part of the outside surface are shown in Figs. 13a through 13e. Two small areas of corrosion are noted at arrows, these are adjacent to smooth areas which extend to the outside surface. This may indicate the presence of a pre-existing stress corrosion crack before overload. A steep sloping step is also noted by a dark band that extends through the center of the photographs and connects the fillet edge with the flat fracture. This may indicate the fracture initiated by shear failure in these areas. Fig. 13f is typical of the fracture surface away from the edge. The fracture is transgranular with a small amount of dimpled rupture and few small areas of initial corrosion.

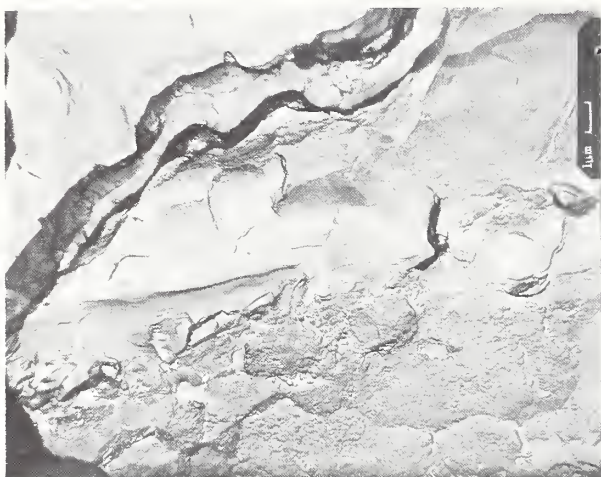
Fig. 14a.

appearance. The upper left corner of Fig. 14a is the outside surface. The wedge shape edge entering from upper right is intercrystalline fracture with a small amount of dimple rupture, then changes in the lower part of the photo to transcrystalline with a larger amount of dimple rupture.

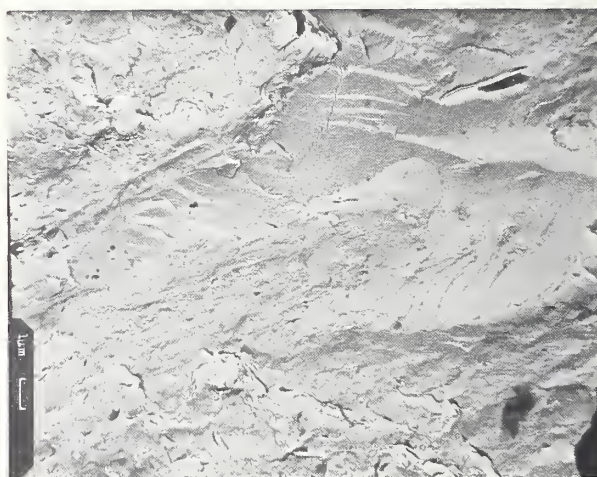
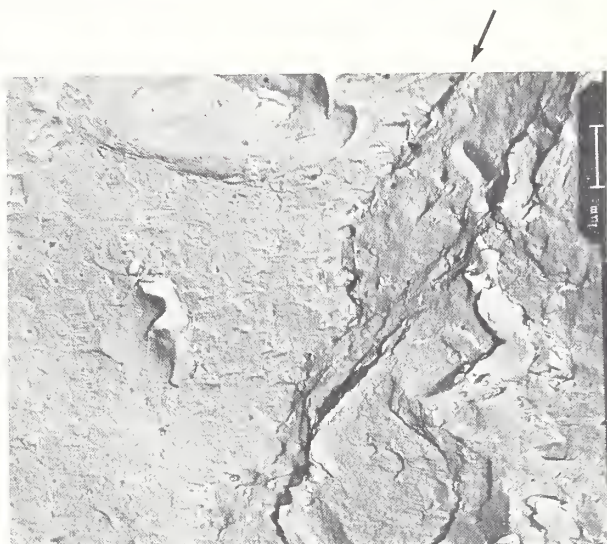
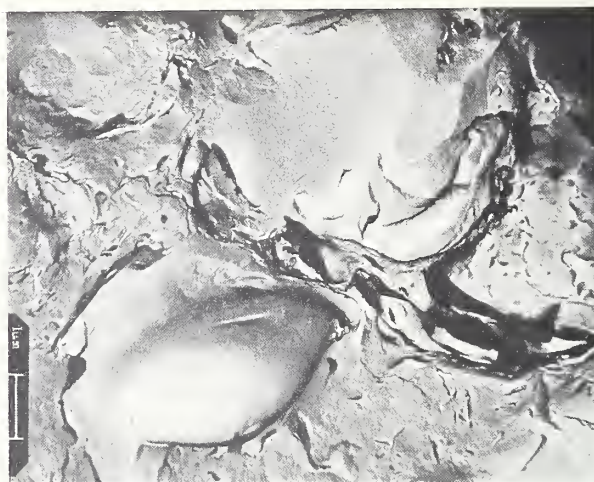
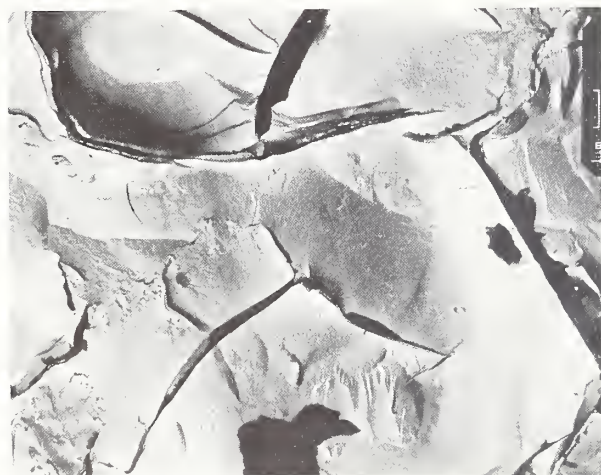
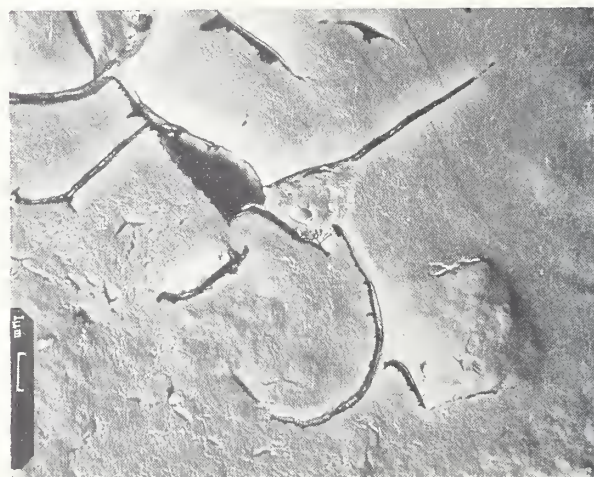
Fracture Surface #6

Figure 14b is an example of cleavage at the fracture edge as compared with low ductility shear in Fig. 14c. Cleavage and evidence of corrosion can be seen in Figs. 14d and 14e. Evidence of mud cracks can be noted in both Figs. 14e and f. In Fig. 14f the prior fracture surface details have been covered or removed by corrosion or oxidization.
