NATIONAL BUREAU OF STANDARDS REPORT

9947

FAILED MCCAULEY PROPELLER HUB

Bureau of Aviation Safety
National Transportation Safety Board
Department of Transportation
Washington, D. C.

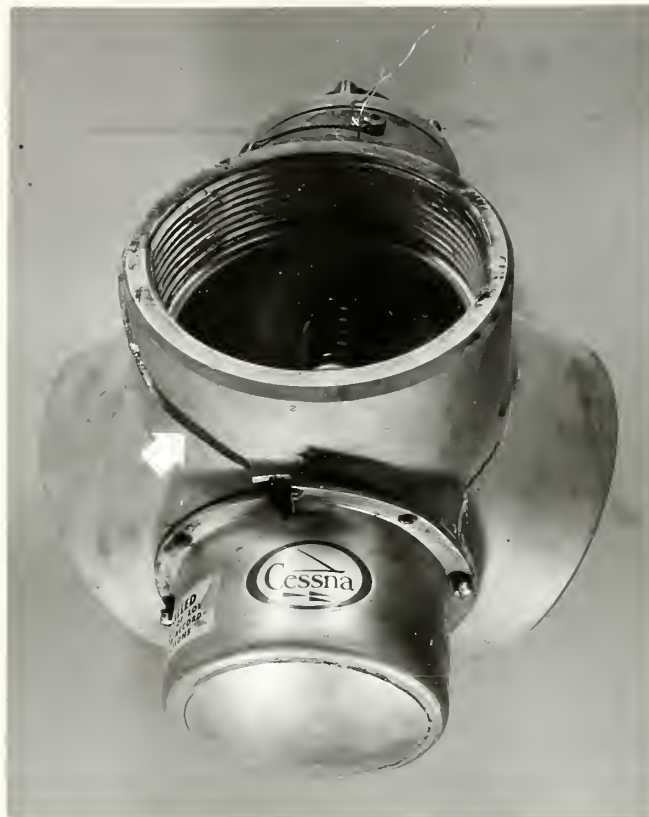
Metallographic Examination: The fracture originated at a fatigue crack near the root of the innermost thread in blade socket No. 2 and extended across the socket (fig. 1). The fracture surface is shown in figures 3 and 4. The fracture was sectioned adjacent to the fatigue crack origin and examined metallographically. Figure 5 shows a representative area of the material in the unetched condition near the crack origin. The material is clean and shows little or no porosity. Figures 6 and 7 show

Figure 1. McCauley Propeller Hub as received. Arrow on photograph points to approximate location of fracture origin on inside of hub. X 3/8

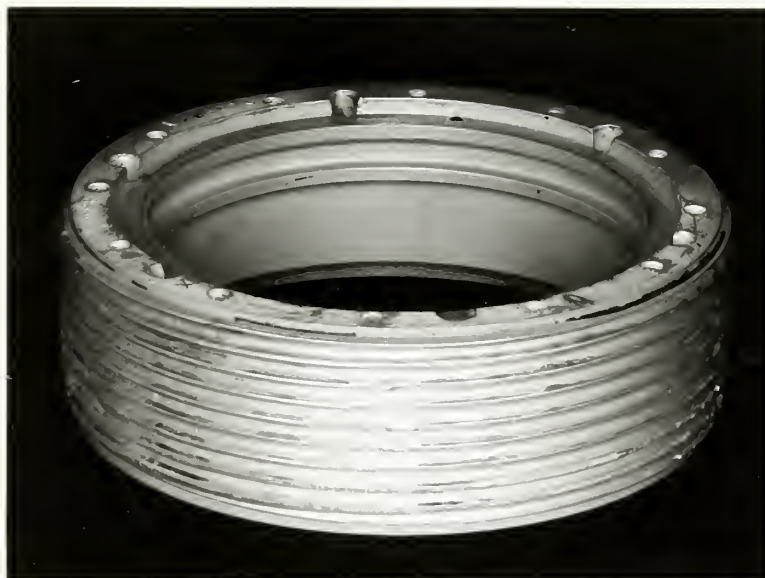
Figure 2. Blade retention nut from blade socket No. 2 as received. X 2/3

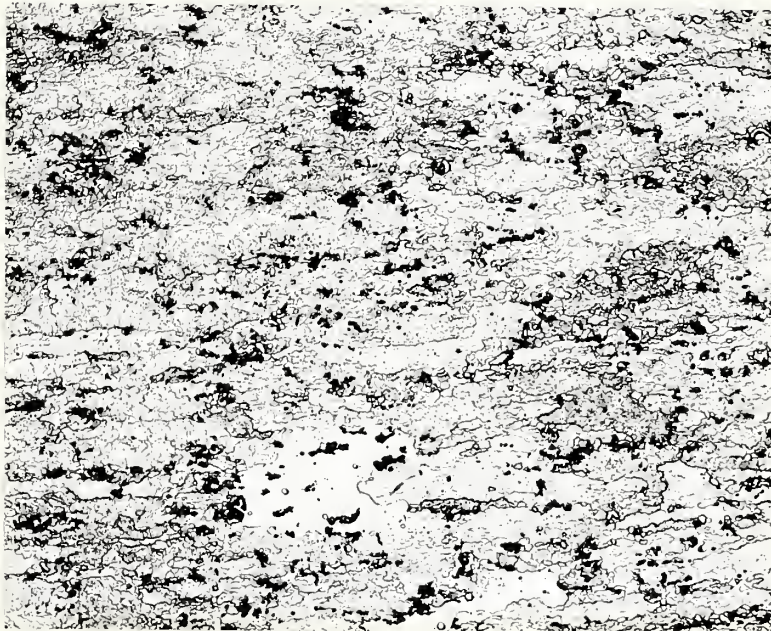
the microstructure of the hub socket adjacent to the crack origin and away from the origin, respectively. There appears to be nothing abnormal or detrimental in the 2014-T6 heat treated structure shown. The smaller grain size observed immediately adjacent to the fracture origin may have resulted from relatively faster cooling after forging in this area. No unusual material condition that may have contributed to crack initiation was found at the origin.

Figure 6. Longitudinal microstructure immediately adjacent to origin of fracture. Keller's etch. X 100

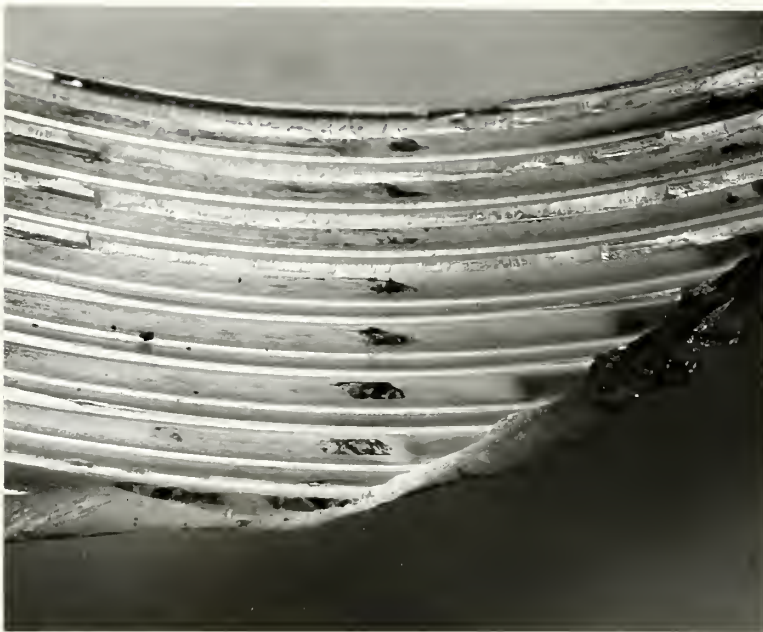
Thread Examination: There was a good deal of fretting in the threads of all three blade sockets as well as in the threads of the retention nut from socket No. 2 (figs. 8 and 9). (The other two retention nuts were not available for examination.) Fretting occurred adjacent to, but not directly at the fatigue crack origin.

The oversize minor diameter found in measuring socket No. 3 indicates a possible mismatch between this socket and its related retention nut. It is conceivable that the mismatch is responsible for the fretting observed in the threads of socket No. 3. Inasmuch as fretting was also observed in the threads of sockets No. 1 and No. 2, it would seem that a mismatch condition was also present in these sockets.

Fretting is indicative of cyclic stressing and it is possible that this stressing could have initiated the fatigue crack that propagated to cause the failure of the hub in socket No. 2. Fatigue cracks may be associated with fretting, and their origins, as in this case, are sometimes found not directly in a fretted area, but adjacent to it.

Figure 8. Threads of failed hub socket showing fretting. X 2

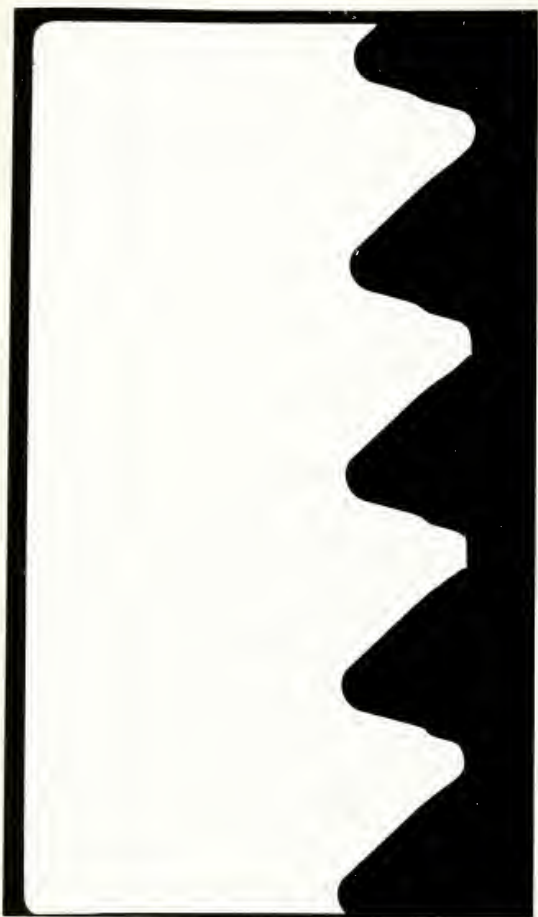
The threads over a large portion of the blade retention nut were rather badly damaged. Figure 10 shows the thread profile in a damaged area as well as in an area where the threads are intact. The thread profile appears satisfactory in the undamaged area.

Figure 10a. Thread profile of
damaged threads of
blade retention nut.
X 7

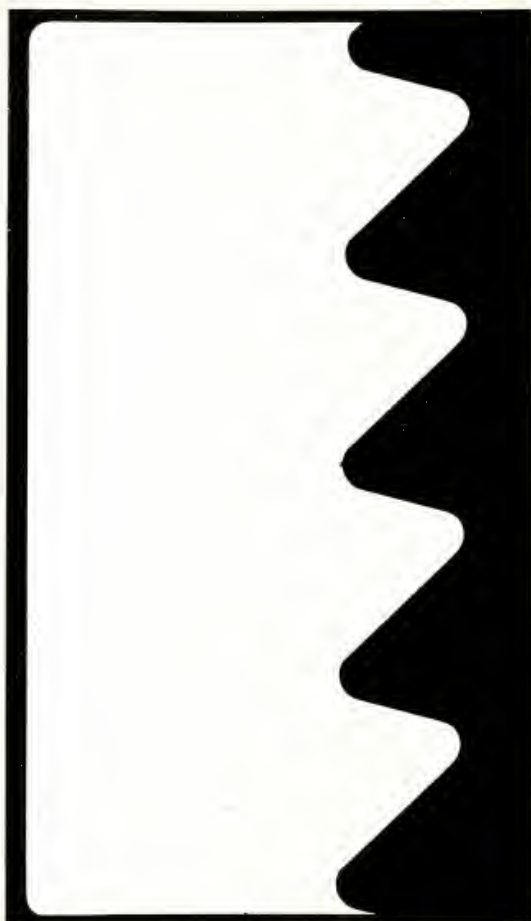
Figure 10b. Thread profile of
undamaged threads of
blade retention nut.
X 7

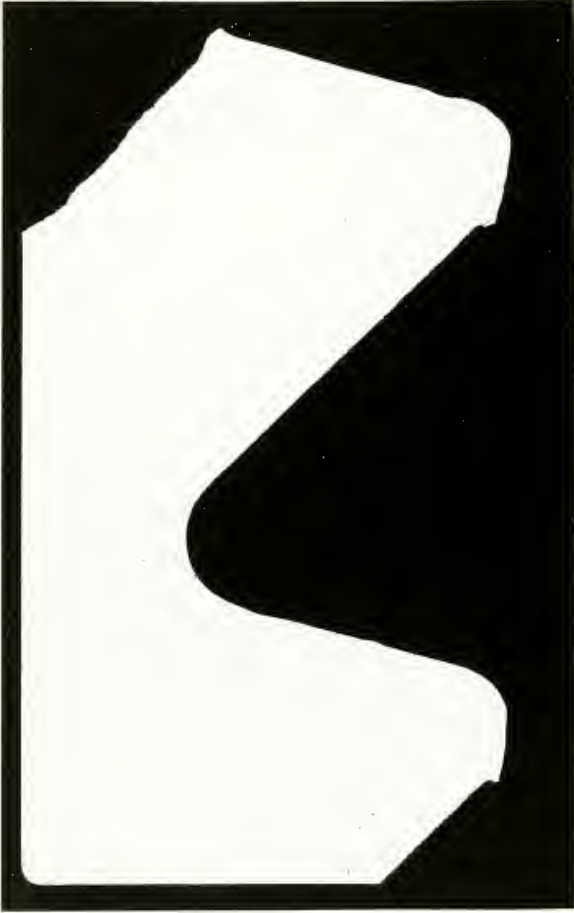
The threads of the failed hub socket were also damaged badly as is shown by the profile of two threads adjacent to the fracture (fig. 11a). Figure 11b shows the thread profile of socket No. 1 which was not damaged and the threads appear to be satisfactory. In figure 12, the thread nearest to the fracture is shown at a higher magnification. The material has been deeply etched to show flow. The top of the thread has been severely deformed. Other damaged threads exhibited deformation of this nature.

Figure 11a. Thread profile of hub socket No. 2 showing two damaged threads adjacent to fracture. X 18

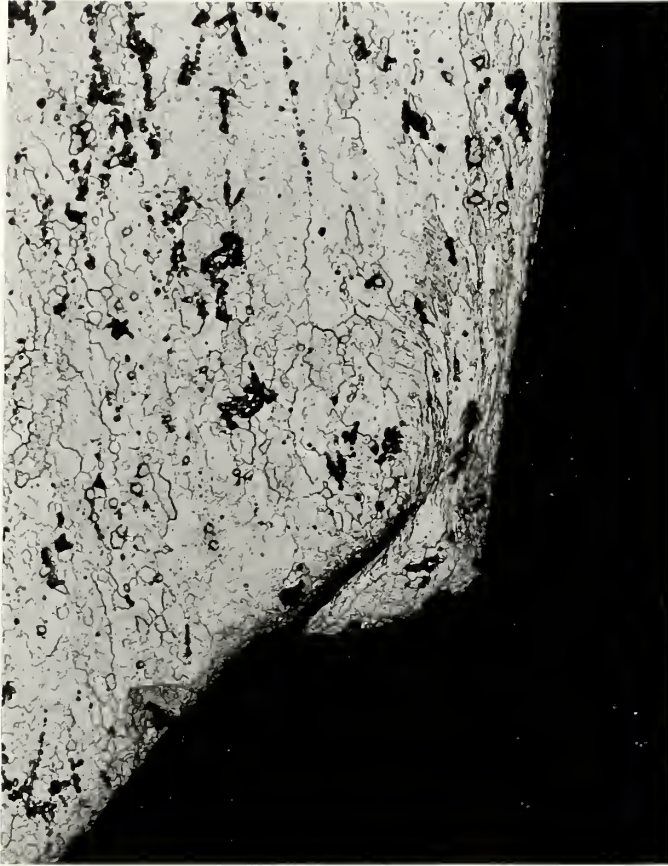
Conclusions: The material in the hub meets specifications for chemical composition of aluminum alloy 2014 and it also meets hardness specifications for the T-6 condition. The blade retention nut meets hardness specifications for aluminum alloy 7075-T6. The microstructure of the hub material appears to be satisfactory. Examination of the thread profile of undamaged threads of both the hub and retention nut indicate that the threads are satisfactory. It is the opinion of this investigator that the hub and nut damage (deformation) observed occurred subsequent to failure, and therefore did not contribute to the fracture.

Figure 12. Thread adjacent to fracture in hub socket No. 2 showing deformation. Keller's etch. X 200
