METALLURGICAL EXAMINATION AND MECHANICAL TESTS OF MATERIAL FROM THE POINT PLEASANT, W. VA. BRIDGE

By
John A. Bennett
Engineering Metallurgy Section
Metallurgy Division

Part I. Examination of Fractures and Adjacent Material
in C13 Eye of Eyebars C11-C13 NN

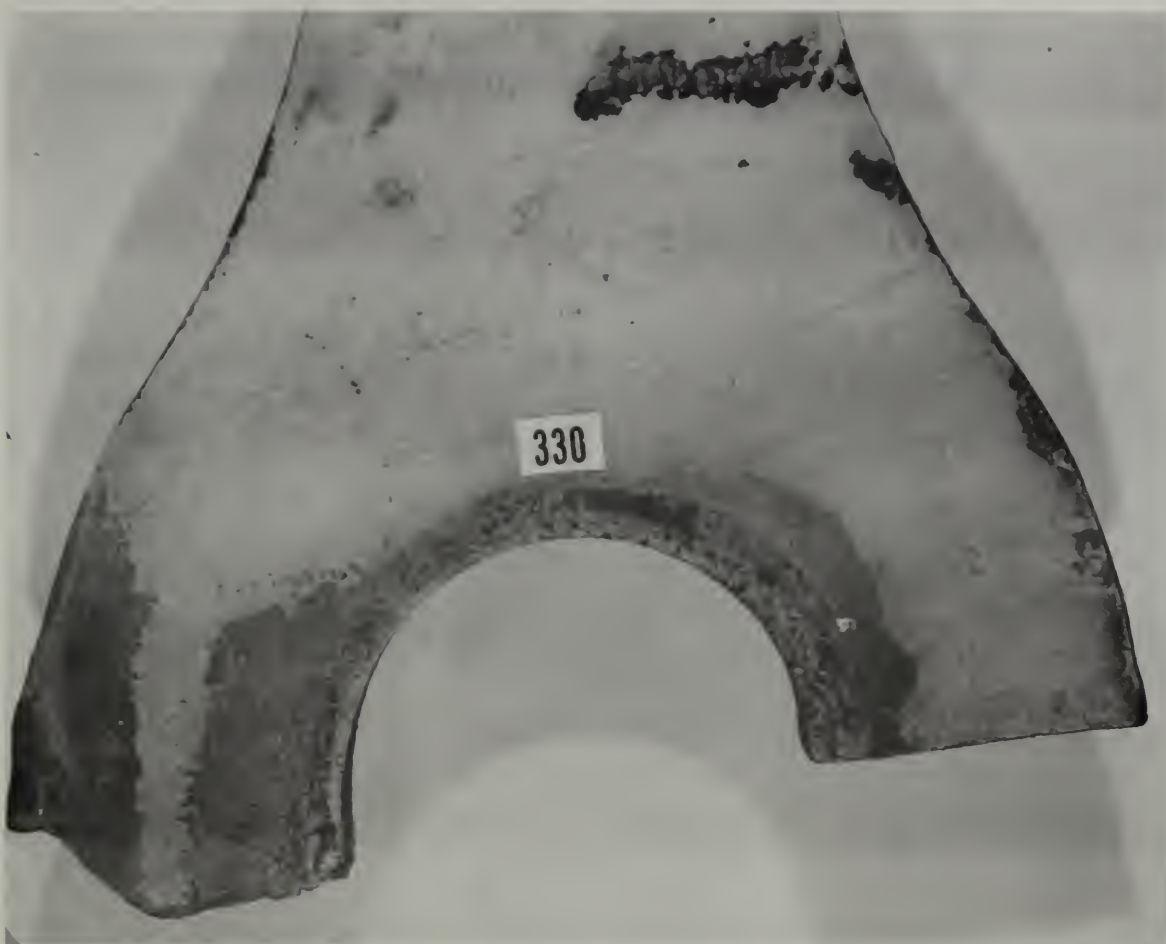
Visual observations: The appearance of the fractured eye when recovered has been described in other reports but will be repeated here for completeness (figs. 1 and 2). The fracture in the lower side of the eye was very brittle in appearance; there was no evidence of plastic deformation adjacent to the fracture except for a small shear lip along a part of one side. Along much of the fracture the paint was intact to within about 1/16 in of the fracture.

1, Inboard piece of the broken eye, as received. The north face is shown, and the lower side of the eye is at the right.

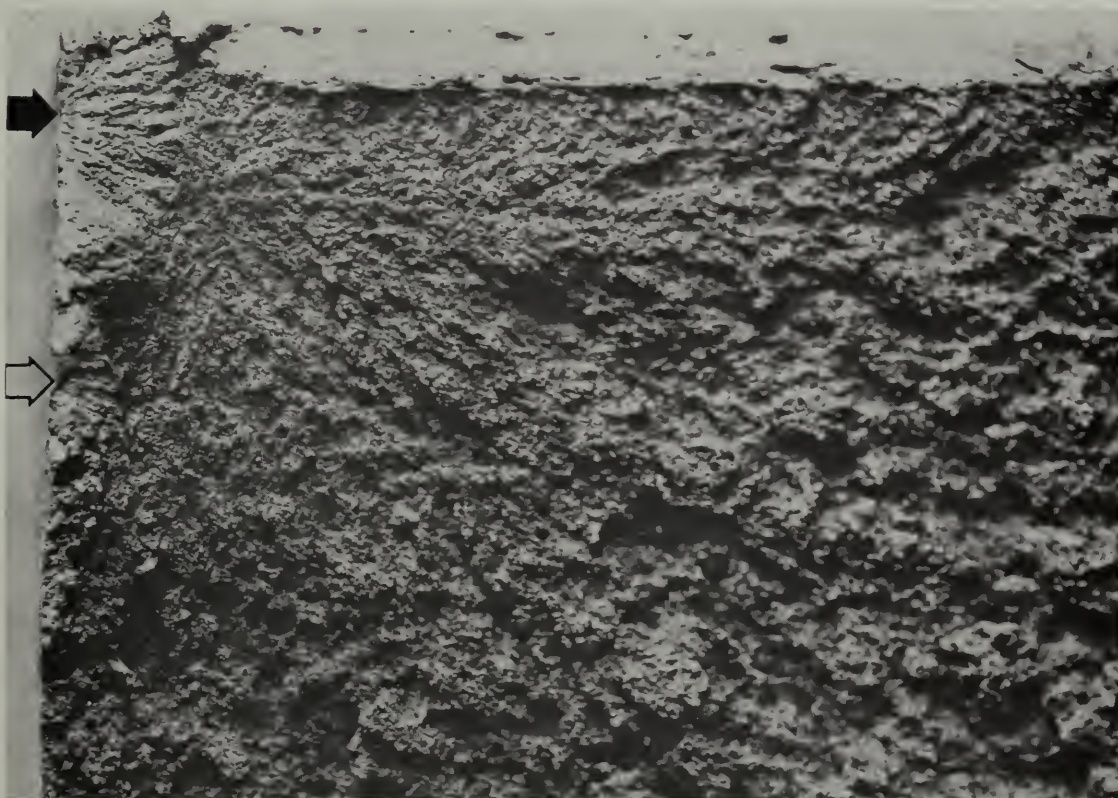
There did not appear to be any marked change in fracture topography associated with the front of the fan-shaped areas visible at the origin on the fracture surface. The larger of these areas (figure 6), had penetrated about 0.11 inch from the hole surface, and the center of it was nearly the same distance from the south face. Figure 16 is a micrograph at low magnification, taken on a plane 0.11 inch from the south face and including the location of the front of the "fan". Although the change in direction of the crack near the middle of this figure may well be associated with the change in appearance of the fracture surface, there are no microscopic differences in the nature of the fracture that we could observe on the two sides of this region.

6. Same as figure 5 at higher magnification. The south face is at the top. 5 X

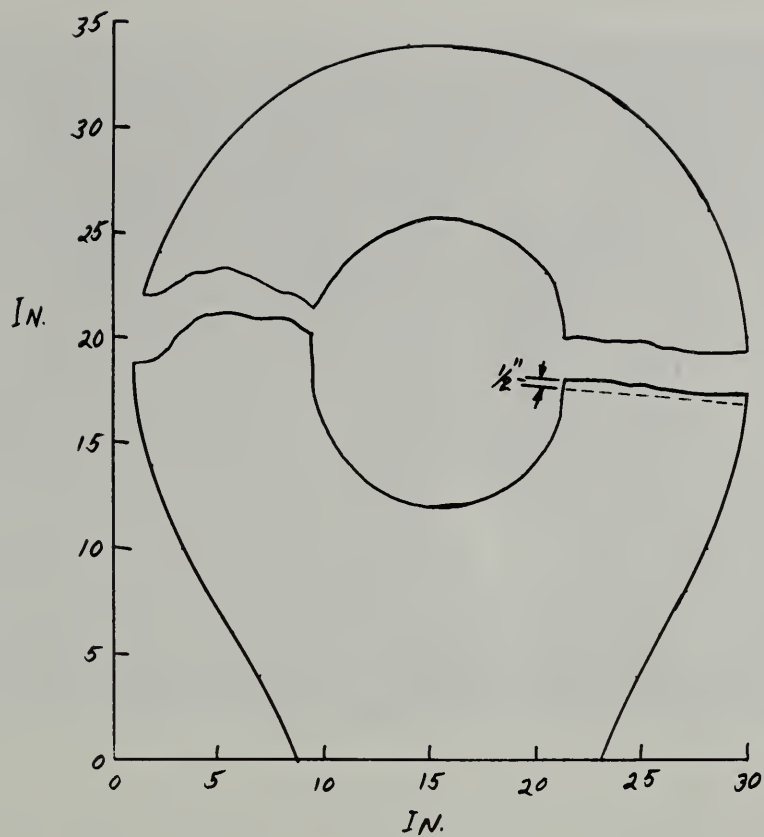
In accordance with the Laboratory Specimen Plan, a segment (designated "0" in the Plan) approximately 1/2 inch thick was separated from the in-board piece of the eye by a saw cut parallel to the lower fracture, figure 9. A number of additional cracks were found on the hole surface in this segment, one group being close to the saw cut, i.e. nearly 1/2 inch from the fracture, (see figures 10 and 11). An attempt was made to locate the origins of these cracks and those in the outboard piece; all of them appeared to have initiated in a region lying between 0.08 and 0.48 inch from the south face. Figure 12 is a sketch, based on visual observations, of the location of the principal cracks.

9. Sketch of the south face of the fractured eye showing the location of the segment cut from the inboard piece.

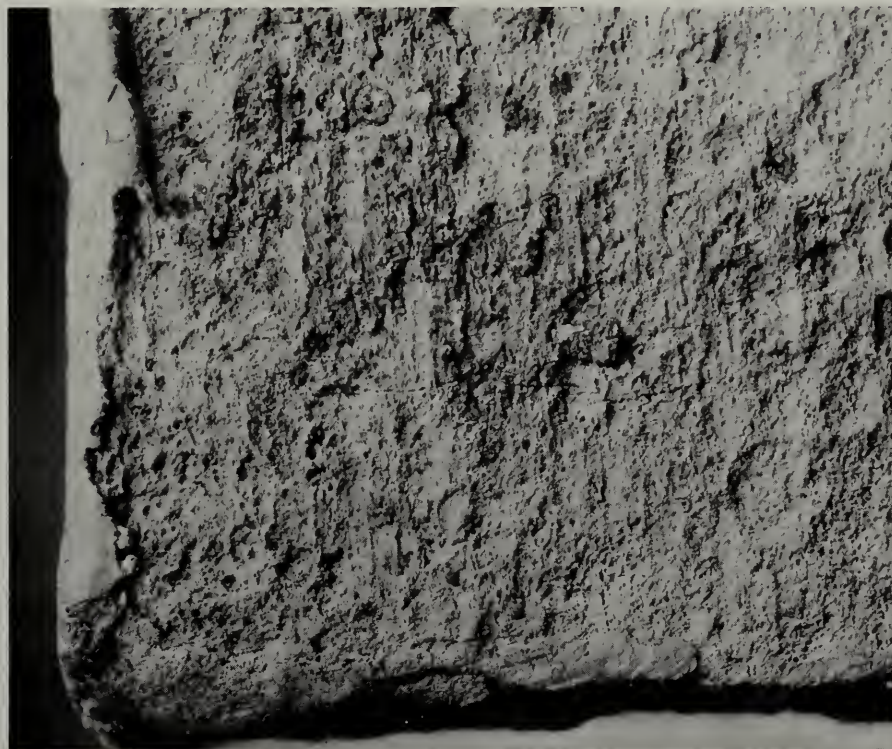
10. Surface of the hole adjacent to the fracture (bottom) in the inboard piece. The south face is at the left. 6 X

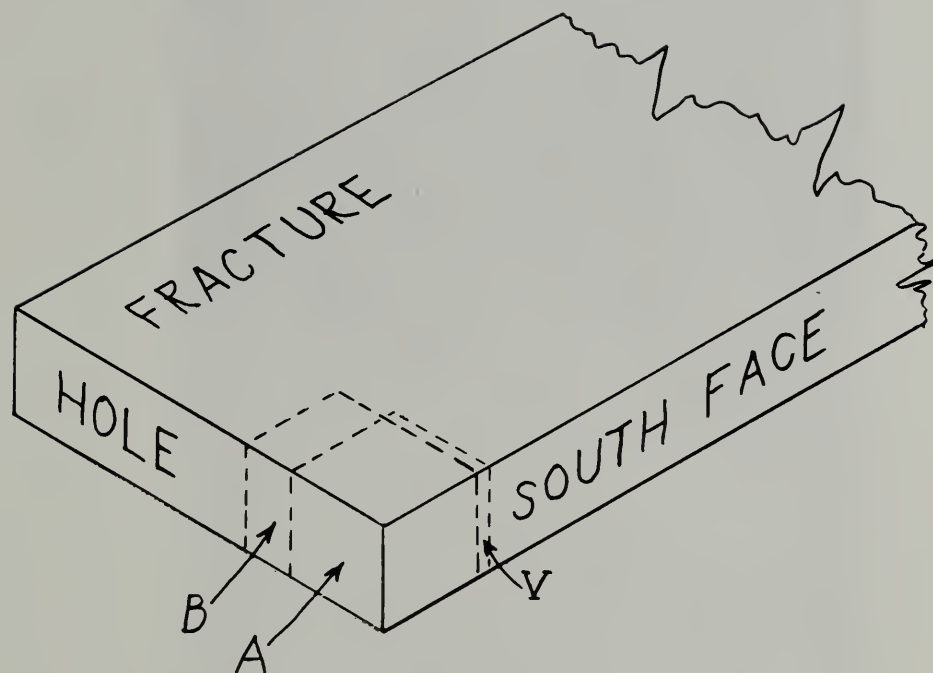
Metallographic examination and hardness surveys: A piece, approximately 1/2 in. on a side, was cut from the portion of segment "0" adjacent to the south face of the eye for metallographic examination. Other, thinner specimens were cut adjacent to the first, as shown in figure 13.

13. Sketch of segment "O" showing the location of metallographic specimens "A", "B" and "V" relative to the surfaces of the segment. The origin of the fracture was on the hole surface near the south face.

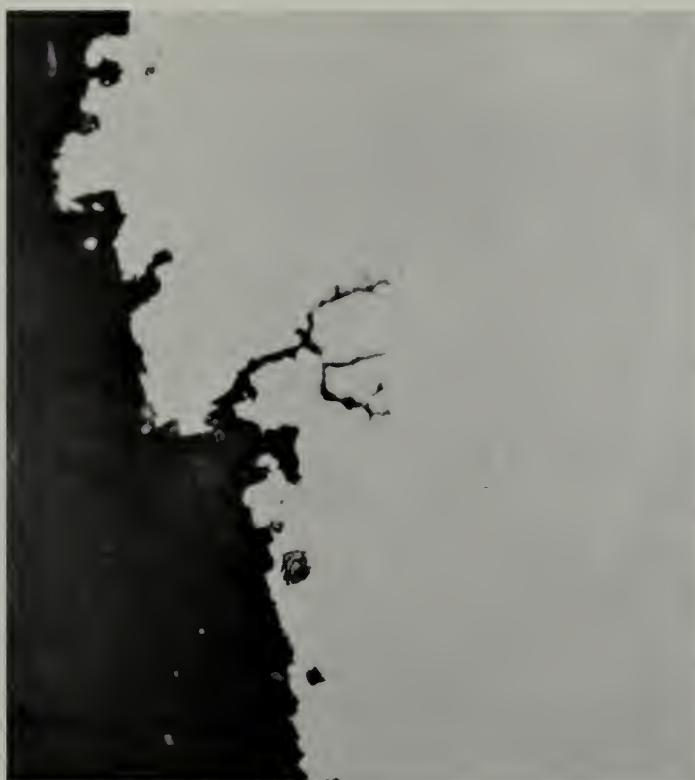
24. Incipient cracks at hole surface, 0.394 inch below south face.
1000 X

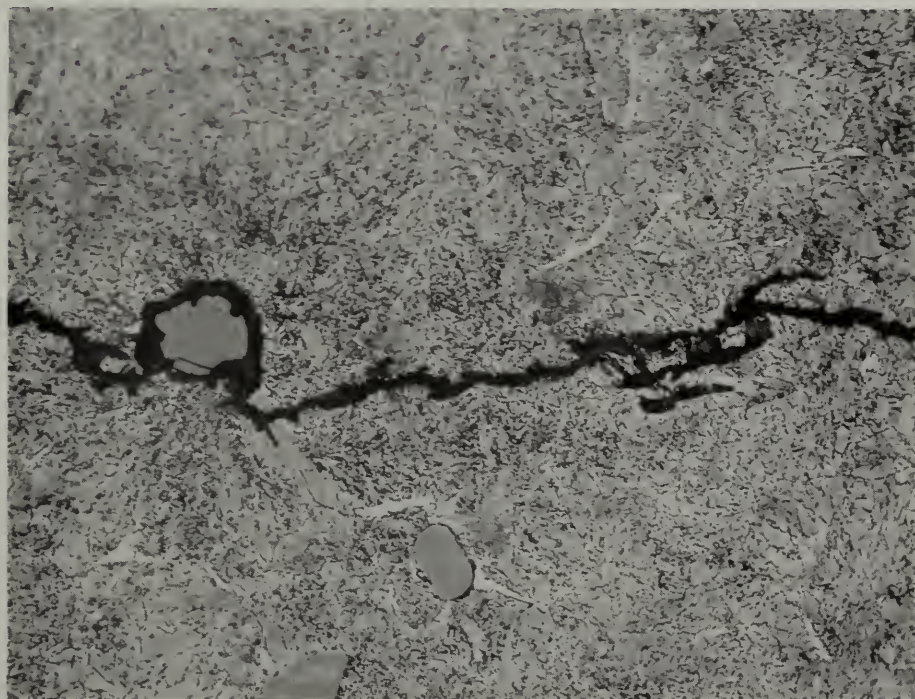
26. Typical crack appearance, 0.394 inch below south face. Etched, picral. 500 X

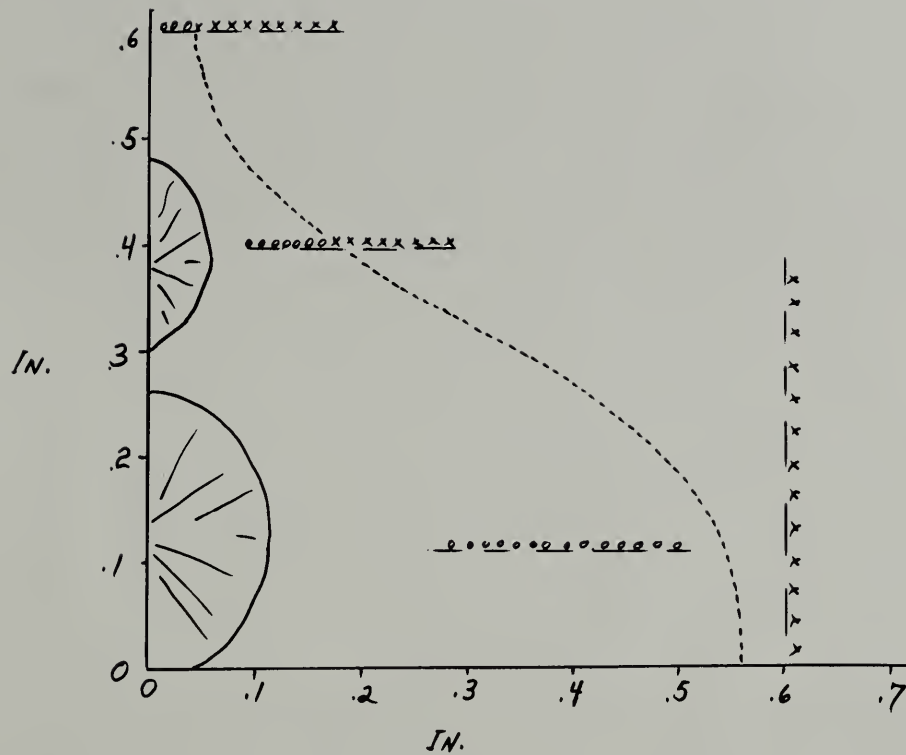
29. Sketch of the area near the origin on the fracture surface; hole surface is at left, south face at bottom. Dashed lines represent location of metallographic sections examined. ooo - no secondary cracks found; xxx - secondary cracks observed.
