NBS REPORT
9981

METALLURGICAL EXAMINATION AND MECHANICAL TESTS OF MATERIAL FROM THE POINT PLEASANT, W. VA. BRIDGE

Part 5

Metallurgical Examination and Mechanical Tests of
Material from the Point Pleasant, W. Va. Bridge

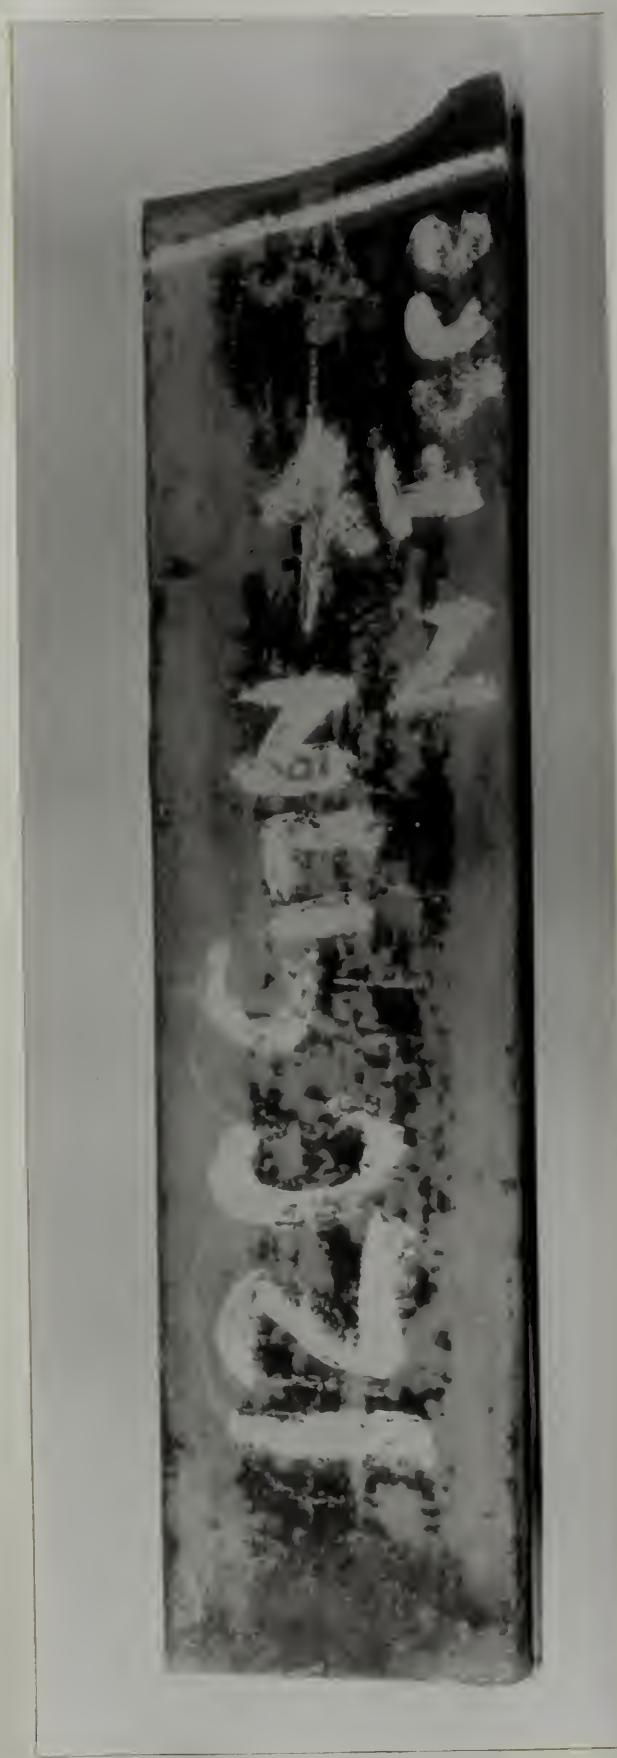
Material: Fragment No. 12C (Bridge Member C₁₇-U₁₇N), shown in Figure 1, was approximately 1 1/4 in. X 6 in. X 24 in., as received. It was quite rusted on all surfaces. There were, however, vestiges of an orange colored paint and of an aluminum paint on the sides of the piece. All specimens for mechanical tests were removed from the fragment in a section extending from about three inches from the fracture surface to about four inches from the flame-cut end. A section was cut from 12C that contained the fracture surface. It is shown in Figures 2a and 2b.

Figure 1. Hanger fragment 12C (Bridge Member C₁₇-U₁₇N) as-received.
Approx. 1/3 X

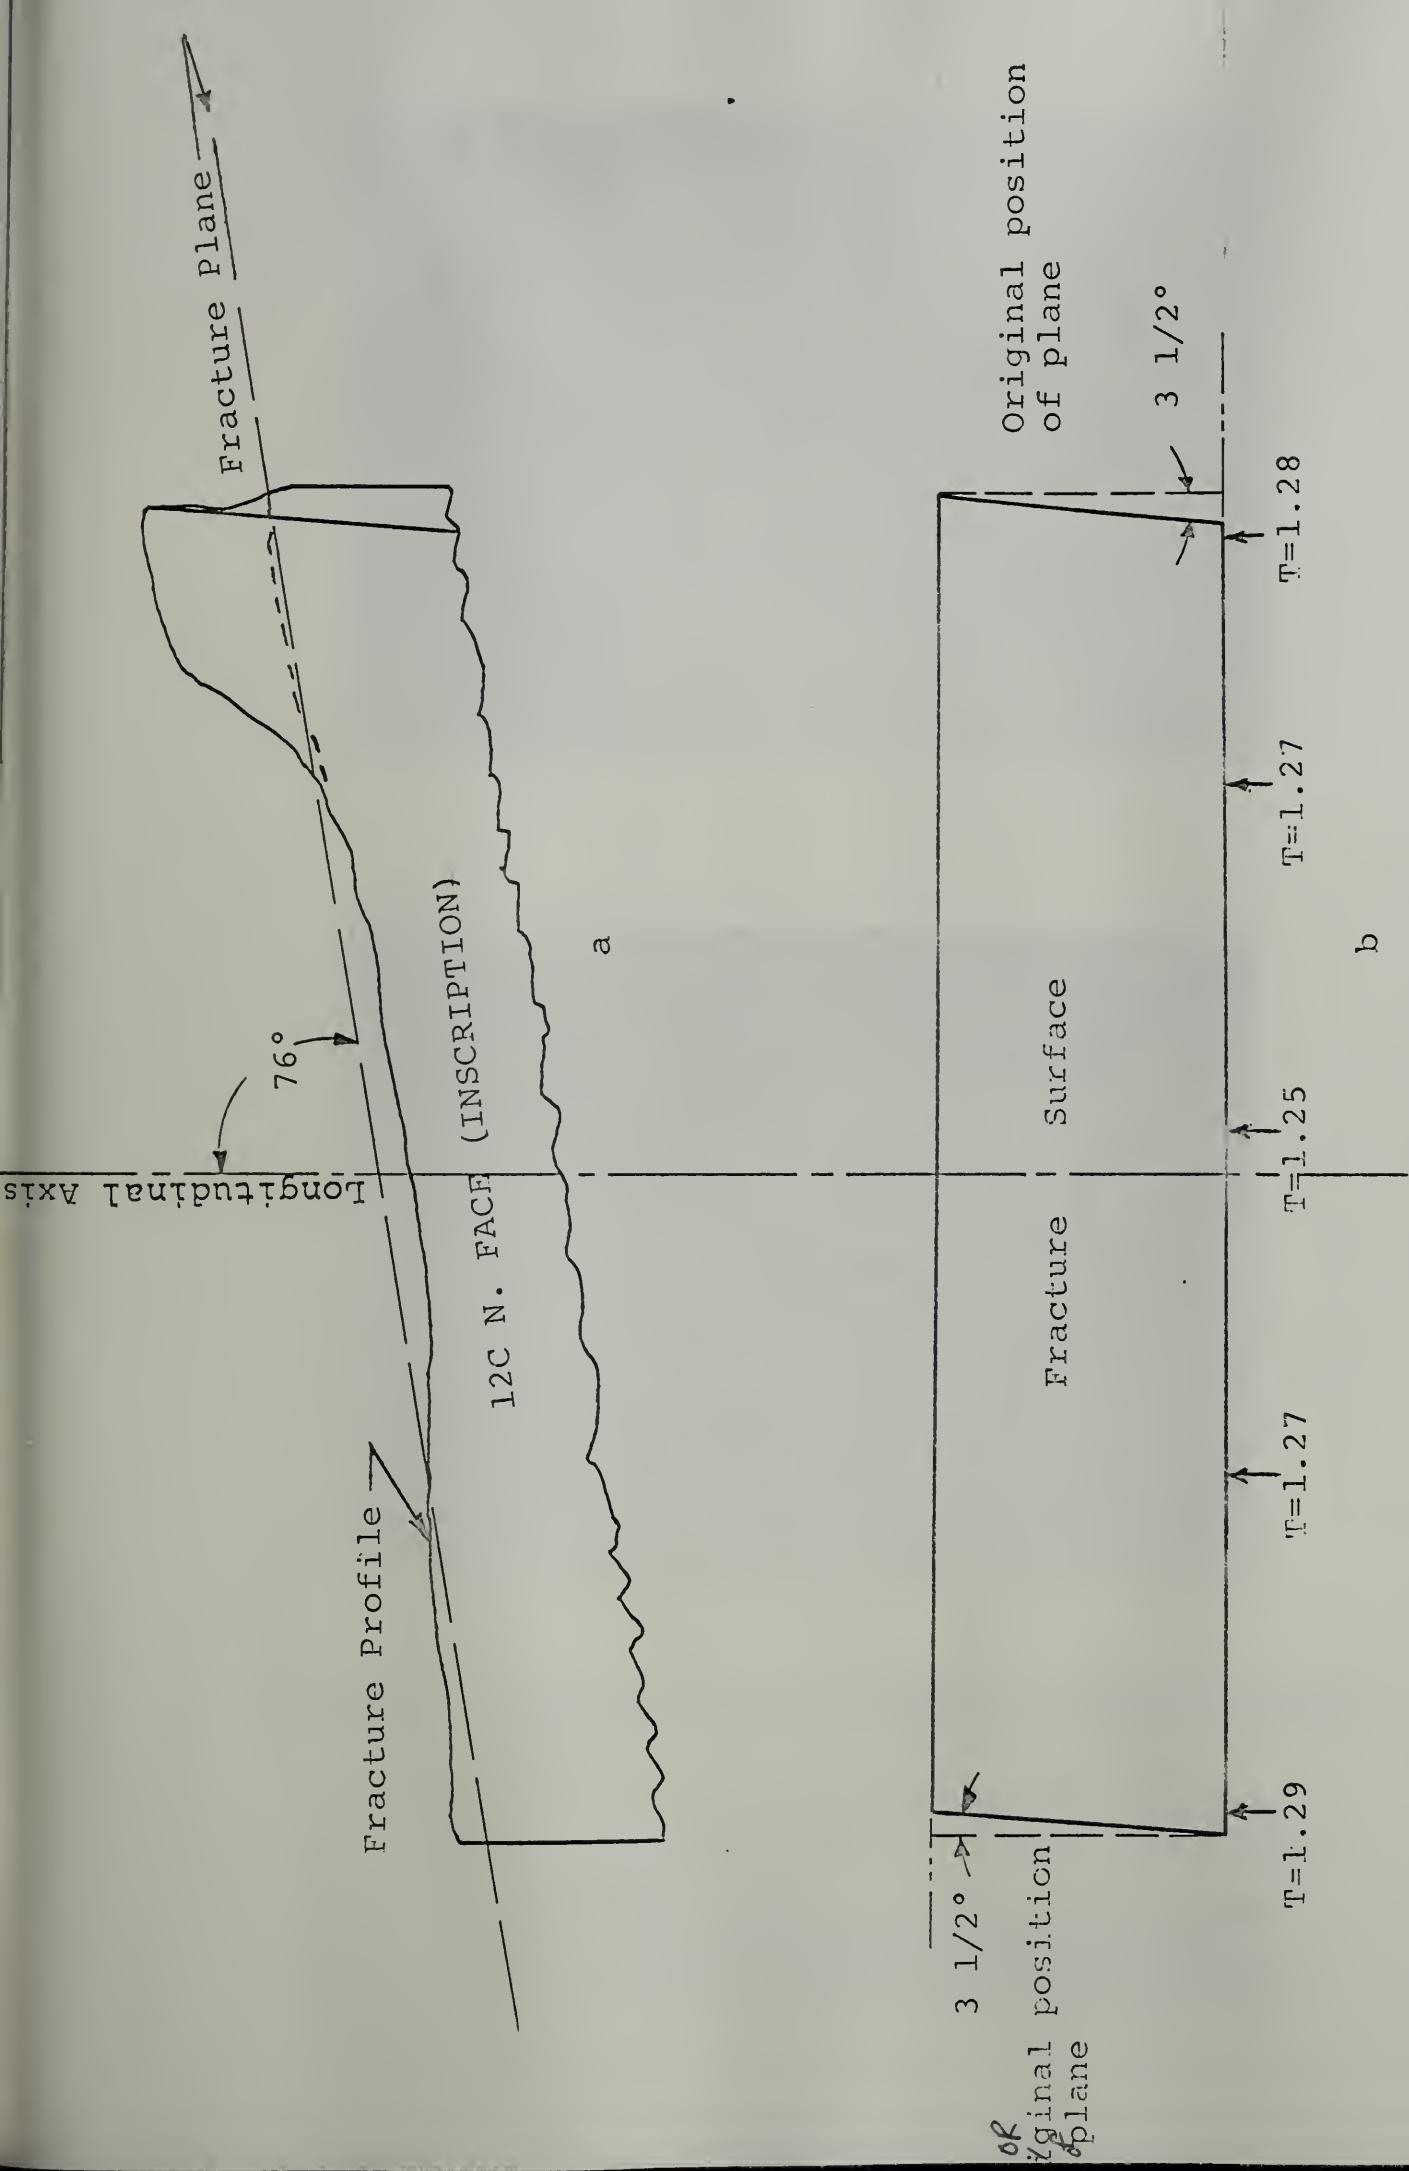
Figure 3. Fractures of 12C hanger section containing fracture surface.

The fracture surface at the origin was a relatively flat area about the size of a thumb nail. The remainder of the fracture surface was hackly. The plane of the fracture was oriented at approximately 76 degrees from the longitudinal axis of the hanger, Figure 3a. Appreciable necking of the hanger occurred prior to fracture (see Figure 3b).

The presence of continuous cleavage throughout a great part of the fracture surface and the presence of secondary cracks adjacent to the main fracture path would seem to indicate that a high energy type of fracture occurred. Torsional or bending stresses were evidently involved. This is indicated by the twisted nature of the fragment. The pre-existing, lead-containing crack, in the 12C hanger was a stress raiser that contributed to initiation of the fracture.

- a. Fracture plane oriented at angle of 76 degrees to longitudinal axis of hanger.
- b. Planes of end surfaces rotated $3\frac{1}{2}$ degrees from original positions. T-values are thickness in inches of section at stations shown.

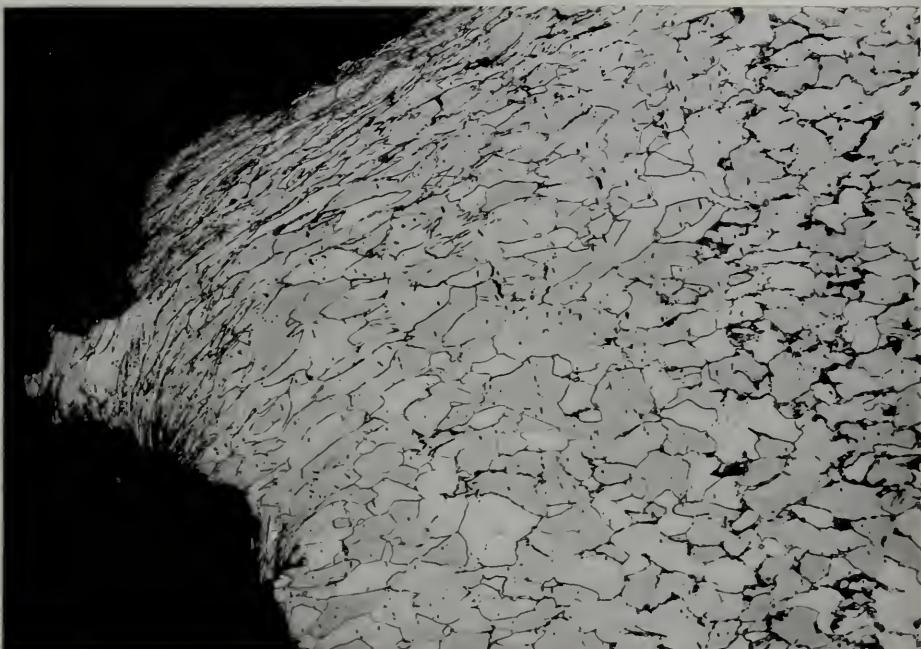
Metallographic Examination: The microstructure of the 12C hanger material was examined at several points along the fracture profile and in areas adjacent to the fracture surface. Decarburization and deformation were observed at the fracture origin, Figure 4a. Continuous cleavage of grains predominated in the section of the fracture profile containing lead, and beyond, (see Figure 4b). Secondary cracks were observed adjacent to the fracture surface approximately one inch from the origin, Figures 5a and 5b. In examination of the structure at mid-section the following were observed:

- a. Decarburization on the side where the fracture originated.
- b. Non-uniform microstructure. A medium-sized grain structure consisting of pearlite in a ferrite matrix in outer areas of the hanger section gave way to coarse grains in a ferrite network in the interior of the section.
- c. A ferrite band extended longitudinally through the middle of the hanger.

It is believed that a crack was formed at what was later to become the fracture origin during fabrication of the hanger. The crack could have resulted from hot shortness of the material. The existence of a pre-existent crack at the fracture origin may be inferred from the FBI report. In this report lead paint found at the fracture origin was considered to have been deposited wet. This would indicate the presence of a pre-existent crack.

- a. Deformation and decarburization at fracture origin. Note large grain size.
- b. Continuous cleavage predominated in the section of the fracture profile where lead was deposited.

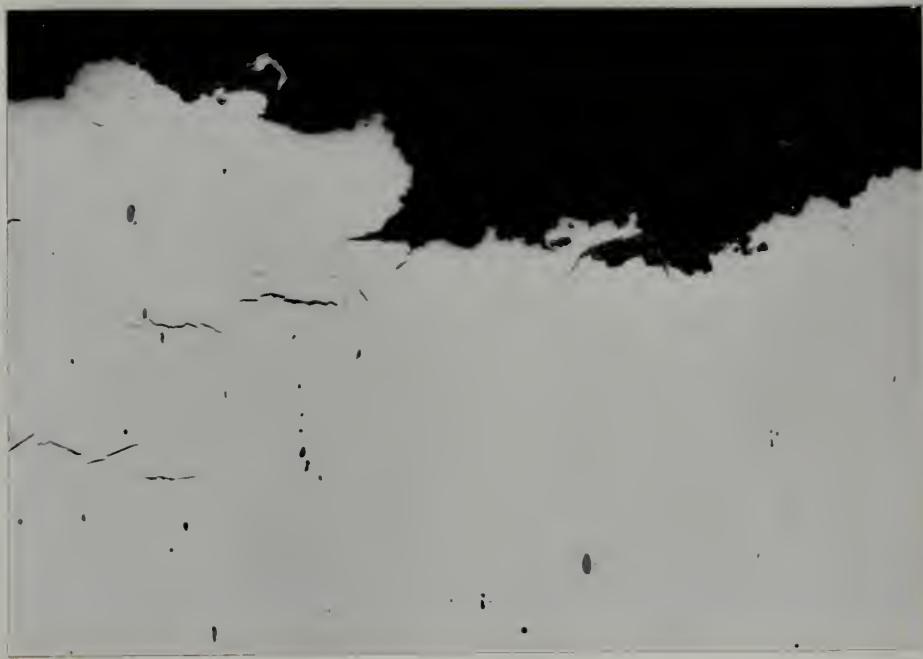
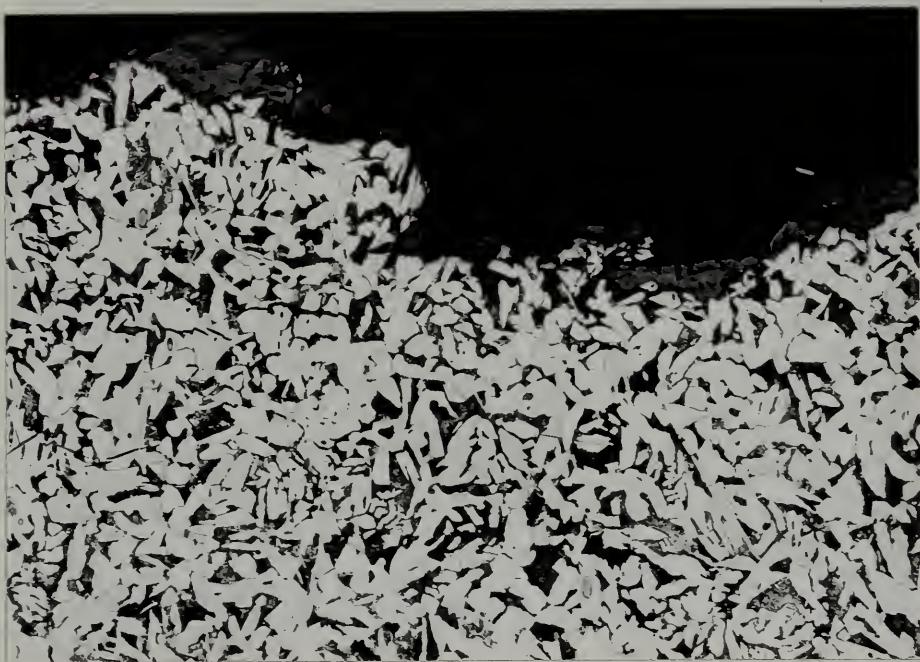
Figure 5. Secondary cracks approximately one inch from fracture origin. X 100

- a. Unetched.
- b. Etched with 1% Nital. Note trans-crystalline nature of secondary cracks.

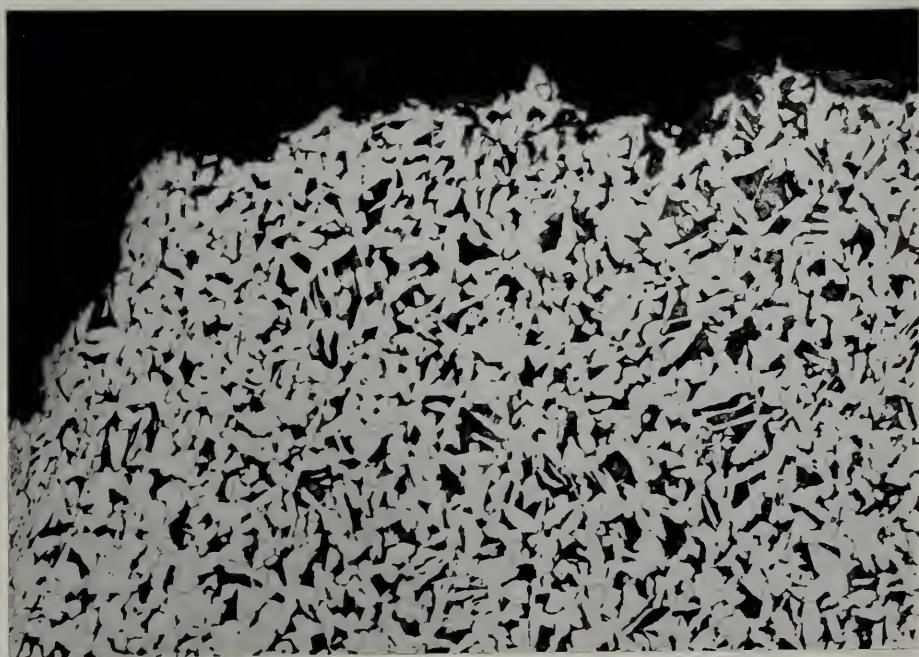
- a. Discontinuous cleavage, Figure 6a.
- b. Additional secondary cracks, Figure 6b.
- c. Propagation of the secondary crack of Figure 2a through a ferrite band, Figure 7.

Figure 6a. Discontinuous cleavage in fracture profile at mid-section. Etched with 1% Nital. X 80

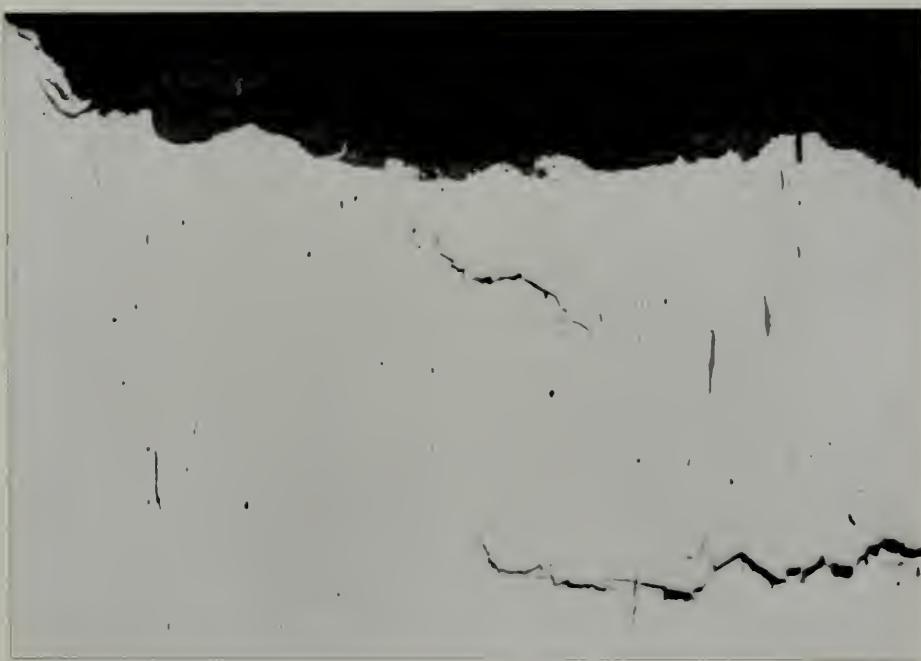
b

Figure 6b. Secondary cracks observed at mid-section. Unetched. X 80

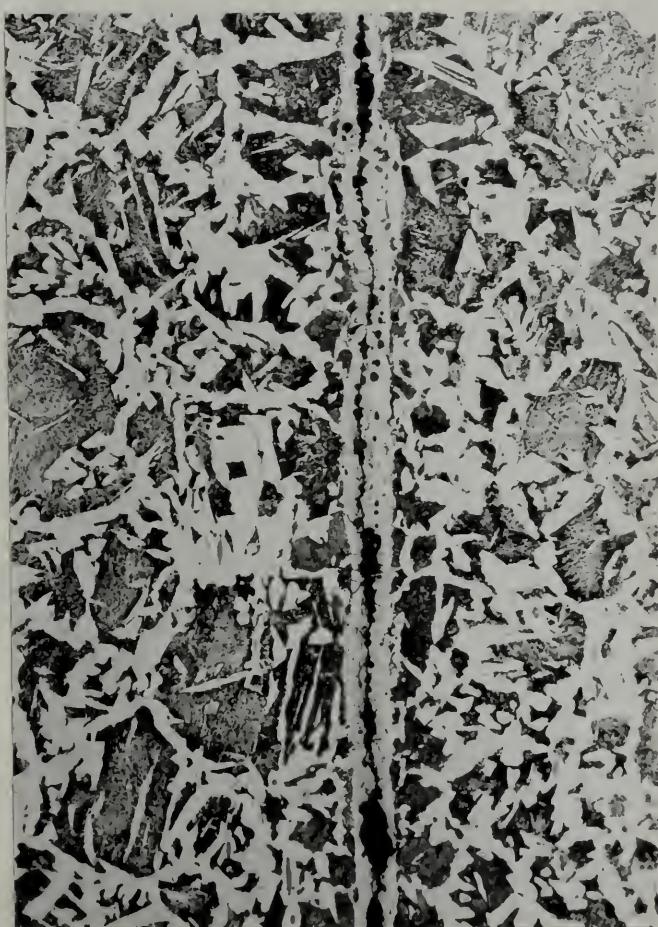
Figure 7. Secondary crack of Figure 2a is shown propagating through a ferrite band. Note large grain size and ferrite grain boundary network (white). Etched with 1% Nital. X 100
