NATIONAL BUREAU OF STANDARDS REPORT

REPORT ON THE PERFORMANCE OF
ASBESTOS FIBER-BASE BUILT-UP ROOFS

7 February 1969

Thomas H. Boone and Leopold F. Skoda

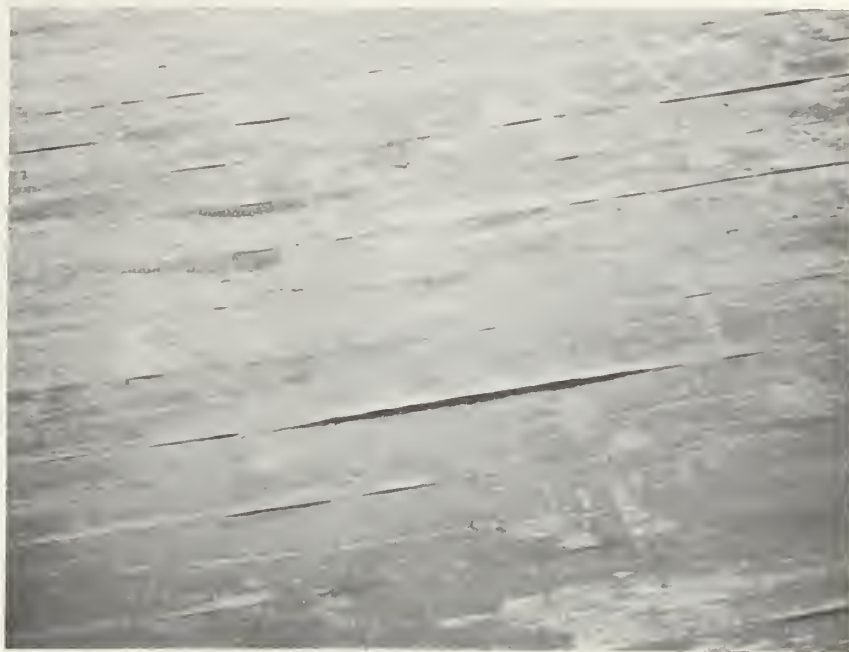
FIGURE 2. Delamination of asbestos felt
on smooth built-up roof.

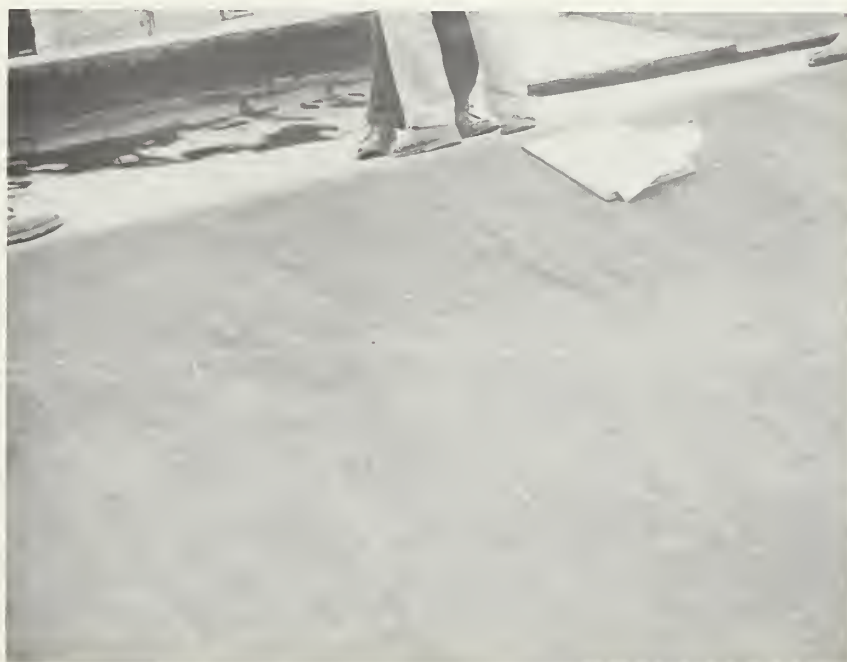
FIGURE 3. Blister caused by poor interply
adhesion.

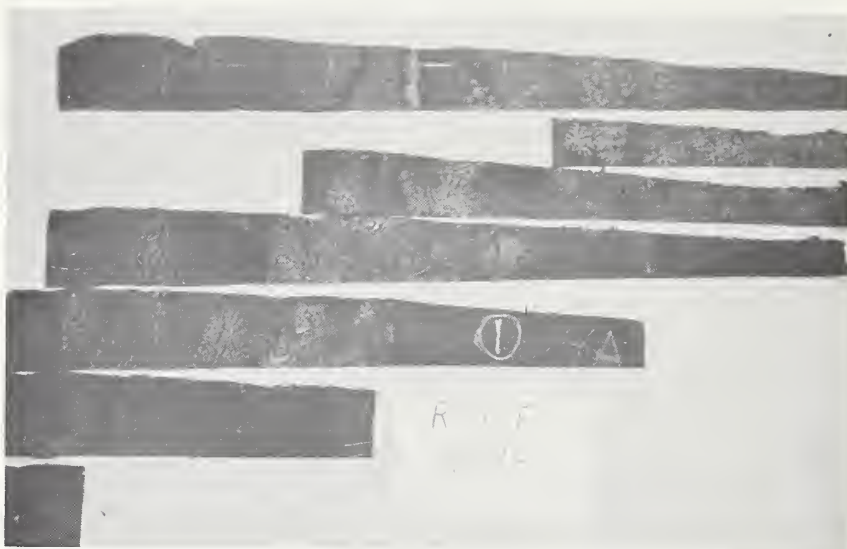
FIGURE 4. Separated plies of asbestos felt from cut-out of roof, FIGURE 3, showing lack of bond between plies.

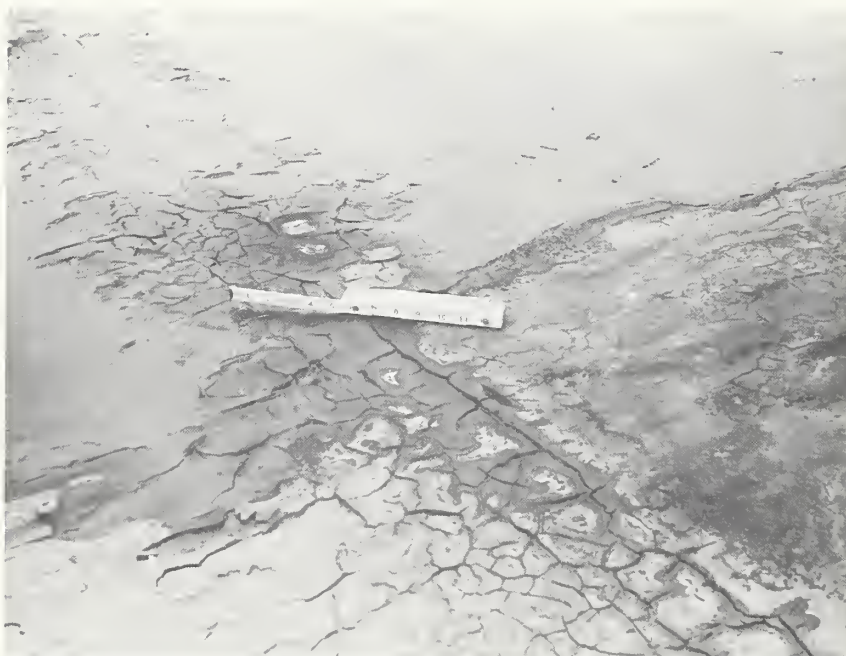
Roof No.	Age Yrs.	By Building Owner	Roof Inspection at Site - 1968	Laboratory Inspection of Cut-Outs
1	13	Excellent service	Well constructed, Excellent appearance	Excellent workmanship, No deterioration noted
2	17	Minor repairs needed	Coating worn, Felt exposed, Felt delaminated (see Fig. 2)	Good workmanship, No deterioration noted
3	18	No leaks	Separation between deck & membrane, blisters.	
4	18	No leaks	Fair appearance, Numerous blisters (see Fig. 3)	Interply loss of adhesion approx. 50% (see Fig. 4)
5	18	No leaks	Fair appearance	Good workmanship
6	31	Excellent service	Well constructed, Excellent appearance	
7	6	Minor repairs needed on top surface	Fair appearance, Poor application of top coating	Excellent bond between plies
8	17	Excellent service	Good appearance	Excellent bond between plies
9	13	Severe leaks, some repairs made	Badly blistered, Top surface cracked & alligatored (see Fig. 5)	Poor adhesion between plies, Similar to roof No. 4

FIGURE 5. Cracking of top coating on smooth surface asbestos built-up roof.

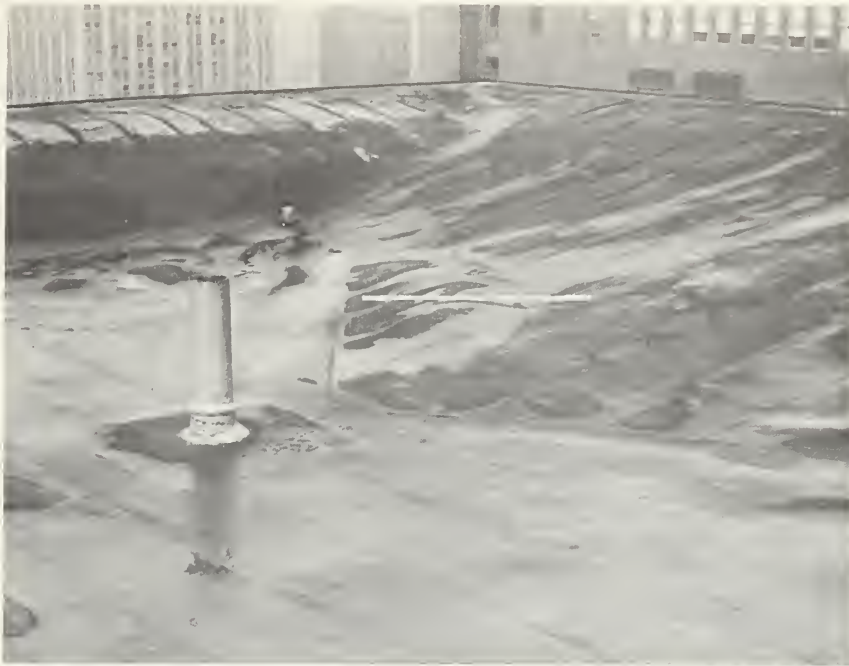
4. In several cases the entire membrane was separated from the deck. This was attributed to moisture from beneath the deck and in one case (Roof No. 11) incompatibility between an asphalt roof placed over an existing coal-tar roof.

10	18	Minor leaks, Some repairs made	Separation of T&G wood deck caused splits in roof membrane	Poor adhesion between plies, Similar to roof No. 4
11	13	No leaks	Large blisters (see Fig. 6)	Poor adhesion between top 3-ply asphalt roof & bottom 3-ply coal-tar roof
12	16	Roof damaged by wind storm	Few blisters of surface coating

FIGURE 6. Large blister caused by incompatibility of top asphalt built-up roof with that of bottom coal-tar roof.

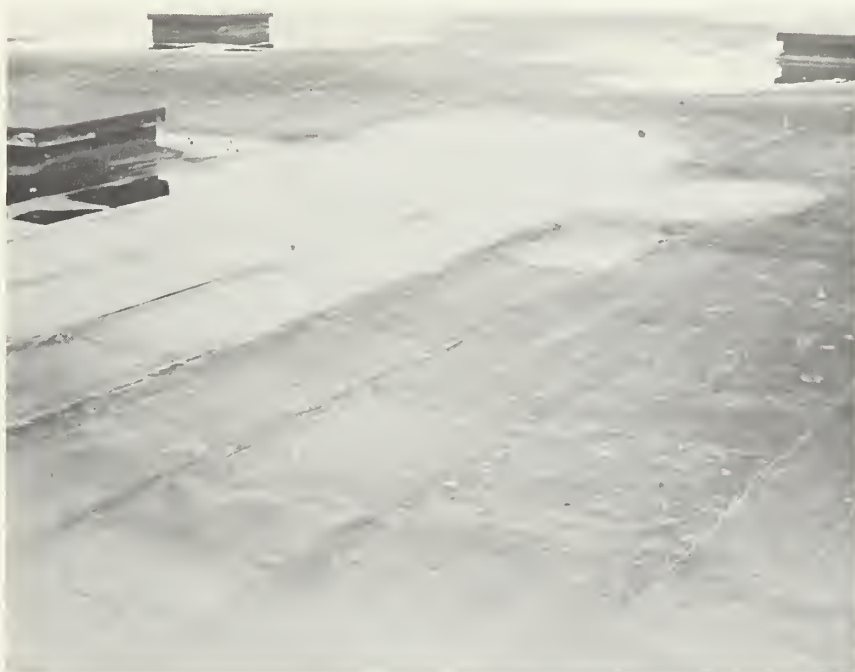
Roof No.	Age Yrs.	By Building Owner	Roof Inspection at Site - 1968	Laboratory Inspection of Cut-Outs
13	11	No leaks	Poor roof design, evidence of deck and insulation movement (see Fig. 7)	Excellent bond between plies, & to insulation
14	9	No leaks	Good appearance	Good bond
15	15	No leaks	Good appearance, Some coal-tar flow	Excellent bond between plies
16	29	Excellent service	Excellent, New coating applied 1967	Excellent bond between plies
17	6	Experimenting with 2-ply system, not entirely successful	Some blisters	Large delaminated areas between plies
18	12	Trouble caused by high humidity within paper mfg. plant. Also 2-ply experiment	Blisters and splits	Some delamination between plies
19	11	Some repair needed, Also 2-ply experiment	Some splits	Some delamination between plies
20	12	Extensive repair, Also 2-ply experiment, Severe leaks	Very poor & troublesome roof, caused by moisture within building.	Some delamination between plies

FIGURE 7. Eleven year old asbestos roof membrane providing leak-free service despite extreme deck and insulation movements.

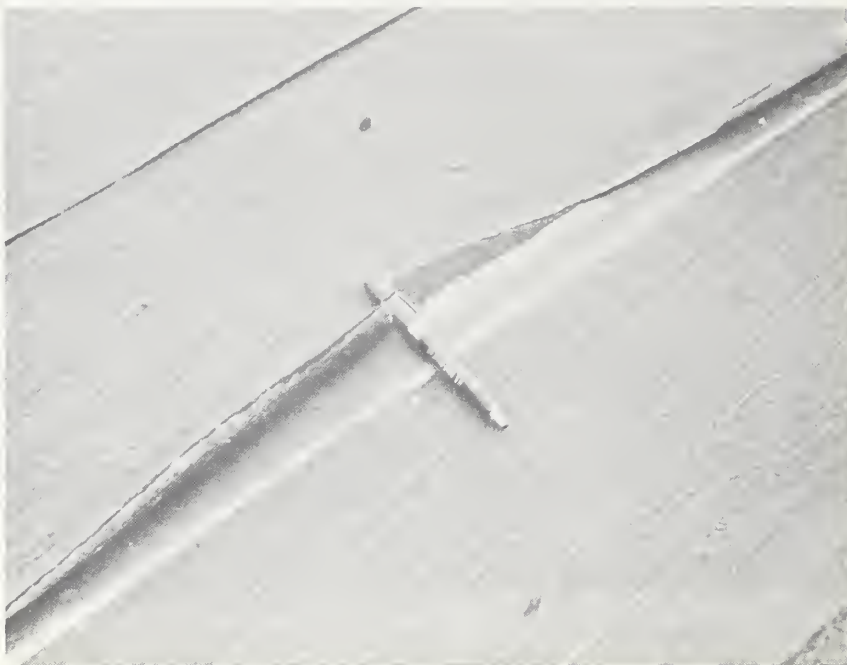
21	18	No leaks	Numerous blisters	Excellent bond between plies
22	13	No leaks	Extensive blisters	Excellent bond between plies
23	10	Subjected to several hurricanes, No leaks	Coating on south exposure worn off, Some felt torn	Excellent bond between plies
24	15	History of leaks	Roof covered with mineral cap sheet, Few large splits	Splits through complete membrane
25	15	Subjected to several hurricanes, No leaks	Coating worn off, Felts at laps delaminated & torn (see Fig. 8)	Excellent bond between plies

Figure 8. Asbestos felts delaminated and torn. This roof was subjected to several hurricanes.
