OBSERVATIONS ON THE BEHAVIOR OF BUILDINGS IN THE ROMANIA EARTHQUAKE OF MARCH 4, 1977

NBS SPECIAL PUBLICATION 490

U.S. DEPARTMENT OF COMMERCE / National Bureau of Standards

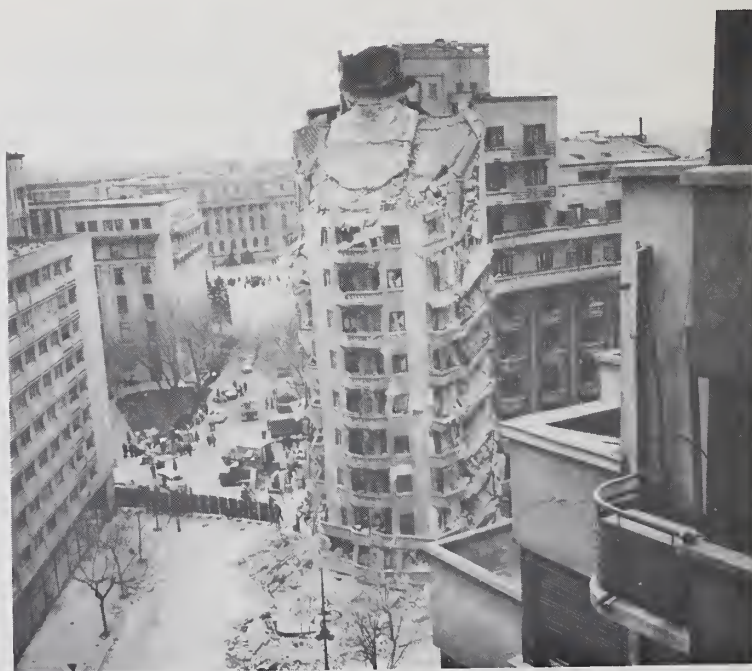
A typical example of partial building collapse precipitated by failure in the lower stories is provided by the photographs in Figures 3.7 and 3.8 taken

soon after the earthquake. Referred to as the Wilson Building, this was a 12-story apartment structure in which failure of the first story columns caused the corner bays to shear off from adjacent bays and vertically impact the ground. The collapse of the top story roofs shown in Figure 3.7 was possibly a follow-up action triggered by this impact.

Figure 3.7. General view of failure of Wilson apartment building.

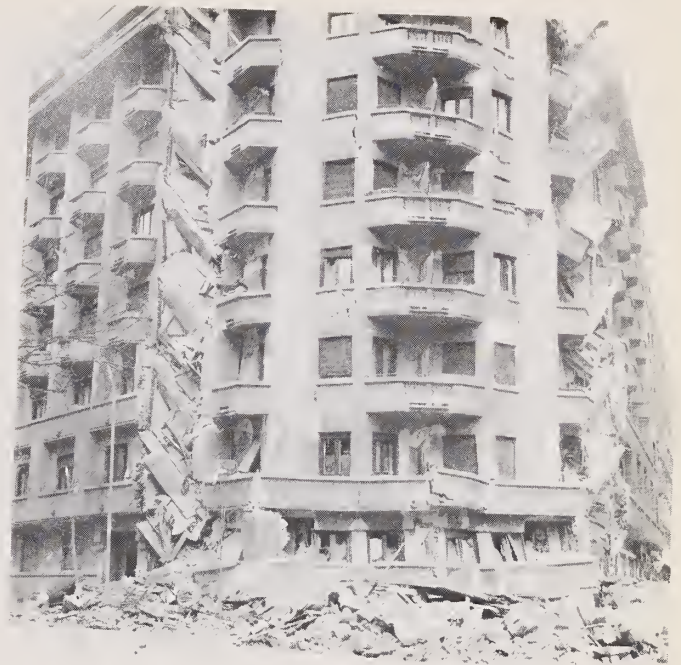
The framing configuration of this building is not apparent from the photograph. In Figure 3.8, the two large pillars in the foreground appear to be reinforced concrete columns, judging from a joint failure at the (present) fifth floor level. Otherwise, there appears to be no reinforced concrete exterior columns in the collapsed portion of the building. The use of two wythes of clay tile units in the construction of exterior walls was common practice for this type of structure.

Figure 3.8. Close-up of damaged Wilson building.

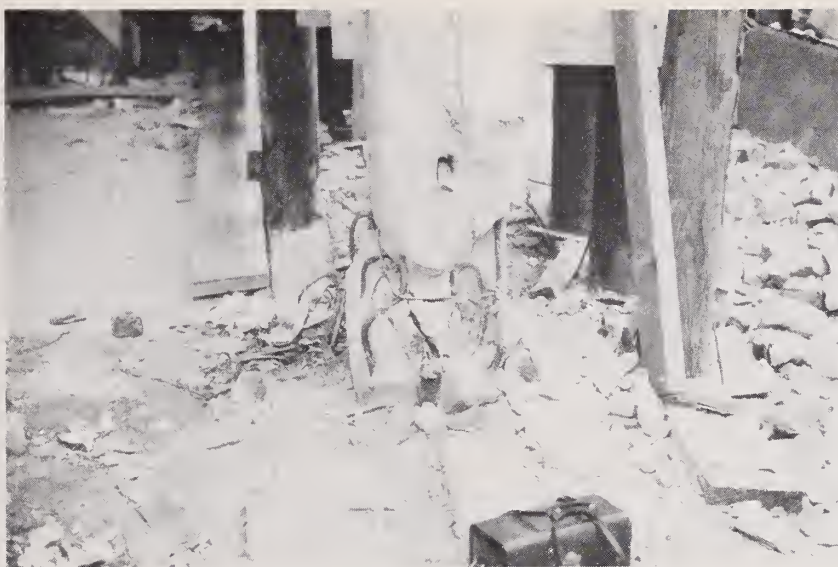
The failure of an interior column (Figure 3.20) exposed four vertical bars, approximately 20mm in diameter, and a single tie, approximately 6mm in diameter, spaced from the base a distance equal to the depth of the column. Four hooked footing dowels projected into the base of the column. The column that failed in shear (Figure 3.21), did not appear to have any ties within the height of the spalled concrete which was twice the depth of the column. All bars were plain.

Figure 3.20. Failure of interior first story column at the base indicating lateral displacement.

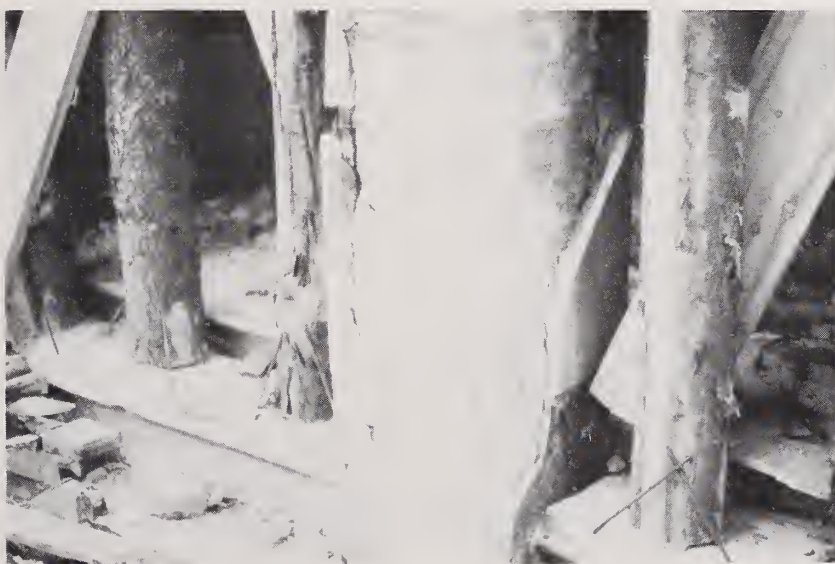
Figure 3.21. Shear failure at the base of first story interior column.

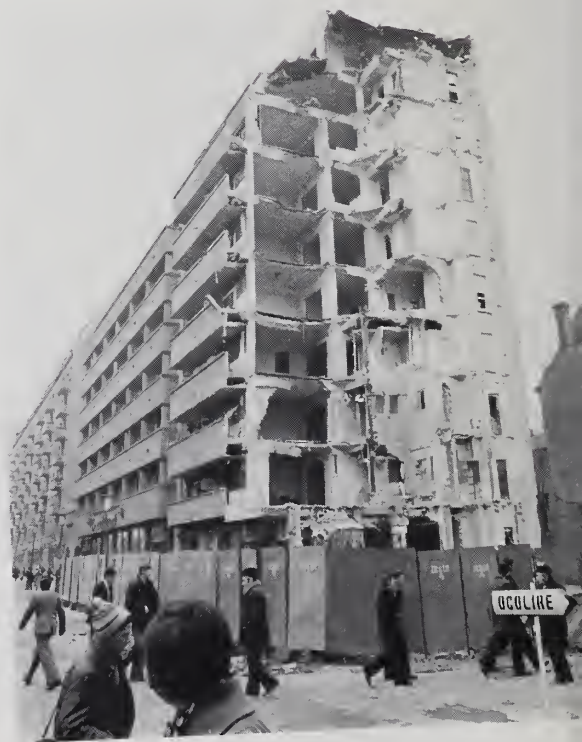
Figure 3.24. Damage due to pounding of the Casata building with the next structure.

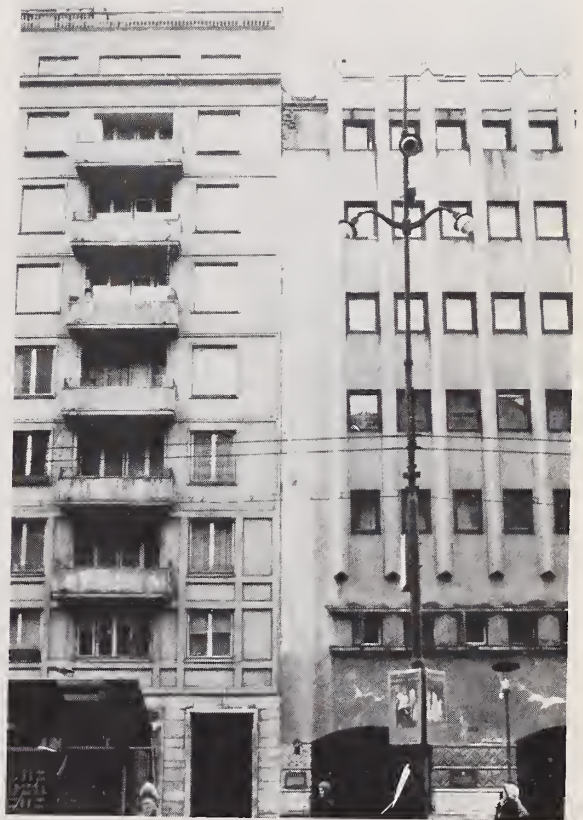
Figure 3.25. Pounding damage to other structures in the Casata building block.

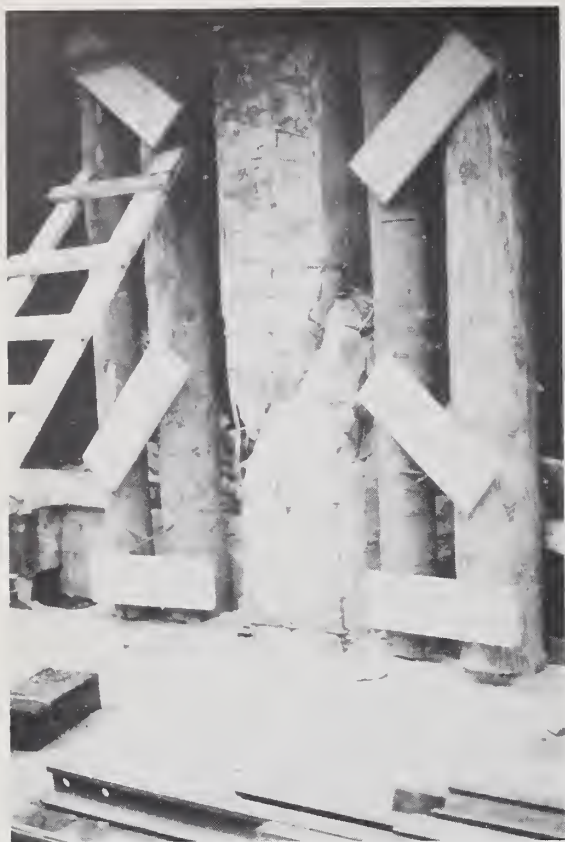
Figure 3.26 shows shear failure observed in an interior first story column. A total of six vertical bars were used in the column, three in each face, and approximately 16mm in diameter. The single ties were approximately 6mm in diameter and were bent only around the corner bars. In general, concrete cover was insufficient and at certain locations non-existent. Note, for instance, that on the unspalled top surface of the column, ties as well as vertical bars are visible with one of the ties inclined 15 degrees with respect to the horizontal.

Figure 3.26. Damage to interior column in the first floor.

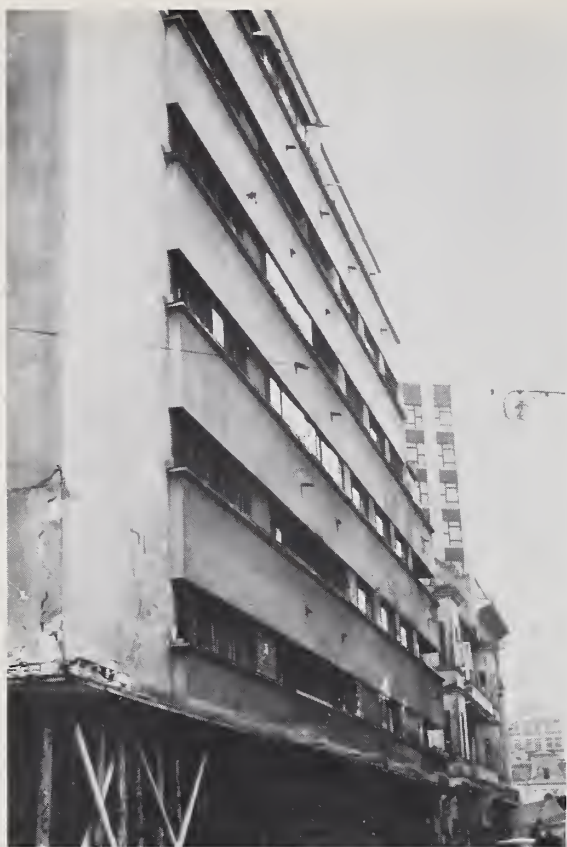
Figure 3.30. West view of Turist building showing substantial facade and masonry damage.

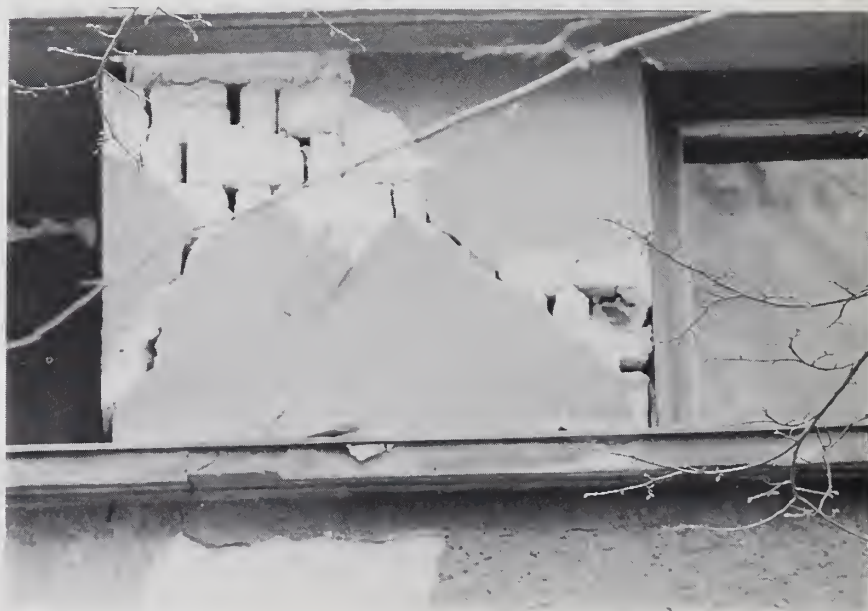
Figure 3.31. Close-up of damaged masonry pier beneath spalled plaster.

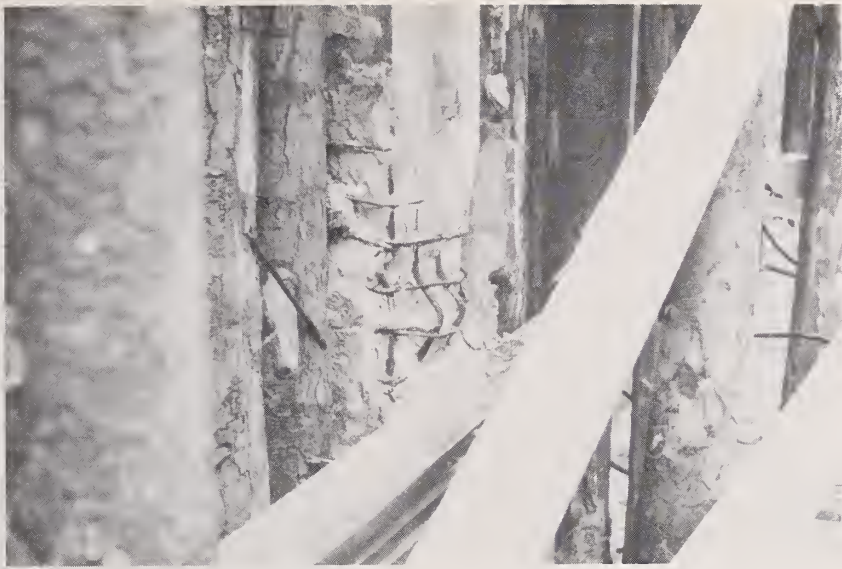
Figure 3.32. Interior view showing failure of first story column at the base.

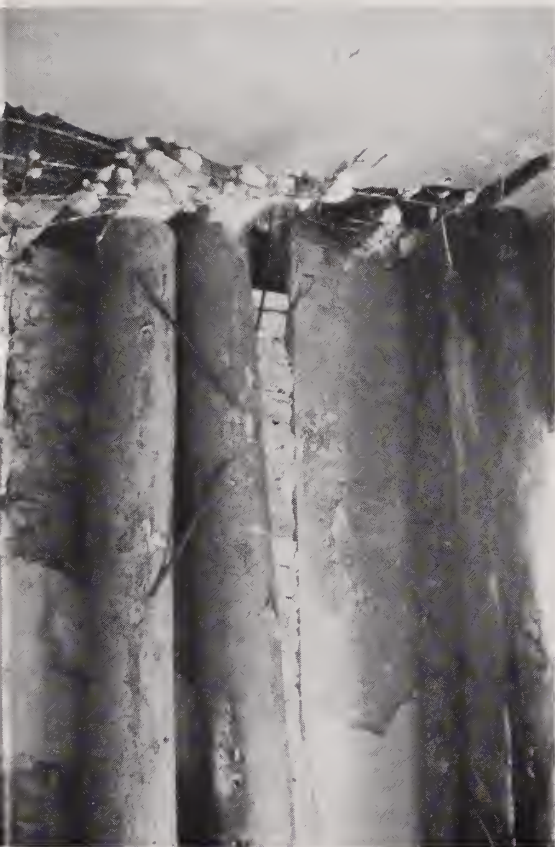
Figure 3.33. Timber logs shoring partially damaged floor slab of second story.

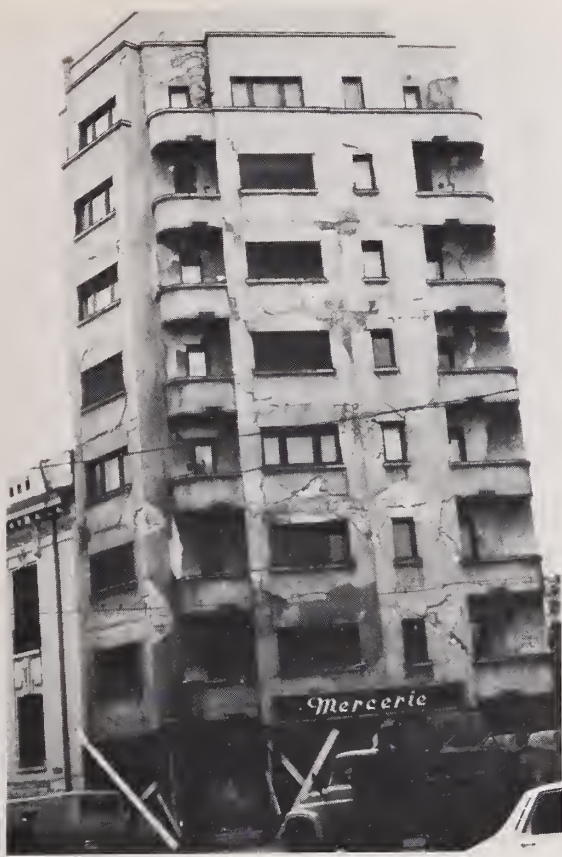
Figure 3.36. Damage of eight-story Mercerie building.

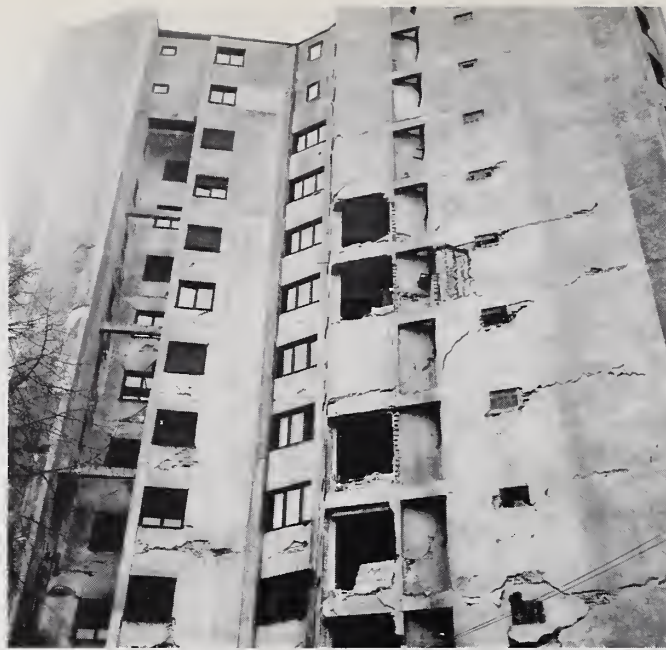
Figure 3.38. Damage of multistory Ambassador Hotel, rear view.

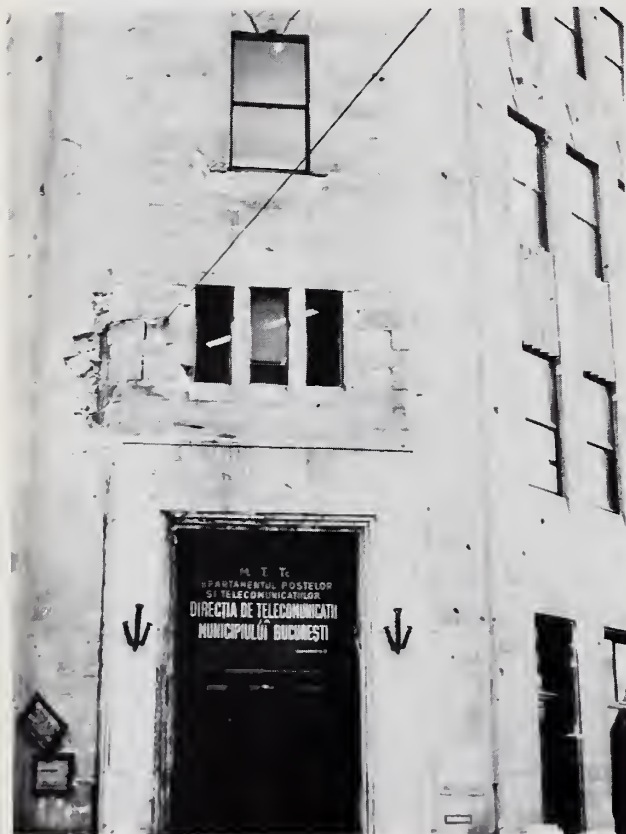
Figure 3.39. Post Office and Telecommunications building showing damage to exterior walls.

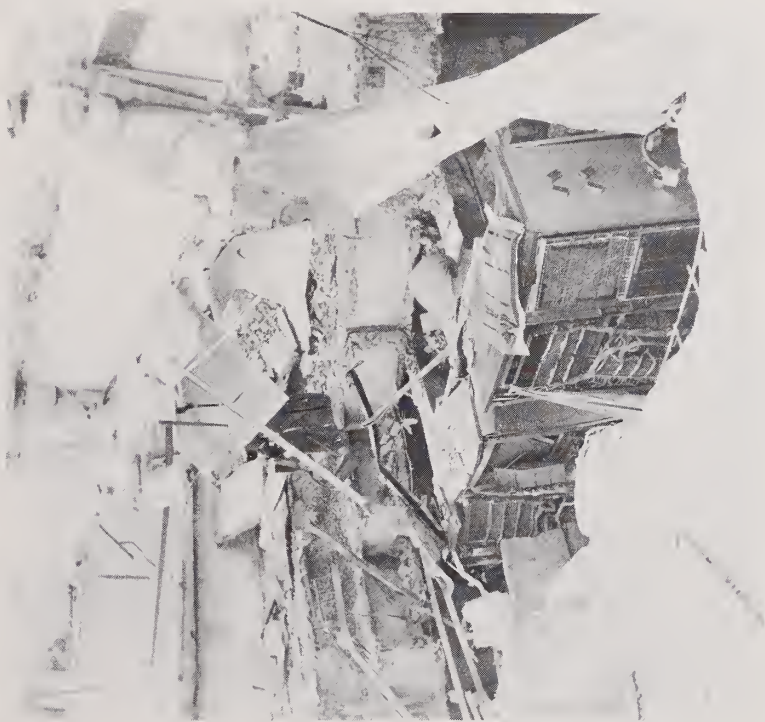
Figure 3.52. Damaged central computer unit.

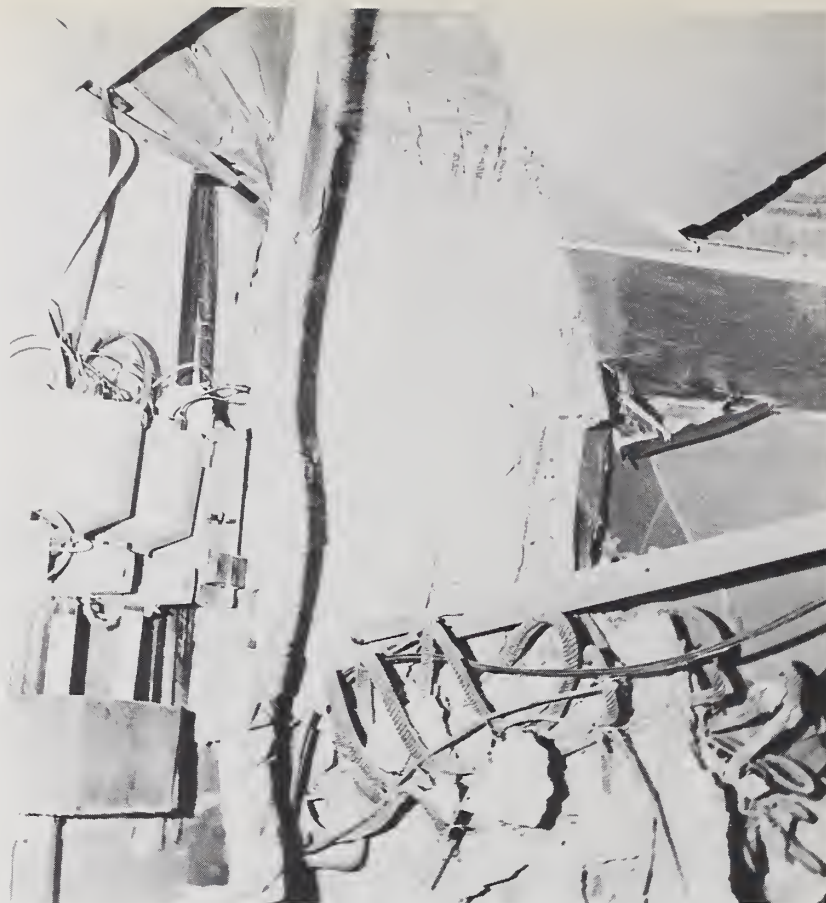
Figure 3.54. Failure of second story column located in the air conditioning room.

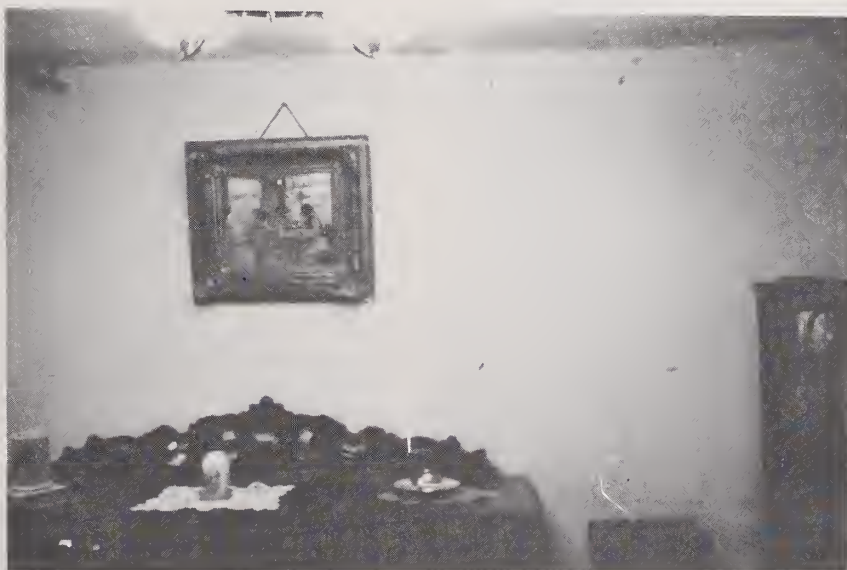
Figure 3.61. Cracking of wall plaster inside second story apartment Building 16.

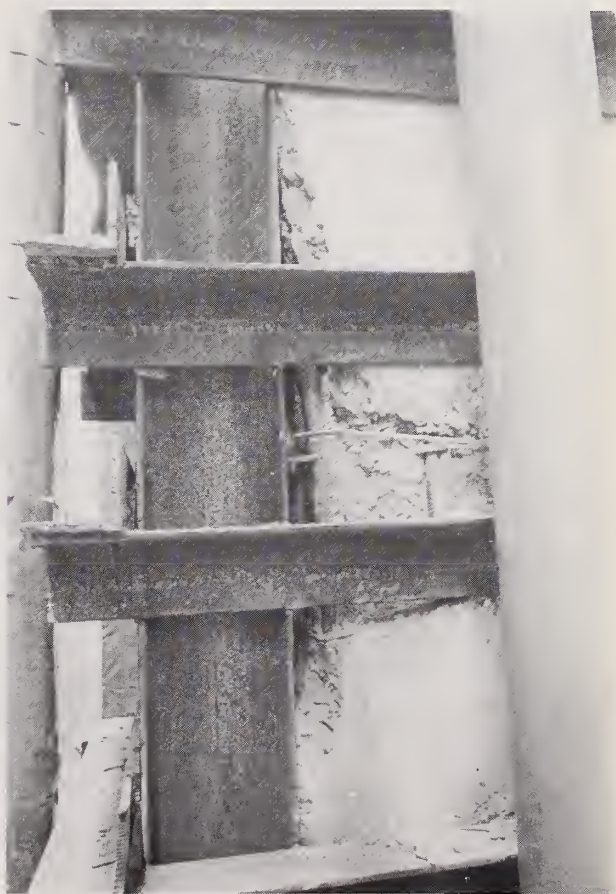
Figure 3.64. Circumferential confinement of a ruptured exterior column in the first story.

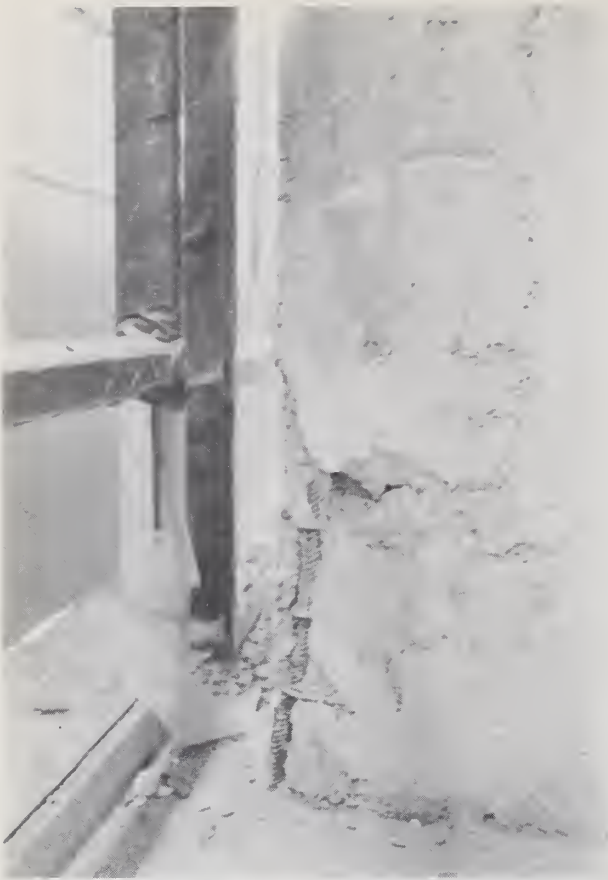
Figure 3.66. Damage at the base of first story exterior column.

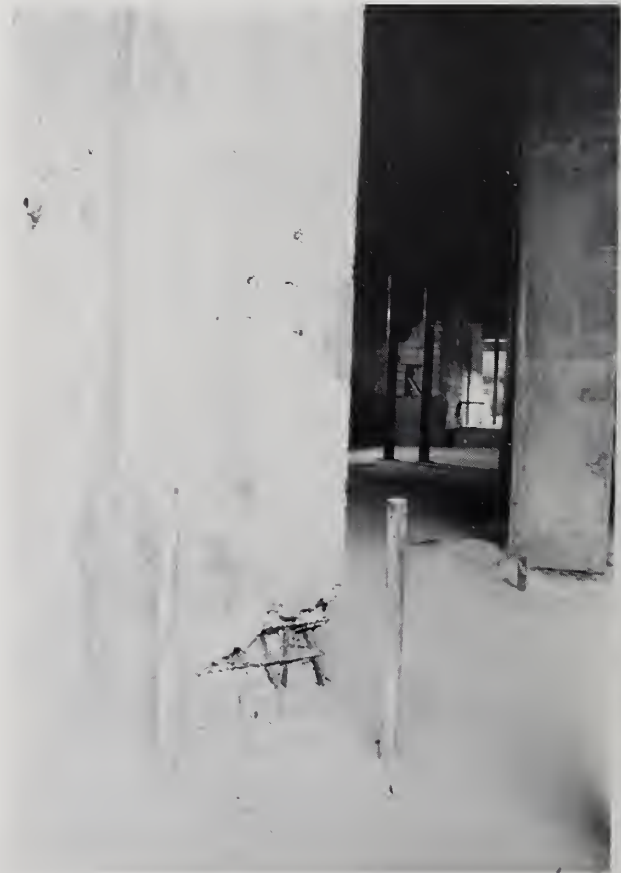
Figure 3.67. Damage at the base of first story interior column.

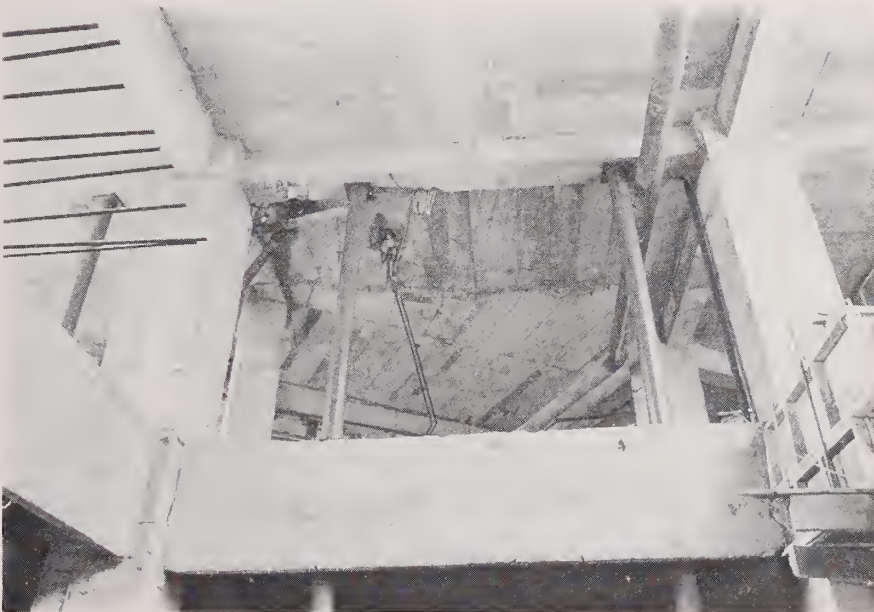
Figure 3.69. Metal pipes used in shoring damaged transverse beams.

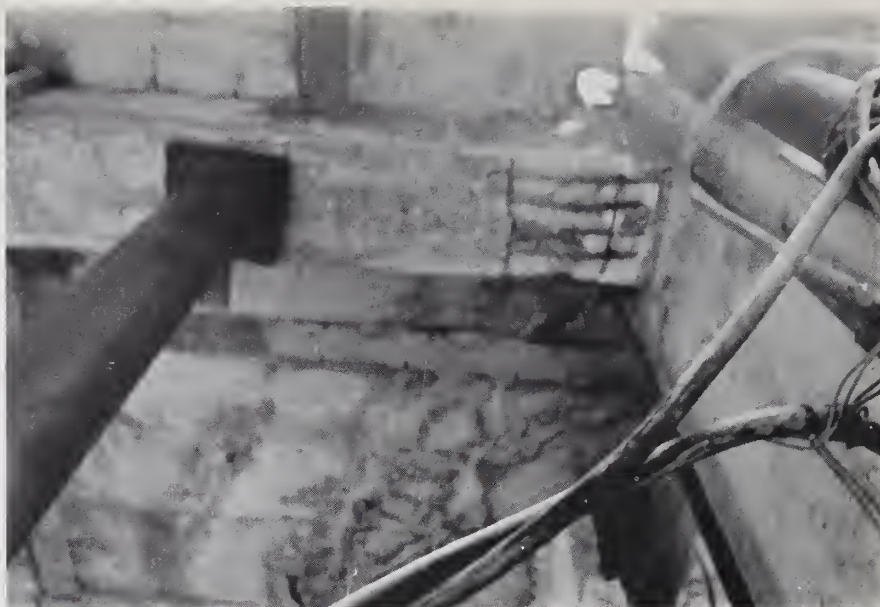
Figure 3.70. Failure of transverse beam at the support.

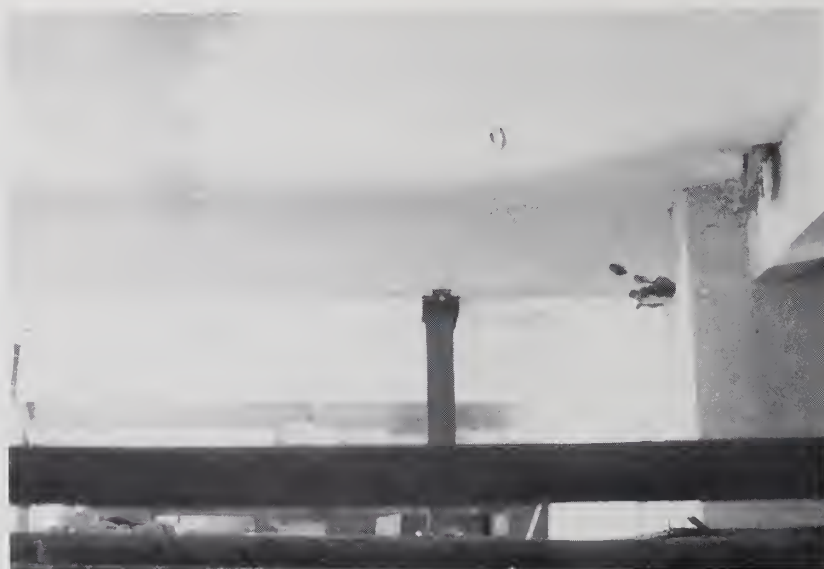
Figure 3.71. Shoring of damaged first story beam in multistory concrete frame building. (Building No. 18)

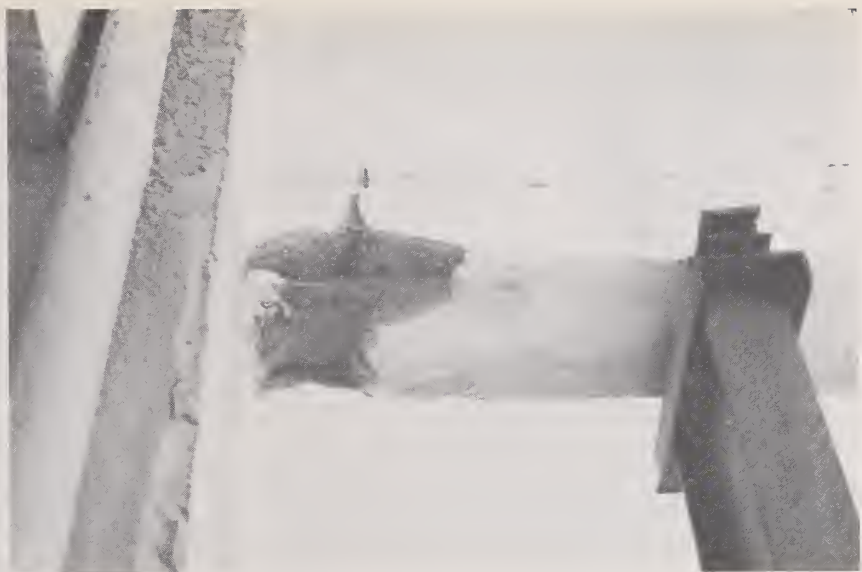
Figure 3.72. Close-up and opposite view of damaged first story beam.

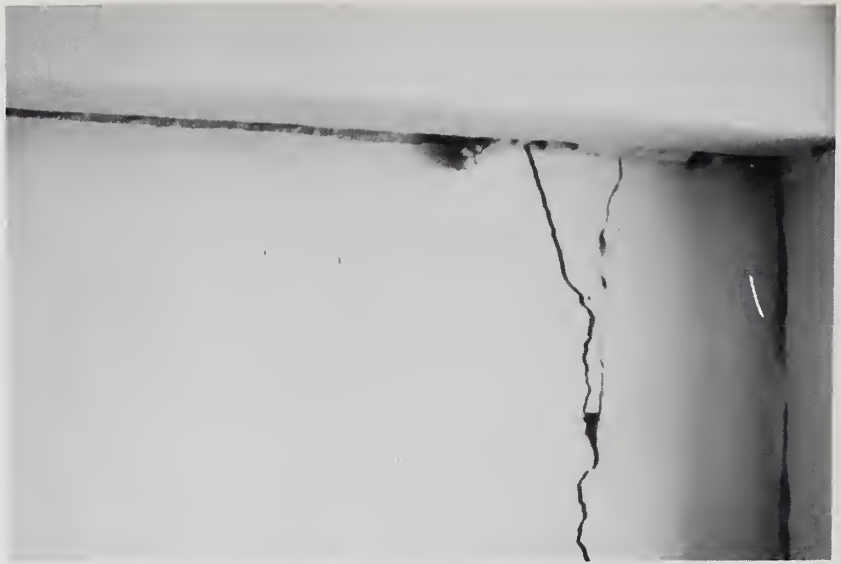
Figure 3.74. Cracking of wall within second story apartment unit.

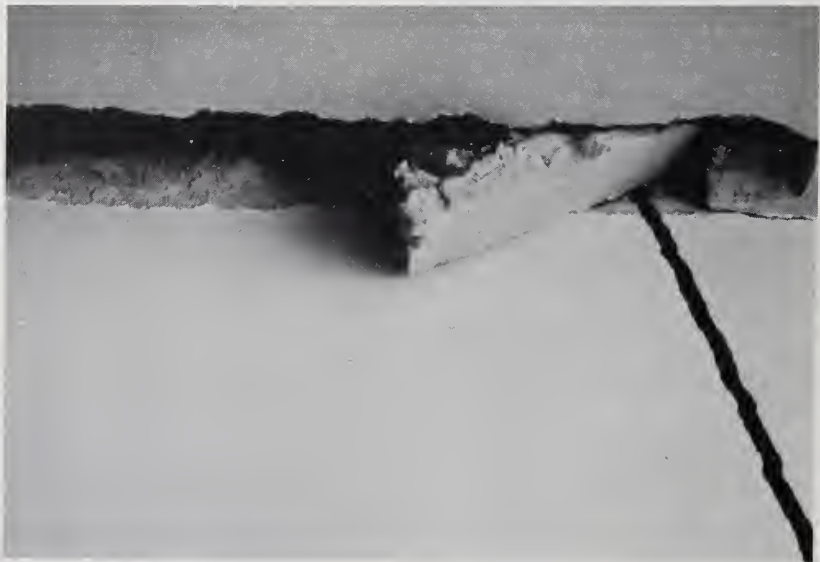
Figure 3.75. Detached masonry units between ceiling and wall.

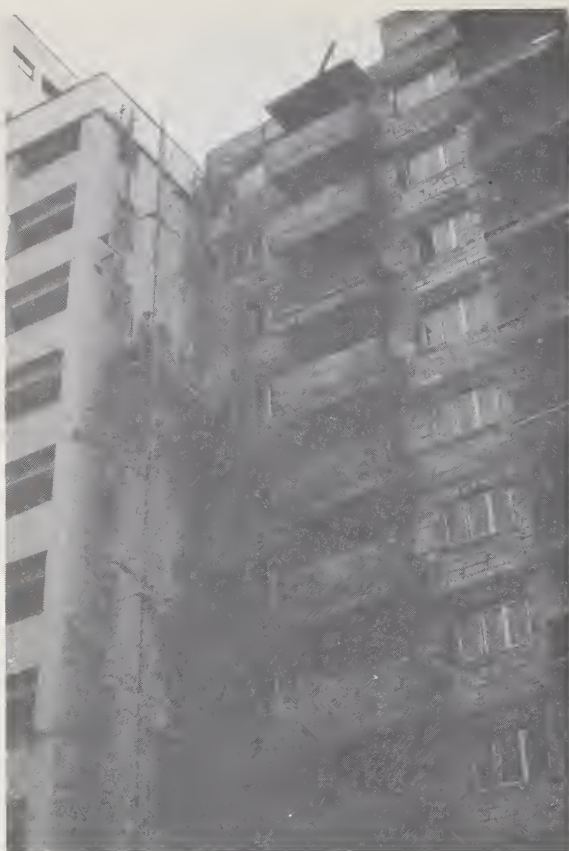
Figure 3.78. Rear view of building shown in Fig. 3.77 showing pounding damage.

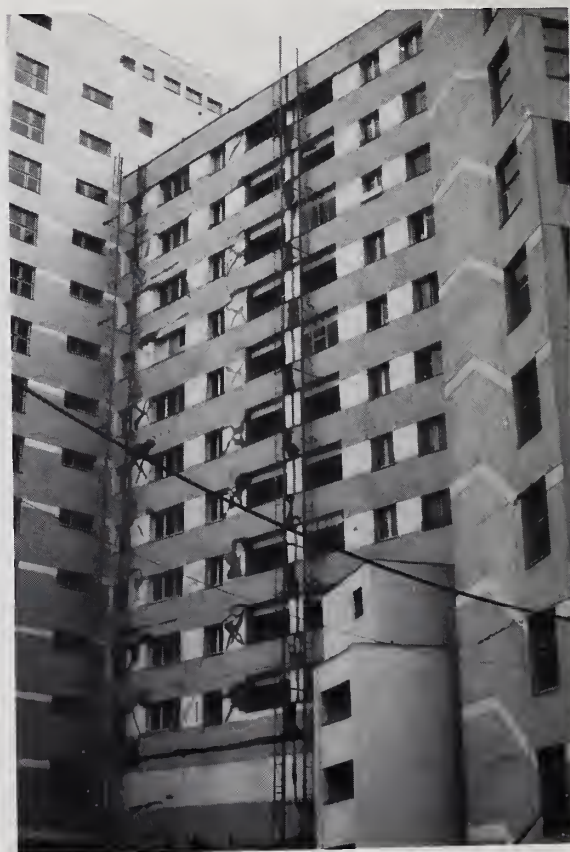
Figure 3.79. Cracking of exterior piers in multistory building.

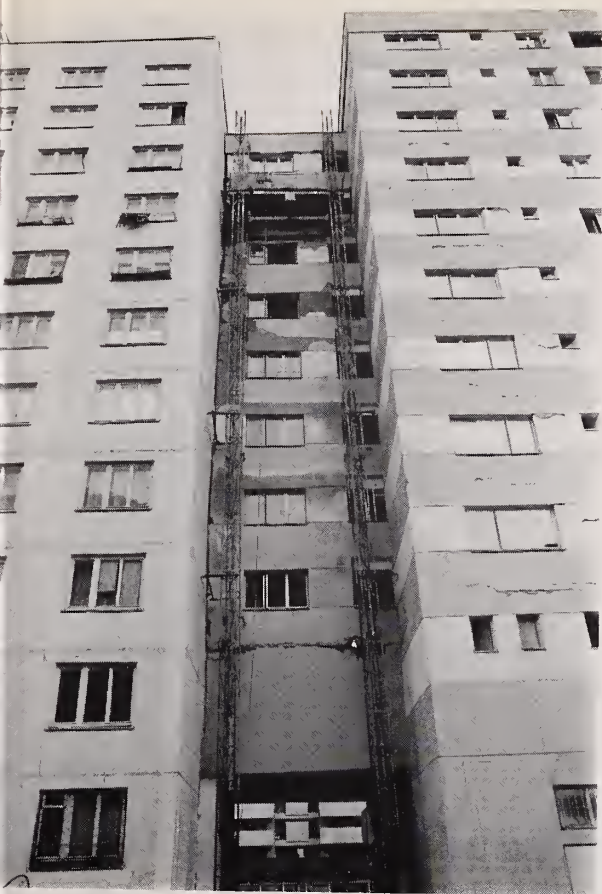
Figure 3.80. General view of superficial damage in concrete frame building next to shear wall building on the left.

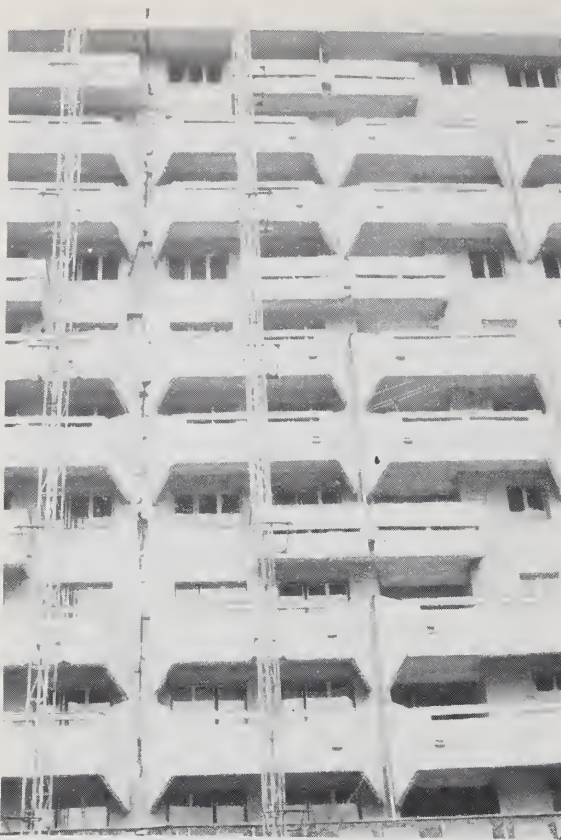
Figure 3.82. Pounding damage to adjacent buildings.

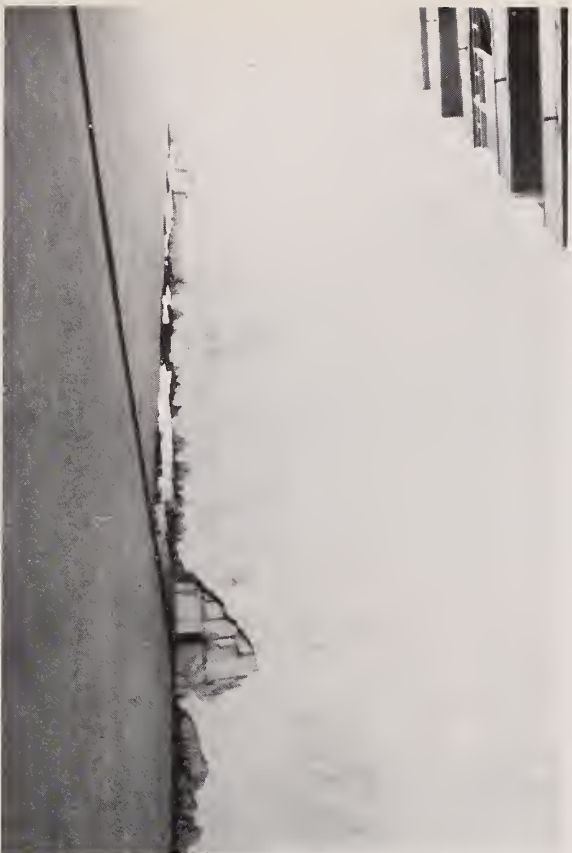
Figure 3.84. Same pounding damage viewed from the opposite side.

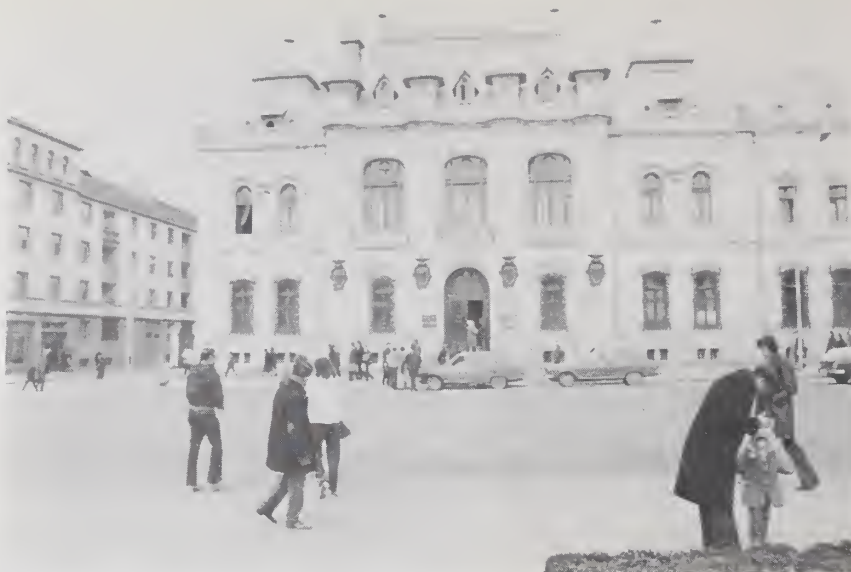
Figure 3.93. Superficial damage of multistory building on campus of National Center for Physics.

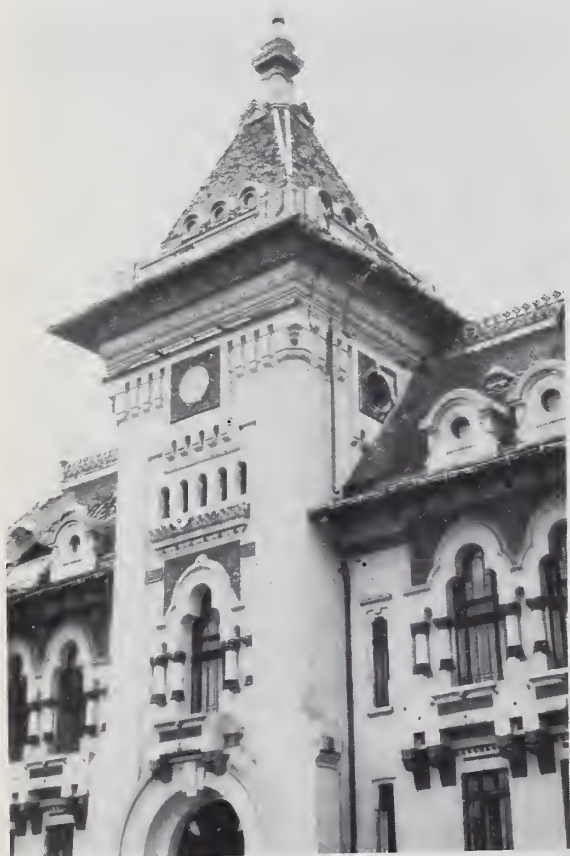
Figure 3.95. View of city administration headquarters building in Craiova showing damaged tower and roof.

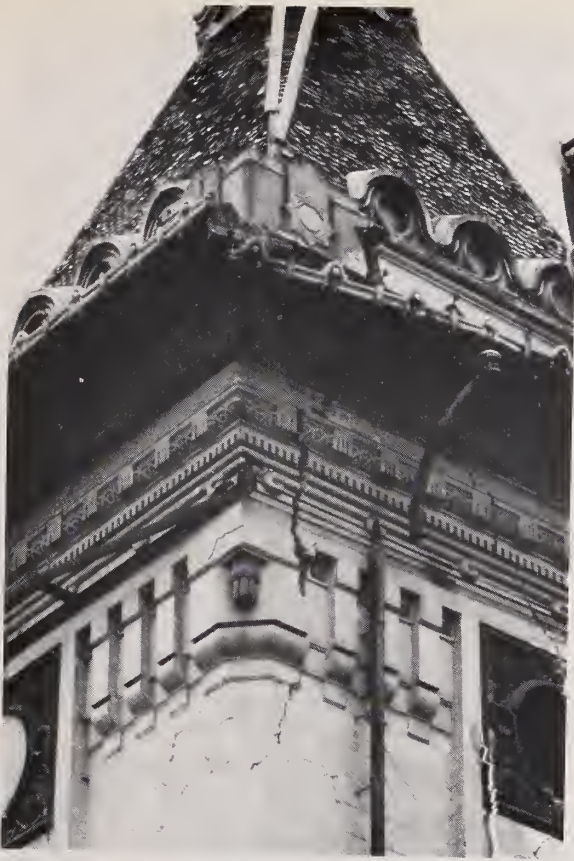
Figure 3.96. Close-up view of damaged tower of city administration building.

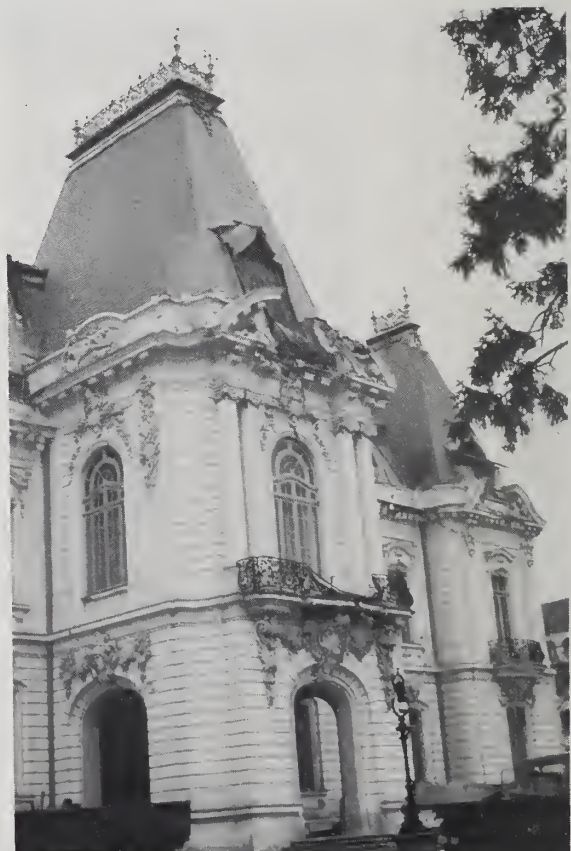
Figure 3.99. Exterior damage to the Art Museum in Craiova.

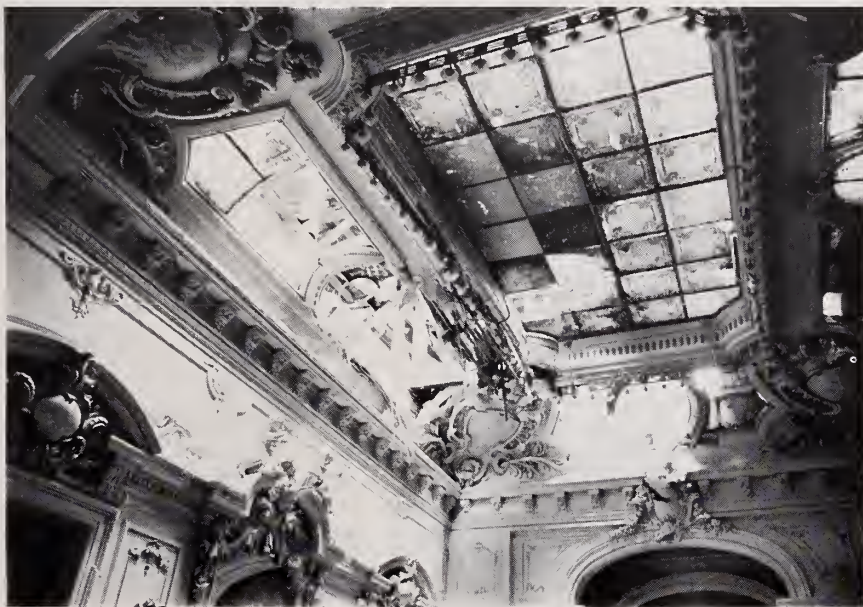
Figure 3.101. Damage of decorative skylight within the first story of the museum.

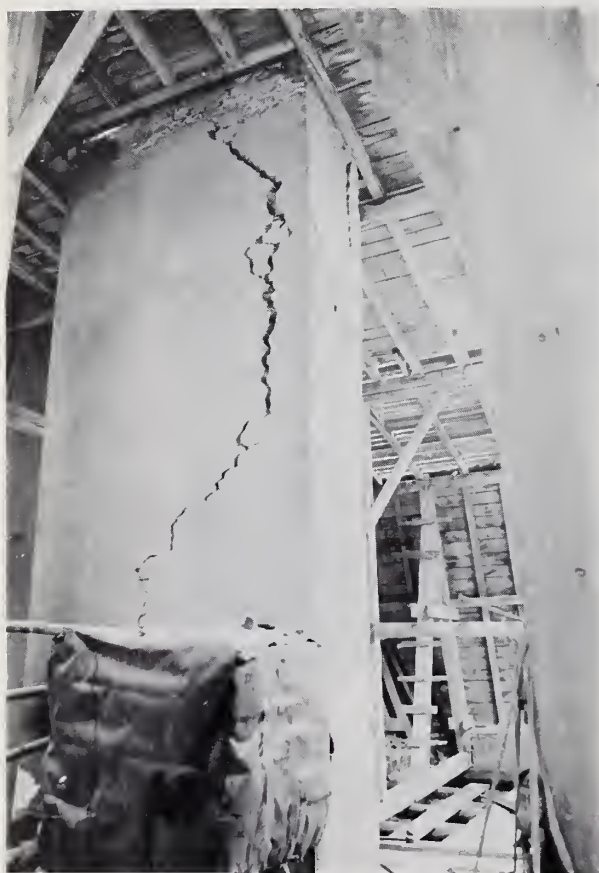
Figure 3.103. Ruptured masonry chimney in the museum attic.

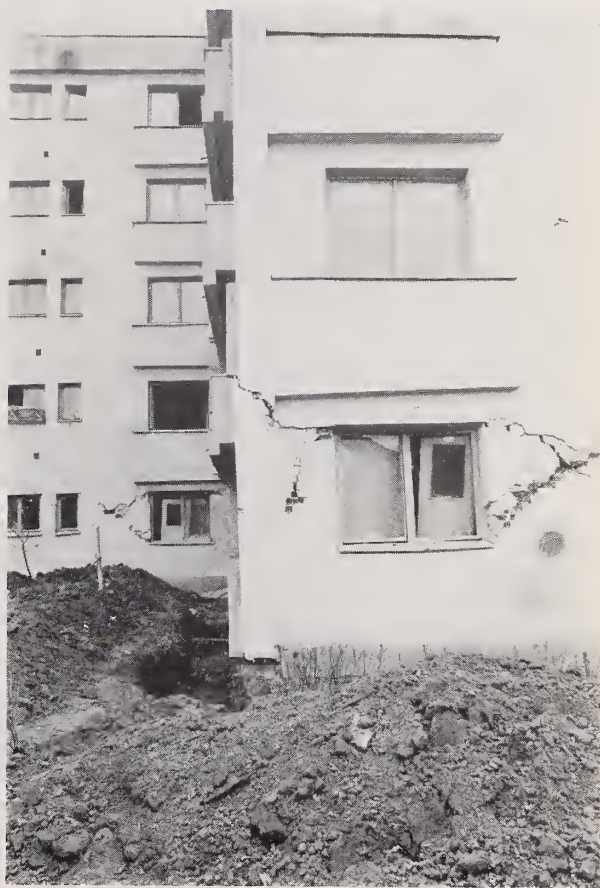
Figure 3.105. Damage of first-story exterior bearing walls.

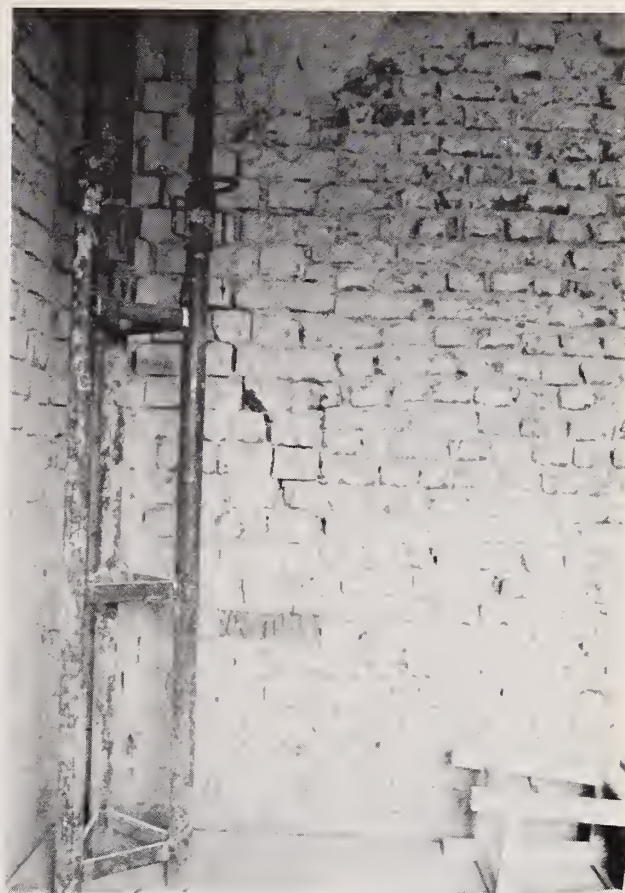
Figure 3.106. Failure of first-story piers.

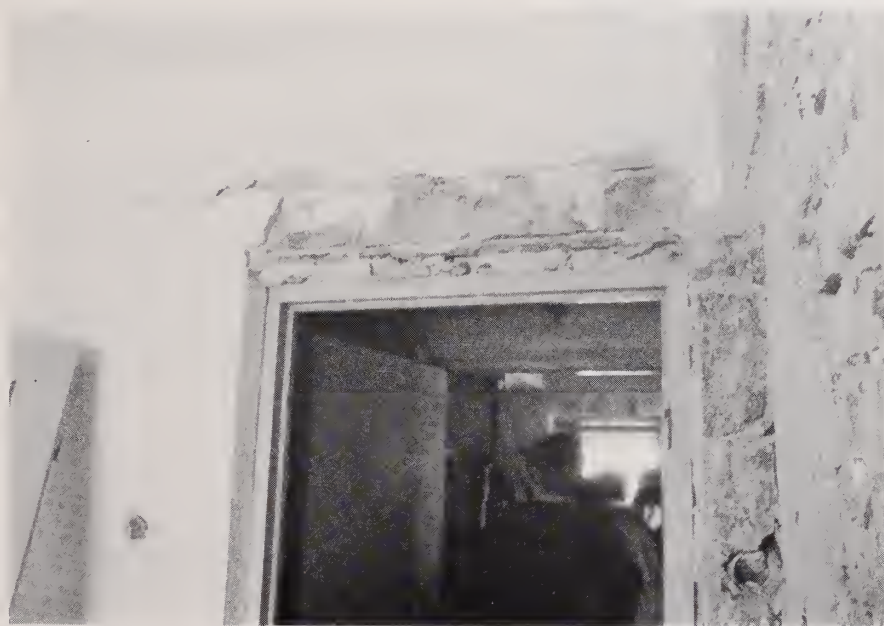
Figure 3.107. Damage of interior masonry wall.

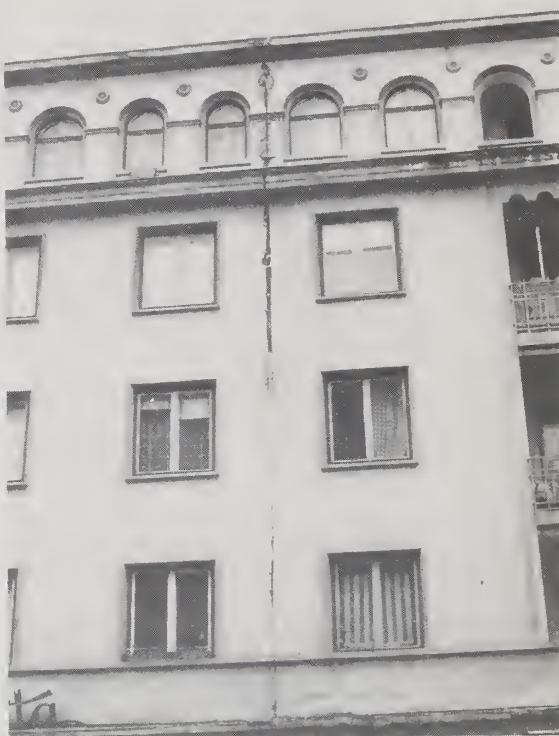
Figure 3.108. Damage of lintel wall in first story.

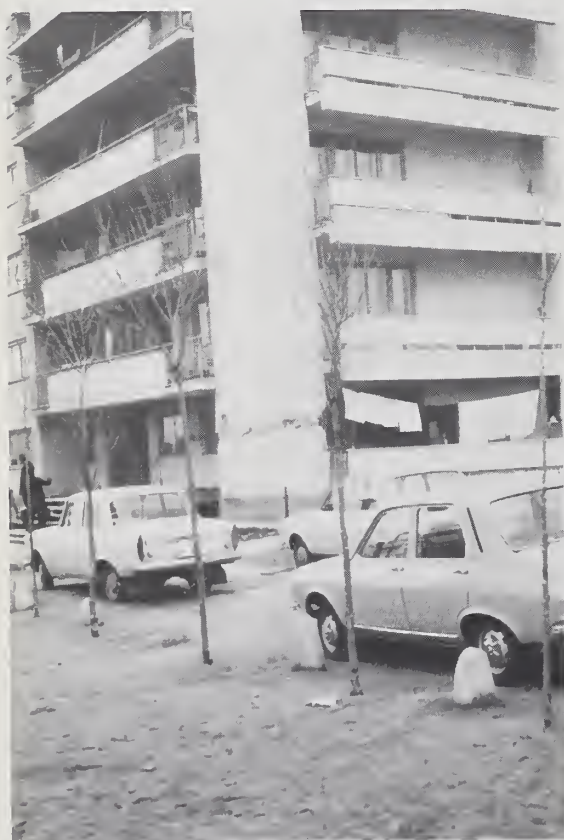
Figure 3.109. Pounding damage between adjacent buildings.
