NBS SPECIAL PUBLICATION 592

An Investigation of the Miyagi-ken-oki, Japan, Earthquake of June 12, 1978

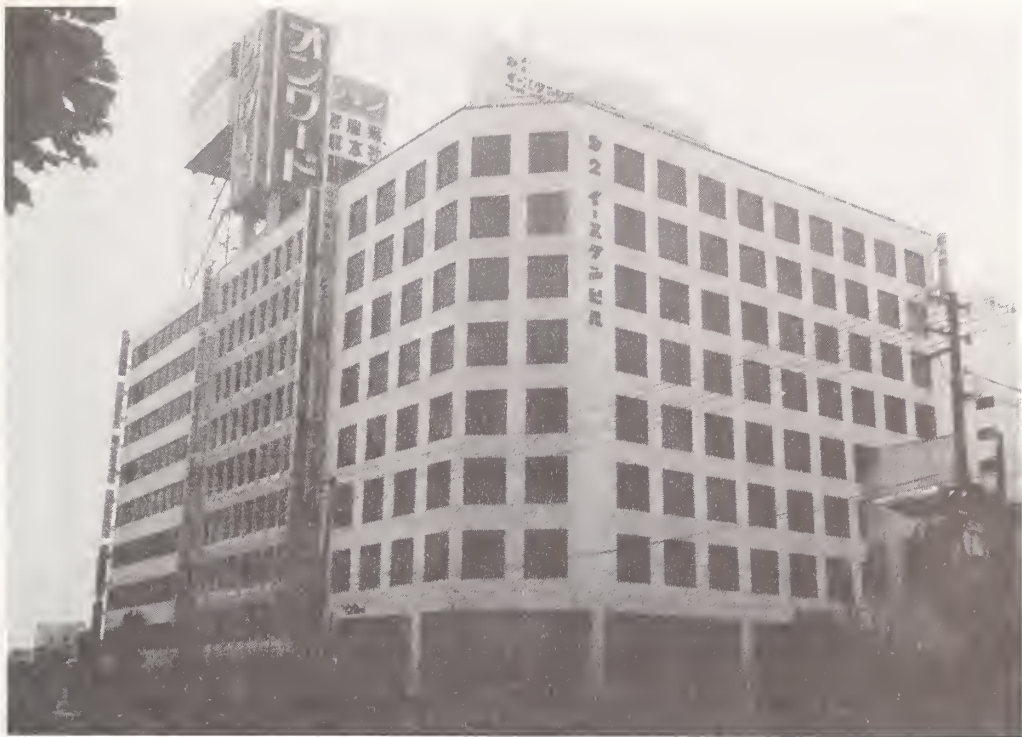
Figure 5.6 Second Eastern Building Company Building, Sendai. A typical modern building in Sendai; the only apparant damage to the glazed tile veneer on the exterior was cracking on spandrels and shear walls.

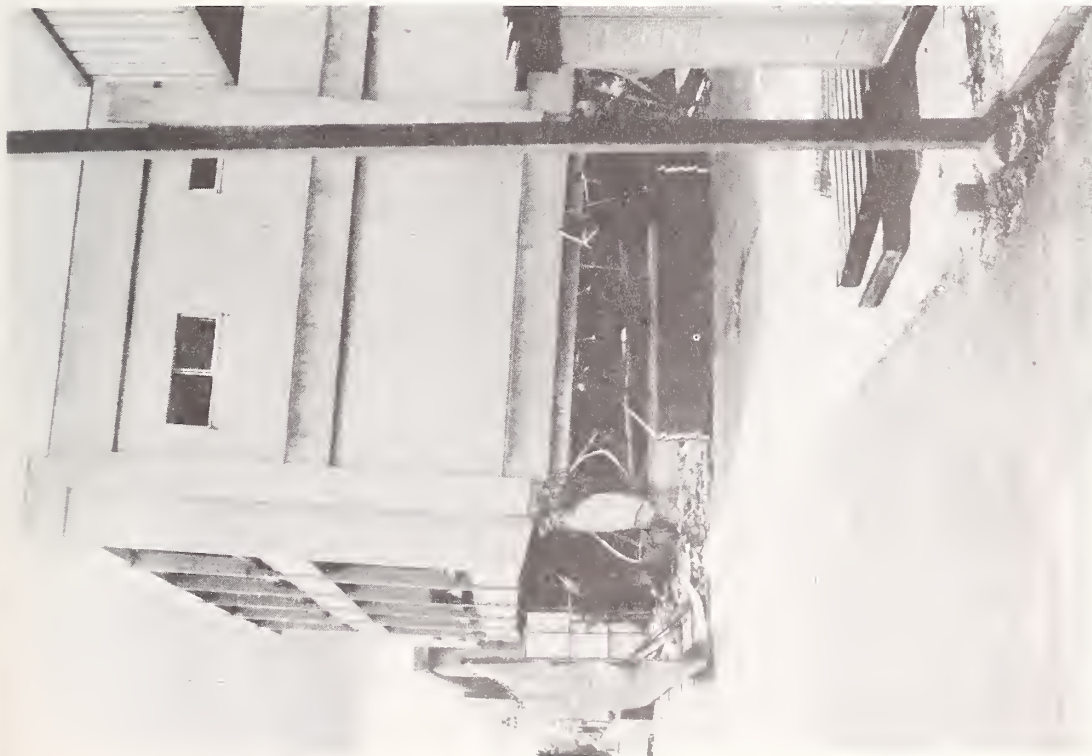
Figure 5.24 Maruyoshi Building, view from the east.
Failure of first story columns occurred
in shear.

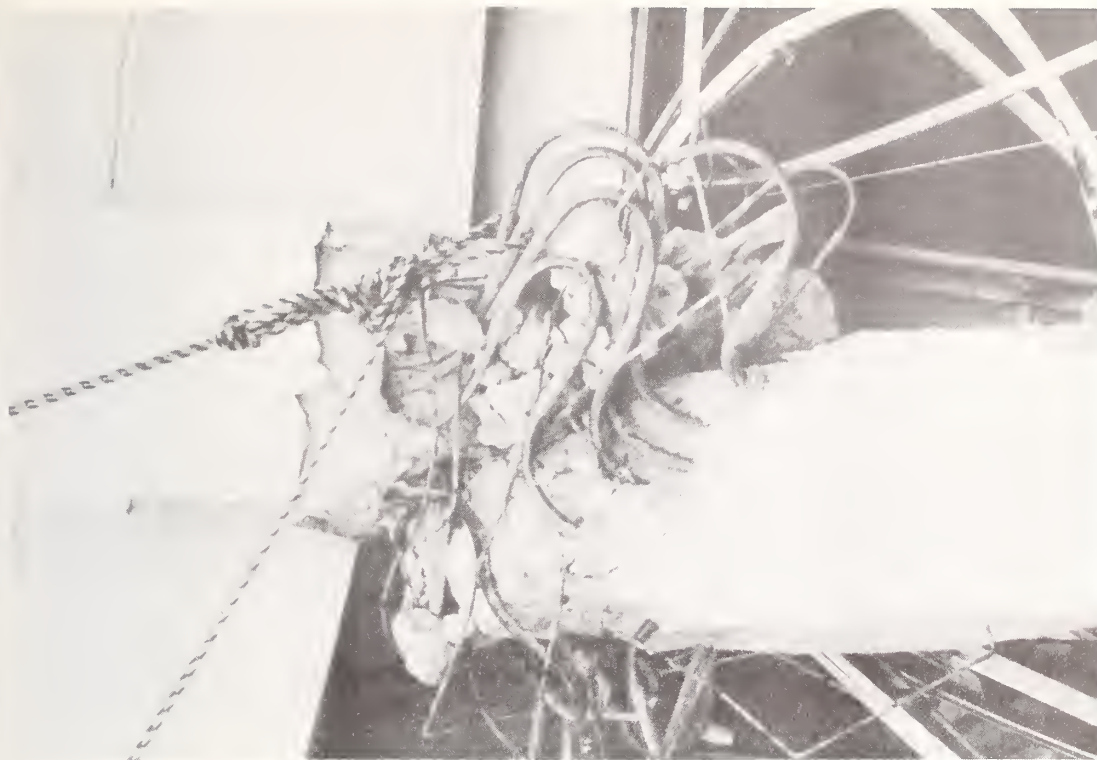
Figure 5.25 Maruyoshi Building. Detail of a joint
at the top of a first story column.

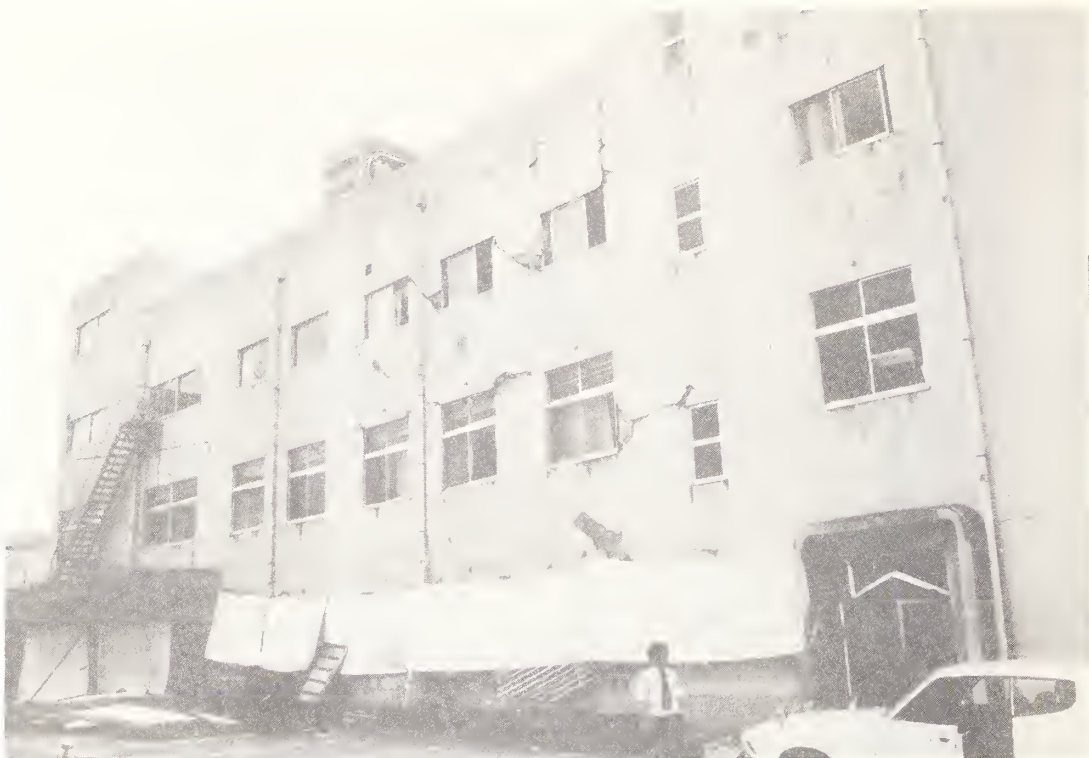
Figure 5.32 Kinoshita Building, Oroshicho area, of Sendai. Extensive diagonal cracking was observed on the east face (rear) of the building.

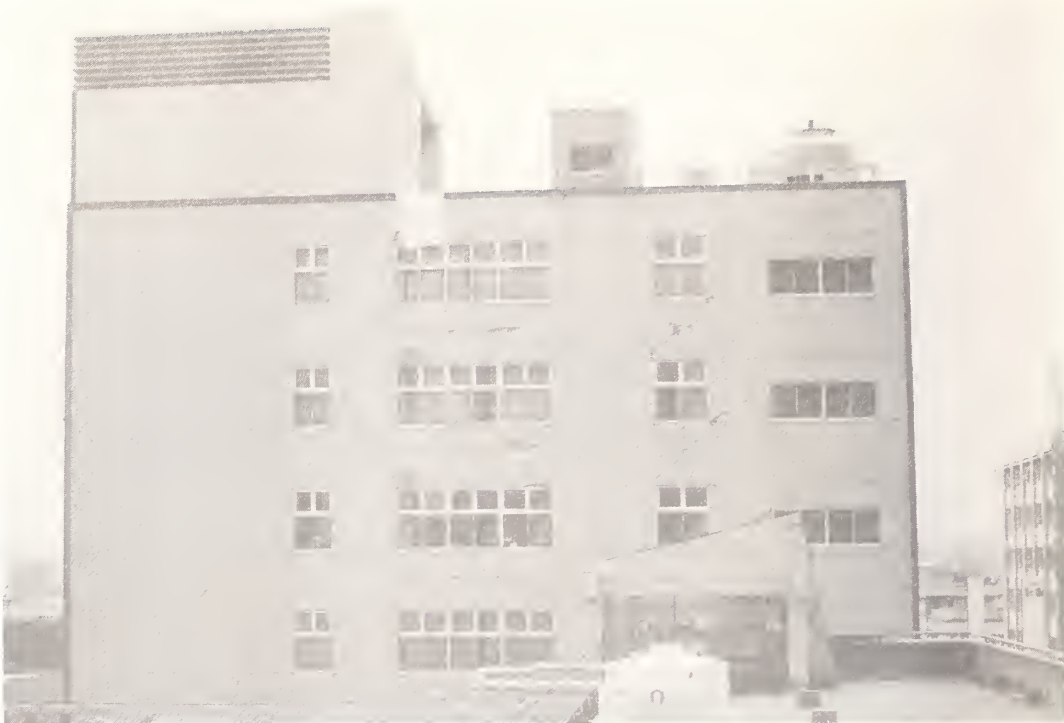
extensive diagonal cracking in the panels between window openings on both east (Figure 5.34) and west faces (Figure 5.35); this damage is especially severe on the west face, as shown in the detail in Figure 5.36. The decorative ceramic brick facing on the north side of the building did not appear to be damaged.

Figure 5.34 Maruhon Building, Oroshicho area, showing shear cracking in the panels on the east face between window openings.

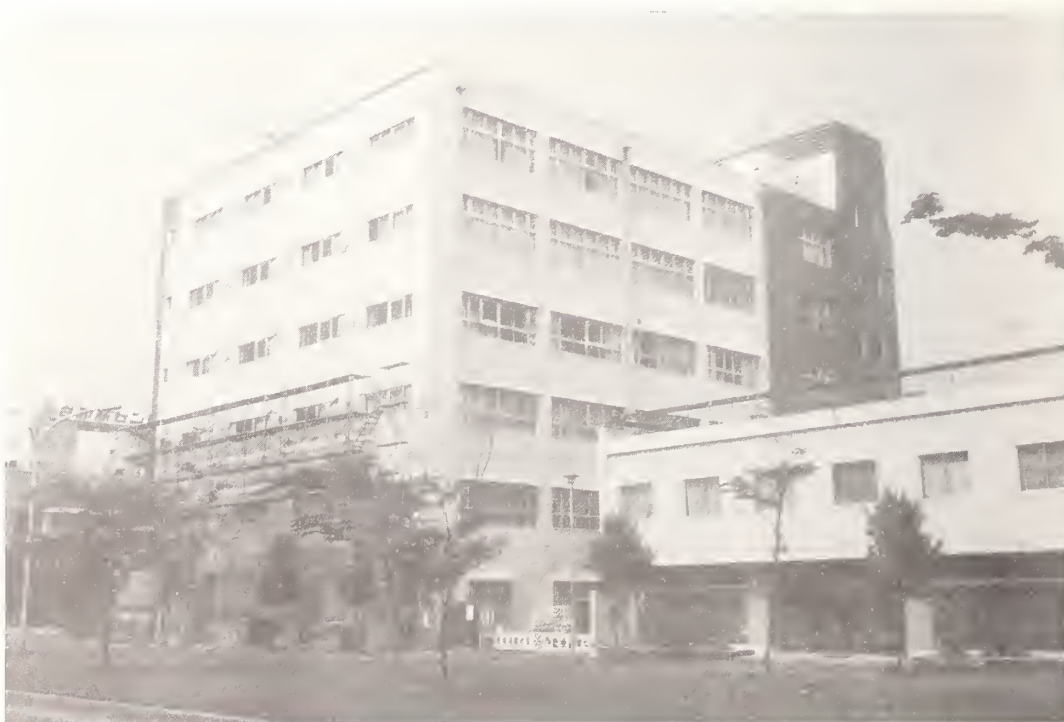
Figure 5.35 Maruhon Building, west face, showing cracking of curtain wall panels.

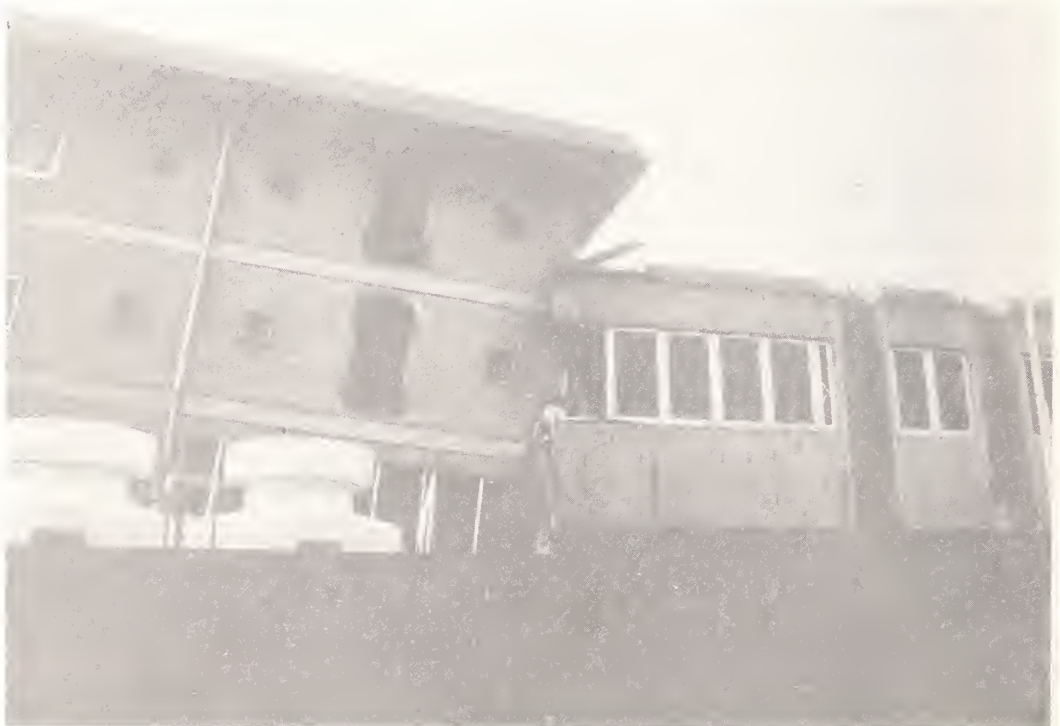
Figure 5.40 Yazaki Industries, showing area of impact between steel and reinforced concrete frames.

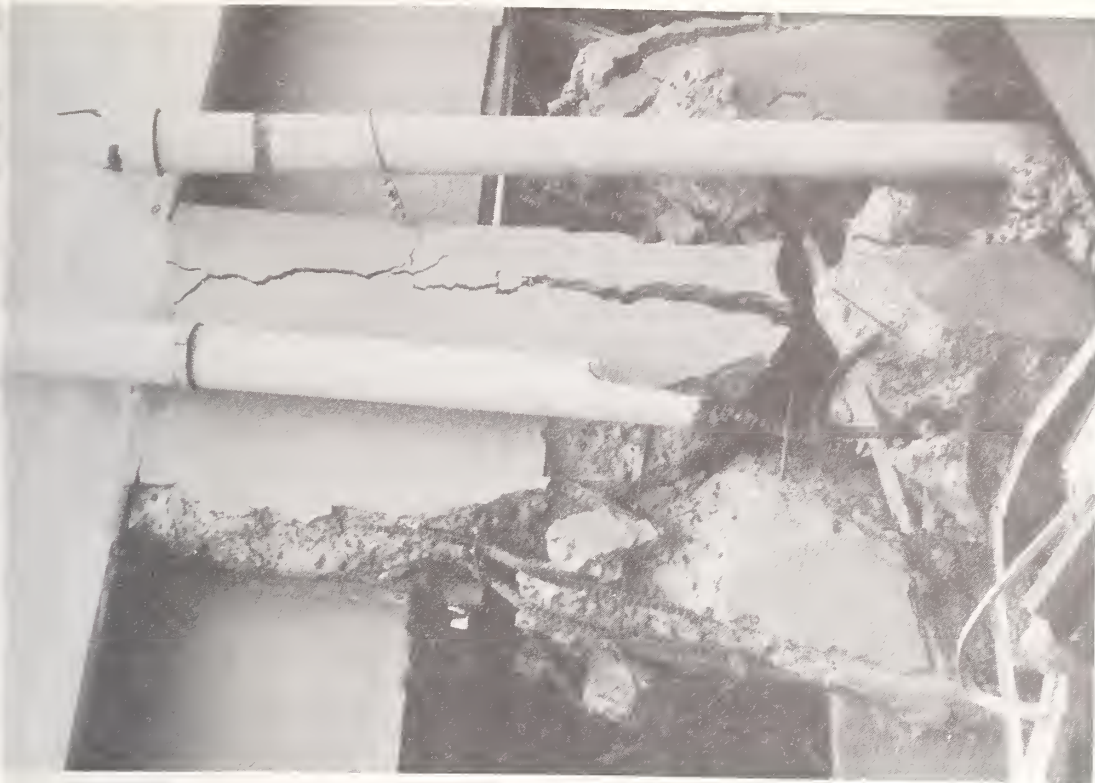
Figure 5.41 Yazaki Industries, showing damage to lower story reinforced concrete column.

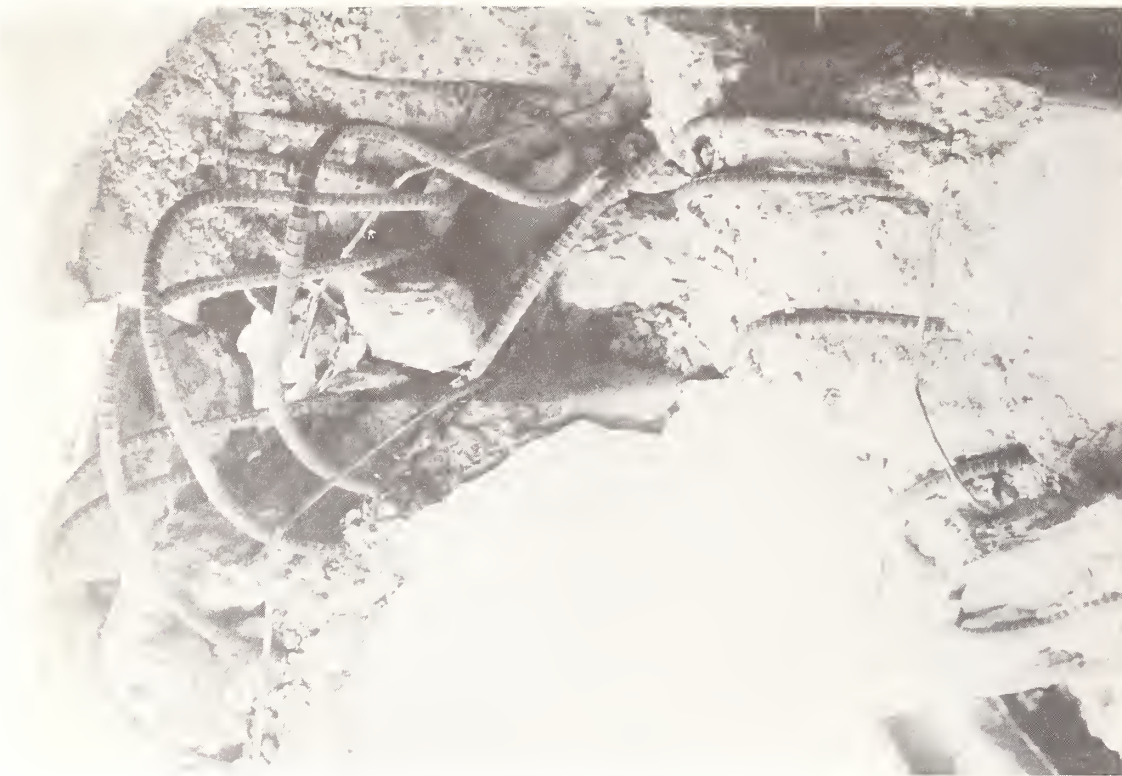
Figure 5.43 Yazaki Industries Buildings. Detail of column shear failure, east side. Note use of deformed bars.

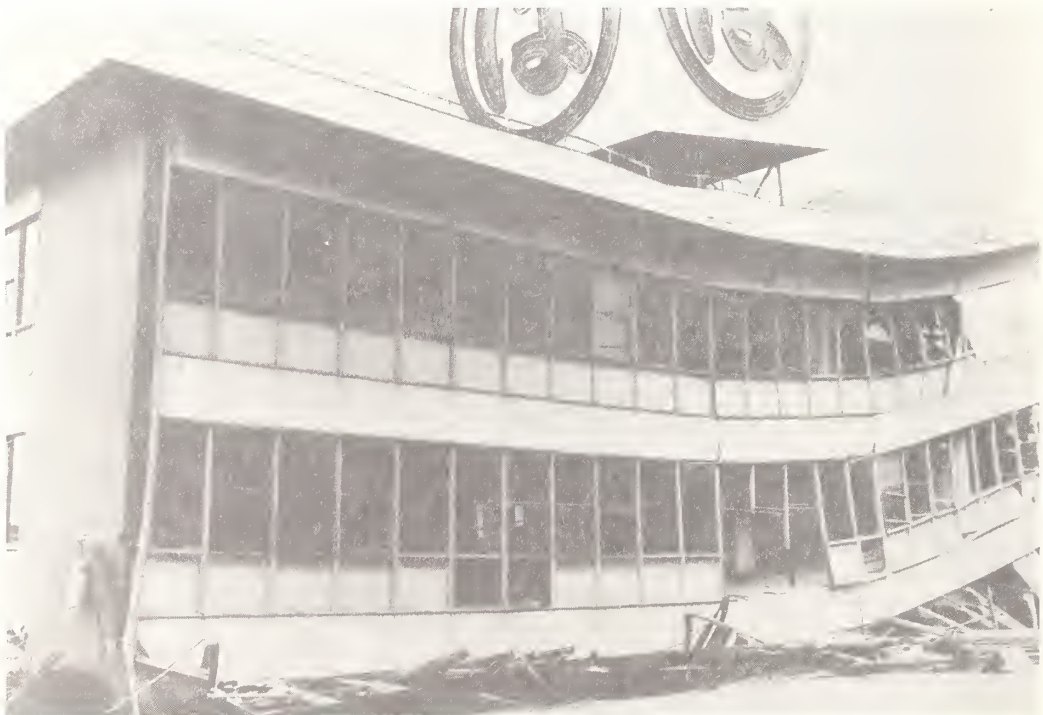
Taiyo Fisheries Plant (No. 11, Figure 5.3). This was a three-story building with a reinforced concrete frame, one span by five, the main axis of which was in the N-S direction. There were shear walls on the north and south ends of the structure. As shown in Figures 5.51 and 5.52, the first-story columns in the middle of the building failed, causing the central portion of the building to collapse but leaving the ends standing. The shear walls at the north end of the structure (running in the E-W direction) were badly cracked. At the time the site was visited, the building was being demolished.

Figure 5.51 Taiyo Fisheries Plant, viewed from the west. The first story columns in the center portion of the building failed, leaving the ends of the building standing. (Japan National Land Agency photograph)

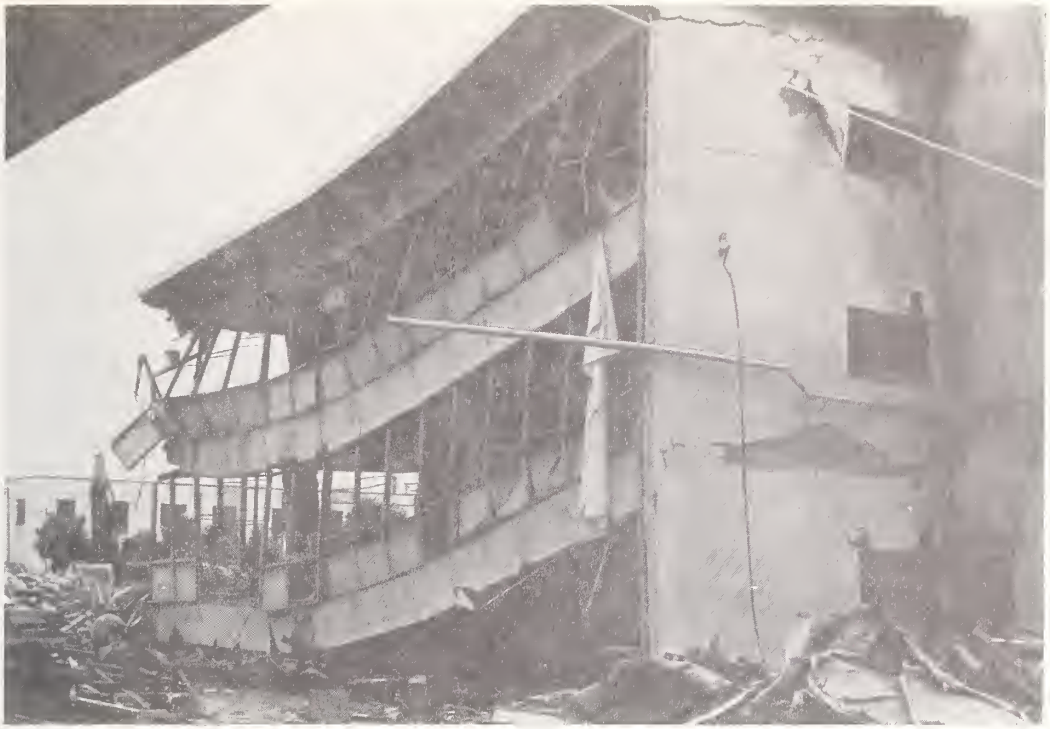
Figure 5.52 Taiyo Fisheries Plant, viewed from the northeast. The reinforced concrete shear wall on the north end was badly damaged.

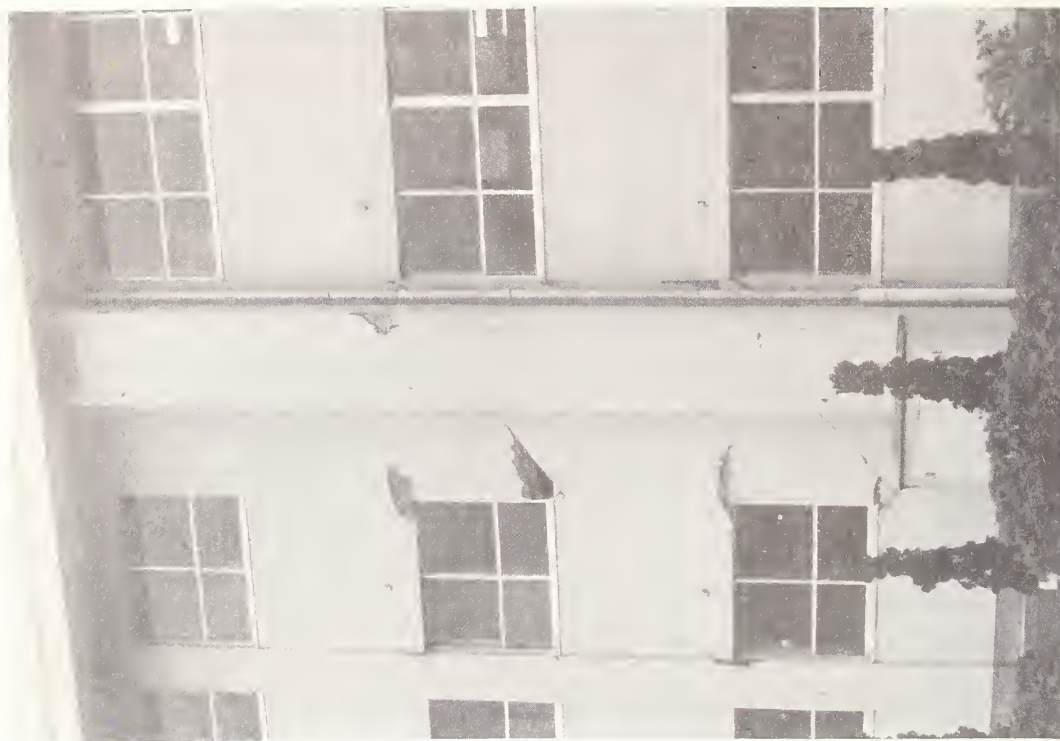
Figure 5.63 Izumi High School, typical classroom building, north face. All faces with the larger infill panels were similarly damaged.

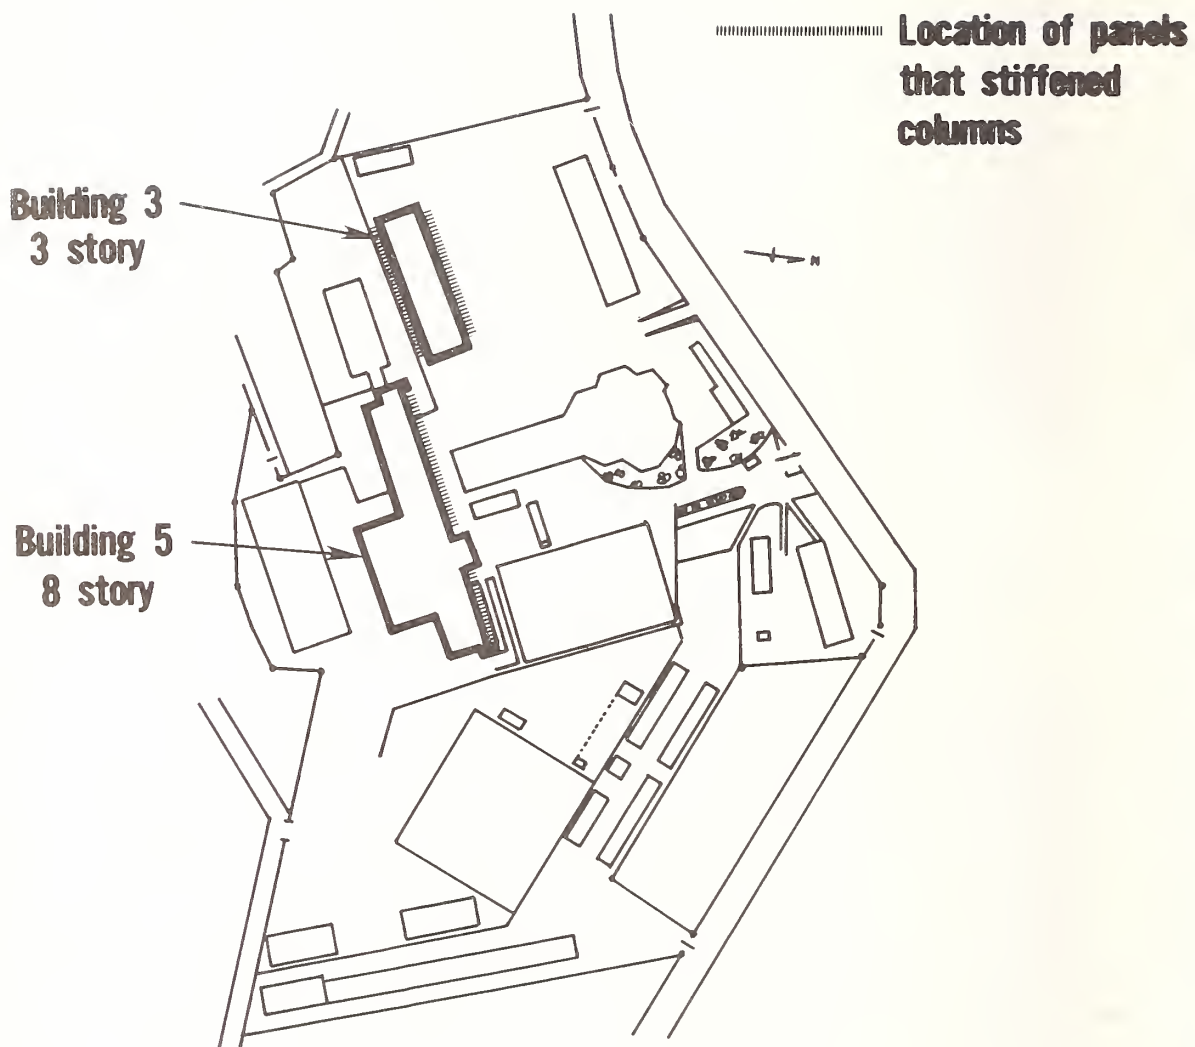
Figure 5.64 Tohoku Institute of Technology, Sendai, plan of campus. Hatching along walls of buildings 3 and 5 shows location of severely damaged columns.

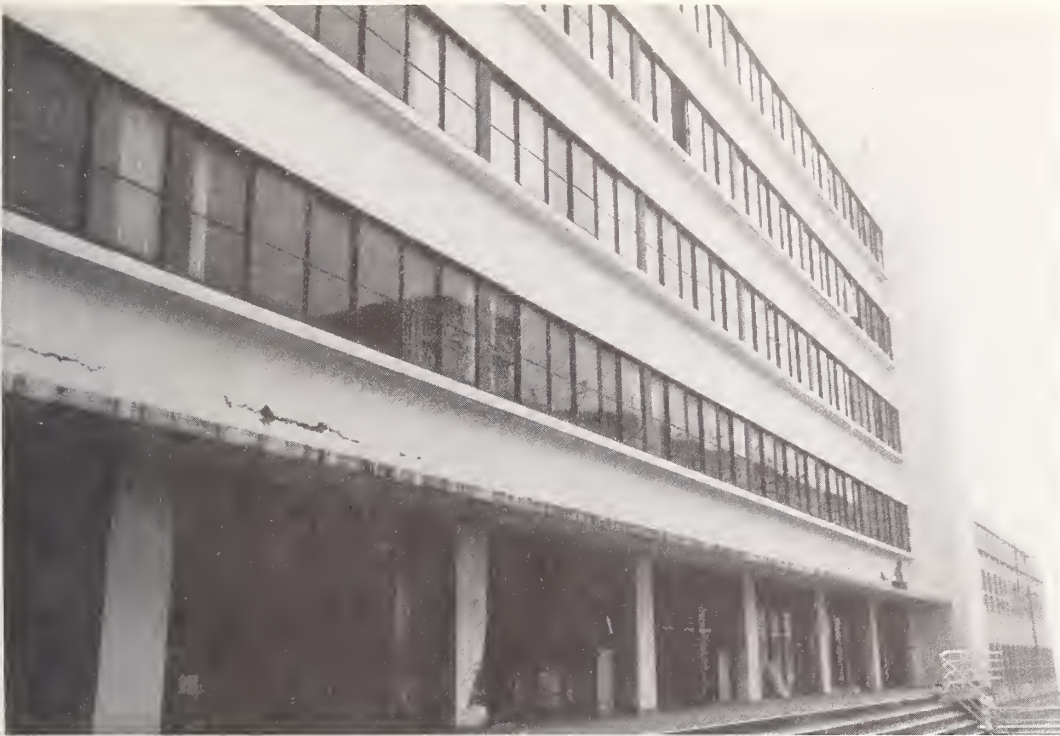
Figure 5.65 Tohoku Institute of Technology. Partial view of the entrance and north facade of building 5. Most serious damage to columns occurred on this side of the building.

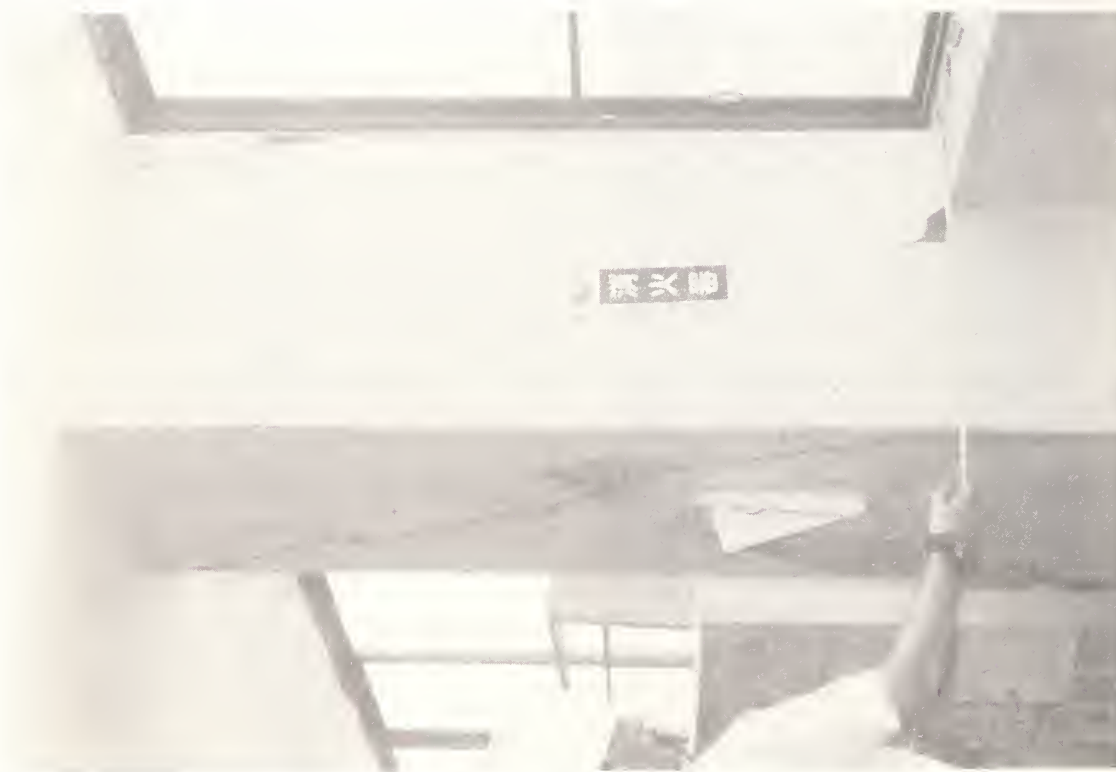
Figure 5.67 Tohoku Institute of Technology. Typical damage to seventh story column of the north facade of building 5.

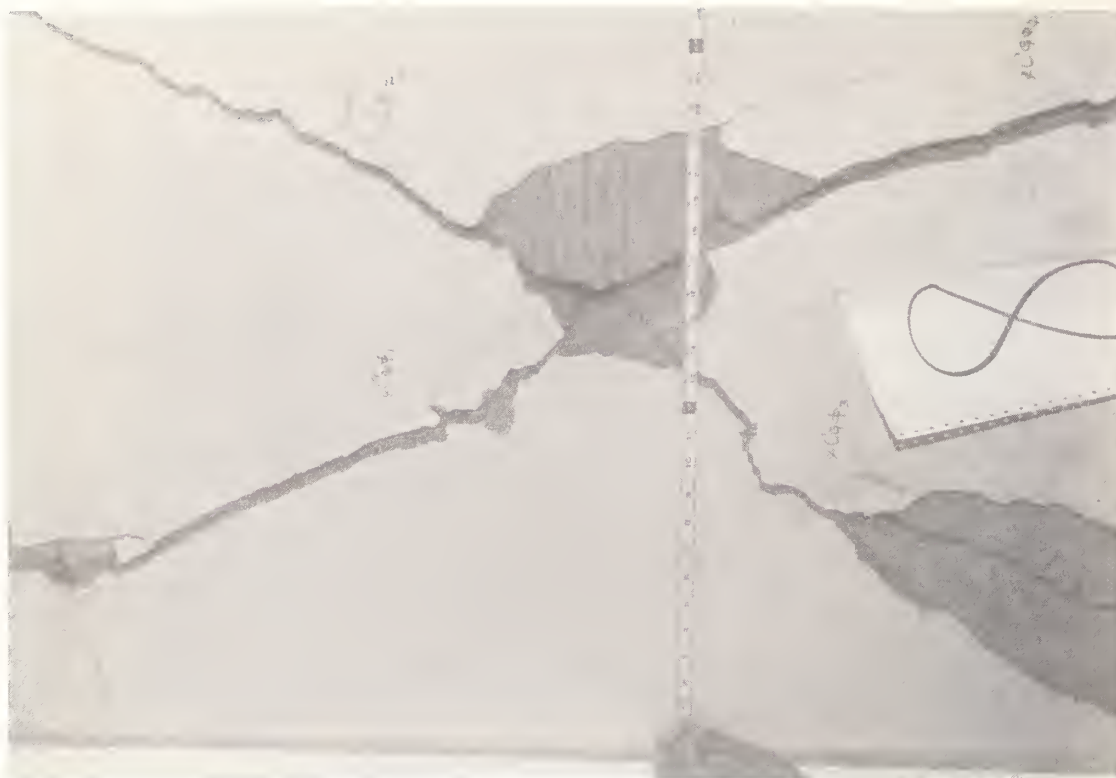
Figure 5.68 Tohoku Institute of Technology, Building 5. Detail of column damage.

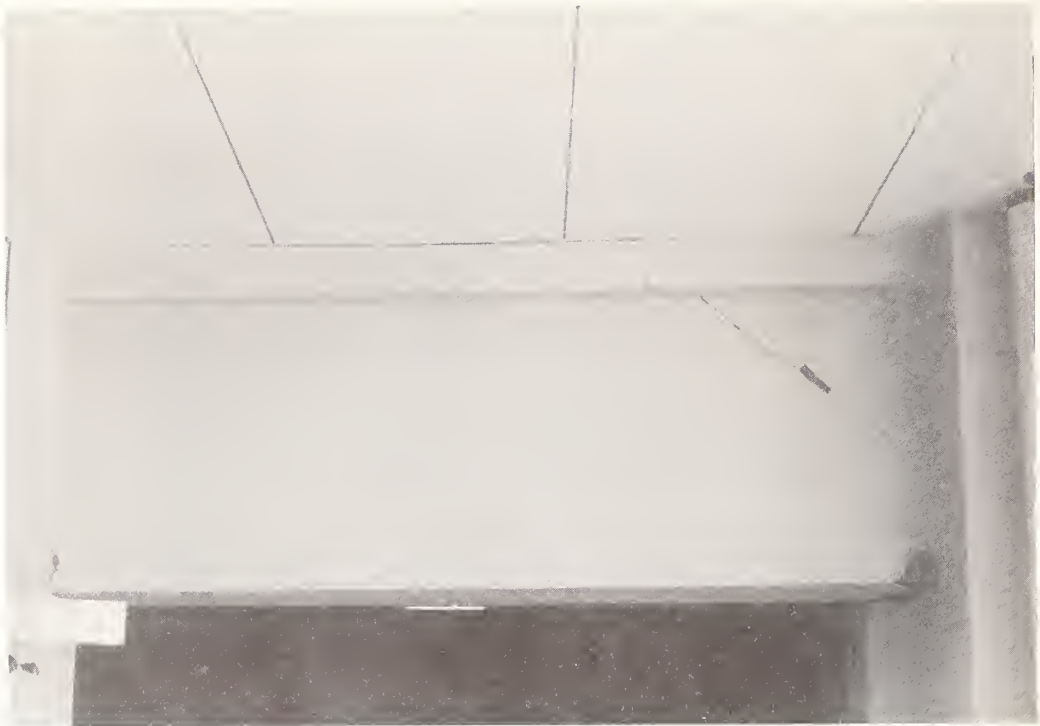
Figure 5.71 Tohoku Institute of Technology, Building 5. The tie beam over a sixth floor corridor connecting two shear walls shows diagonal cracks at both ends.

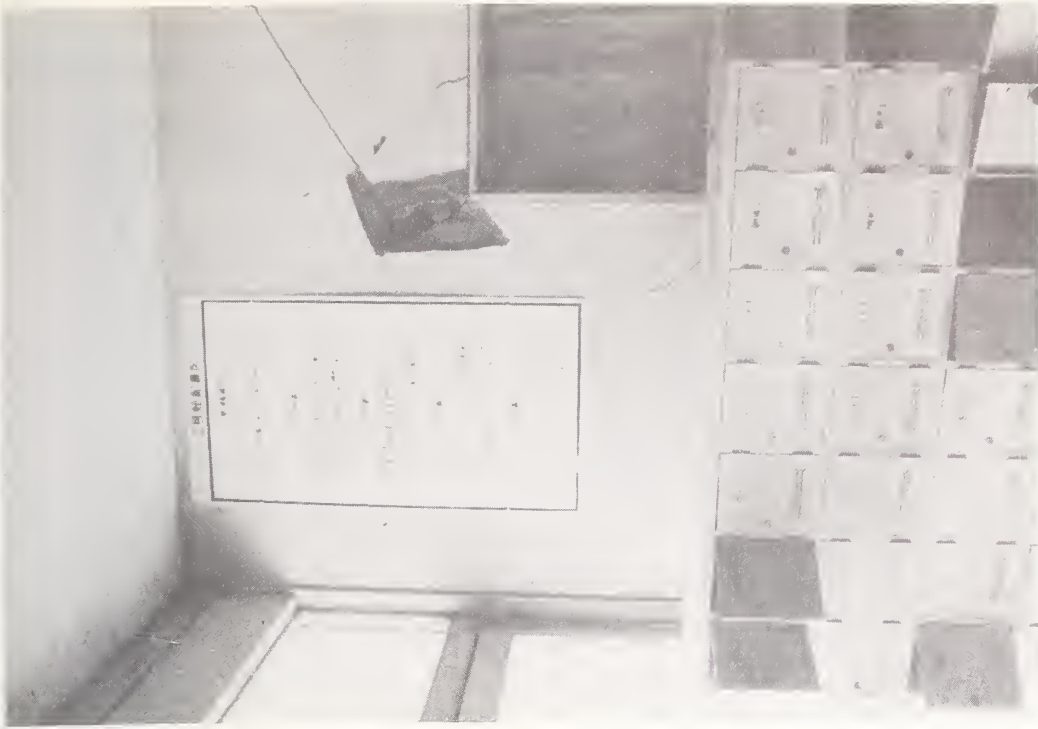
Figure 5.78 Tohoku Institute of Technology, Building 3. Interior surface of shear wall at east end of building.

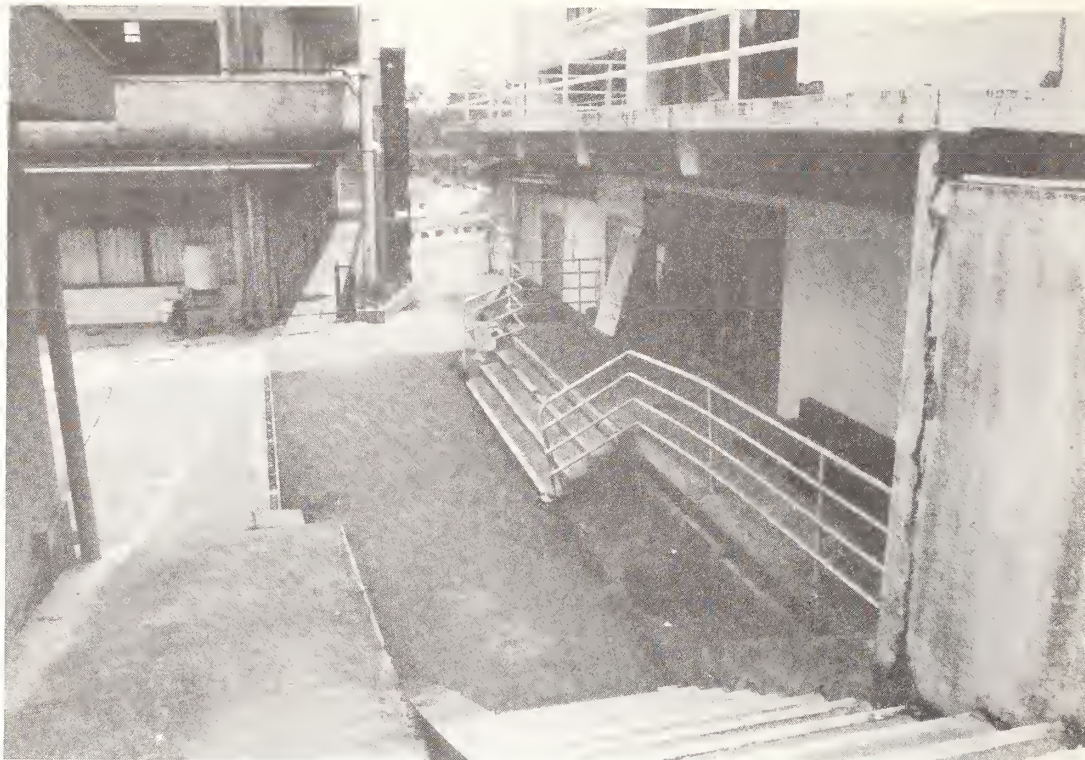
Figure 5.79 Tohoku Institute of Technology, walkway and north entrance of building 5 shows settlement of backfill along length of building.

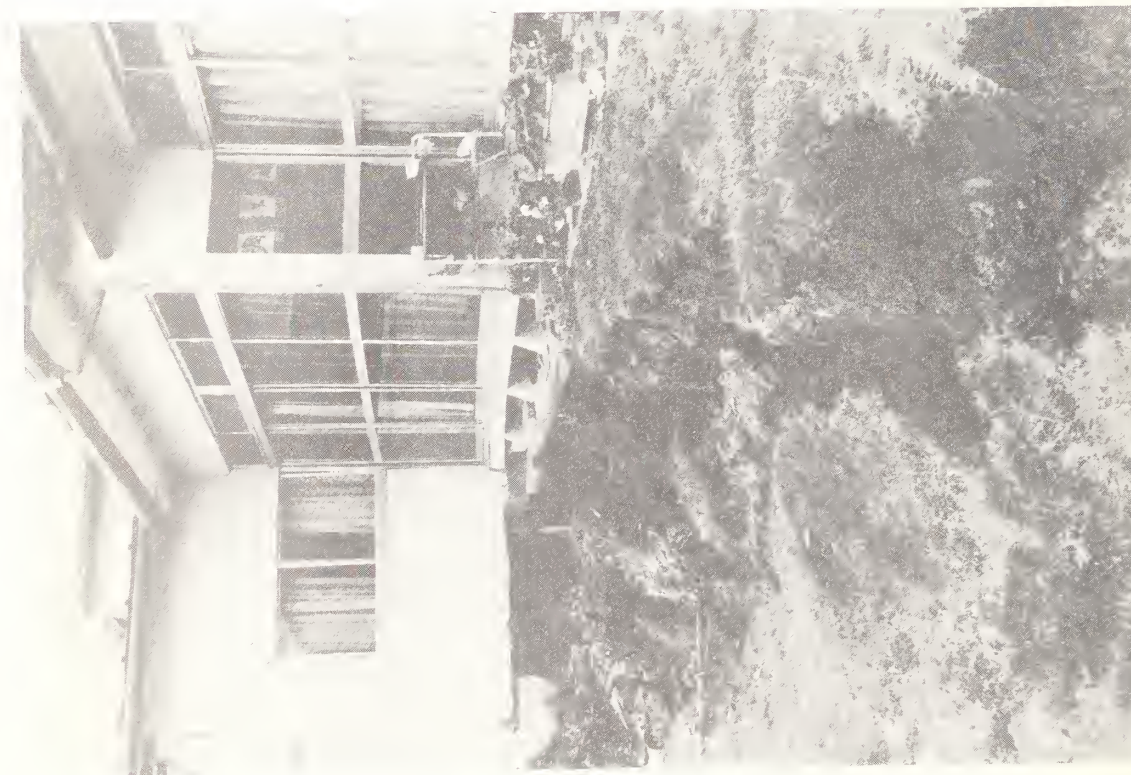
Figure 5.84 shows an example of the ground cracking resulting from subsidence in one of the hilly areas in Sendai. The loss of foundation support has caused extensive cracking in the building walls. In Figure 5.85, the front steps and breezeway have separated some 30 cm

Figure 5.84 Sendai. Damage to single family residence due to loss of foundation support. (Japan National Land Agency photograph)

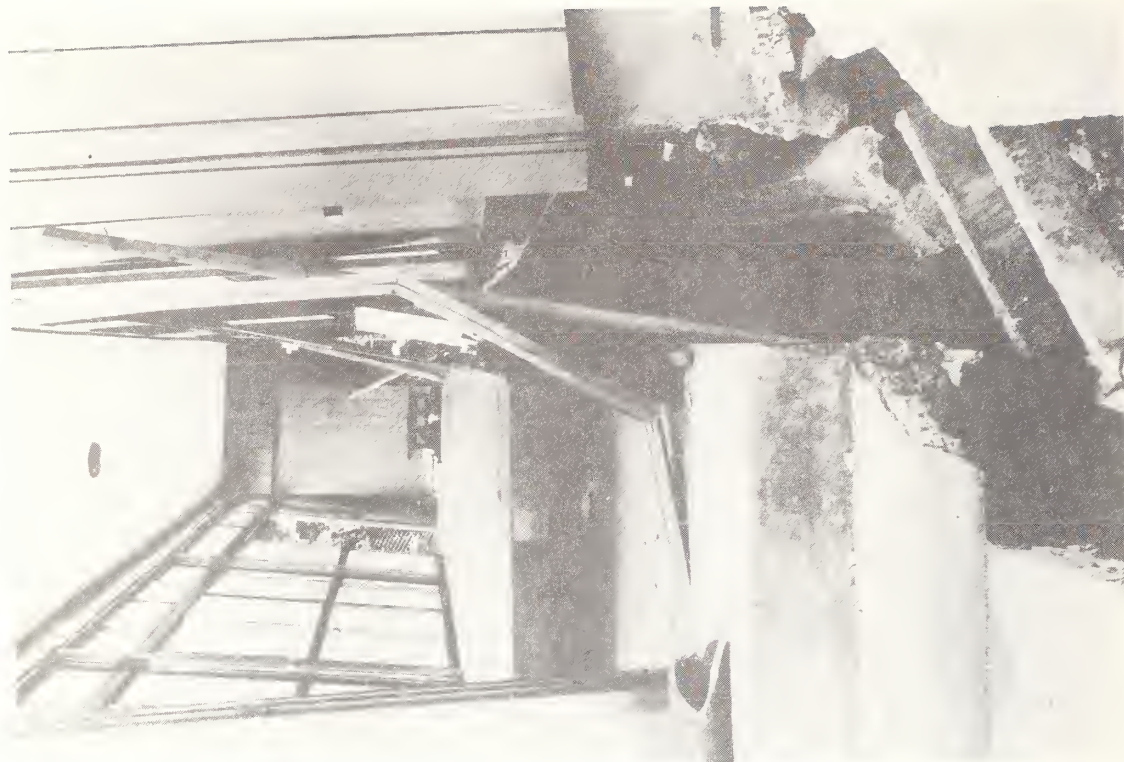
Figure 5.85 Sendai. Damage to single family residence due to ground settlement. (Japan National Land Agency photograph)

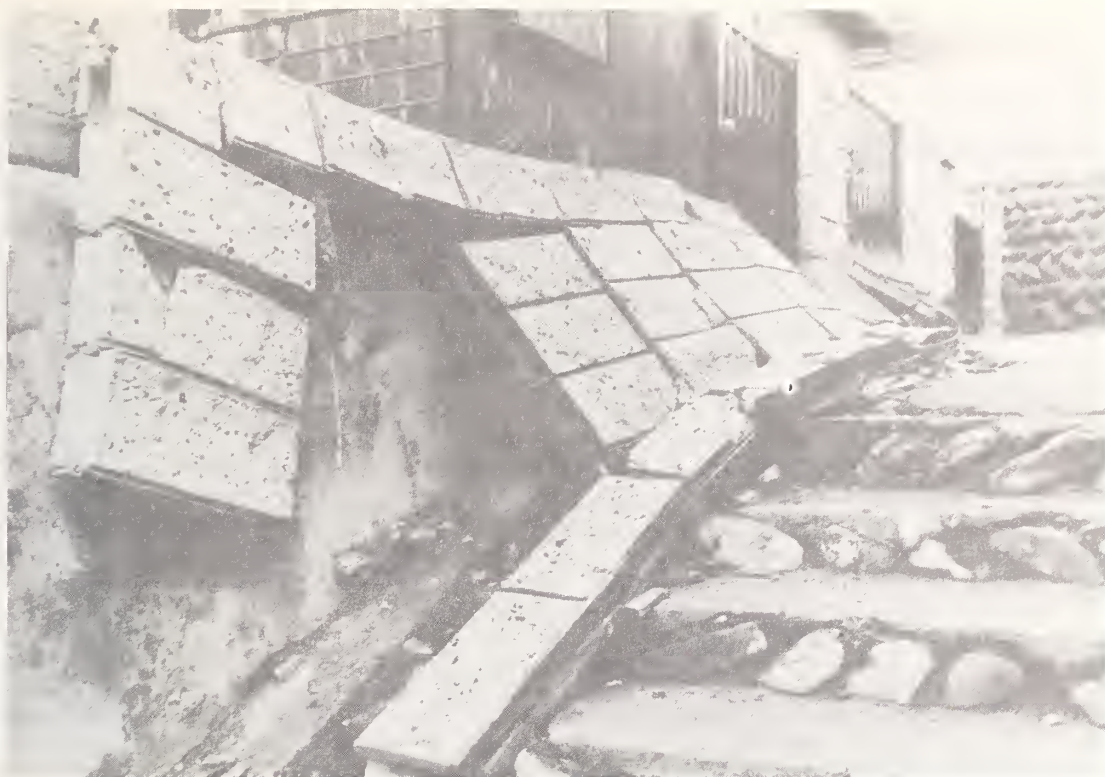
Figure 5.88 Failure of a reinforced concrete masonry privacy wall in Sendai.
(Japan National Land Agency photograph)

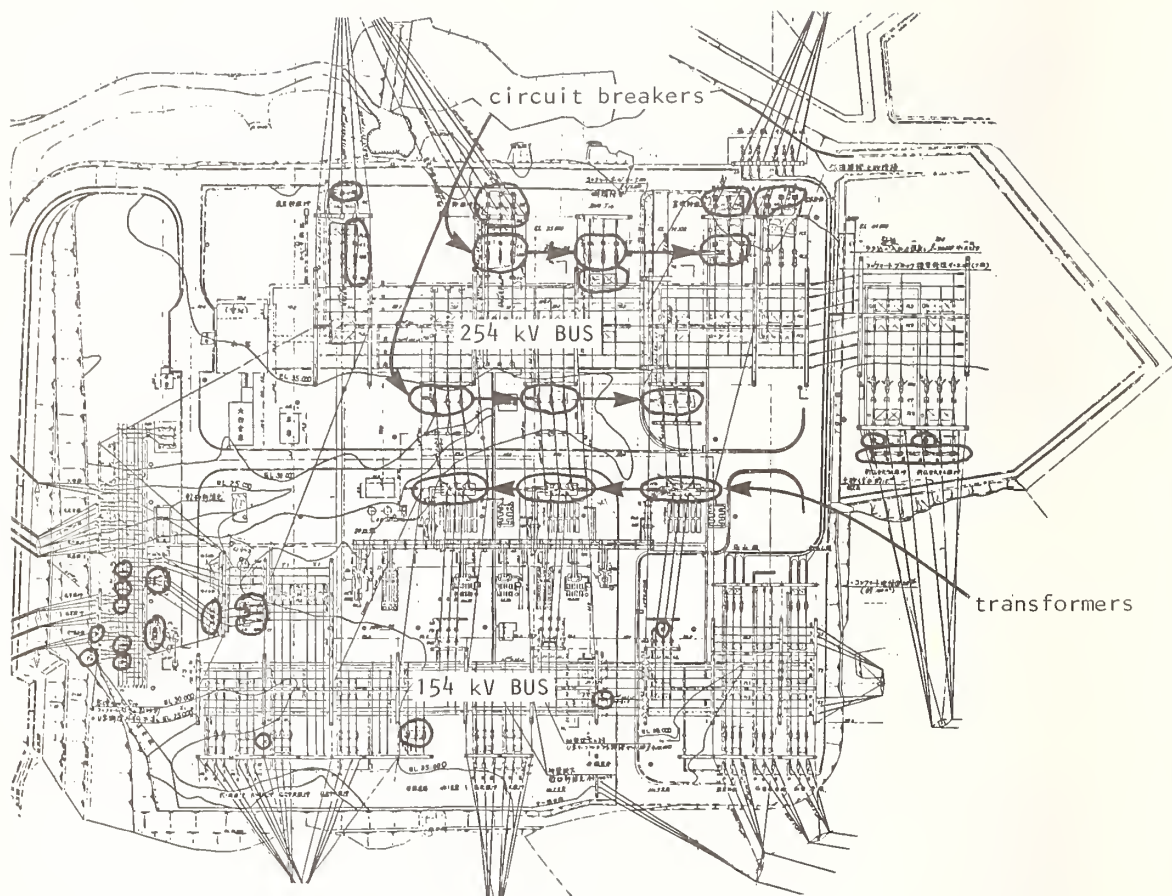
Figure 6.20 Sendai Substation, Izumi: plan of the facility showing the location of damaged equipment (circled). The solid contour lines indicate areas that were filled.

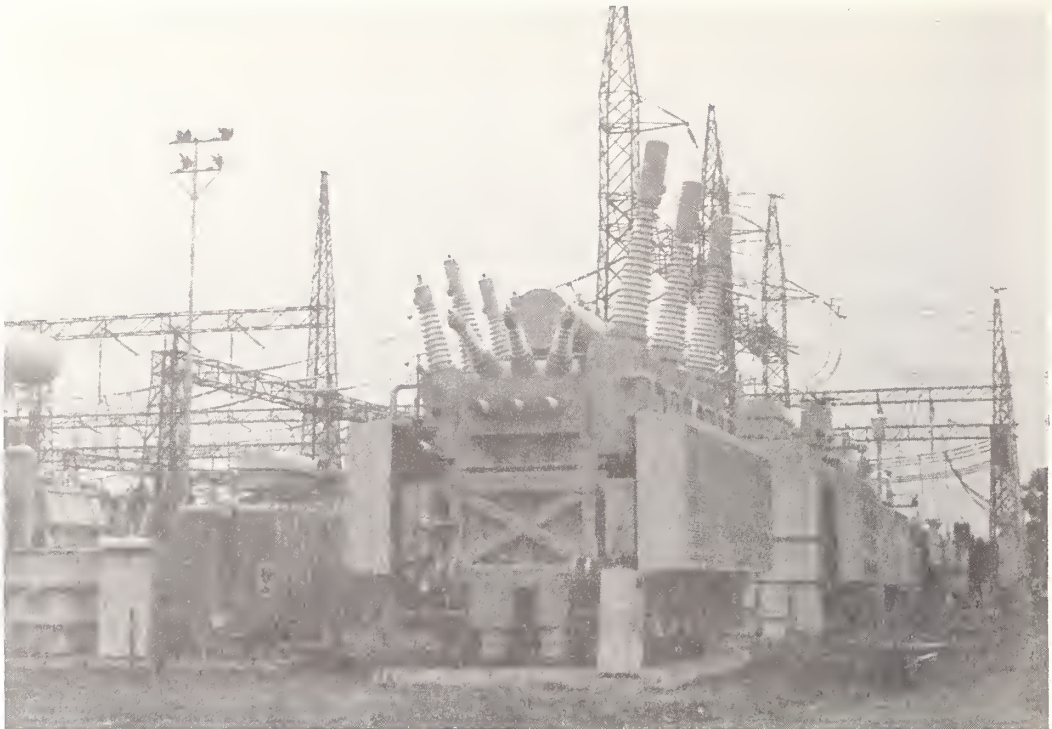
Figure 6.29 Sendai Substation, Izumi; a repaired but still disconnected transformer. All of the transformers at the substation lost some bushings or lightning arrestors. Some damaged parts were being replaced at the time of the investigation.

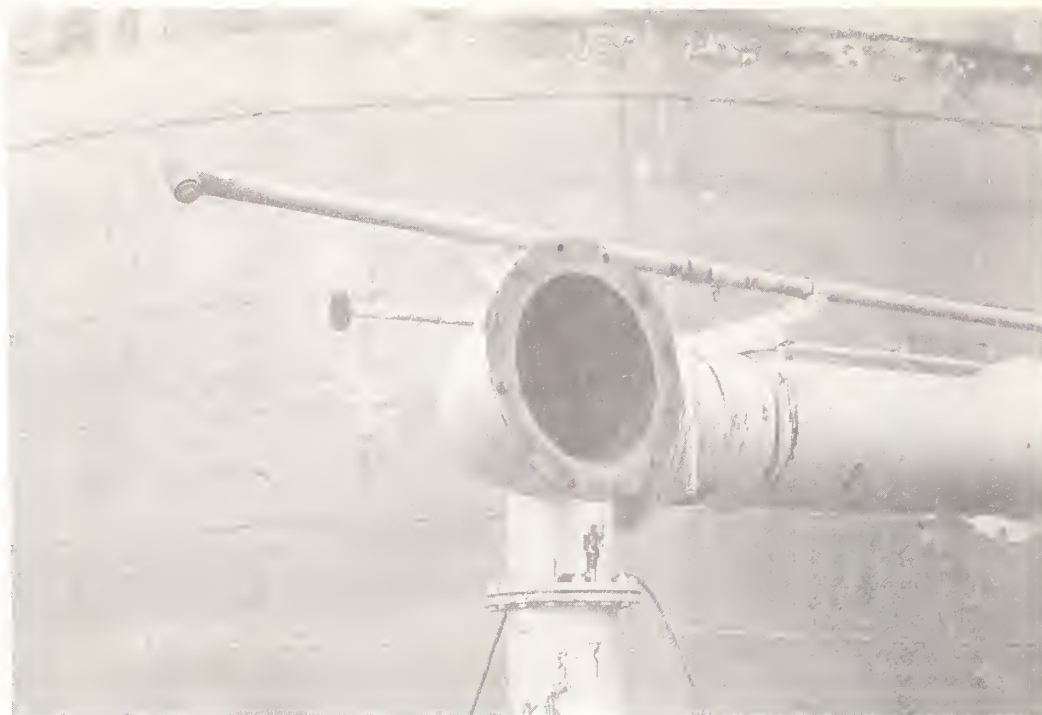
Figure 6.37 Haranomachi Plant, Sendai City Gas Bureau: sheared pipe flange connections in the pipeway structure in the vicinity of the collapsed gas holder.

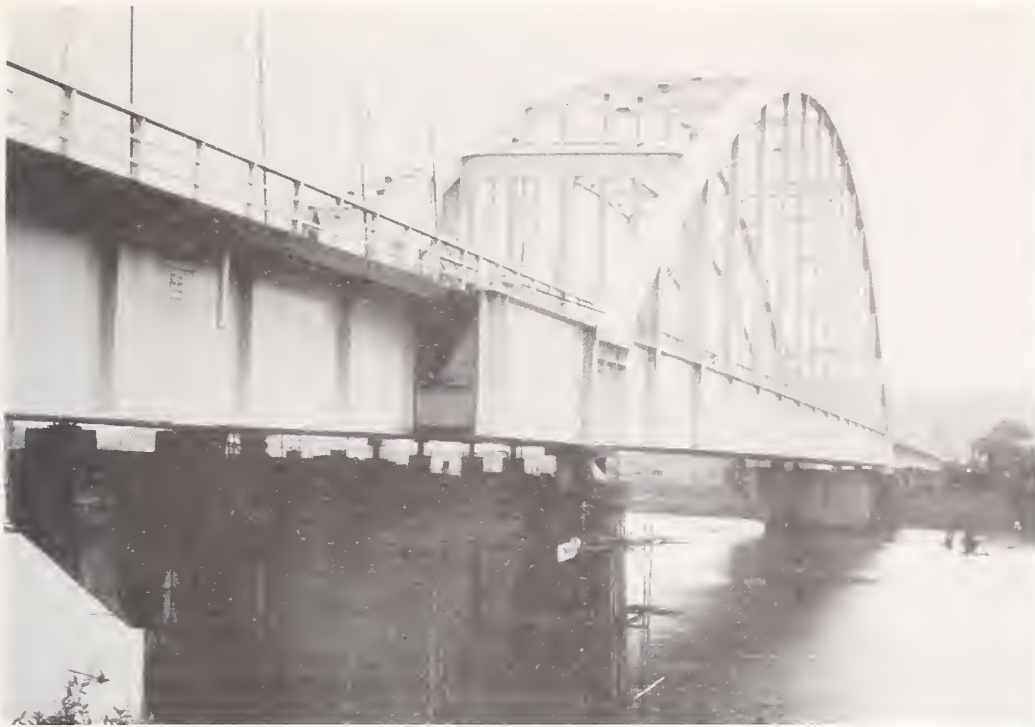
Figure 7.33 The main tied arch span of the Tenno Bridge with the cracked wall pier in the foreground. Note the smaller, pedestrian bridge in the background.
