NBS SPECIAL PUBLICATION 592

An Investigation of the Miyagi-ken-oki, Japan, Earthquake of June 12, 1978

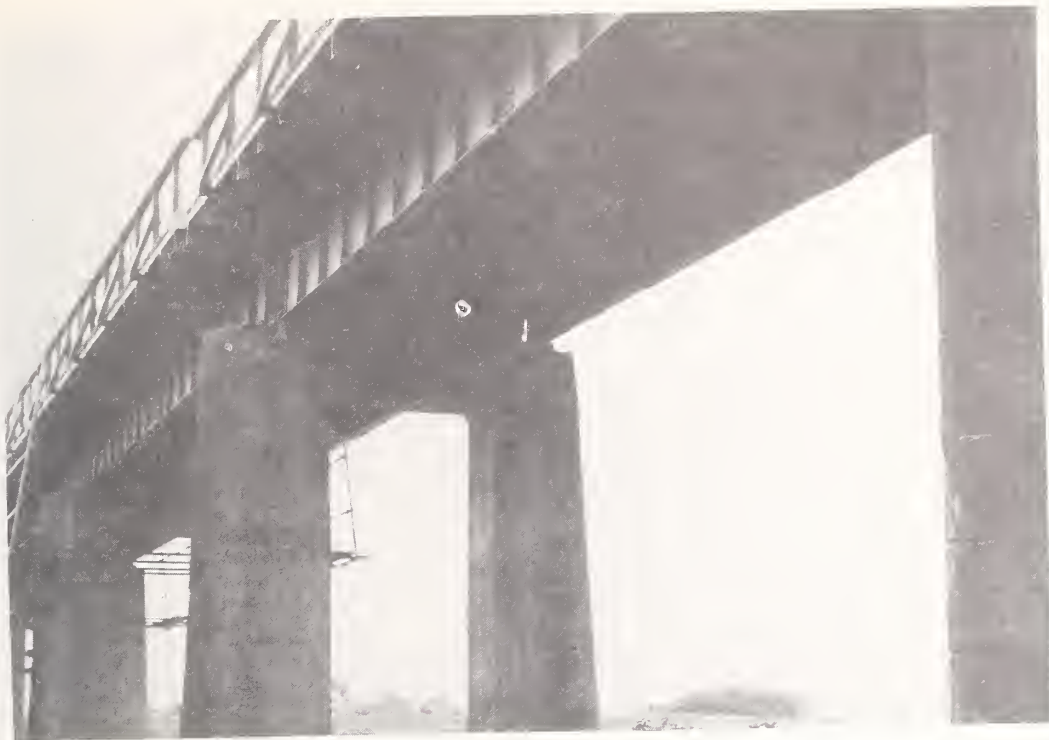
Figure 7.37 Spalled concrete at bent cap of Kimazuka Bridge.

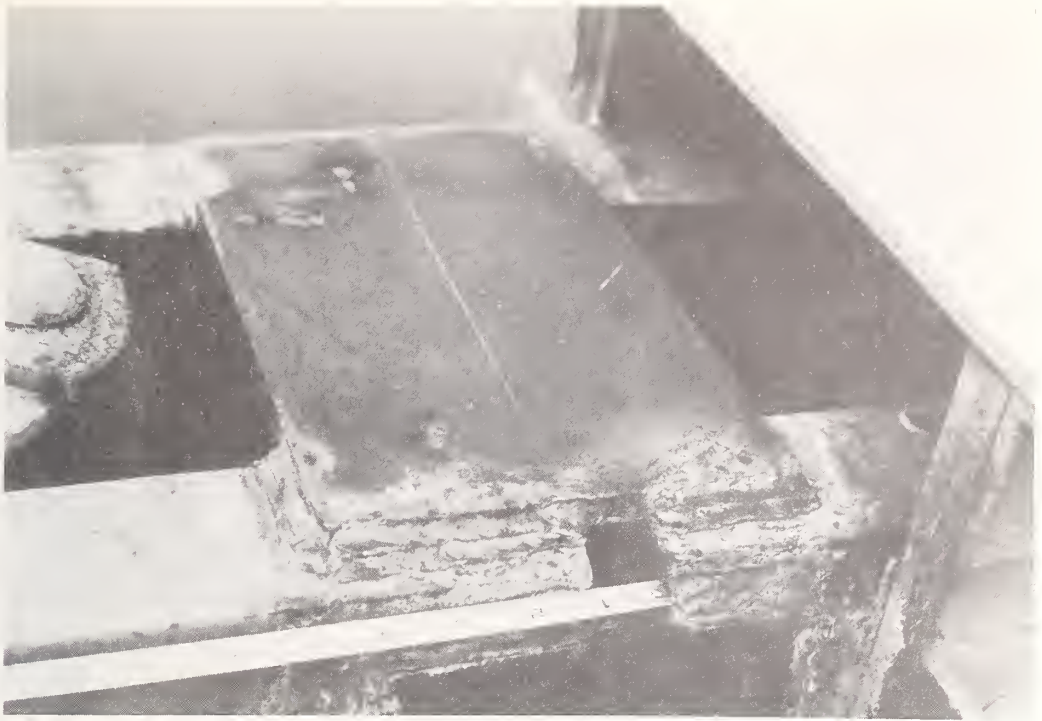
Figure 7.41 Maiya Ohashi Bridge. Steel plates welded to the top chord channel members. Note the clean fracture at a line passing through the centerline of the rivet holes of the lattice bracing and the permanent 2.5 cm separation.

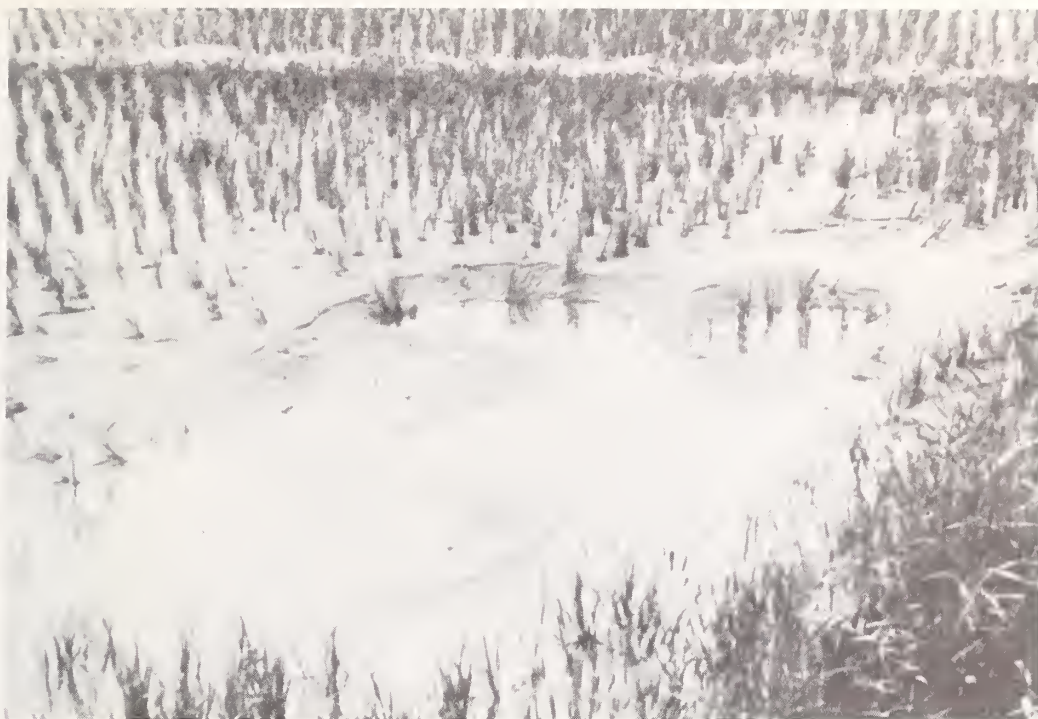
Figure 8.16 Site 5, Old Kitakami River - Sand boils in rice field. Plants are several centimeters tall. Damage to the dike at this site was minor. (Photo courtesy K. Kawashima, PWRI)

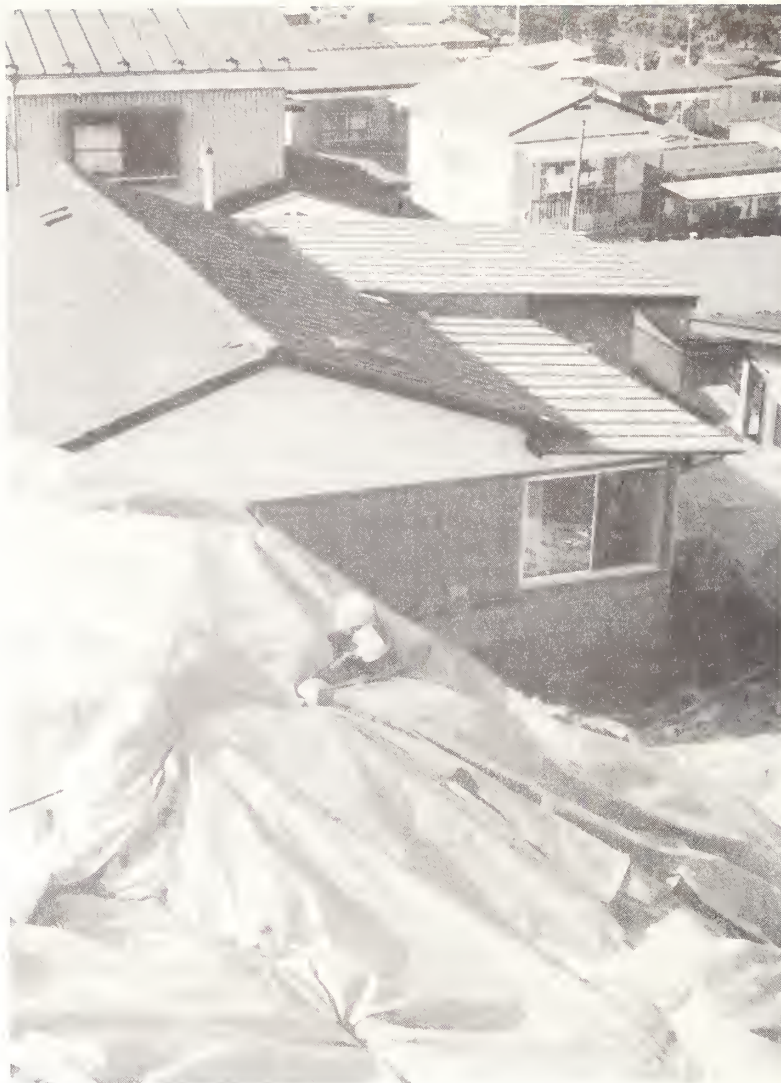
Figure 9.19 Toe of slump and house below in danger of being overridden by slide mass. House has been evacuated.
