NIST Special Publication 1000-5

June 2004
Progress Report on the
Federal Building and Fire Safety
Investigation of the
World Trade Center Disaster

Volume 4
Contains Appendices G, H, and I

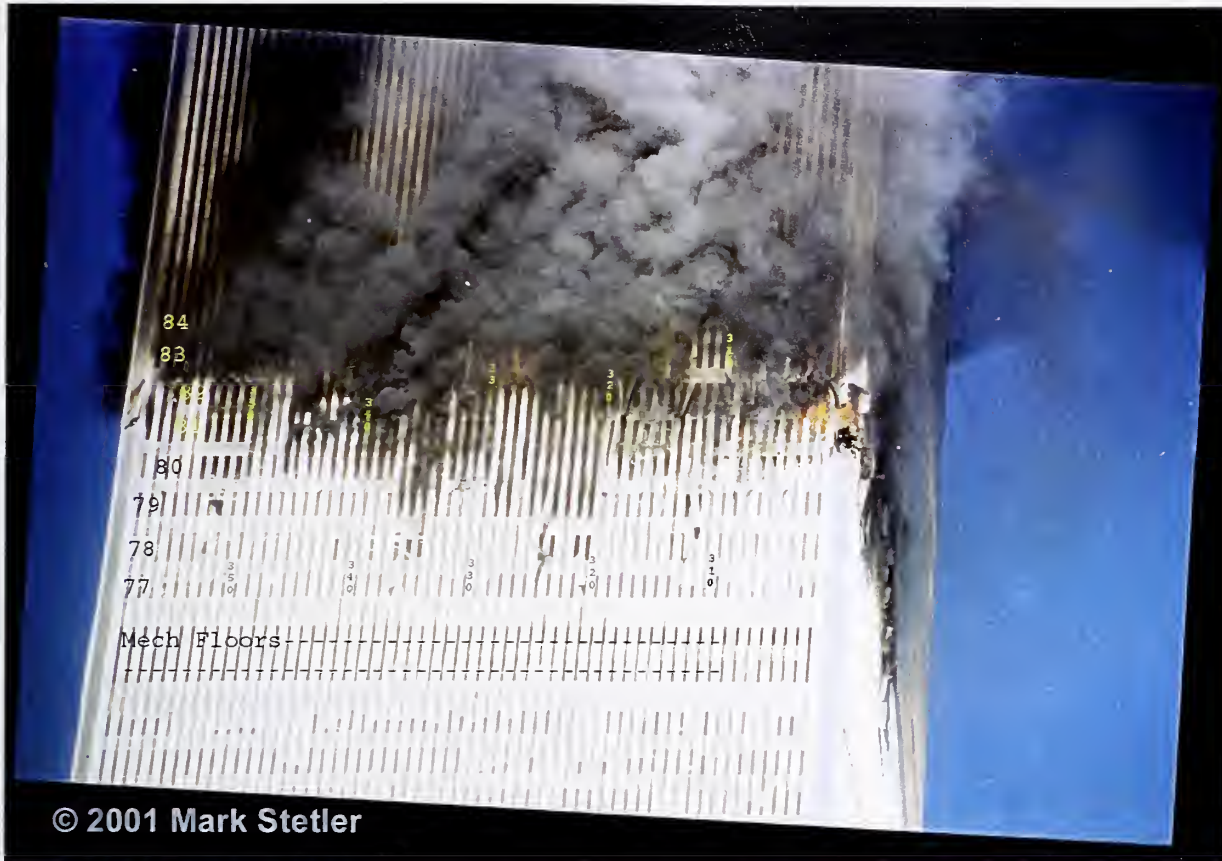
Figure H-6. Photograph taken at 9:26:20 a.m. on September 11, 2001, showing the east face of WTC 2. It has been enhanced, and lettering indicating floors and columns has been added.

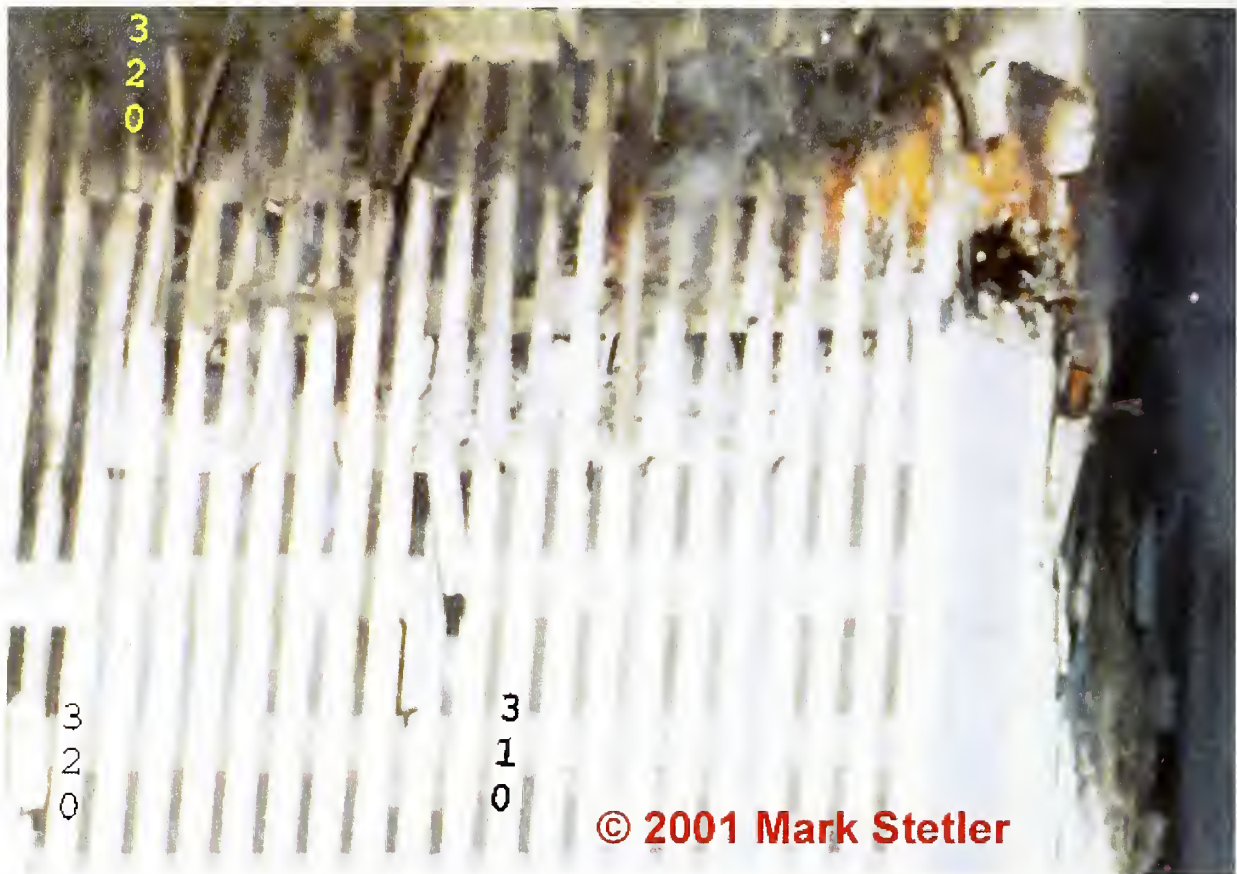
Figure H-7. This photograph is cropped from the image shown in Figure H-6. It was taken on September 11 and shows the east face of WTC 2 at the northeast corner from floor 77 to floor 82. Note the large piles of debris evident on floor 80 and floor 81.

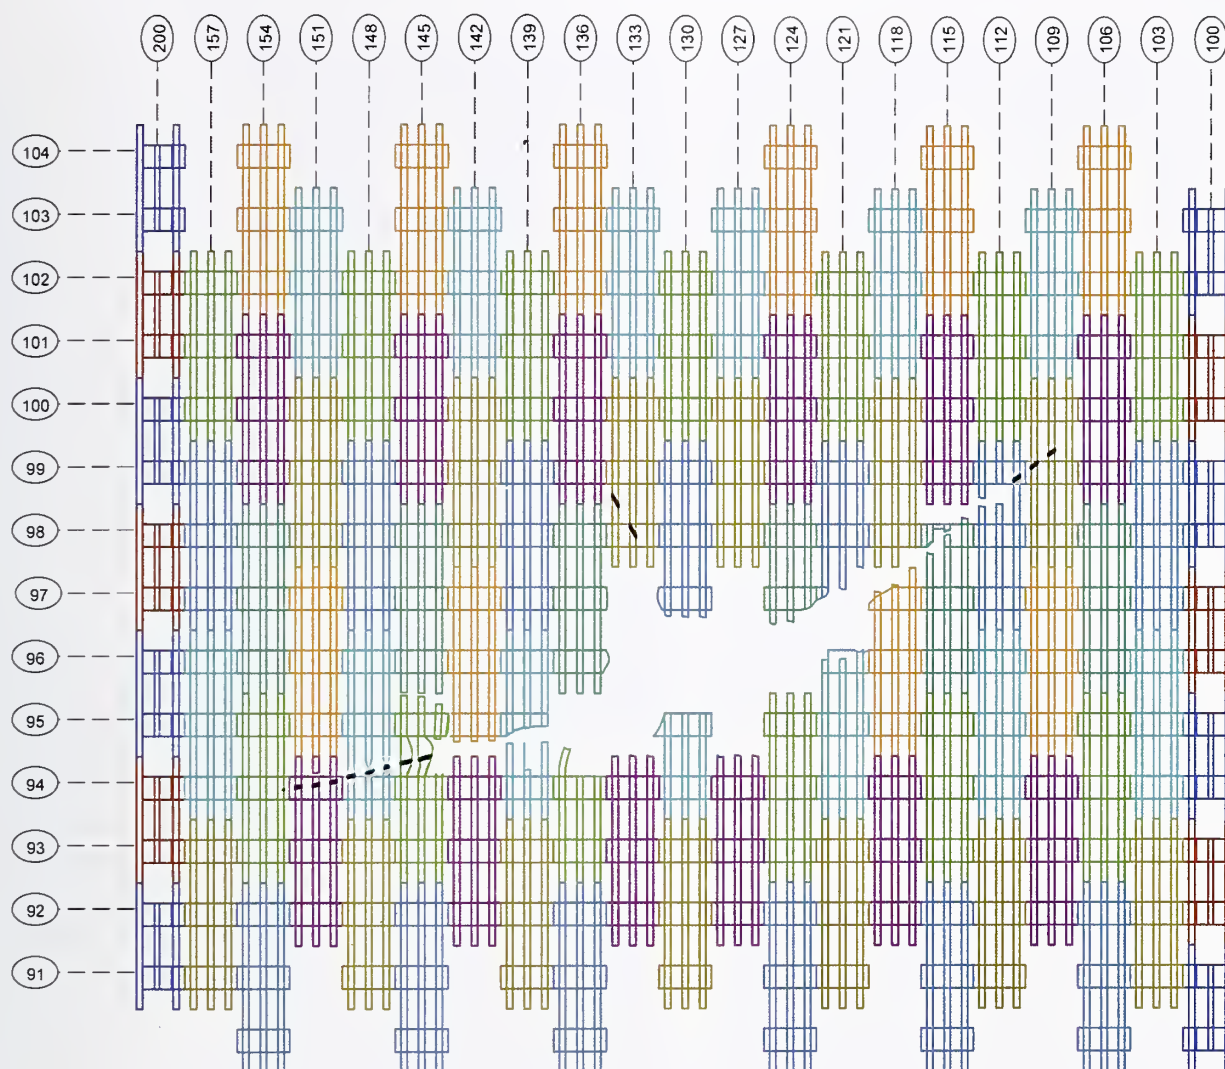
Additional insights into the initial damage inflicted on the towers by the plane strikes can be obtained by considering locations where fireballs are observed immediately following the plane strikes as well as locations where windows are missing. Videos and photographs recorded during and immediately following the plane strike on WTC 1 show that significant fireballs formed at the plane strike location on the north face, as well as near the center of the east face and on the western side of the south face. Figure H-13 compares window damage for the four sides of WTC 1 immediately after the plane strike. The floors shown extend from 91 to 100. The missing windows on the north face are consistent with the plane strike location and strike angle. The plane struck very close to the center of the face. Interestingly, the damage on the east and west faces appears to be asymmetric with a much higher number of windows missing on the east face than on the west. This observation is consistent with the formation of a fireball on the east side of the tower and not on the west side. Areas obscured by smoke are also much larger on

Figure H-12. A drawing of the damage to the steel façade of WTC 1. The dark dotted lines show locations where the airplane wings and vertical stabilizer marked the aluminum cladding on columns.

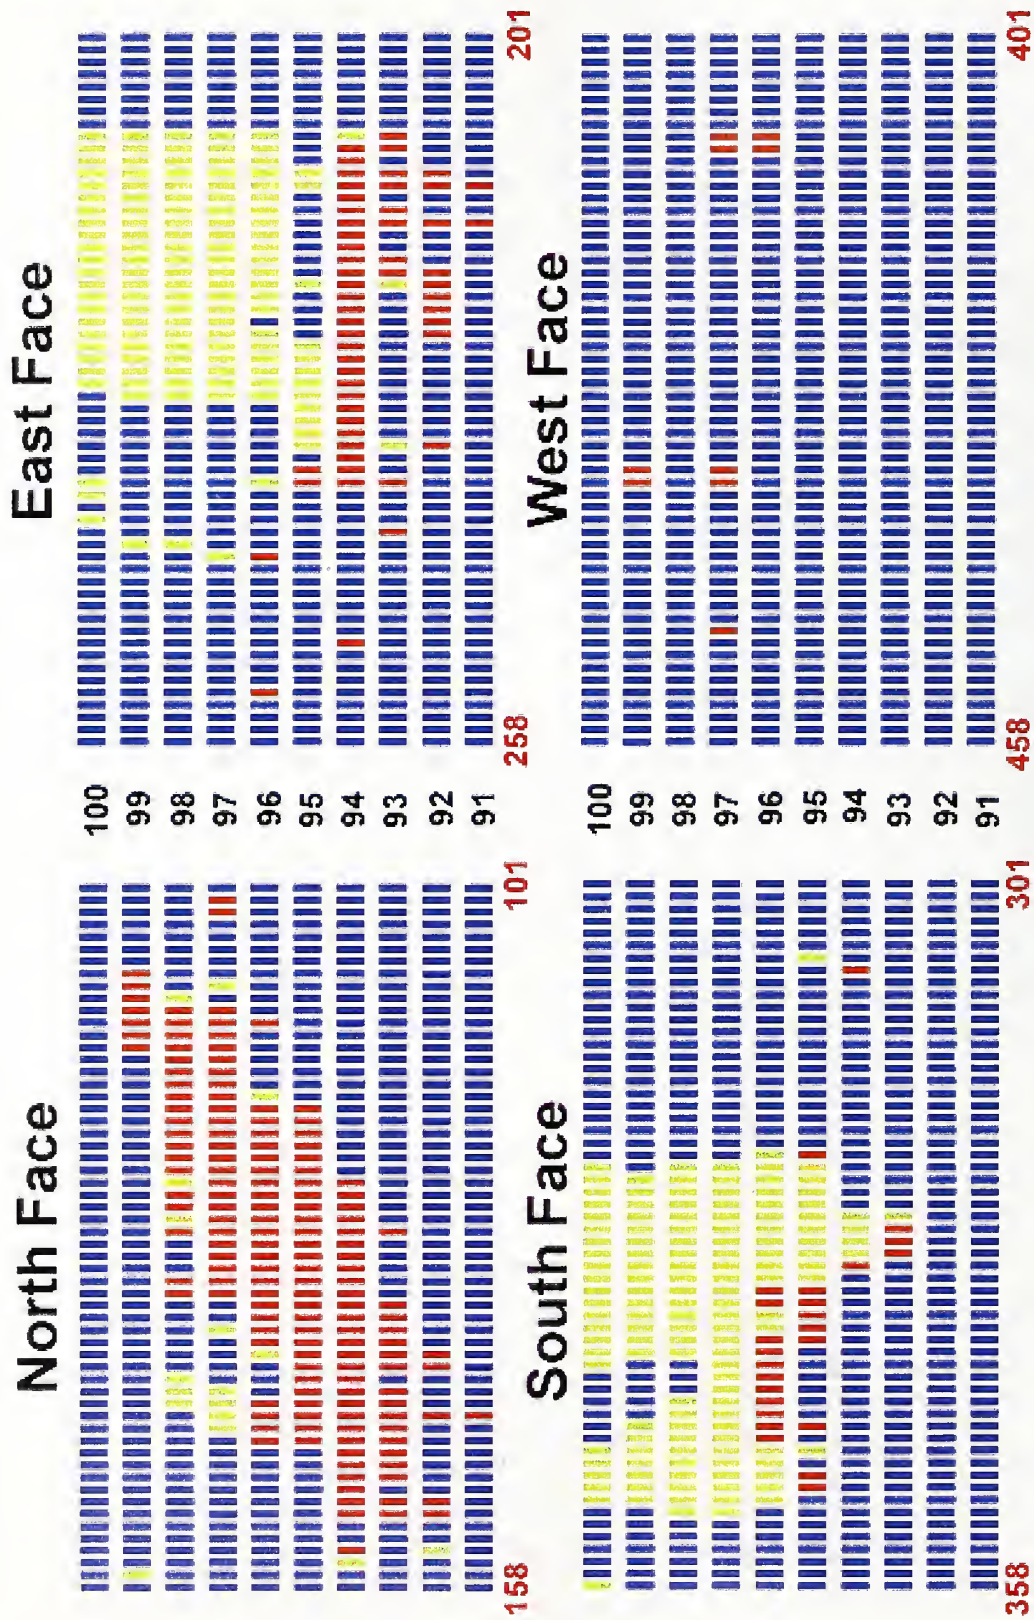
Figure H-13. The condition of windows is shown for the four faces of WTC 1 around 8:47 a.m. shortly after it was struck by American Airlines Flight 11. The colors represent ■ - window open, ■ - window in place, and ■ - not visible.

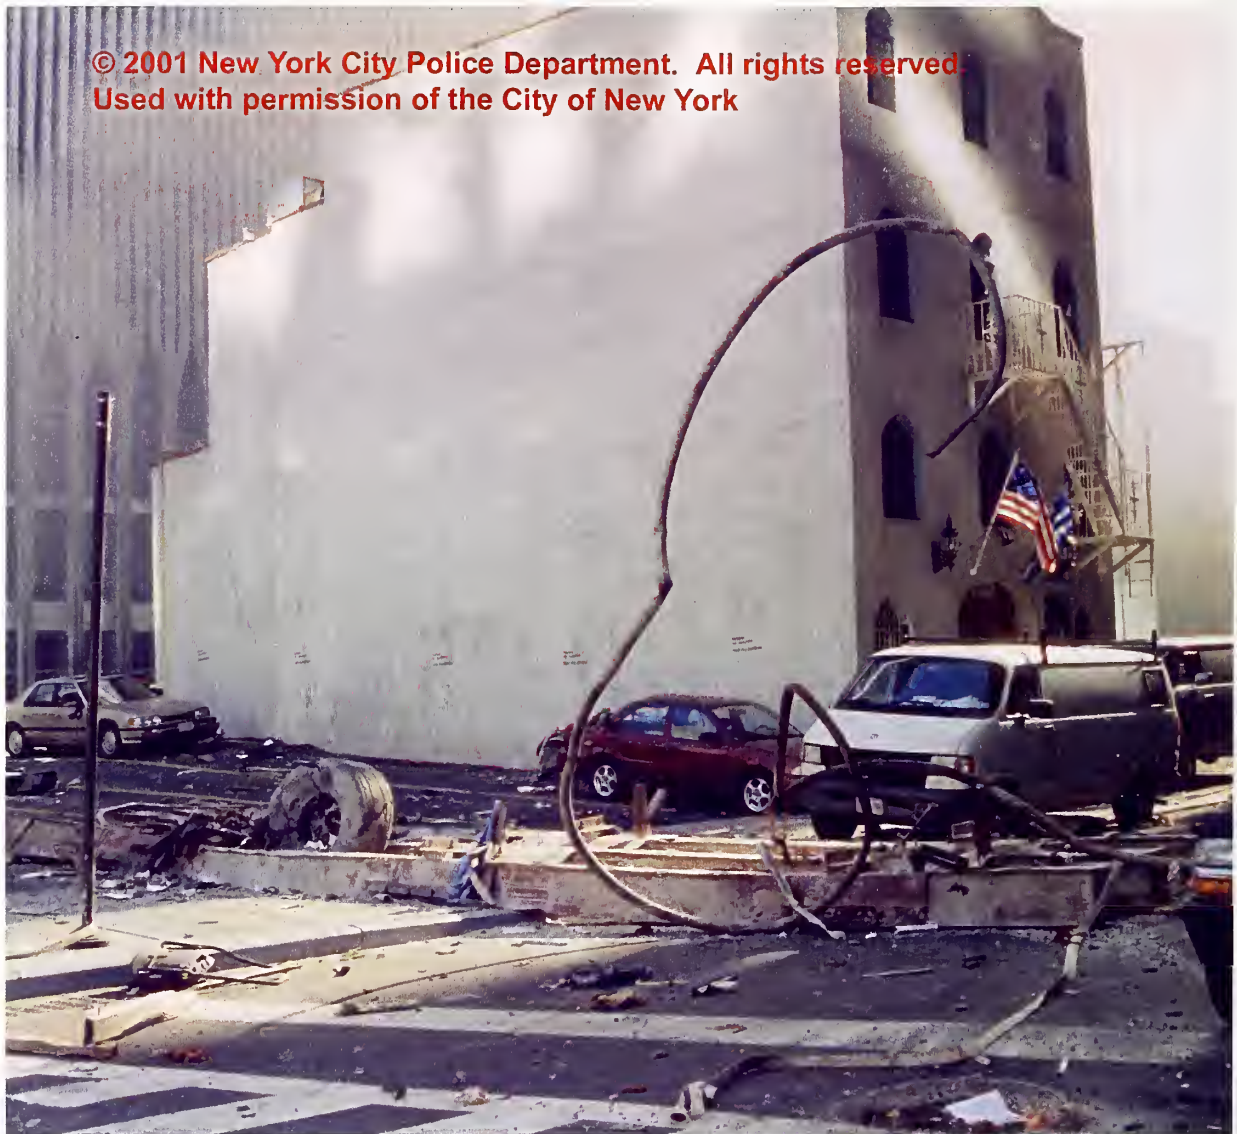
Figure H-14. Photograph showing a full panel section lying in Cedar Street near its intersection with West Street. An aircraft wheel can be seen imbedded in one of the windows. The building behind the panel is Saint Nicholas Greek Orthodox Church and the lower section of WTC 2 can be seen across Liberty Street.

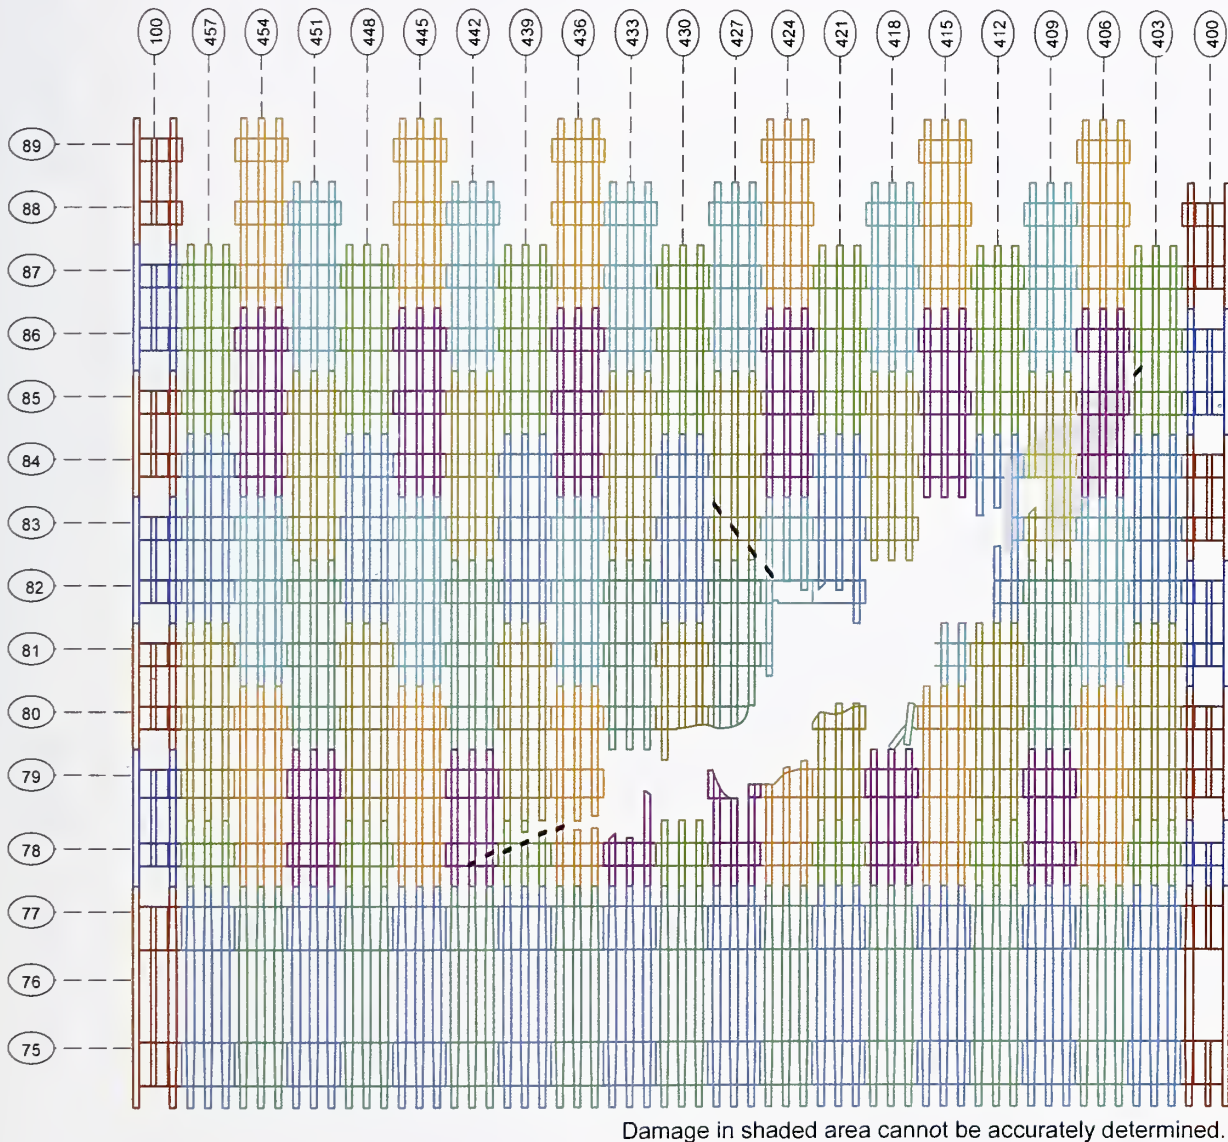
The results of an analysis of the damage to the steel façade of the south face of WTC 2 are provided in Fig. H-19. Much of the steel damage pattern is revealed, but it should be noted, as indicated, that a portion of this face on the east side of the plane strike location was constantly obscured by smoke, and the detailed pattern could not be discerned. The FEMA report (McAllister 2002) also includes a figure describing the damage to the steel façade inflicted by United Airlines Flight 175. The pattern in Fig. H-19 differs somewhat from that provided in this earlier study. Some inconsistencies in façade dimensions have also been corrected in the current version.

Figure H-19. A drawing of the damage to the steel façade of WTC 2. The dark dotted lines show locations where the airplane wings and tail marked the aluminum cladding on the columns. The area shaded in gray was hidden by smoke and could not be observed.

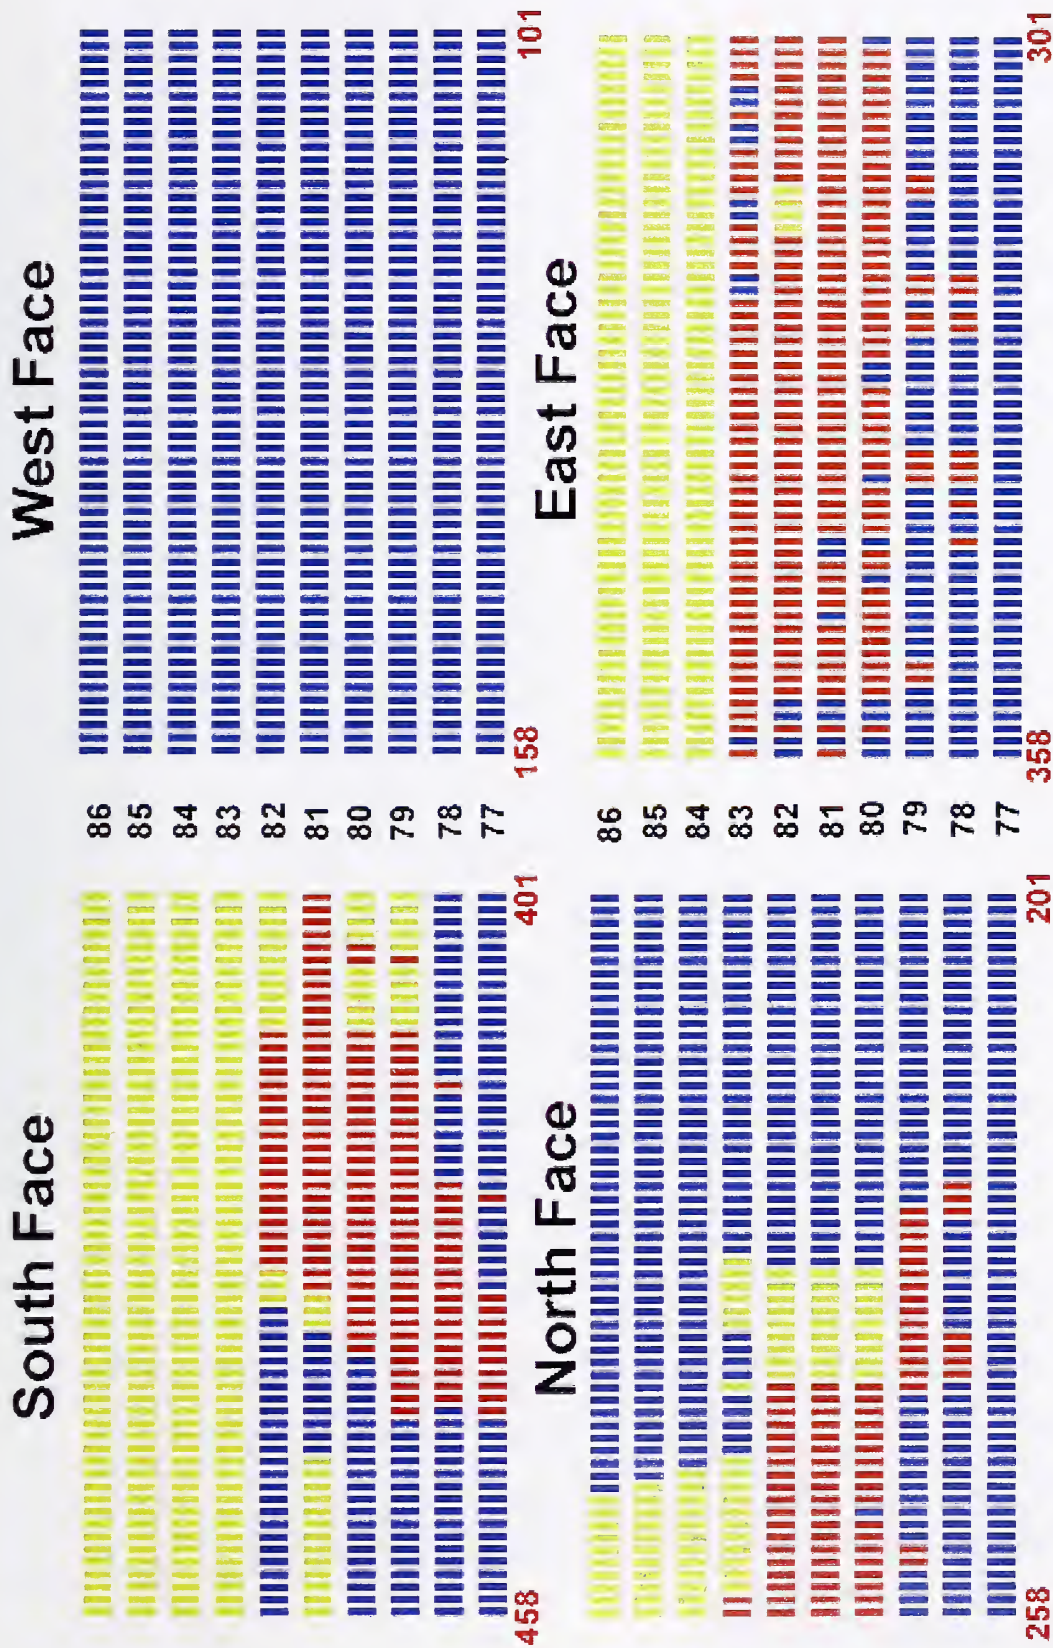
Figure H-20. The condition of windows is shown for the four faces of WTC 2 around 9:03 a.m. shortly after it was struck by United Airlines Flight 175. The colors represent ■ - window open, ■ - window in place, and ■ - not visible.

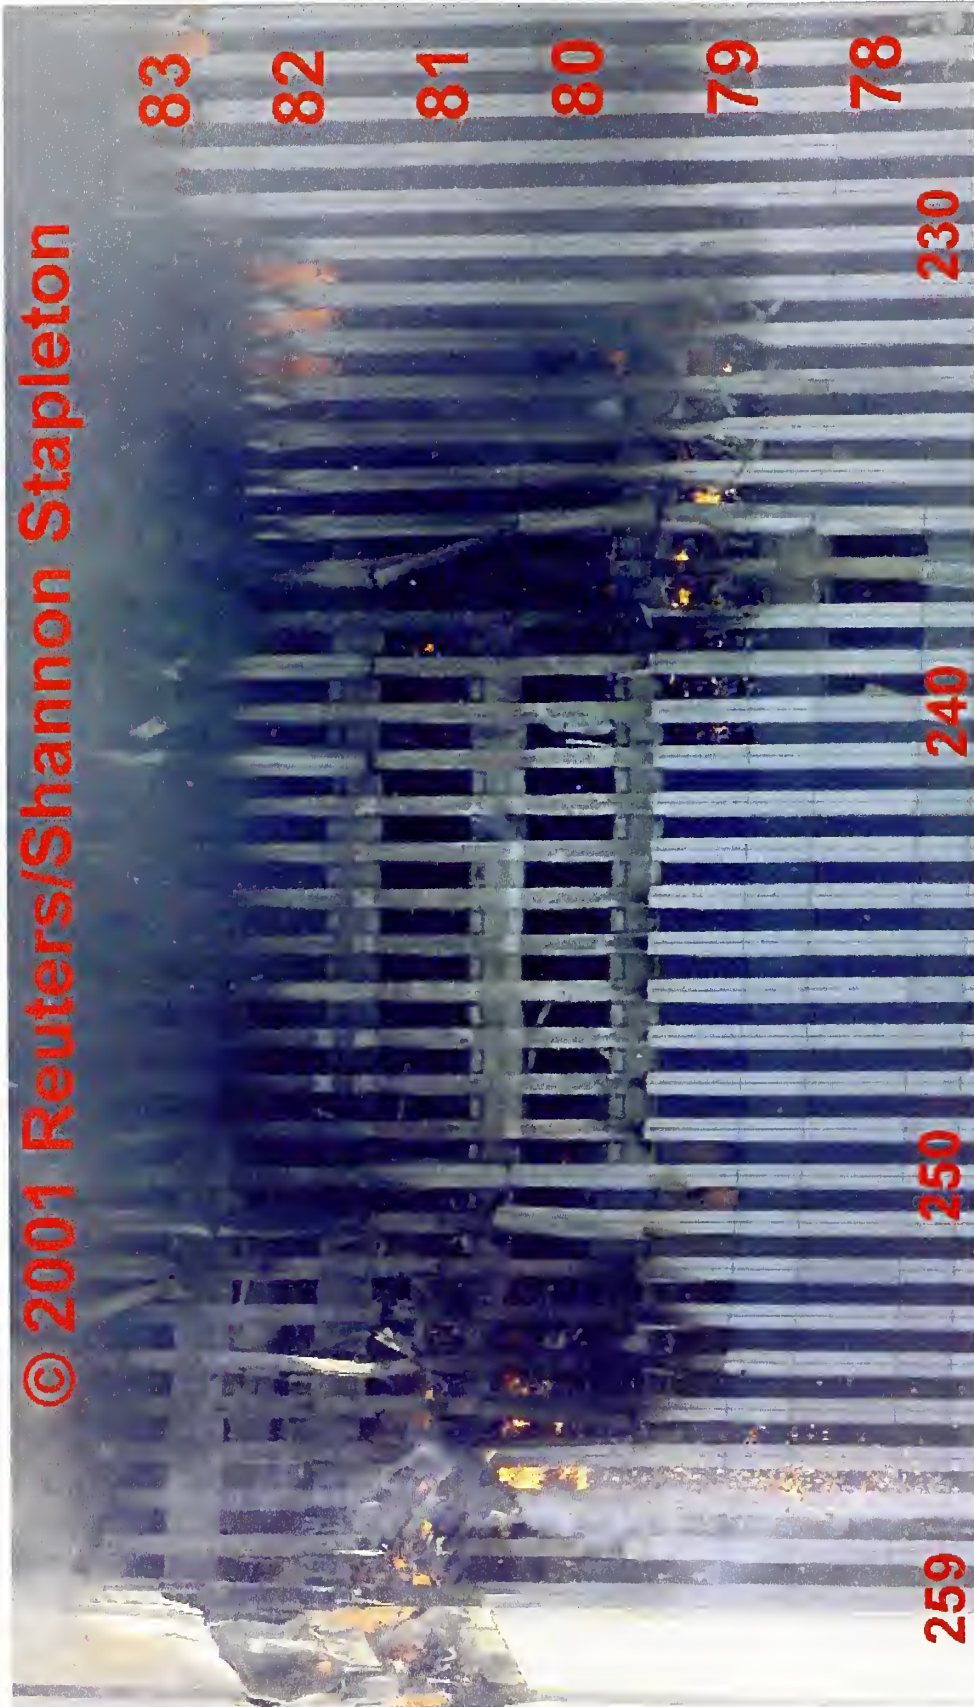
Figure H-21. An enhanced photograph of the north face of WTC 2 taken at 9:58 a.m. shows the east side of the north face. Piles of debris are evident on floor 80 and floor 81 on the northeast corner and on floor 79 to the right of column 230. The "cold" area extends over floor 80 to floor 82 from roughly column 229 to 240. There is a break in column 253 on floor 81, and the adjacent column, 254, is bent. Floors 80, 81, and 82 appear to be partially collapsed. It appears as if the collapsed floor 83 in the northeast corner has broken into sections.
