NIST Special Publication 778

Performance of Structures During the Loma Prieta Earthquake of October 17, 1989

H. S. Lew, Editor

January 1990

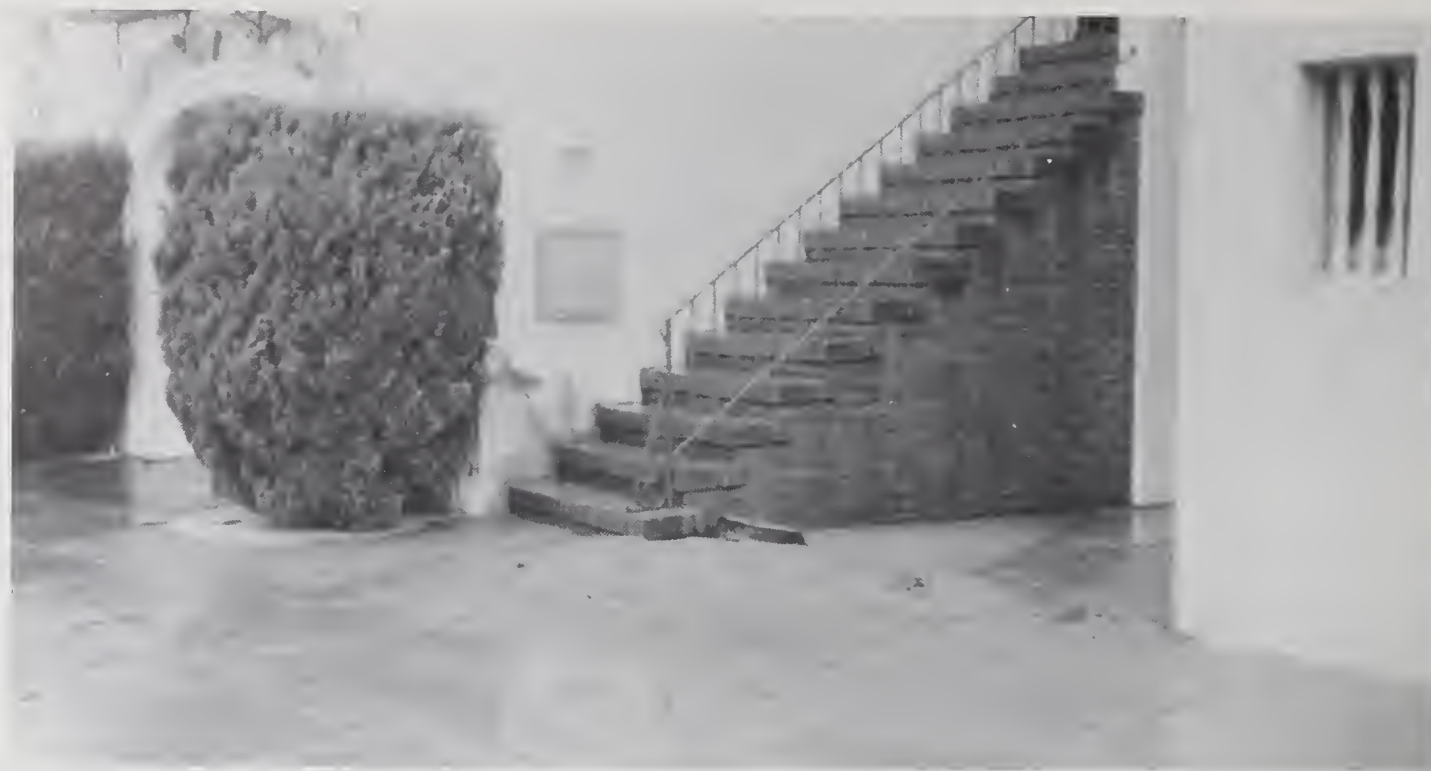
Figure 3.3.3 Sand boil in the Marina District of San Francisco.

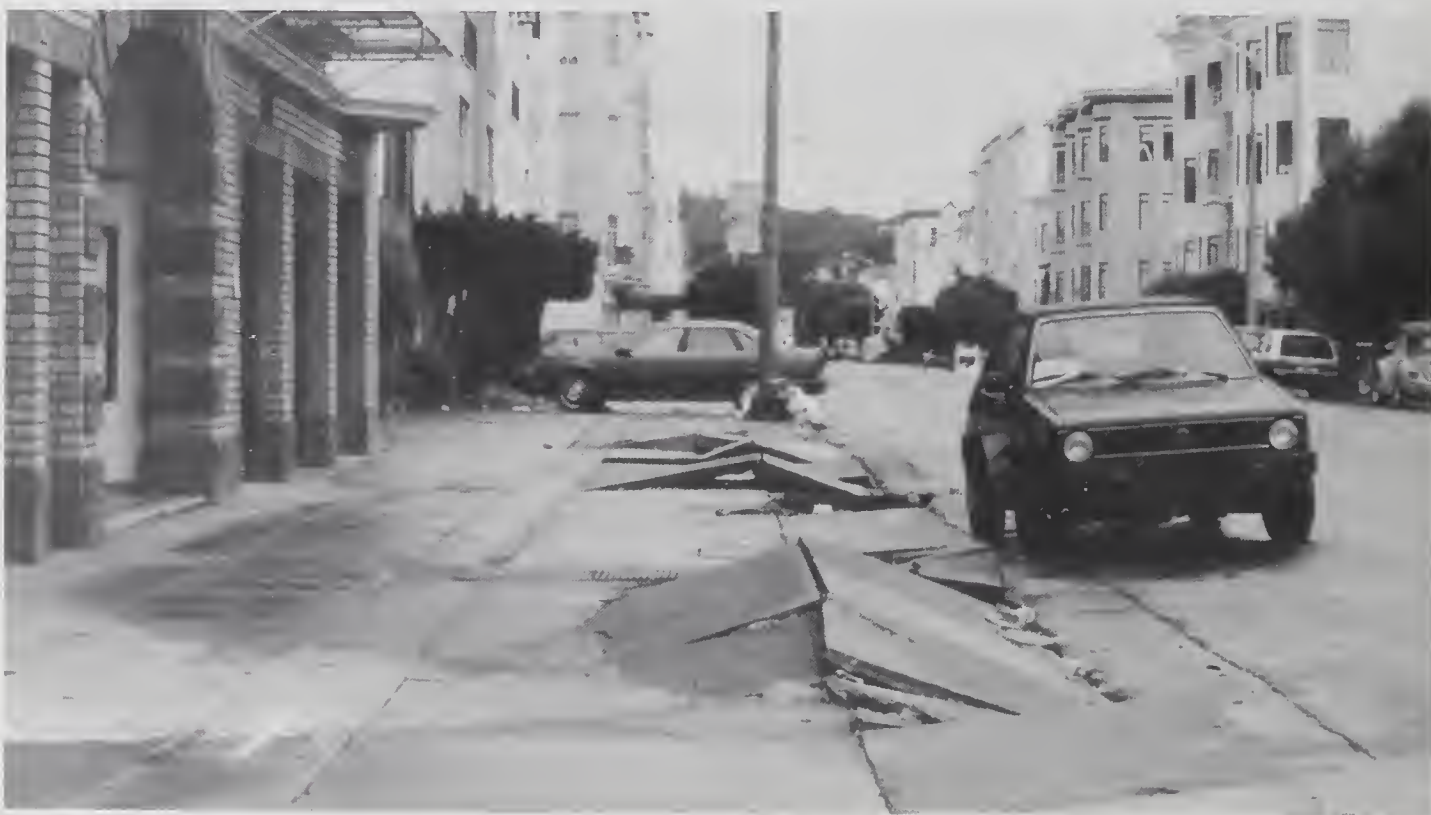
Figure 3.3.4 Typical liquefaction damage in the Marina District of San Francisco.

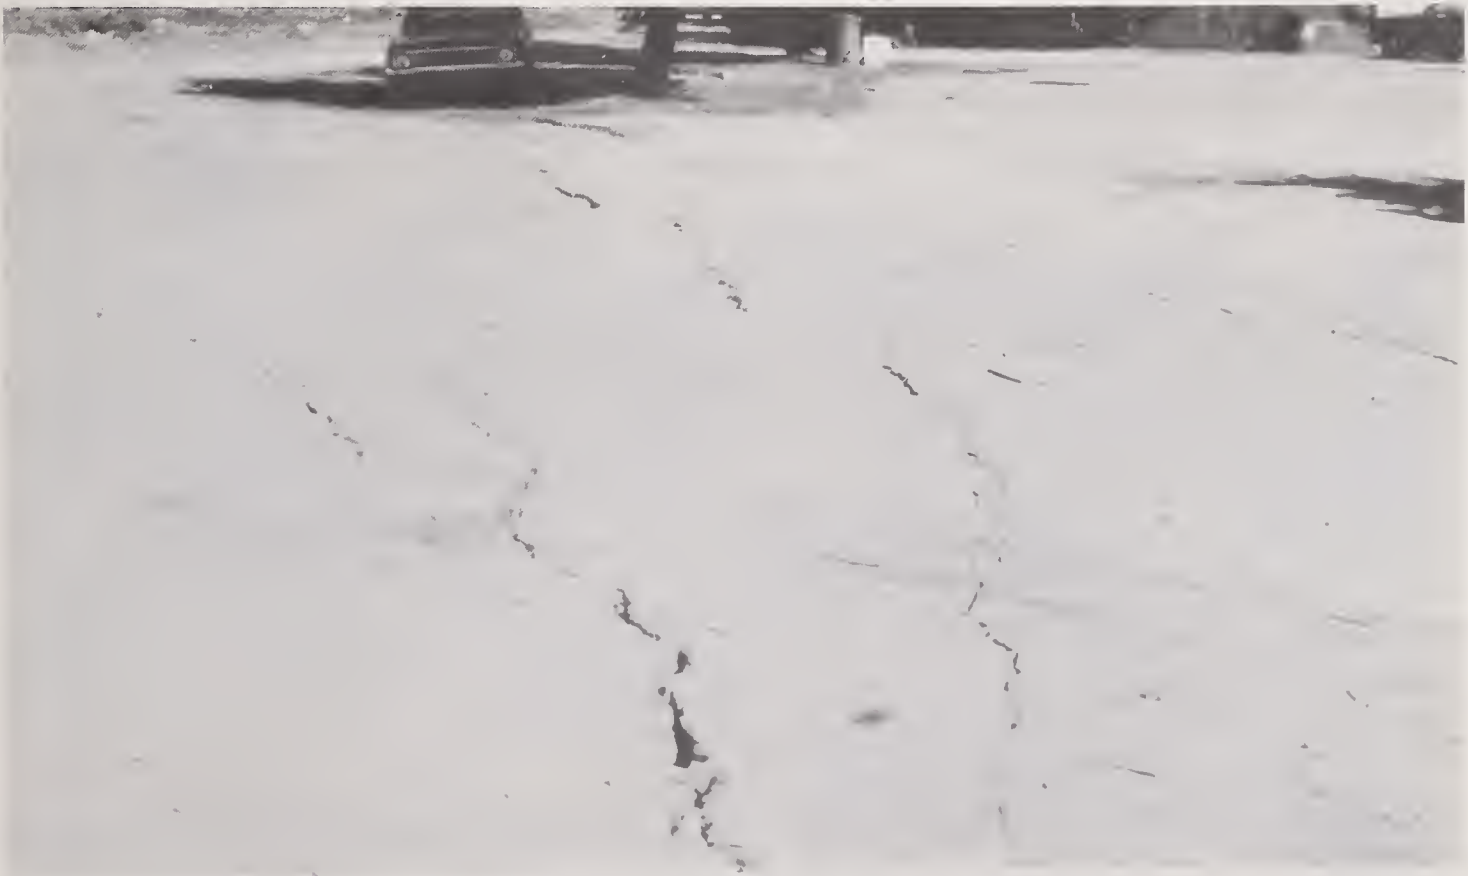
Figure 3.3.9 Tension cracks behind Pajaro River levee.

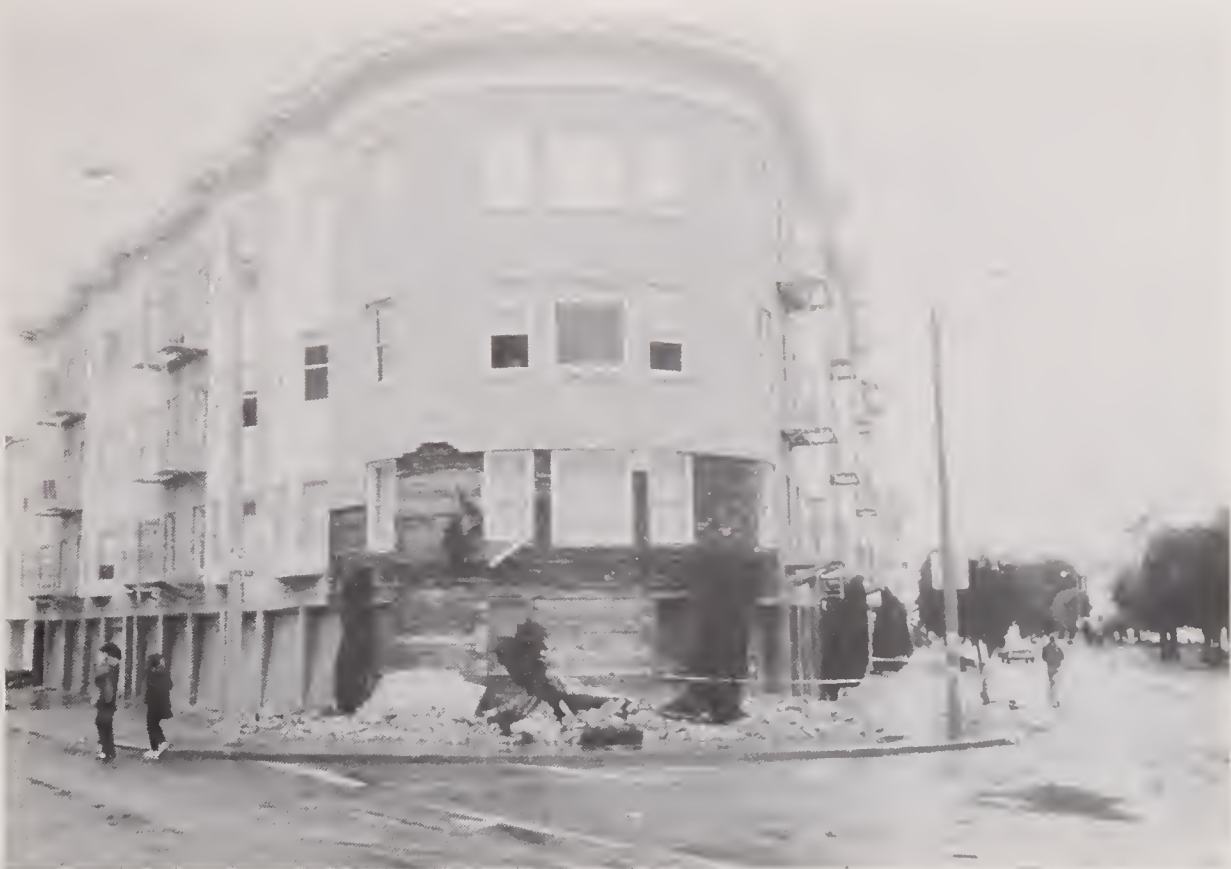
Figure 4.2.17 Example of building with failure of brick masonry facade (location #2).

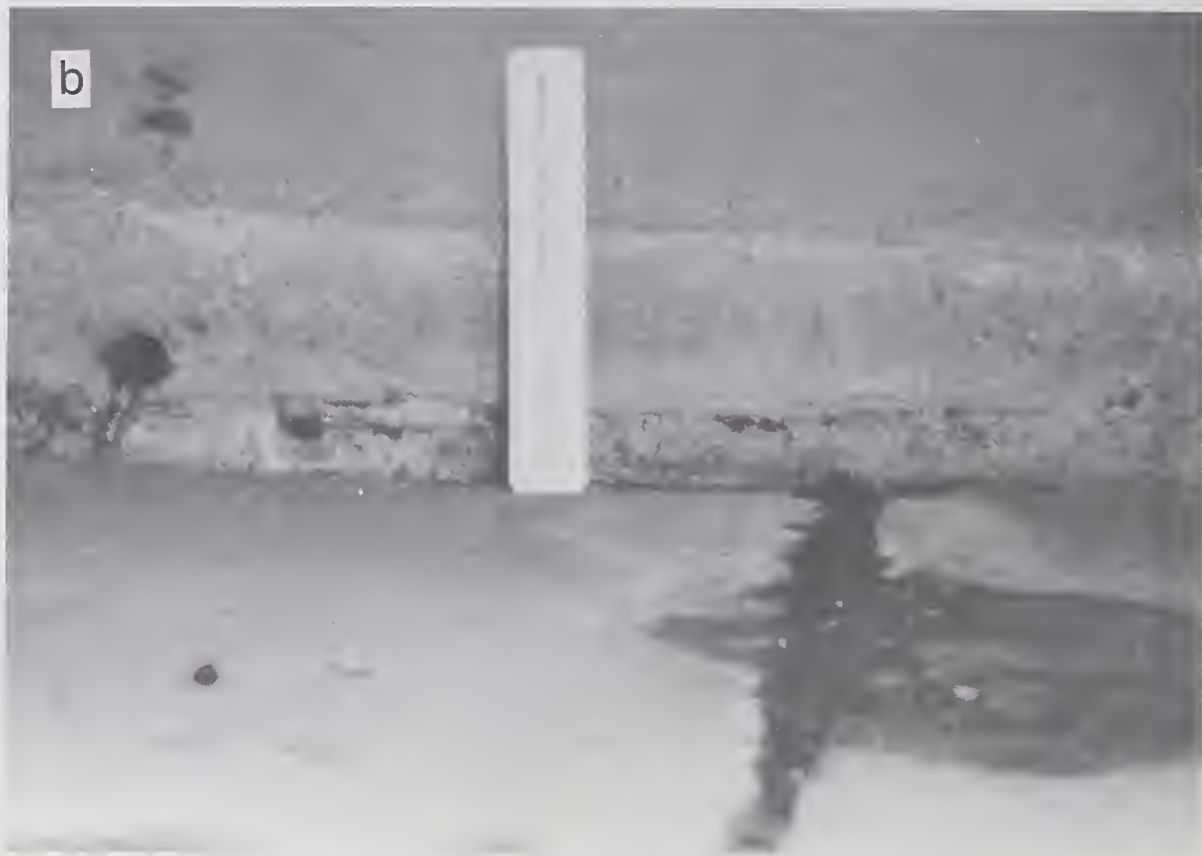
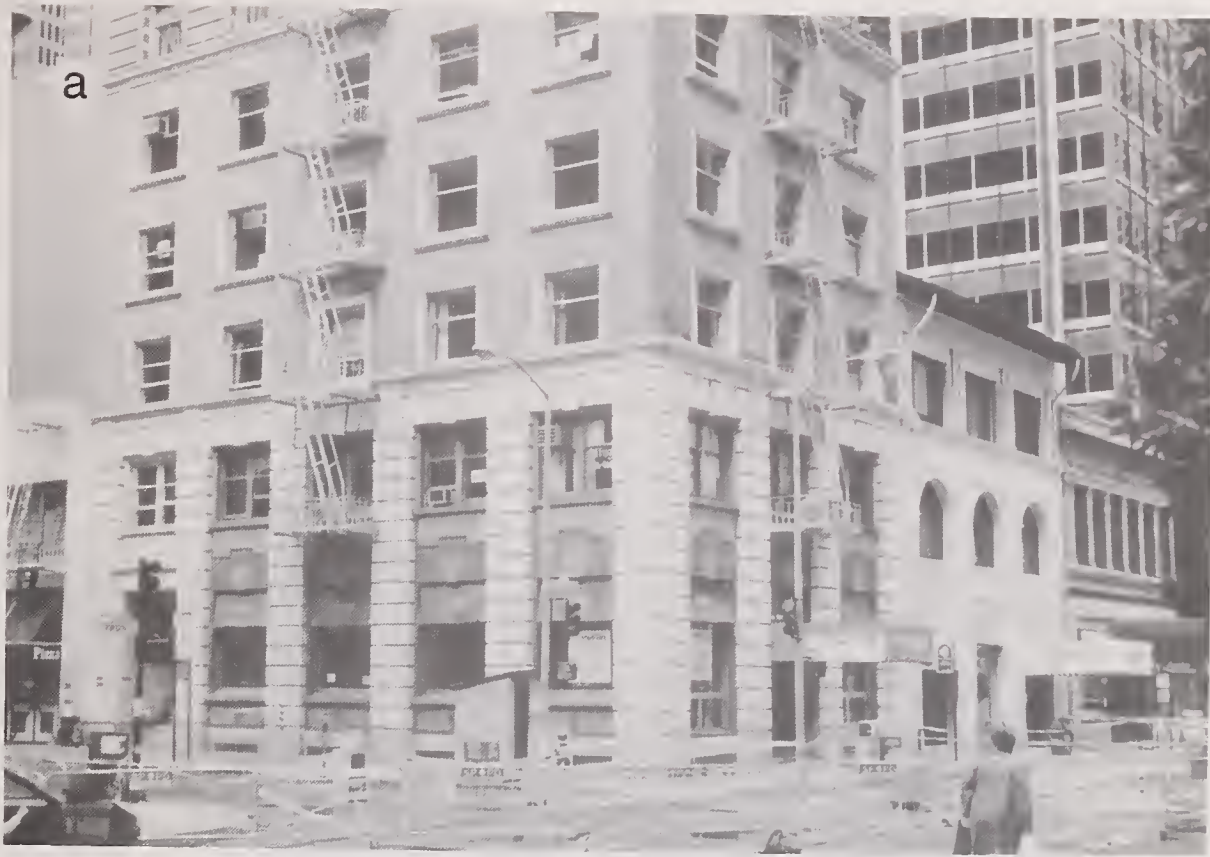
Figure 4.2.26 (a) Sidewalk showing distortions due to differential settlements, and (b) close-up view of intersection of sidewalk with retaining wall showing magnitude of differential movement.

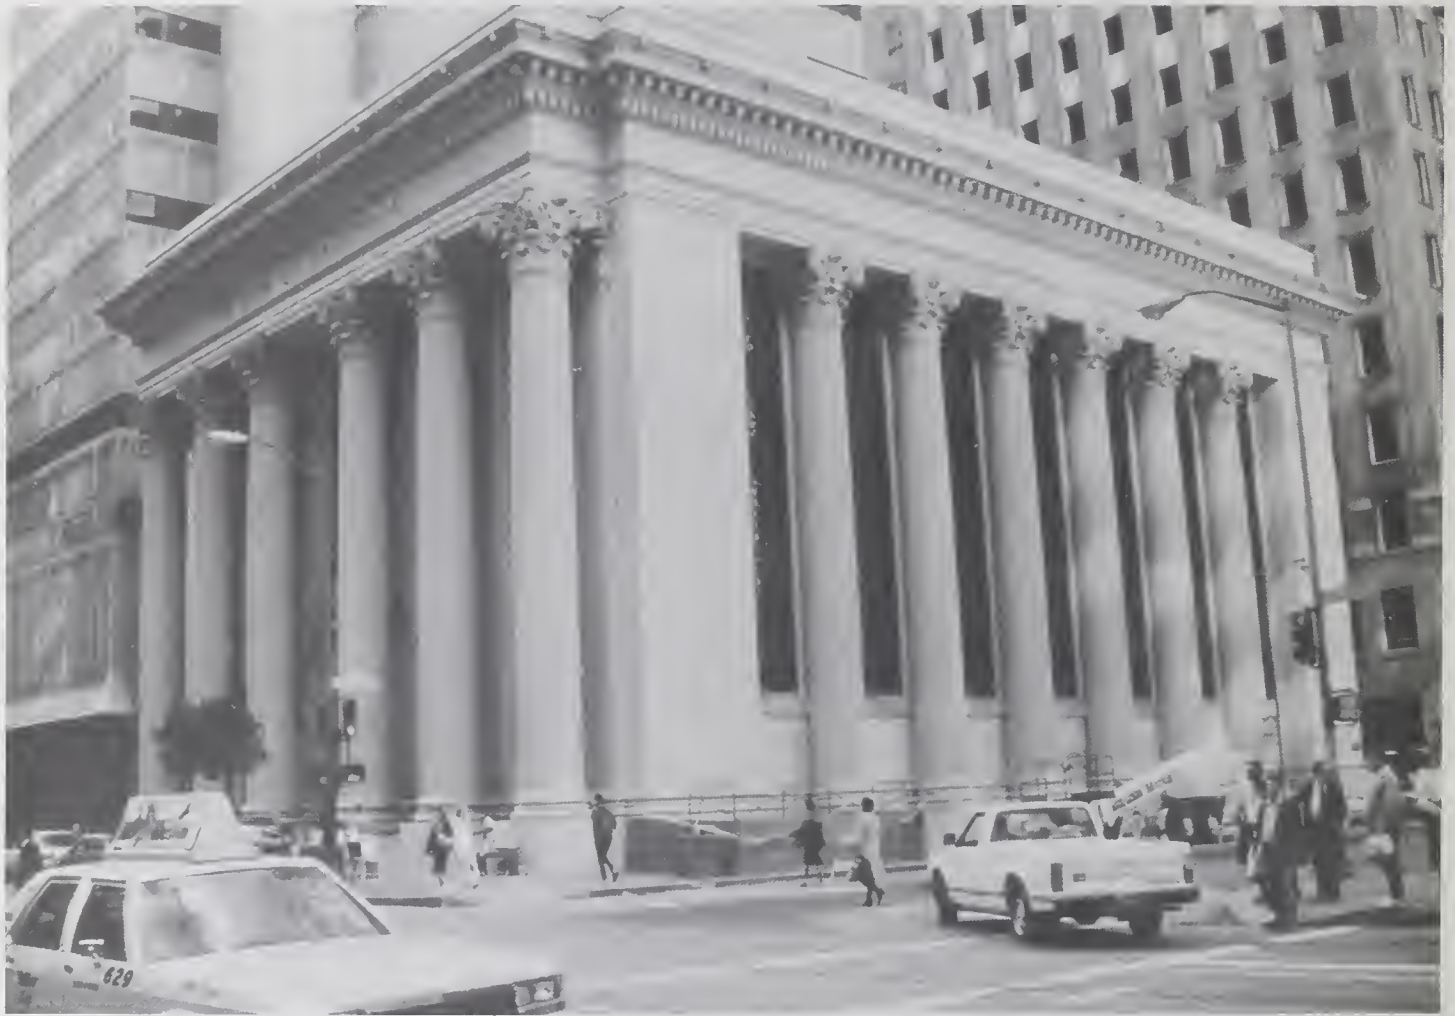
Figure 4.2.30 Damage to the stone facing of the Bank of California building.

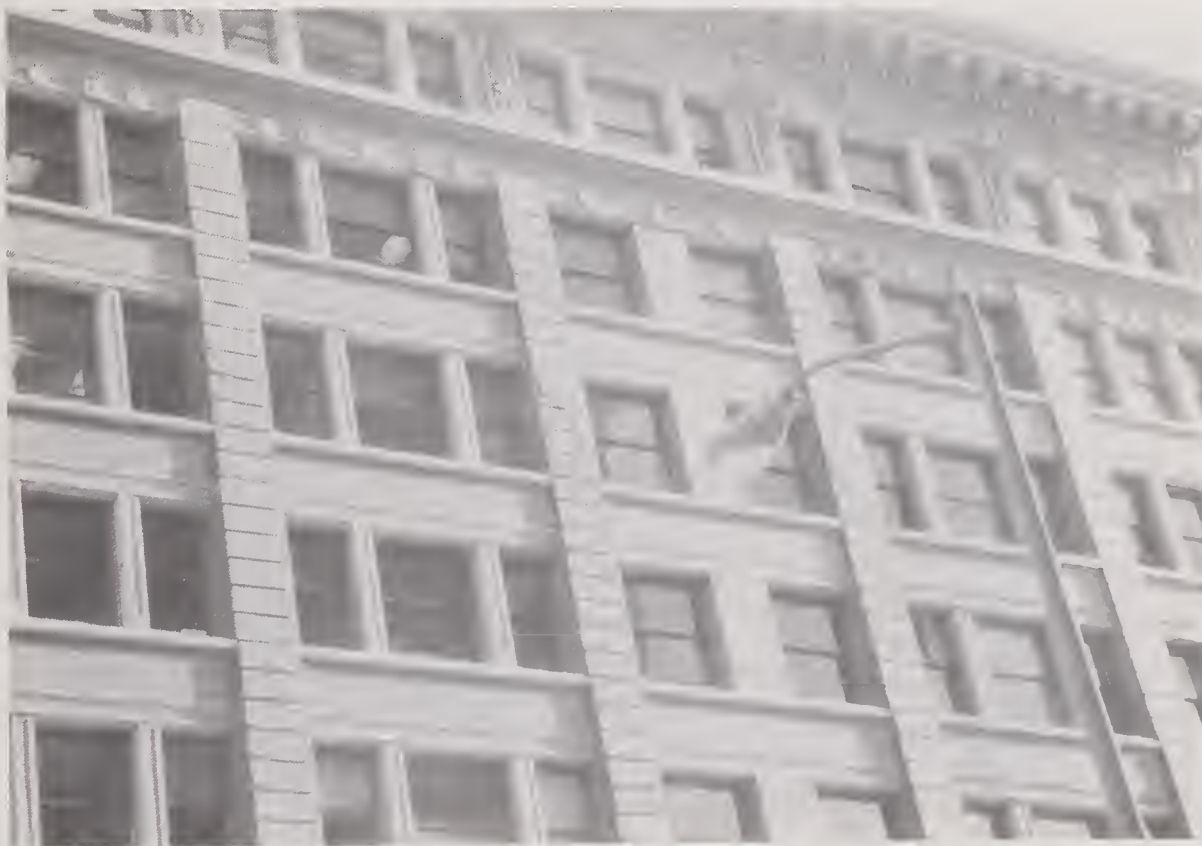
Figure 4.2.32 Example of damage to masonry cladding of Wells Fargo Bank building (location #7).

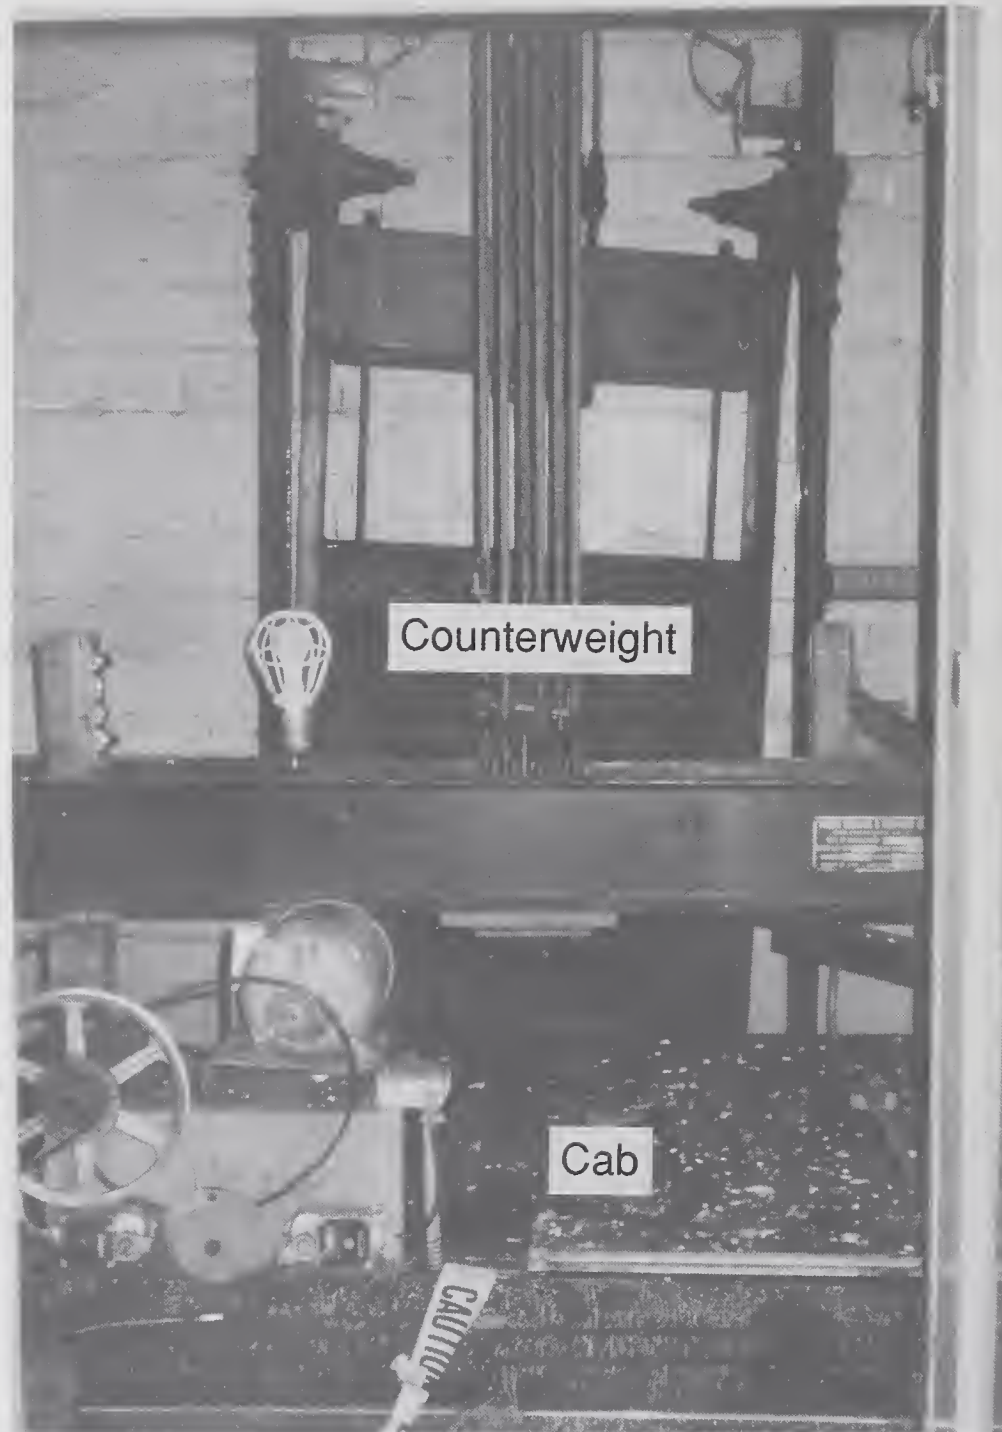
Figure 4.2.35 Elevator counterweight jumped out of its track and collided with the cab in the Old Federal Building (location #9).

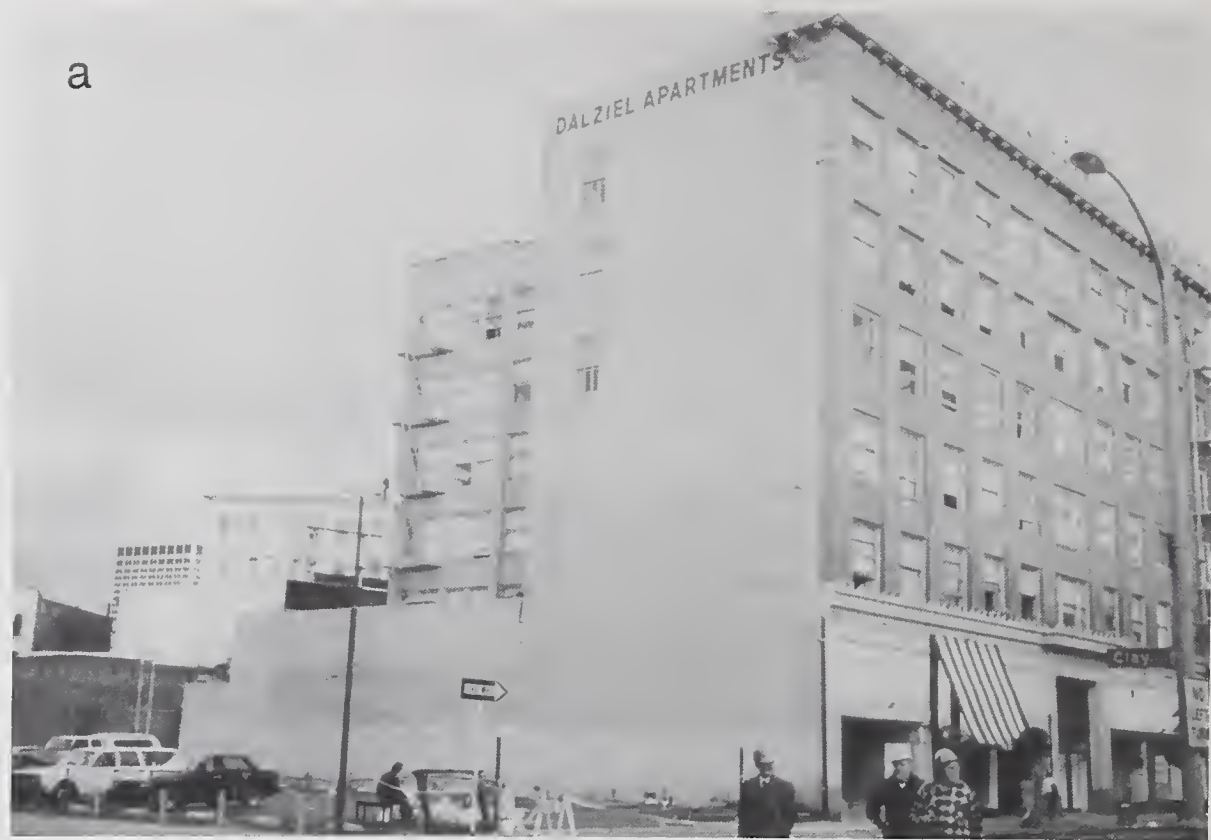
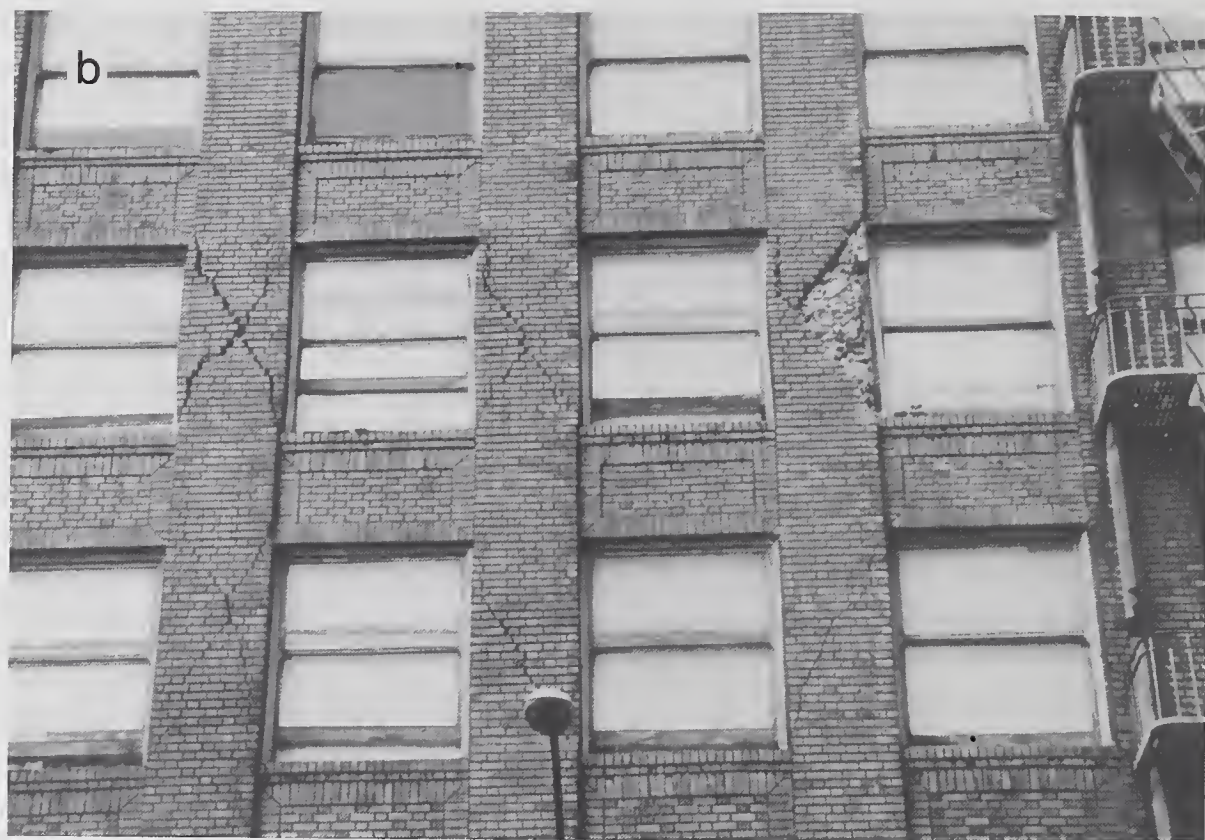
Figure 4.3.2 Dalziel apartment building: (a) overall appearance and (b) close-up view of cracking in masonry piers (location #1).

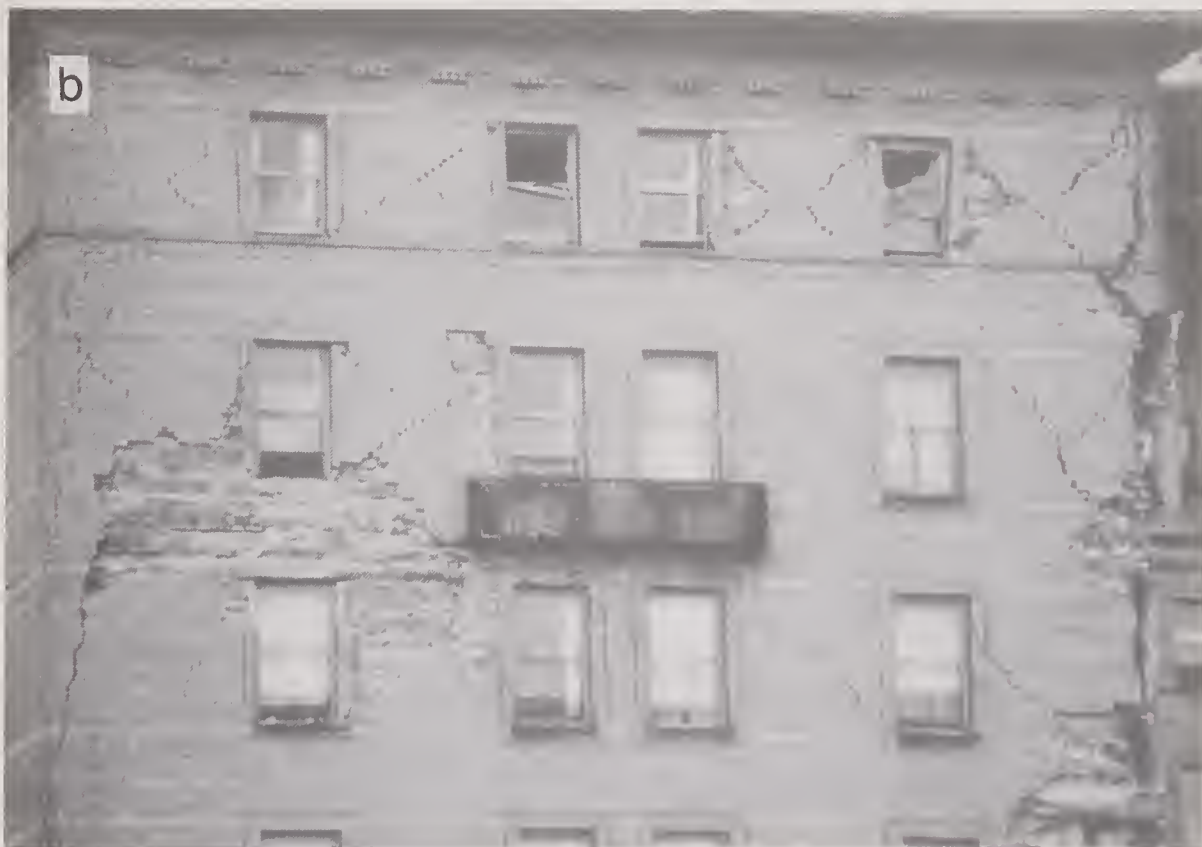
Figure 4.3.3 Oakland Hotel: (a) View of west wing and (b) close-up view of damaged masonry infill (location #6).

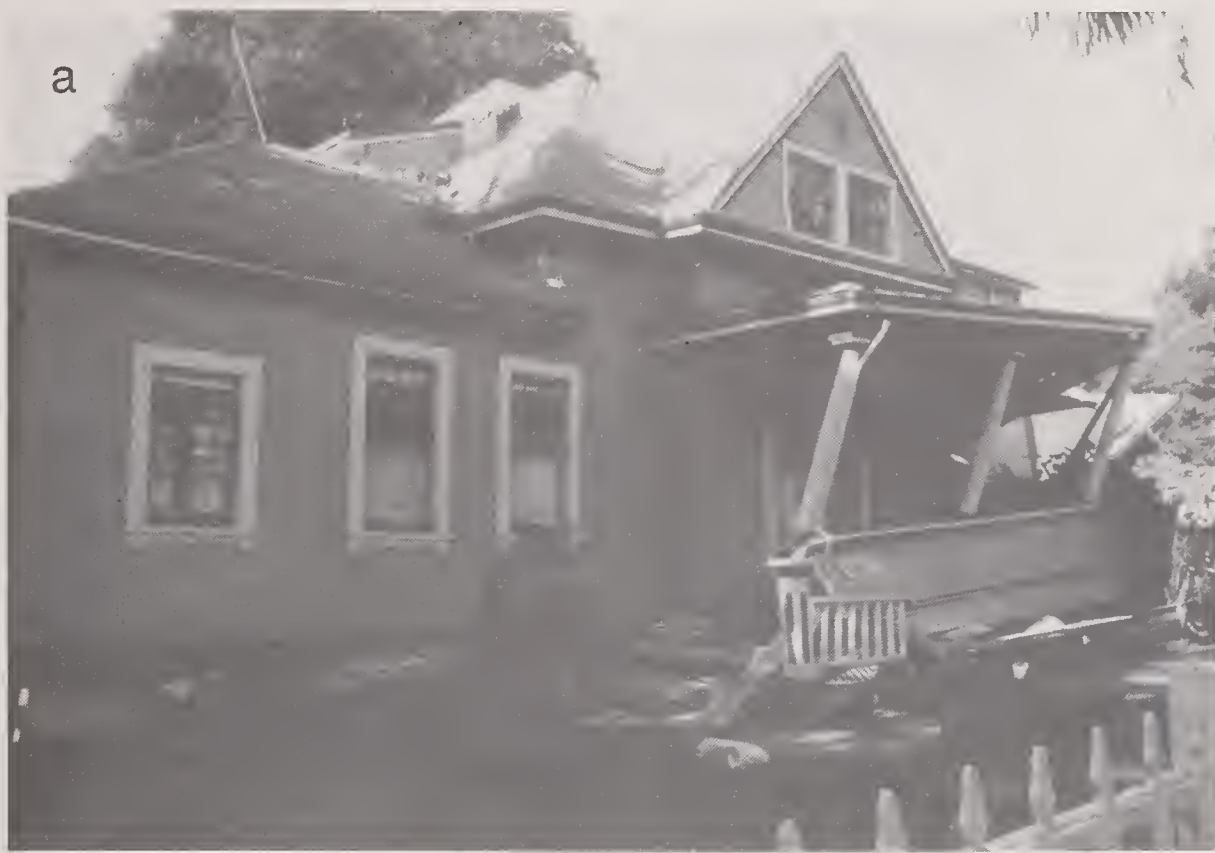
Figure 4.4.2 Examples of failures of houses in Los Gatos: (a) large house suffered large distortion and (b) a small house was rocked off of its foundation.

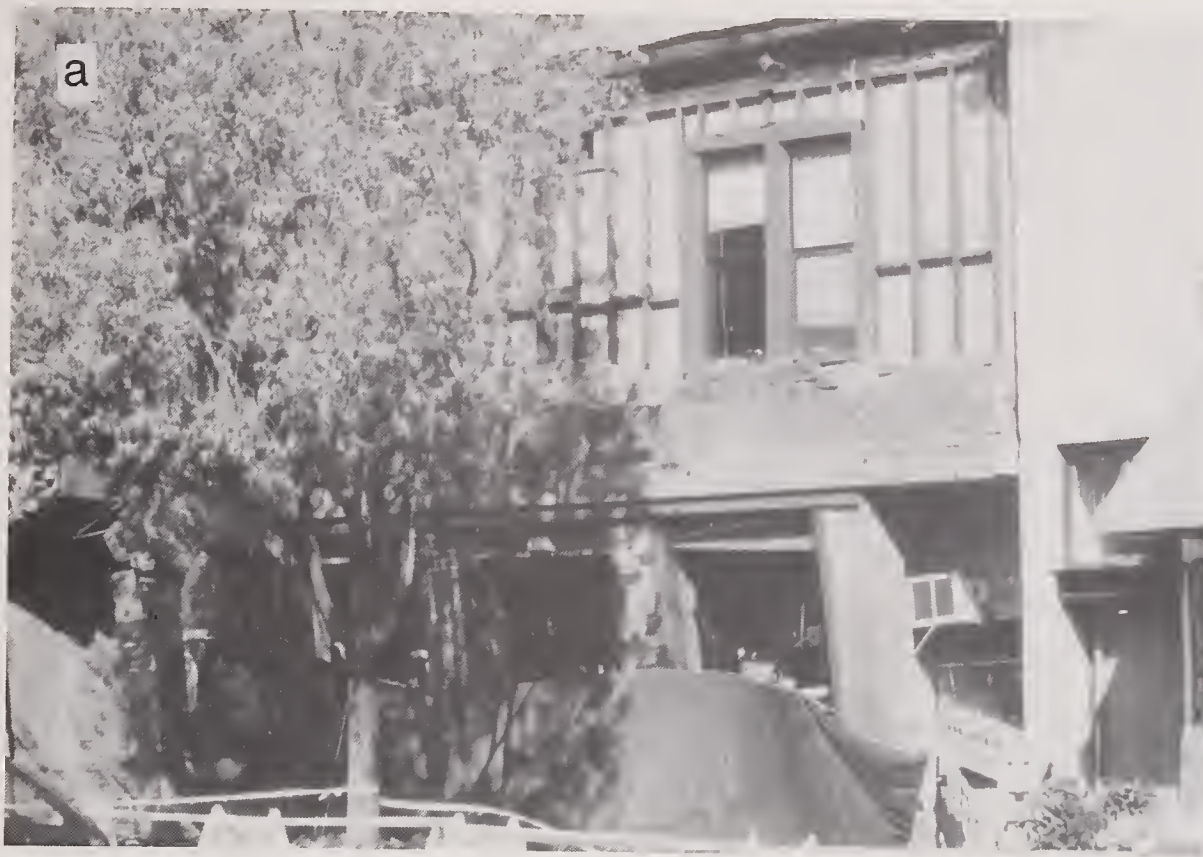
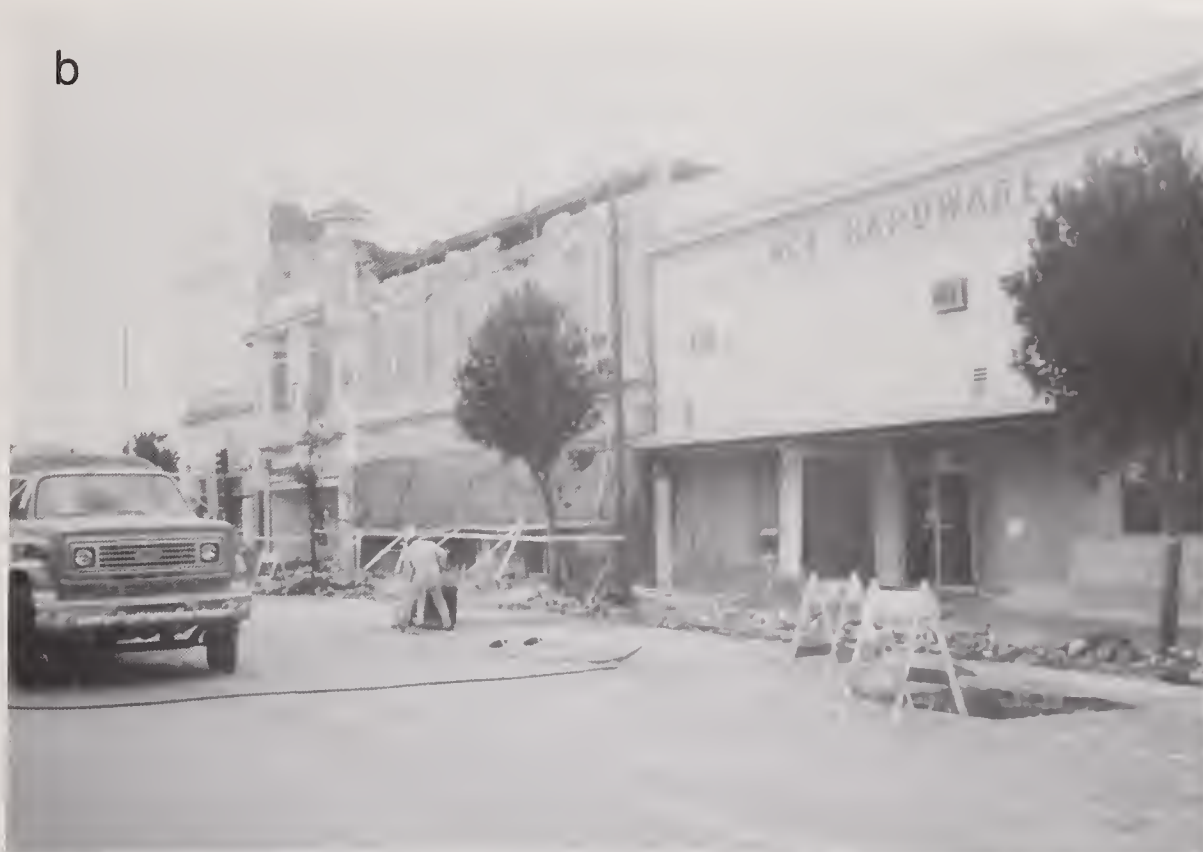
Figure 4.4.4 (a) Failure of wood-framed building with masonry walls and multiple opening in first story (Los Gatos); (b) typical damage to parapets and storefront windows (Watsonville).

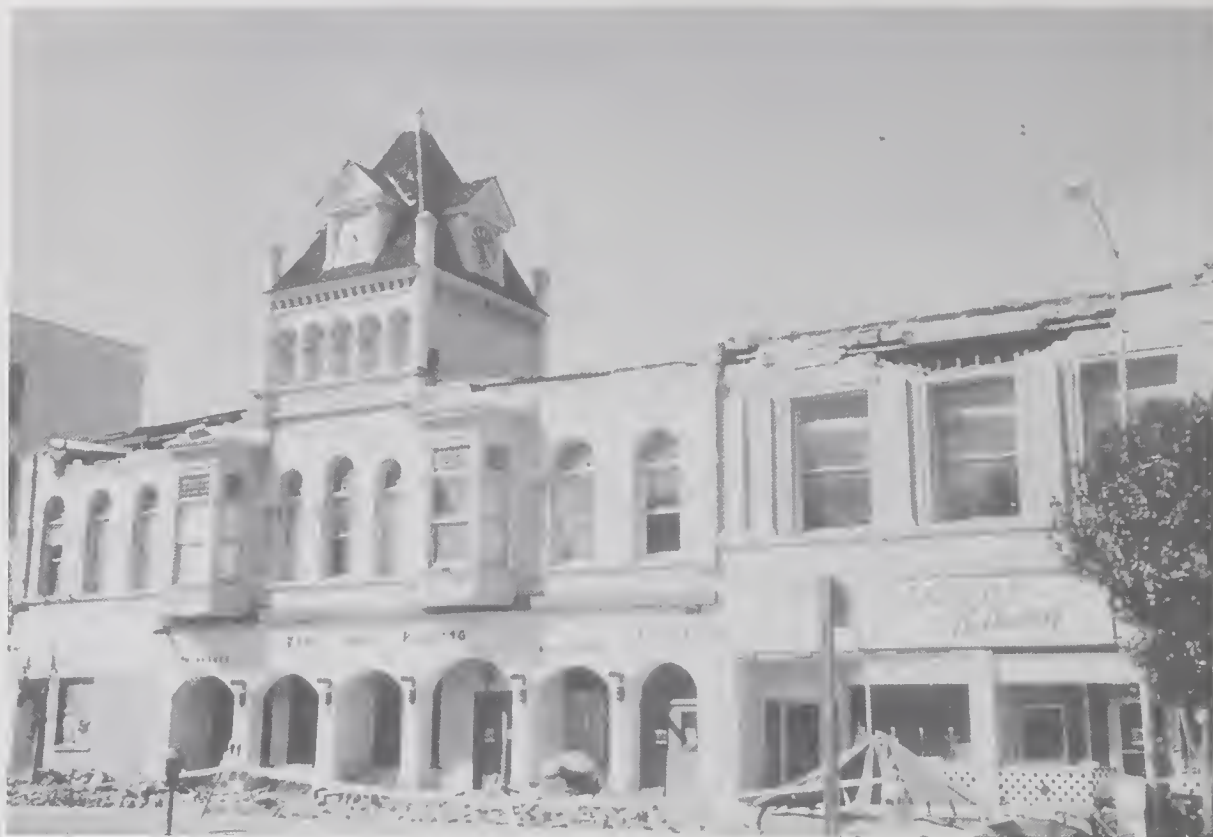
Figure 4.4.5 Falling brick from this old masonry building in Watsonville caused one death.

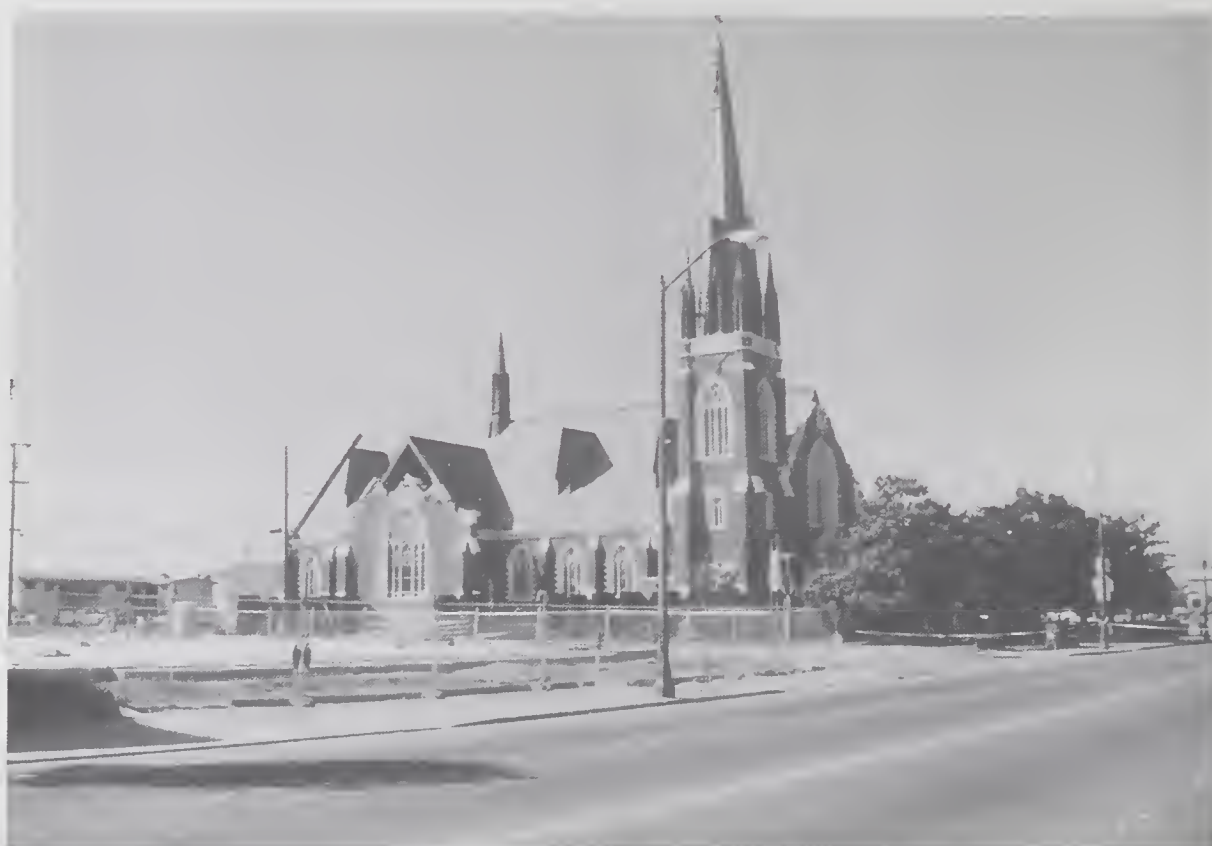
Figure 4.4.6 St. Patrick's Church in Watsonville was severely damaged.

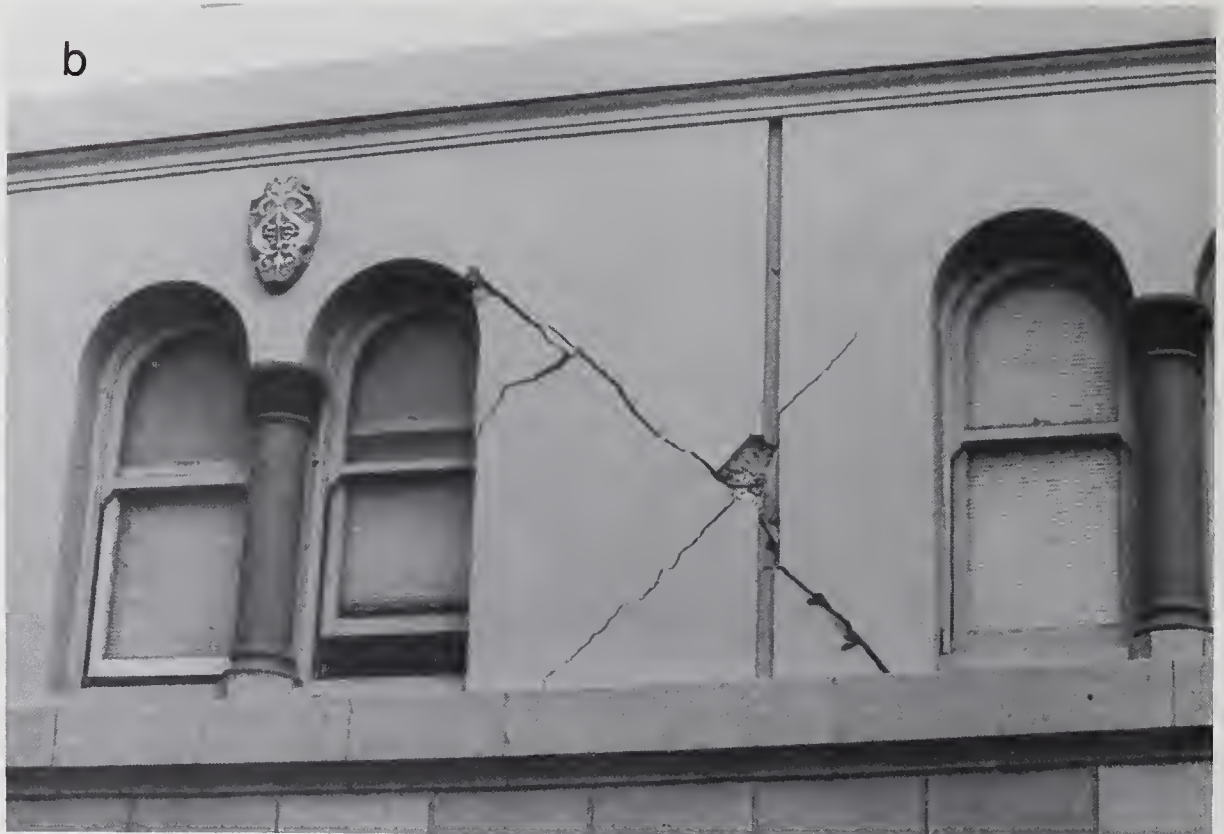
Figure 4.4.11 (a) Seven-story, reinforced concrete building suffered severe cracking; (b) Close-up view of damage to second-story walls.

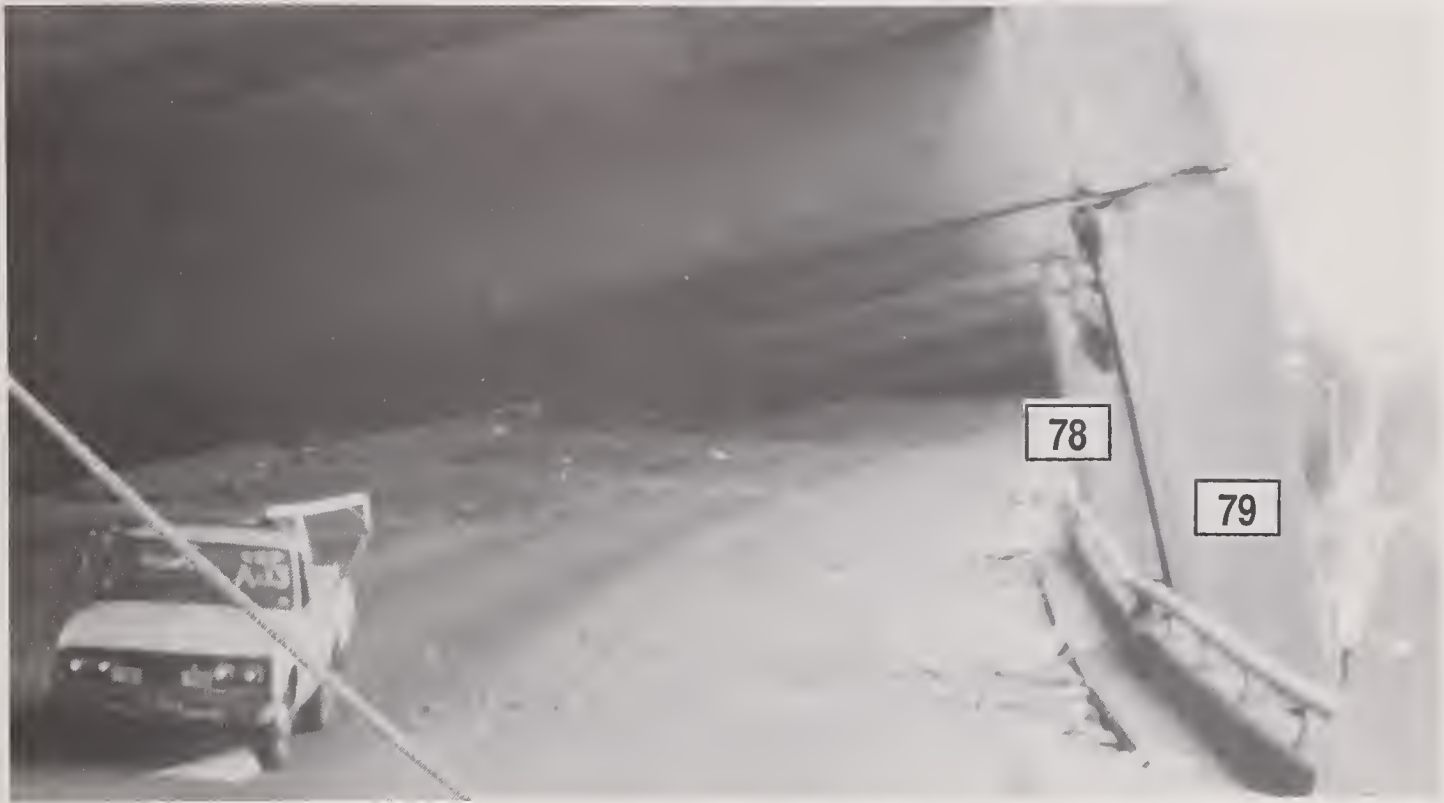
Figure 5.6.32 There was, apparently, a belief among motorists that it was safer to stop beneath the bent girders, as shown here, looking south from Bent 80.

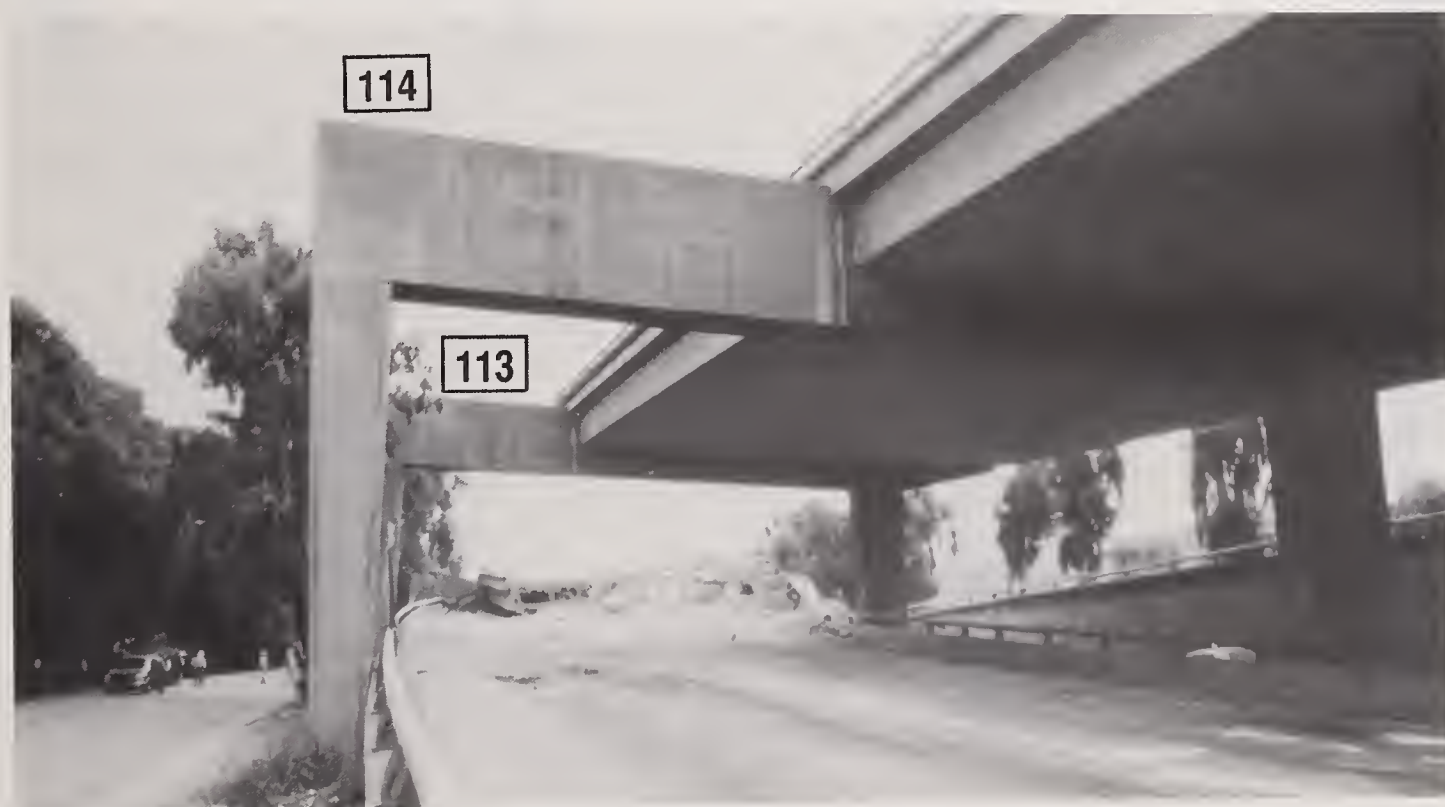
Figure 5.6.41 View looking south along the east side of Cypress Structure from Bent 115. The northern limit of the collapse extended to within six feet of Bent 113.
